SUBJECT: Brownsville Dam Removal Report- Brownsville, Oregon

Brownsville Dam Removal Report

October 2007

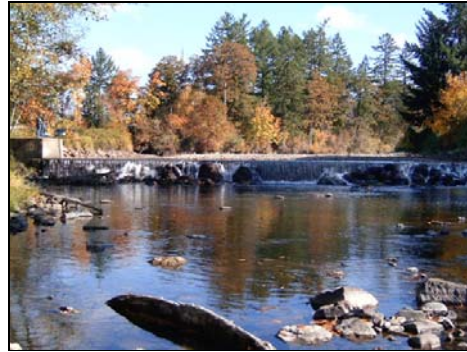
The Brownsville Dam was constructed as a hollow-core concrete dam.
