Indian Creek Aquatic Restoration

Oregon Wildlife Heritage Foundation

Narrative Summary:

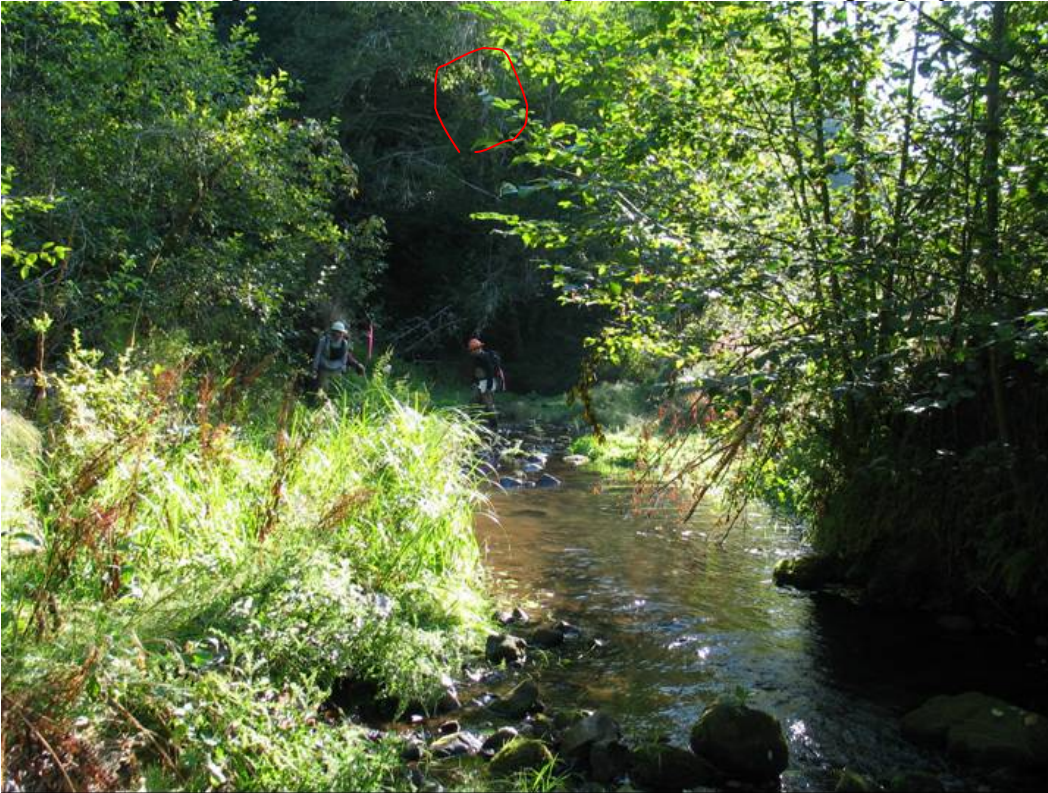
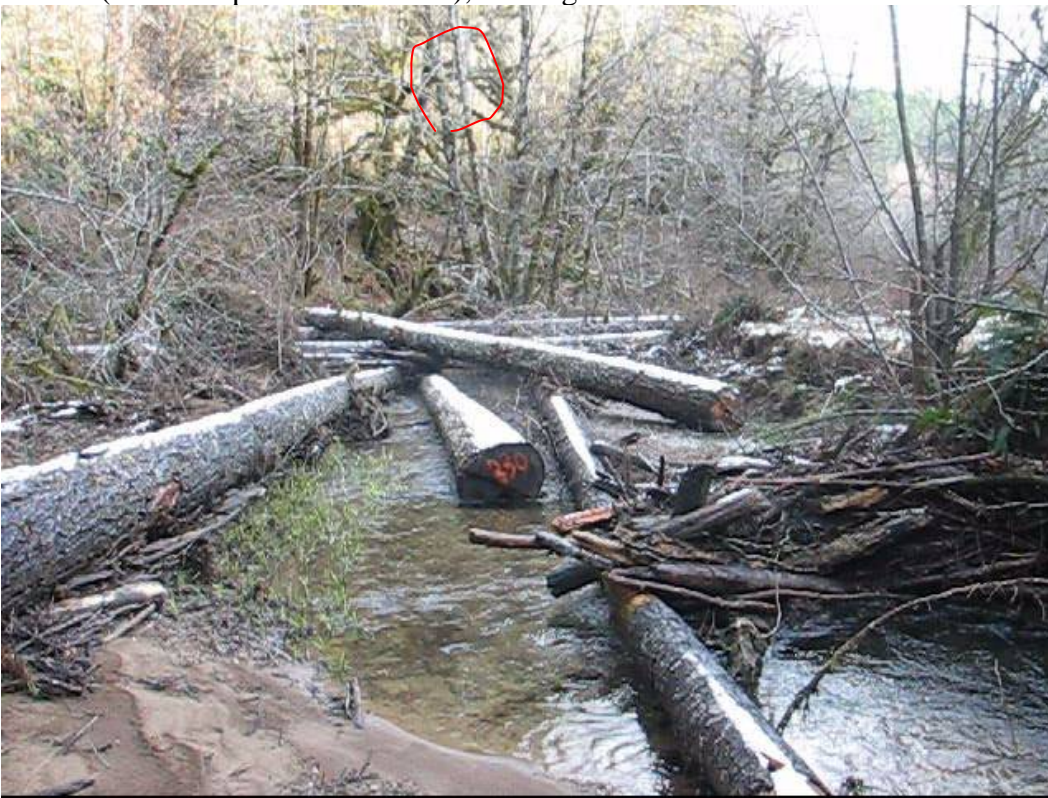
New Comments: The structure has helped collect small woody debris and sediment, scour pools, and encourage the high water to inundate the low-level floodplain on the left side.

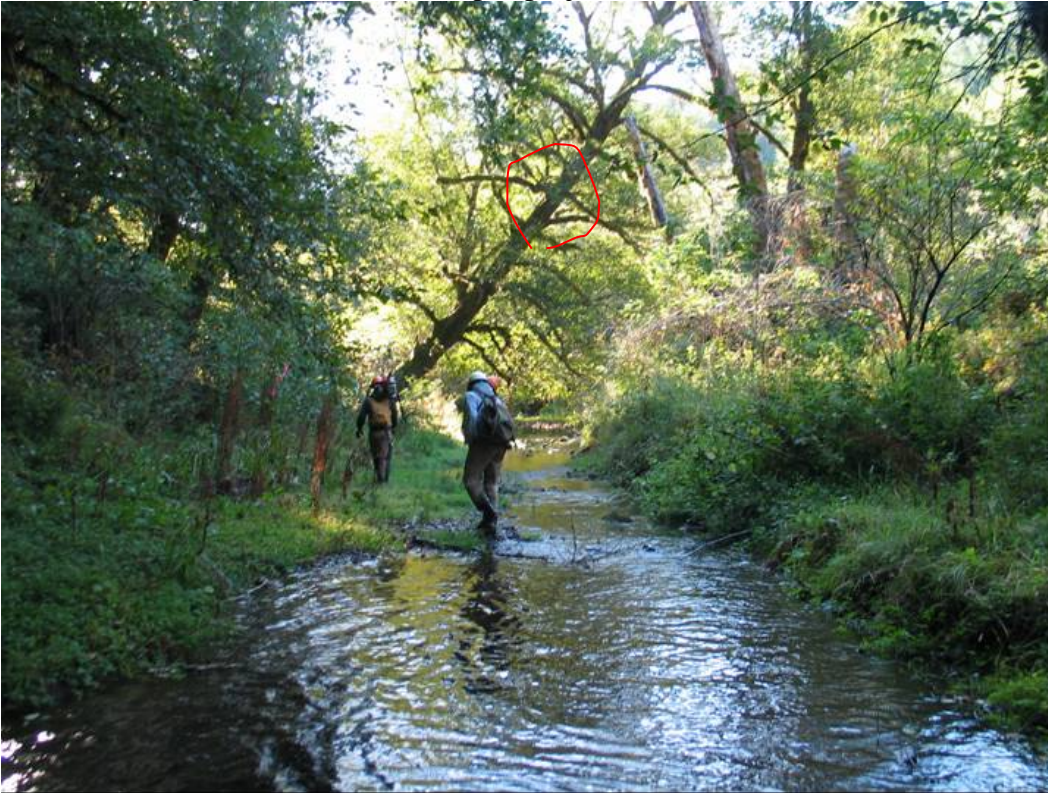
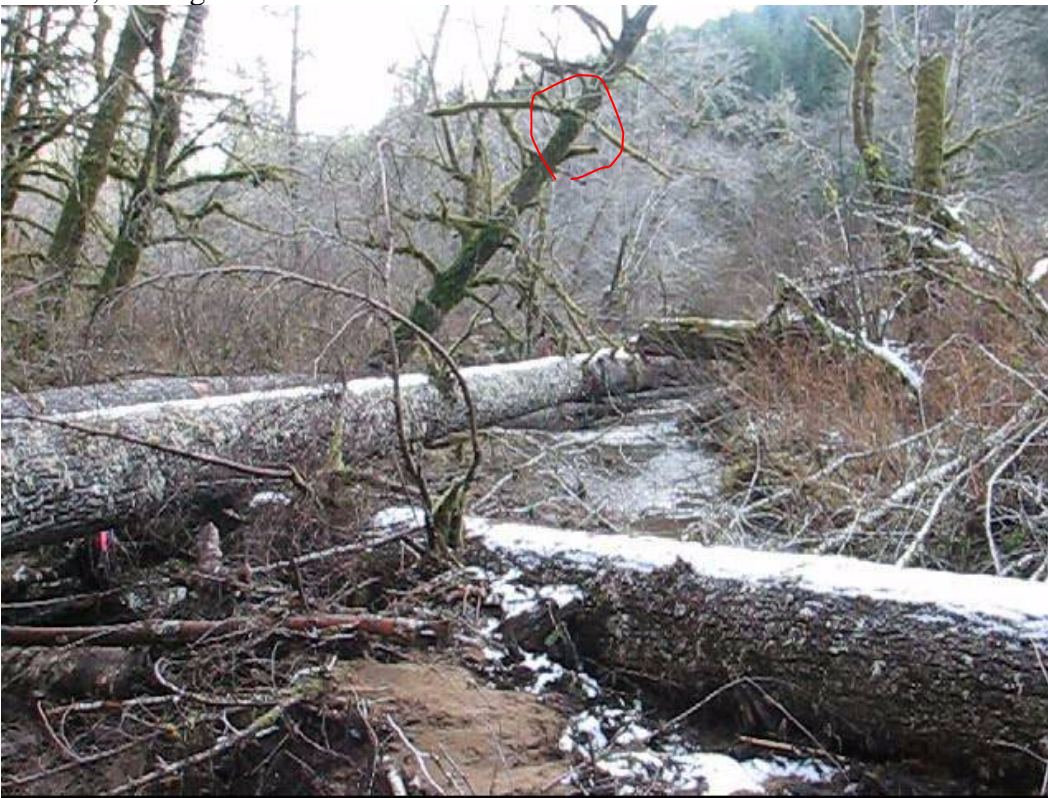
New Comments: Recent fine sediment accumulation appears to have occurred extensively around the structure.

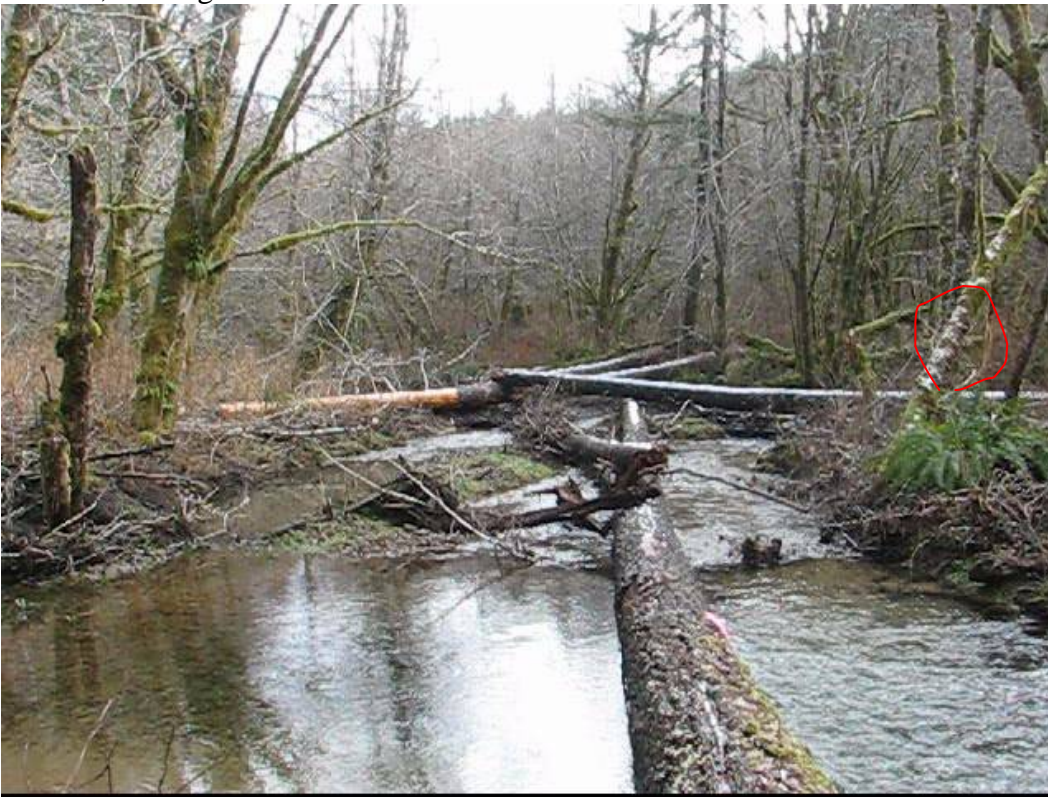
Site # 8, looking downstream - 2007

New Comments: Recently formed side channel habitat and channel braiding around the structure was observed.

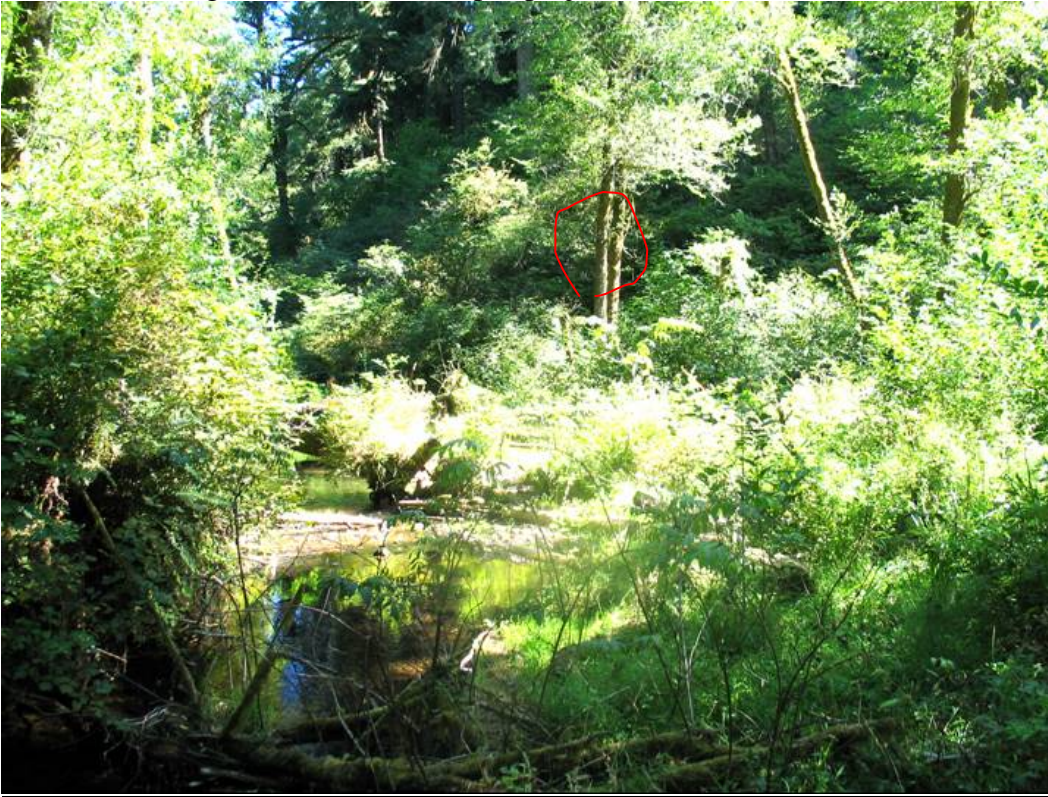
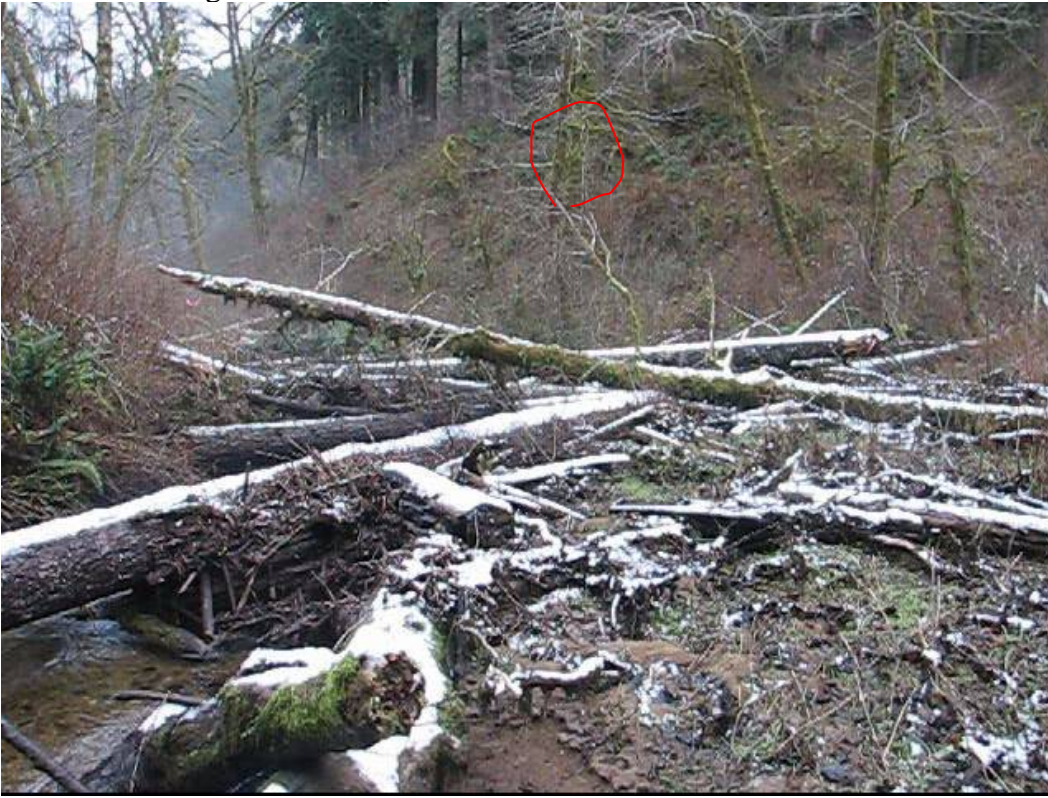
New Comments: Good collections of small woody debris around the structure was observed along with a new gravel bar which formed above the structure.

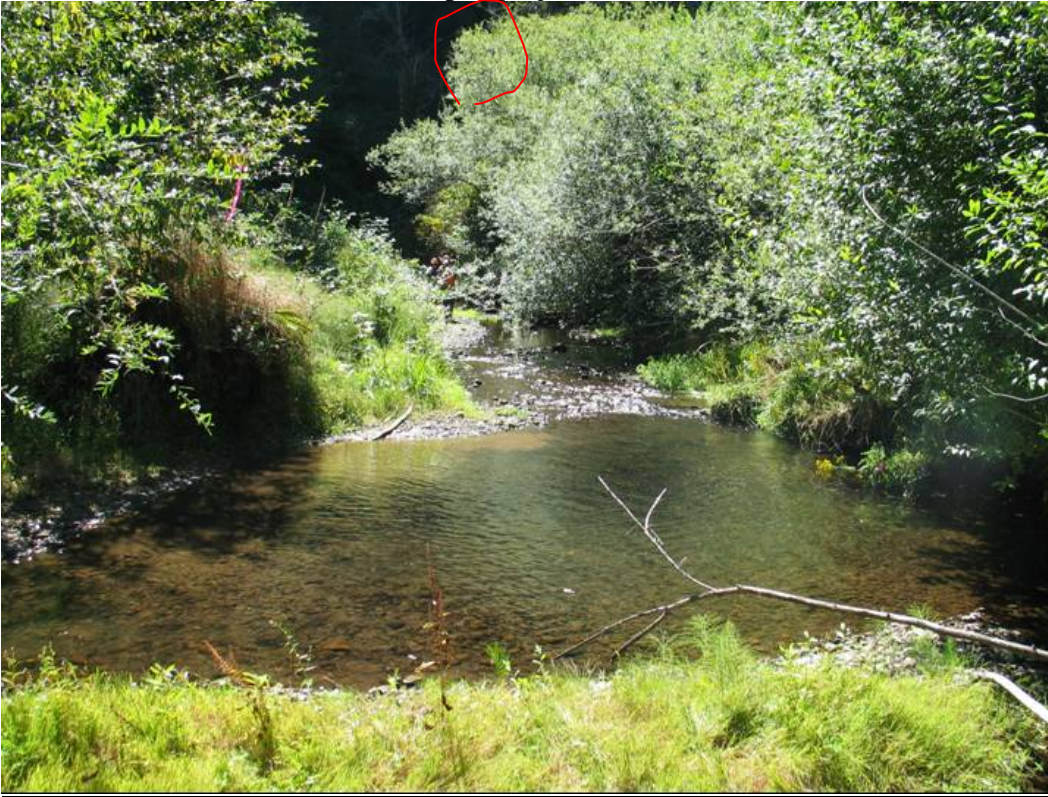
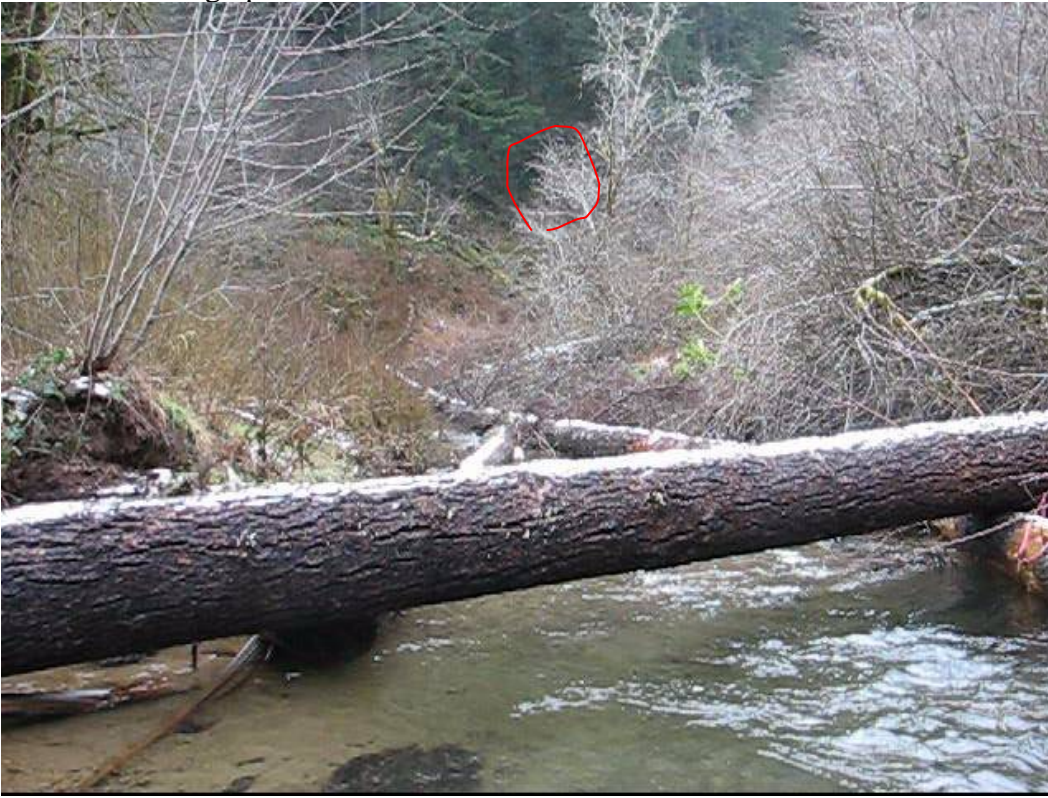
New Comments: Some recent scour was observed from newly placed logs.

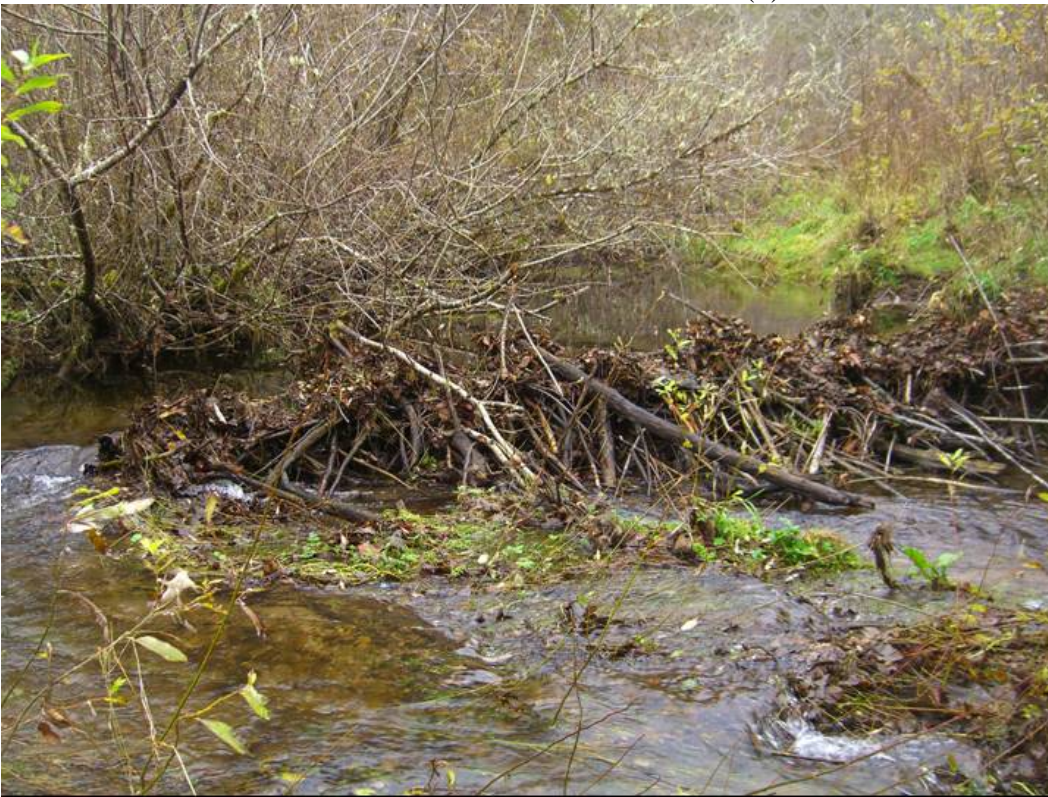
New beaver dam found between Site #18 and #19 – 2007 (2)

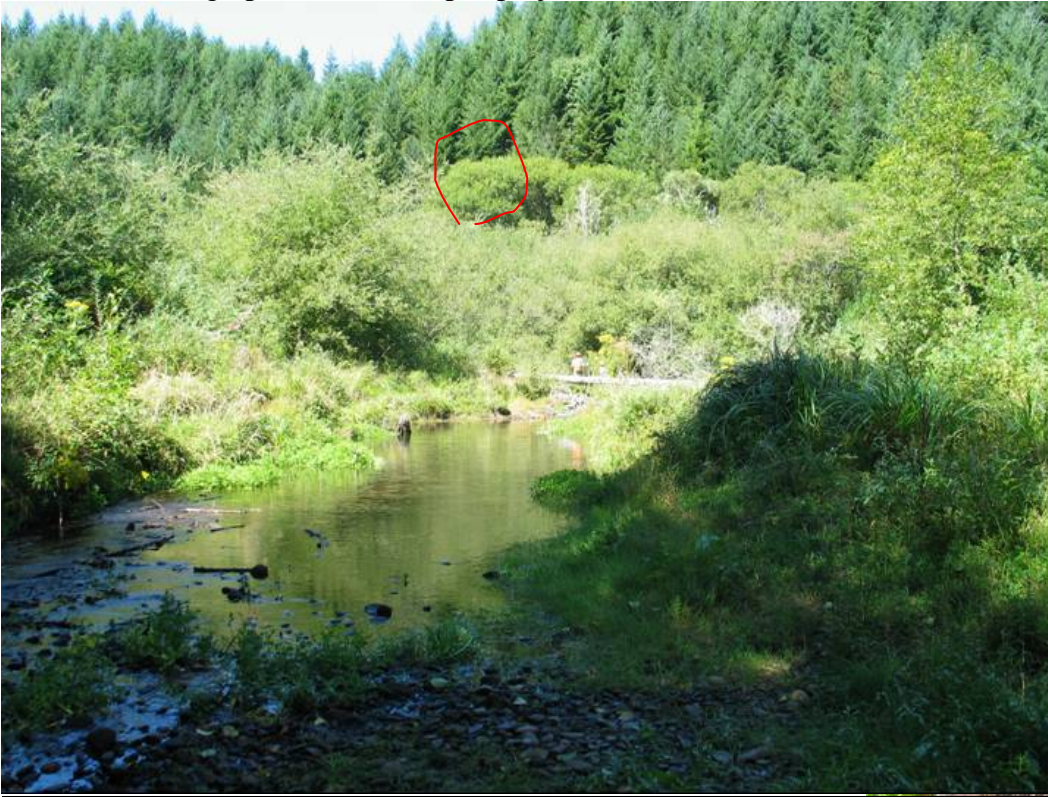
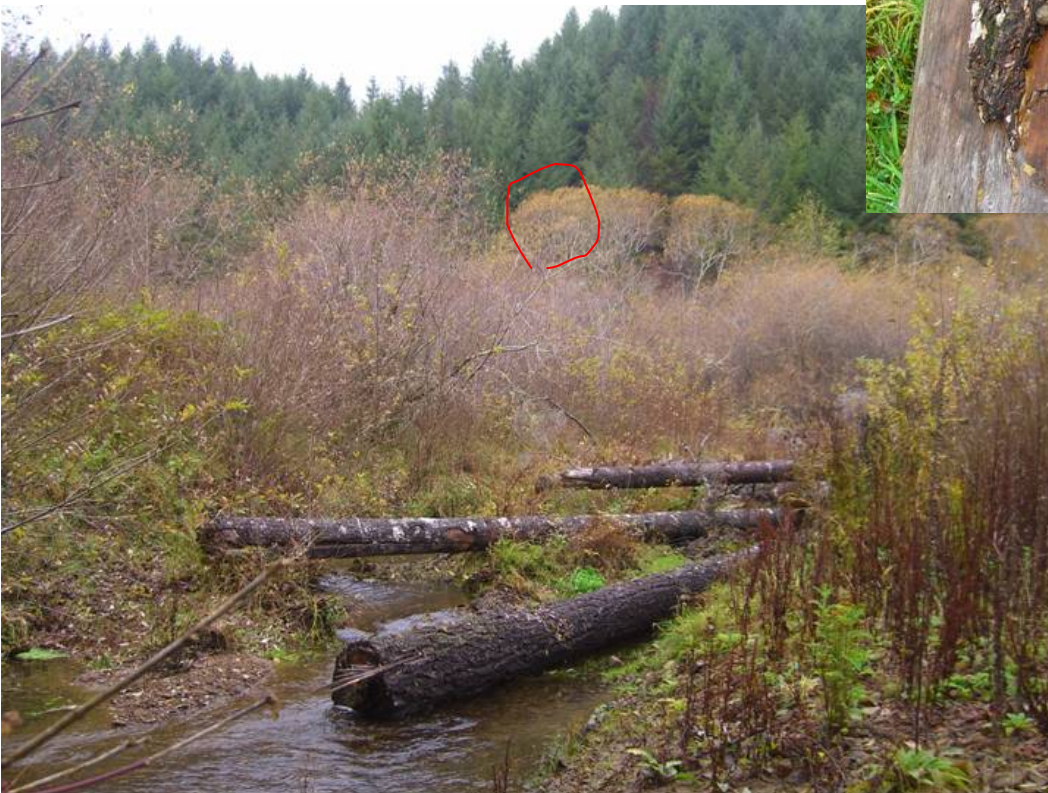
New Comments: A couple of existing logs from a previous habitat project located on the right bank have swung downstream since the reference photos were taken.

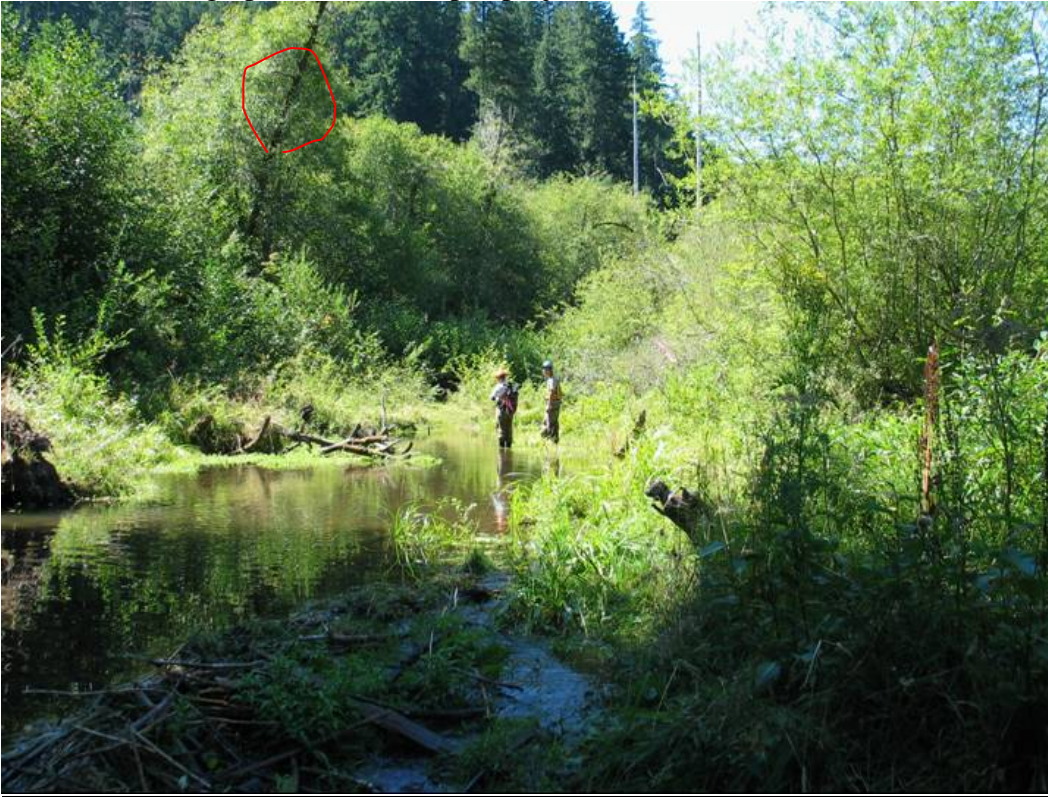
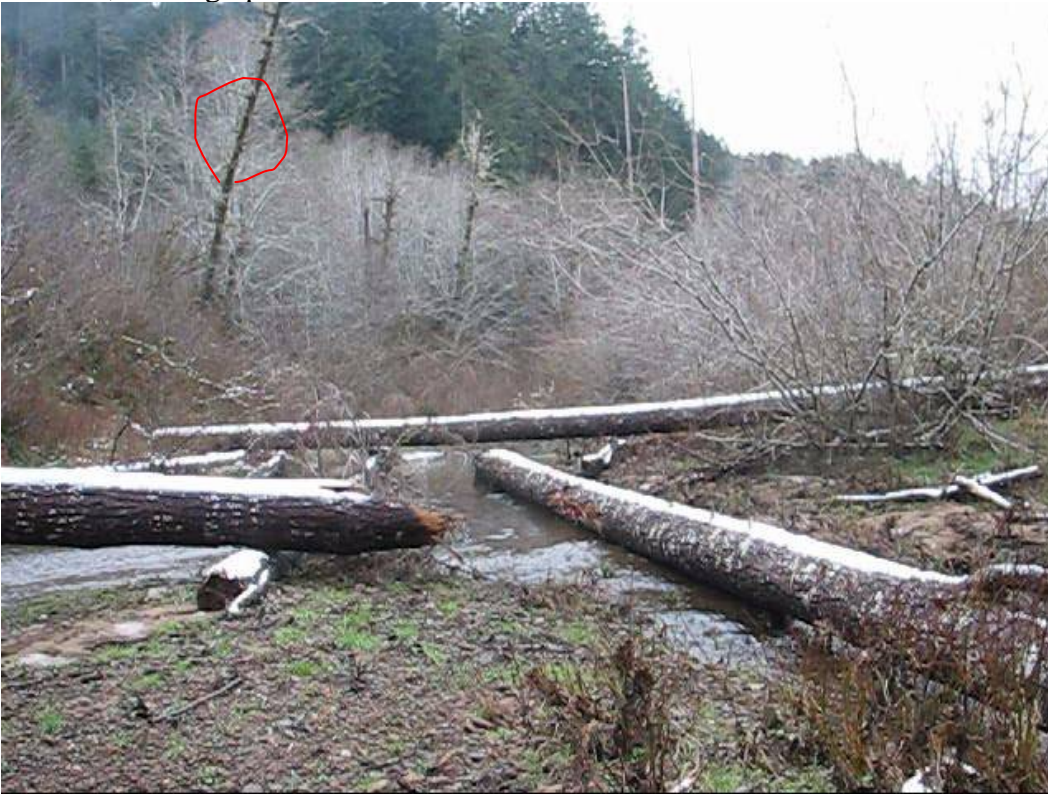
2006 Comments: The placed trees have already altered the stream enough to build up gravel in the center of the channel and create side channels going around the gravel pile.

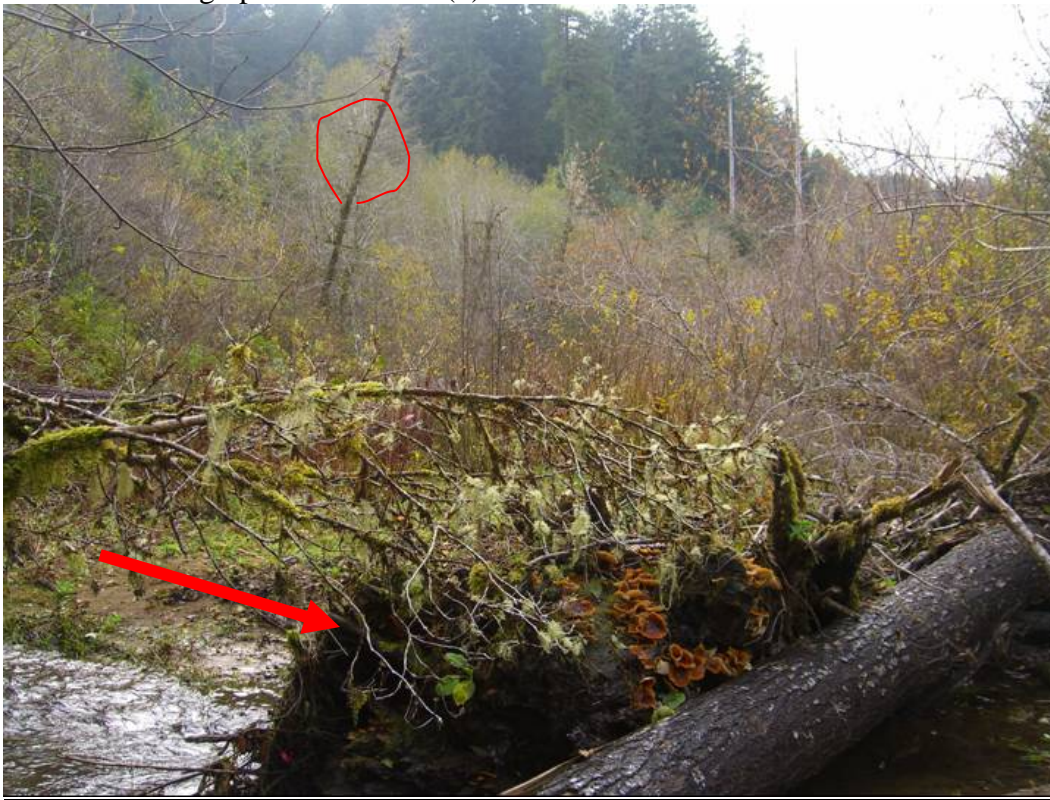
Site #20 looking upstream – 2007 (2)

New Comments: Now the majority of the flow is coming from the left side of the photo as a result of the gravel/sediment island that started developing since 2006 (see previous photo). The root wad that was upstream got caught partially by the tree in the photo here. On the upstream end of the structure, the placed tree is helping scour a deep pool in the middle of the channel.

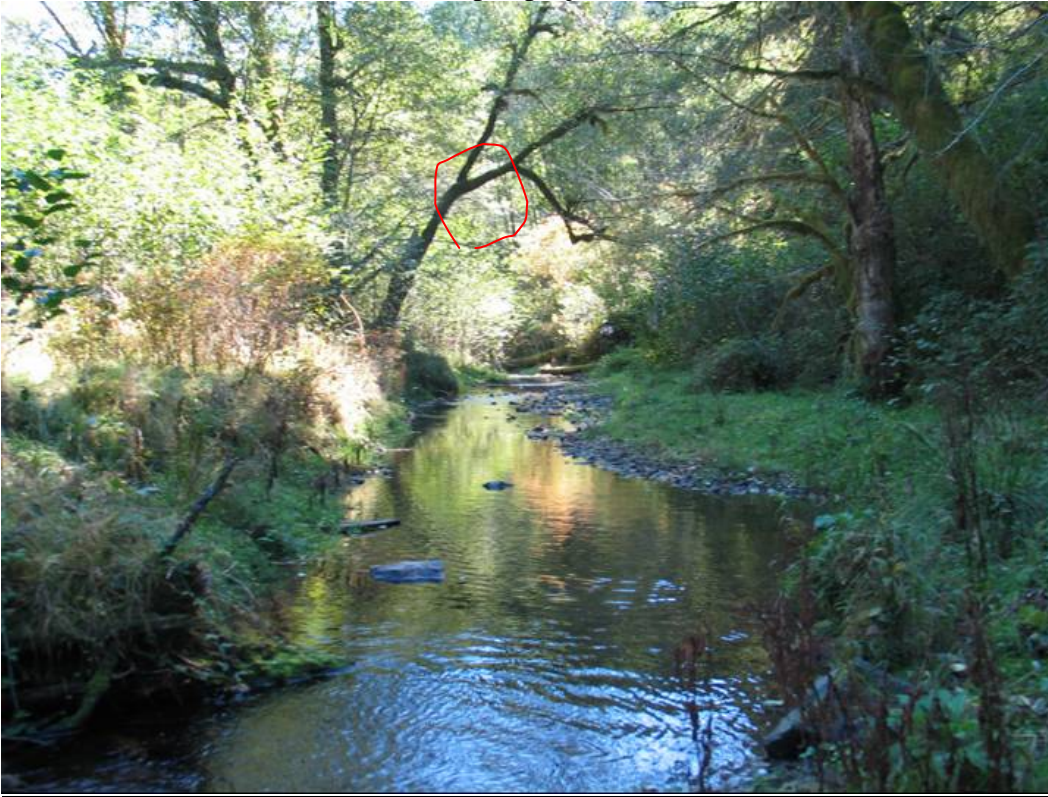
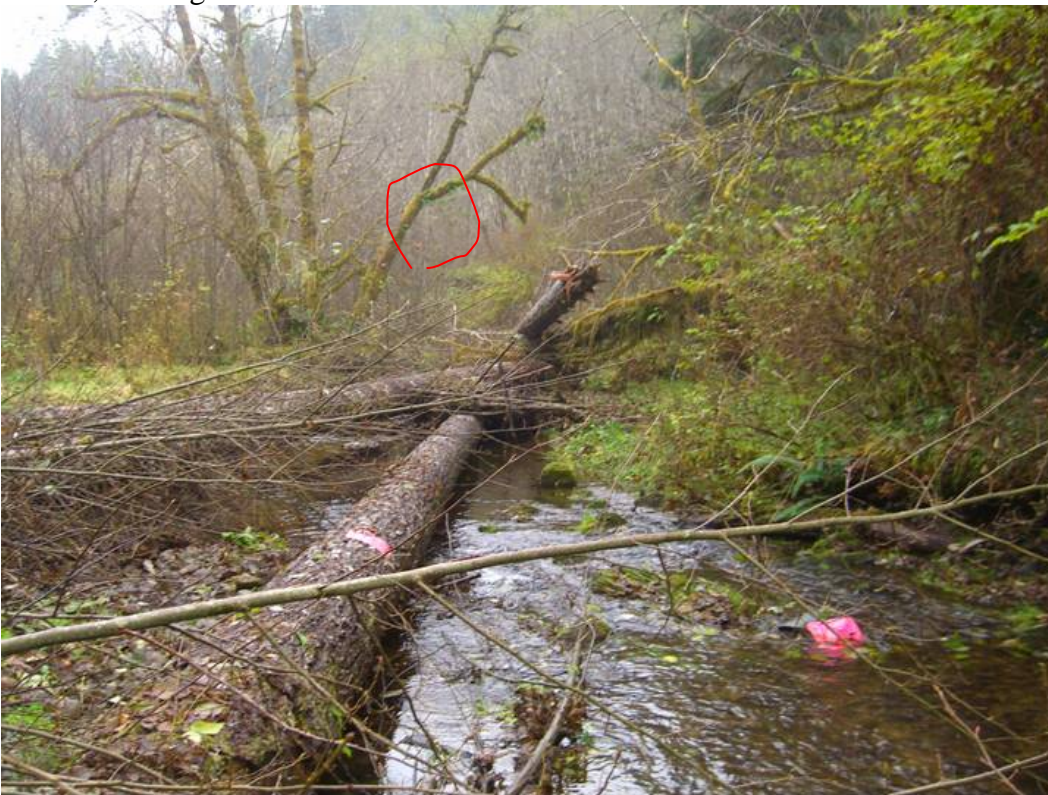
New Comments: A high number of juvenile fishes (particularly coho and cutthroats) were observed throughout the entire Maria Creek, and a large portion of them seemed to be taking advantage of the pools associated with the these new structures.

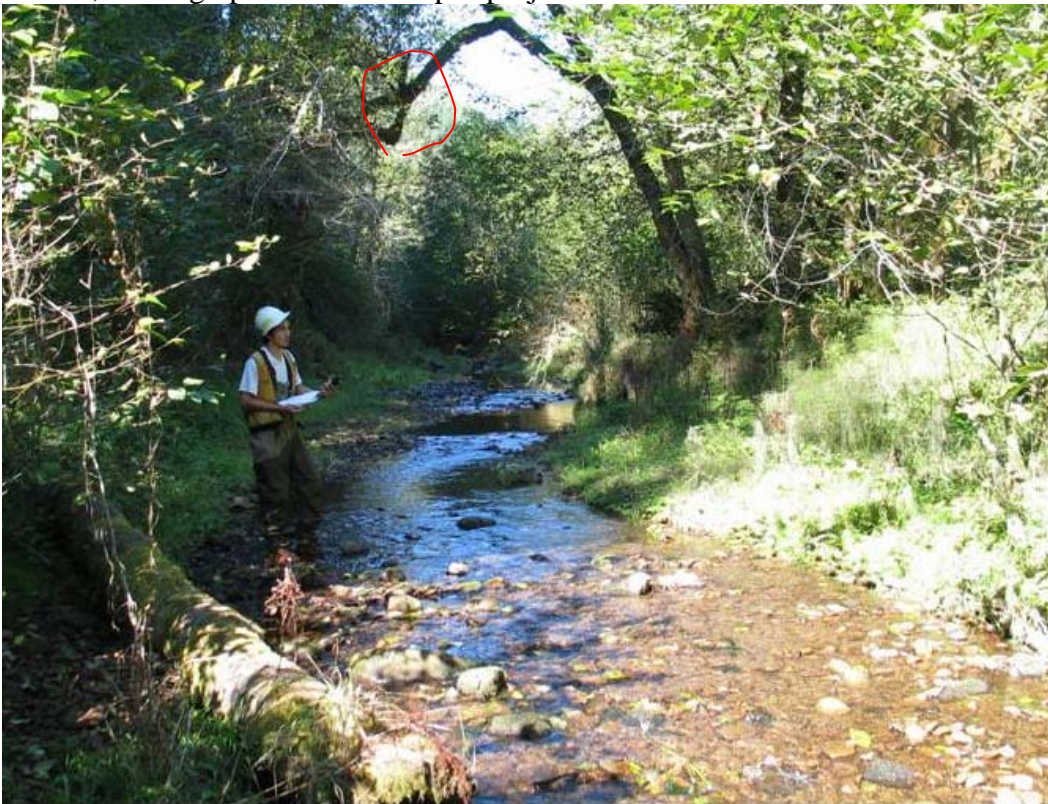
Site #4, looking upstream – 2005 pre-project

New Comments: The structure has affected the channel enough to develop a point bar at the downstream end of this structure, causing the stream to become more sinuous.

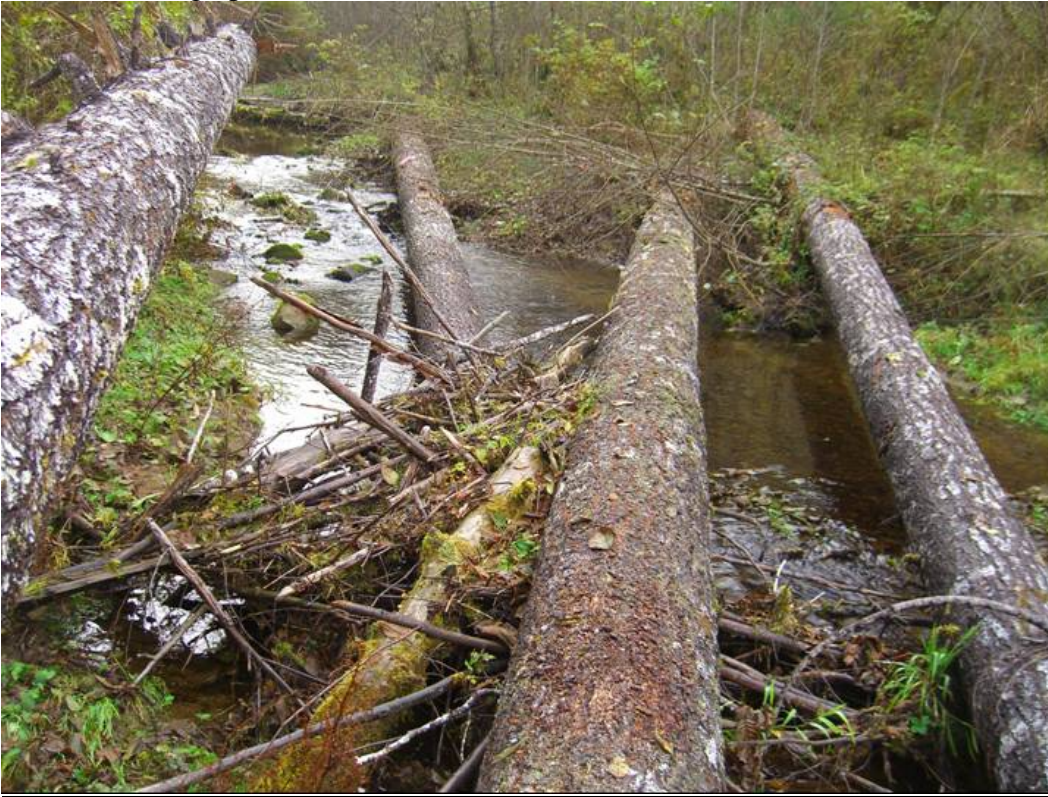
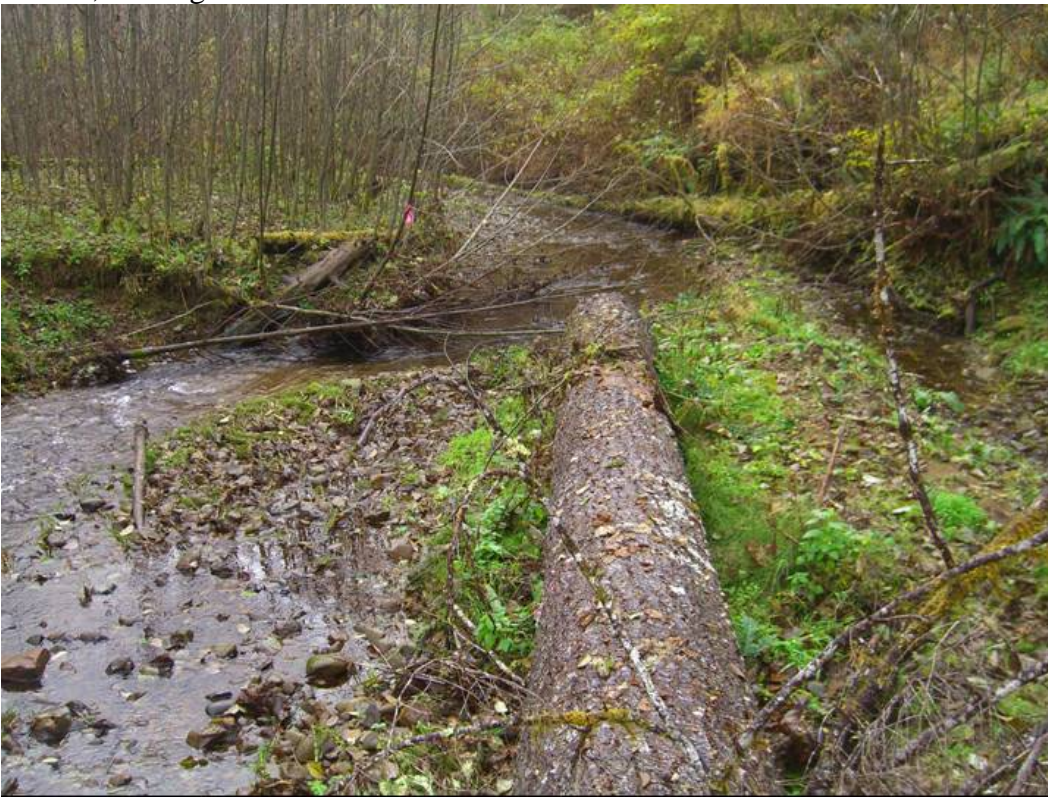
New Comments: The trees configuration with a tree holding on top of the lowest tree helped collect the small woody debris that would have otherwise flushed out of the system. The bottom picture shows how the downstream end tree helped form the gravel bar and caused the stream to meander.

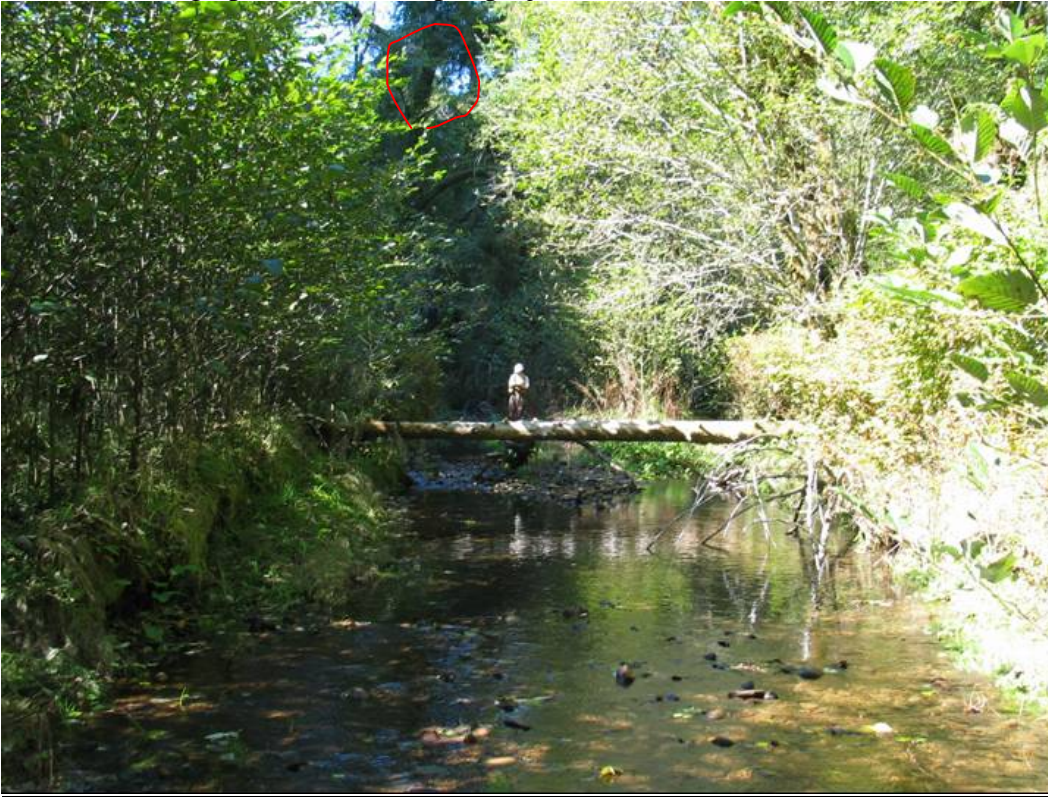
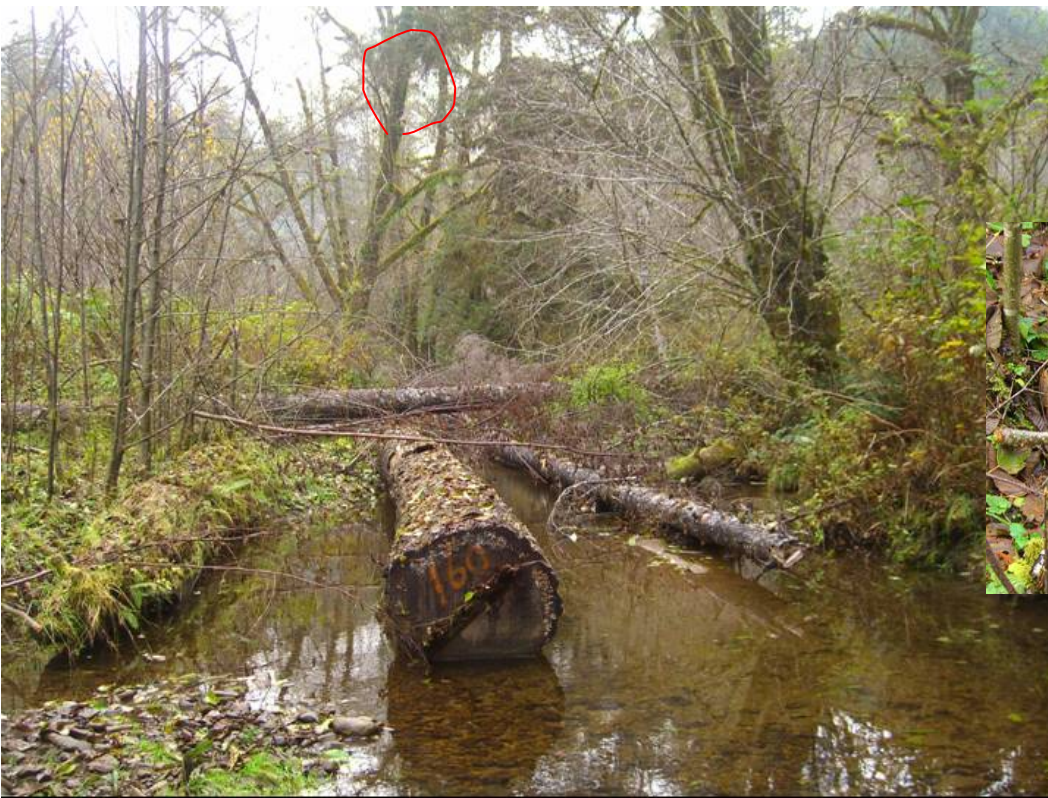
The photo above shows the 6 inch DBH alder that the eager beaver munched down right below this structure site.

New Comments: The structure is helping the water seep out into the low-level floodplain zone (covered with small alders) during high water events. It's also adding various scour depths in the channel unit.

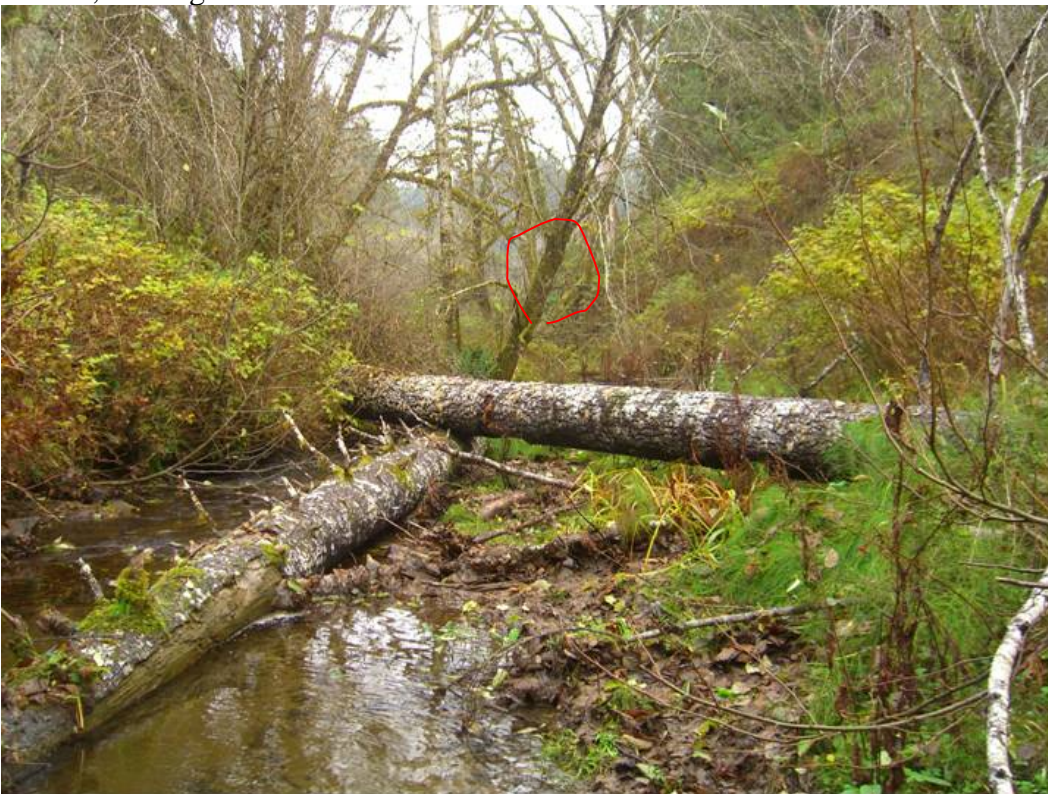
Site #6, looking downstream – 2007

New Comments: Collected small woody debris and sediment, and helped create more scour holes in the channel unit.

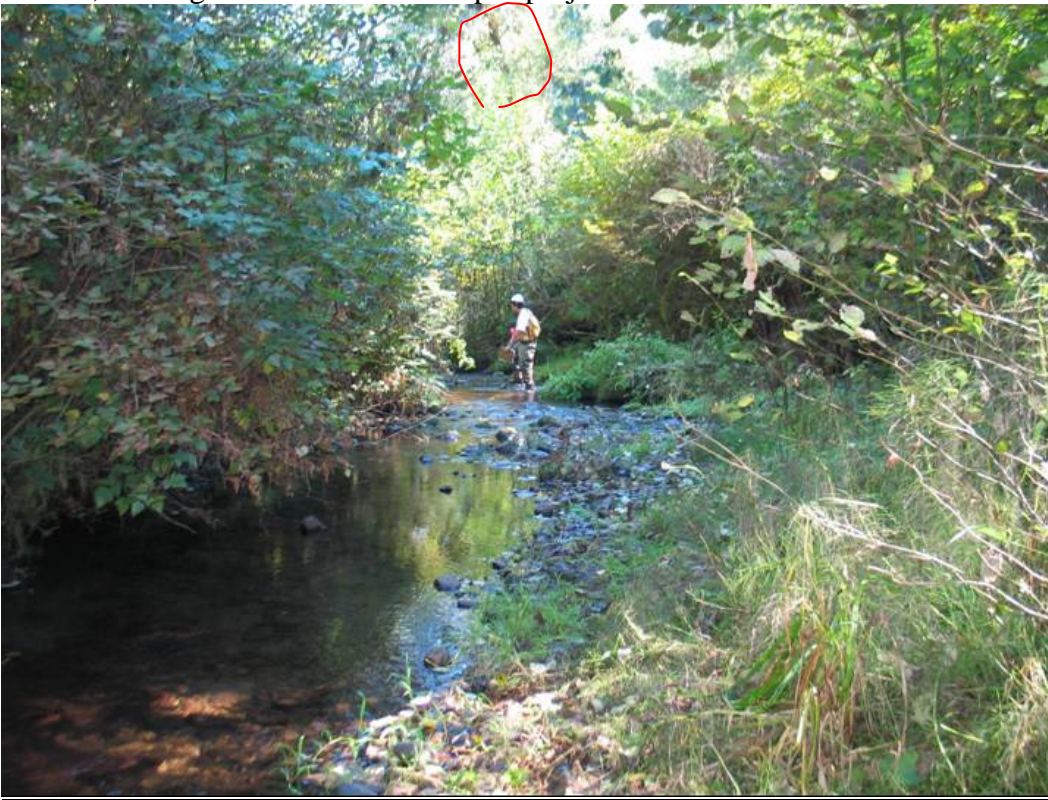
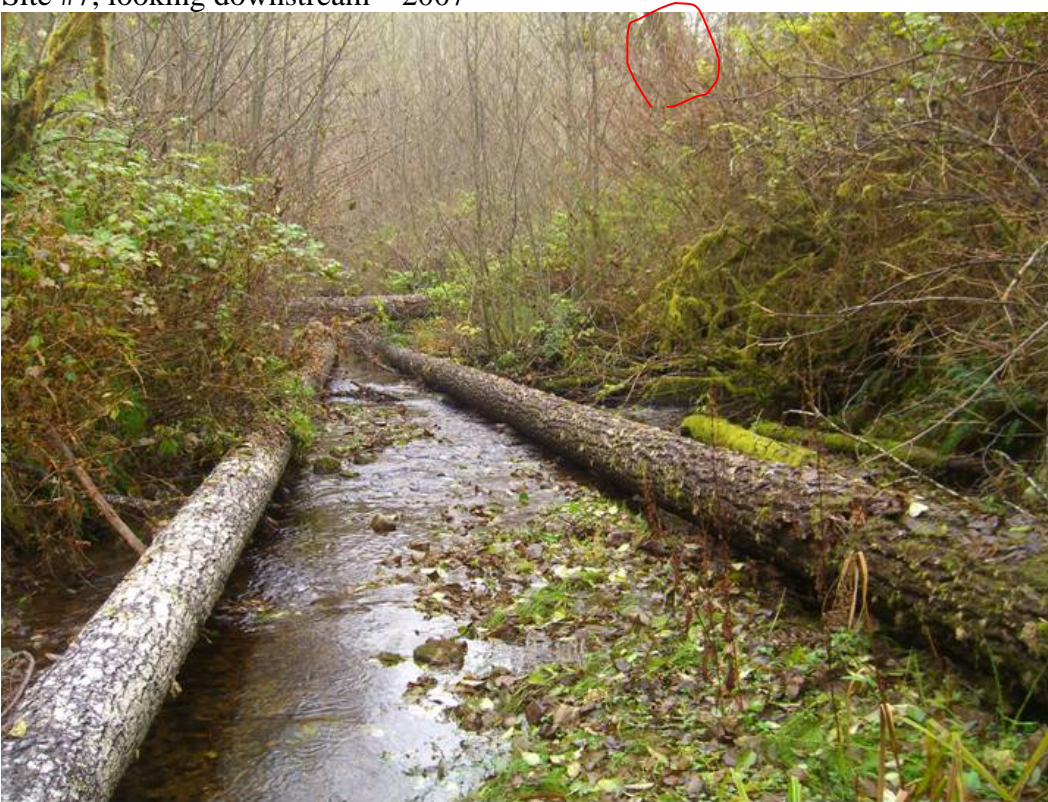
New Comments: This structure hasn't brought about major changes yet on the upstream end, but we should see more changes over time, considering how low the trees are placed in the stream.
