Indian Creek Aquatic Restoration

Oregon Wildlife Heritage Foundation

Narrative Summary:

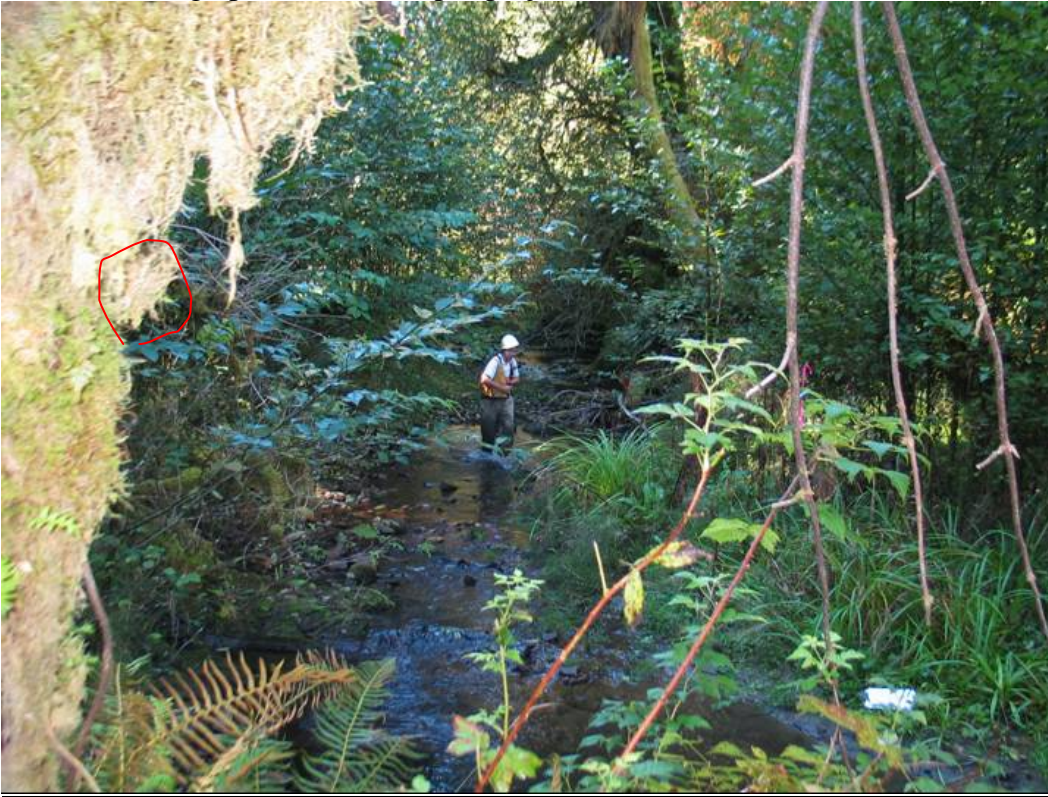
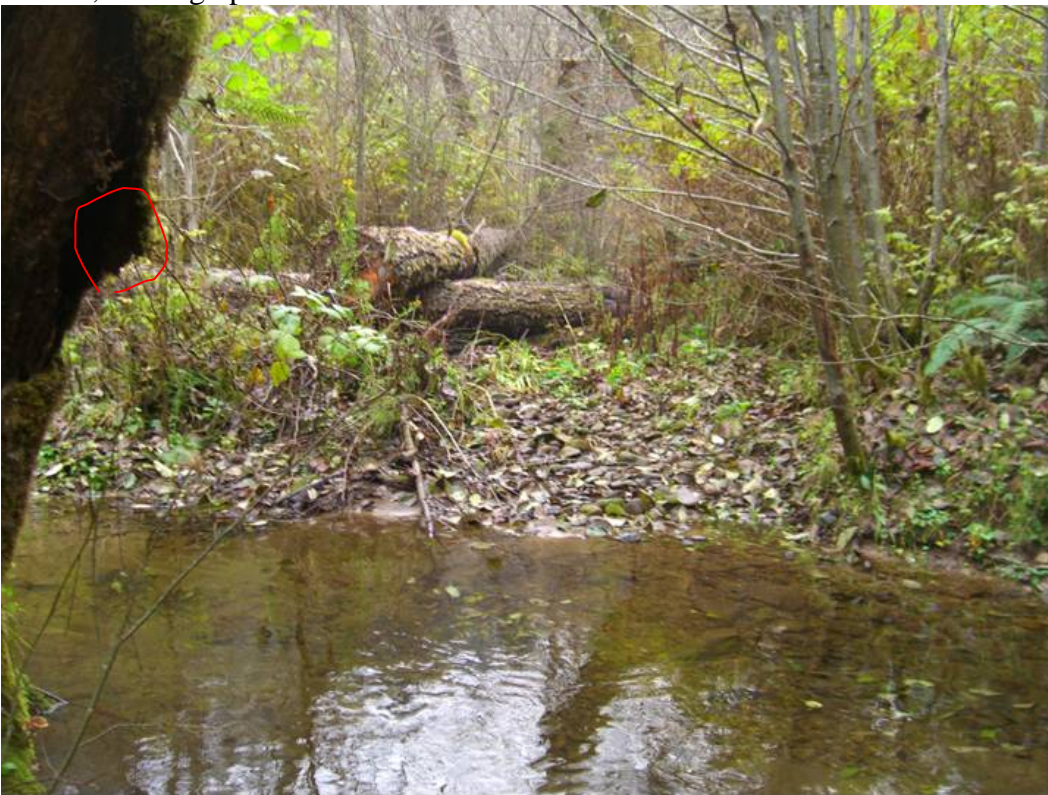
New Comments: This site has changed tremendously. The structure has caused the channel to meander around the trees, leaving a prominent point bar at the downstream end of the structure (center of the picture). This has increased the channel flow to slow down quite a bit, and created a nice pool.

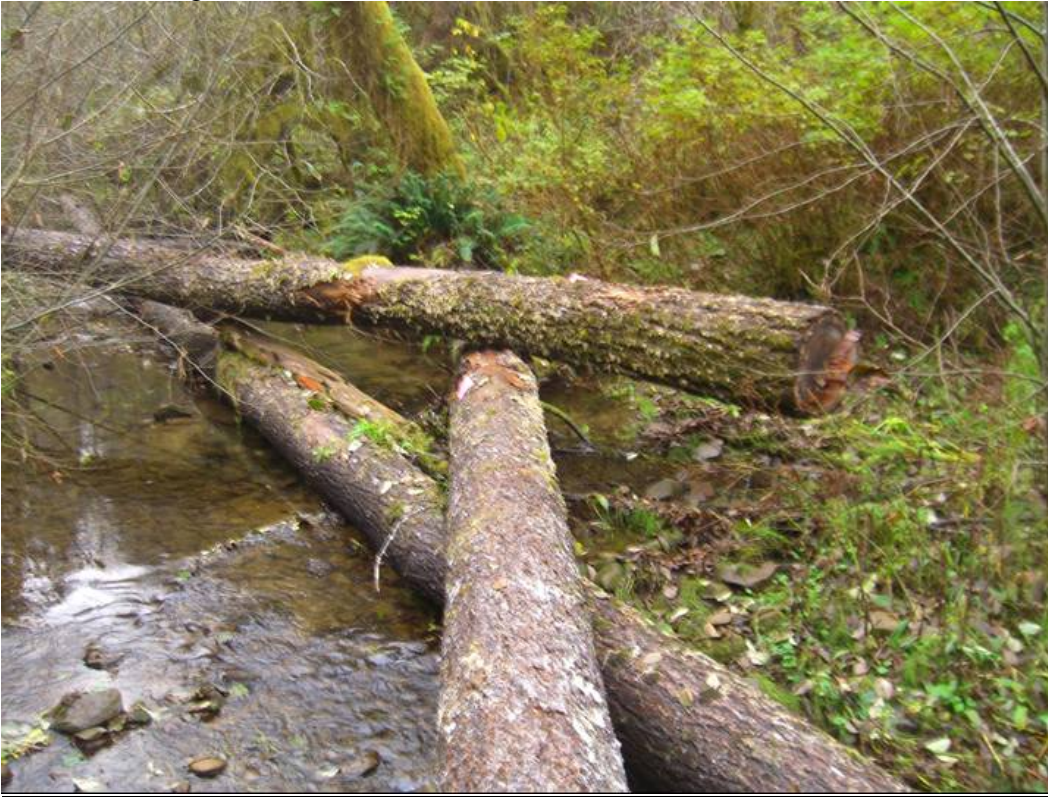
Site #8, looking from side – 2007

New Comments: This photo shows the configuration of the trees that helped create the point bar creation and the meander in the stream.

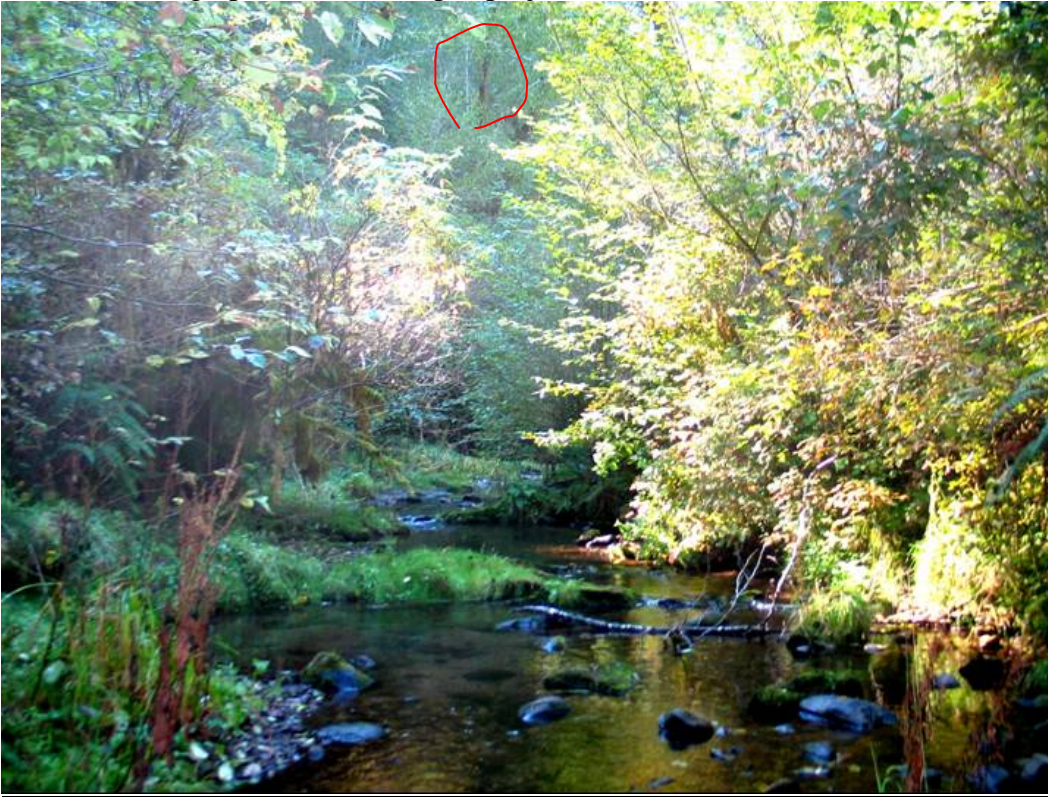
Site #9, looking upstream – 2005 pre-project

New Comments: There was small woody debris collected around the new trees in addition to some beaver cuttings that were scattered in here. There is tributary that comes in on the left side, so we look forward to see future debris collection at this site.

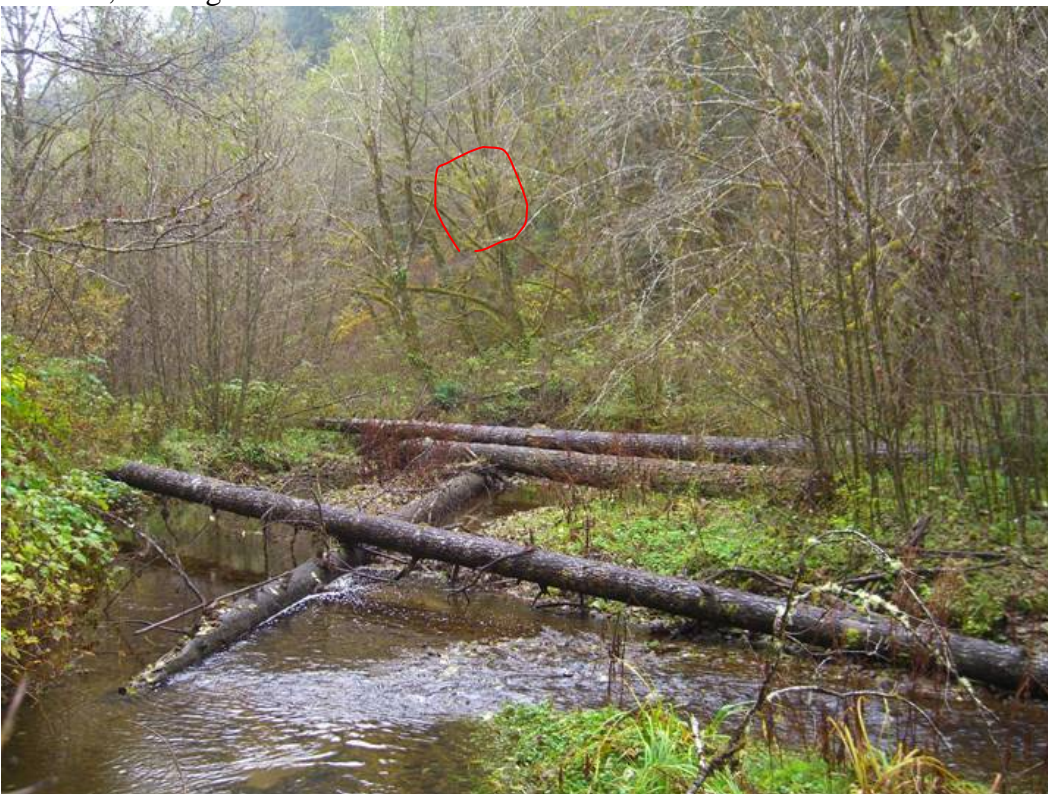
Site #24, looking downstream – 2007

New Comments: The jam has collected some new sediment over the winter and the mid-channel island seems to be enlarging towards the structure as a result of that. The structure trees are nicely staggered, yet laying very low on the ground, so we expect to see more changes in the future.

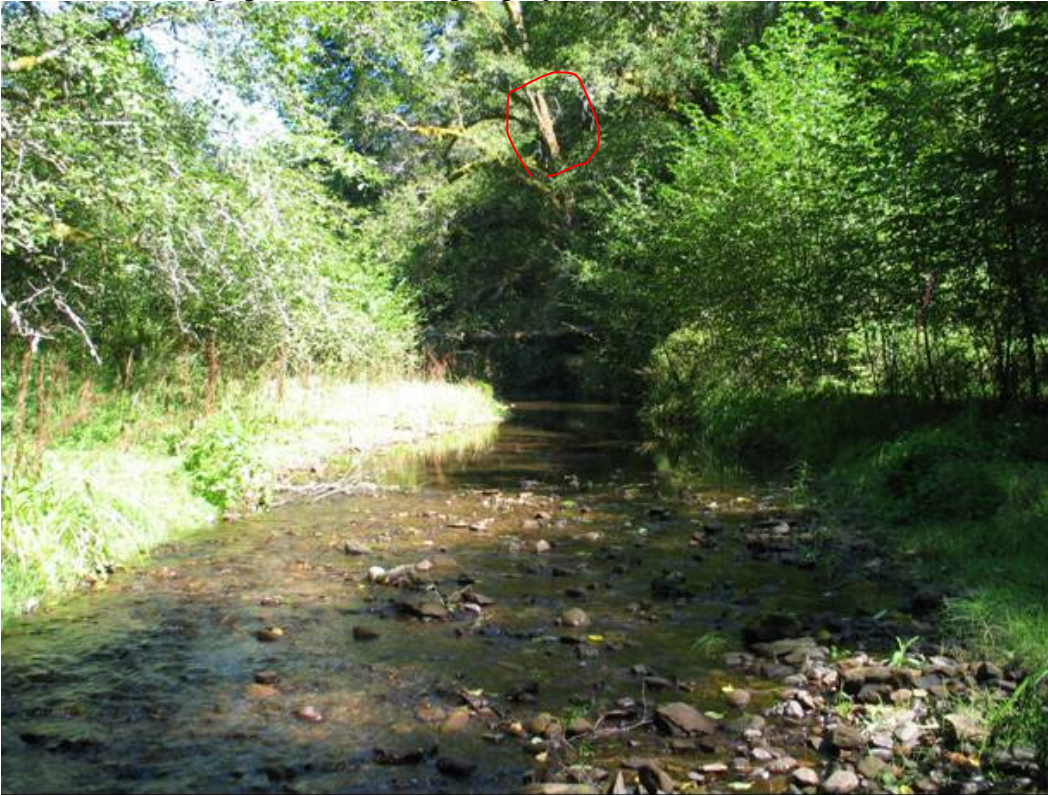
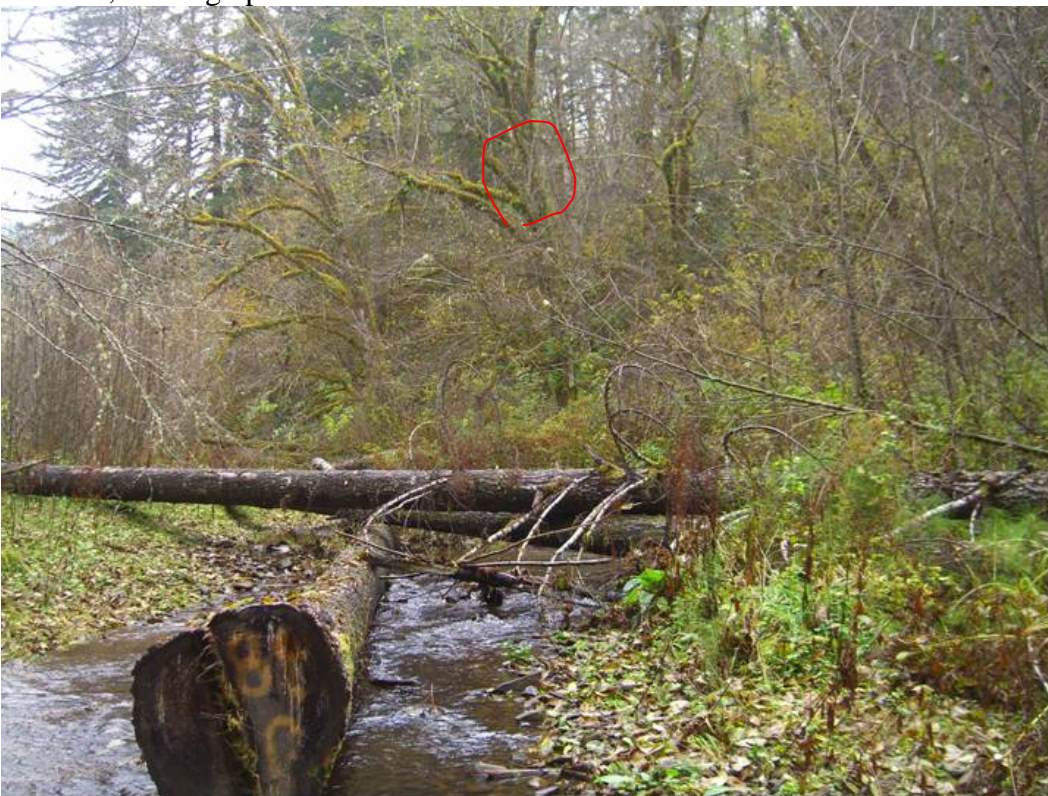
New Comments: Very nice configuration of the structure: a low lying tree in the center of the channel and more trees staggered on top of each other, which added elevation to collect small woody debris / sediment.

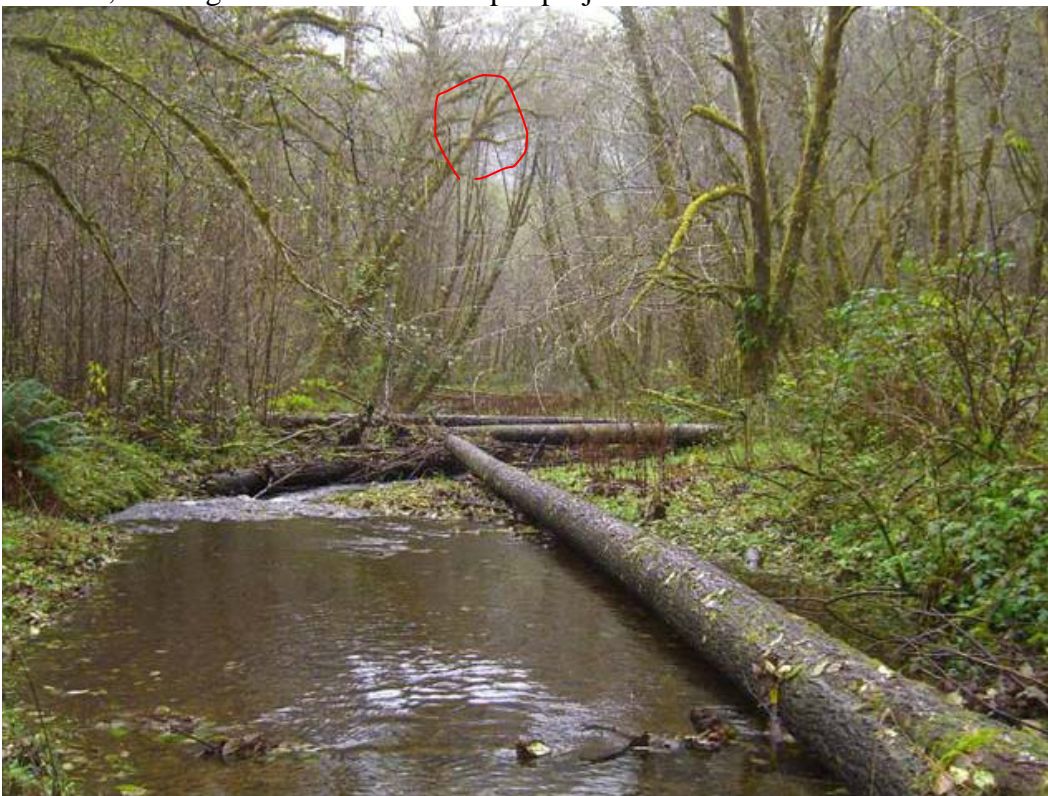
Site #25, looking downstream – 2005 pre-project

New Comments: The jam seemed to have caused the stream to become more sinuous. Because Rogers Creek has a wide floodplain, it was easier to work the trees in right to the bottom of the stream.

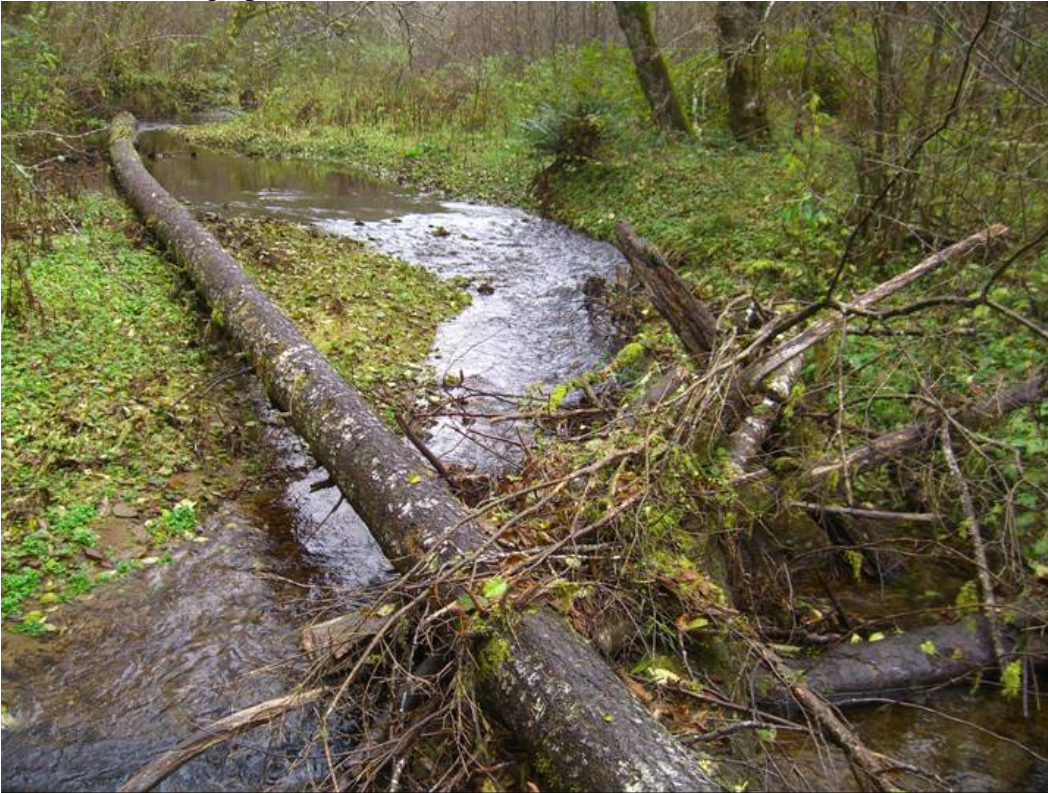
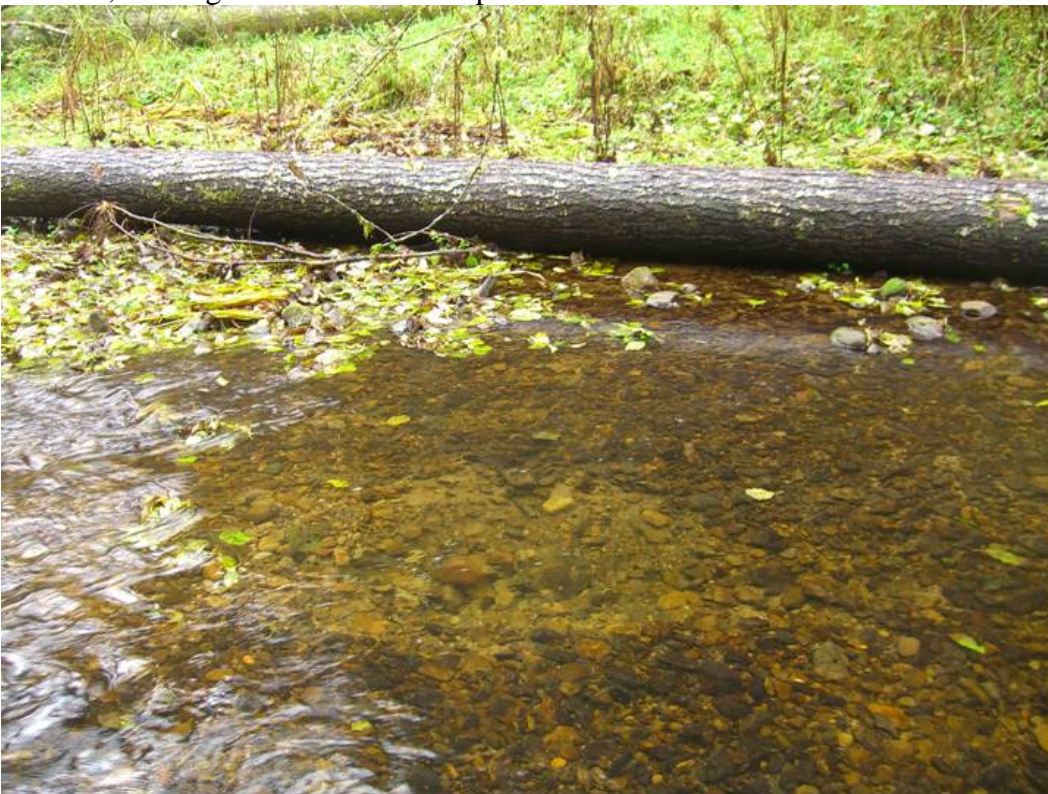
New Comments: The photo above showcases the small woody debris collection that was observed at the site, which is hard to grasp from the photo on the previous page. The tree also helped scour a pool underneath. The photo below shows the salmon redd (probably a Coho) created this winter right by the structure tree.

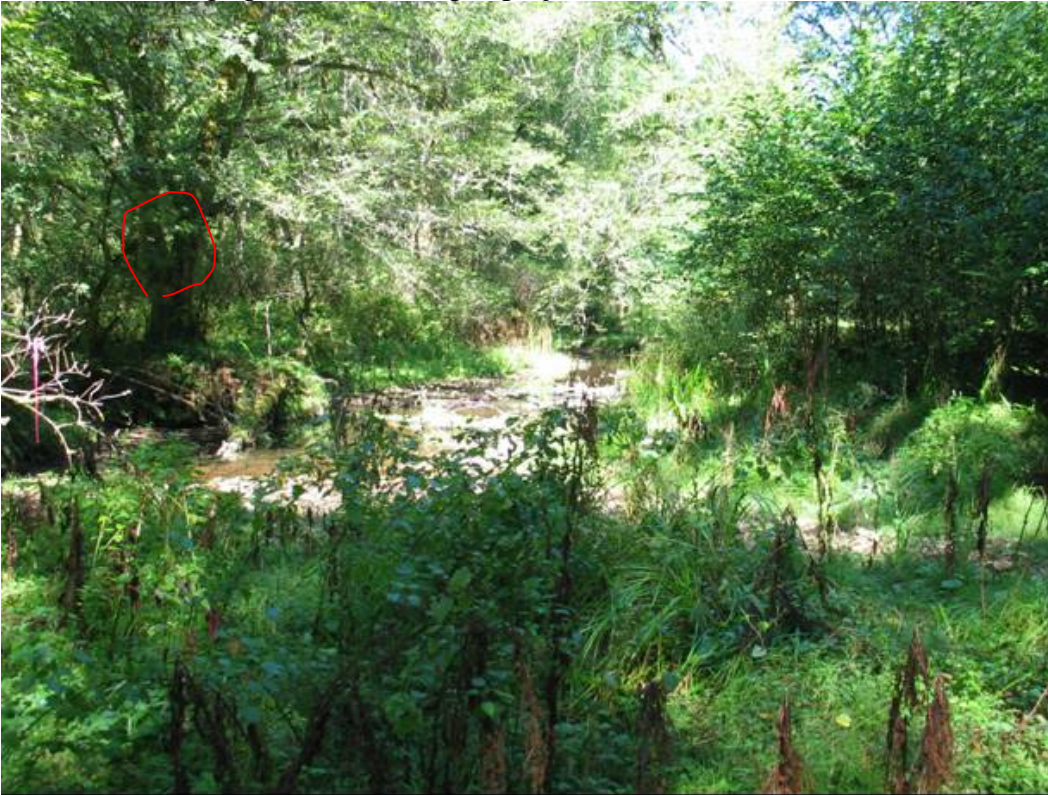
Site #25, looking upstream – 2005 pre-project

New Comments: The structure is helping regain the floodplain interaction by causing the high flow water to move into the low-level floodplains on both side of the bank.

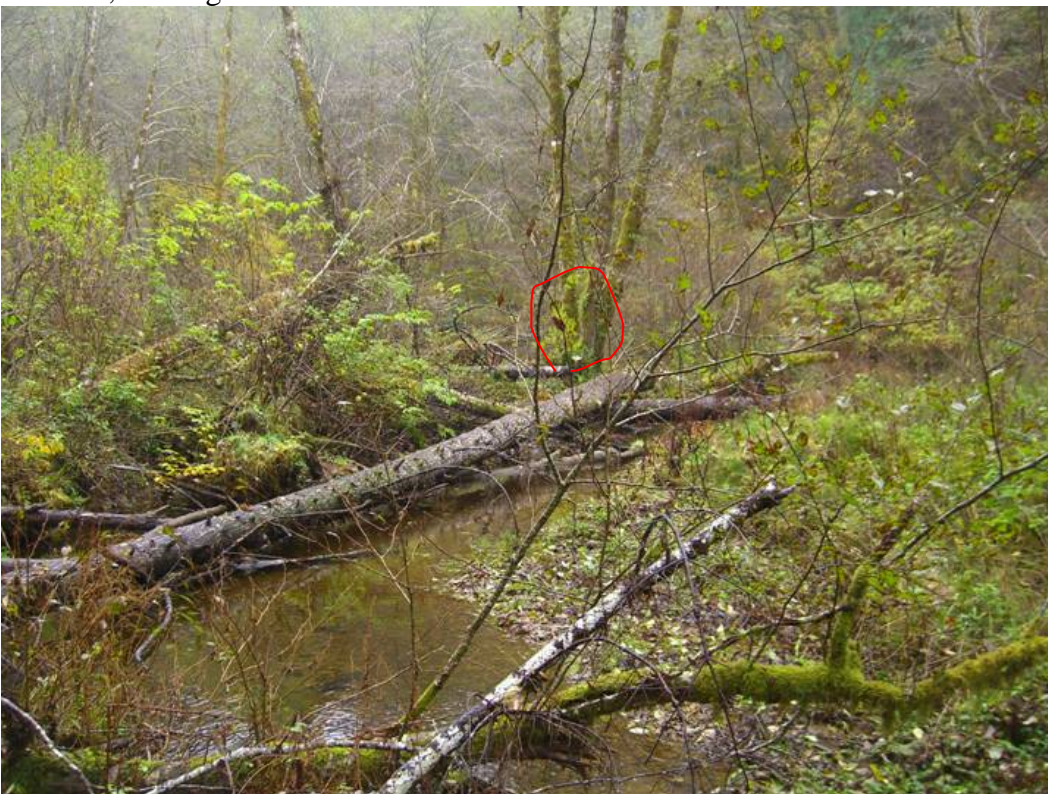
Site #27, looking downstream – 2007

New Comments: Collecting more small woody debris and sediment, helping maintain and increase the channel meander.

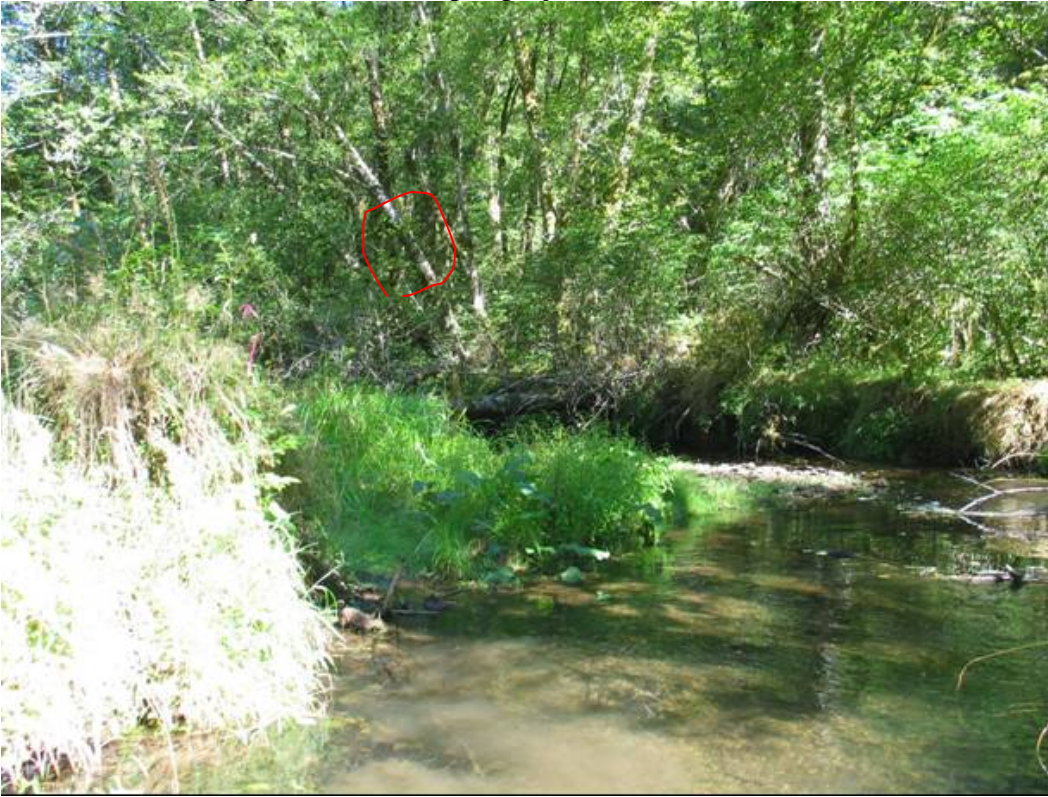
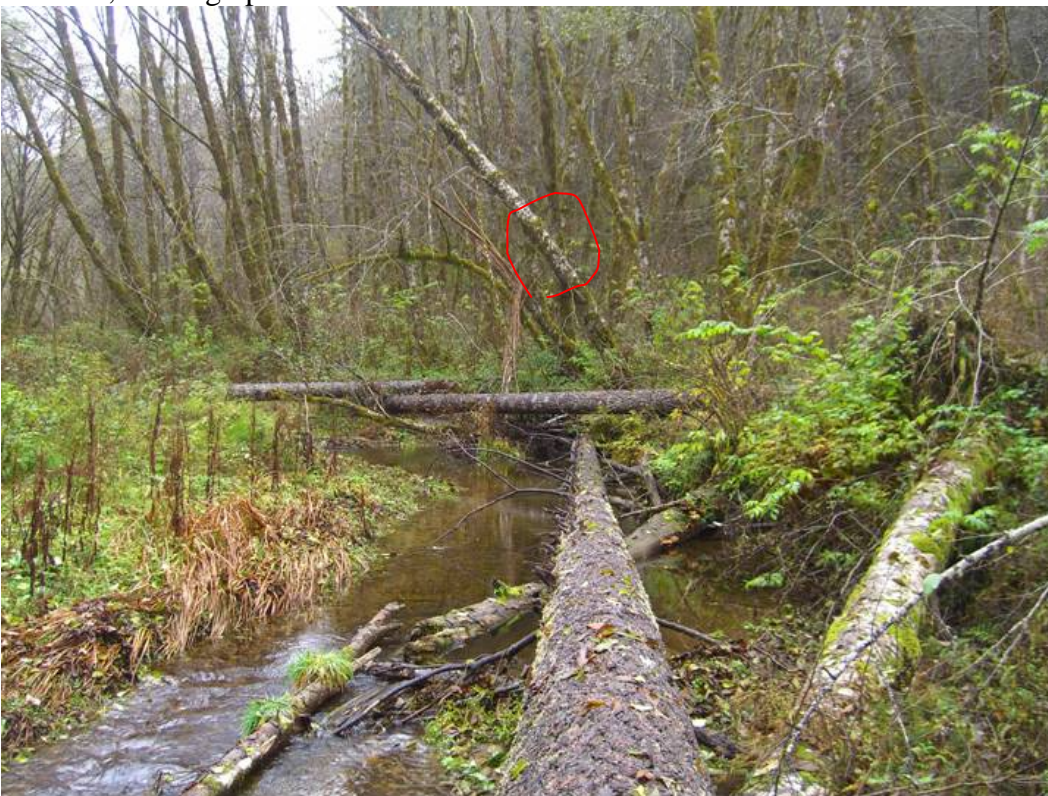
New Comments: The tree in the center here has helped scour deep pools in this channel unit. The amount of gravel decreased from this site downstream; in future years, we'll monitor how much gravel will be added to these downstream sites. The angle of the photo is slightly different, but it shows the same general area.

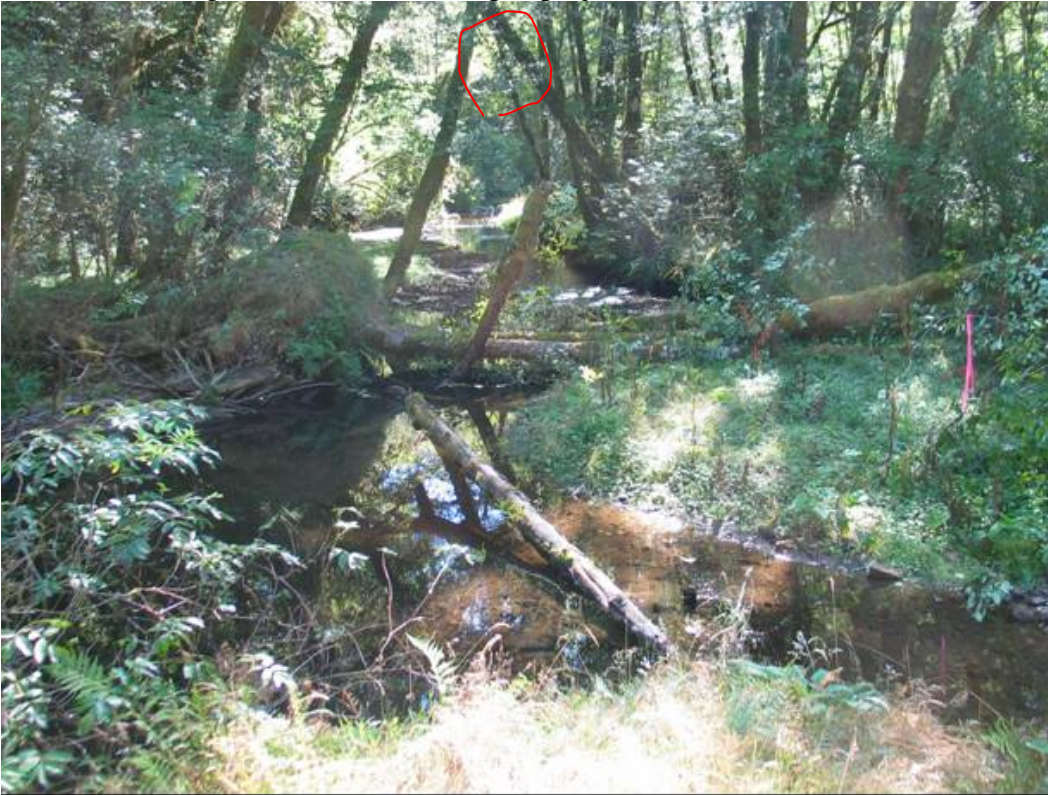
Site #28, looking downstream – 2005 pre-project

New Comments: There is a mid-channel island that is forming under the right hand tree and the deep pool under the left hand tree is maintaining and increasing its depth as a result of the wood scouring.

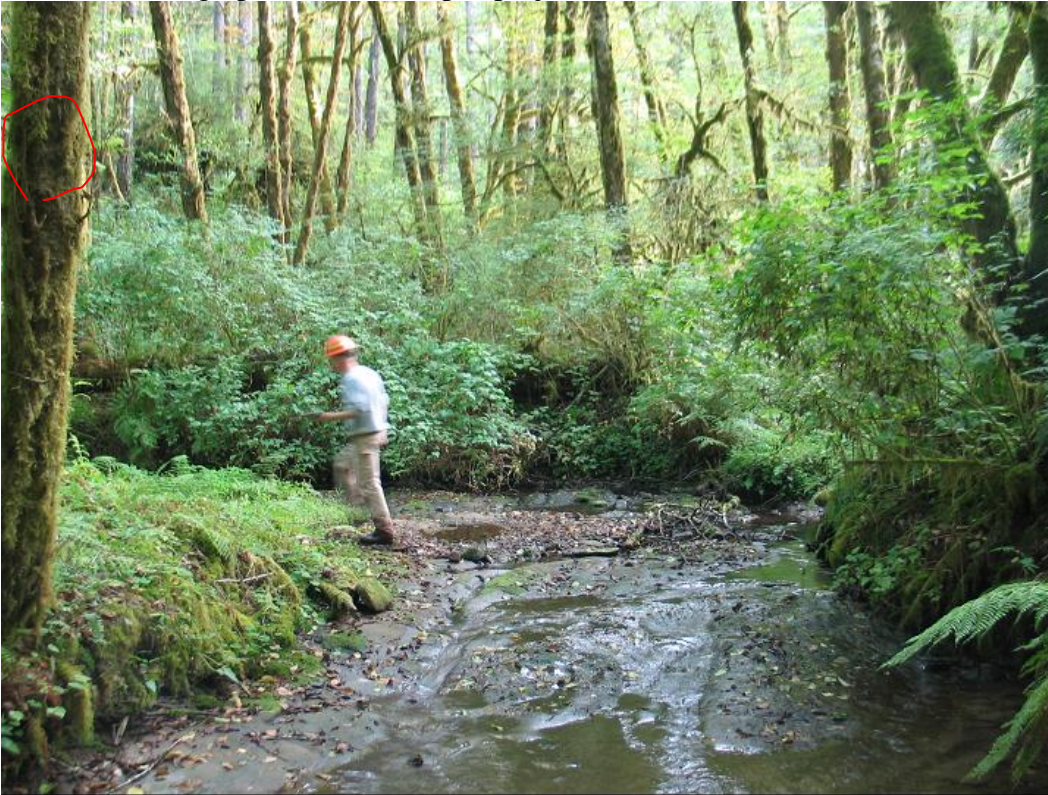
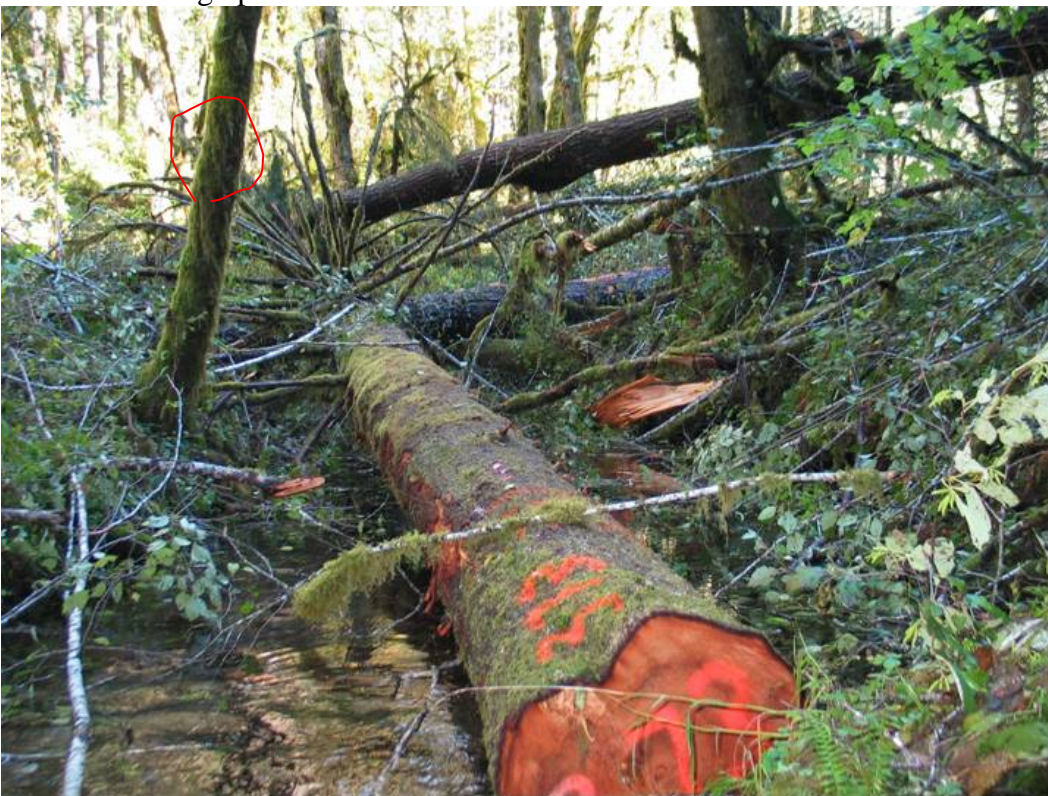
New Comments: The structure is starting to collect sediment and detritus all around these trees and changing the way this site looked drastically. I almost did not recognize it was the same site.

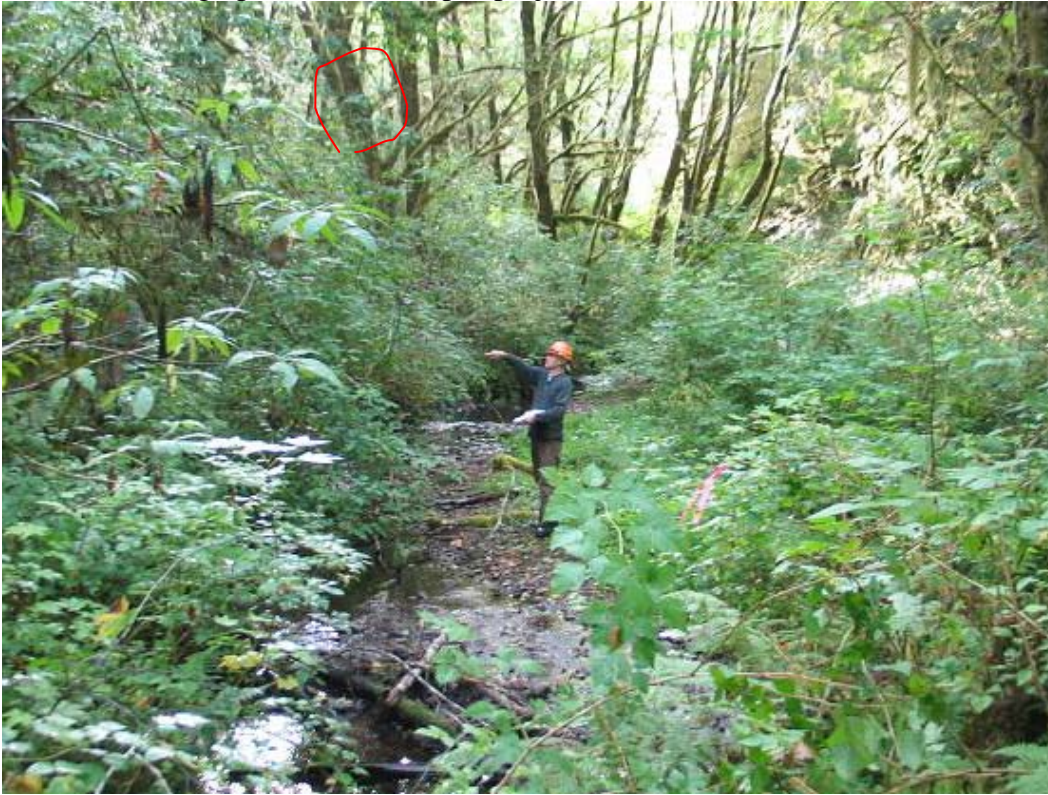
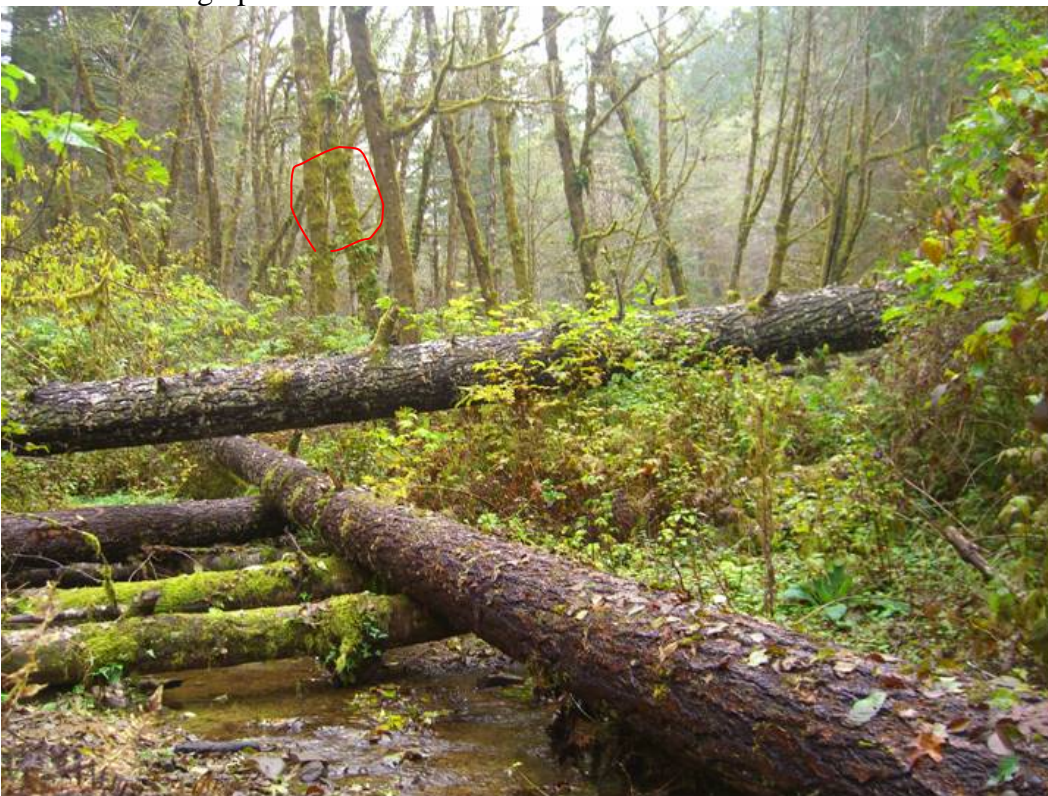
New Comments: Although a majority of the site was covered with bedrock, gravel and fine sediment accumulation is starting to take place in the upstream and downstream end of this structure.

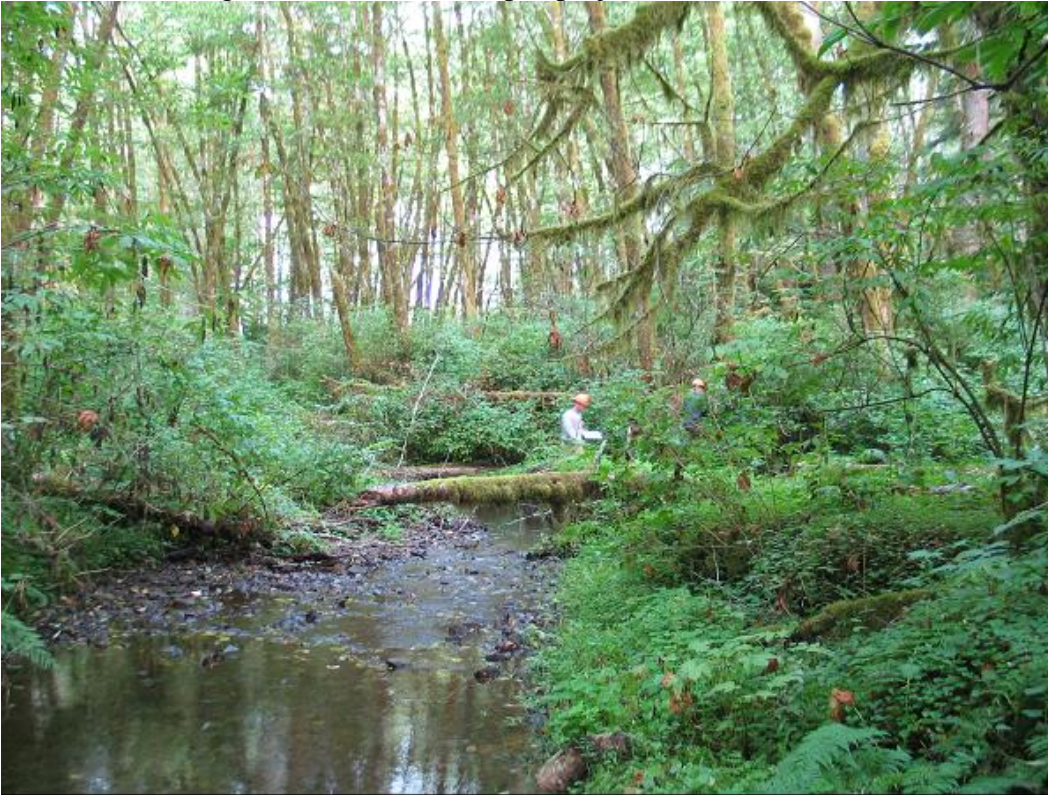
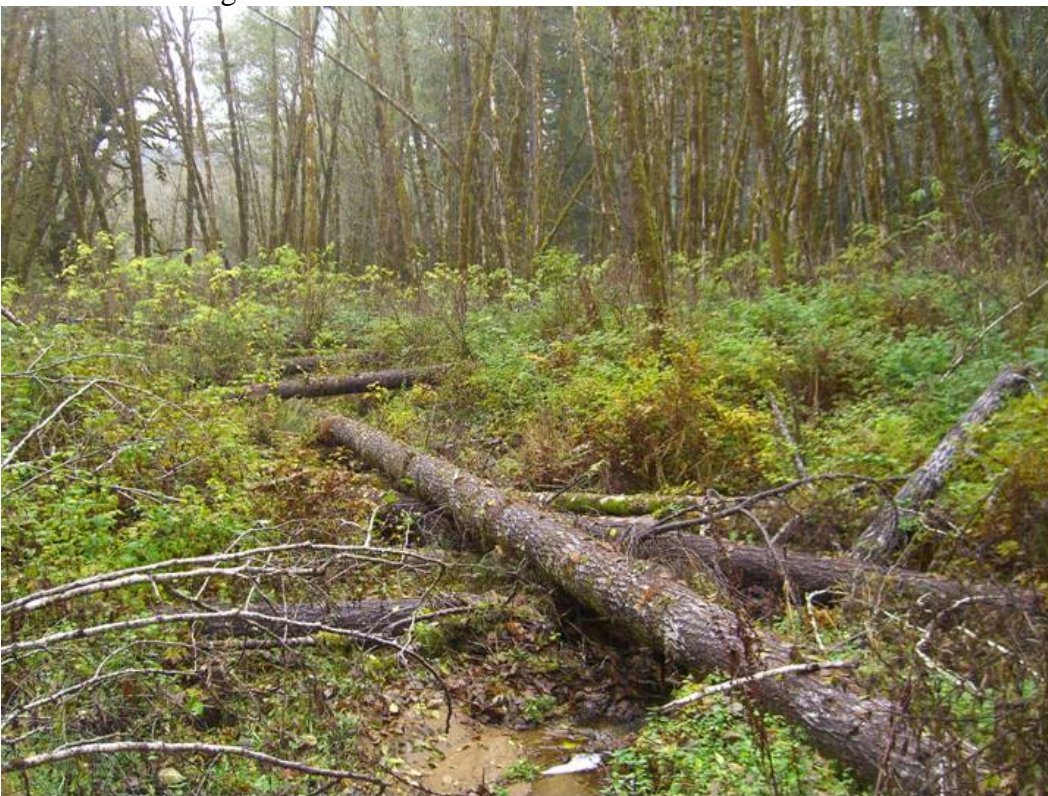
New Comments: Looking at the amount of fine sediment that was collected above the gravel layer, there might have been a small debris slide that deposited all the sand and clay into the structure sites.

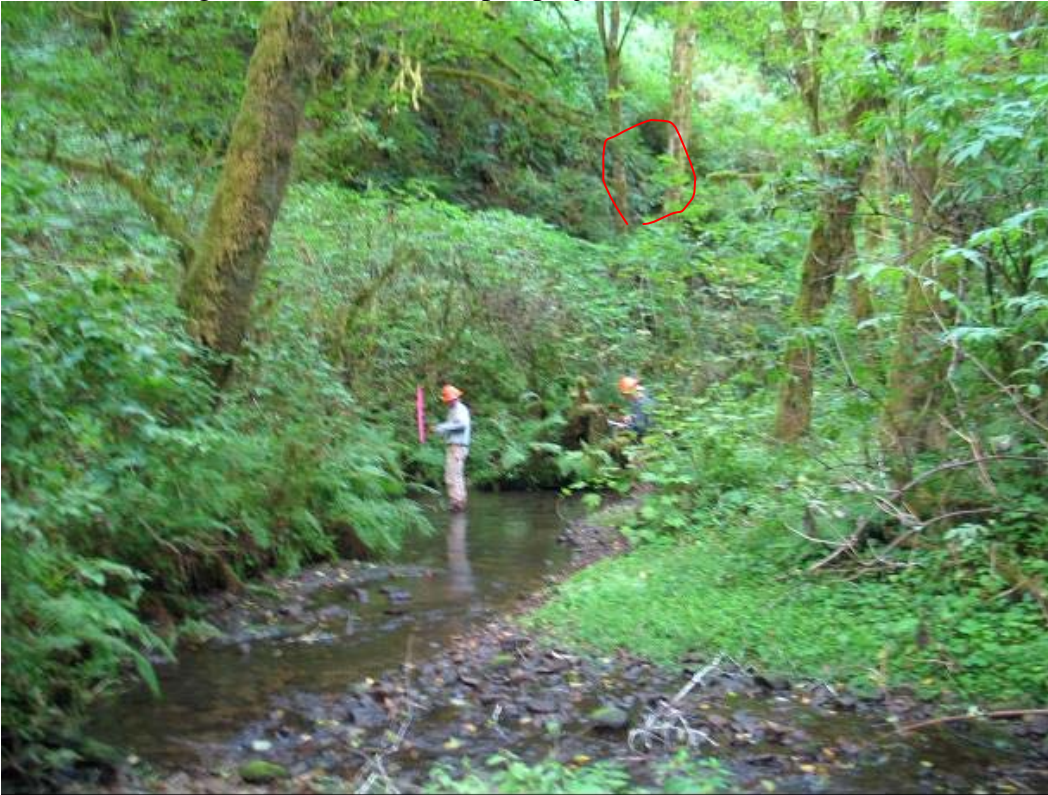
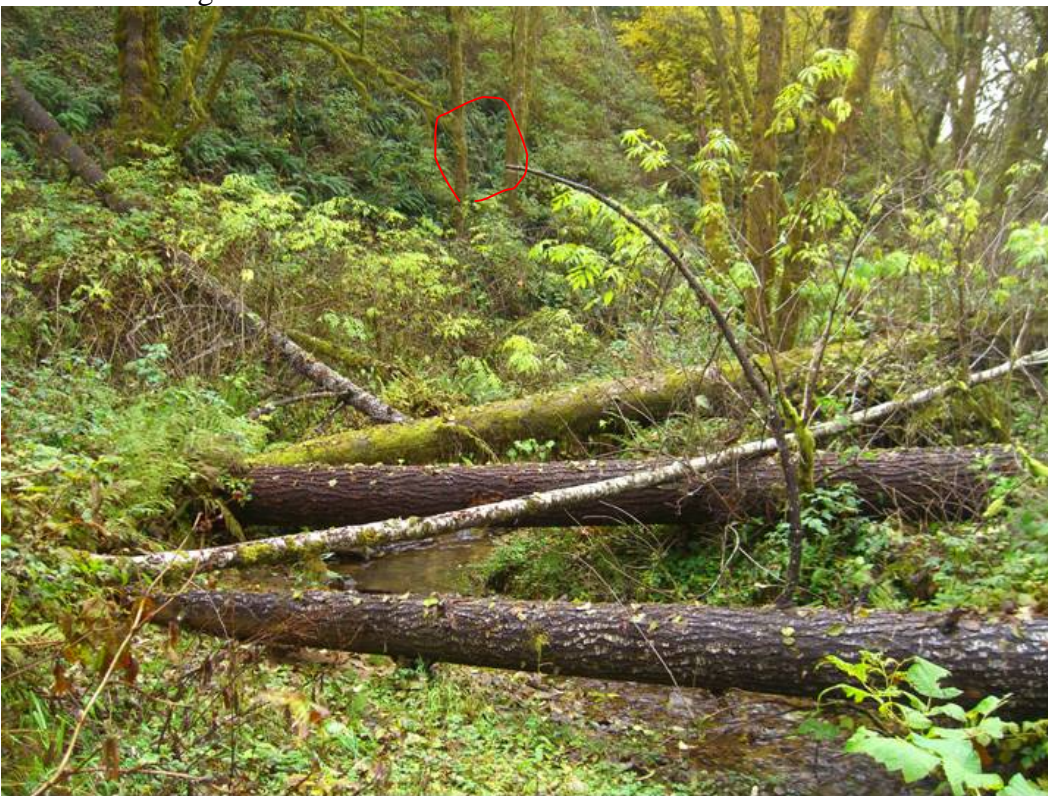
New Comments: The large standing alder on the left fell down into the stream, so that is why you don't see it in the more recent photo. The trees are right on the bottom of the stream, so we look forward to see future changes.

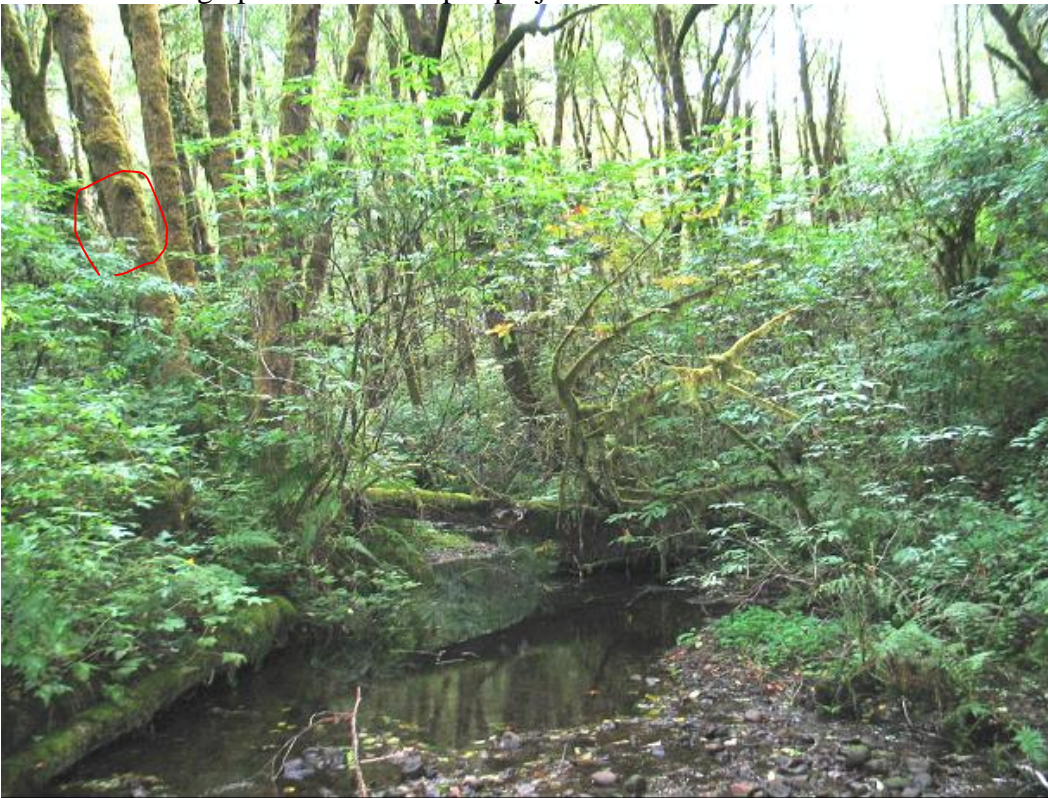
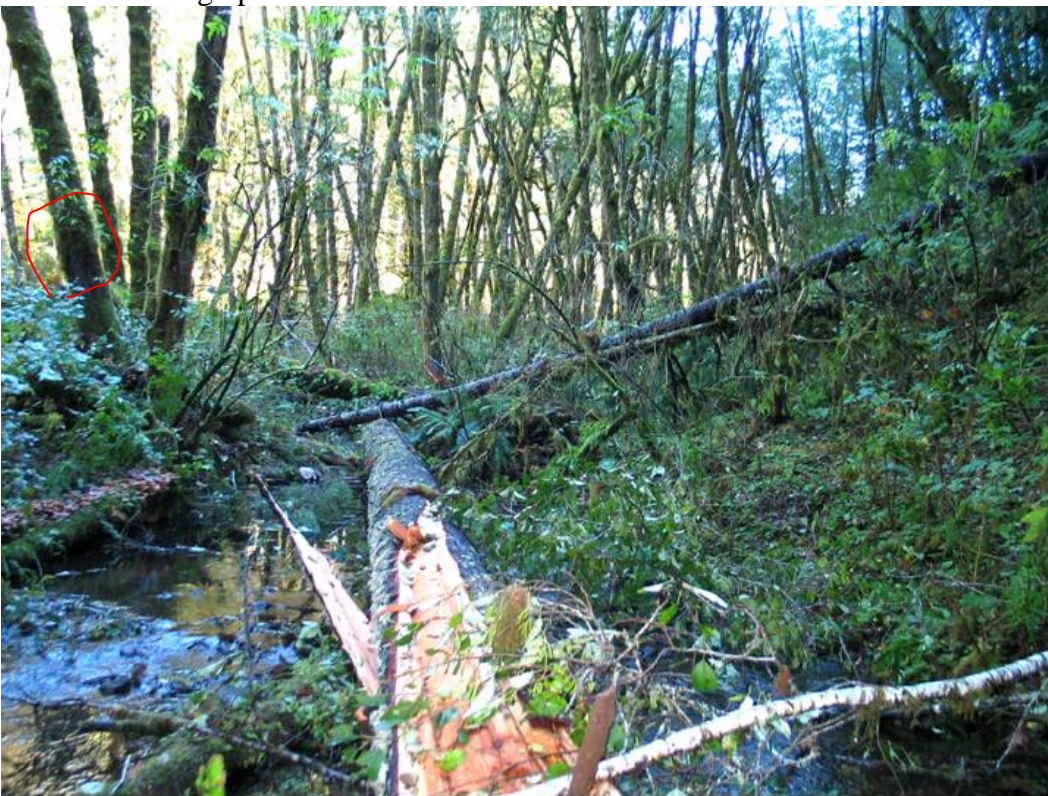
New Comments: Gibson Creek seems to collect a lot of leaf litter and other coarse organic material, and as a result the structure is collecting that and sediment actively around the placed trees.

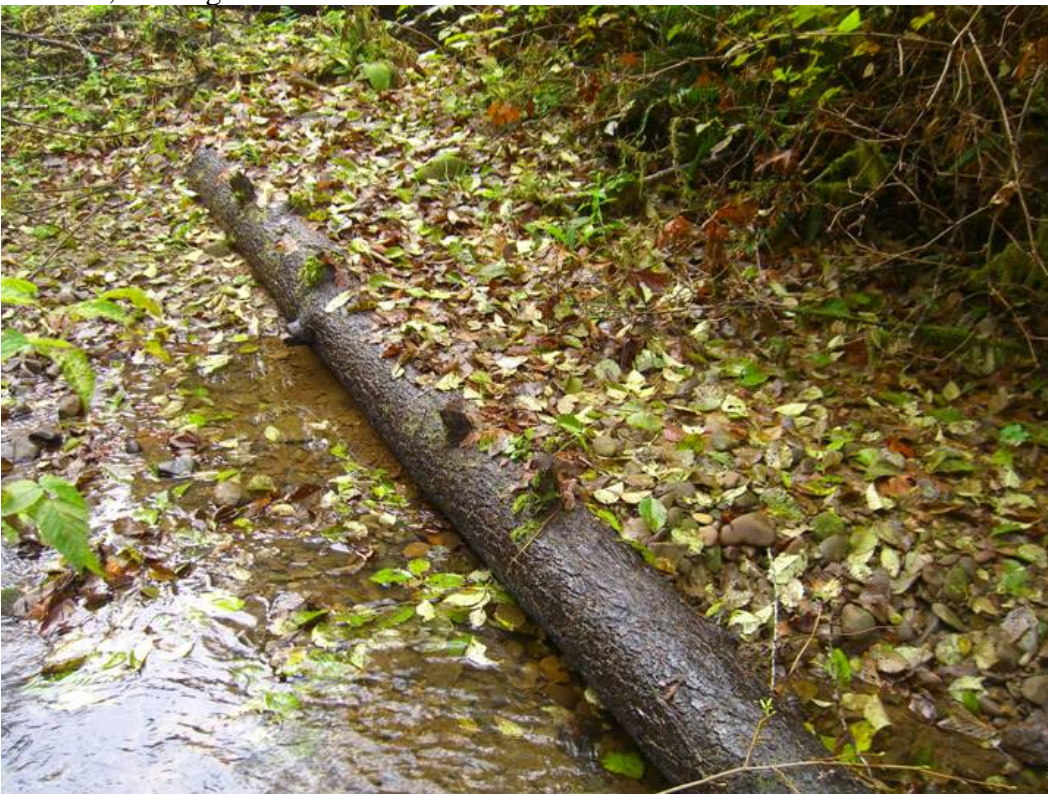
Site #14, looking from side – 2007

New Comments: The two photos above show how much gravel has accumulated by the large wood projects, making the trees blend in with the habitat very well.
