Indian Creek Aquatic Restoration

Oregon Wildlife Heritage Foundation

Narrative Summary:

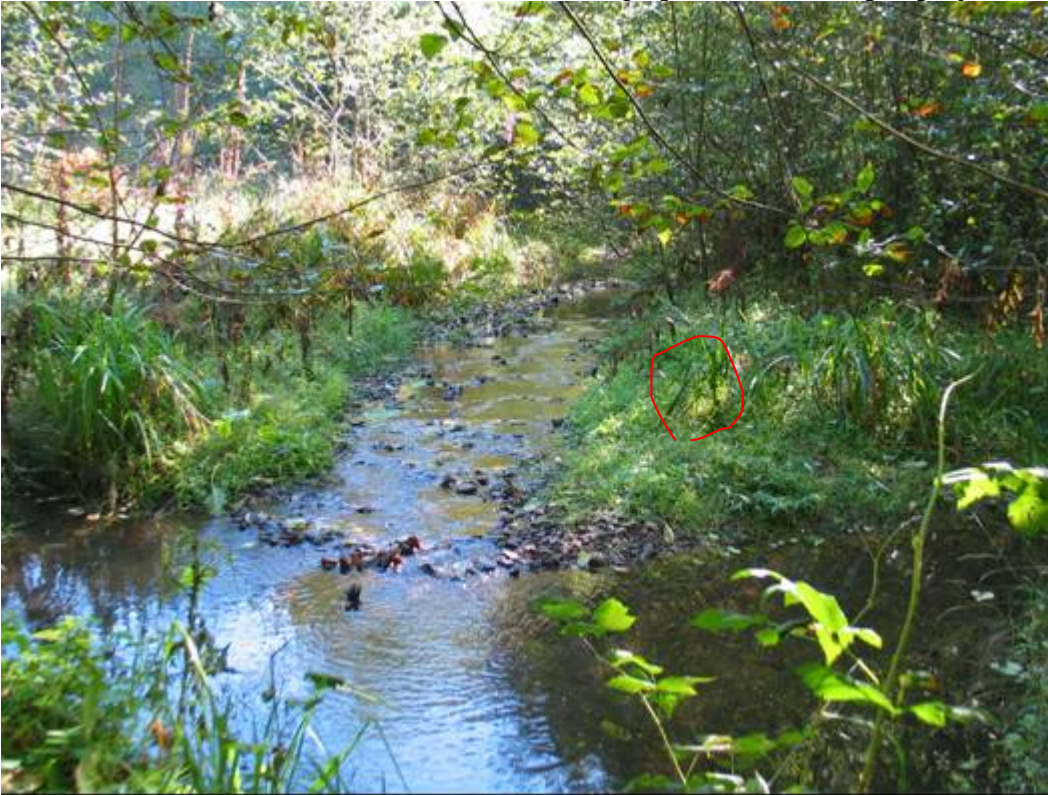
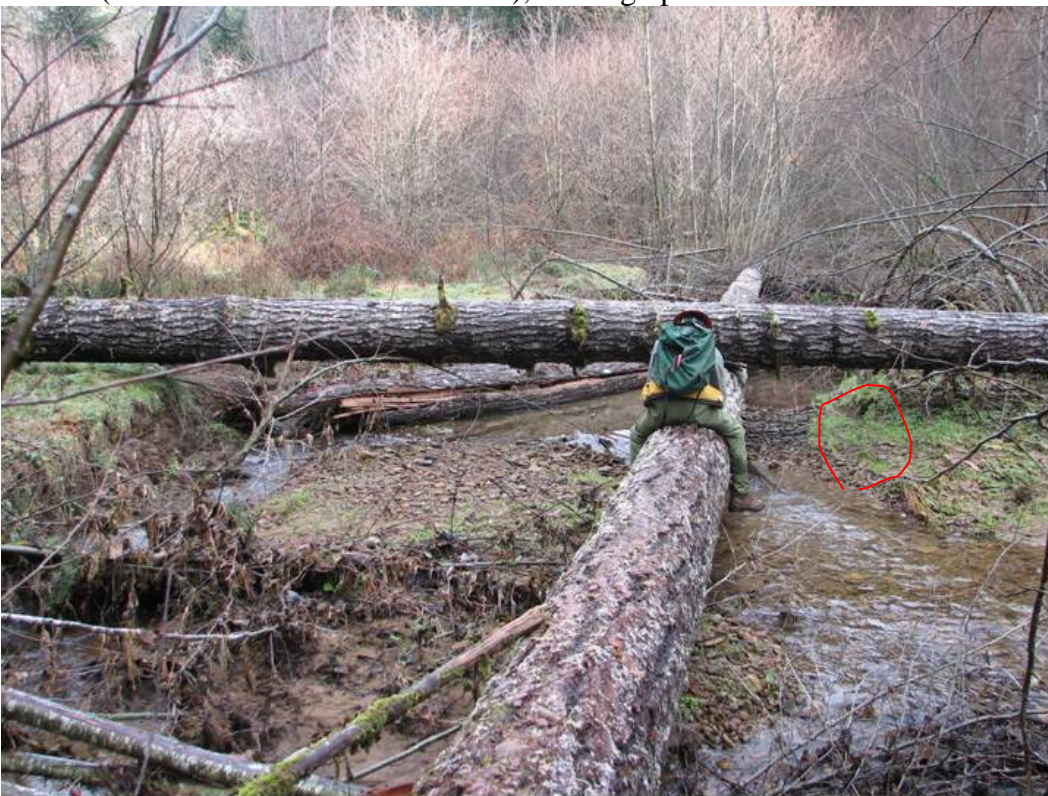
New Comments: Considering the size of the watershed (~1,000 acre watershed = smaller), I was surprised to see the amount of changes as I observed on Taylor Creek from the 2006-2007 winter storms. Newly collected gravel, fine sediment, and small woody debris were observed around virtually all of the 15 structures.

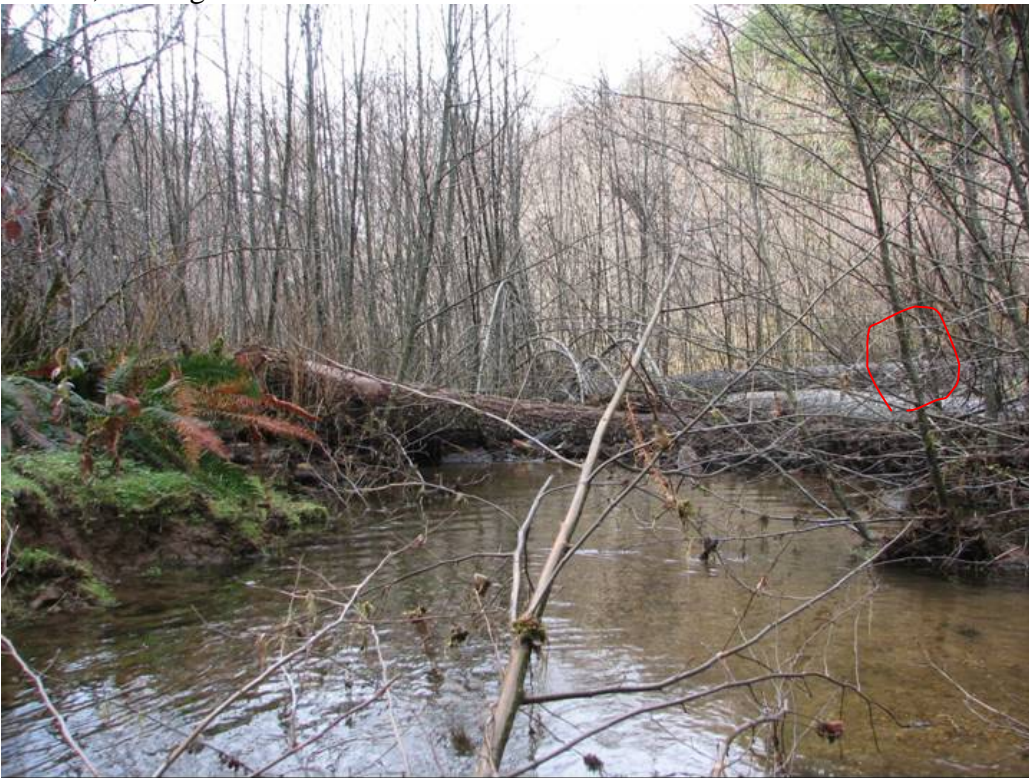
Site #1, looking downstream – 2007

New Comments: Lots of small woody debris collected at upstream end made a new side channel on right side (looking upstream) of the channel going through alders. Scour pools created by logs. Sediment deposited on upstream side. Overall floodplain width increased from new gravel collection dispersing onto the banks. Coho carcasses were found at Site #1 and immediately downstream by some of the cabled tie-down structures.

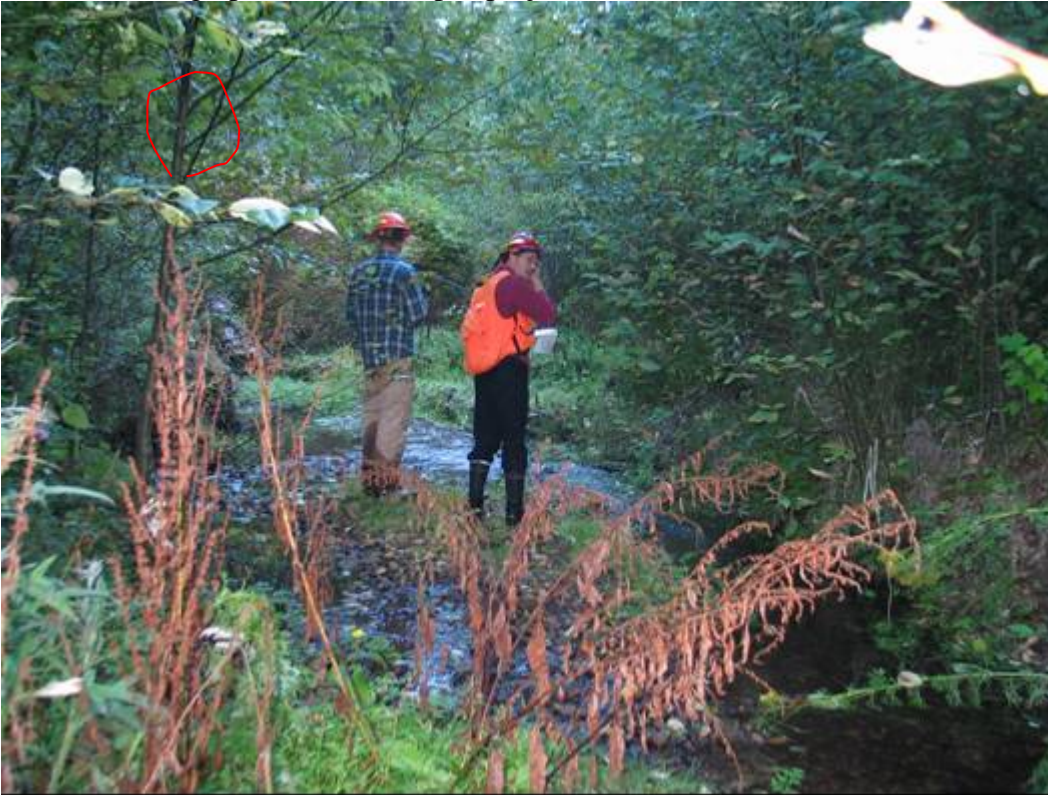
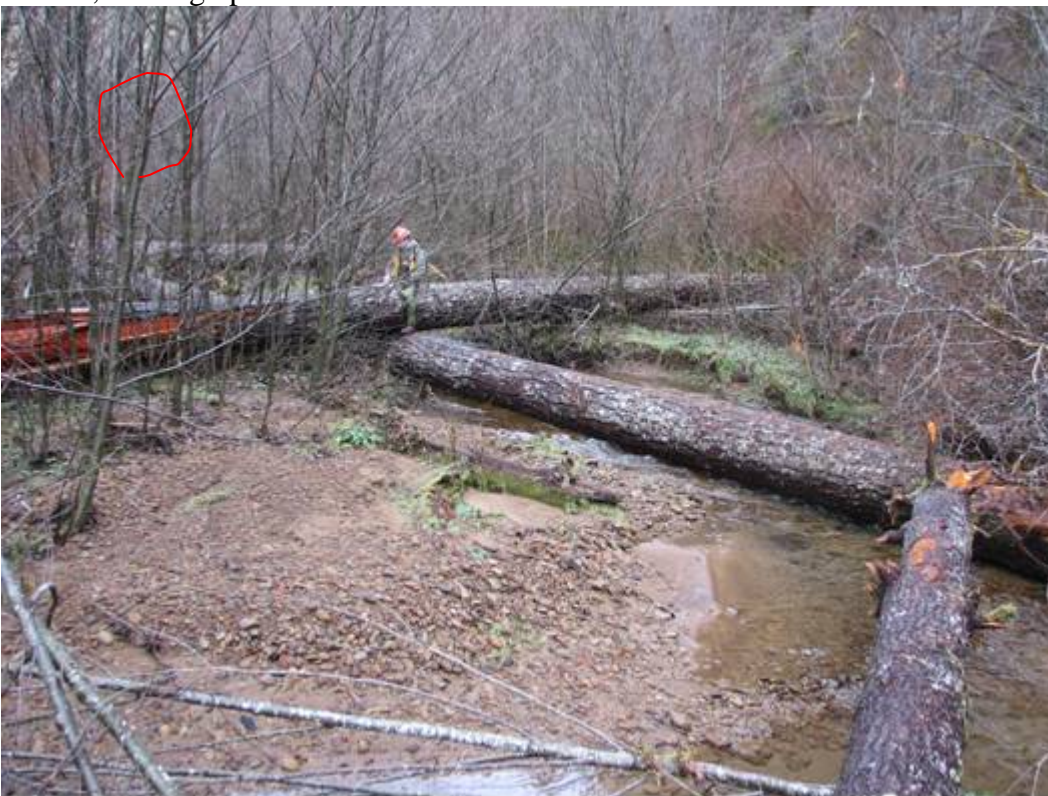
New Comments: Design made on the spot. More gravel found along the structure. Site has increased complexity in terms of the channel formation from the placement trees (stream forced to move through the multiple trees).

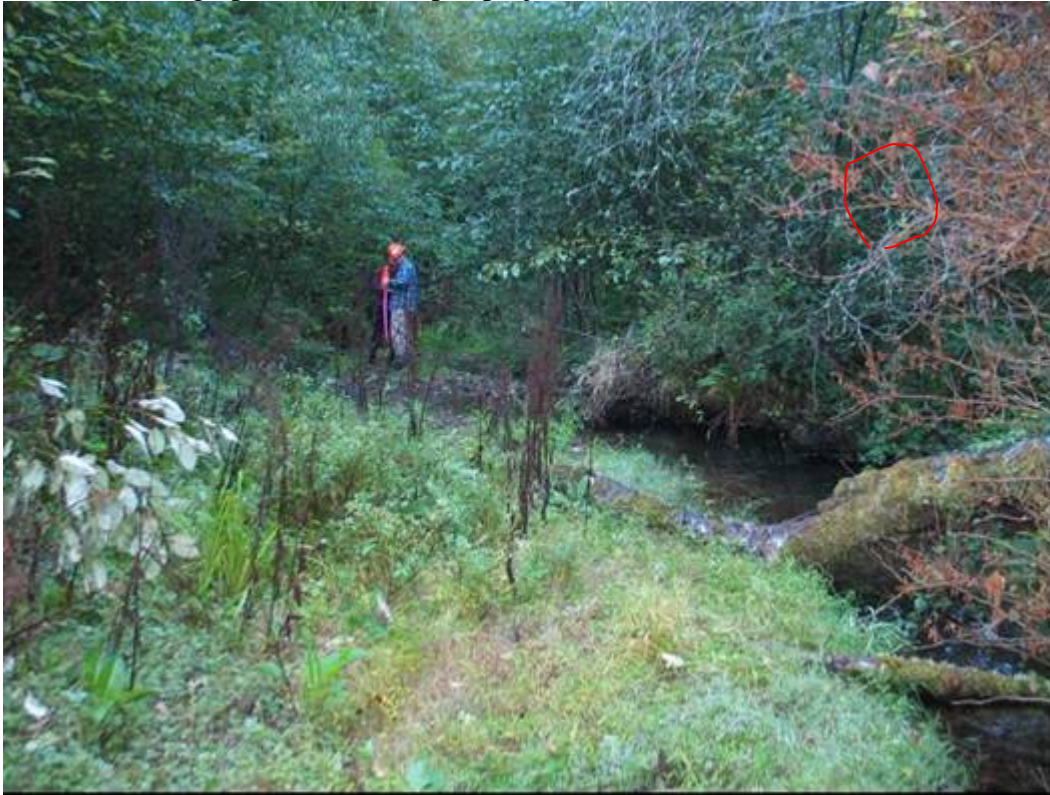
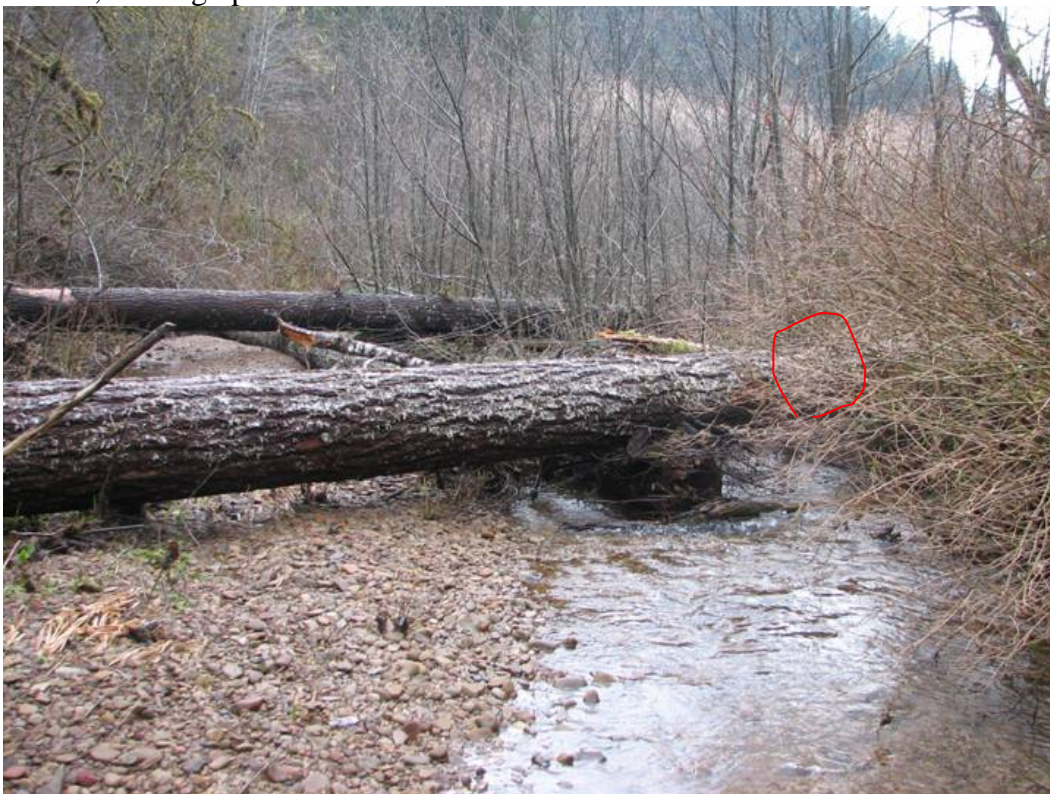
Taylor Creek Site #2 Looking Upstream

New Comments: Biggest changes (in terms of channel complexity) were observed in the lower 5 structures. Widened channel floodplain from newly derived gravel, side channel formation / channel alteration (with more sinuosity), and additional scour pools were observed throughout the structure sites in these lower reach.
