Lobster Creek Sediment Abatement Assessment of U.S. Forest Service Road-Stream Crossings

conducted by
The Curry Soil and Water Conservation District:
Aaron Fitch
Erin Minster
and
Swanson Ecological Services, LLC

on behalf of
The Lobster Creek Partnership

October 2011

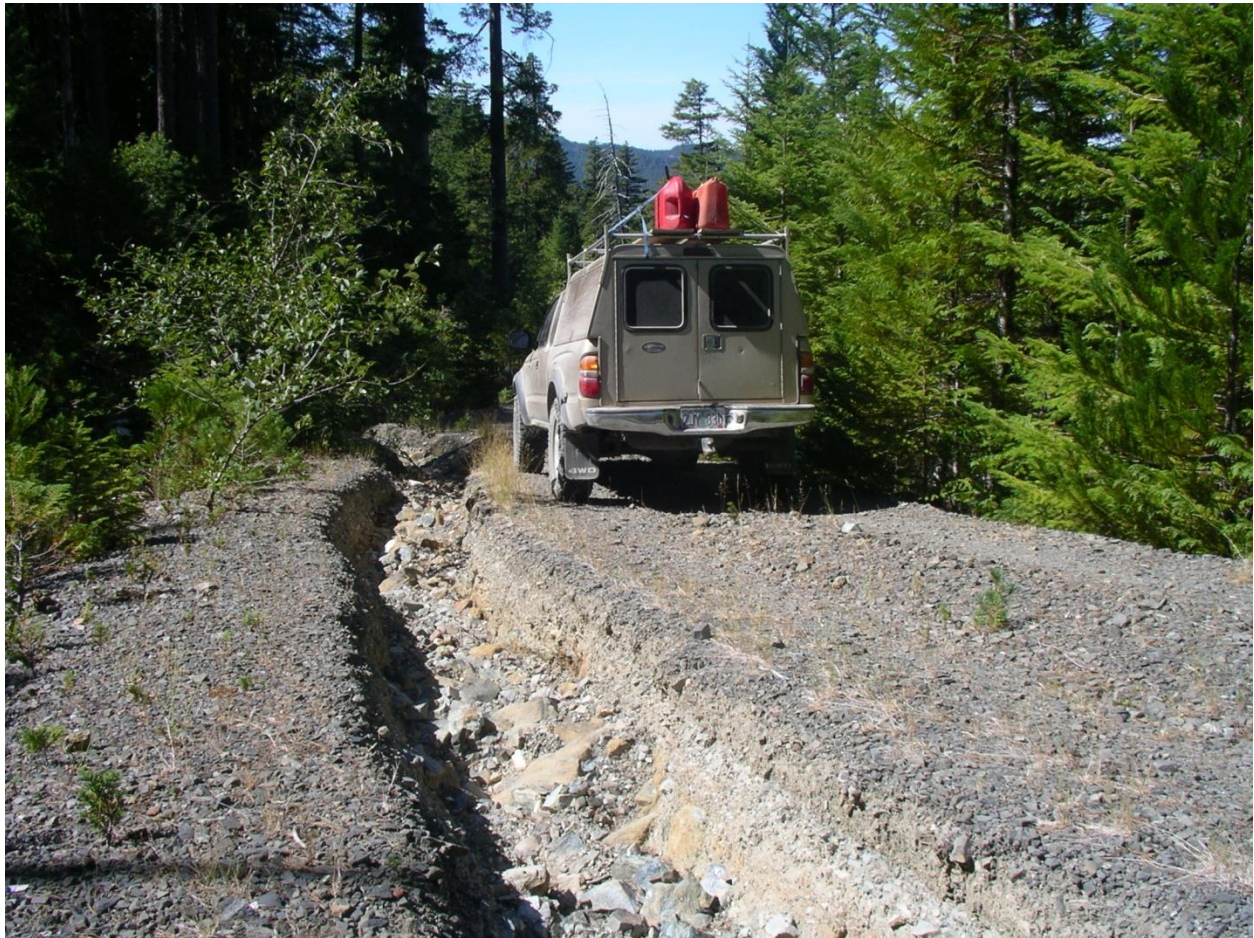
FSR3237130: The road was reassessed up to the intersection with FSR3237132. **The initial 0.5 miles are deeply rutted because the ditches are no longer functioning: the road should be graded with a dozer, waterbars installed, and the ditches cleaned.**

FSR3237130: Lack of routine maintenance such as ditch cleaning and road grading may prevent water from leaving the road prism, which can result in gullies and/or slides that contribute sediment to the stream network and increase costs.

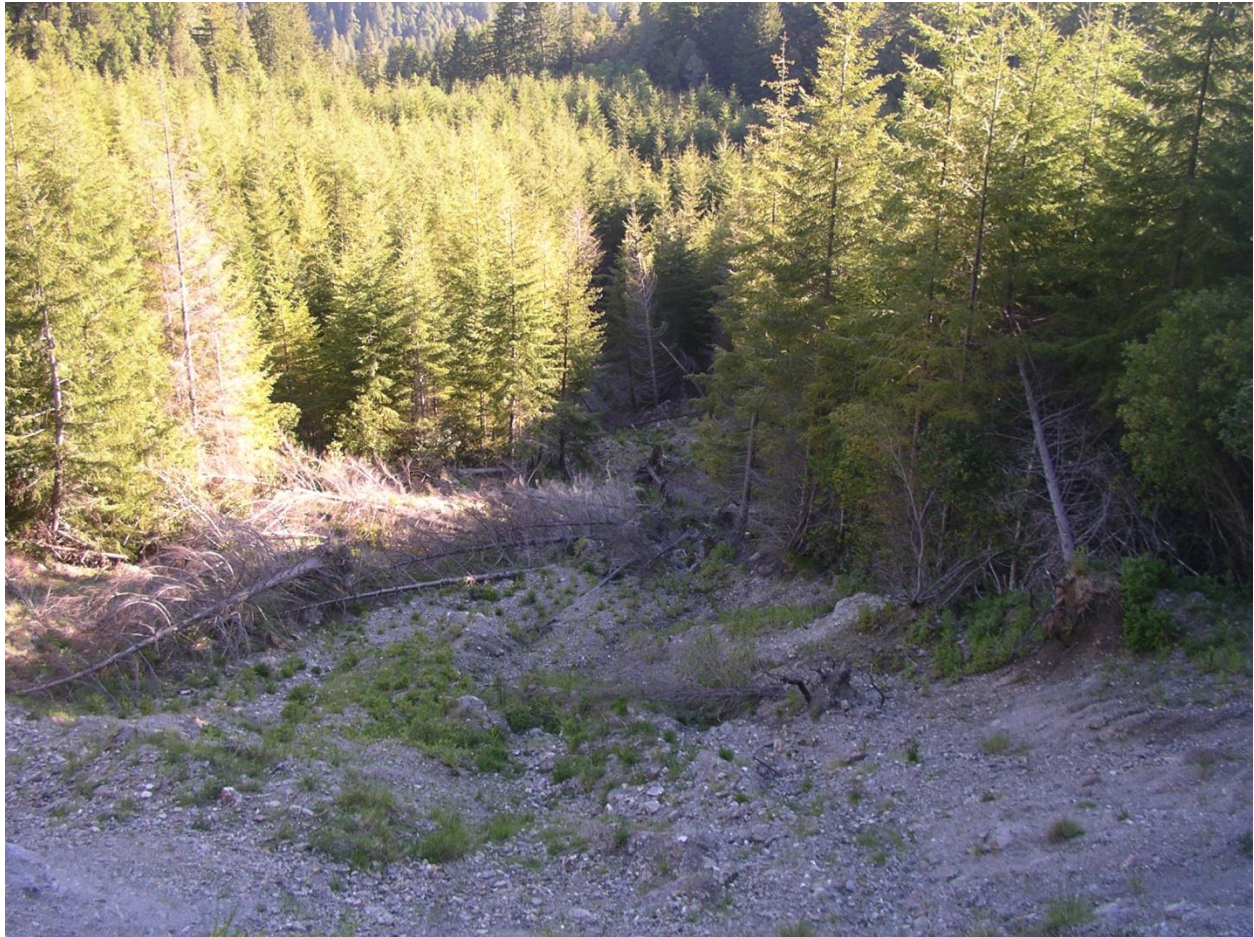
FSR3340140: Road fills displaying cracks, scarps, and/or horsetails are at risk of failure. In Lobster Creek these failures have potential to “run-out”, which destroys forest and timber resources and may contribute sediment to the stream network. Reconstruction often requires realignment, which can be a significant, if not prohibitive, expense.

FSR3340140: Between mp 0.00 and the intersection with FSR3340150 the road is susceptible to both large scale movement and failure of the road fill. Near mp 0.90 a large fill failure occurred within the last few years that narrowed the drivable surface to less than 10 ft in width. The slide was likely triggered by runoff; it ran out for approximately 500 ft, consuming 3-4 acres of reprod. Within this segment of road there are four road-stream crossings that are Moderate-High priorities. These culverts are at or near the end of their useful life, and most of the sites are prone to plugging. Failure rates may be slow at a few sites, but they should be addressed given their potential to initiate slides. Between the intersection with FSR3340150 and mp 1.870 the road is in relatively good condition, but brush is beginning to encroach on the drivable surface. The road-stream crossings within this segment are relatively stable and in good condition, but headwalls could be constructed at one or more of the sites to reduce the risk of diversion. Beyond mp 1.870 there are a few slumps that are still drivable, and the need for minor drainage improvements. Two road-stream crossings near the end of the road should be addressed. Mp

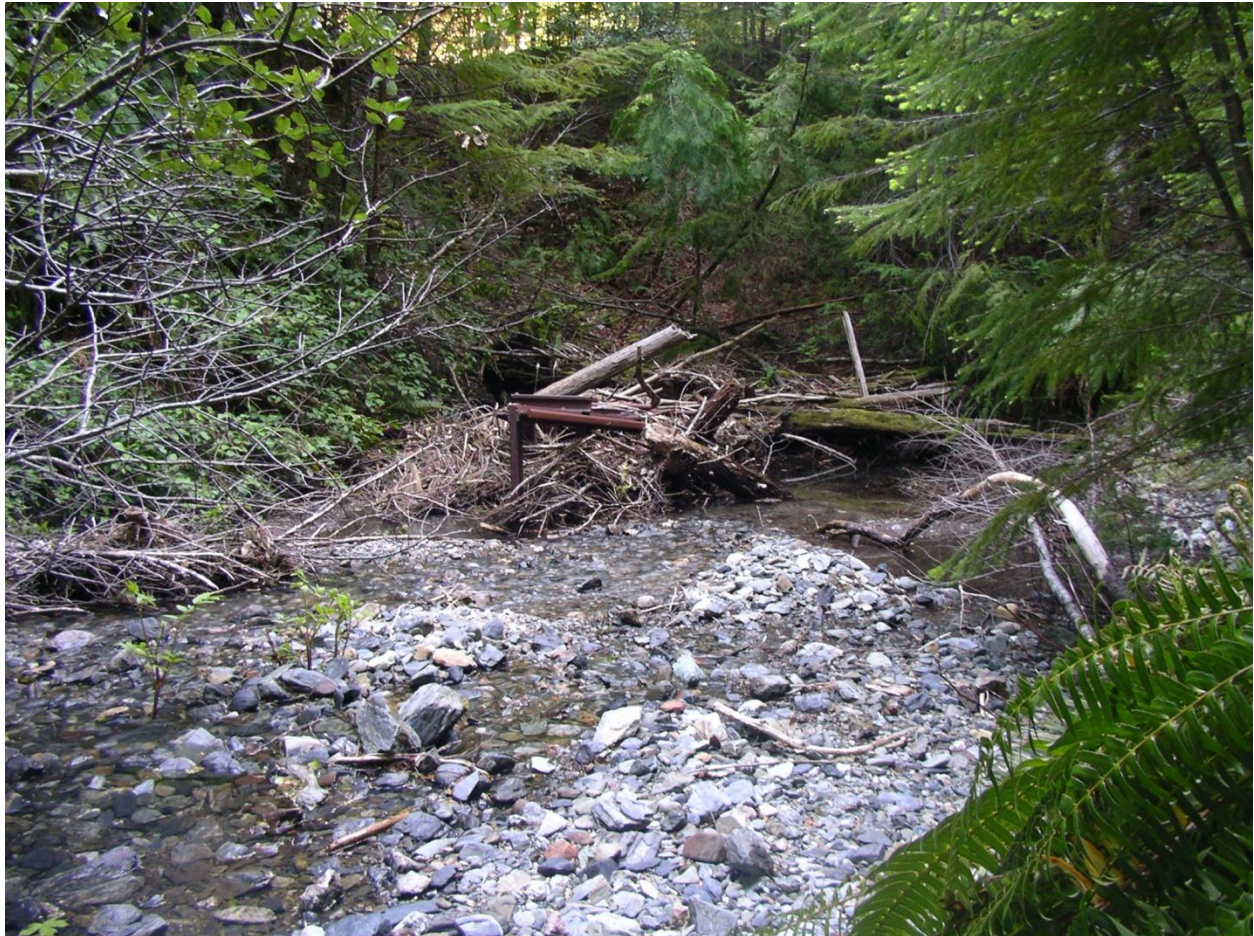
3.790 could be retrofitted with a headwall to increase capacity. Mp 3.870 may be a fish passage site; further investigation is needed. In addition, there is a larger railroad iron trash rack at mp 3.870 that has prevented the site from plugging, but it is getting buried and is at risk of plugging. Beyond mp 3.87 the road ends in a stand of old growth; if no future management is planned for this area, the crossing at mp 3.87 could be a candidate for decommissioning.

FSR3340140 mp 3.870: “Trash Racks” constructed with I-beam or railroad track were installed at many of the larger crossings to prevent culverts from plugging. In general these structures have performed well, but overtime 100’s – 1000’s of cubic yards of sediment have deposited upstream, which can “starve” the downstream channels of needed bedload, and increase reconstruction costs. These structures also create or contribute to fish passage impediments and barriers.
