MOSS CREEK REHABILITATION PROJECT

**GOVENER'S WATERSHED ENHANCEMENT BOARD
(GWEB)
PROJECT #88-041B**

1996 MONITORING REPORT

**SUBMITTED BY
TILLAMOOK COUNTY SOIL & WATER CONSERVATION
DISTRICT**

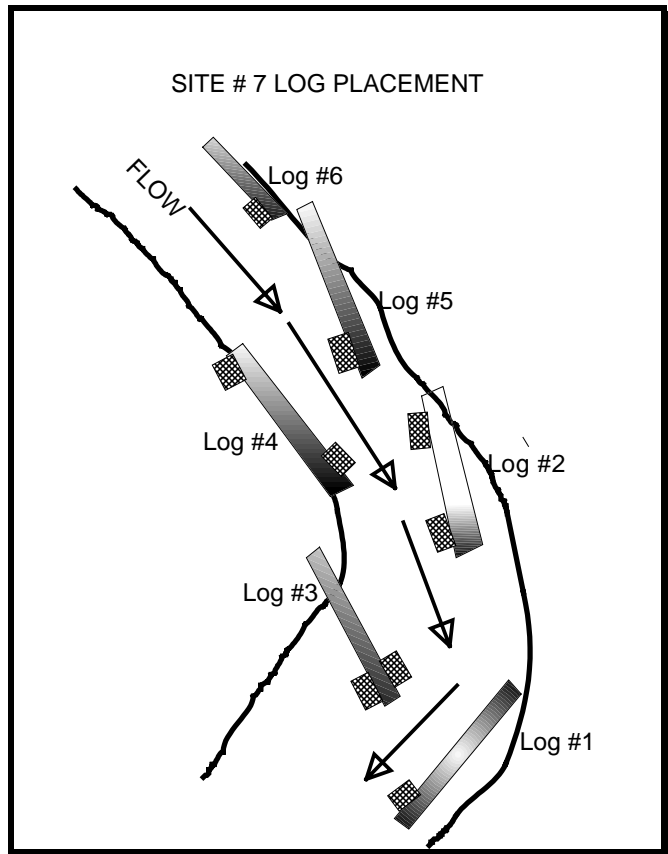
Log Number 3 is located across creek on north side. Log is at a 45 degree angle with stream flow. This log extended across the creek. Approximately 3 feet of the log extending onto the south side was sawed off. This left approximately two thirds of the log extending across the creek channel. The log is 33 feet long and 3 feet in diameter. The end that is out of the channel is wedged against the upstream side of a tree. Gravel bar has built up on this side. Two gabion baskets, 6'x3'x3' filled with rock, were placed on the downstream end of the log that extends into the channel. One gabion was placed on the upstream side of the log and one placed on the downstream side. Cable was wrapped around the log three times and through the gabion on the log's downstream end. Cable was wrapped around the log and through the gabion twice on the log's upstream side. (see figure)

Log Number 4 is located on same side of channel and upstream from log number 3. It is 42 feet long and 2 1/2 feet in diameter and parallels the stream flow. Two rock filled gabions, 6'x3'x18", were placed at both ends. Gabions were placed on opposite sides. Log was drilled twice at both ends. Cable was run through the log and gabions at both ends. (see figure)
