# 2003 Restoration Project Effectiveness Monitoring Report

## Fish Passage Improvement Projects

### Summary

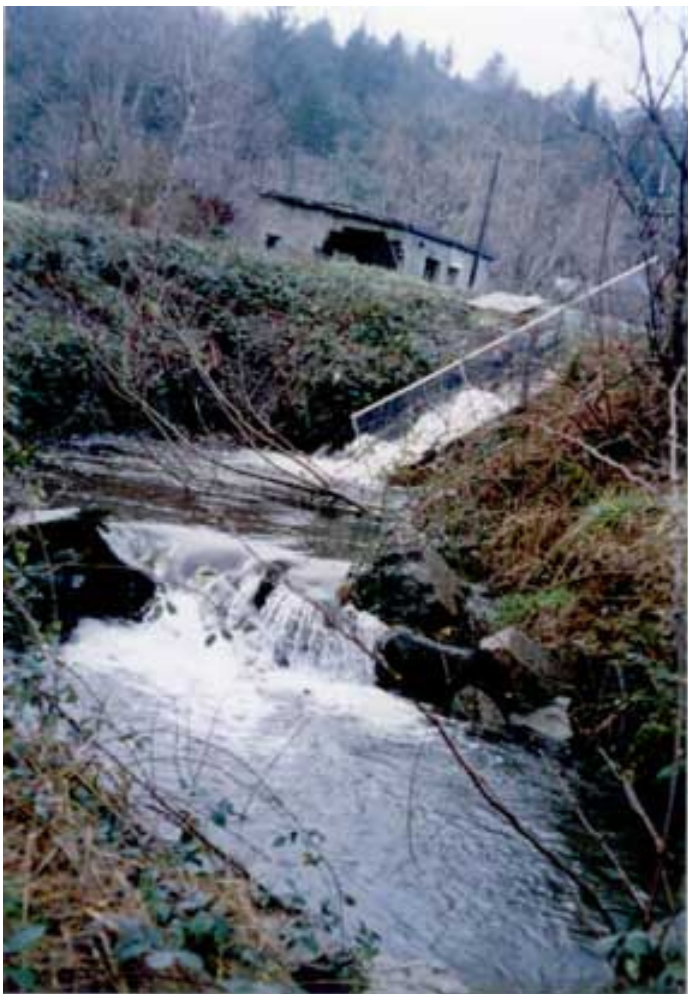
Boulder weir constructed to raise water level at fish ladder upstream, 11/96 View of original weir and first new downstream weir, 01/99

Original boulder weir with smaller step after more weirs installed, 01/99 Closeup of first new downstream weir, 01/99

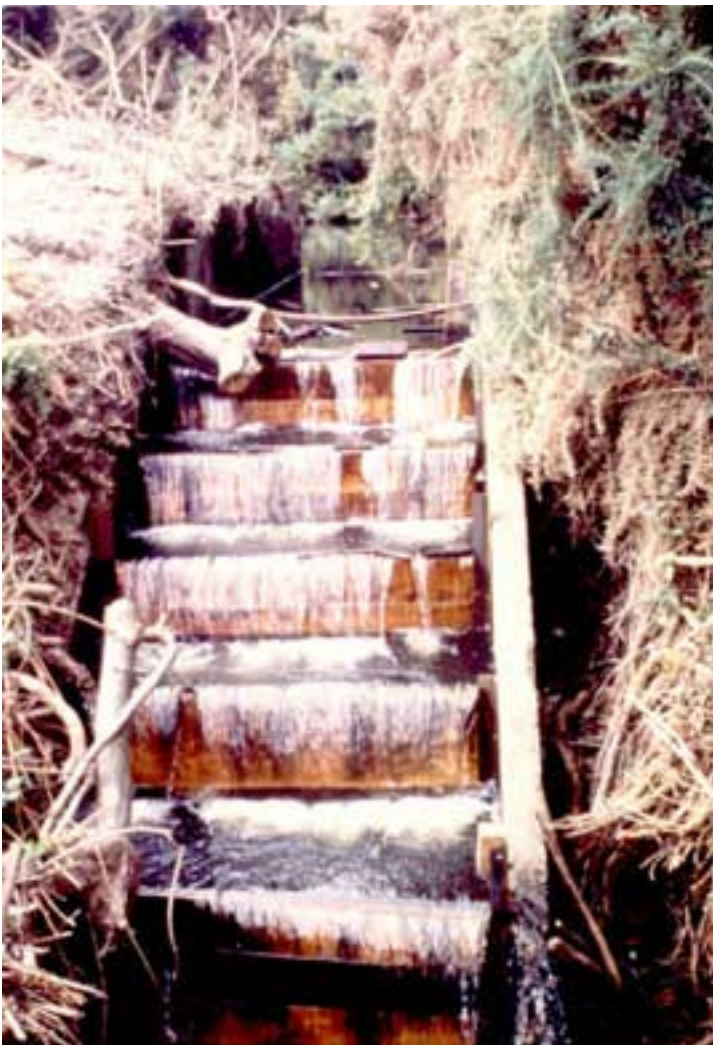
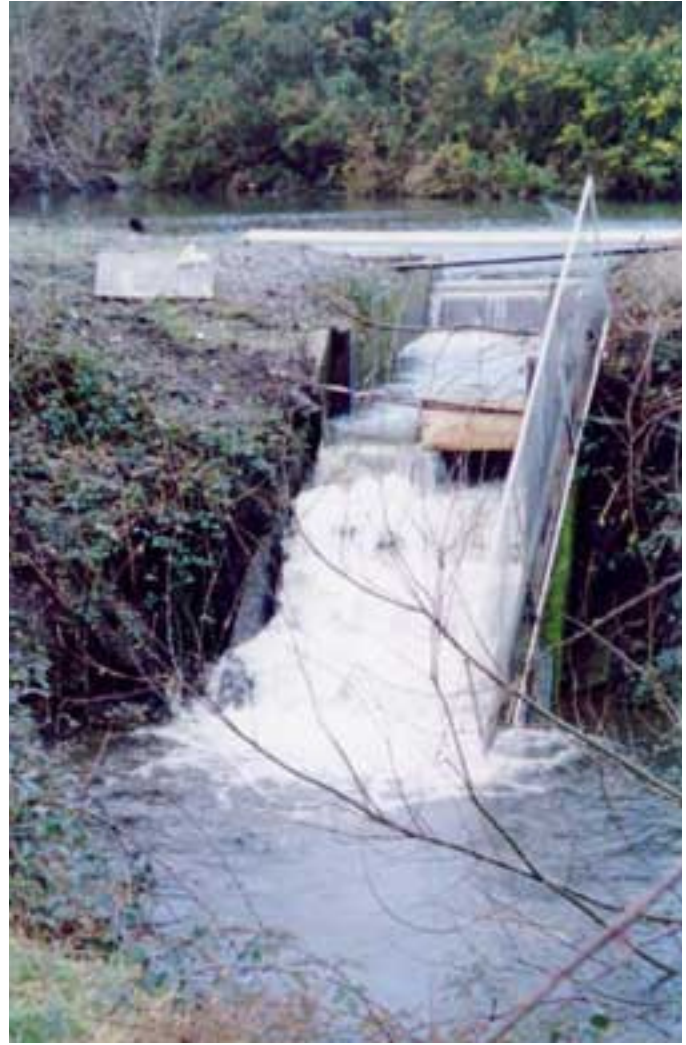
**Bagley Creek – Jump Pool Weirs cont.**

One of two downstream weirs showing jump height, 02/14/00 Other downstream weir showing jump height, 02/14/00

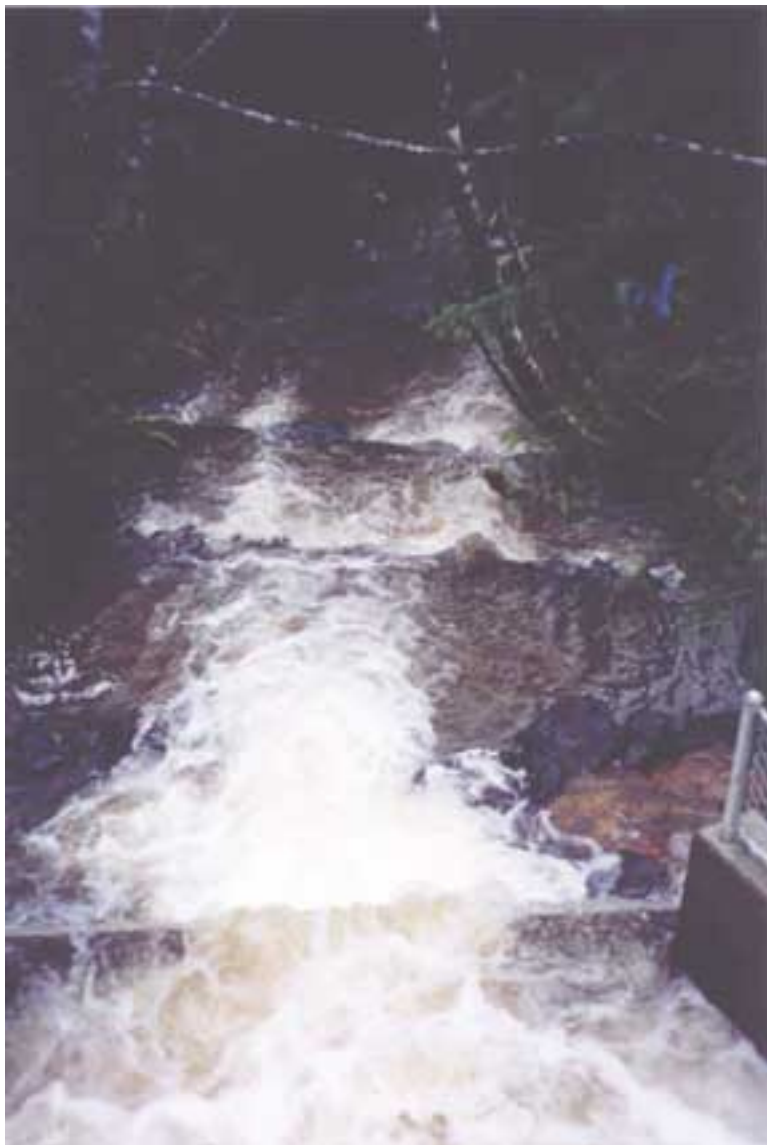
## North Fork Hubbard Creek Reservoir Spillway and Jump Pool Weirs

Looking downstream at jump pool weirs. Top weir not intact. 02/02/99

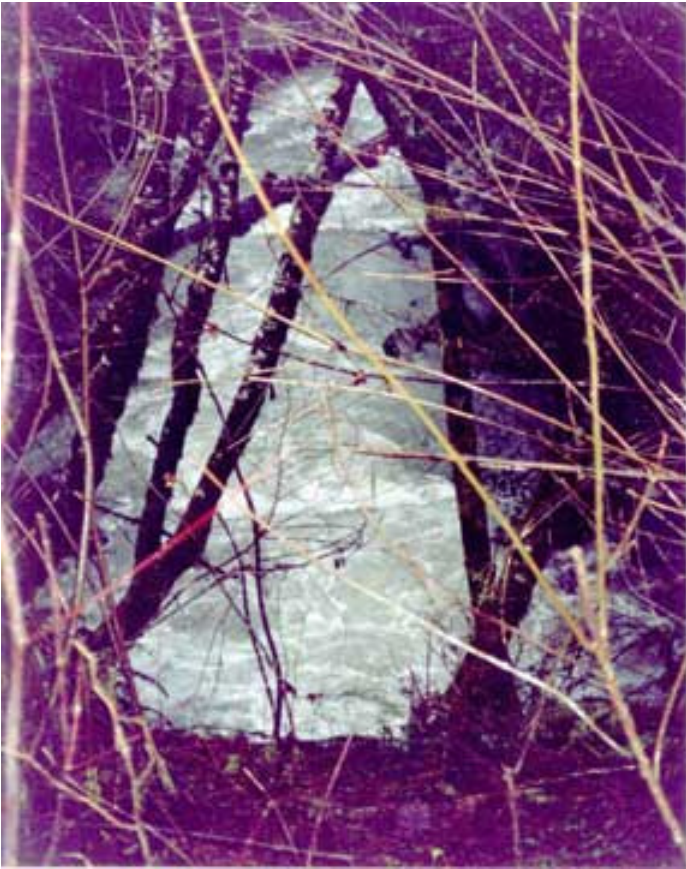
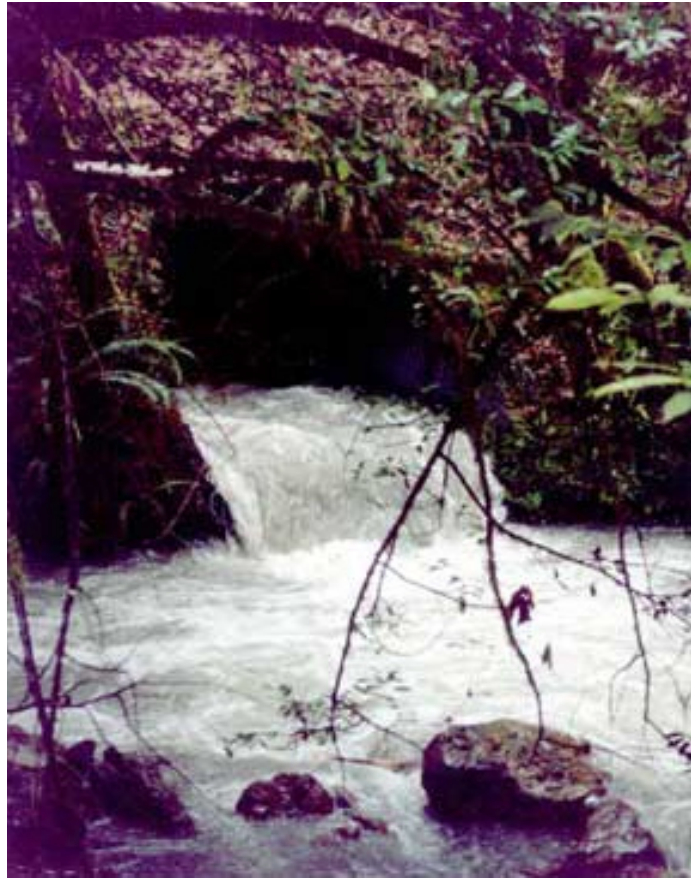
**Deadline Creek – Jump Pool Weirs, 02/23/99**

View from road looking downstream at three boulder weir steps Culvert outlet drop with reduced height due to boulder steps

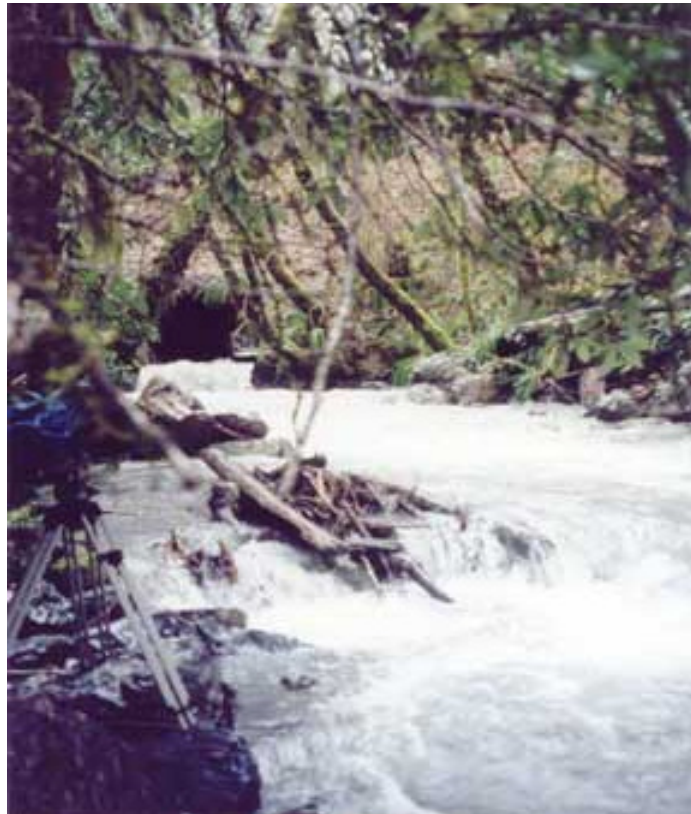
Looking upstream at two of the steps

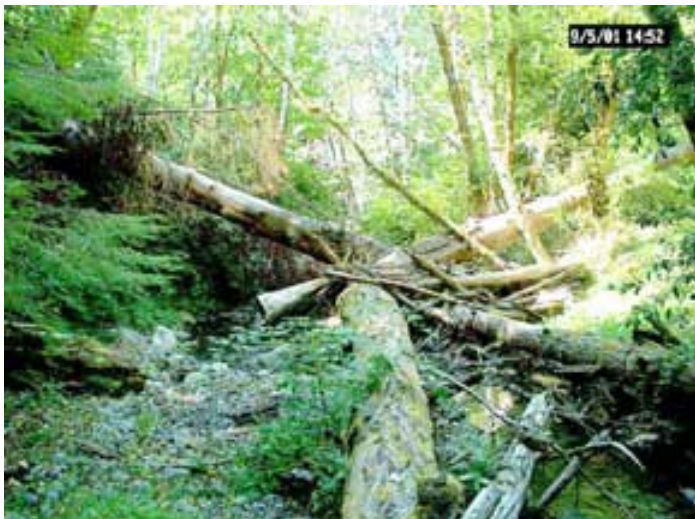
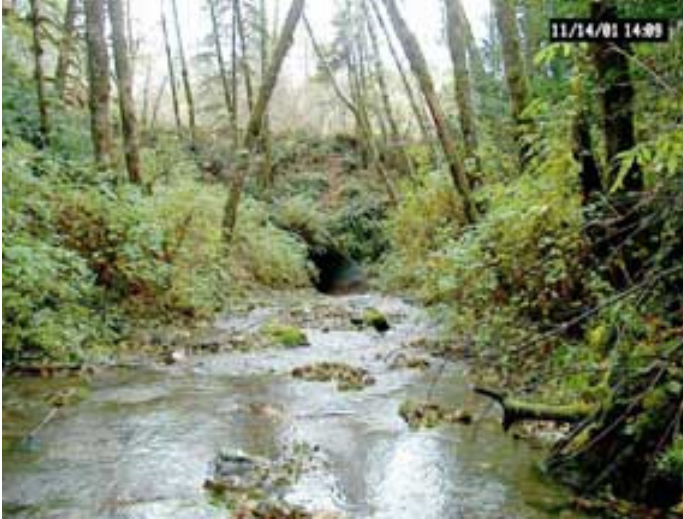
**Deadline Creek – Jump Pool Weirs, 2001**

Large wood placement downstream of jump pool weirs, 09/05/01    Looking downstream at the inlet, 11/14/01

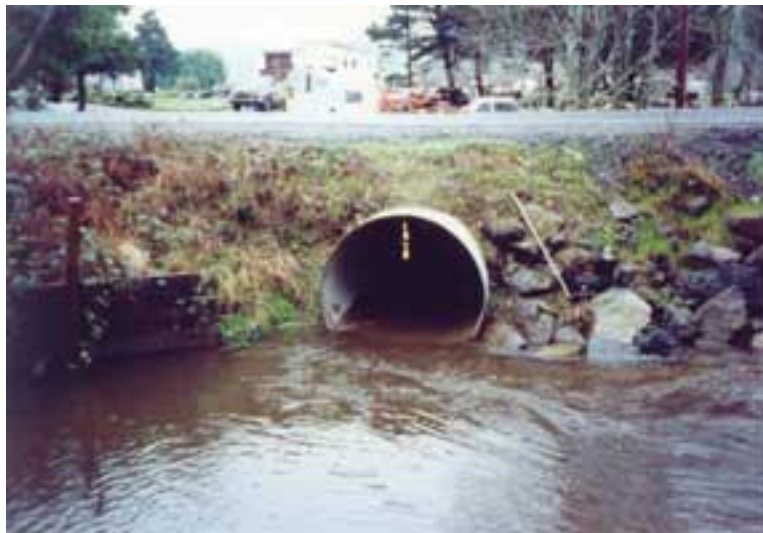
The new 6' diameter, 50' long culvert was installed at about 2.5%. The inlet is an excavated fire pond where Bagley Creek is forced into a 90-degree turn into the culvert. The 6' wide culvert constricts the 9.3' to 11' wide bankfull channel. On 2/14/00 velocities were measured during a 85-90% bankfull flow. Velocities inside the culvert ranged from 1.5-2.9 fps, with at least one measurement below 2.0 fps on all cross-sections except one (representing a 10' interval). The average water depth was only 6". The gravel and sand substrate may be caused by deposition of the coarse particles in the inlet pond. If this is occurring, the inlet pond may fill with sediment within a short period of time. The lack of resting areas creates a velocity condition that is marginal for juvenile passage. Seeding the culvert with boulders would ensure the existence of resting opportunities. The site should be checked during summer conditions to see if water flows subsurface through the substantial accumulation of sand in the downstream half of the culvert.

View into inlet, 02/14/00

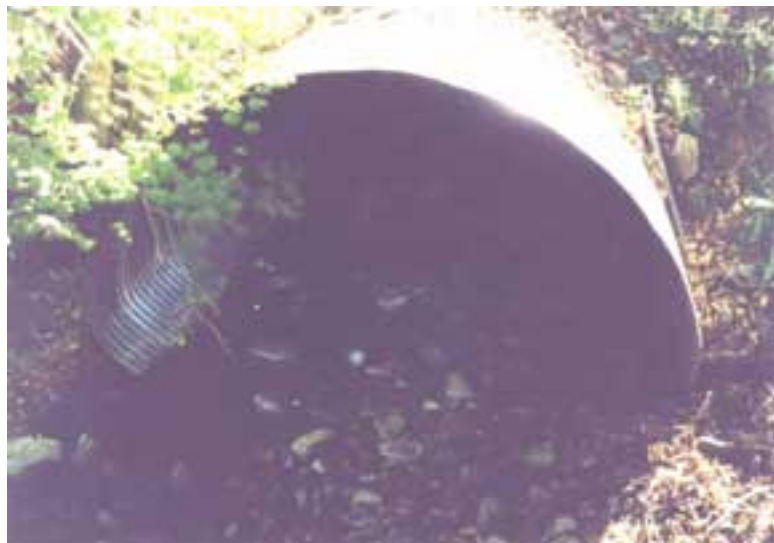
Looking upstream at outlet from riprap

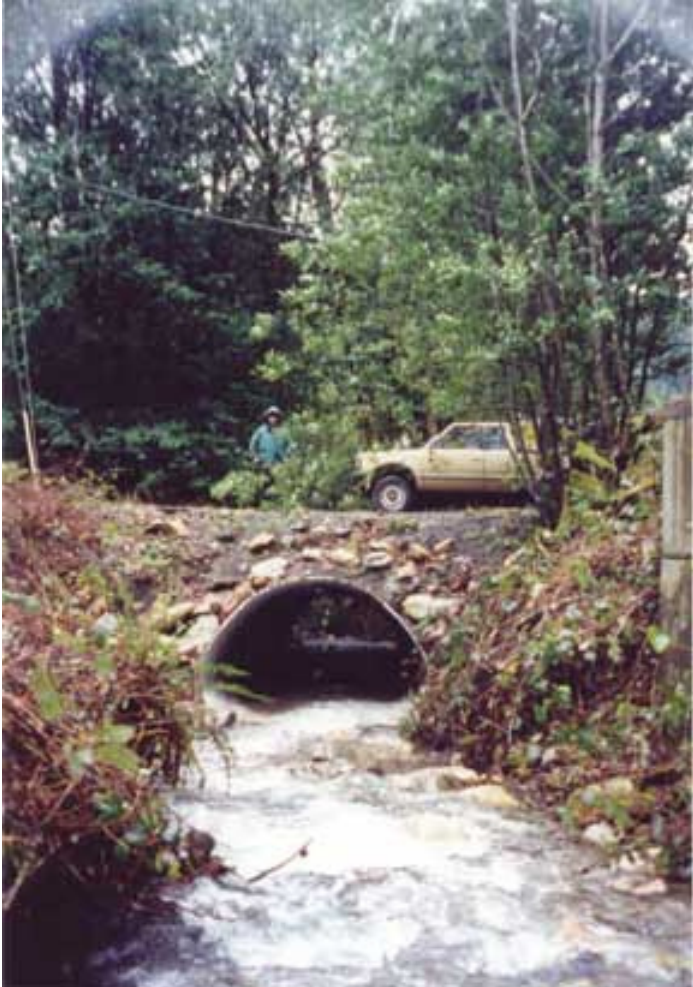
Looking downstream at the beveled inlet

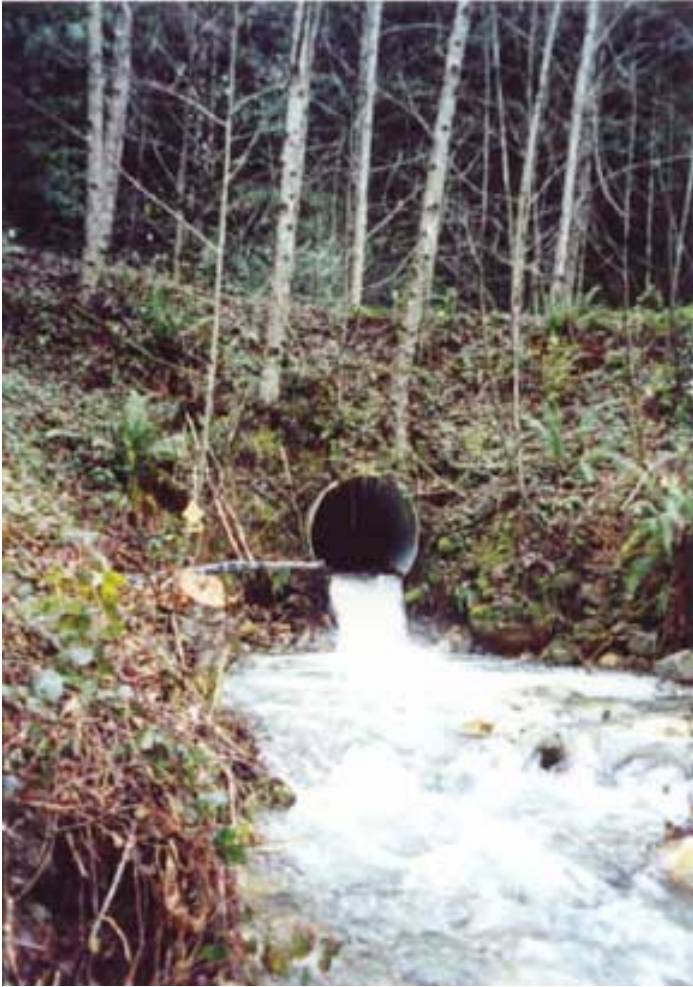
Another barrier with 3-4' drop, upstream on a private road

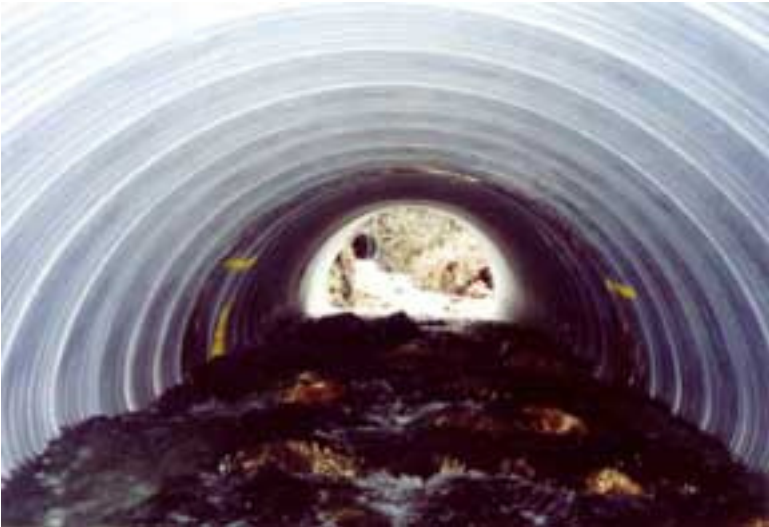
Looking upstream through the culvert at boulders

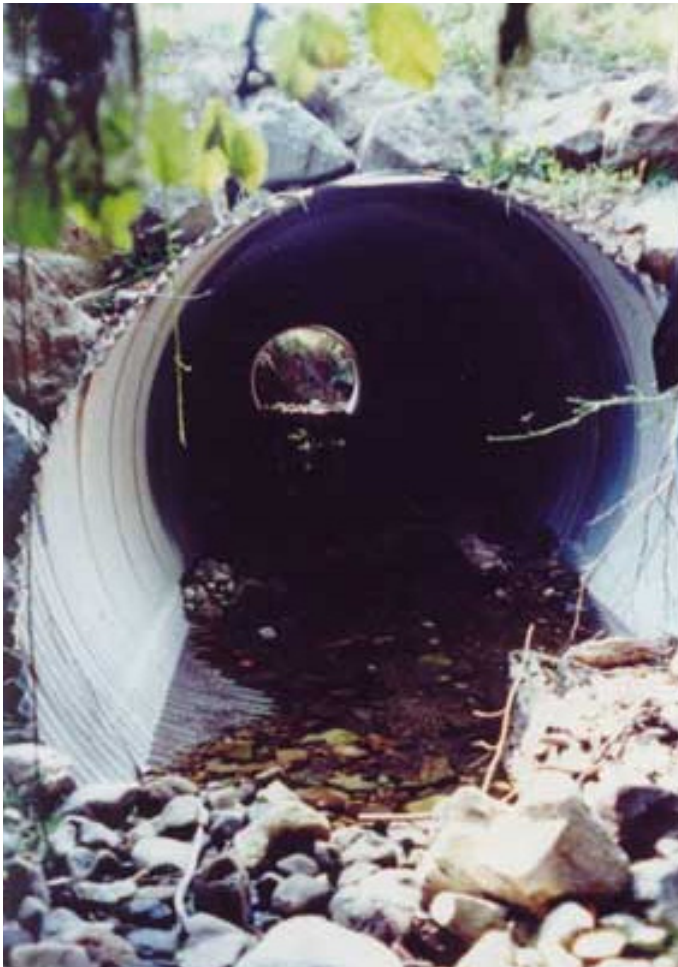
Looking downstream at the material collecting at the inlet, 09/30/99 Outlet, no drop, 09/30/99

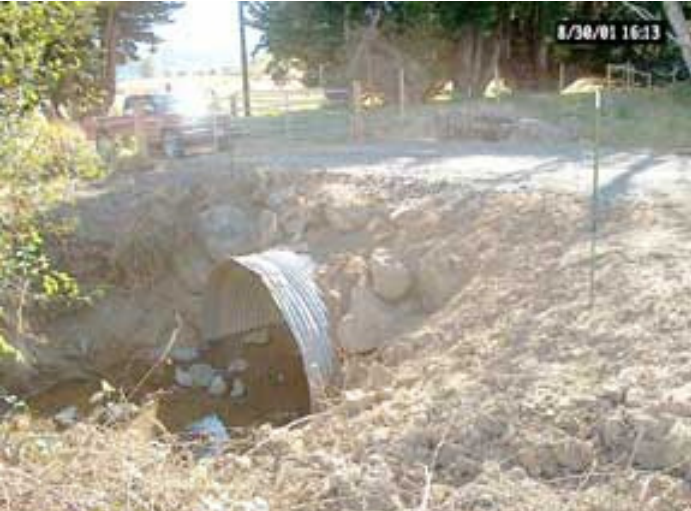
Outlet of the downstream culvert following installation, 08/30/01

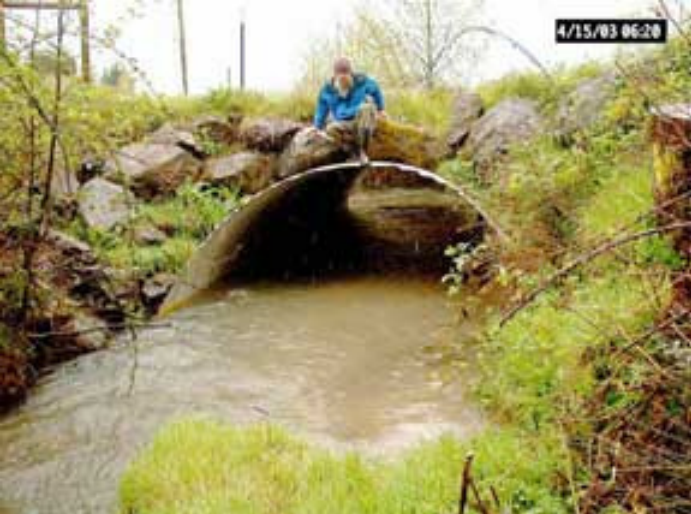
Inlet of the downstream countersunk culvert, 04/15/03

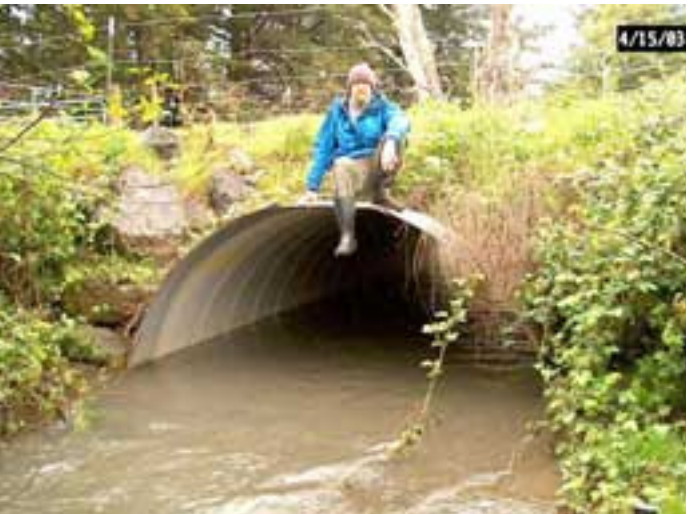
Outlet of the downstream countersunk culvert, 04/15/03

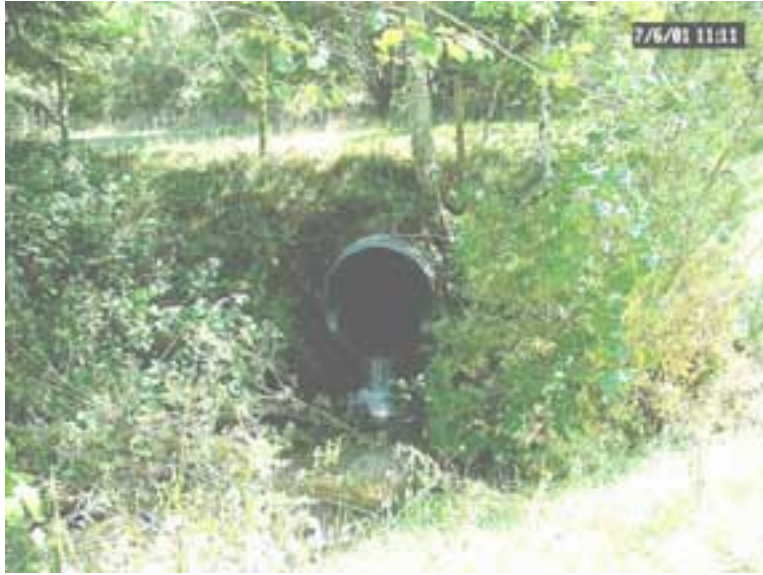
Looking at the outlet of the former culvert, upper crossing, 07/06/01

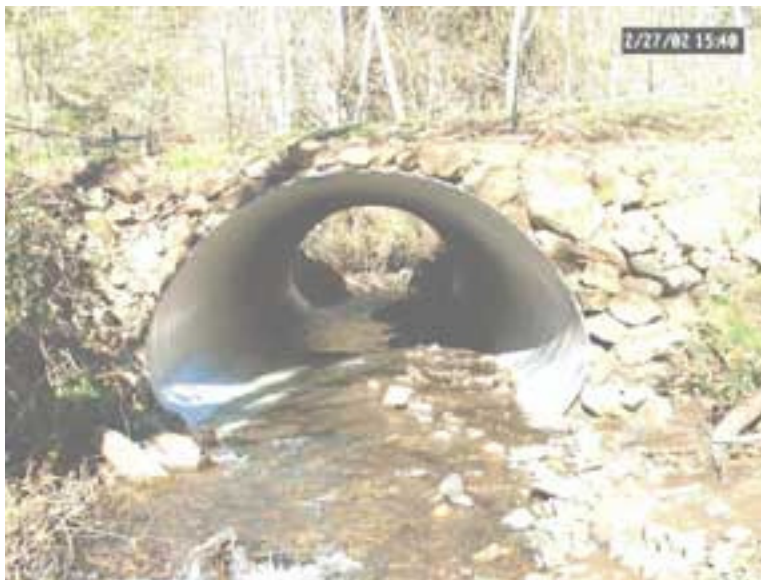
Looking upstream at the countersunk culvert, notice shallow deposition, 02/27/02

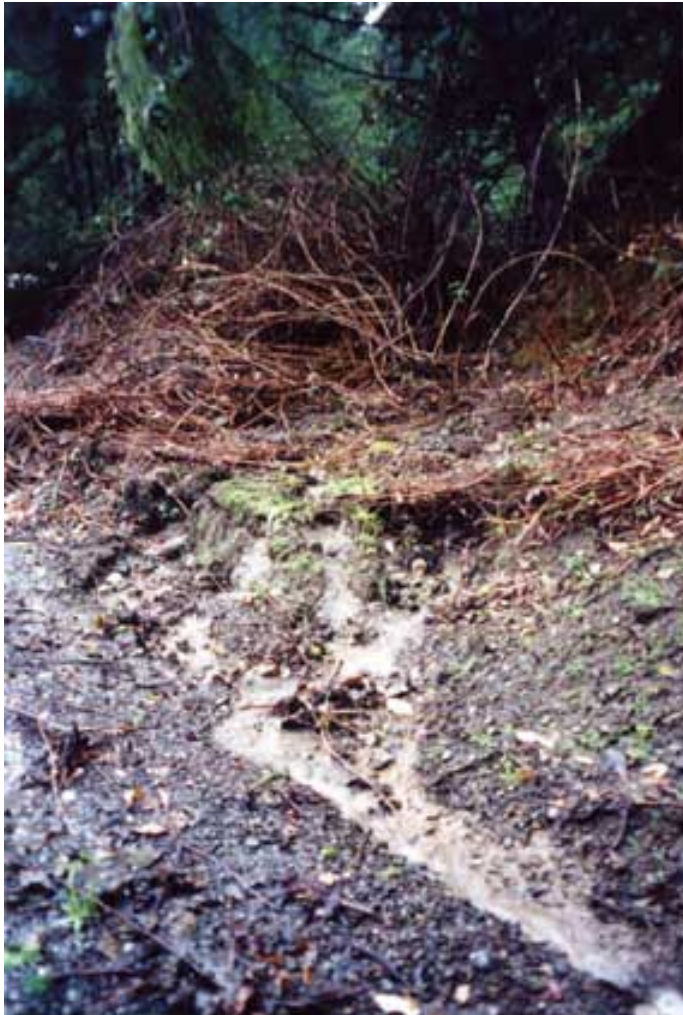
Schoolhouse Creek – Culvert with Baffles, 02/02/99

Exposed fill adjacent to inlet eroding during rainstorm

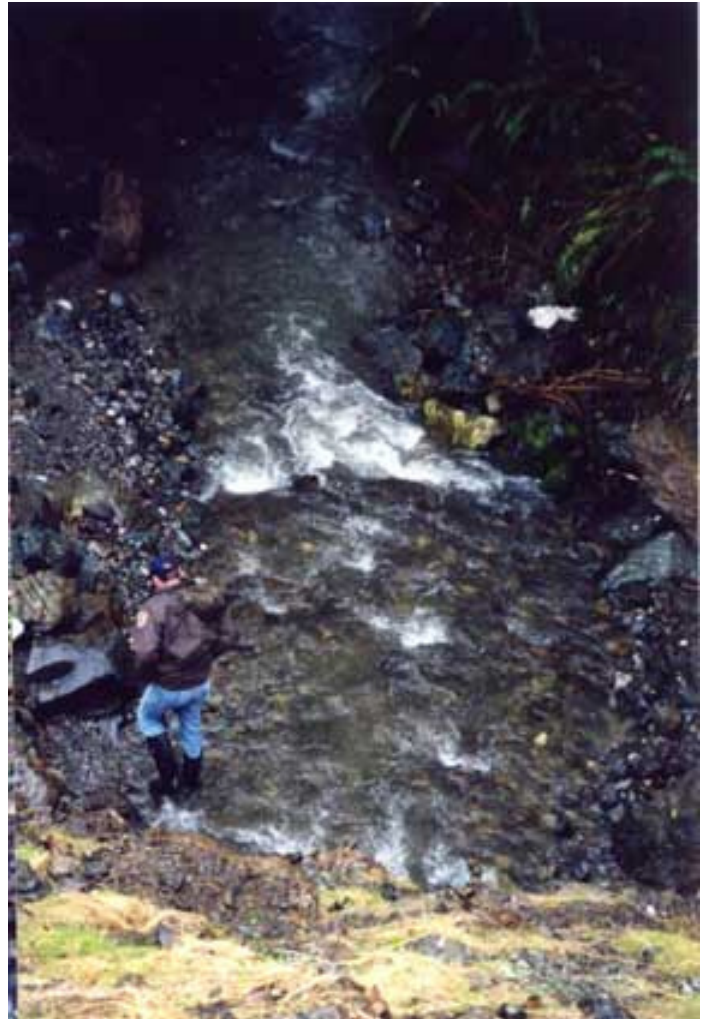
Outlet with jump pool weirs, and straw mulch on road fill

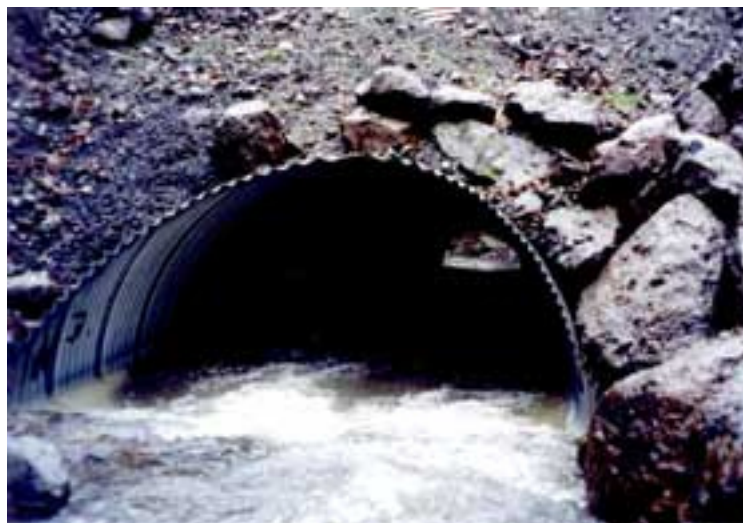
Culvert inlet, "daylight" riser noticeable in the upper center of photo

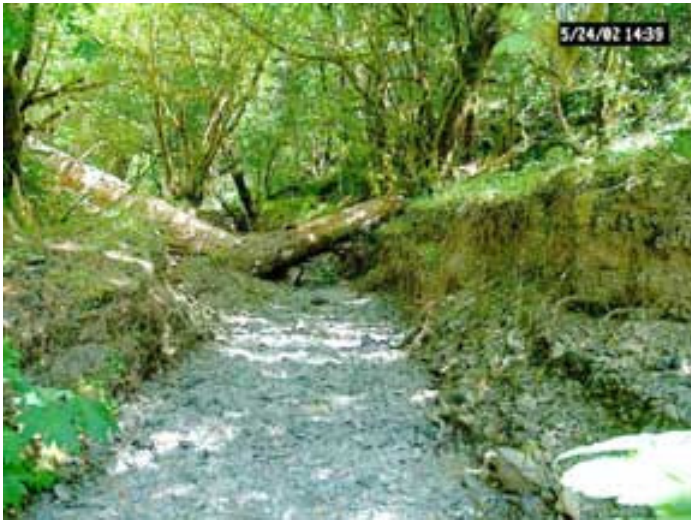
Looking upstream at wood placement, notice degree of downcutting

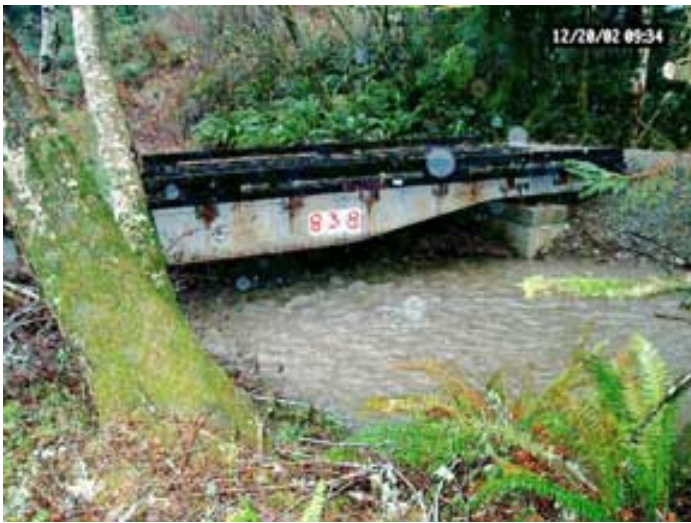
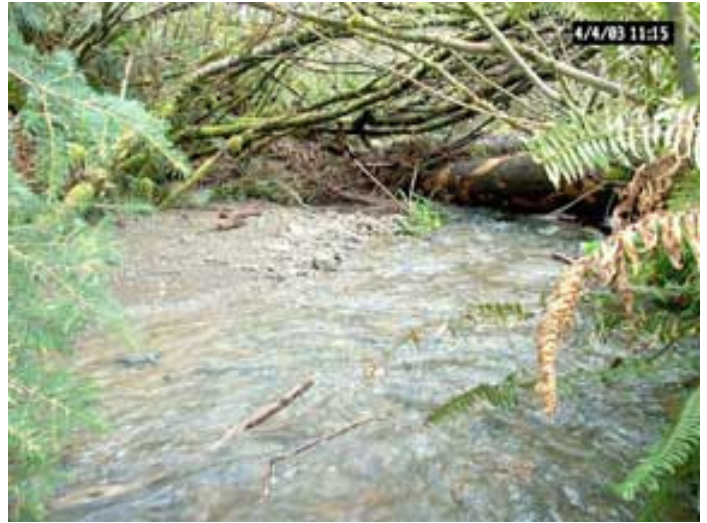
Looking upstream at bridge installed at the upper site, 12/20/02 Sediment released from culvert removal - stored at large wood, 2003

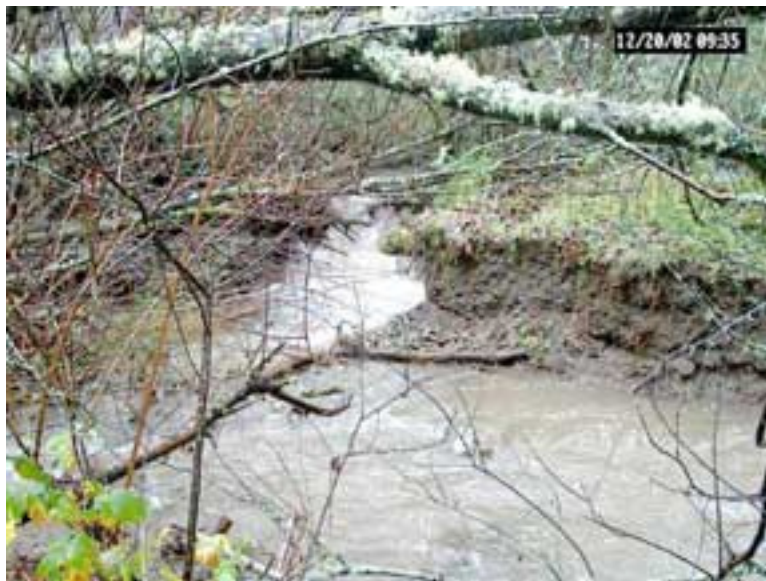
Looking upstream at split channel - terminus of the headcut migration from culvert removal, 12/20/02

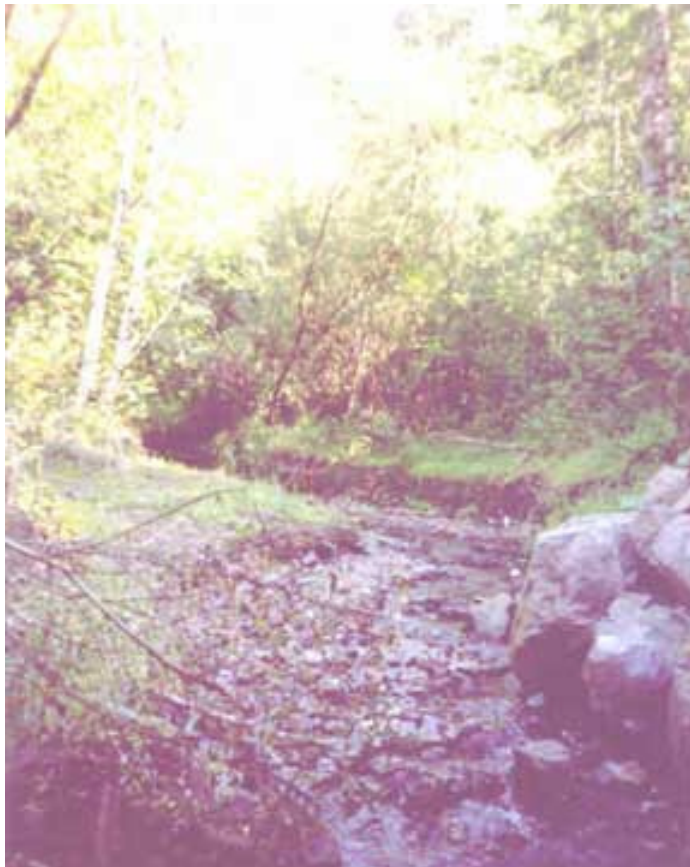
Looking upstream from bridge – notice the start of downcutting, 01/31/00

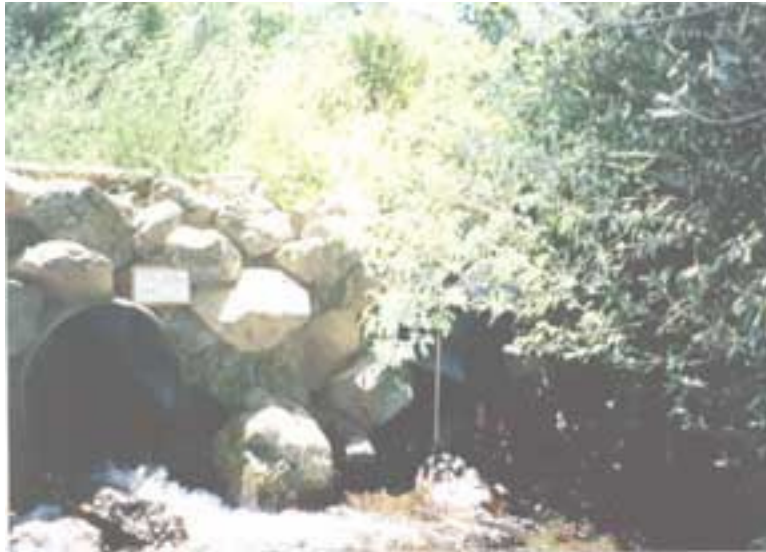
Outlet of former crossing – acting as a complete blockage during summer flows

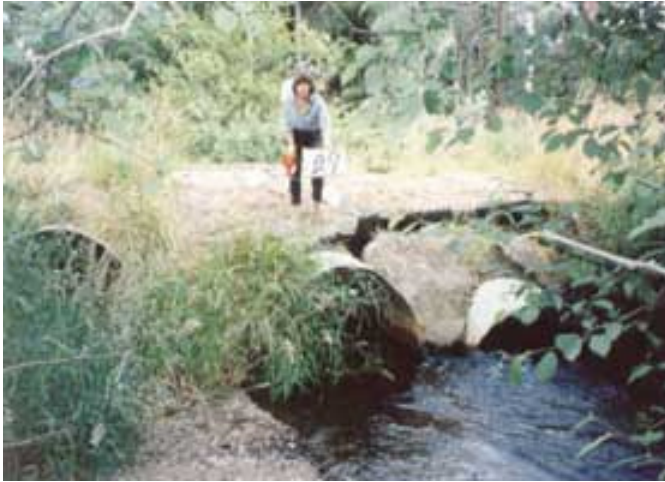
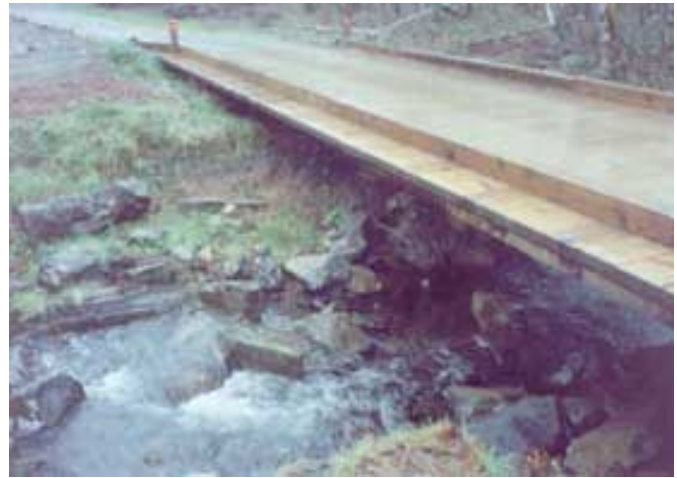
Outlet of former crossing – notice 3 culverts, 2 of which are failing    Looking from upstream at the bridge

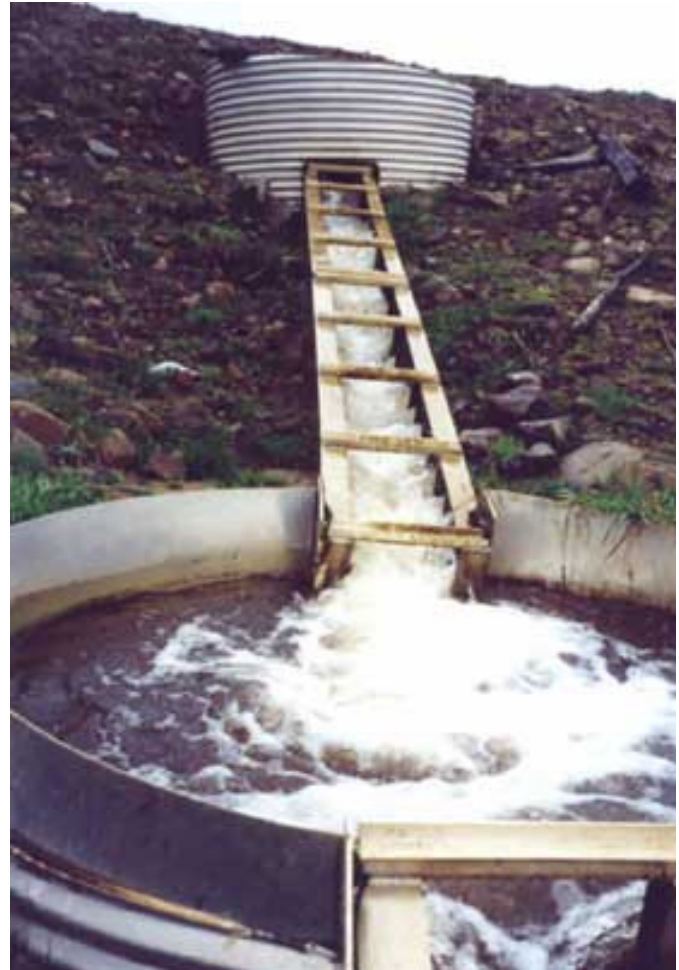
Close-up of flow in resting riser looking upstream, 02/02/99

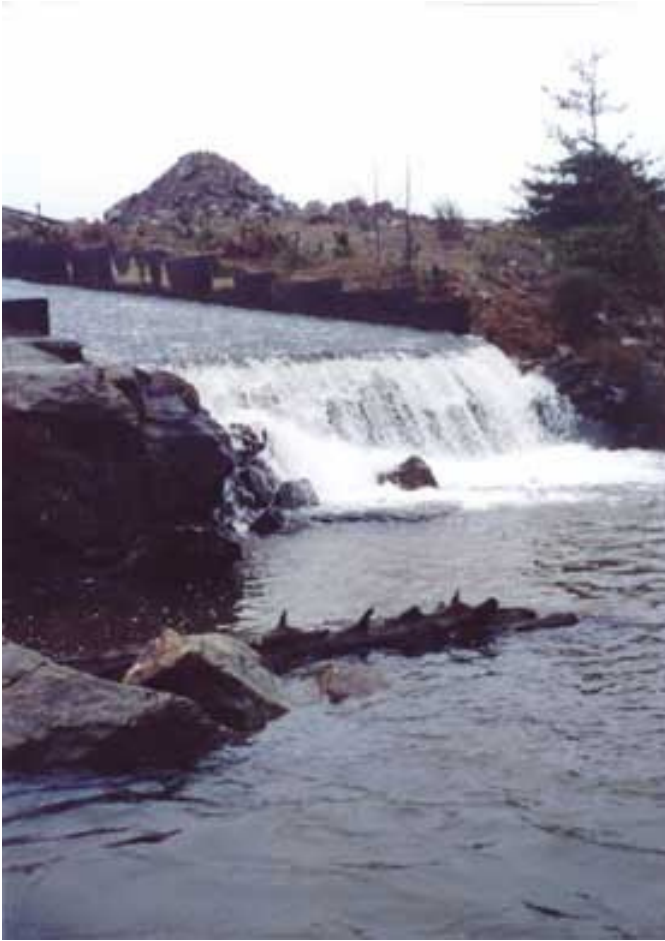
Impassable spillway, 02/02/99
