2001 Restoration Project Effectiveness Monitoring Report

2000-2001 Project Effectiveness Monitoring Report

Road Stormproofing Projects

South Coast and Lower Rogue Watershed Councils
July, 2001

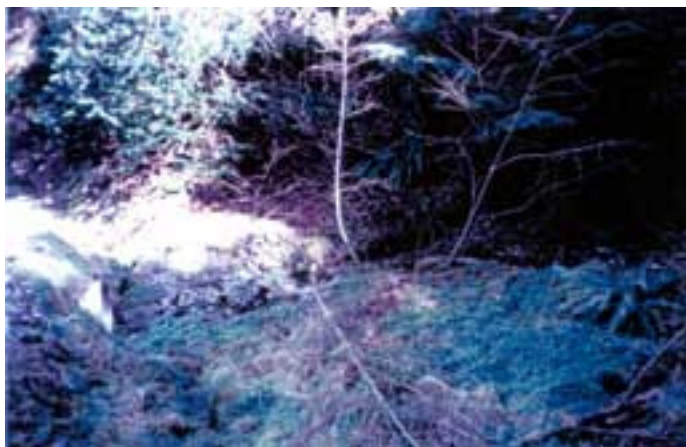
Big Draw Road MP2.25

Big Draw Road MP 2.25. No significant changes have occurred at the site since the Final Report. Alders are growing on the outlet fillslope. Lowering of the inlet base level (culvert increased from 24" to 42") had caused a headcut above the inlet, but it is now stabilizing. At the outlet, downcutting below a 5-6' drop continues to be controlled by an old pipe creating a step in the stream bed. A spring from the cutbank seeps into the ditch and out below the culvert with a rusty stain - watch for future effects on the road fill. [Note: site at MP 2.25 was reversed with site MP 2.15 in the Final Report for SC-72: Table of Final work sites and in the photo caption].

Deposit upstream of inlet with headcut, view from side, 04/06/99

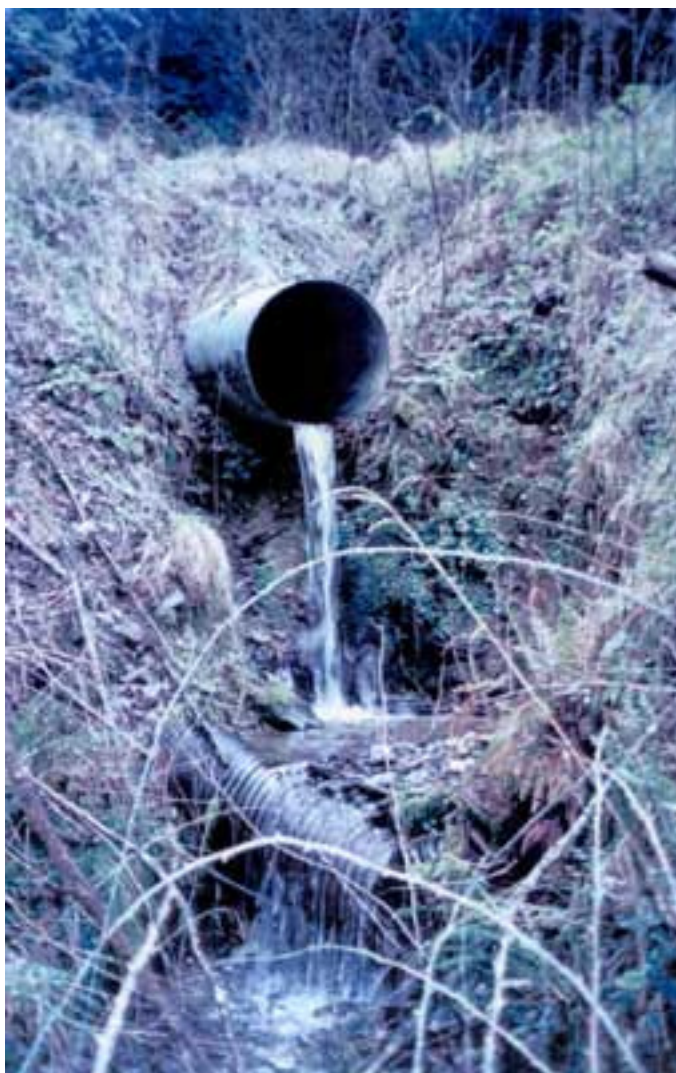
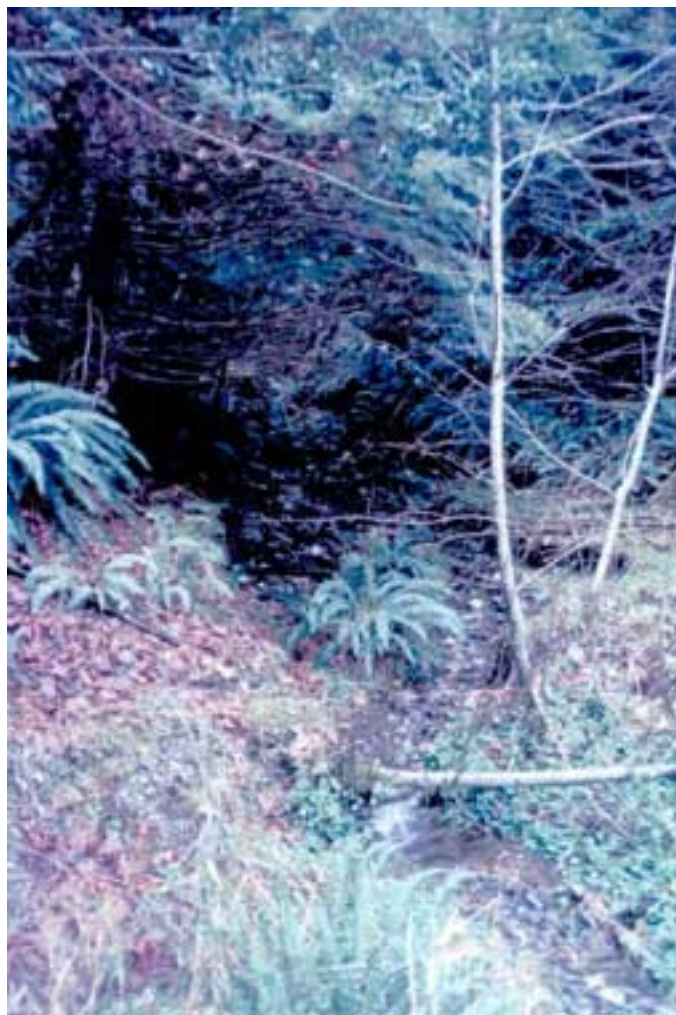
Old pipe creating step in channel, preventing downcutting 01/10/01 Headcut stabilized, view upstream, 01/10/01.

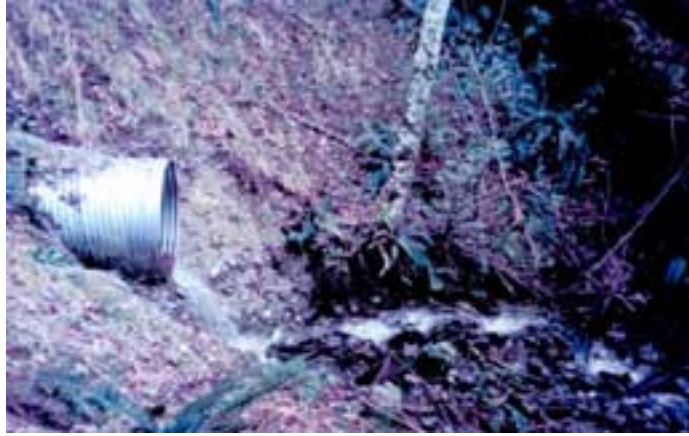
Big Draw Road MP2.55

Big Draw Road MP 2.55. Both fill slopes are still well-vegetated and the undercutting below the 3-4 ft outlet drop has not increased. Sediment up to cobble-sized is still depositing in the culvert and the invert is showing signs of surface rust . On the outlet slope a few small rills are developing from road runoff diverting over the fill edge (see photos).

Outlet showing small undercut erosion site, side view, 04/06/99

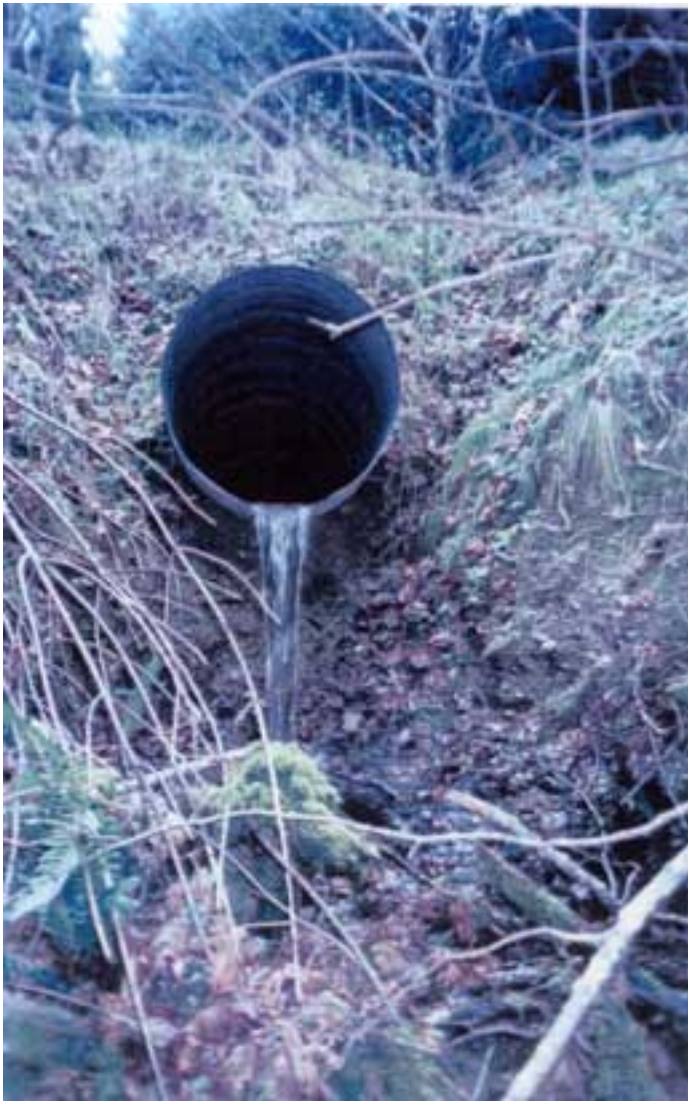
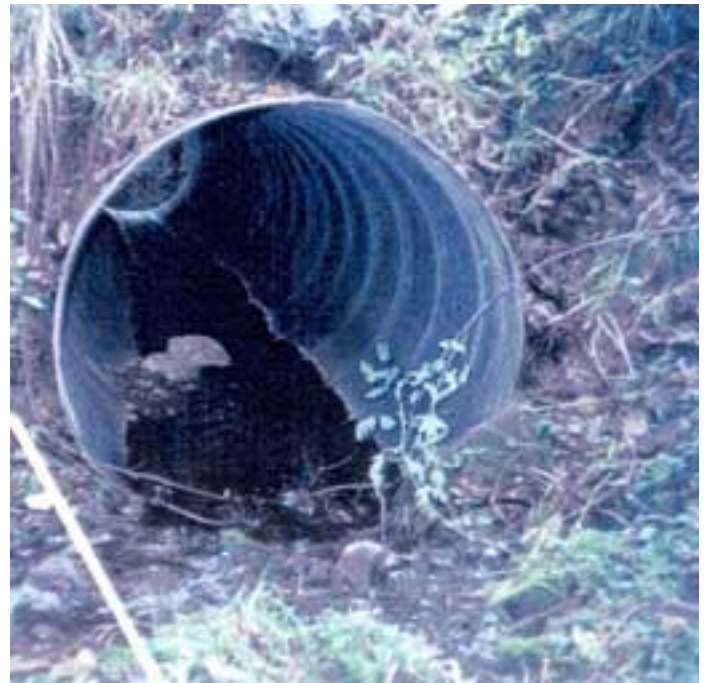
Outlet view from downstream, small rills on fill, 01/10/01 Inlet with rusting invert and substrate deposit, 01/10/01

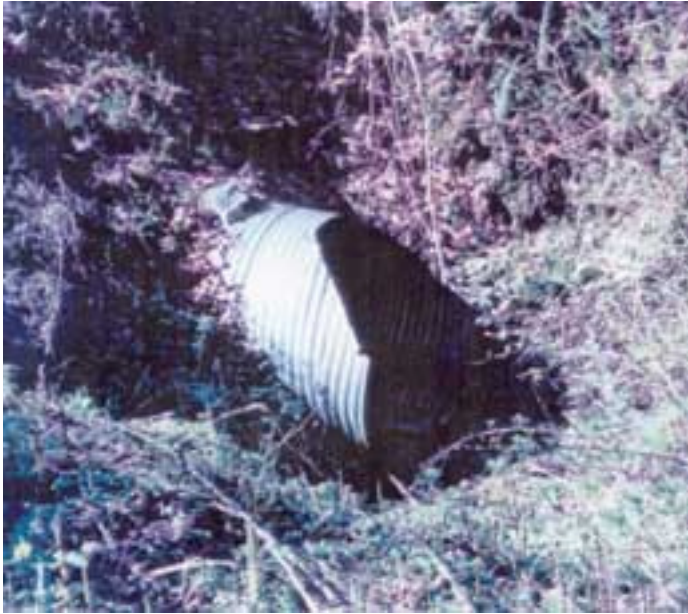
Deadline Road MP0.25

Deadline Road MP 0.25. Both the inlet and the outlet fillslopes are becoming densely vegetated by small alder, salmonberry, and black raspberry (see photos). The hillslope to the left of the outlet (looking downstream) is comprised mostly of fill from an old landing, and is beginning to fail. The stream appears to be undercutting the toe of the slope, and thus causing the failure. The orientation of the culvert may have contributed to the erosion.

Inlet view showing vegetation, 04/06/99

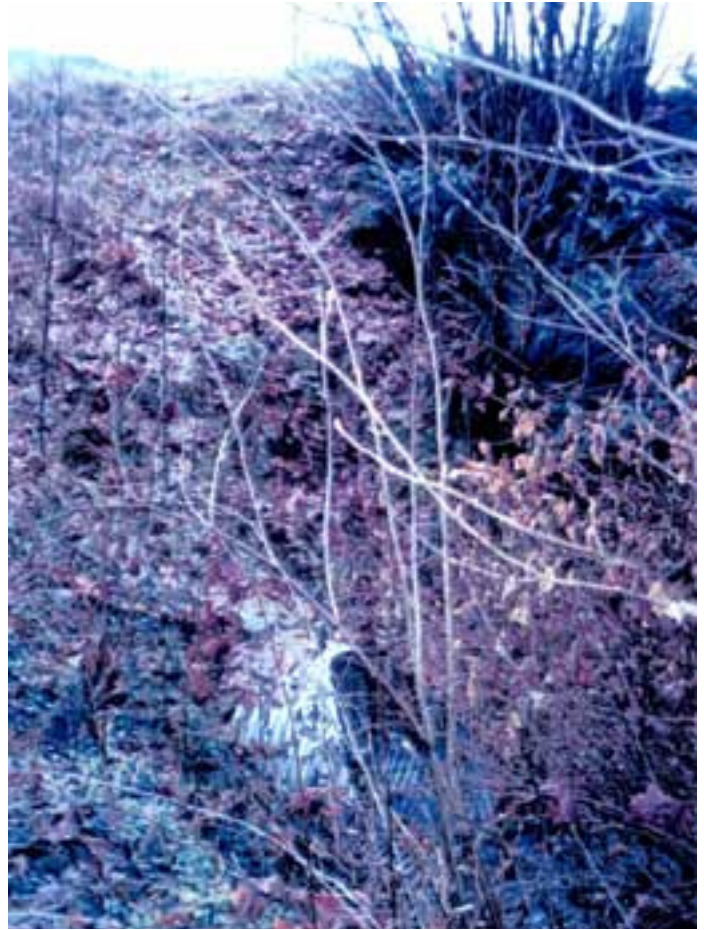
Inlet view note alders in foreground, 01/10/01

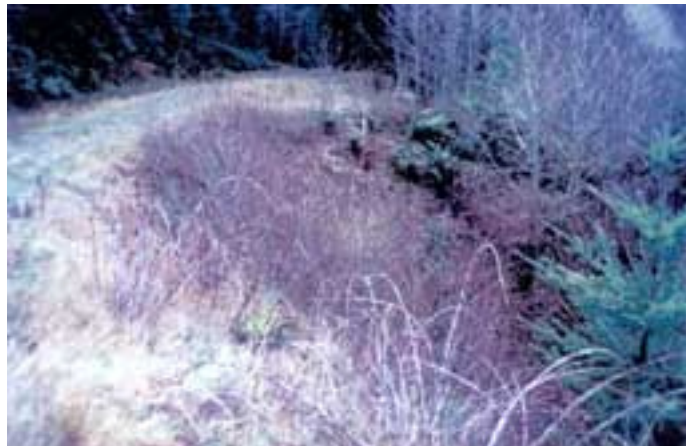
Outlet side view overgrown by vegetation, 01/10/01

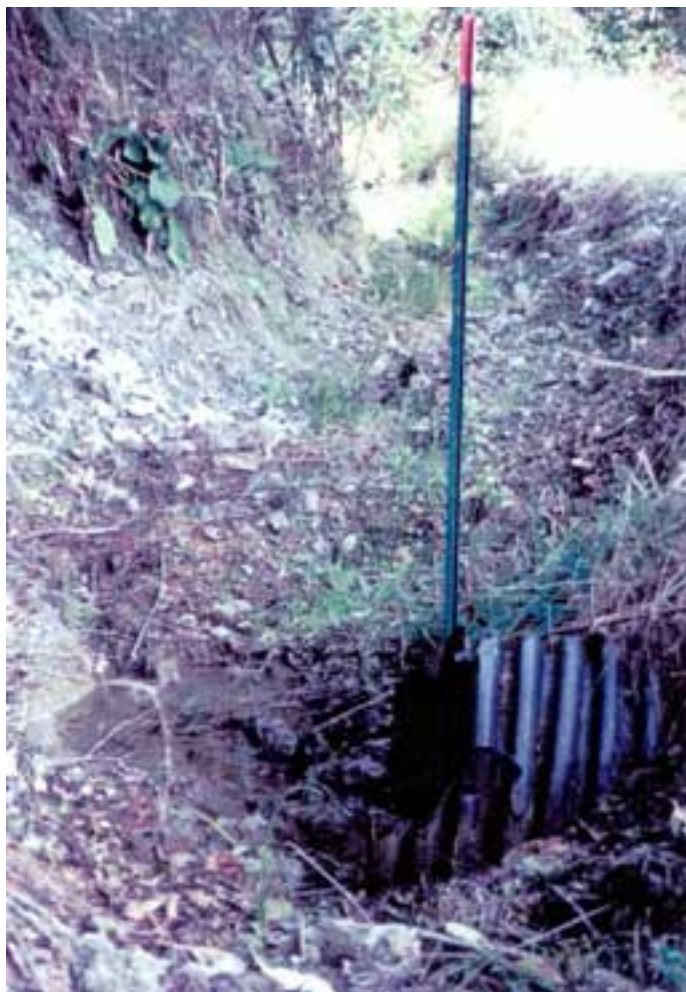
Bark Shanty Road MP0.50

Bark Shanty Road MP 0.50: The plastic cross-drain improves the drainage along an unstable seeping cutbank with ponding and water-loving vegetation in the ditch. In 1998 the fill was saturated from seepage under the new pipe and a small fill failure was evident. During the November, 2000 visit some ponding was still evident, but the fill was not saturated (top photo). The new pipe is intended to reduce the rate of failure of the fill or prevent enlargement. Saturation likely prevented adequate compaction of the fill during culvert installation, and contributed to the small fill failure. Recent signs of additional cracking along the edge of the fill were evident during the November 2000 visit (bottom photo).

Inlet view, note ponding, 11/20/00

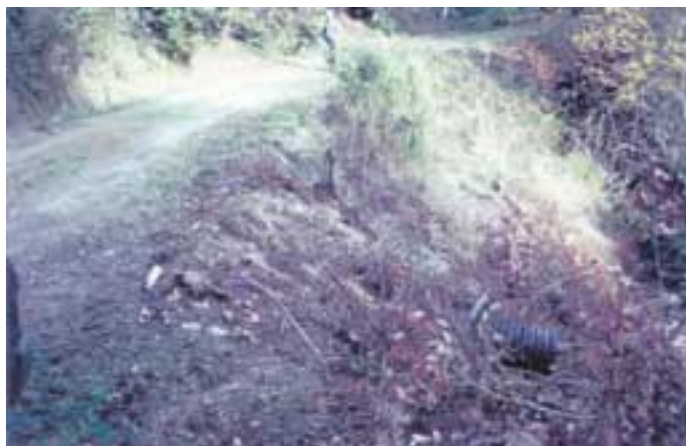
Outlet view, note cracking along edge of fill, 11/20/00

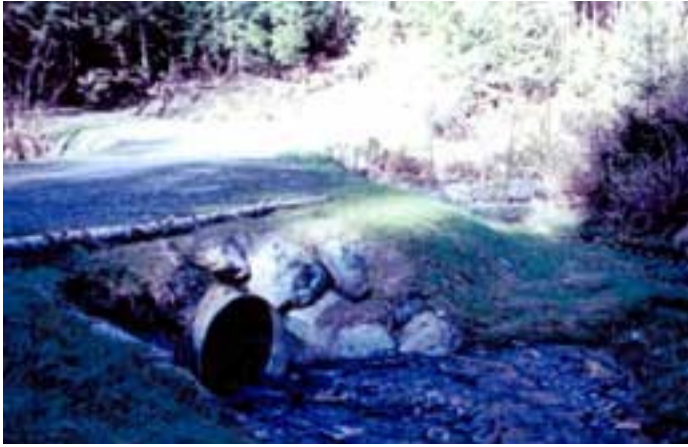
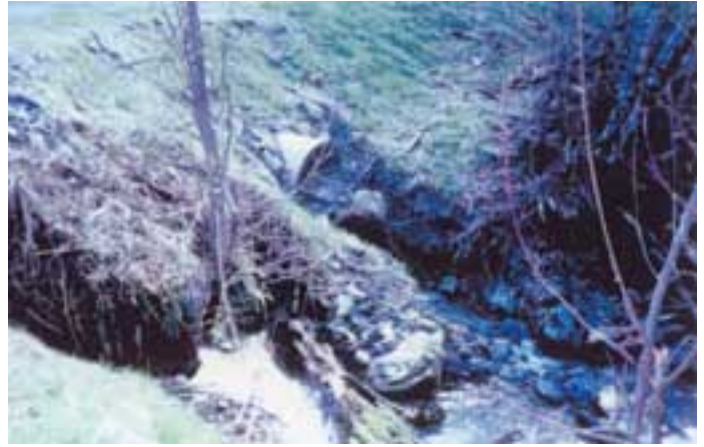
Upper Fall Creek MP3.097

This pipe was installed to pass flow from a fork of the South Fork of the South Fork of Fall Creek. This pipe also serves as an overflow in case the pipe at the South Fork of the South Fork of Fall Creek plugs. The overflow channel was not used as of the winter of 1998-99, and has good grass cover for erosion control. The outside edge of the fill is cracking where it was not adequately compacted (see photos).

From left bank at inlet, showing old overflow channel, now From right bank at outlet, 04/06/99 covered with grass, 04/06/99

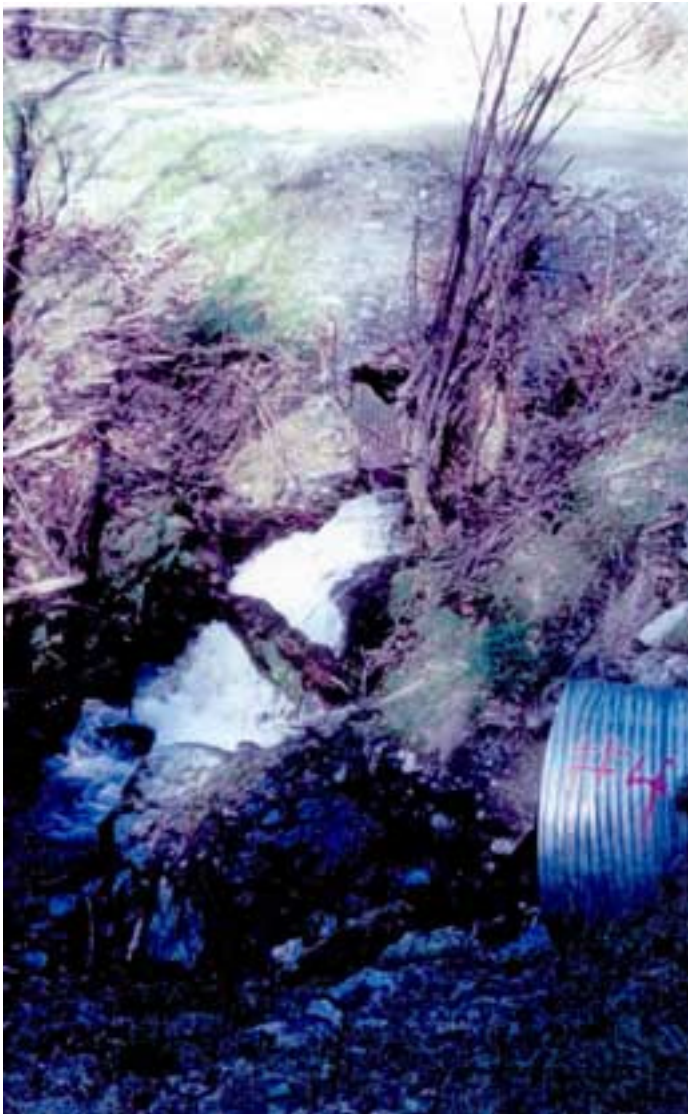
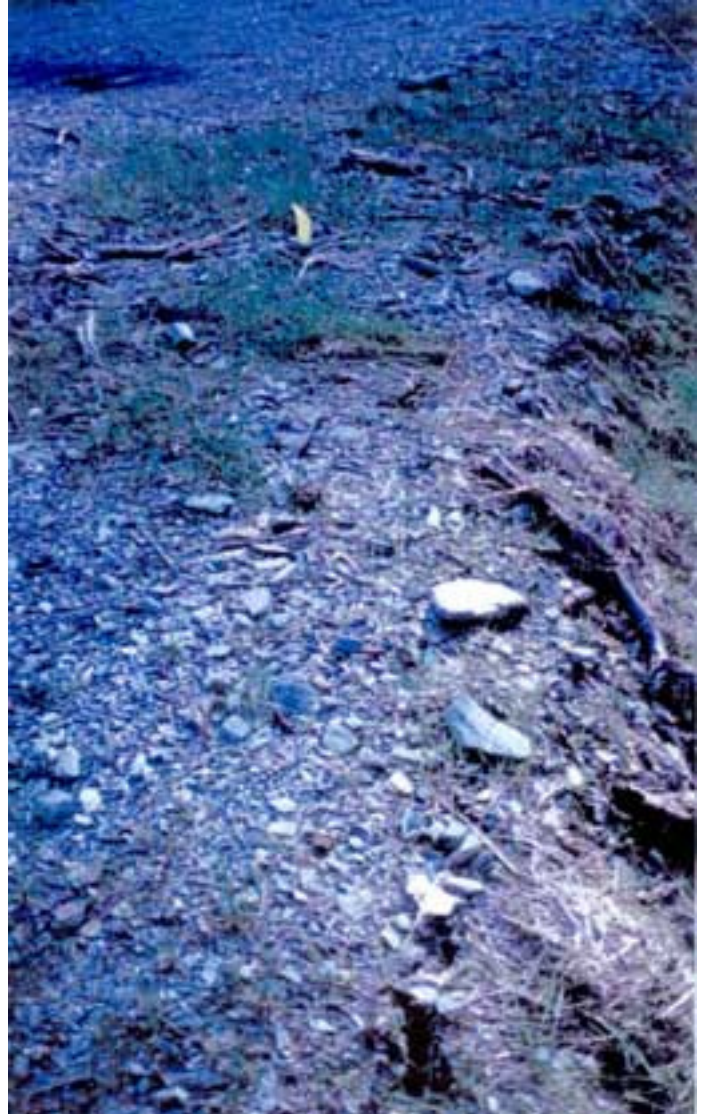
From left bank at outlet, new pipe in foreground, 04/06/99 Outside edge of outlet fill, note crack from settlement, 04/06/99

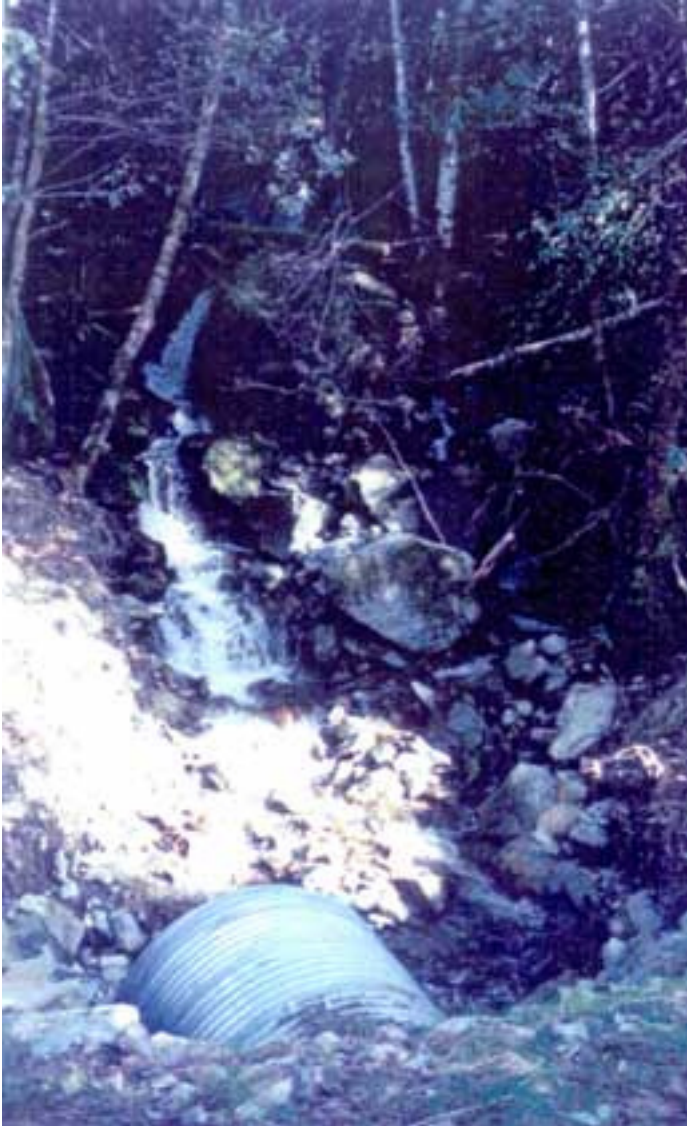
Upper Fall Creek MP3.203

The inlet is well armored with rock, and the ditch runoff that flows into the inlet basin will not erode at the armored section (see photos). In 1999, the fill had settled and contained some cracks and moisture.

View of Fall Creek looking upstream, 04/06/99

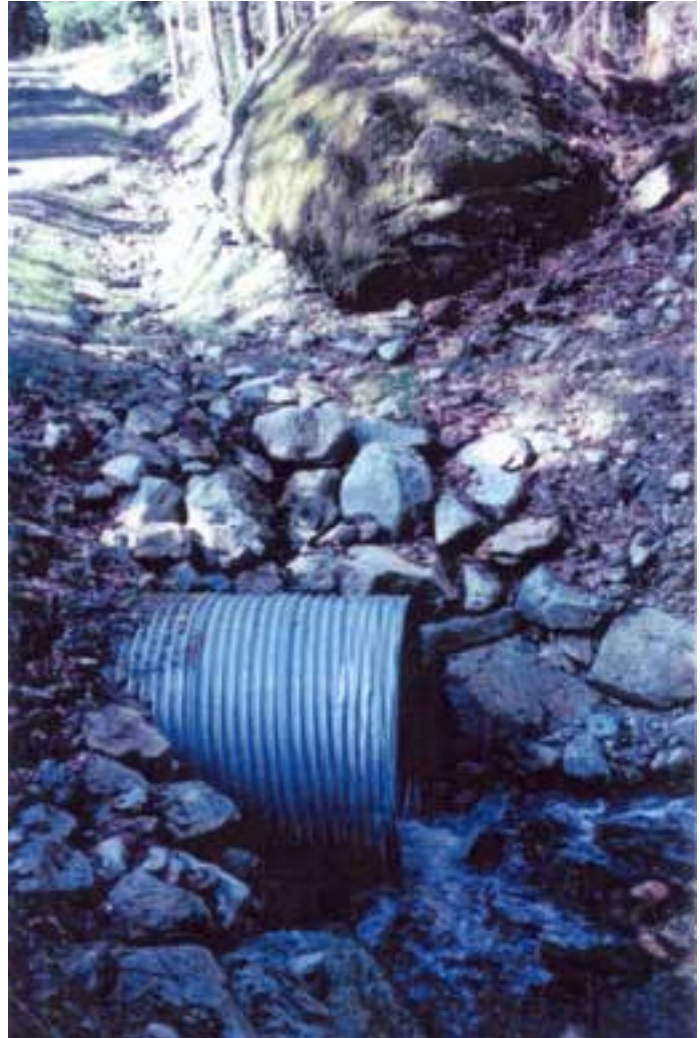
View of armored inlet, ditch runoff into inlet basin, 04/06/99

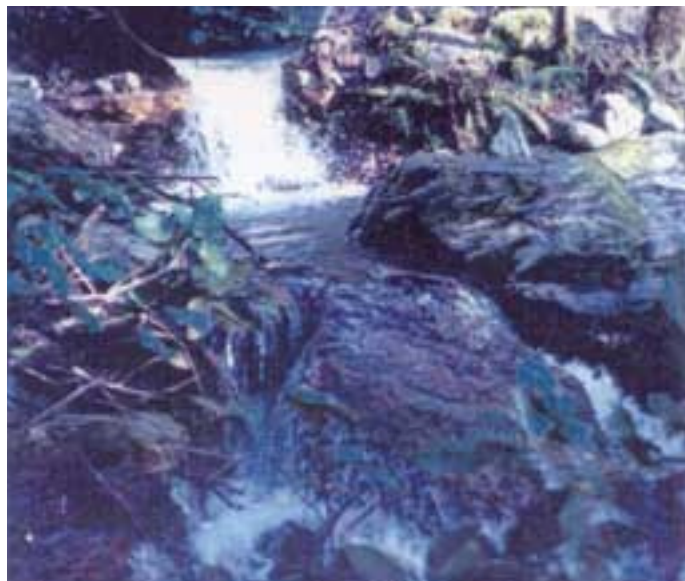
Outlet, view from downstream, right bank on flat rock in channel, 04/06/99

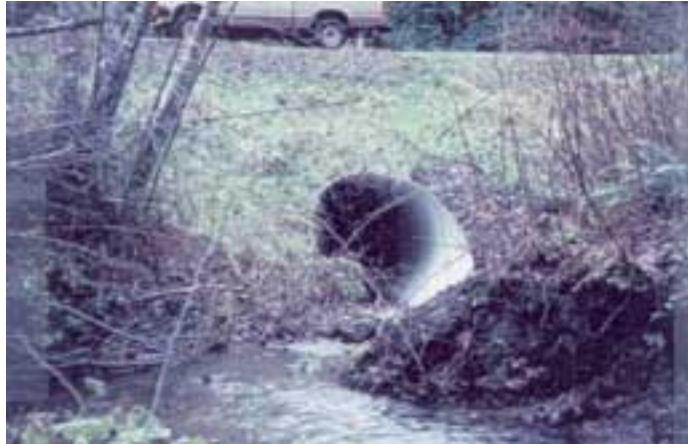
Bark Coffee Road MP0.015

This culvert was identified as a fish barrier during a 1998 road survey, but upon review of the available habitat above and considering a natural barrier downstream, fish passage was not an objective for this site. The increase in culvert size and the lowering of the base level created a headcut that migrated approximately 200' upstream (middle photo). At the time of this visit the stream appeared to be at a stable gradient. Both fillslopes are growing grass with the exception of a small section to the right of the inlet where the ground is saturated due to ditch flow (top photo). The outlet jump height was reduced by approximately 1 foot (bottom photo).

Inlet showing deposition at left after headcut migration, 01/10/01

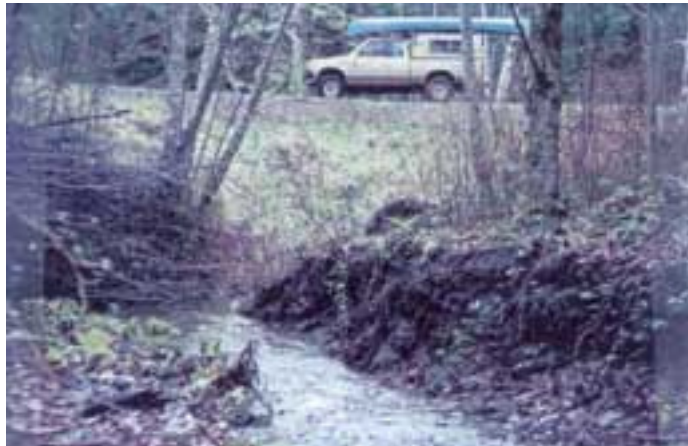
Inlet showing headcut, 01/10/01

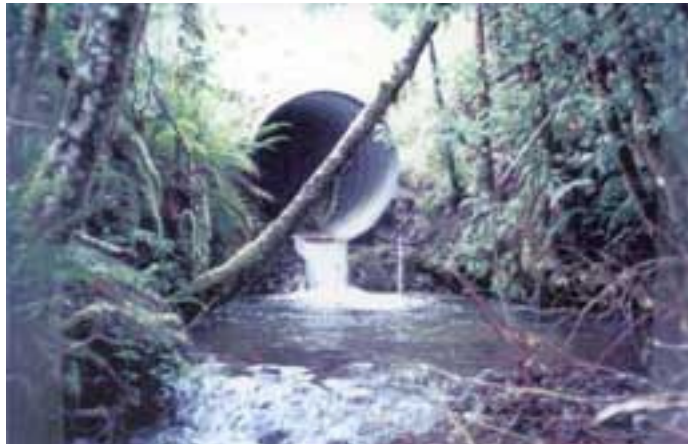
Outlet with drop height reduced, 01/10/01

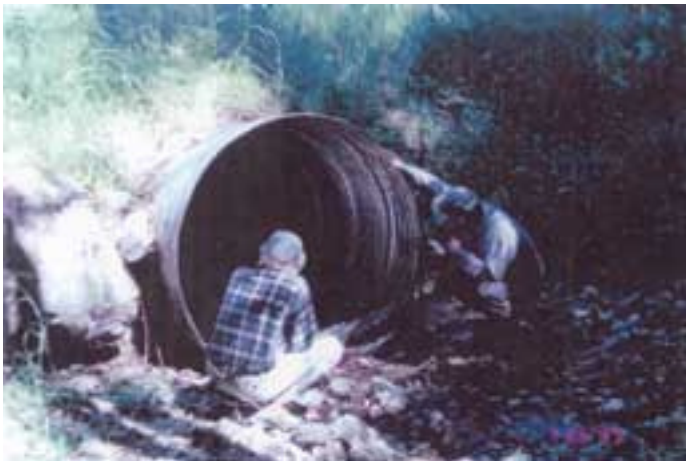
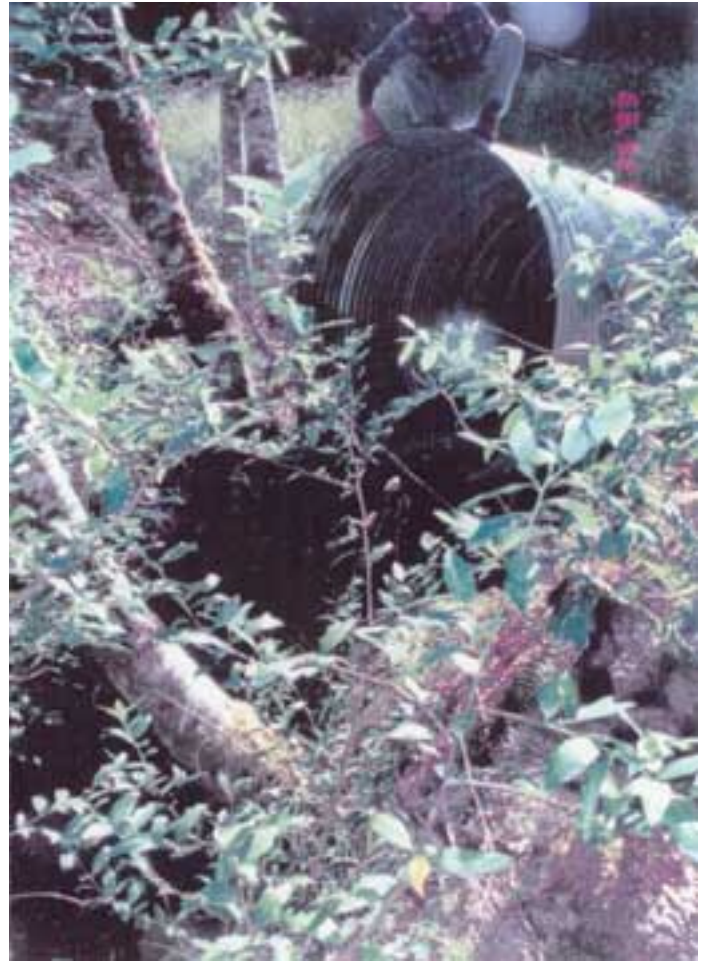
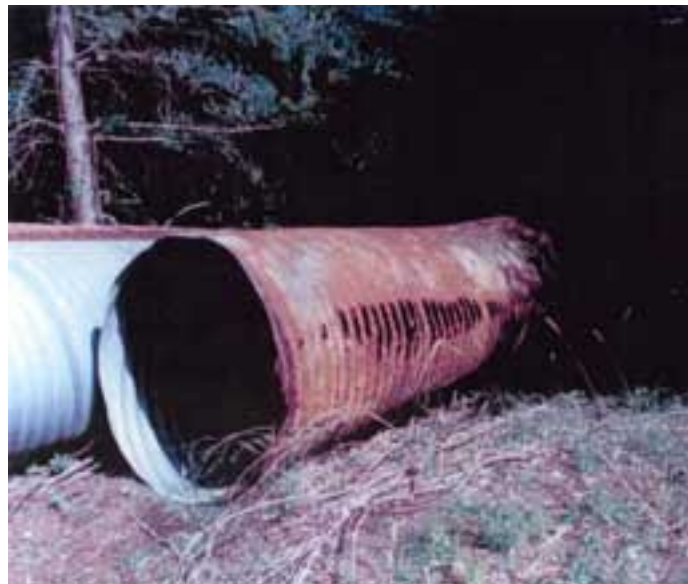
Coffe Butte Spur 2 MP1.711

The installation appears to be stable and revegetated (see photos).

View of new culvert inlet, 07/26/99

View of new culvert outlet, 07/26/99

Pipe that was replaced

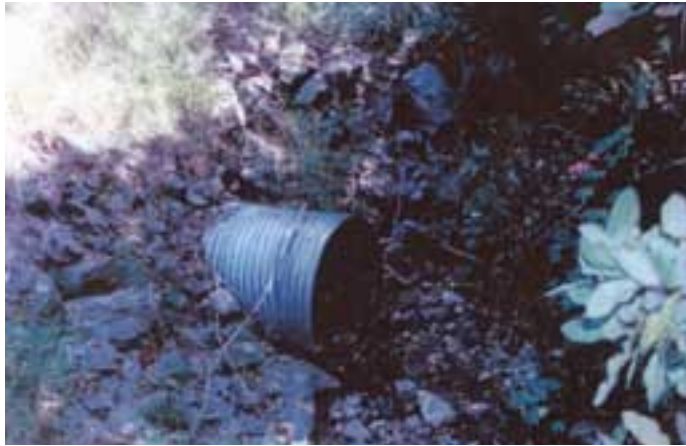
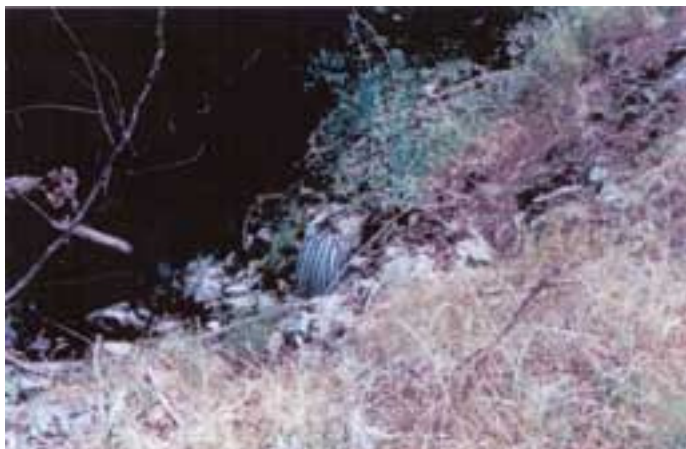
Coffee Butte Spur 2 MP1.834

The installation appears to be stable and revegetated (see photos).

48" pipe, inlet on rock, 07/26/99

Outlet on rock, 07/26/99

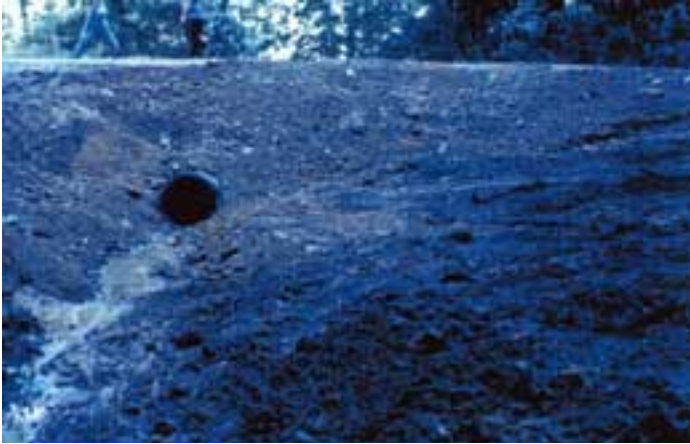
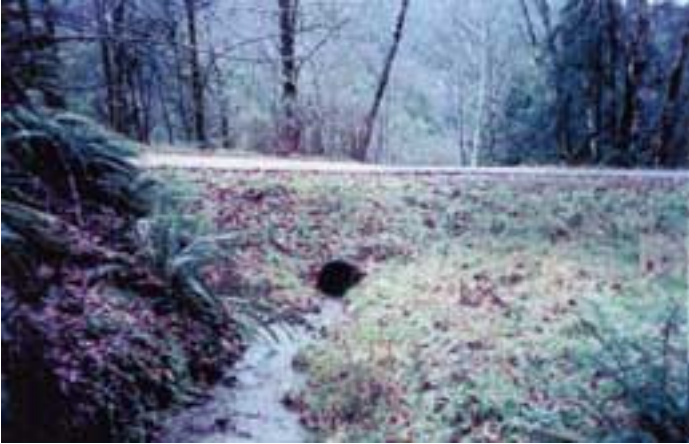
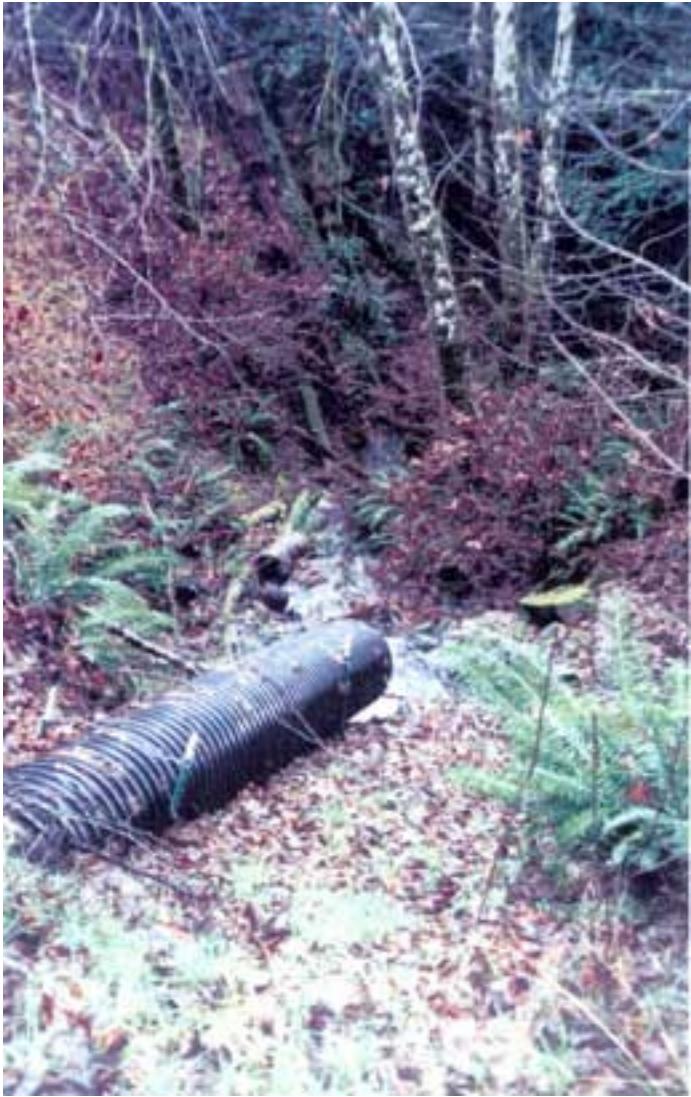
Lobster Creek Road MP4.81 (Mainline, cost share road)

As of January 2001 both the inlet and outlet slopes were revegetated with grass and there were no signs of surface erosion. There is evidence of a fillslope slide at the outlet but it appears to have happened during installation. The outlet is extended with approximately 15' of downspout that is anchored in place with metal posts (see photos).

Inlet after installation, 09/17/99

Inlet, 01/10/01

Outlet, 01/10/01

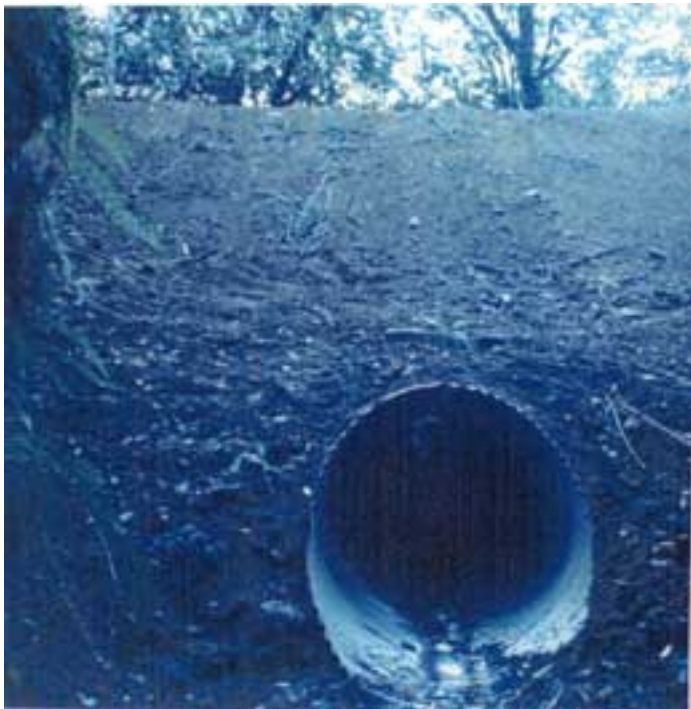
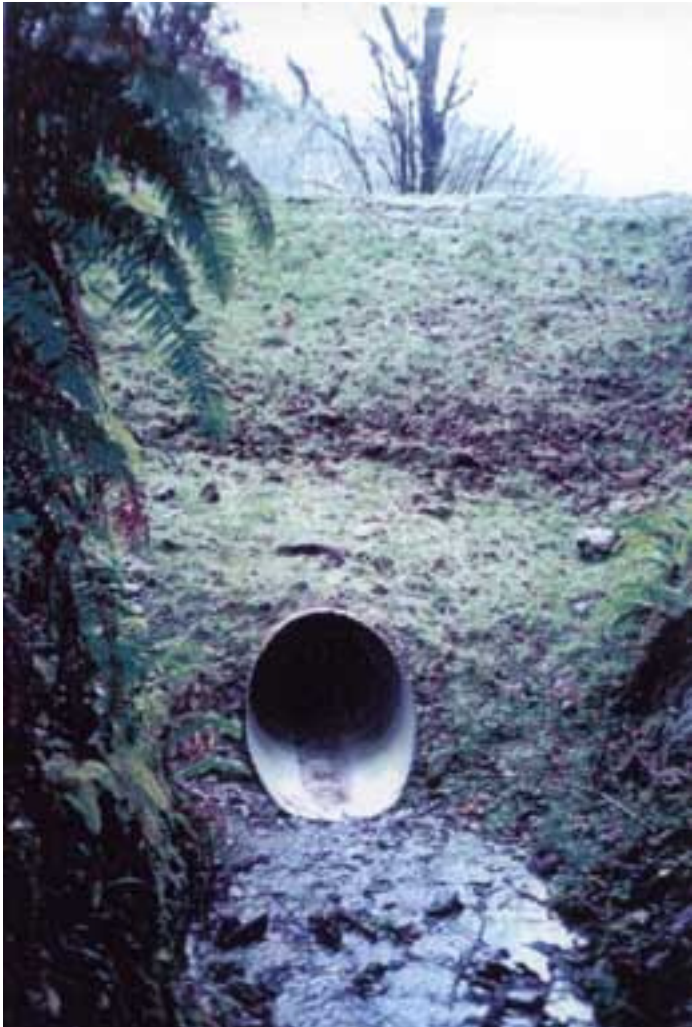
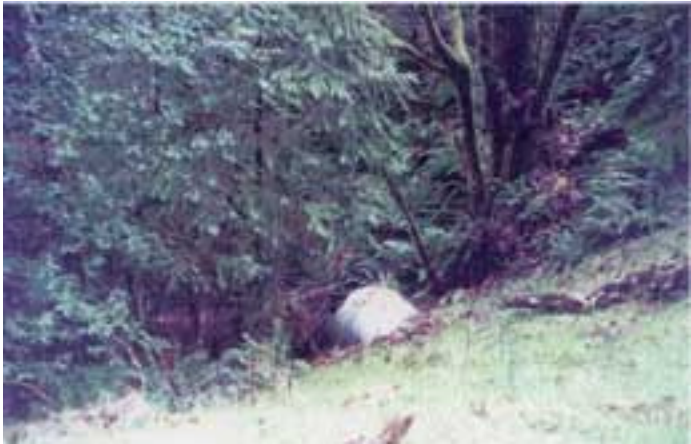
Lobster Creek Road MP4.87 (Mainline, cost share road)

The remains of the 48" pipe from Bark Coffee MP .015 site were salvaged and brought to this site to be used as a downspout. At the time of this visit the downspout was functioning well. Both fillslopes were vegetated with grass (see photos).

Inlet, 09/17/99

Inlet, 01/10/01

Outlet with downspout, 01/10/01

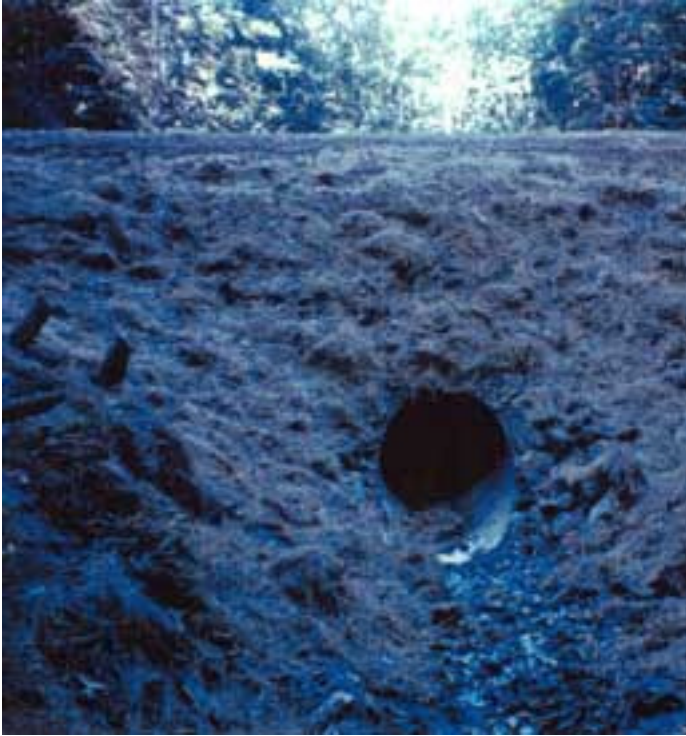
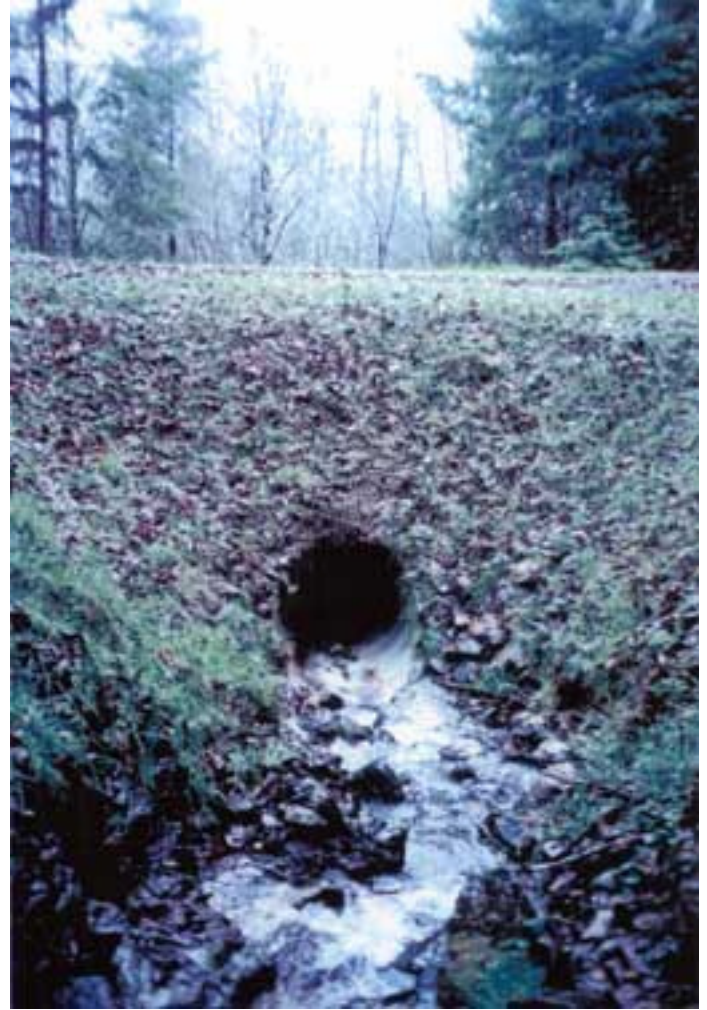
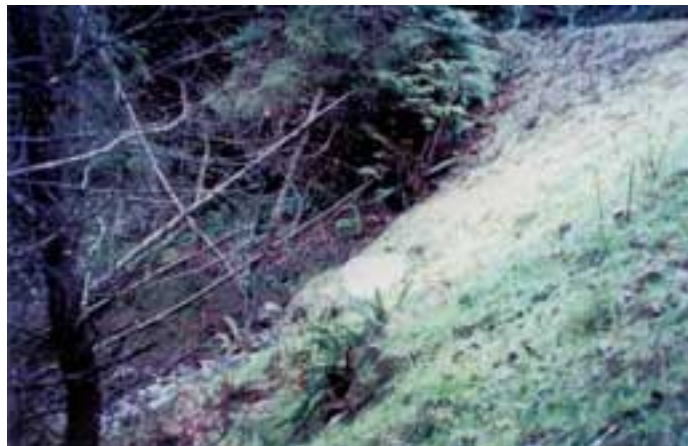
Lobster Creek Road MP8.10 (Mainline, cost share road)

As of January 2001, no problems were visible. Both slopes were well vegetated with grass, and the outlet posed no threat of undercutting (see photos).

Inlet, 10/01/99

Inlet, 01/10/01

Outlet, note stable bank, 01/10/01

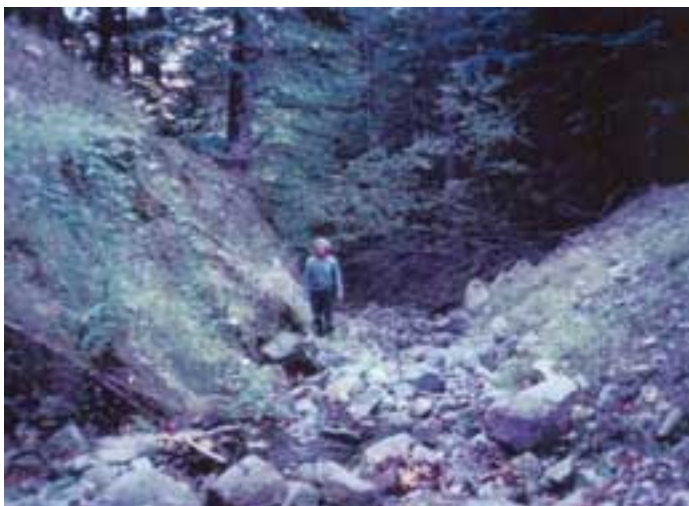
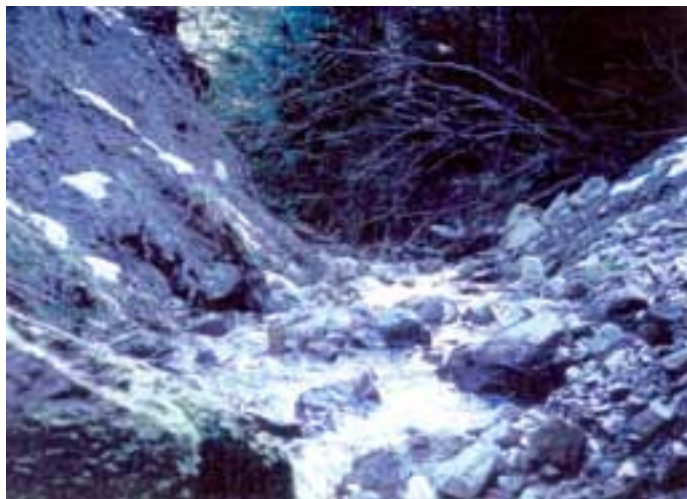
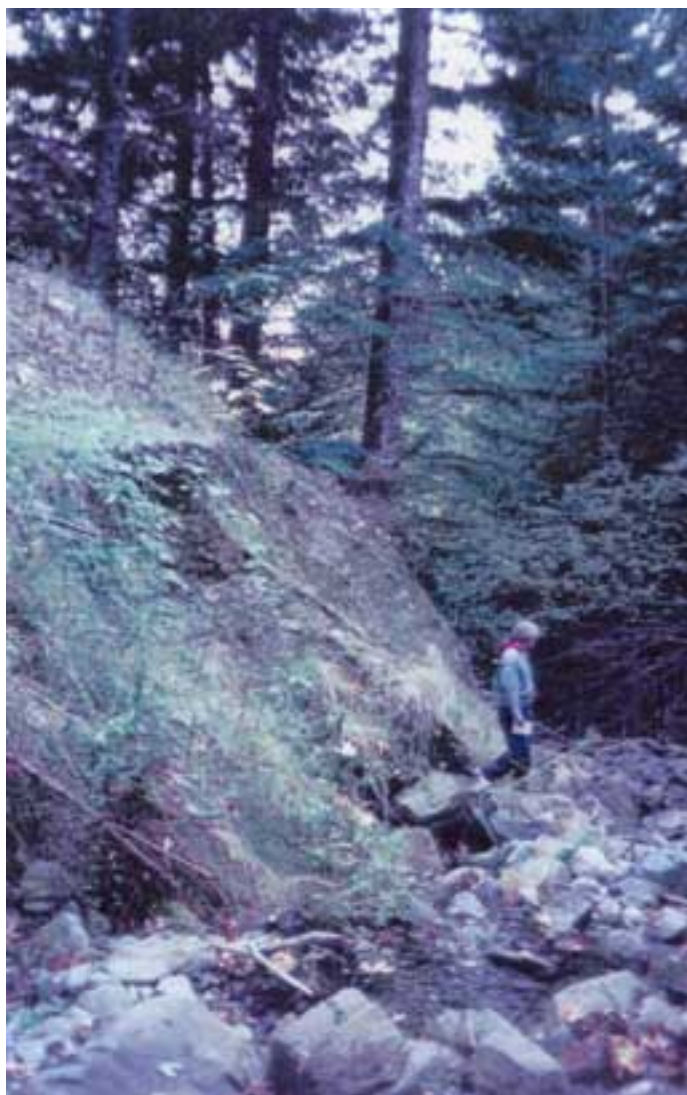
Upper Fall Creek Top Spur MP0.50

Upper Fall Creek - Top Spur MP 0.50: It appears that no additional downcutting occurred in the stream bed between April, 1999 and January, 2001. The sideslopes are beginning to revegetate, though the oversteepened slope on the left recently failed and appears to still be unstable. It appears that >90% of the original fill remains in a stable location on site (see photos).

View looking downstream, 11/20/00

View looking downstream, 04/06/99

View of left bank looking downstream, 11/20/00

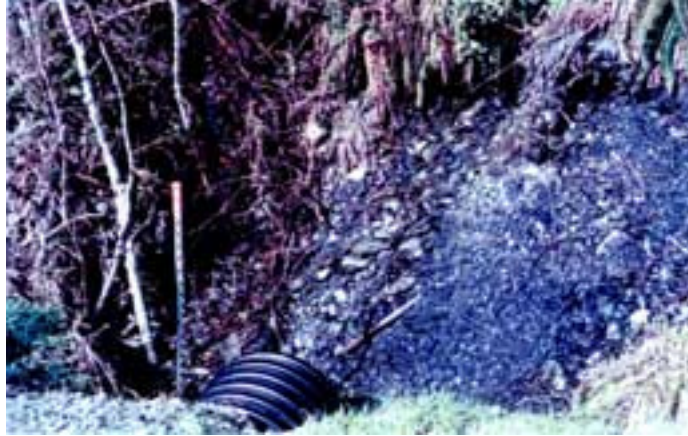
Upper Fall Creek Road MP1.28

Typical 18" plastic ditch relief pipe also drains small springs from cutbank, 04/06/99

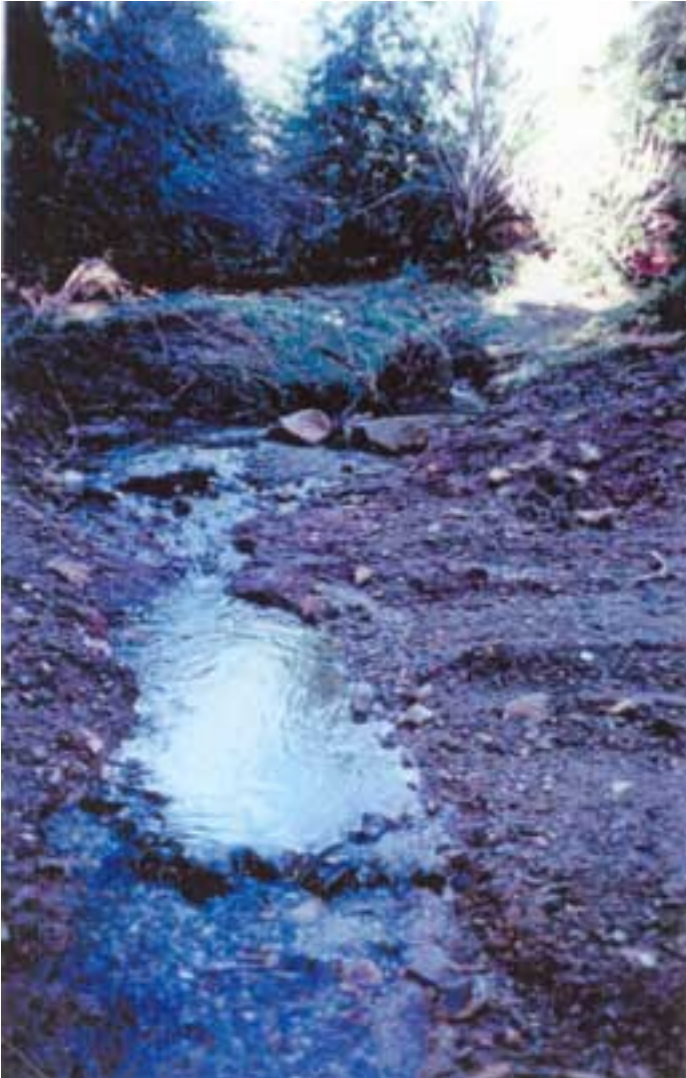
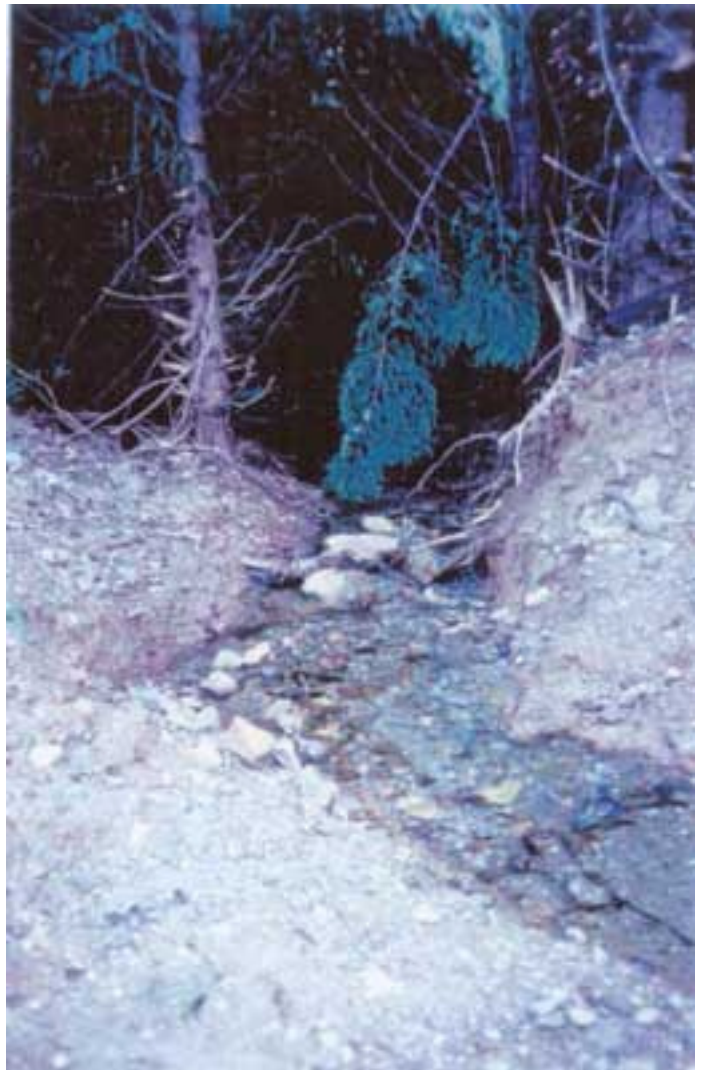
Upper Fall Creek Road Spur 3 MP0.111---1998 Excavated crossing

MP 0.111 Excavated in 1998. The sideslopes are still driveable, so vehicles are tearing down the banks. As of April, 1999, needed a barricade to allow revegetation.

View upstream, 04/06/99

View downstream, 04/06/99

On excavated road crossings with gentle slopes on the approach, vehicles may continue to be driven across stream banks, leading to continued erosion and poor revegetation. We will be recommending barricading structures such as deep trenches (aka tank traps) or boulders to block vehicle access.
