2001 Restoration Project Effectiveness Monitoring Report

2000-2001 Project Effectiveness Monitoring Report

Road Stormproofing Projects

South Coast and Lower Rogue Watershed Councils
July, 2001

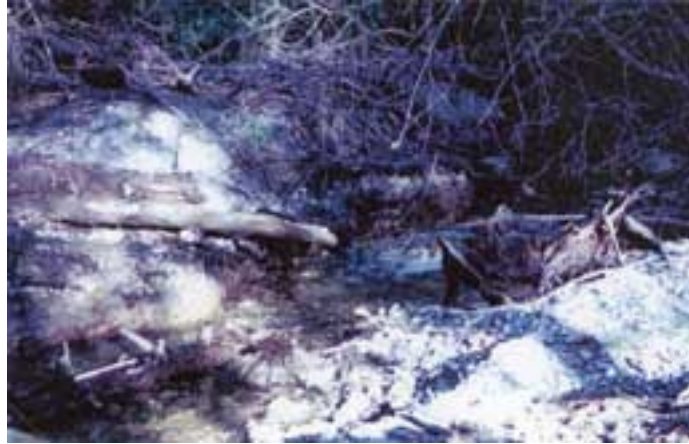
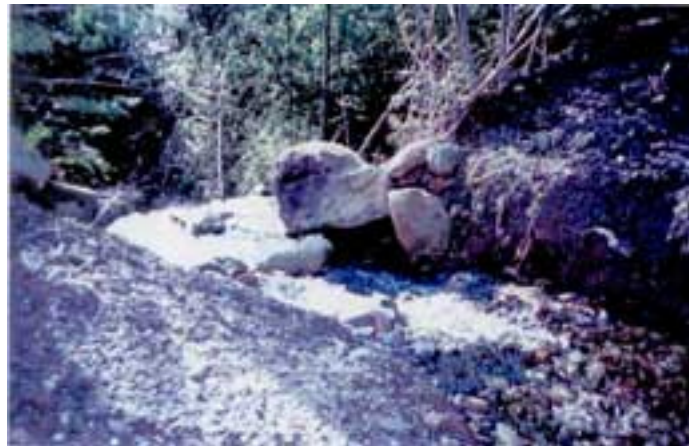
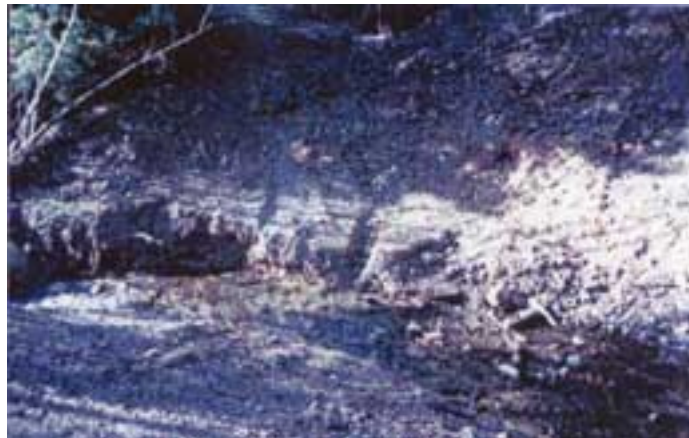
Upper Fall Creek Spur 3 MP0.180

MP 0.180 Excavated in 1998. Sideslopes have 35% gradient, and stable surface. Photos show downcutting through the stream bed of about 18" vertical.

Pulled existing 18" pipe and excavated crossing fill in 1998

View upstream of deposits exposed from migration of headcut, 04/06/99

View downstream, 04/06/99

View to north of 18" downcutting, sideslopes, 04/06/99
