**2000 – 2001 Monitoring Report**

# **Riparian Improvement Project Effectiveness**

## **South Coast/Lower Rogue Watersheds**

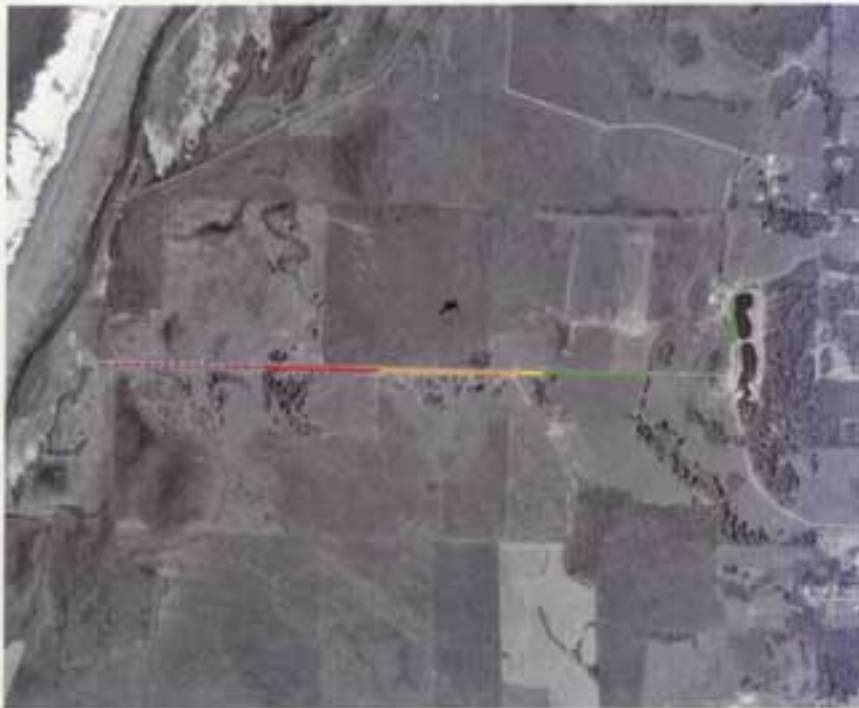
### Langlois Creek Riparian Survival

Seedlings experience noticeable wind burn on the north-northwest side of the trees in plantings on Floras and Langlois Creeks. Survival/stocking decreased toward the ocean along Langlois Creek (plate 2). Wind dessication reducing soil moisture is suspected as the reason why growth rates on shore pine on Crook Creek decrease with proximity to the ocean (plate 3). However, soil textures could also vary and have not been analyzed. Stocking/survival on a planting near the ocean on Sixes River is excellent (plate 4). It would be useful to map the survival/stocking classes to overlay with soils and proximity to the ocean. Site-specific soil conditions may be somewhat different than the mapped NRCS soils.

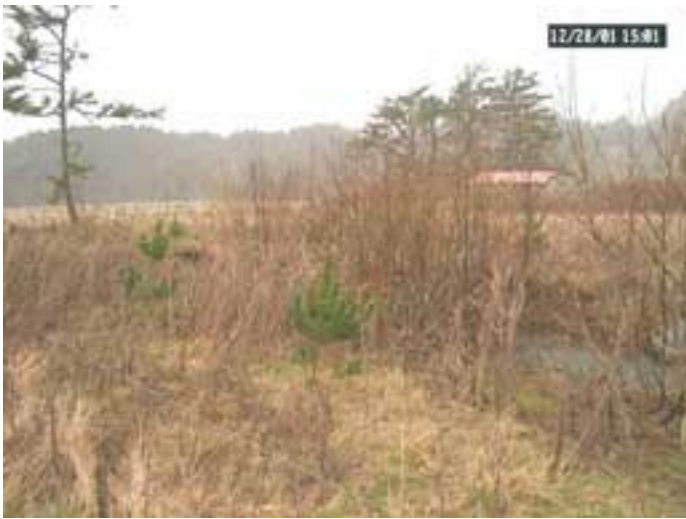
Willow cuttings were purchased for 1996, but willows have since been propagated from species near the planting site. Many of the past willow plantings were associated with bioengineering projects (covered in a separate monitoring report). Photo points for monitoring these types of plantings are preferable to accounting for individual cuttings. Willows can fully occupy a site after livestock exclusion without planting (Appendix A, Crook Creek and plate 3, bottom left).

Willow along Crook Creek, thistles in shore pine, 12/28/01

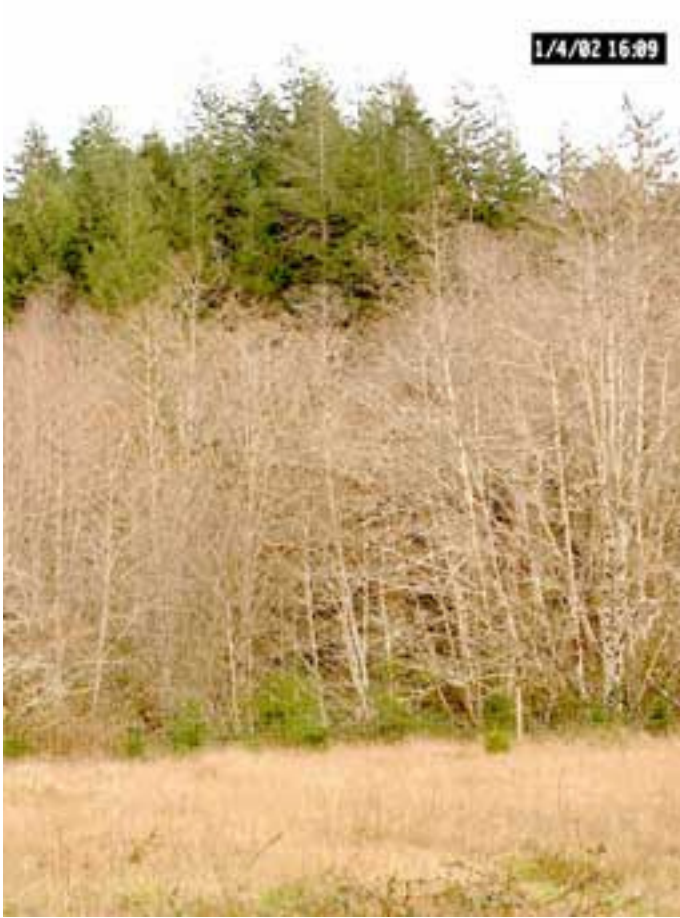
Blackberry does not appear to kill trees as readily as grass competition. In some areas blackberry has provided protection from livestock grazing when the fence was not maintained (plate 8). Blackberry appears to reduce vigor, resulting in elongated (etiolated) trees. In cases where trees have not survived the blackberry competition, it is not clear whether they have been shaded out, physically damaged by the canes, or chewed by voles that thrive under cover (plate 9). Forested sites typically had an alder overstory that shaded the seedlings and reduced vigor. Where the riparian alder were adjacent to pasture, the seedlings had more light (plate 7, top left and plate 10, top and bottom right).

Cedar Ck (EC-06), 01/04/02, Doug-fir & Sitka spruce Cedar Ck (EC-09), 01/04/02, surviving conifer on under alder upstream reach

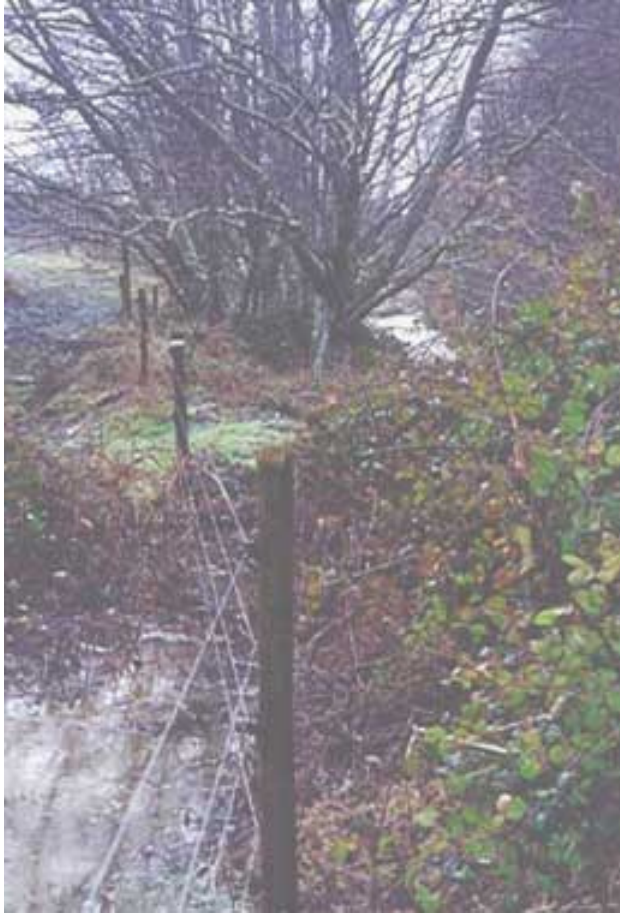
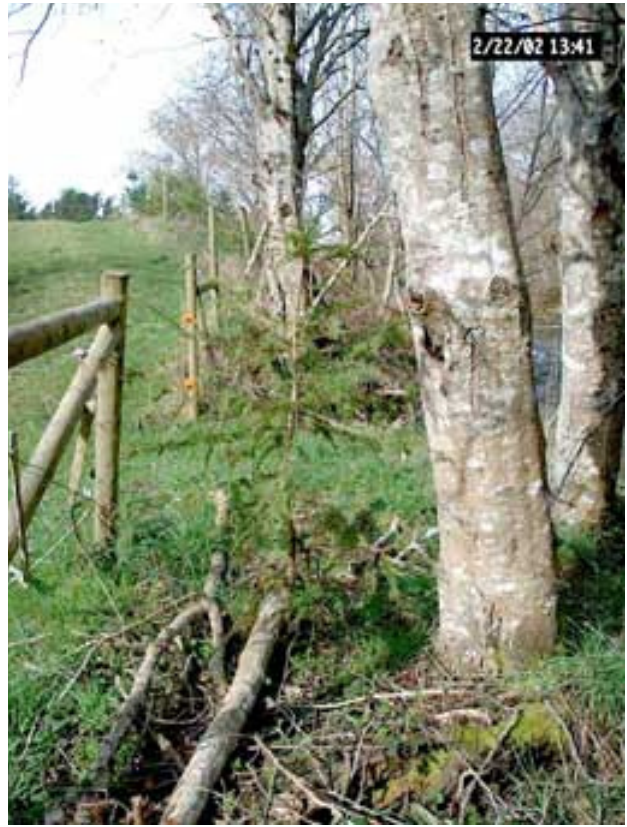
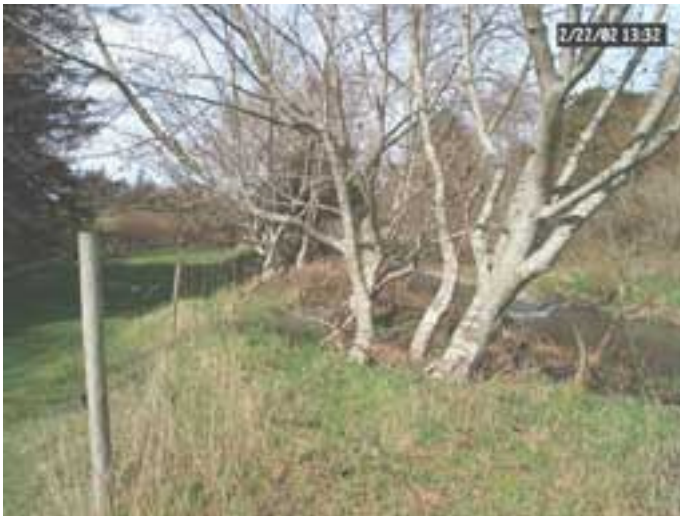
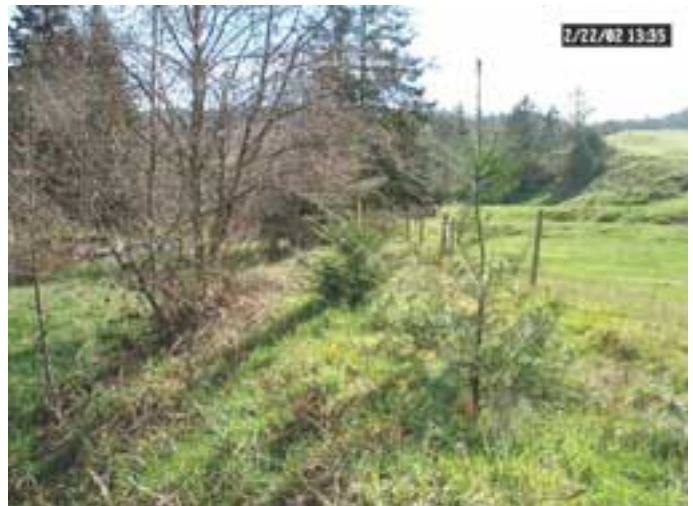
Plate 10

Willow Creek, FL-05, coast redwood next to alder, blackberries  
canopy opening to the south, 02/22/02

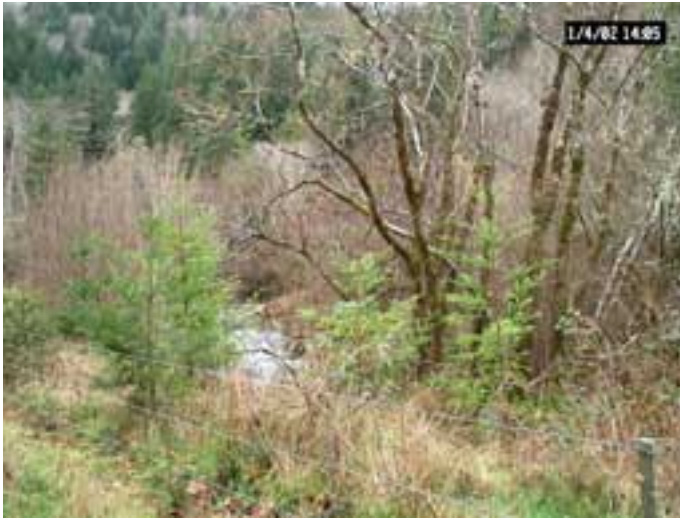
In 1996, 500 incense cedar seedlings were planted in riparian areas (outside of their normal habitat in this region), but the exact locations are unknown. Where observed in Cedar Creek (plate 11, top left), they are slow-growing but healthy. One landowner purchased 50 ponderosa pine to plant within 0.5 mile of the coast. The 25% that survived are growing well.

Cedar Ck (EC-07), 01/04/02, 3-5' incense cedar

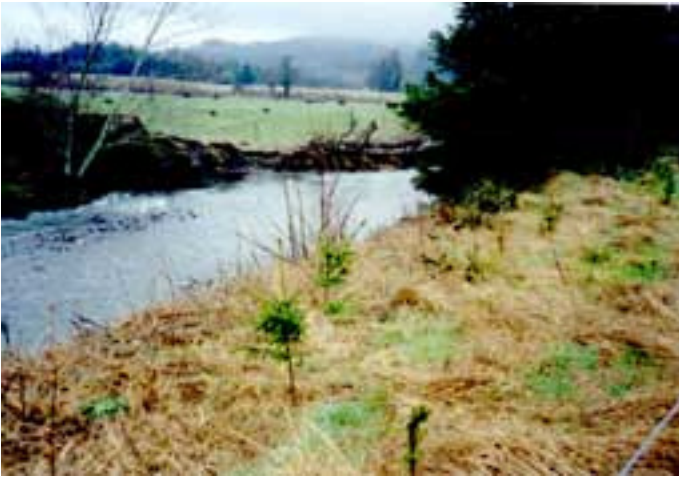
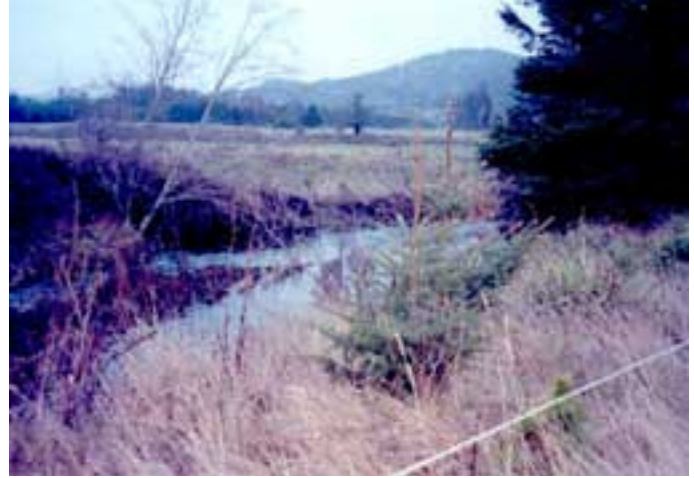
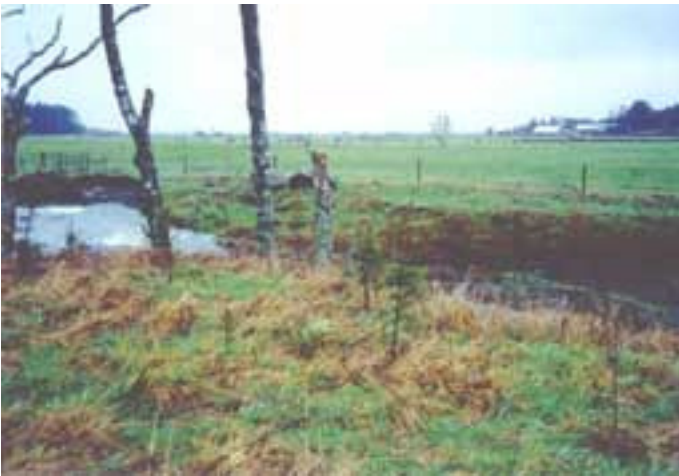
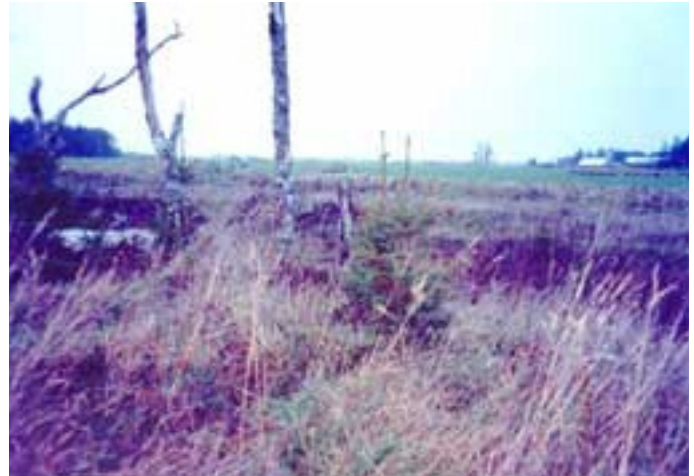
Species vary in their rate of root development and growth. For example, sitka spruce has been observed to lag behind other trees in the first few years, but growth accelerates after the root system develops (plates 12 and 13). Spruce is not doing as well as we'd hoped in the "blow zone" at the downstream end of Floras, Elk, and Pistol Rivers. Hay bales were placed at one site to provide wind protection, but the spruce tips got brown when they grew above the barrier. More willows are being planted to provide cover for the spruce.

Early growth of spruce trees slow until root systems develop

Accelerated growth after root development, same view as left

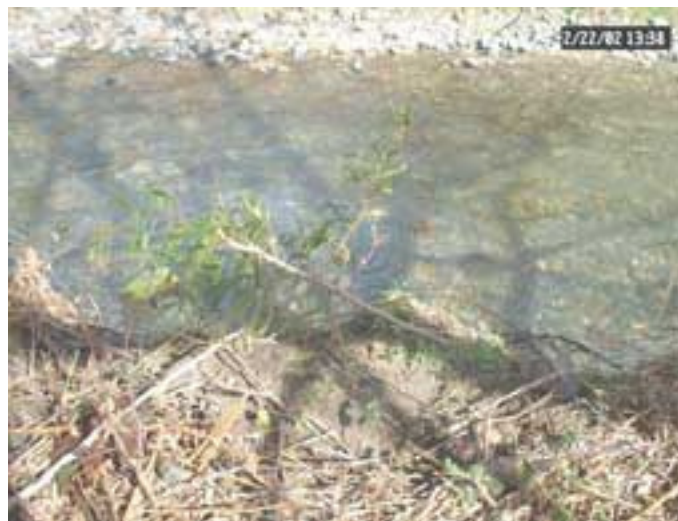
FL-05, coast redwood bent over and damaged from high flow, silt deposited at base

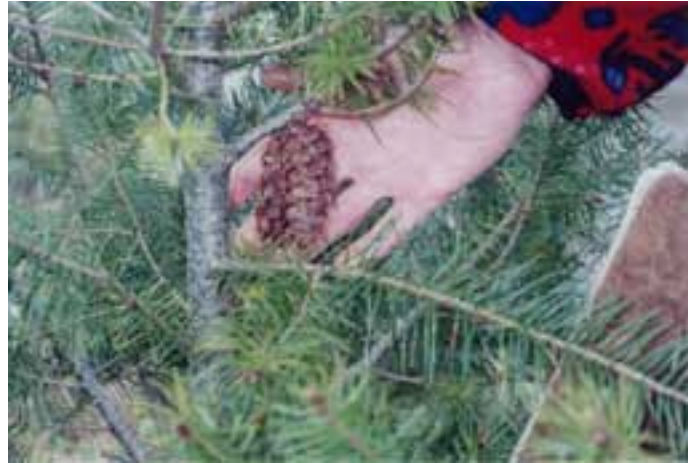
Premature cone development on young Douglas-fir

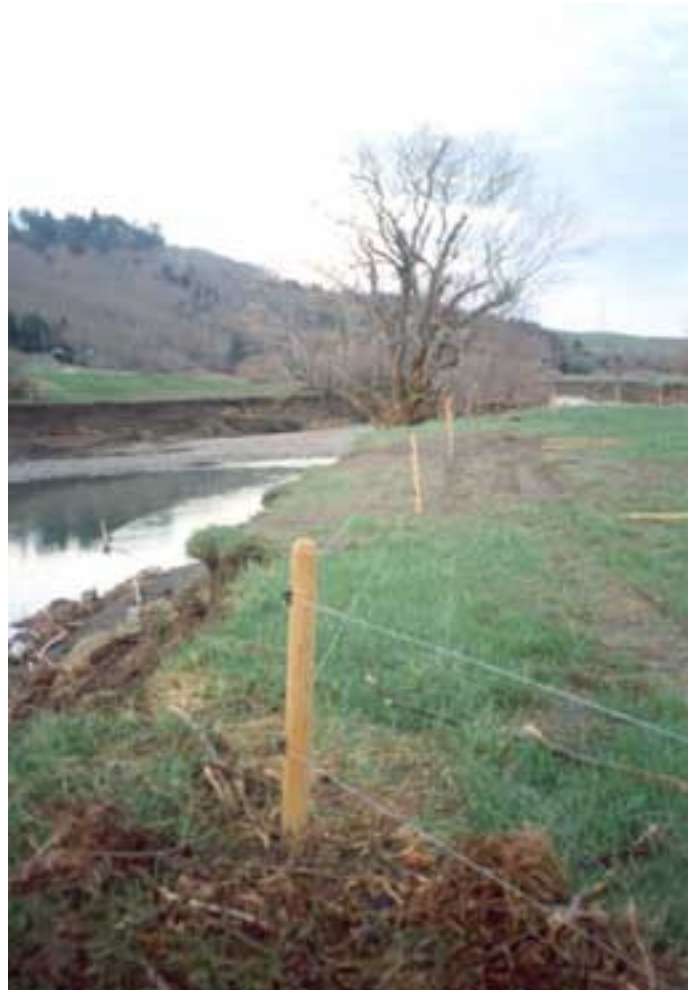
Chronic bank erosion makes fence maintenance an ongoing problem for landowners (plate 15, bottom right). Negotiations over wider setbacks can be difficult with landowners that already are volunteering to forego the use of part of their land. To decrease mortality from livestock browsing and reduce fencing costs where soil, vegetation, and channel conditions indicate that the fenced riparian setback is likely to be eroded, additional discussion will be needed. Narrower setbacks could be traded along inside bends and wider setbacks along the outside bend and downstream to anticipate channel migration. Although funds are generally unavailable for bank stabilization, providing structures that incorporate wood, planting willows and installing rock vanes and weirs are preferable to rip rap bank protection (plate 16). Sloping of banks to reduce erosion also creates a mineral soil planting site that is easier to revegetate (plate 17, top and bottom right), unless the exposed soils are droughty.

Floras Creek, 04/97
