PROJECT COMPLETION REPORT

Dodge Canyon Culvert Replacement Project

(OWEB Grant Agreements #205-162 & #206-284)

Elk Creek Watershed Council

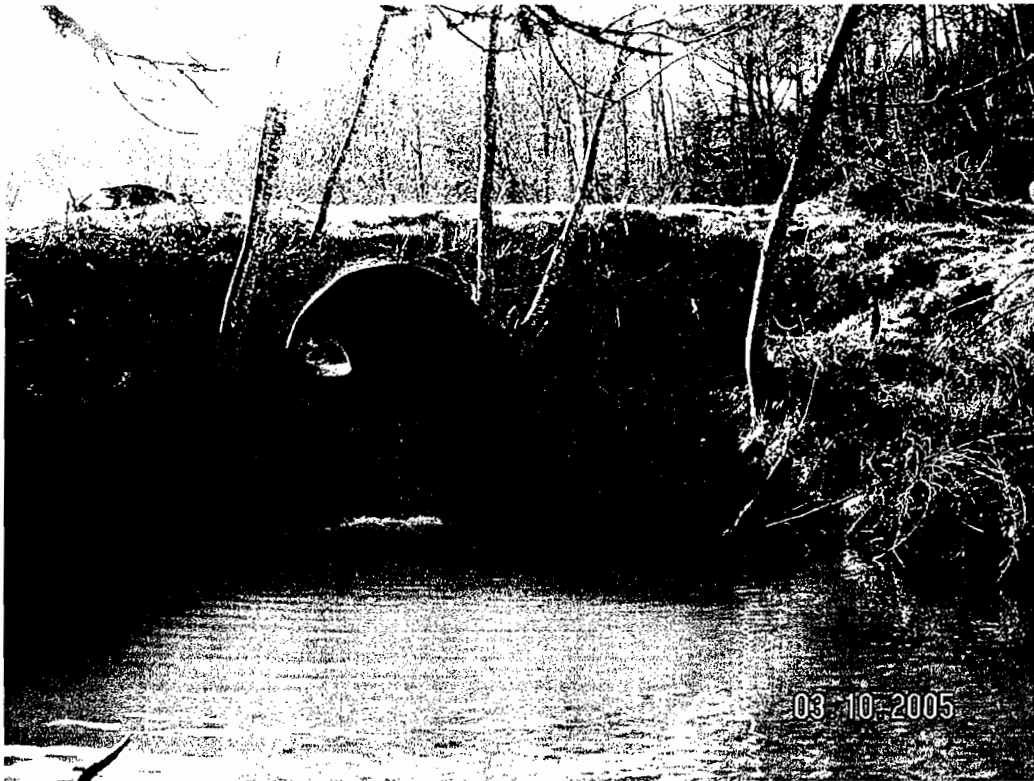
Dodge Canyon Creek – Culvert #1 (March 2005)

In early 2004, the Elk Creek Watershed Council identified a perched, undersized, 60" steel culvert that was blocking fish passage into more than a mile of Coho, Steelhead, and Cutthroat Trout habitat on private land on Dodge Canyon Creek, a tributary of Elk Creek. The Council approached the landowner and obtained permission to begin seeking funding to replace the barrier. Members of the Watershed Council conducted a preliminary survey of the site and decided that two (2) small, undersized culverts on a side tributary should be replaced at the same time. These two culverts were blocking almost ½ mile of additional habitat.

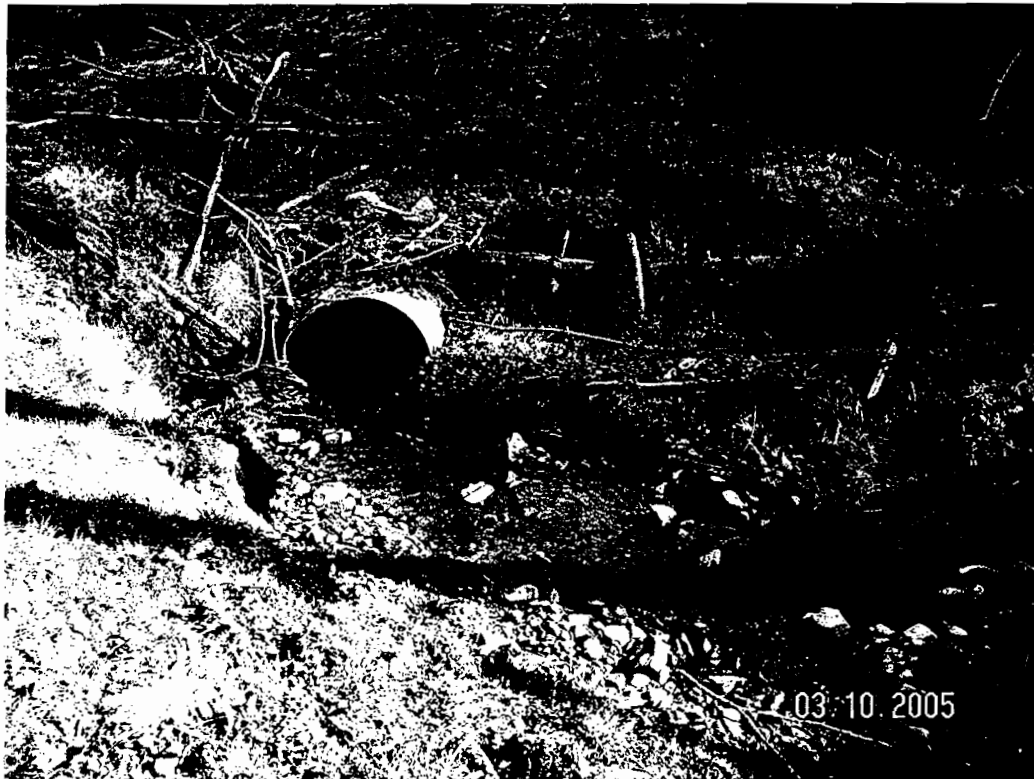
Dodge Canyon Creek – Culvert #2 (March 2005)

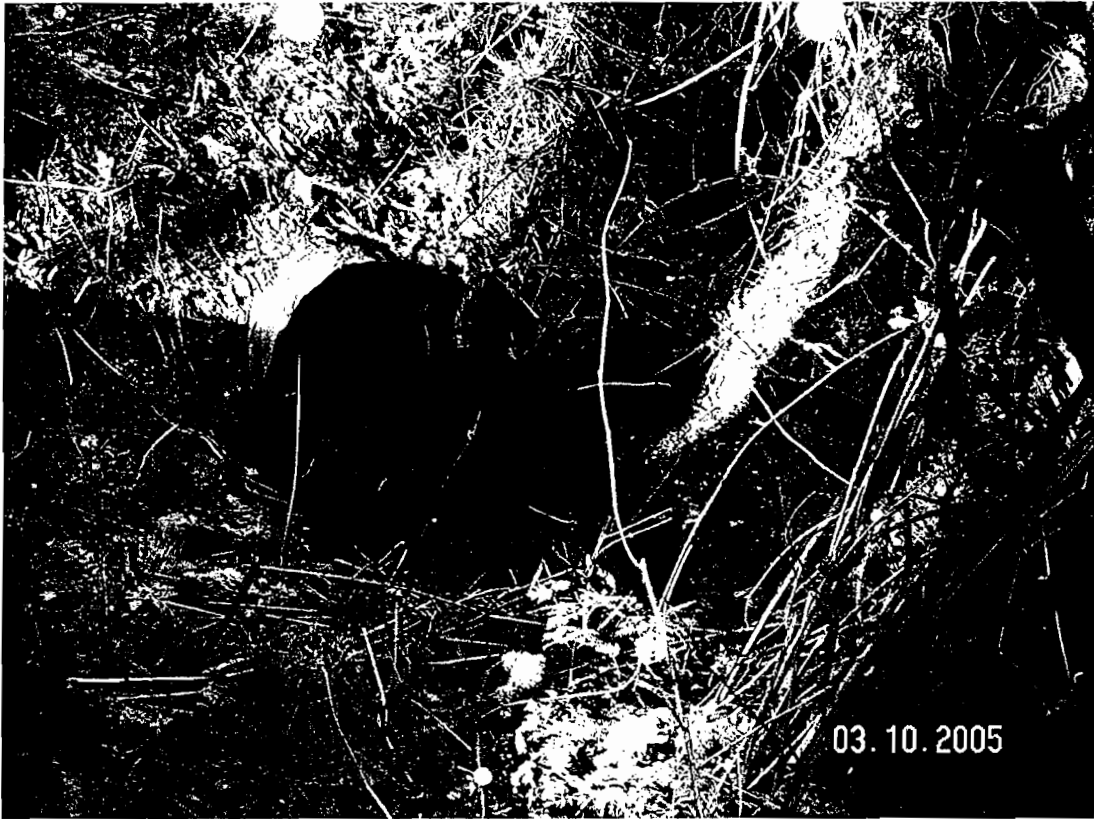
Dodge Canyon Creek – Culvert #3 (March 2005)

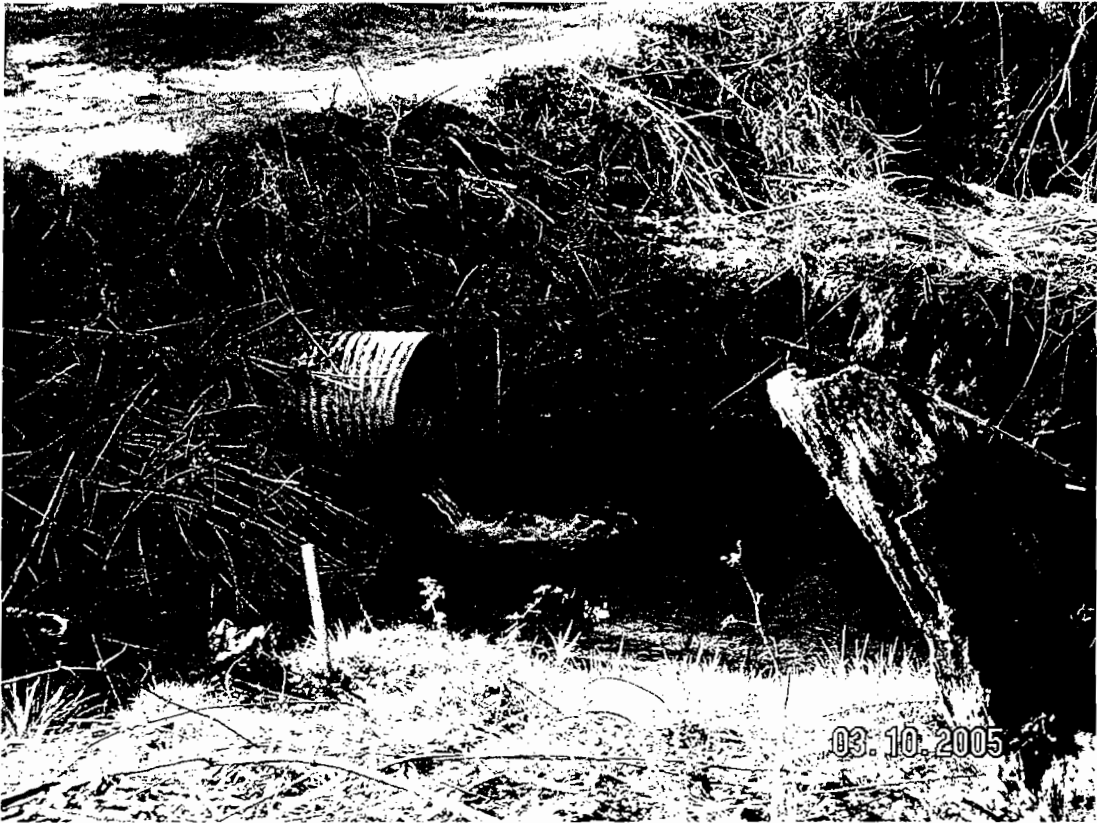
Dodge Canyon Creek - Culvert #4 (March 2005)

In the meantime, another partial barrier to adults, and a complete barrier to juveniles, was identified on another tributary about ½ mile up Elk Creek (Thompson Creek). This 60" steel culvert was blocking access to more than 1½ miles of habitat. The Watershed Council hired a local consultant to write an application for OWEB funding to replace this culvert. By replacing all these culverts at one time, with a single contractor, the Council hoped to save money.

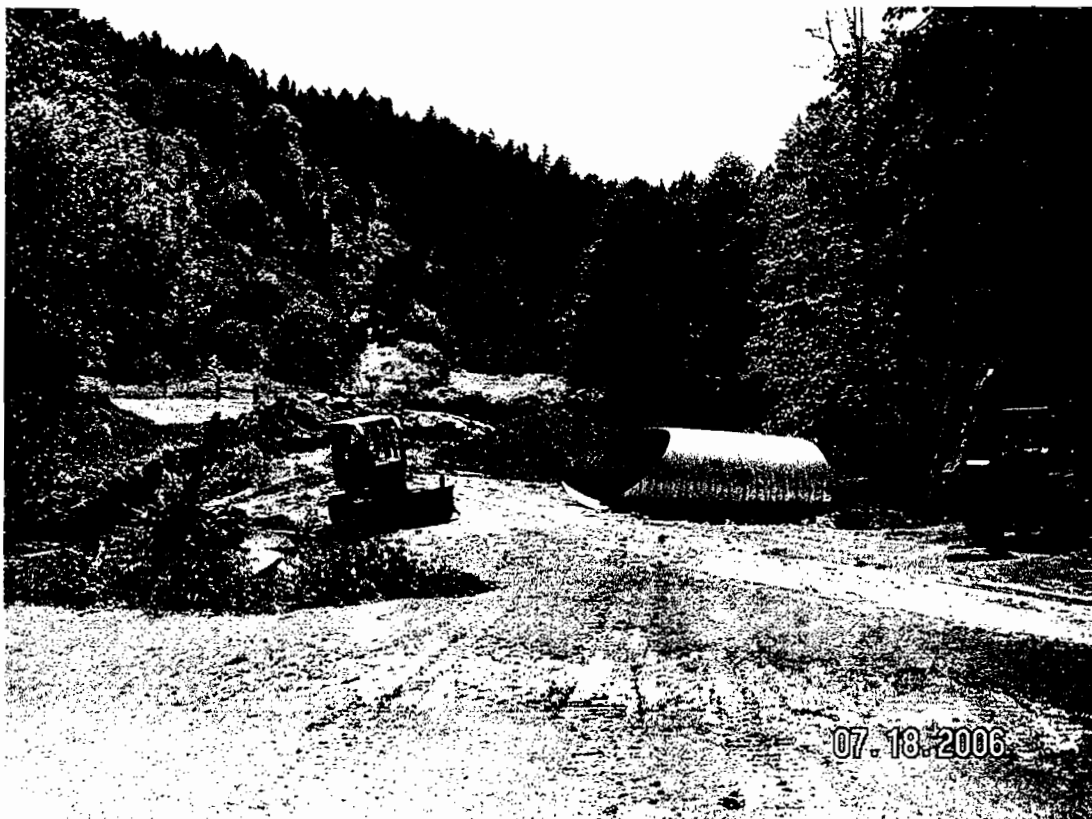
Excavation of Culvert #1

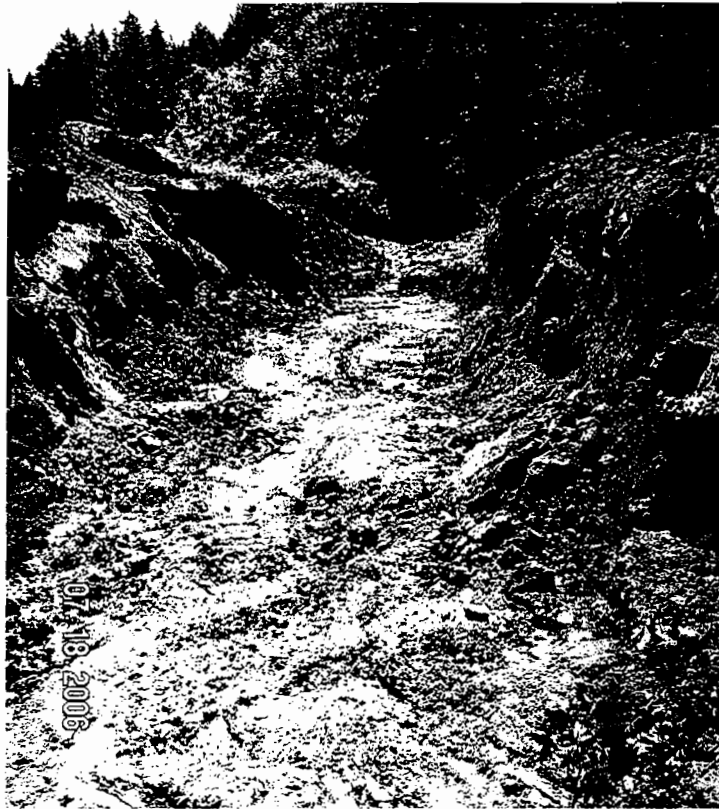
Soon after the first of July, the contractor began work on Culvert #1. the stream flow was diverted into a ditch which carried the water into the small tributary just above Culvert #2. Several problems were encountered when the old culvert was removed. First, beneath the old culvert was a layer of soft, wet serpentine clay. This necessitated digging down another two feet, installing geotextile fabric, and refilling with foundation rock. The other problem was the high water table. While the foundation was being dug, water kept seeping in. A sump hole was dug at the inlet end of the trench, and a pump was set up to pump out the water. This helped, but the bottom was still wet and muddy. The water also caused the sides of the trench to collapse so that the dirt needed to be removed and the final trench was wider than necessary. The addition of the foundation rock provided a solid base to set the large pipe.

Culvert #1 – Serpentine “Bottom” & Crumbling Sides

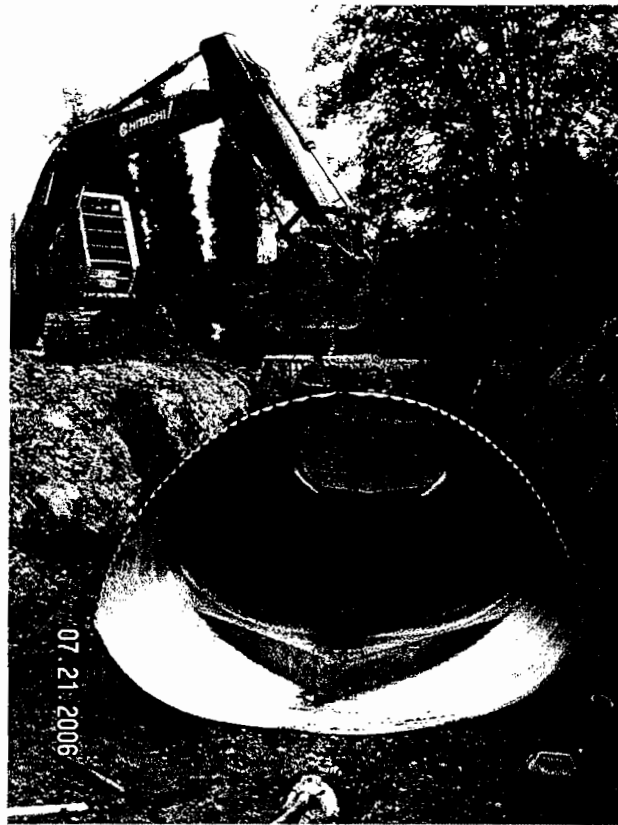
Culvert #1 – Bolting the Sections Together

Culvert #1 was a large arch, twelve (12) feet wide and almost eight (8) feet high. At eighty-six (86) feet long, it was shipped in four sections. Each section was lowered into the trench with a large excavator. As each section was set in place, a neoprene gasket was placed around the joint where it connected to the previous section, and the two sections were secured with a steel band consisting of three pieces bolted together. When all four sections were bolted together, the placement was checked against the construction stakes.

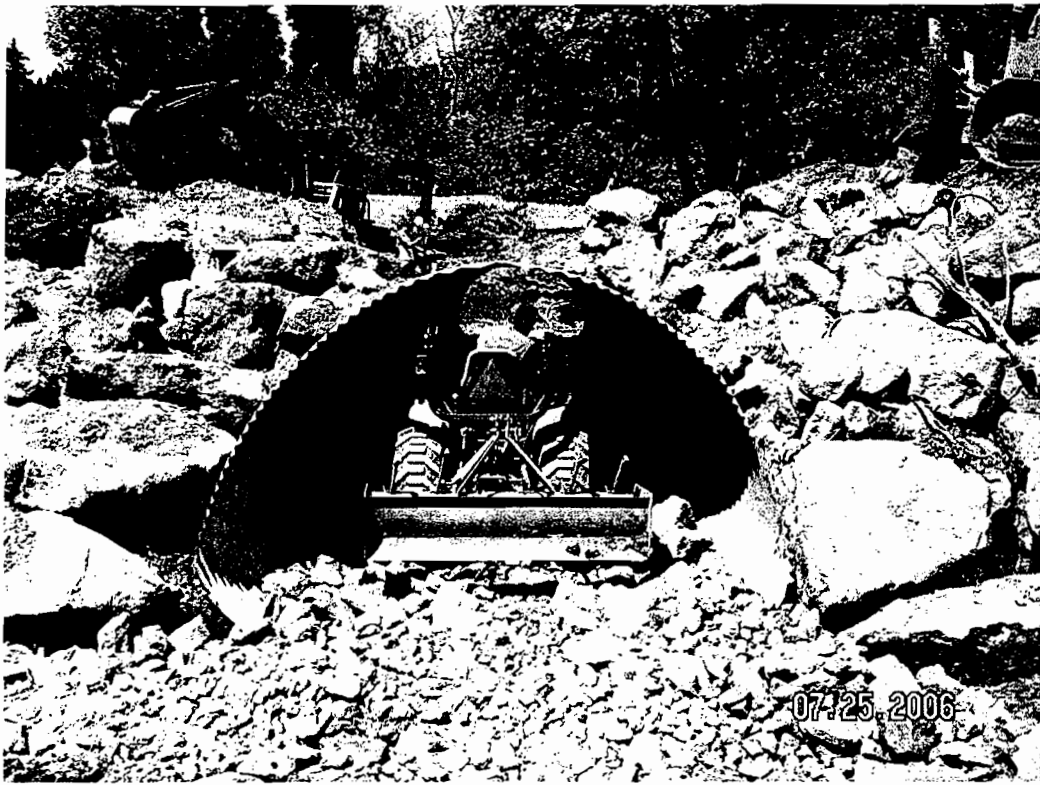
Culvert #1 – Placing the Embedded Rock

After the concrete had set, the trench was back filled with dirt and compacted with a power tamper. The bottom of the culvert was then embedded with two (2) feet of class 3 rip rap and river gravels. A small tractor with a bucket was able to drive into the culvert and place the rock. The river gravels were "washed in" with a water hose to settle the fines, and to prevent the stream from completely submerging into the rock during low flows. The banks were shaped and rip rap was placed around the inlet and the outlet.

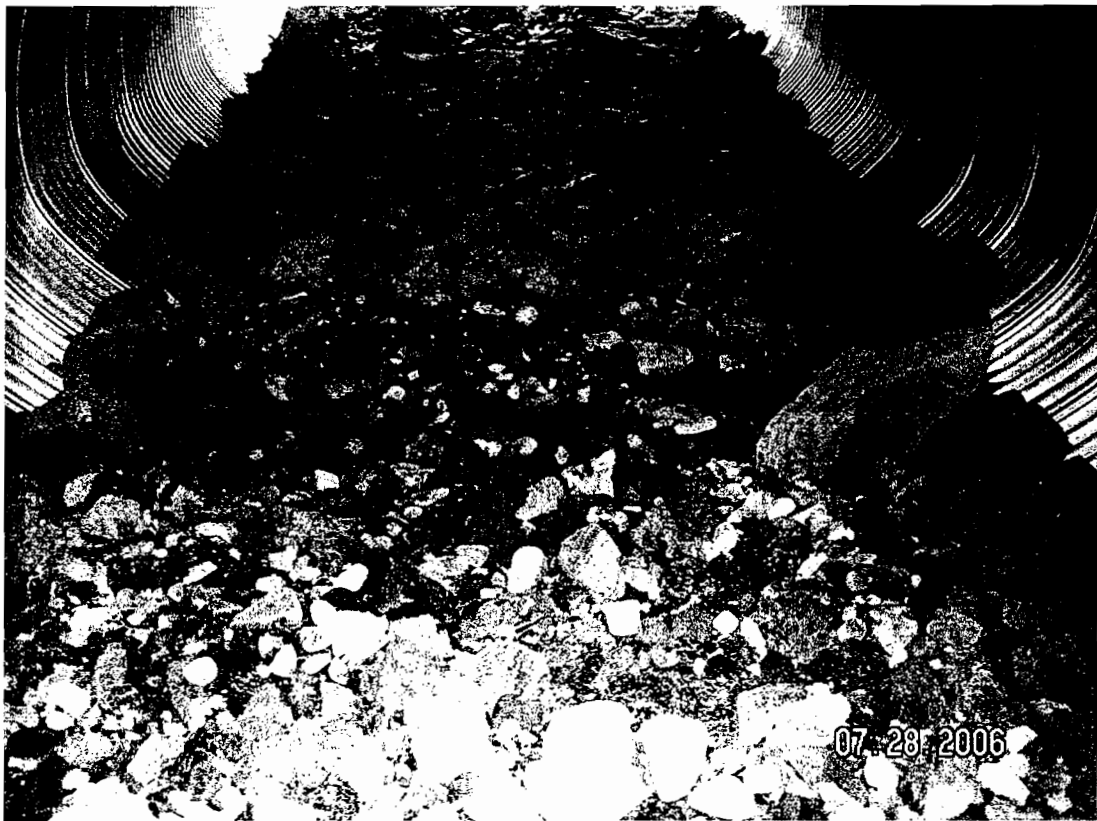
Culvert #1 – Embedded Rock

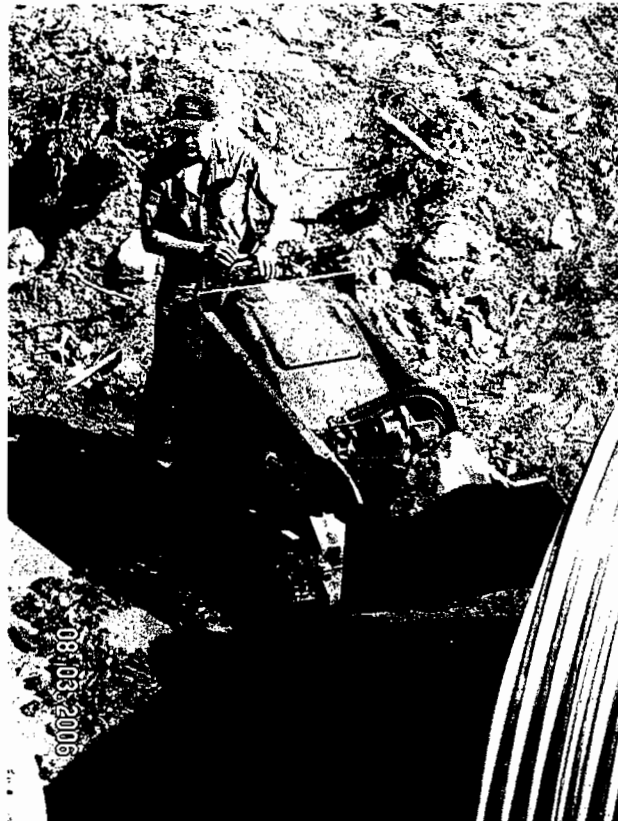
Culvert #4 – Placing the Embedded Rock

This culvert was only 83" high so the tractor could not drive into it to place the embedded rock. Instead, the contractor rented a small, hand operated machine on a track with a hydraulic bucket. This machine was about four (4) feet long and three (3) feet wide with rubber tracks on the bottom, and a small bucket on the front. It was about three (3) feet tall, with handles on the back where the operator could stand and control it. The tracks allowed it to move forward and backward and to turn, and there were controls to move the bucket up or down, or to rotate it to dump the contents. It worked well for getting the embedded rock into the culvert, but tight turns on the rough rock surface caused a track to come off. The machine had to be lifted out with the excavator, but the track was put back on fairly easily.

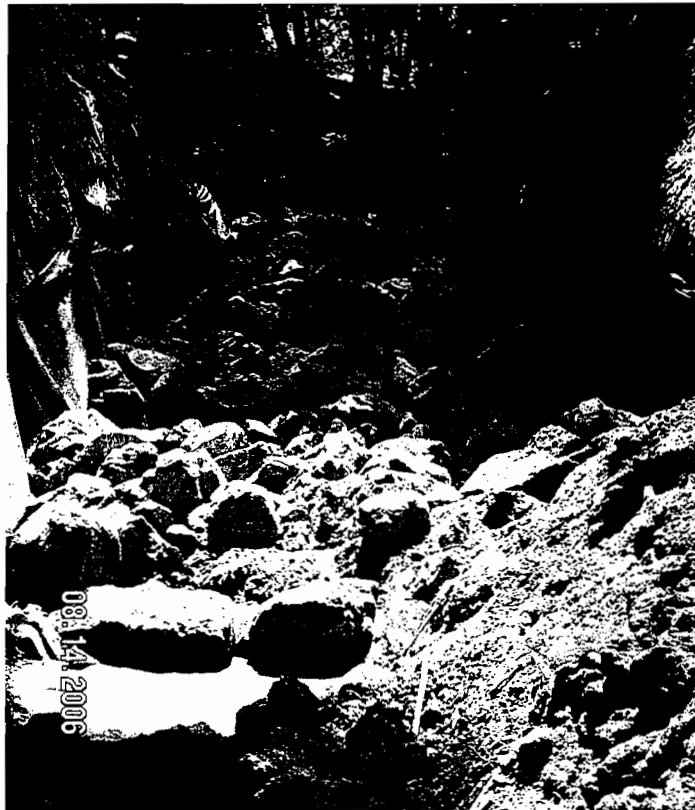
Culvert #3 – Building the Foundation

The flow from the tributary was diverted through a trench with a section of pipe under the road. The trenches for the structures were dug with the excavator according to specifications in the designs. The bottom of the trenches was lined with geotextile fabric, with ample amounts extending up the sides of the trench. A two (2) foot layer of large rocks, with the spaces filled with crushed rock, was built up on top of the fabric. The top of this foundation layer was rough and irregular, with the tops of the larger rocks sticking up. A layer of washed river gravel was washed into the spaces on top. Next, the sides of the foundation, where the footings would rest, were smoothed with finer gravel and topped with a layer of concrete mix. The sections of culvert were placed with the footings on the layer of concrete and bolted together. The geotextile fabric was folded

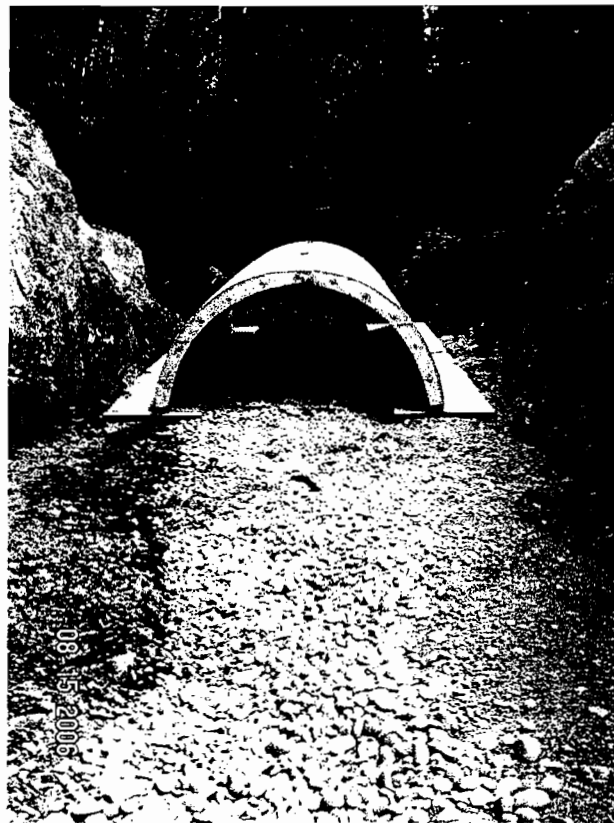
Culvert #3 – First Section on Rock Foundation

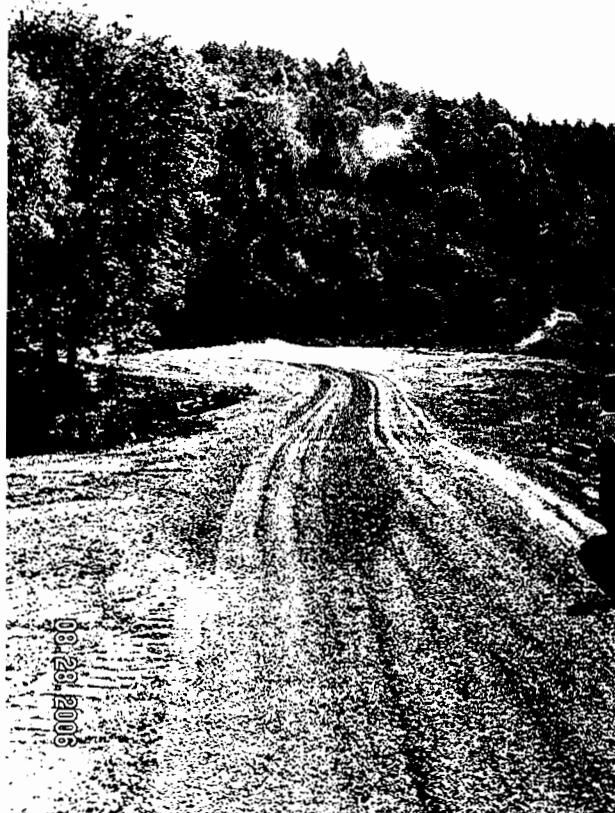
Project Site – Roadway over Culverts #1 and #2

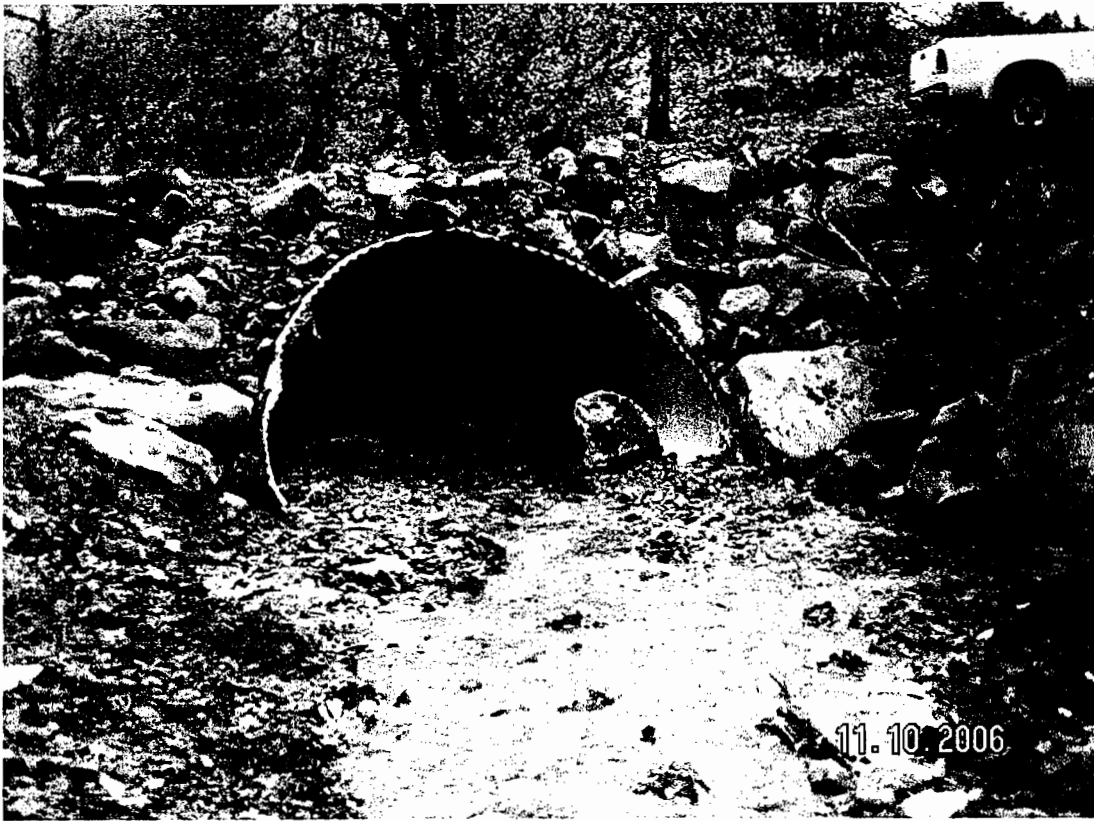
Culvert #1 – November 2006

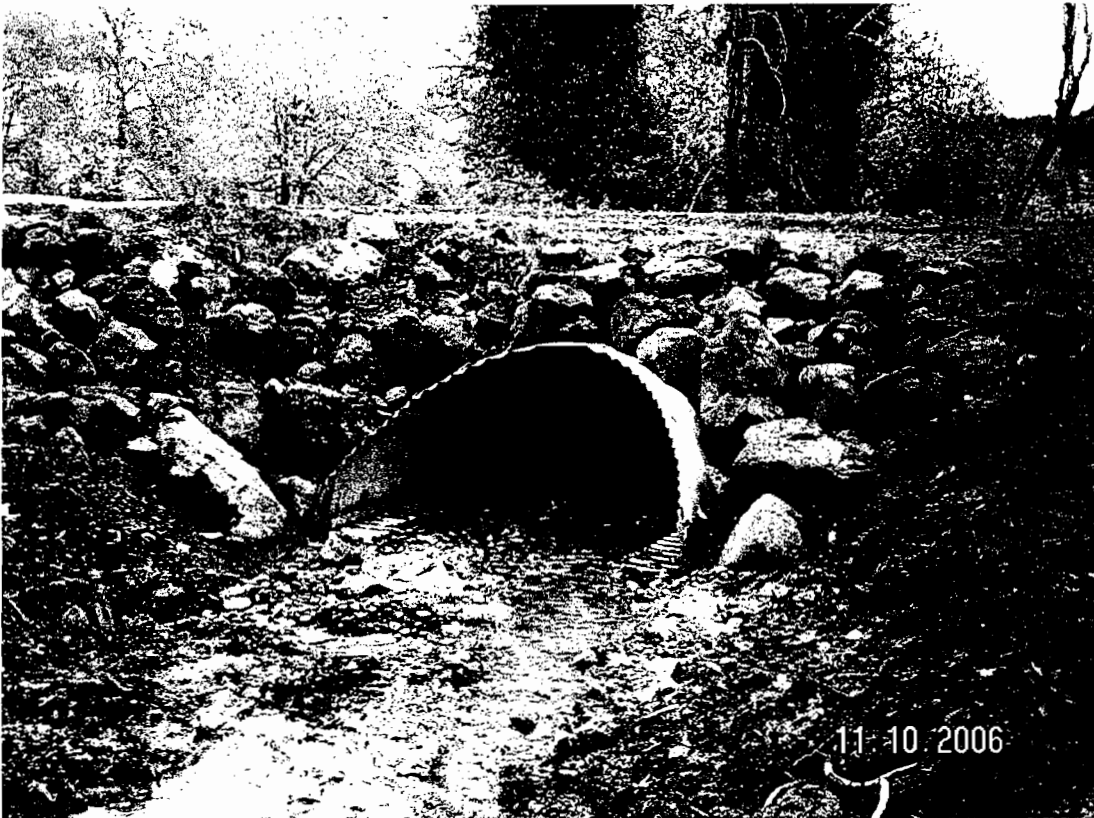
Culvert #2 – November 2006

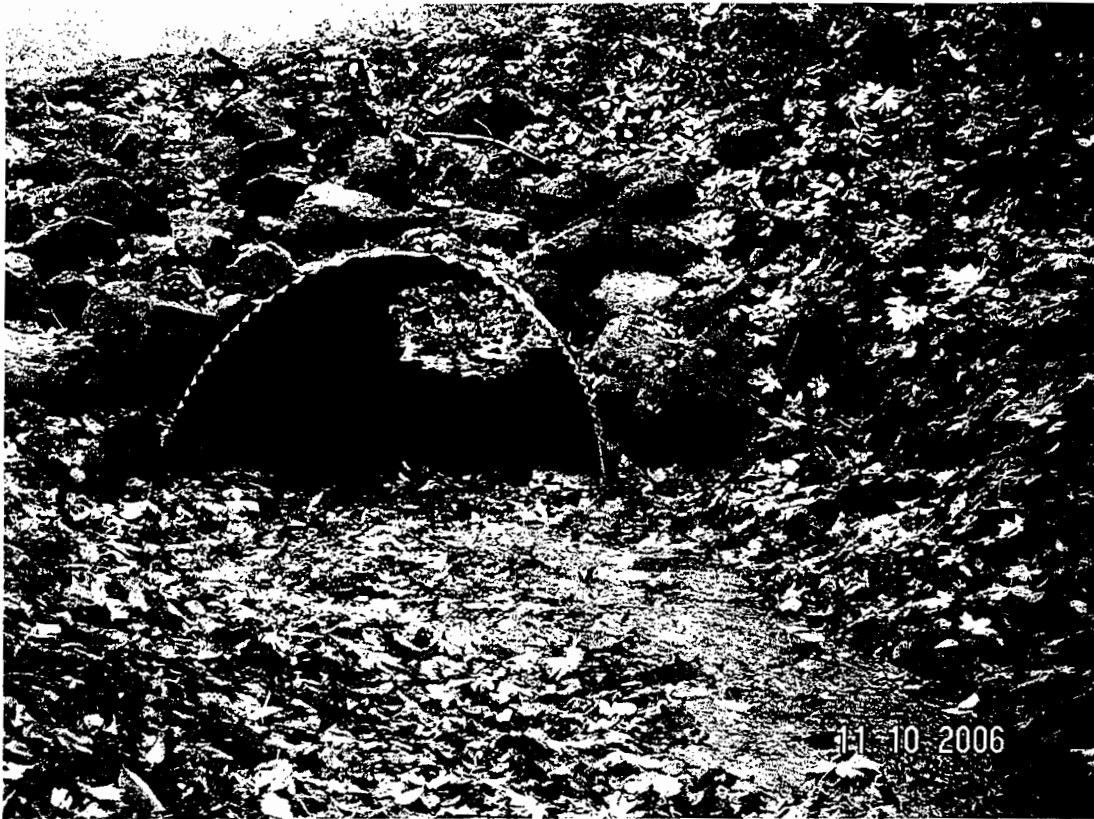
Culvert #3 – November 2006

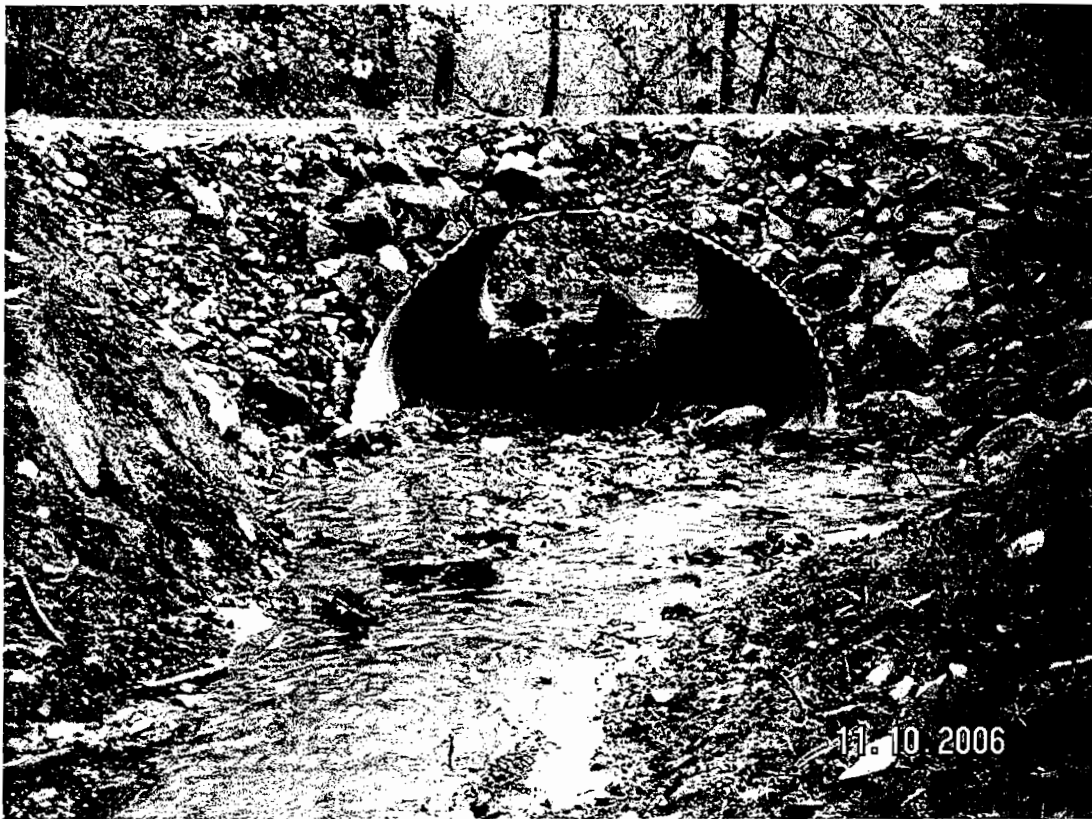
Culvert #4 – November 2006
