# Market Creek Fish Passage

## Conceptual Project Design Report

March 24, 2015

Prepared By: Curry Soil and Water Conservation District, Swanson Ecological Services, LLC, and Northern Hydrology & Engineering

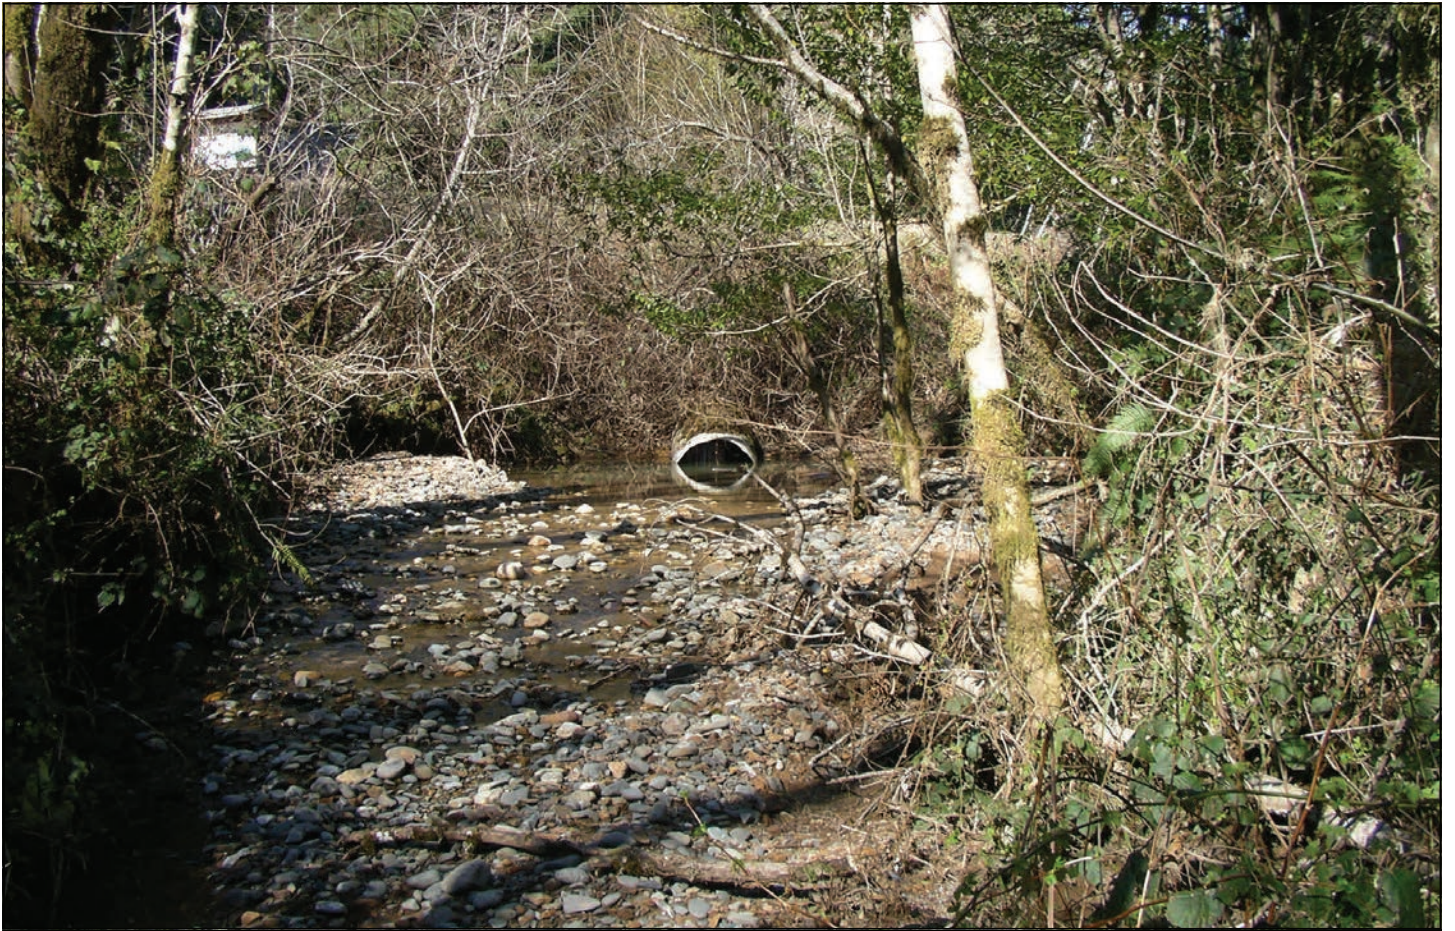
Top photo shows the outlet of the County Road culvert, which is bowed and partially submerged. The bottom photo shows the inlet of the County Road culvert and the segment of open stream channel that exists between the two culverts.

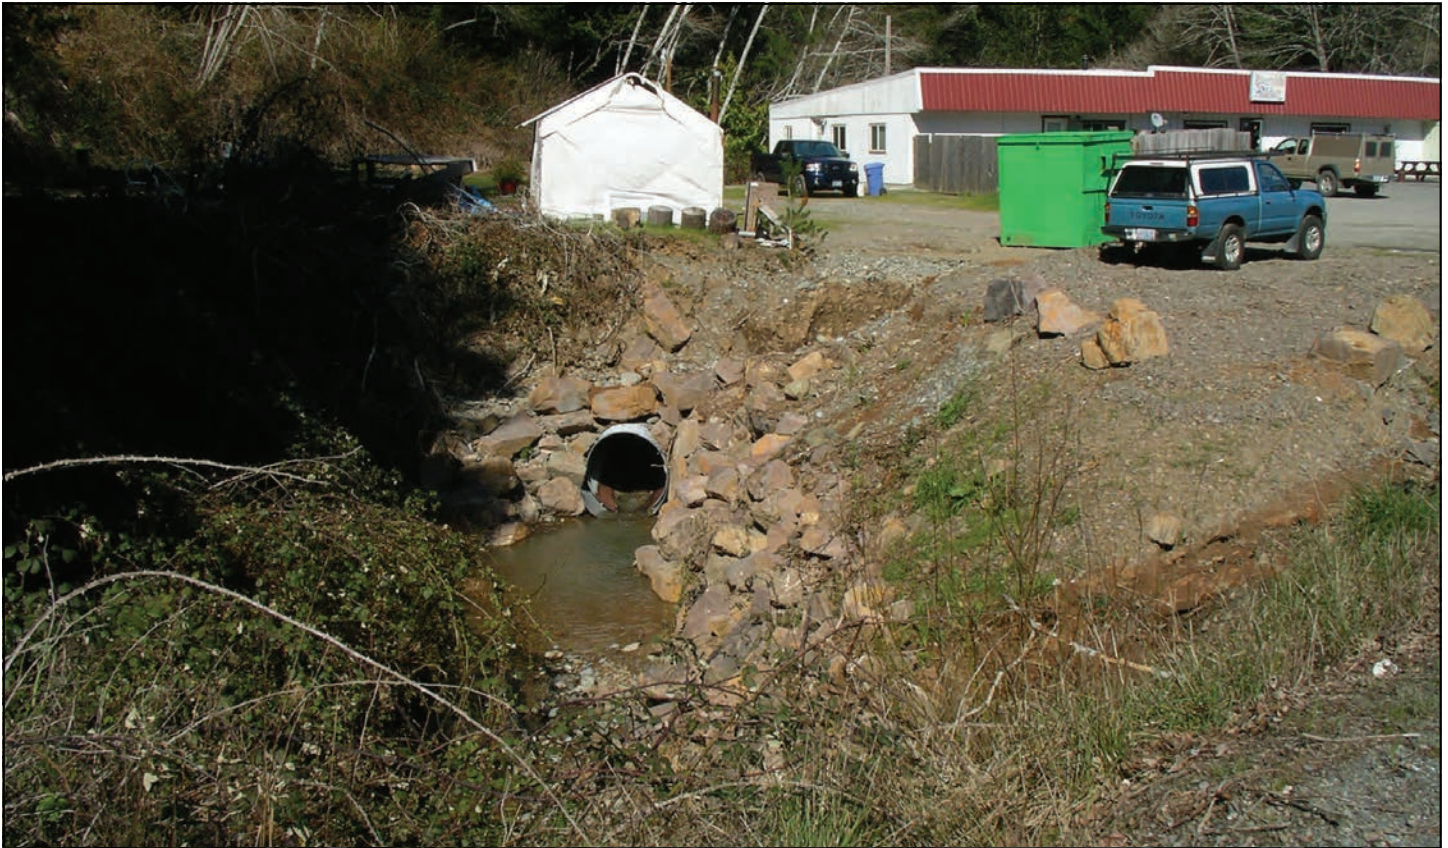
Top photo shows the outlet of the existing Riverside Market culvert, and the usable commercial area that was created by the culvert installation. In NHE's conceptual design this fill will be removed and a "daylighted" engineered roughened channel will be constructed in its place. The bottom photo shows a sinkhole that formed in 2012, which prompted the landowner to insert a 20 ft segment of 36 inch diameter pipe into the inlet so the fill could be reconstructed.

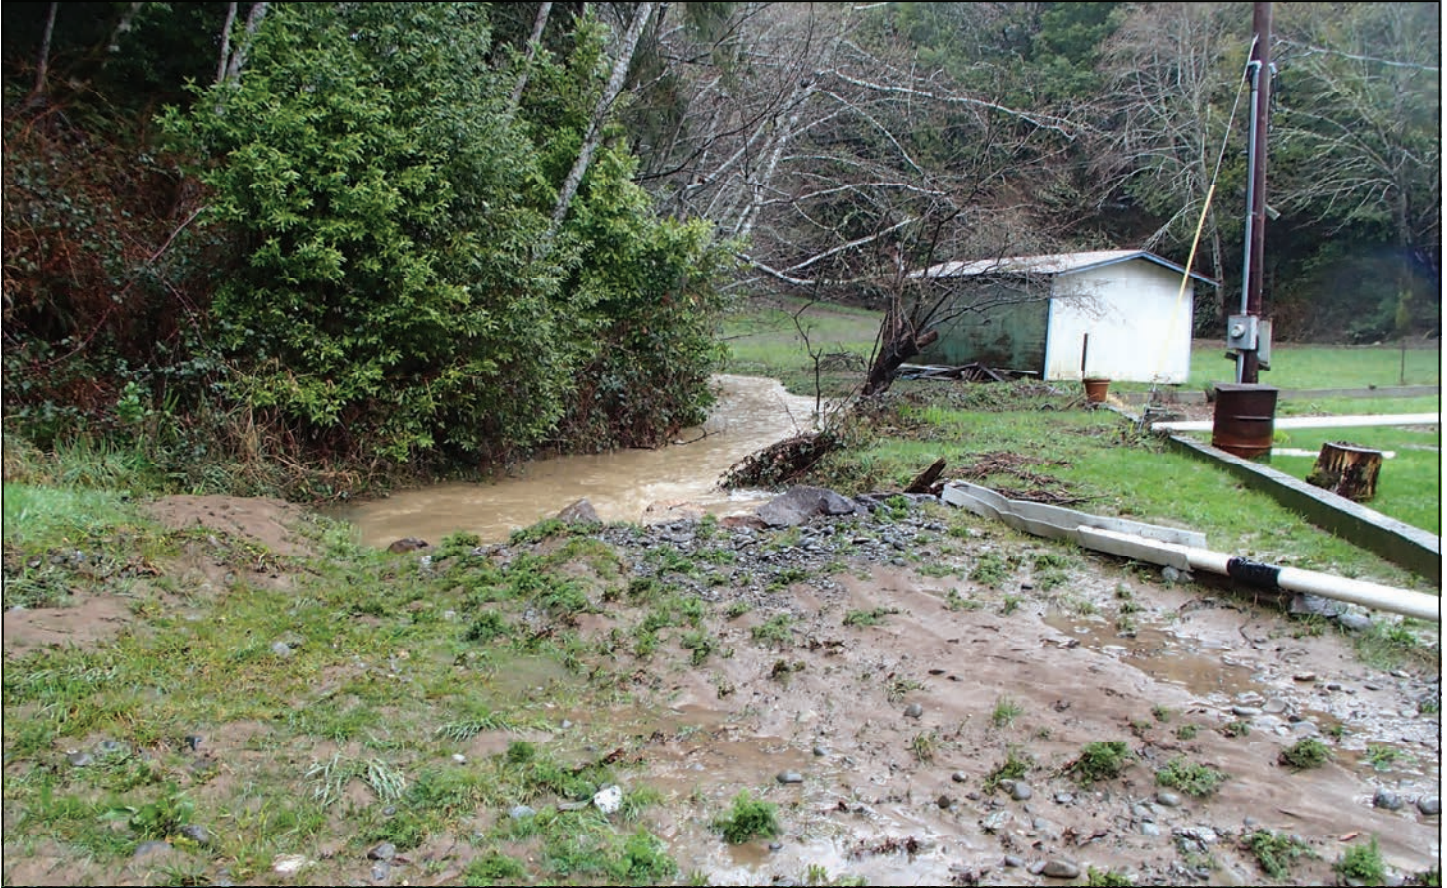
Top photo shows the inlet of the Riverside Market following peak discharge during a 'typical' high water event in 2014. The 36 inch diameter insert further reduced the capacity of the pipe, which causes the stream to overwhelm the culvert and divert on a regular basis. The bottom photo shows the culvert outlet and some of the scour that occurs when the stream runs across the parking lot.

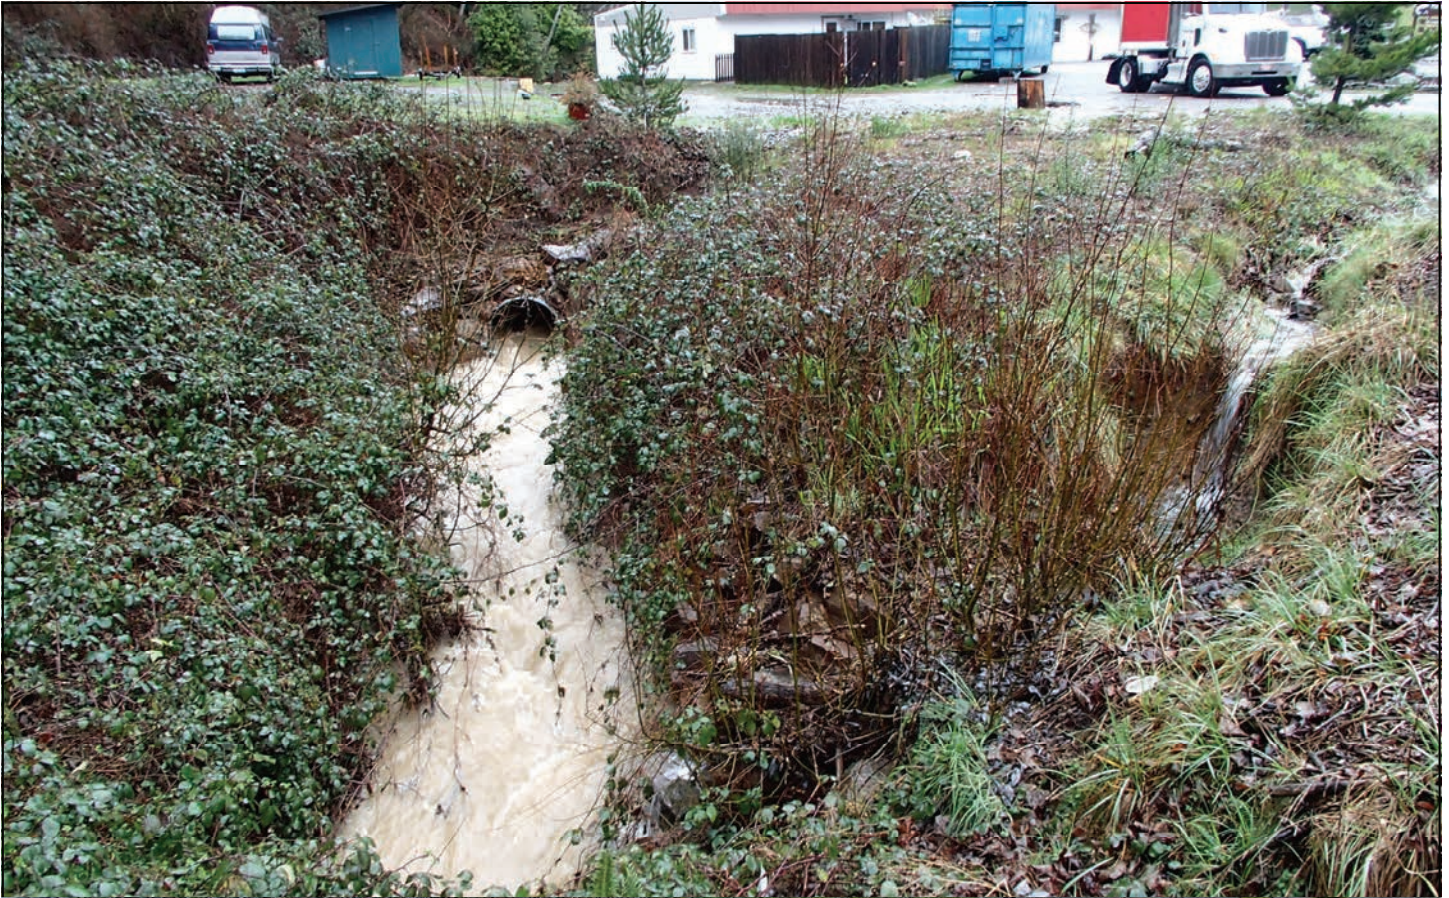
Top photo shows the outlet of the Riverside Market culvert, the segment of open stream channel, and erosion in the county road ditch that results when the stream diverts. The bottom photo shows the Chetco River backwatering the outlet channel below the county road. Note the contrast between the backwater and the segment of open stream channel, with respect to refugia.

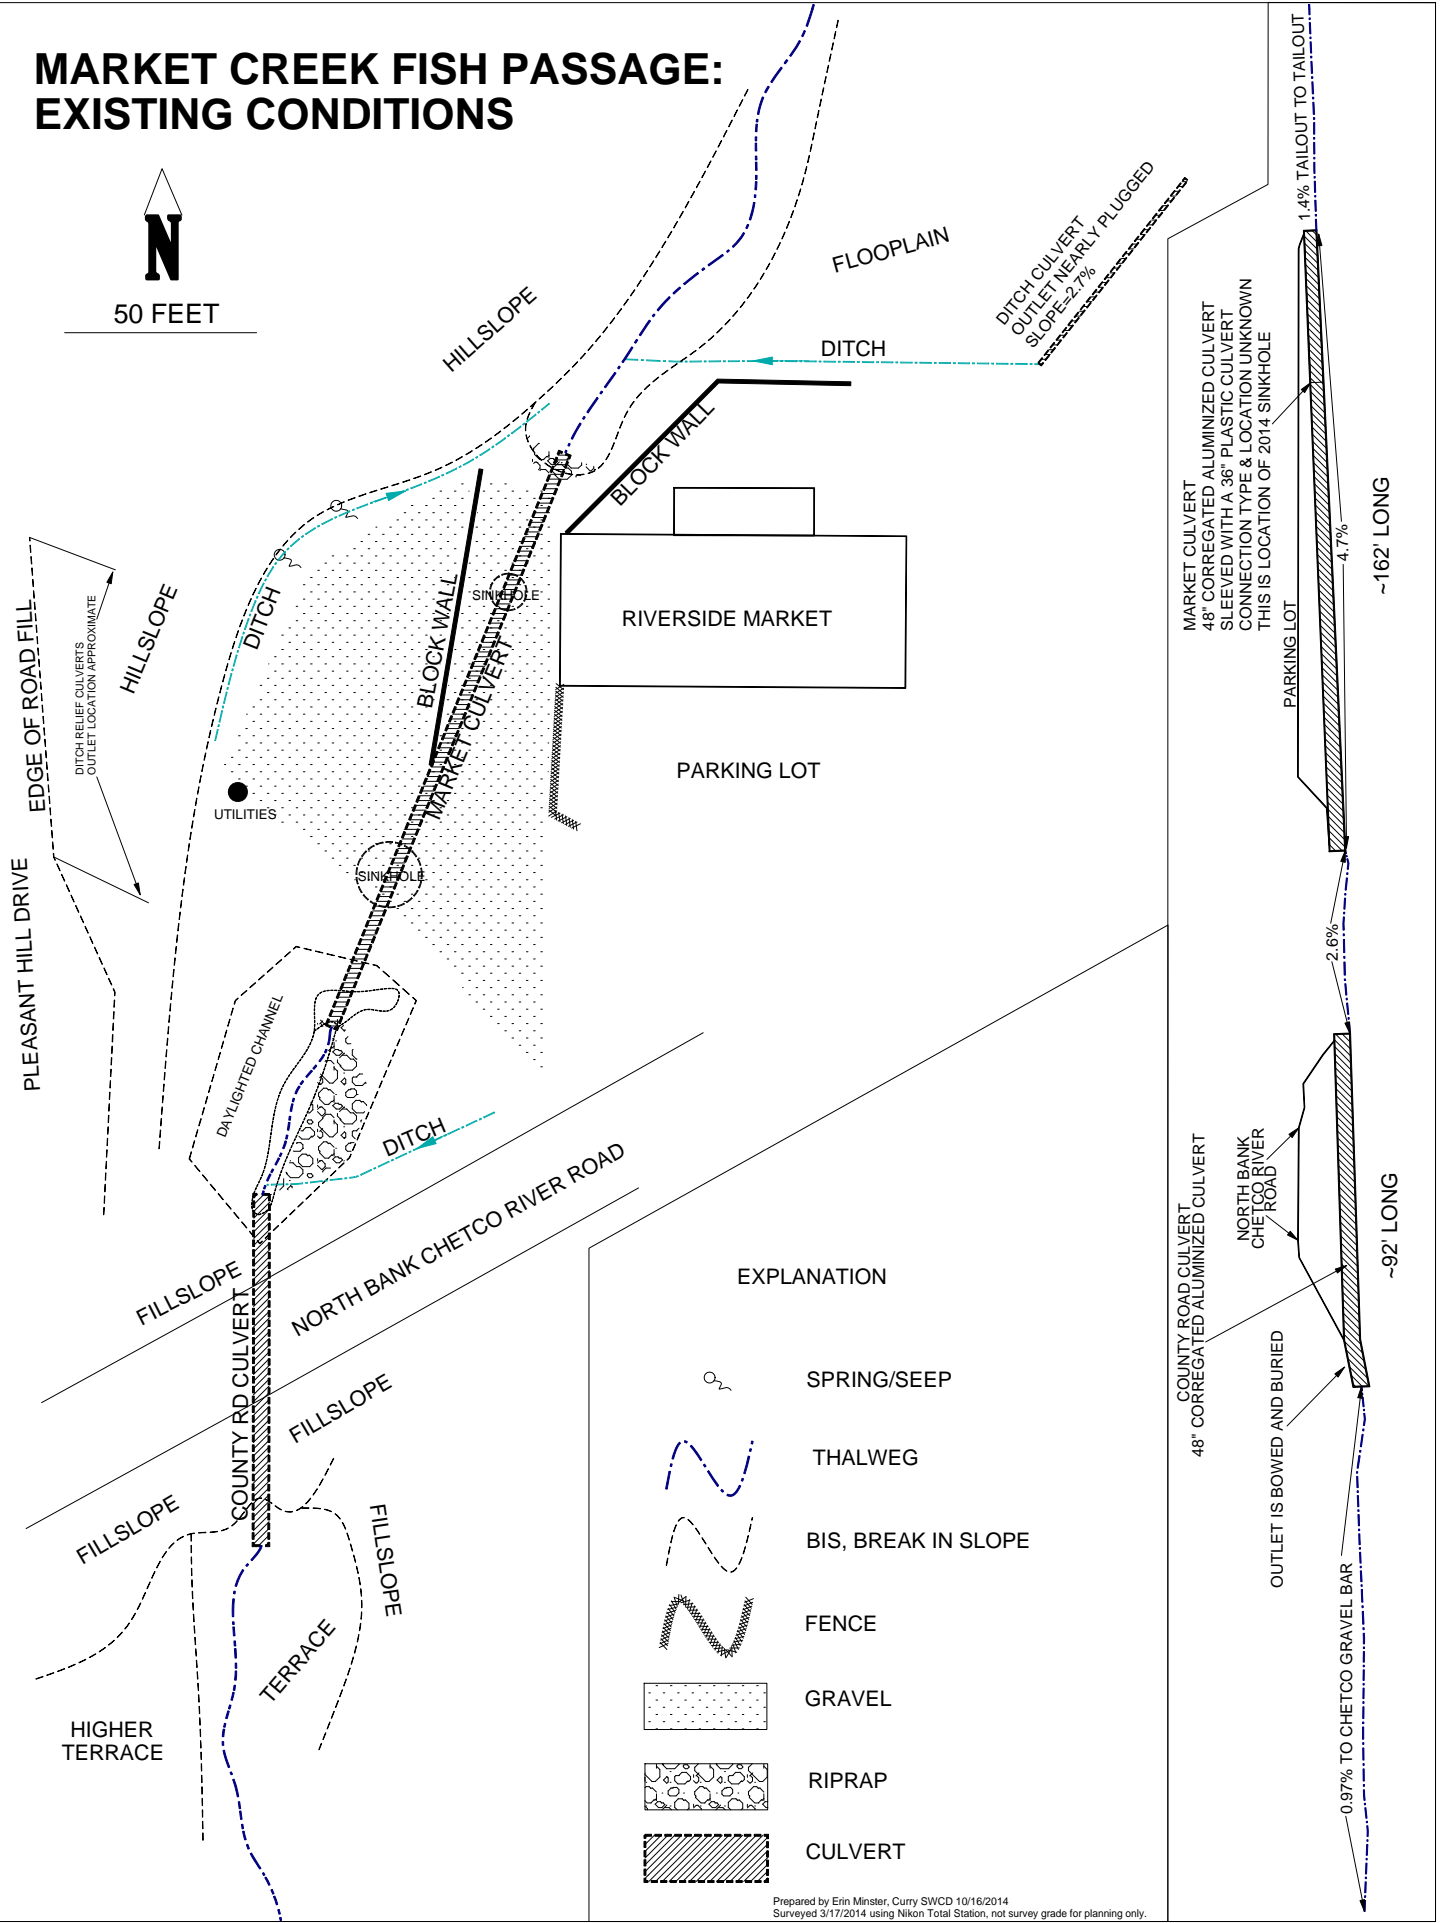
# MARKET CREEK FISH PASSAGE: EXISTING CONDITIONS

MARKET CULVERT  
48" CORRUGATED ALUMINIZED CULVERT  
SLEEVED WITH A 36" PLASTIC CULVERT  
CONNECTION TYPE & LOCATION UNKNOWN  
THIS IS LOCATION OF 2014 SINKHOLE

COUNTY ROAD CULVERT  
48" CORRUGATED ALUMINIZED CULVERT  
NORTH BANK CHETCO RIVER ROAD
