# **Aquatic Inventory Project (AIP) Habitat Surveys: Butte Creek – 2008 & 2012**

Survey conducted by  
**Aaron Fitch & Erin Minster**  
**Curry Soil and Water Conservation District**

Report by  
**Erin Minster – Curry SWCD**  
**Matt Swanson – Swanson Ecological Services, LLC**

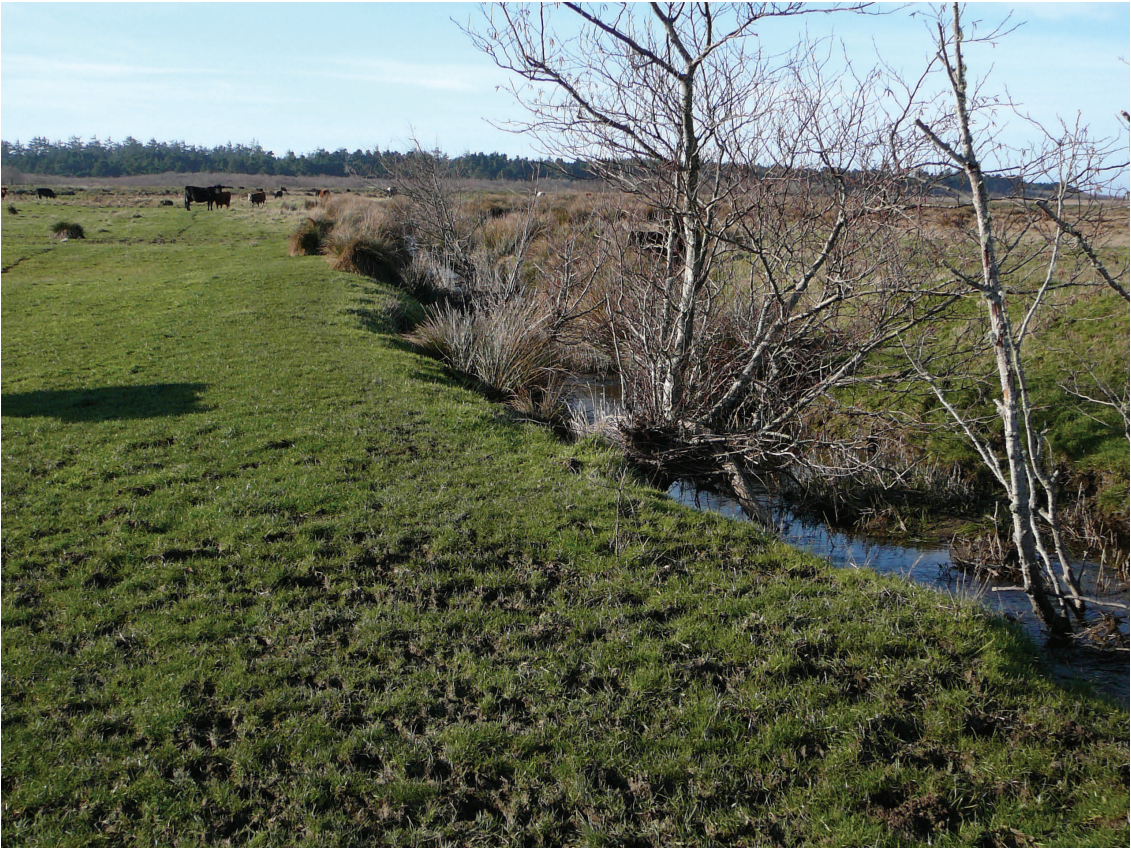
**Figure 1**

2008 Reach 1, unit 1, looking downstream at ditch channel outlet to New Lake.

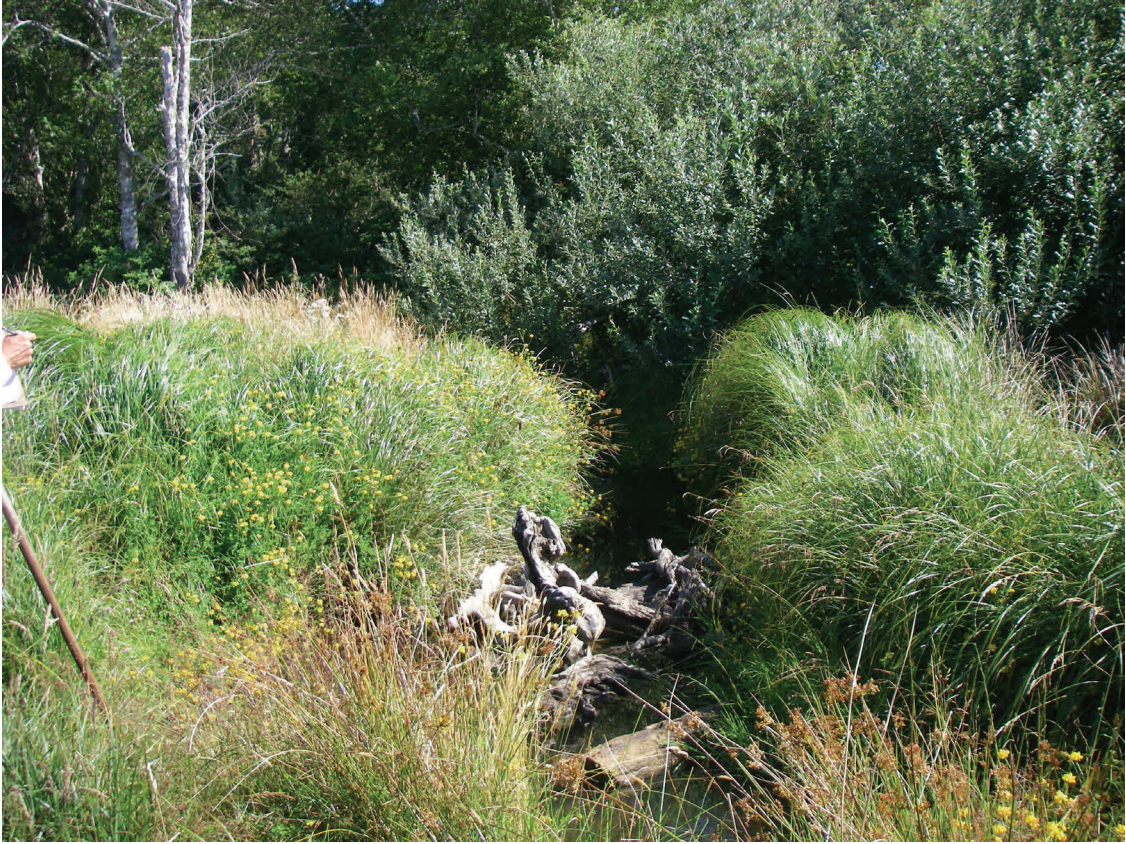
**Figure 2**

2012 Reach 1, unit 2, large wood placement looking downstream.

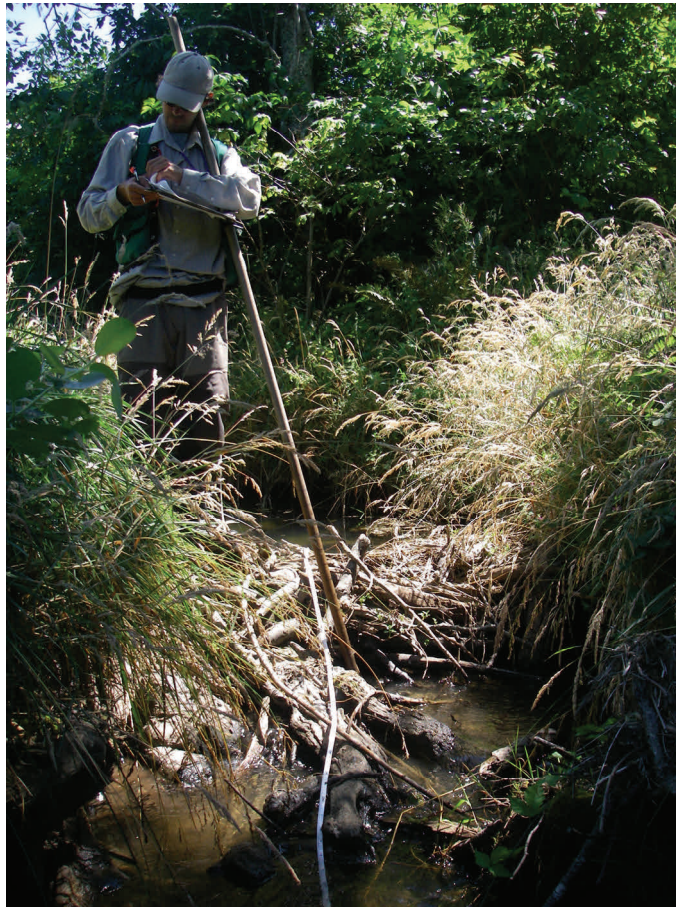
**Figure 3**

2012 Reach 2, unit 25 looking upstream at small beaver dam.

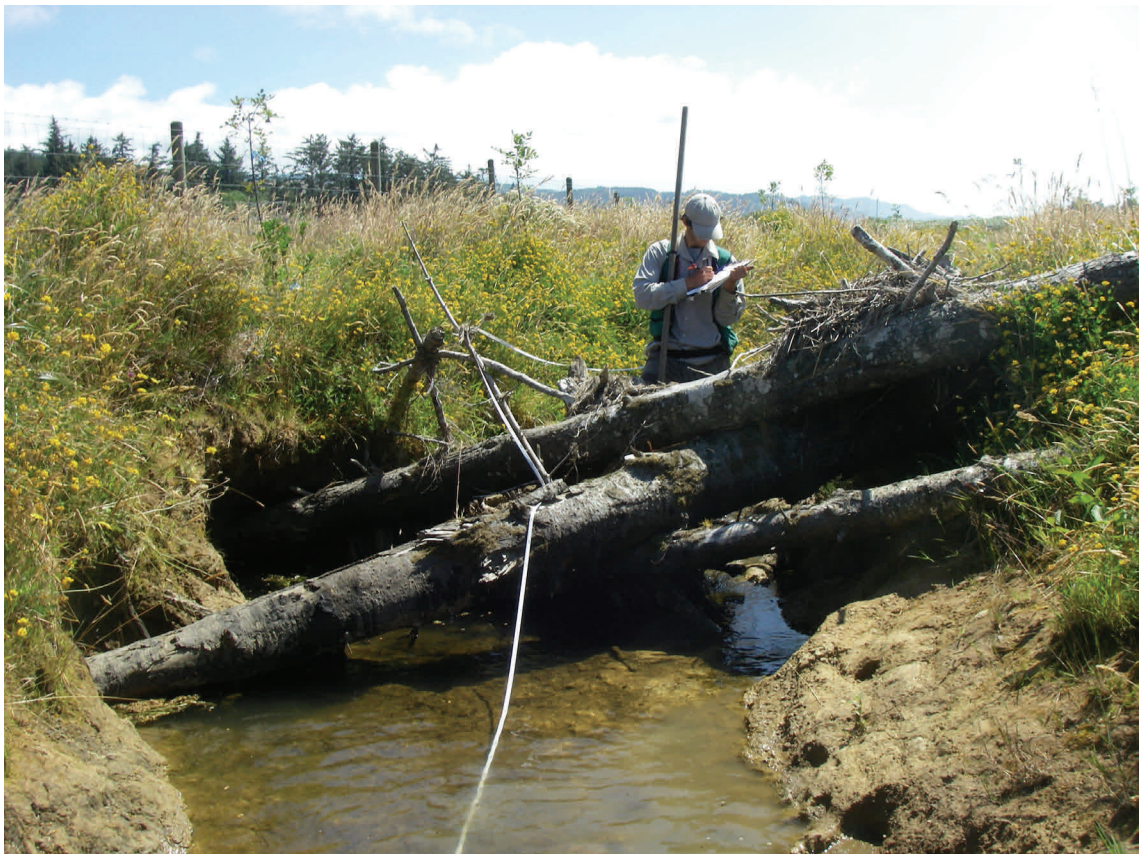
**Figure 4**

2012 Reach 2, unit 32, looking upstream at large wood placement within newly constructed channel reach.

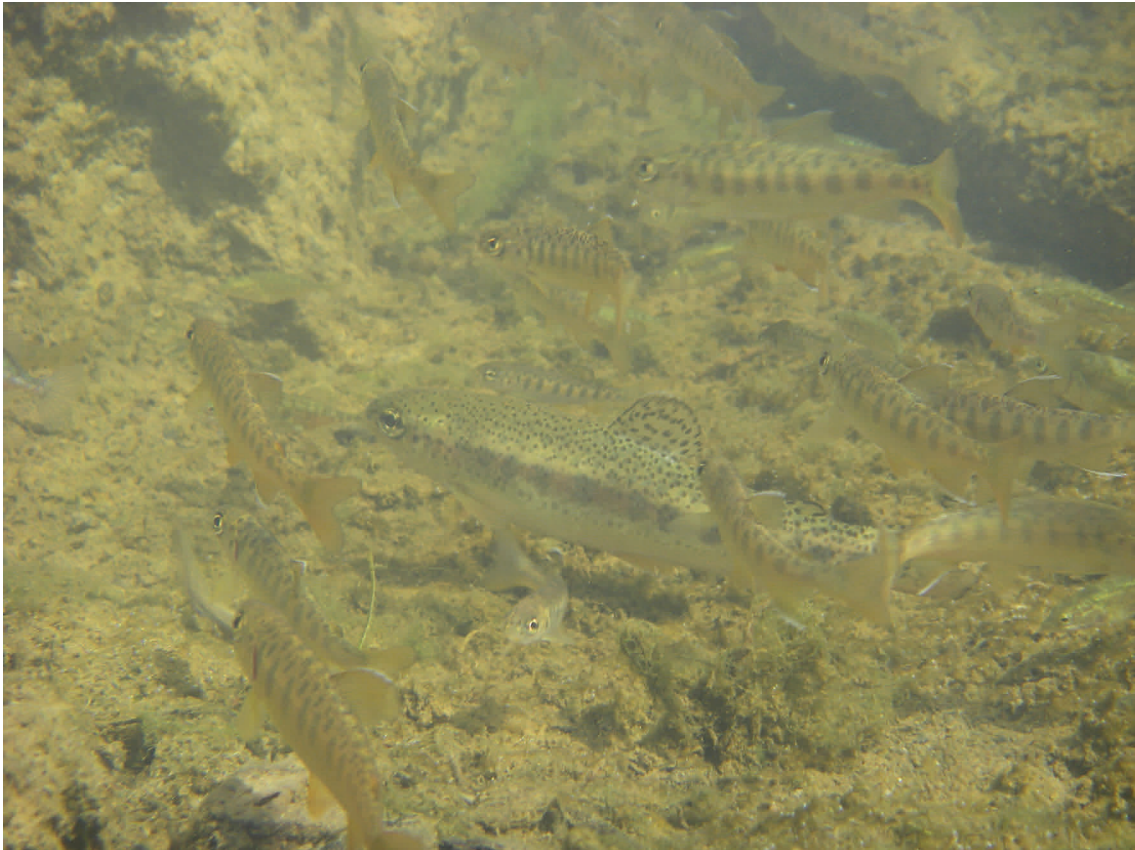
**Figure 5**

2012 Reach 2, unit 43, coho and cutthroat trout utilizing new habitat.

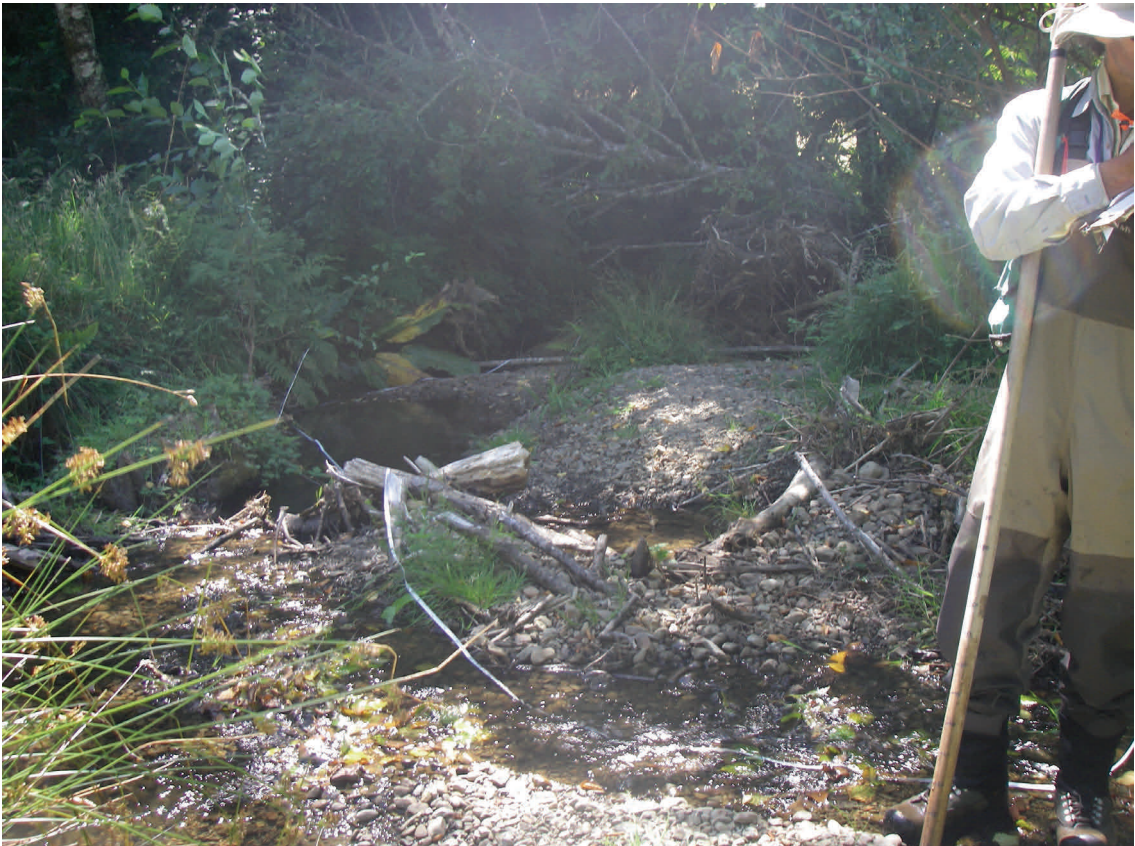
**Figure 6**

2012 Reach 3, unit 108, looking downstream at 2 small debris jams create some channel complexity within the channel.

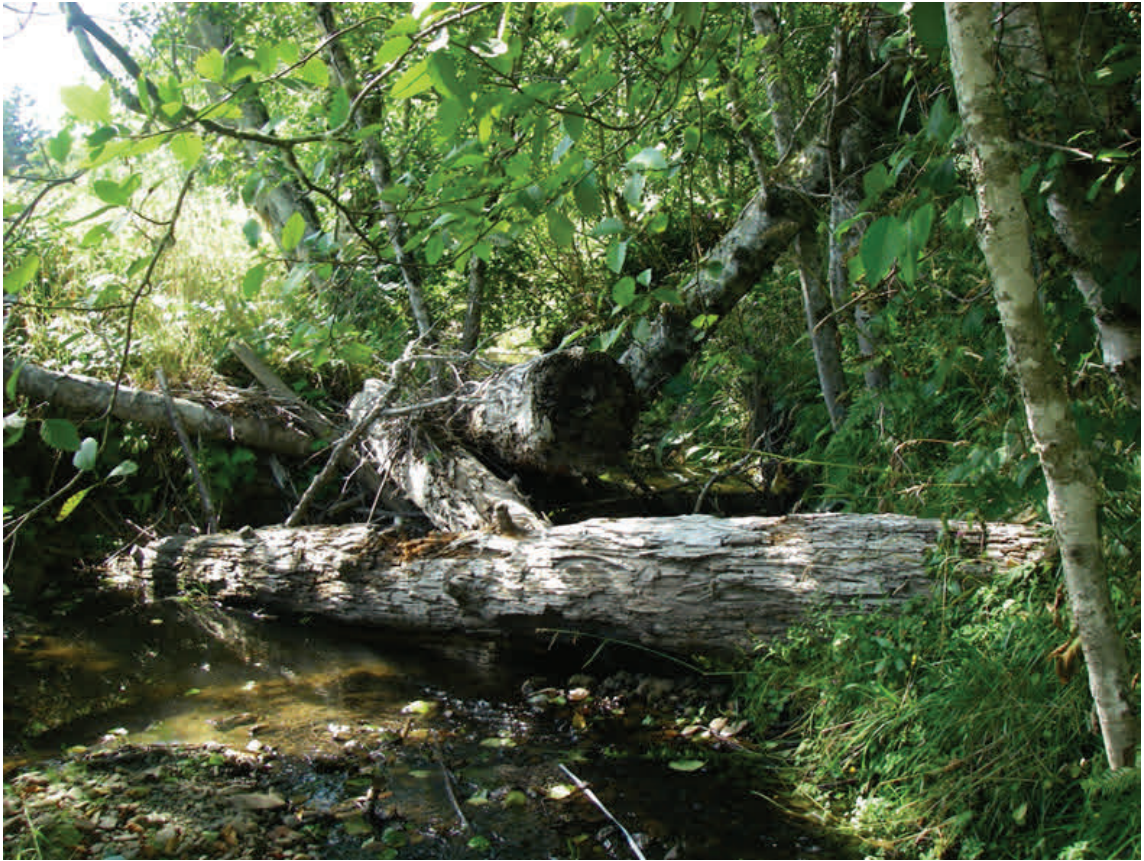
**Figure 7**

2008 Reach 2, unit 179, lateral scour pool with large wood placement looking downstream.

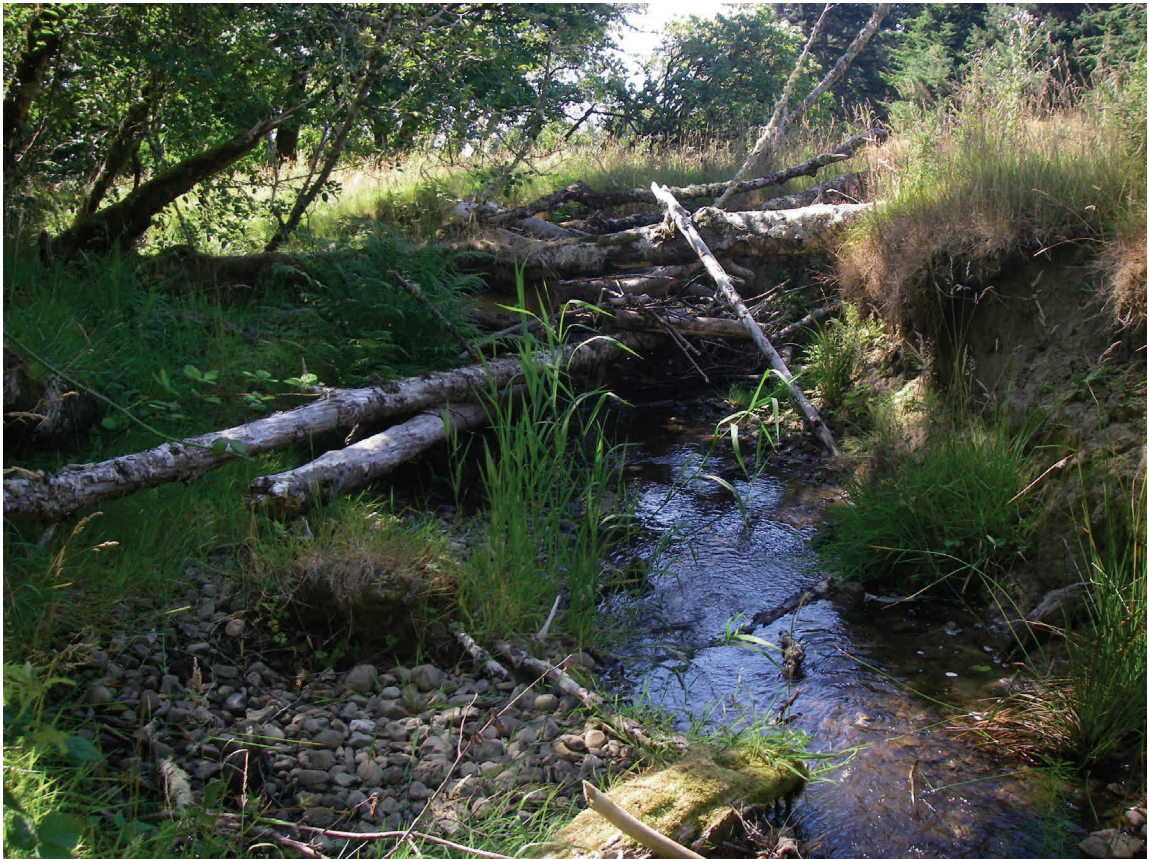
**Figure 8**

2012 Reach 2, unit 143, looking upstream at debris jam.

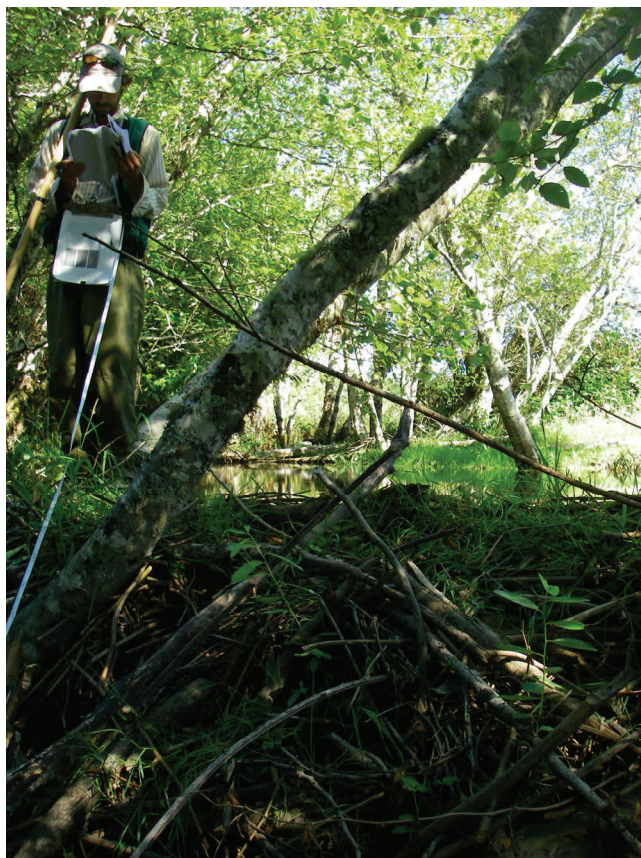
**Figure 9**

2008 Reach 2, unit 185, surveyor is standing at top of beaver dam, looking upstream.

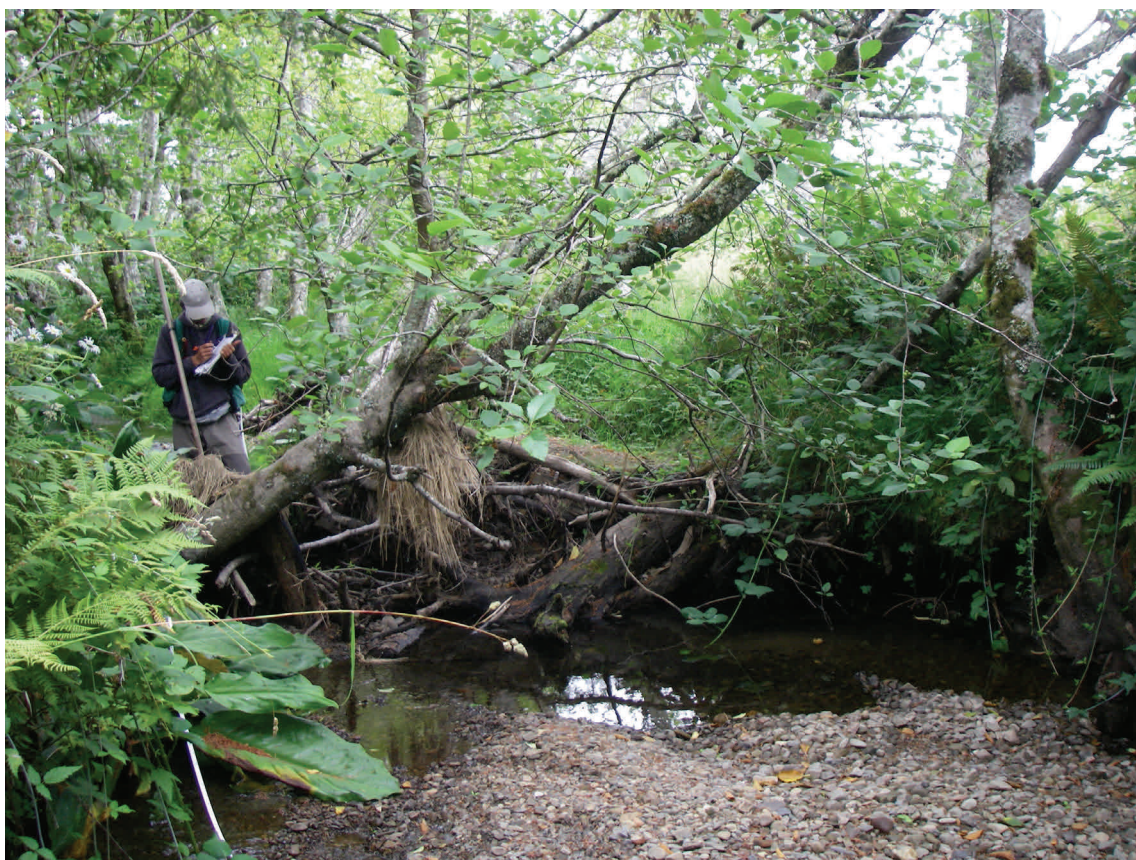
**Figure 10**

2012 Reach , unit 166, same beaver dam as above photo is now just a debris jam, looking upstream.
