Tenmile Lakes Delta Building Study

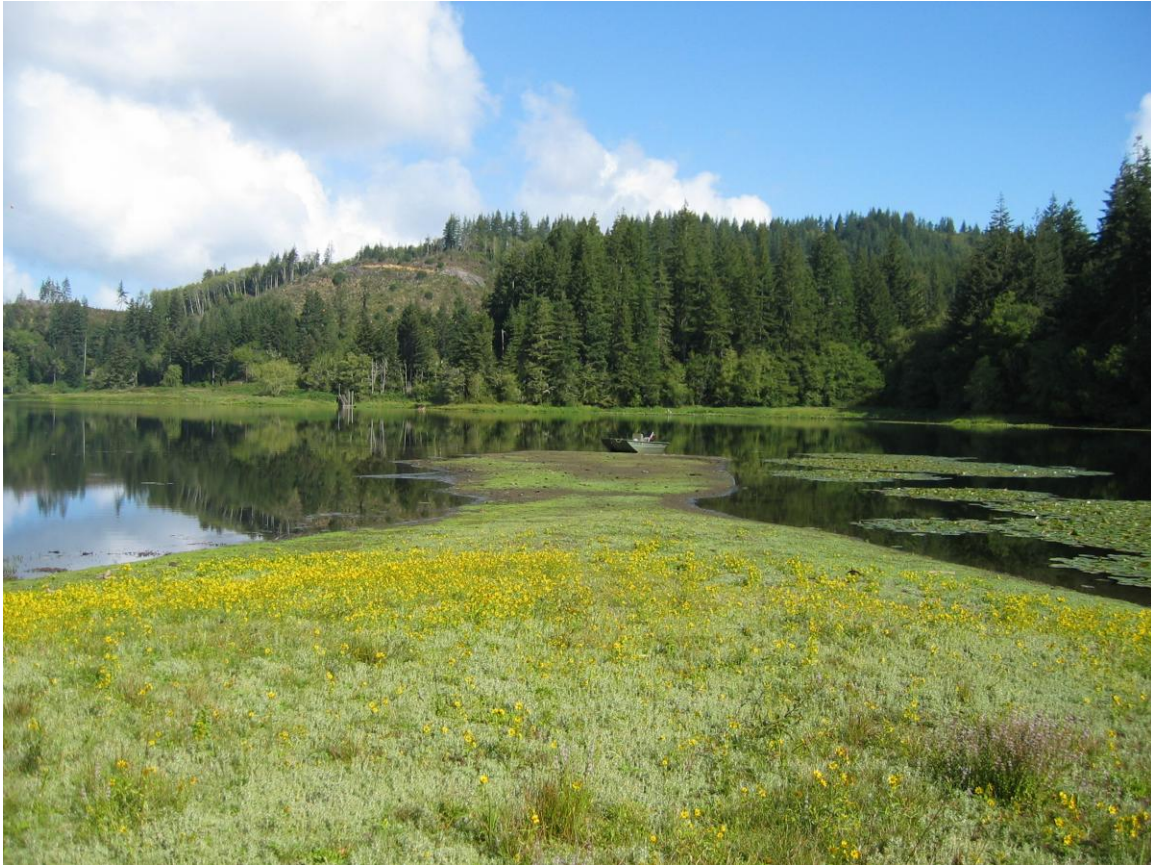
9-14-04 Johnson Delta

2004- Johnson delta was 192 ft. long by 40 ft. wide.

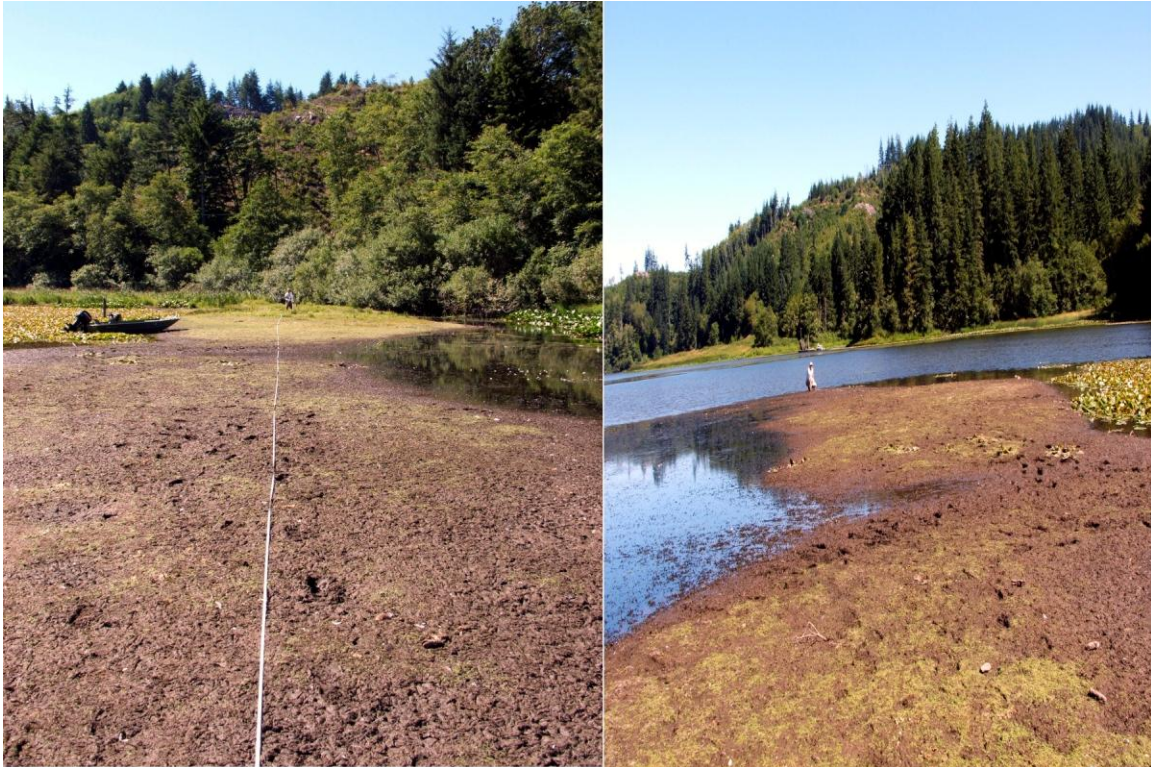
Johnson Delta 7-20-2006

2006- The delta grew to 220 ft. long by 50ft. wide.

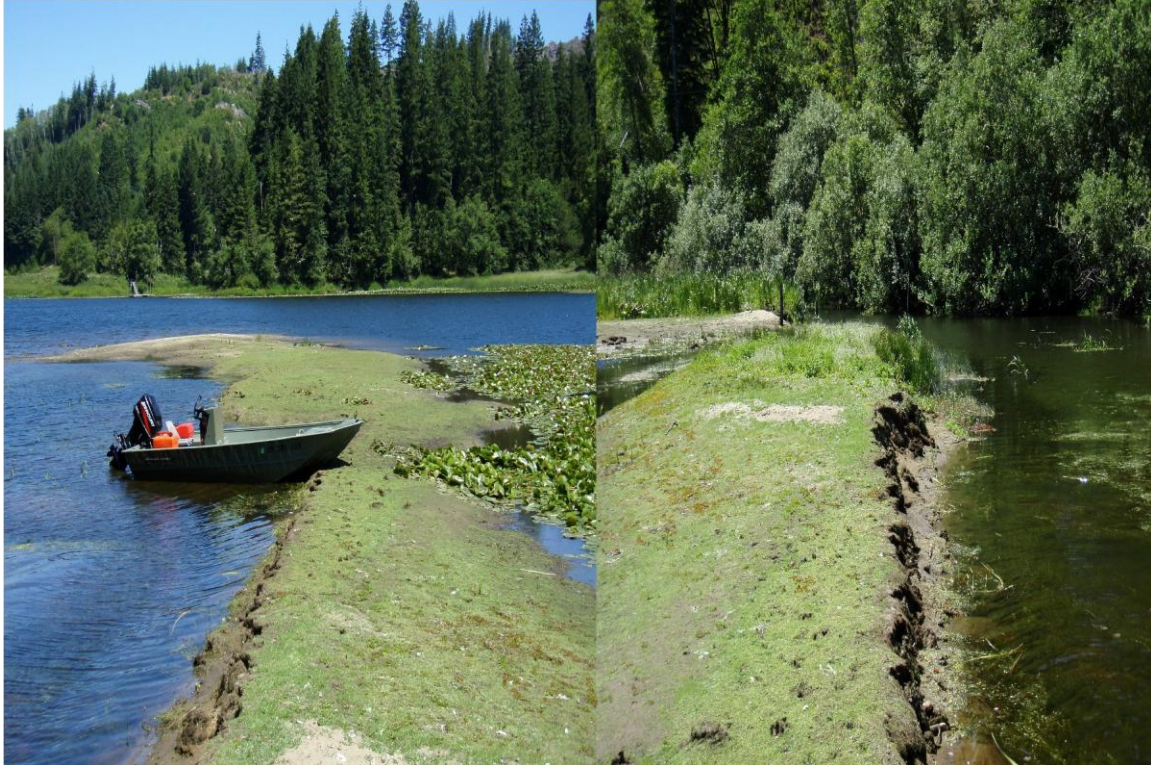
Johnson Delta 7-6-07

2007- This site was completely blown out. The south side was under water, and survey points could not be reached. New survey marks were made using 2ft sections of rebar to mark survey points. Site where survey equipment was placed was also affected by the high flows. A new survey point had to be established. The stake is now at 5ft; old one was at 4'3". New survey point is at 4'7.5" on old post. Survey lens height at 4'10.75". New tpost height is 5'1.5". * Means new survey point. We created 3 new survey points to measure and record the changes to the delta. The original 0' is now 81'6", and continues from there. The water level was lower than previous surveys, so widths were taken at each survey transect, but height on the north side was surveyed from rebar marker that would be away from the water's edge. Survey point 4., water's edge was 8'3" away from north survey marker. Survey point 5., water's edge was 6' away from north survey marker, and original center was under 2ft of water. Survey point 5., the original center and south survey points were under water. Only the north side was exposed, and was 4'6" away from the water. New south and center survey points were established in this survey. All centers that were re-established are in the middle (half) of the width of transect. All

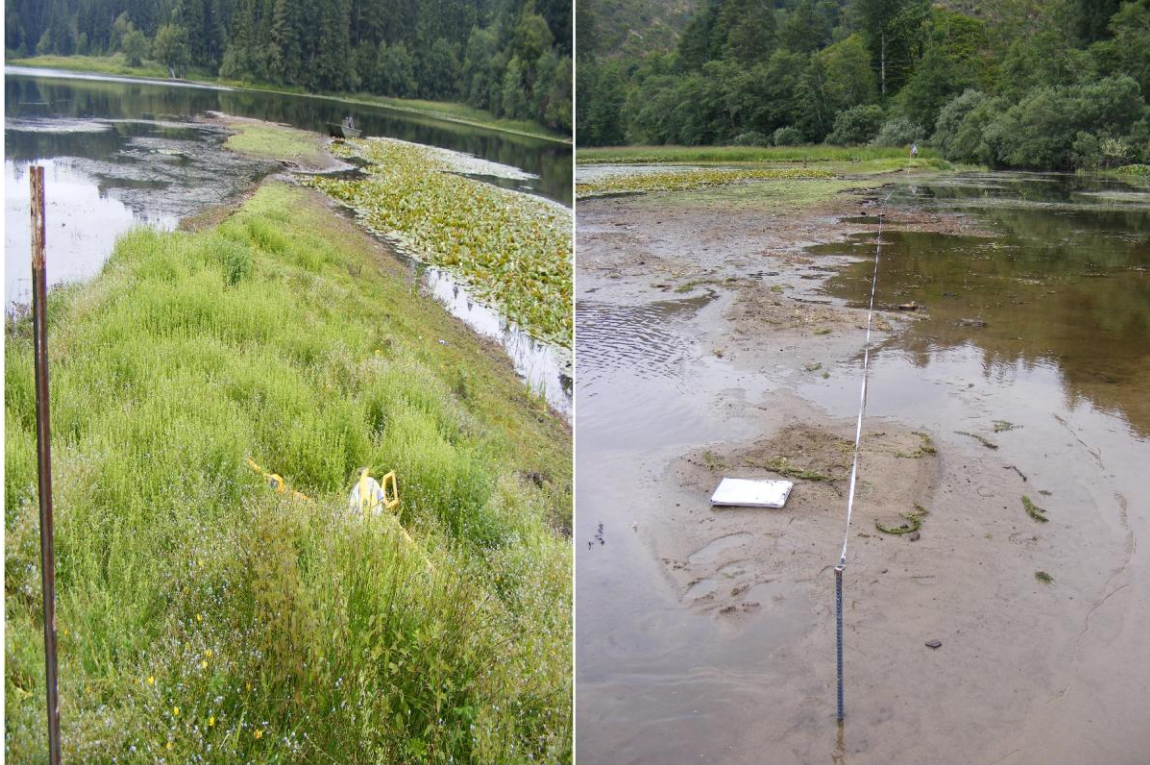
Johnson Delta 7-17-2008

2008- No elevations were shot this year. Adjacent landowner pulled some of the rebar, so we replaced the missing rebar and took physical measurements of the delta. Lake height was higher than last year ~6.33ft. New piece of rebar was placed at end of delta, 37 feet up from the end of last year's end point.

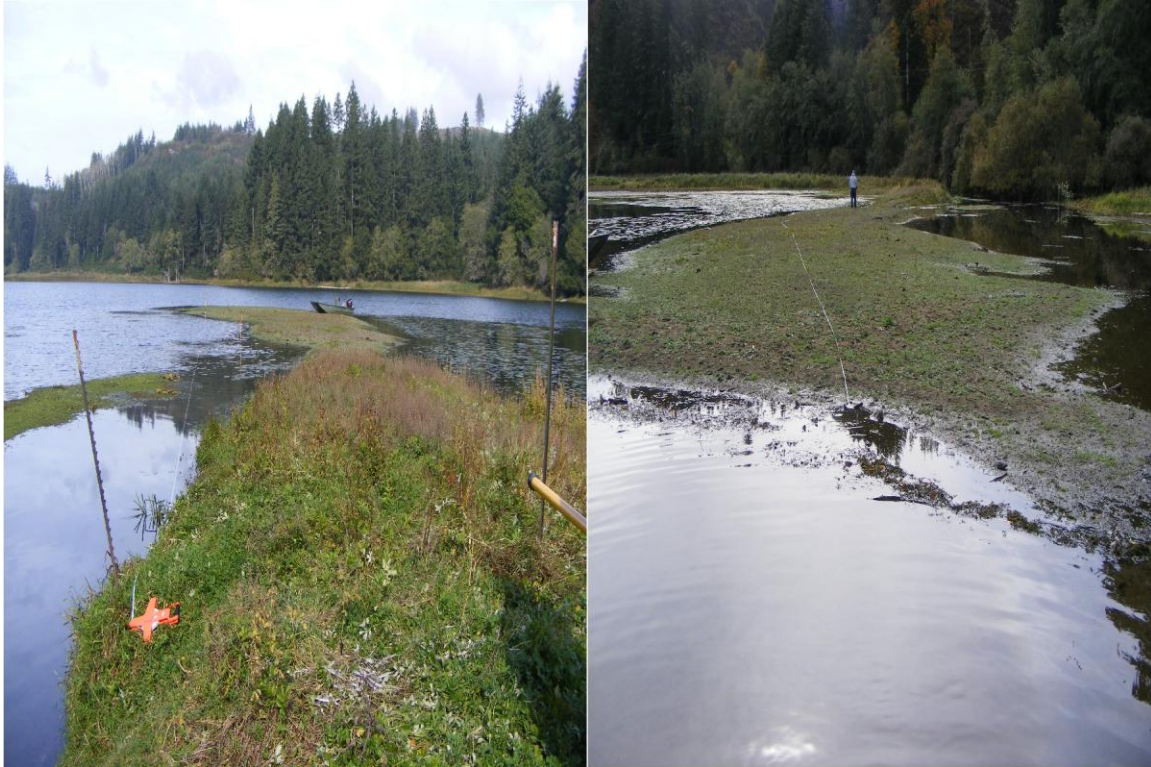
Johnson Delta 10-23-09

2009- This year we just obtained lengths and widths and established new survey points. This site is difficult because the amount of water coming out of this creek in the winter time. The water is constantly changing the shape of this delta. This site will be surveyed more intensively in 2010.

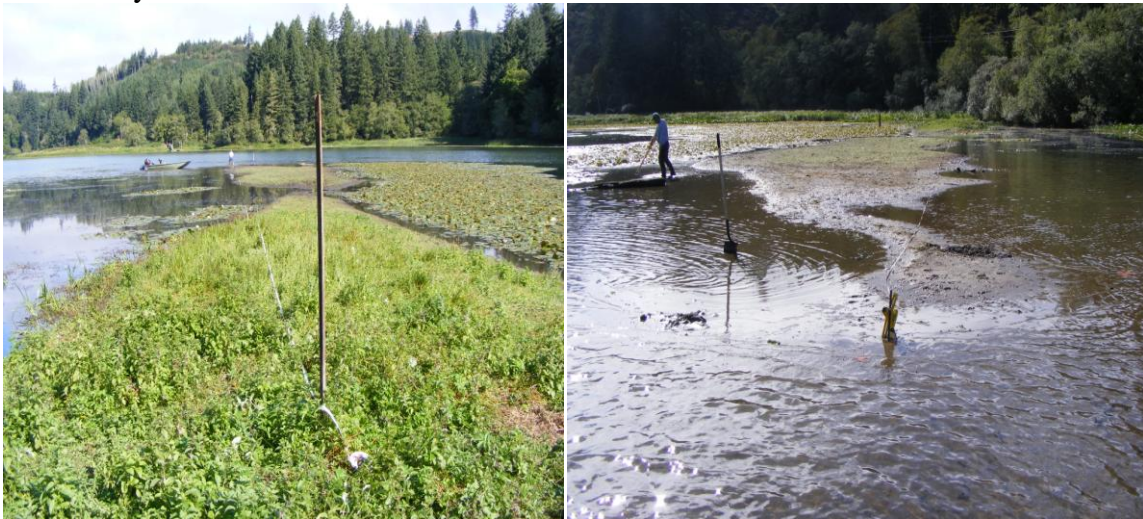
9-14-2010 Johnson Cr. Delta

2010-Delta is 242 feet in length. Tpost/survey marker is 4'9" in length. Instrument height is 4'9" to the bottom of the lens (# taken to account for i/h variation and sediment accumulation at instrument placement).

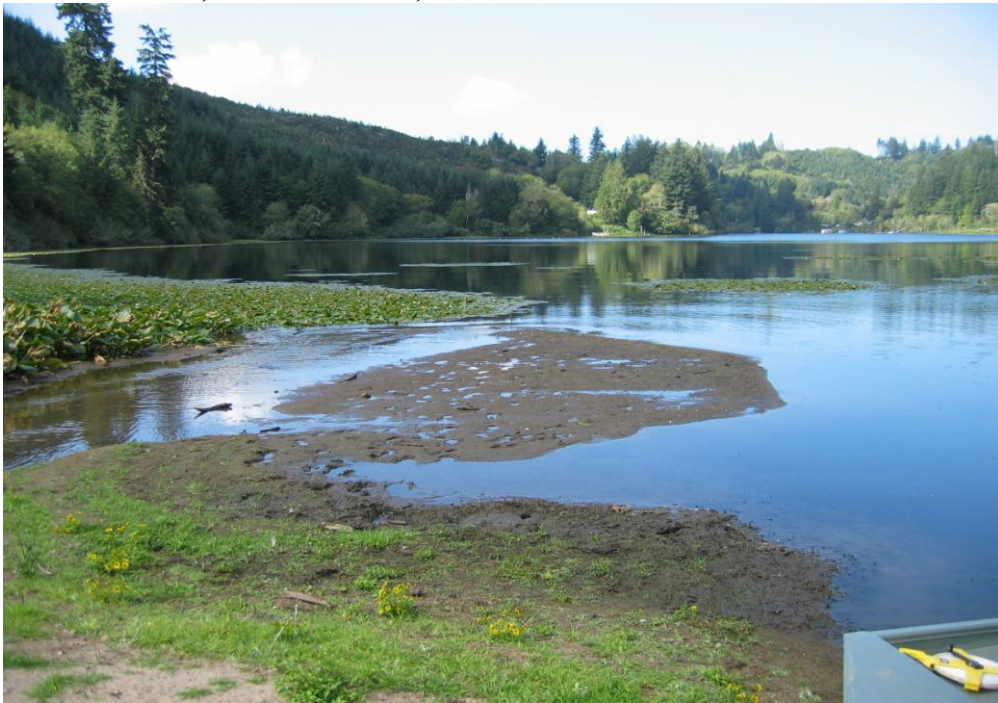
Benson Delta 9-14-04

2004- The delta measured a length of 75ft. by 21ft. in width.

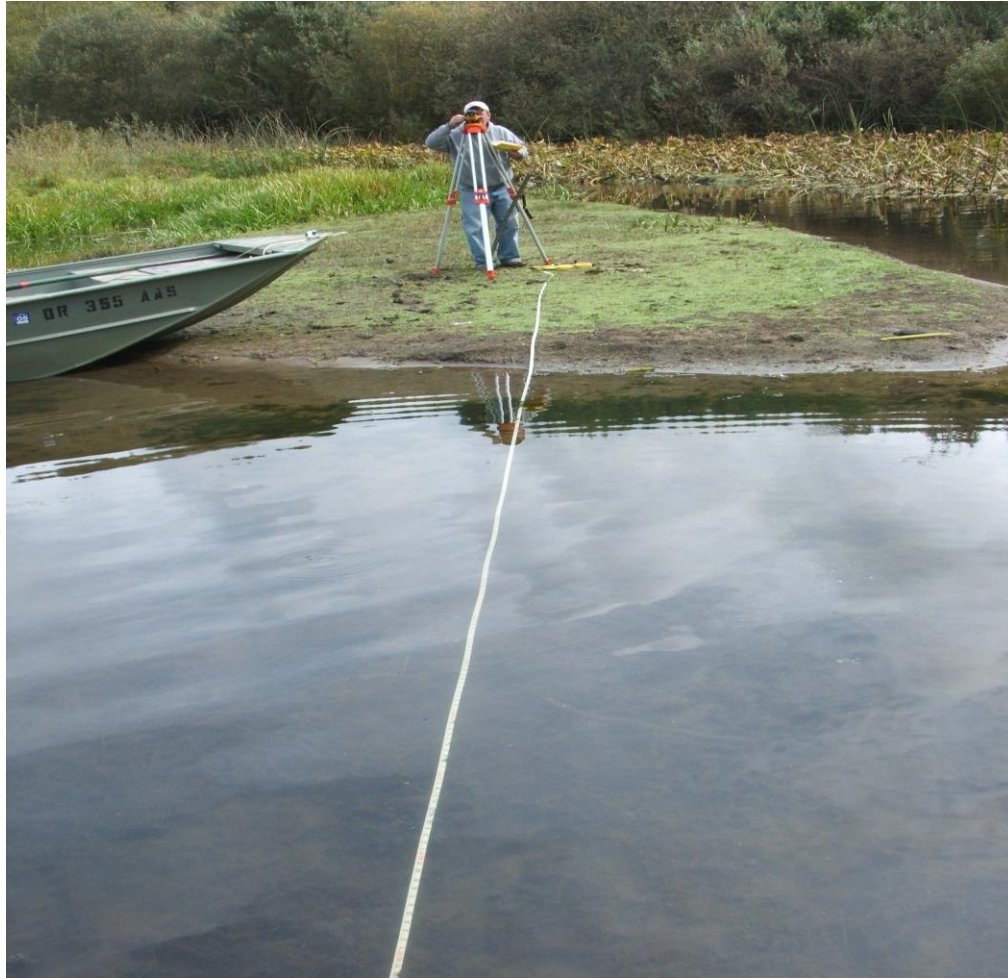
Benson Delta 10-7-05

2005- Measurements taken, but lake height was almost a foot above the level needed to sample, so physical measurements are off.

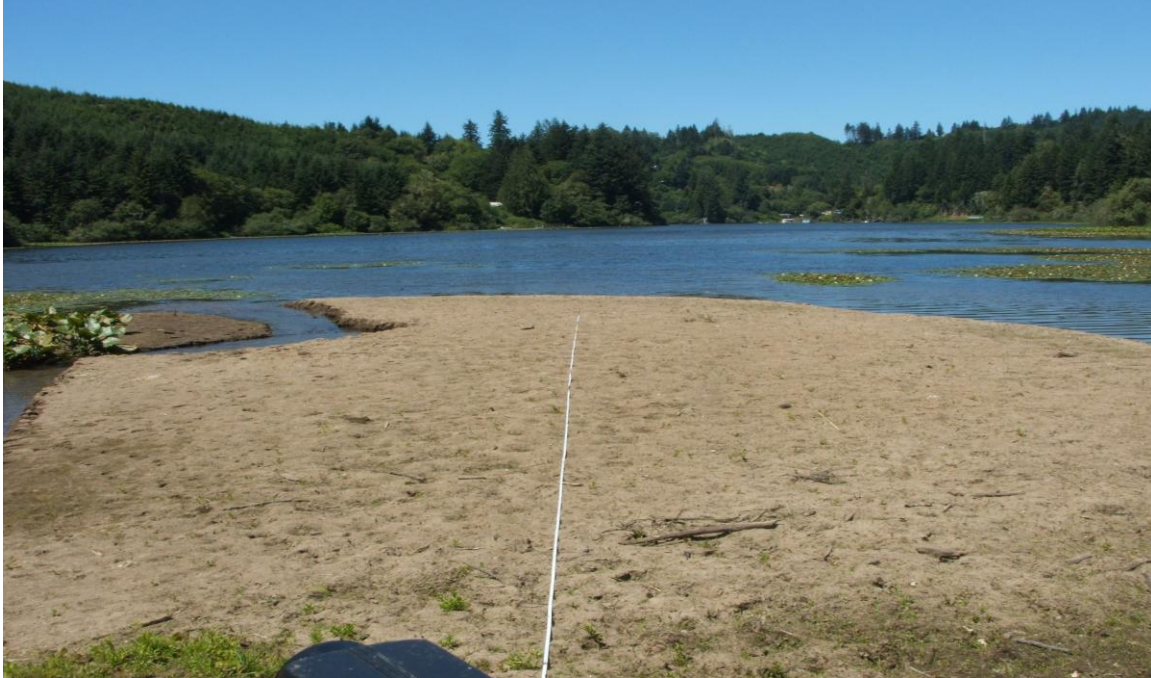
Benson Delta 7-20-2006

2006- The delta grew to a length of 106ft. by 48ft. in width.

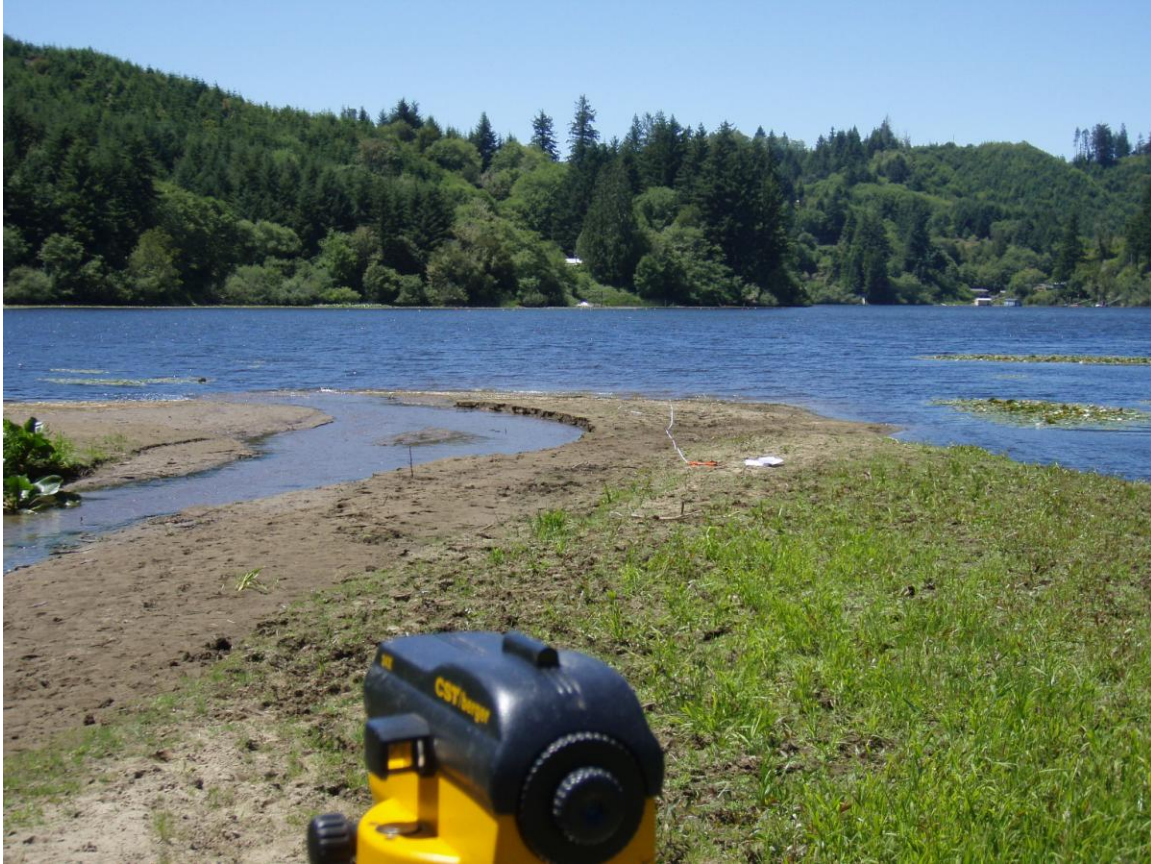
Benson Delta 7-6-2007

2007- Some measurements of the new land mass. End of delta roughly 30' from first survey point, no width. 10' up from tip of delta, width-22'3". 20' up from tip of delta, width-19'9.5". 30' up from tip of delta, width-18'. 40' up from tip of delta, width-16'9.5". 50' up from tip of delta, width-25'5". The east side of survey, most points were under water because stream had changed course and had eroded some of the delta. All rebar has 4"x4" safety caps placed on top of them, and pushed down to ground level.

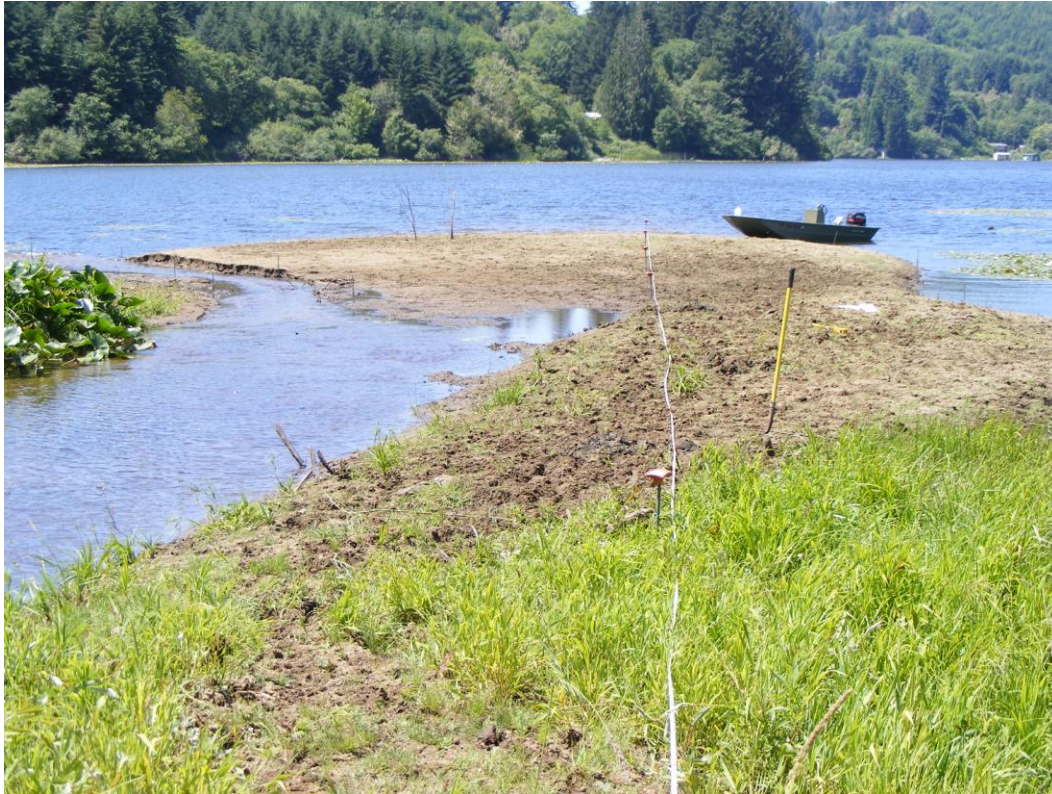
Benson Delta 7-17-2008

2008- This year, the land mass really expanded into the lake. New survey points were established. Format has changed for survey data. We are now counting up from the survey marker, working towards the tip of the delta. A lot of sediment came in and covered the existing survey marks. Survey marks were dug up to show the amount sediment accumulation. This is shown in the data as cap and ground. Cap is measured from the top of the survey mark, which was buried, ground in at the top of the sediment that covered the survey mark.

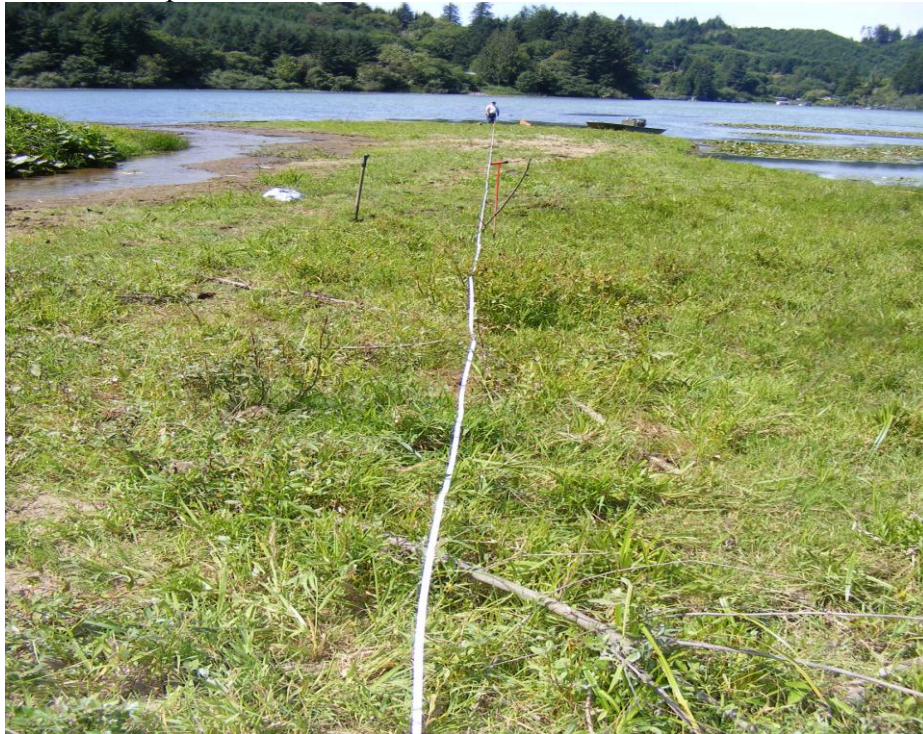
Benson Delta 8-11-2009

2009- This year we have implemented a procedure in which we measure the sediment accumulation on top of the survey caps. The delta seems to be gaining mass on top, and our survey post has been removed, so knowing sediment accumulation on top of the delta for surveying would not be known. We feel that the 4"x4" safety cap on top of the rebar will keep the rebar from migrating down in the sediment.

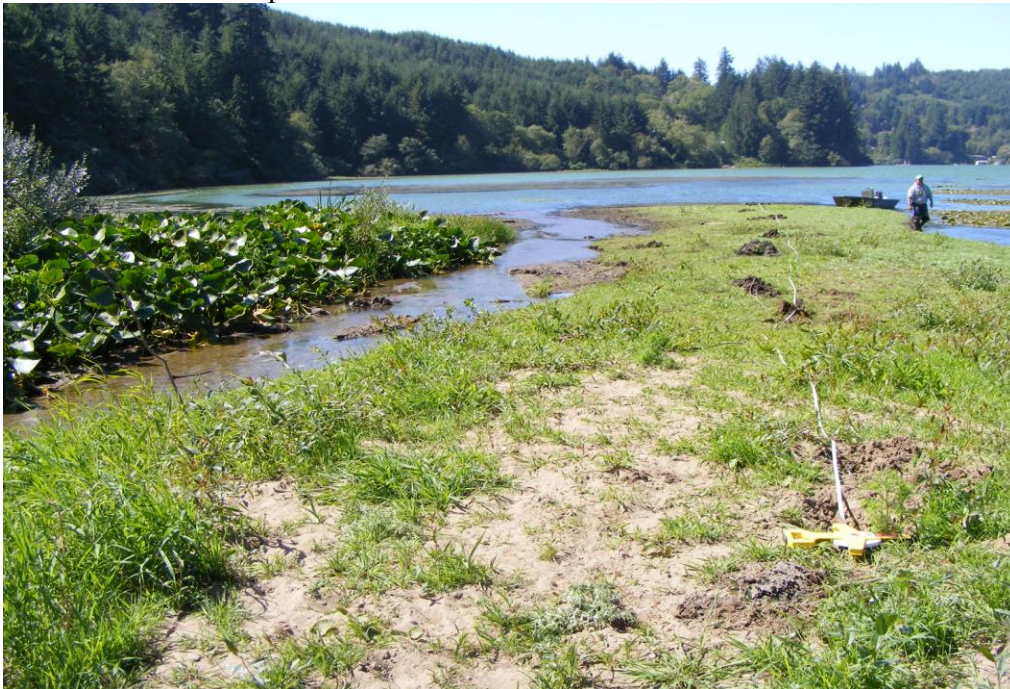
Benson Delta 9-3-2010

2010- Some markers were under a lot of sediment, and in the water table. These could not be reached, so measurement were taken as deep as possible, and estimated from there. Benson Creek is constantly changing its course through the delta to the lake. This has made it difficult to obtain accurate measurements of the east side.

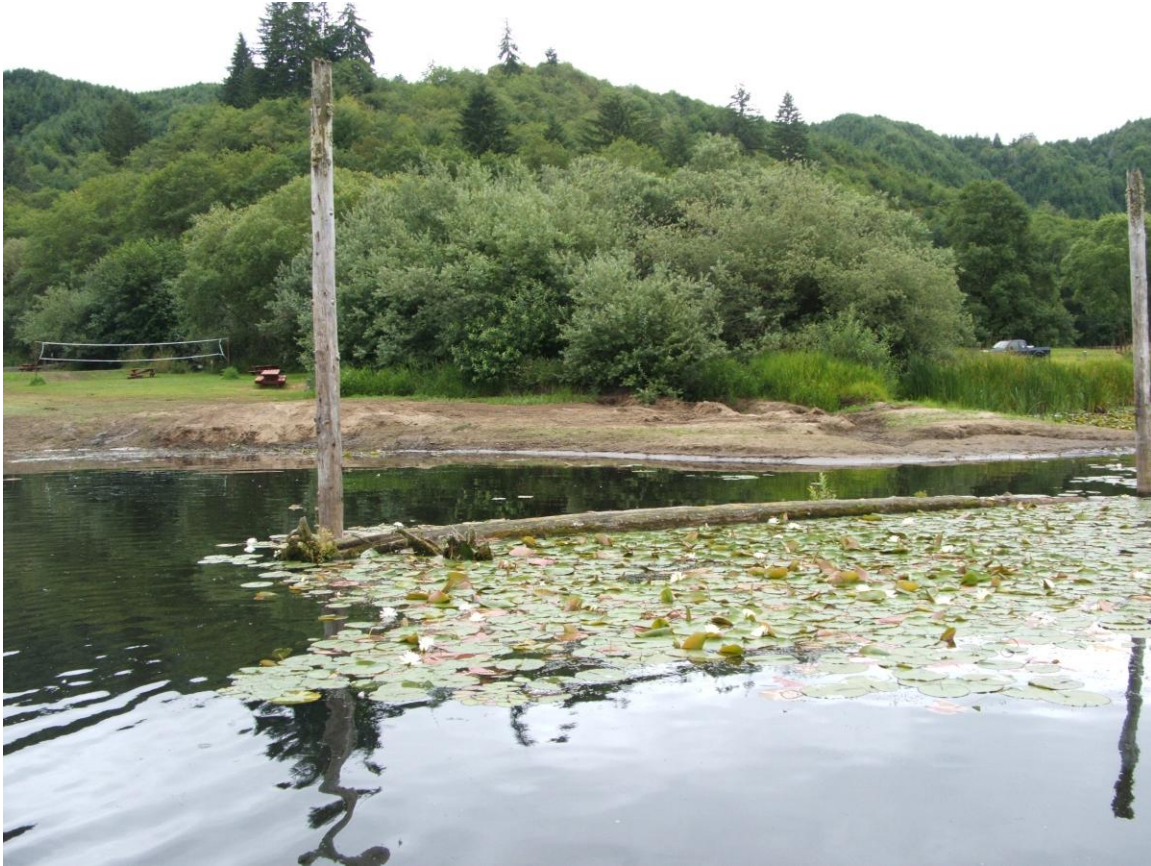
Sunlake 7-20-2007

2007- Site bulldozed by landowner to make a beach. Site destroyed, will relocate site to Big Creek.

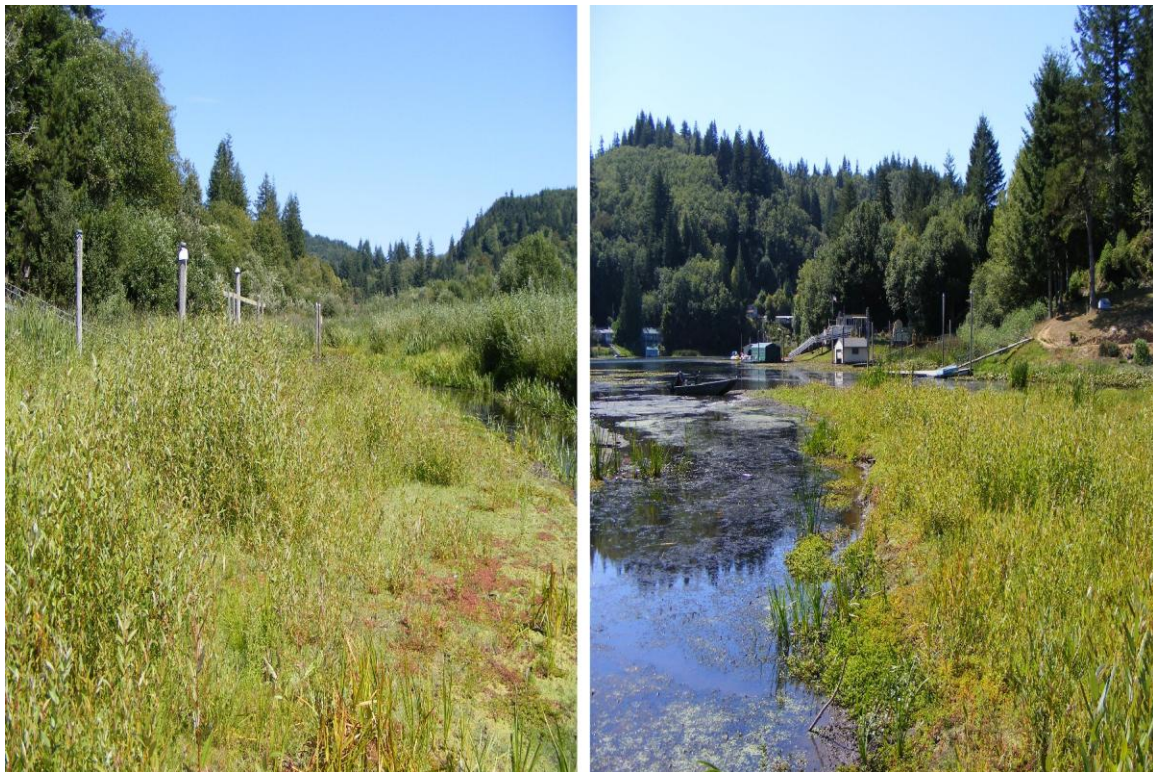
Delta cuts far left, leaving the last 2 survey points under water. It is 44' to the south of the original centerline. 237' down the reel tape.

**Big Cr. Delta looking upstream and downstream from location of survey equipment
8-27-09**

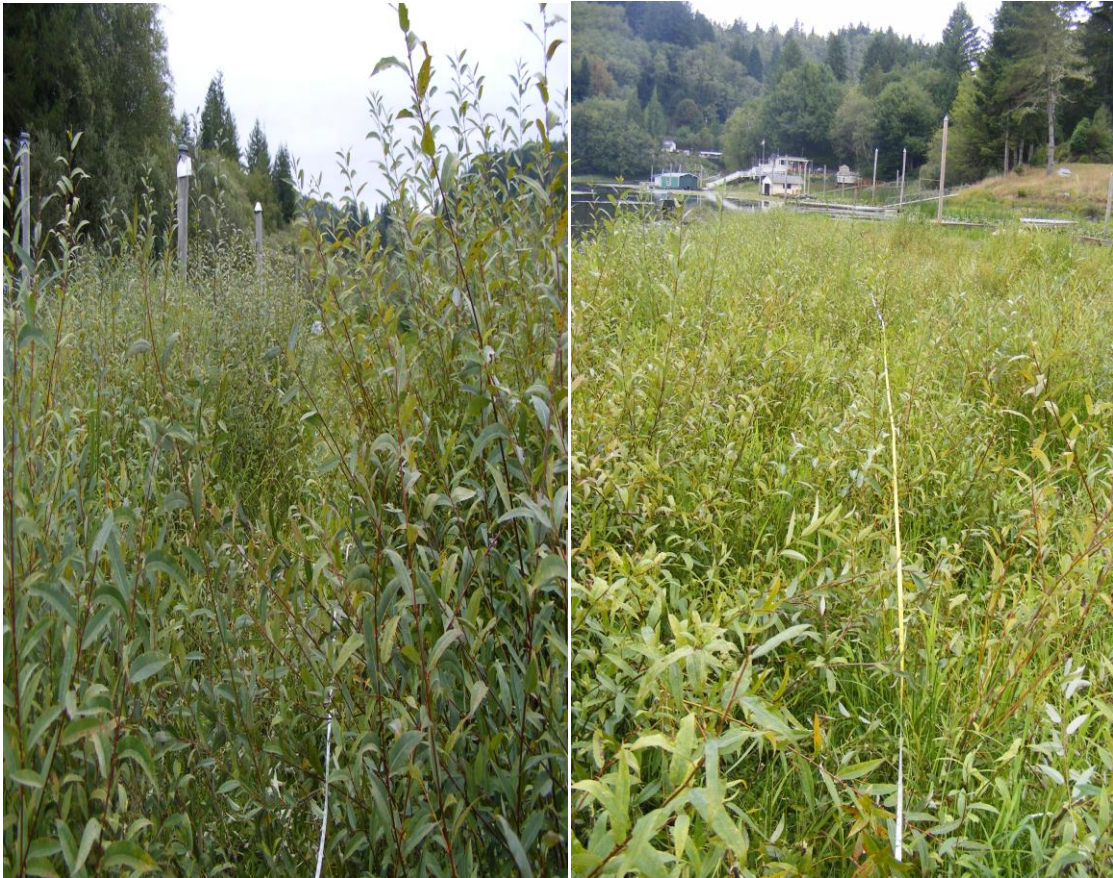
2010- Willows have really taken over this site. This has made surveying and doing sediment accumulation on survey markers almost impossible. Instead, we were only able to get lengths at 6 survey sites and total delta length. This site seems to be turning into a wetland.

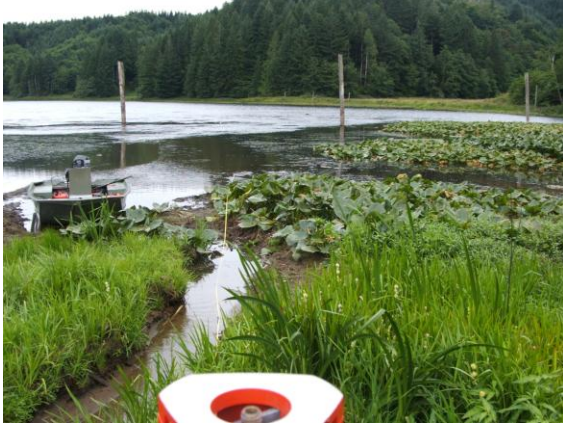
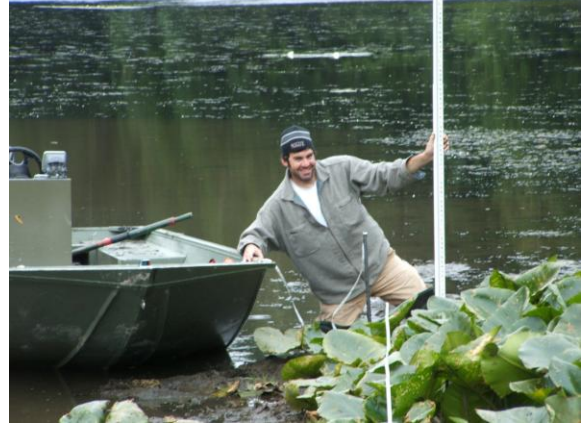
Murphy Delta 7-20-2007

2007- Delta was observed and landowner granted us permission to survey. Though there was a landmass present, the type of soil was very loose and organic, which would be associated with wetlands.

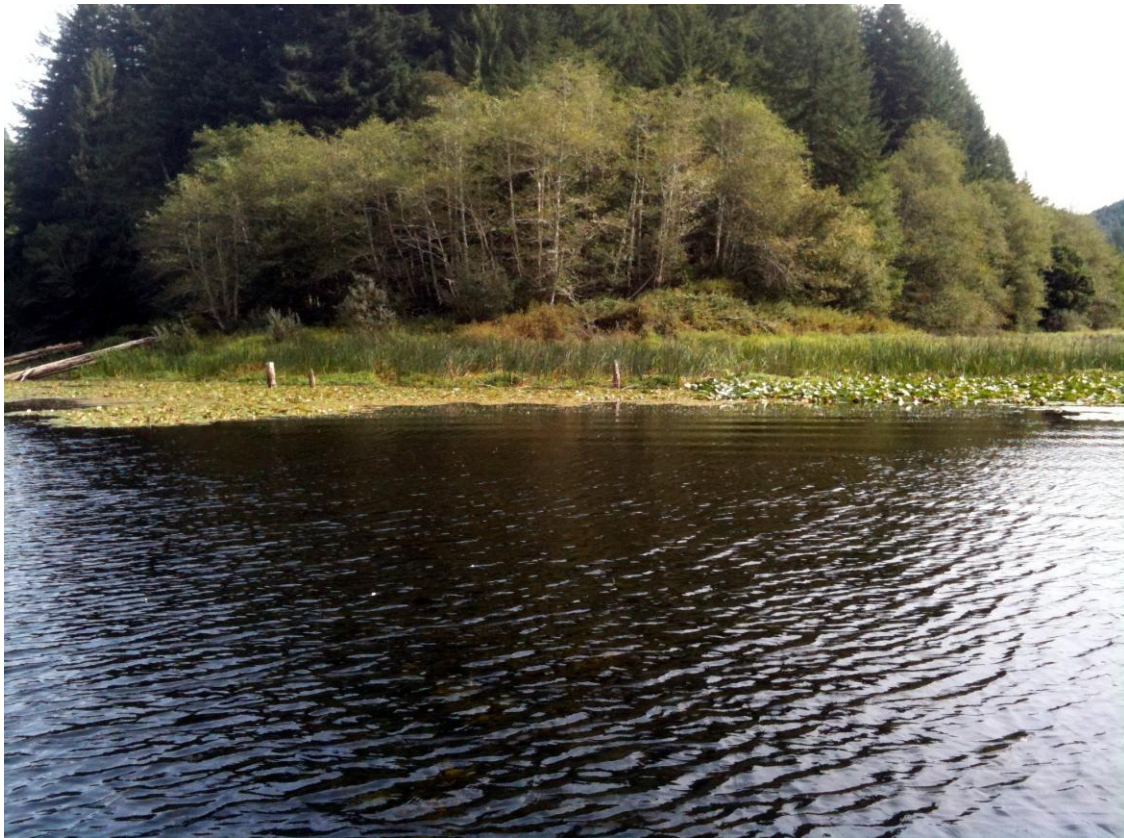
September 2010. Mouth of Murphy Creek at 6.43 lake level. No sign of sediment accumulation or delta building.
