Salmon Run G.C. – Hole 3: Tributary & Wetland Restoration

Preliminary Project Design

December 23, 2014

Prepared By: Curry Soil and Water Conservation District & Swanson Ecological Services, LLC

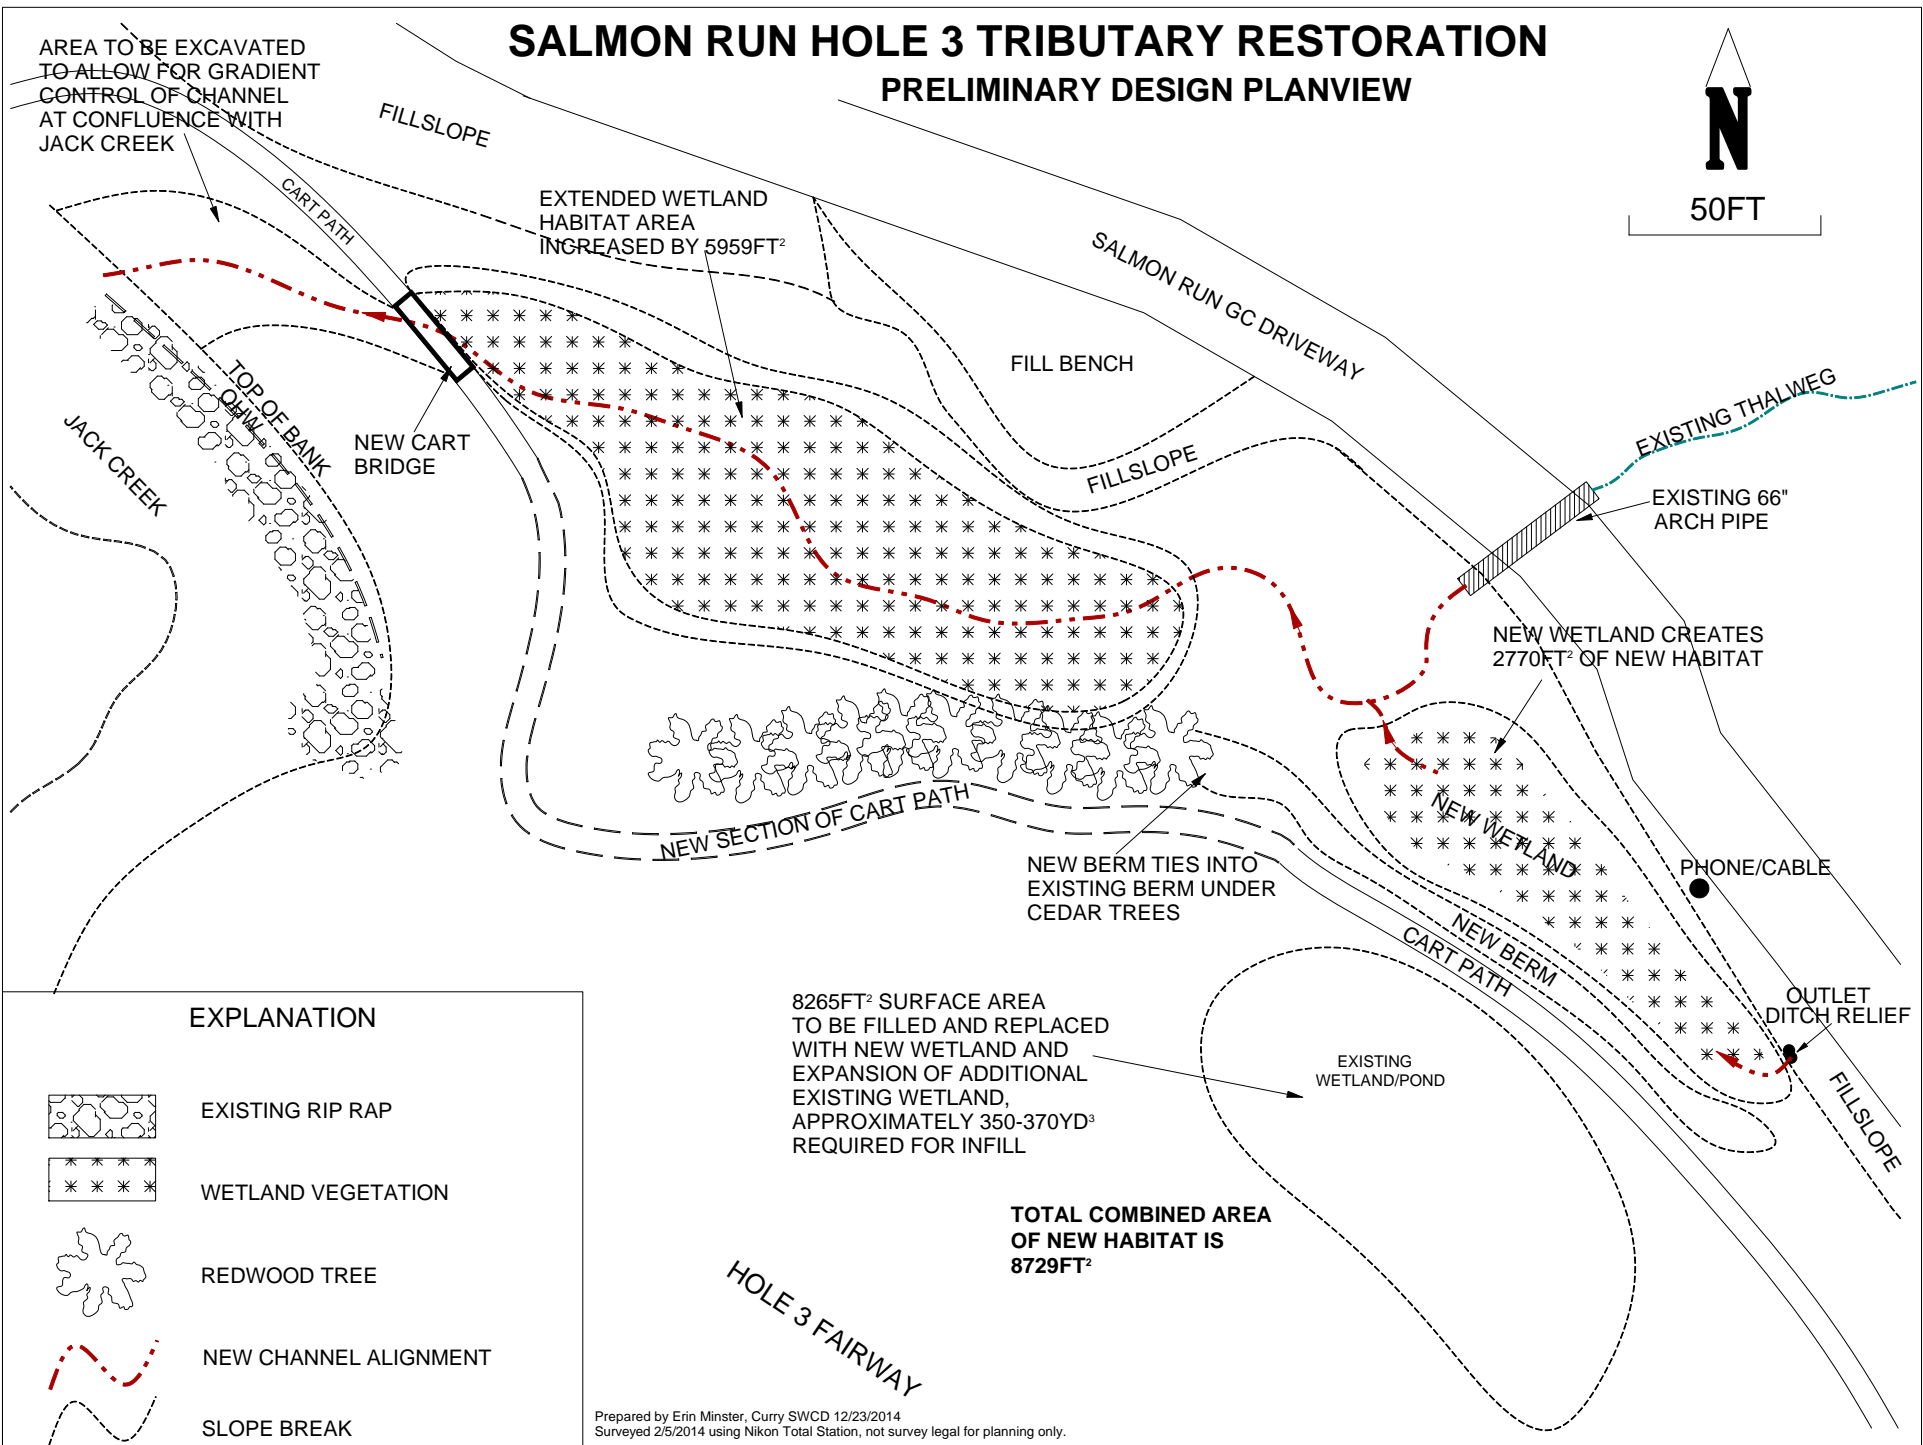
SALMON RUN HOLE 3 TRIBUTARY RESTORATION PRELIMINARY DESIGN PLANVIEW

AREA TO BE EXCAVATED TO ALLOW FOR GRADIENT CONTROL OF CHANNEL AT CONFLUENCE WITH JACK CREEK

EXTENDED WETLAND HABITAT AREA INCREASED BY 5959FT²

NEW WETLAND CREATES 2770FT² OF NEW HABITAT

8265FT² SURFACE AREA TO BE FILLED AND REPLACED WITH NEW WETLAND AND EXPANSION OF ADDITIONAL EXISTING WETLAND, APPROXIMATELY 350-370YD³ REQUIRED FOR INFILL

TOTAL COMBINED AREA OF NEW HABITAT IS 8729FT²

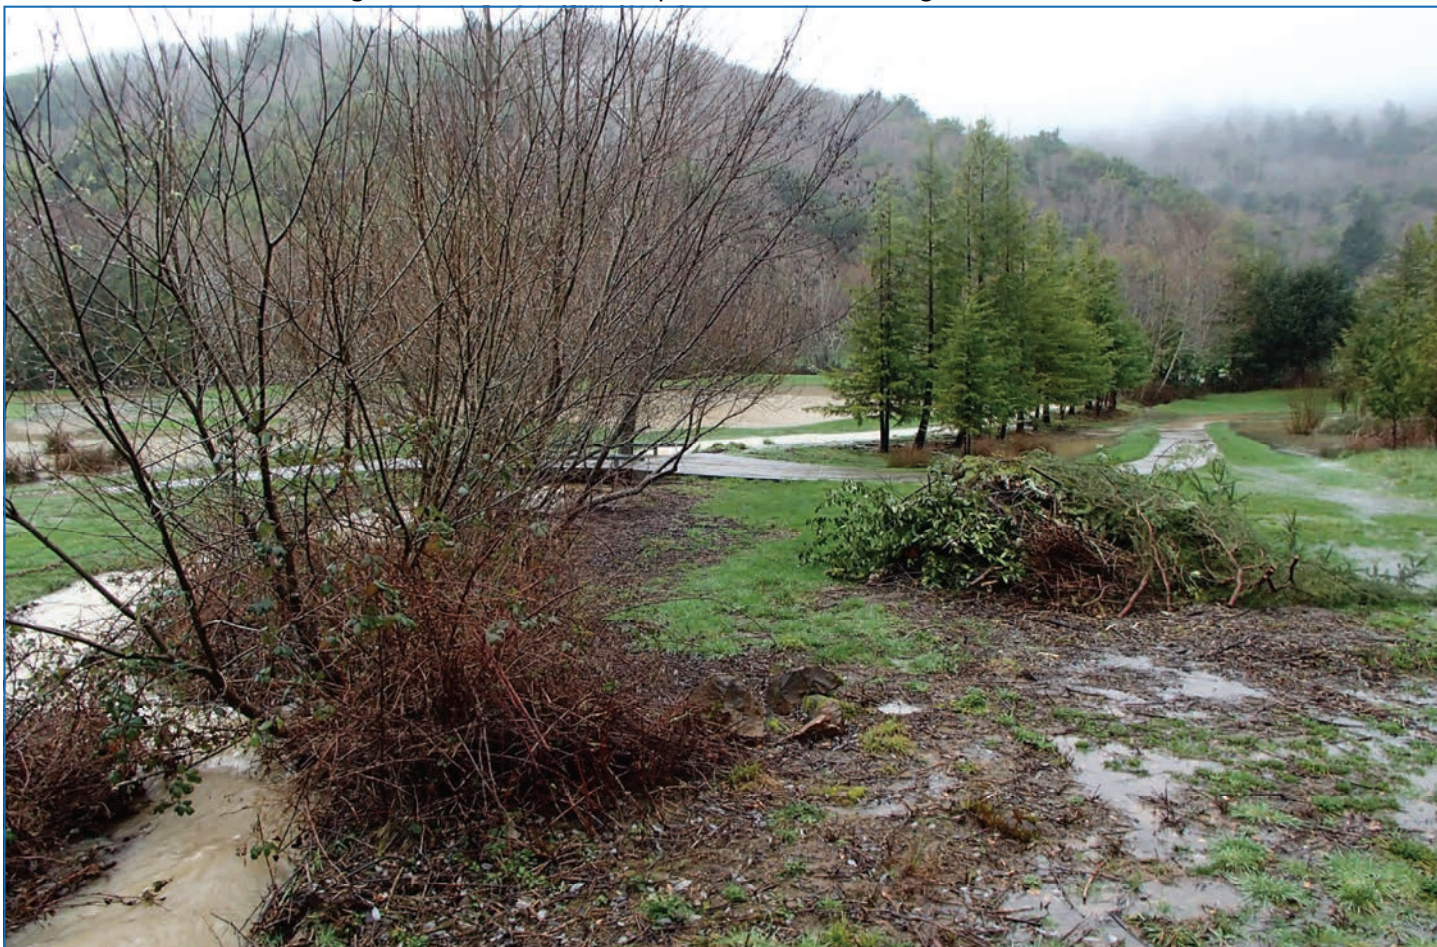
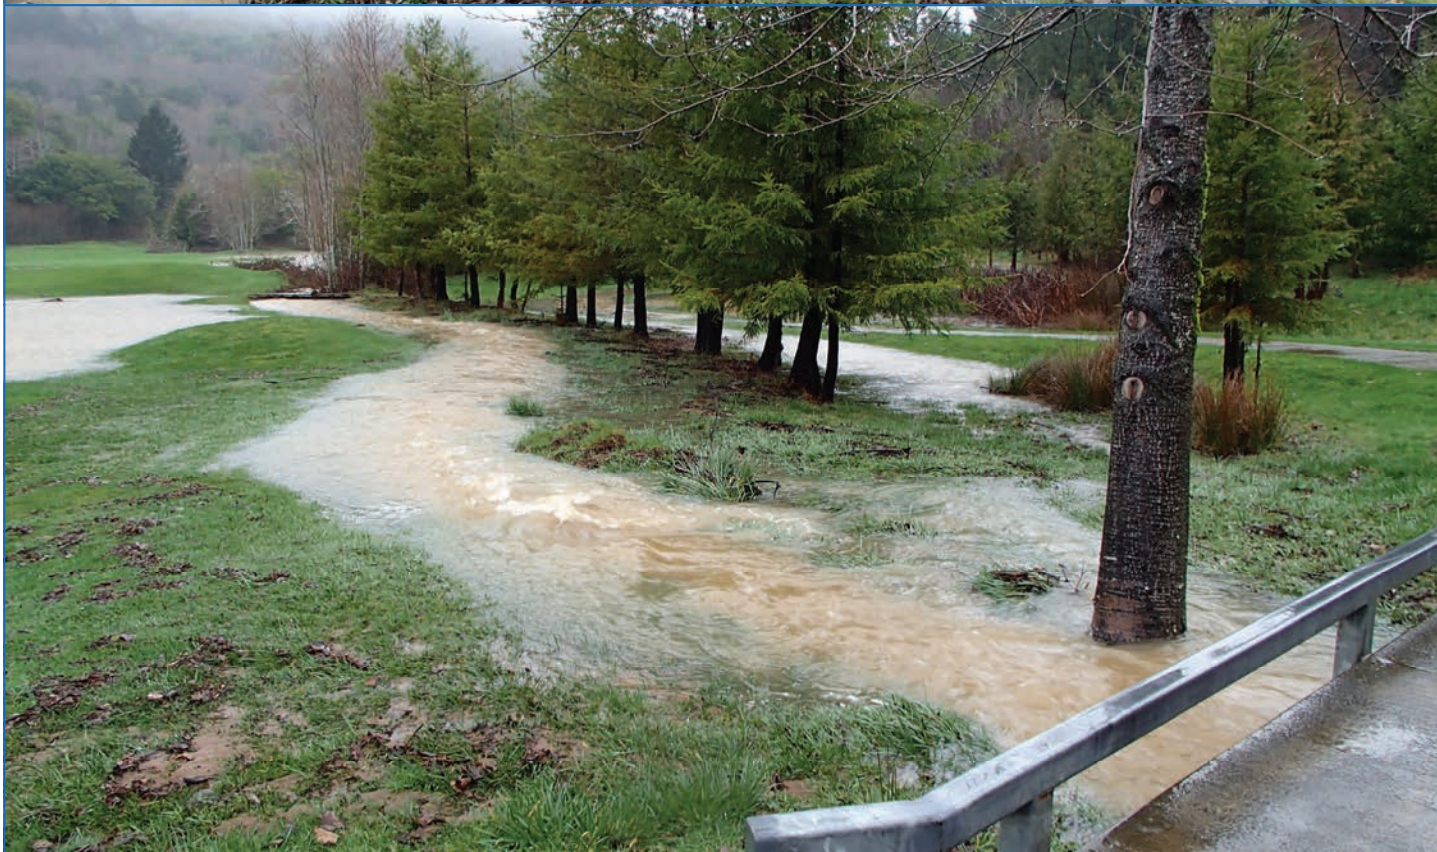
Salmon Run Hole 3 Restoration: Top photo was taken from the golf course driveway crossing during a high flow event, and shows the existing channel on the left side of the photo and the proposed reroute alignment on the right side. Bottom photo shows a close up of the existing channel from the cart path bridge—notice how the stream diverts out of the its corridor to both the right and left—this creates potential fish stranding as the water recedes.

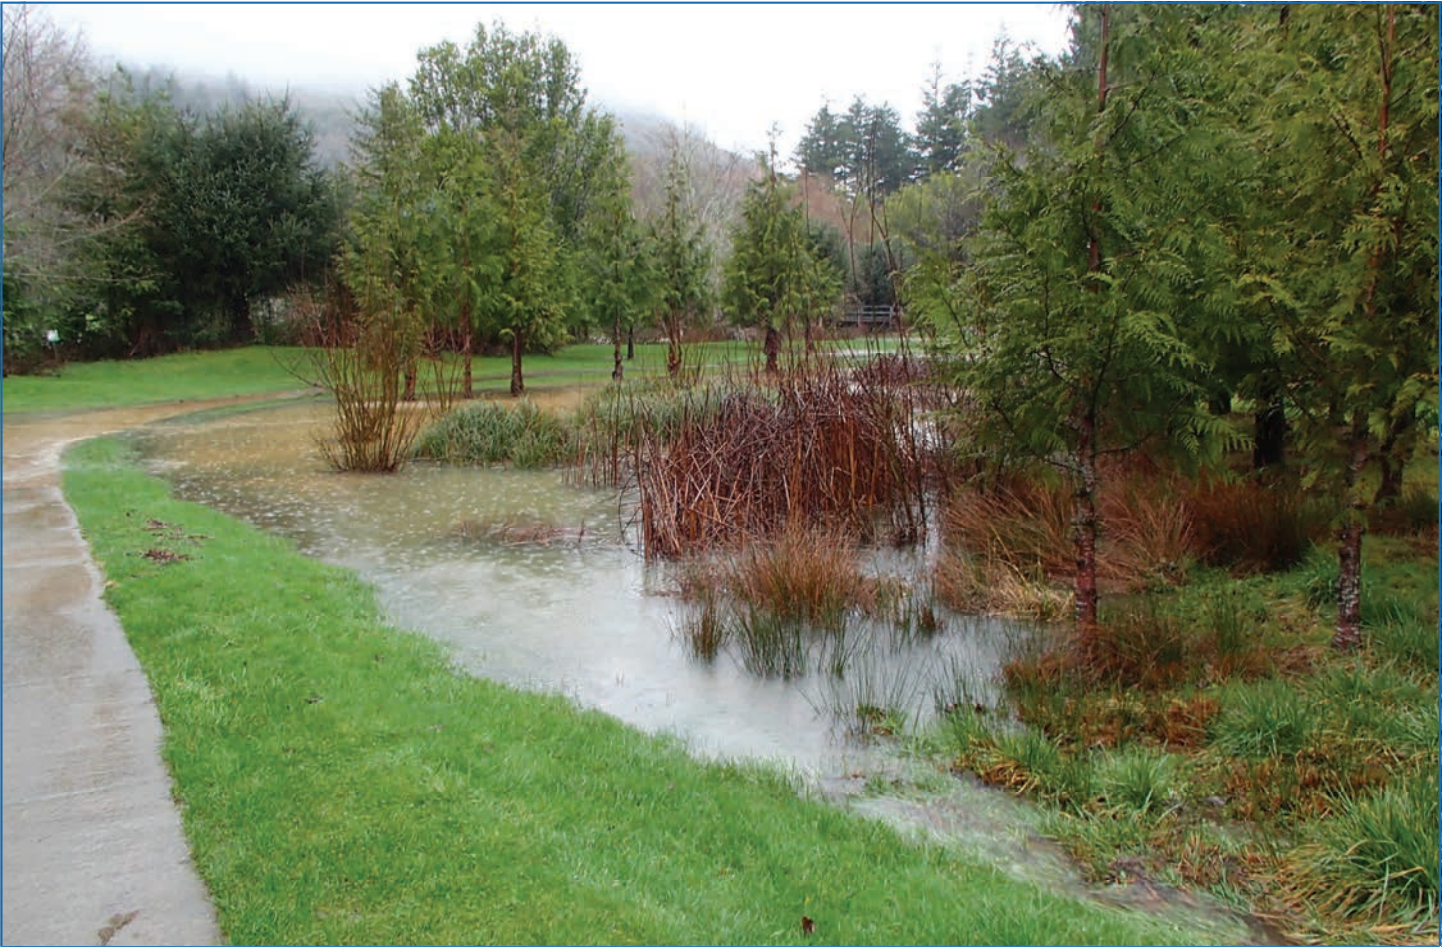
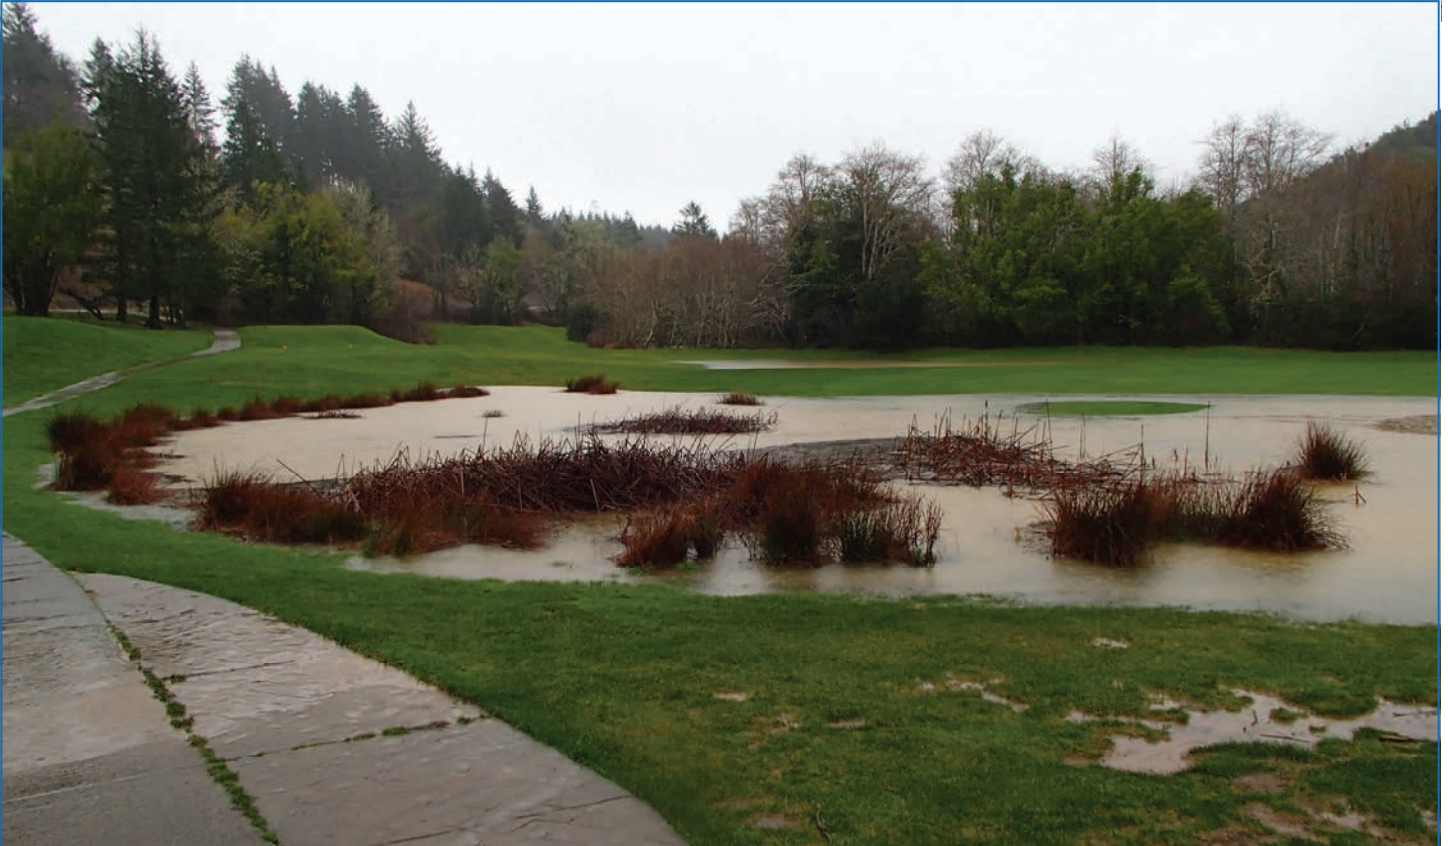
Salmon Run Hole 3 Restoration: Top photo shows the smaller existing wetland that the new channel would be routed through. In the preliminary design the cart path will be relocated so the wetland can be enlarged and the channel can be elongated. The bottom photo shows the larger existing wetland which is located in the fairway of Hole 3 — during a high flow event, such as the one shown in these photos, fish are at risk of being stranded in both of these wetlands.

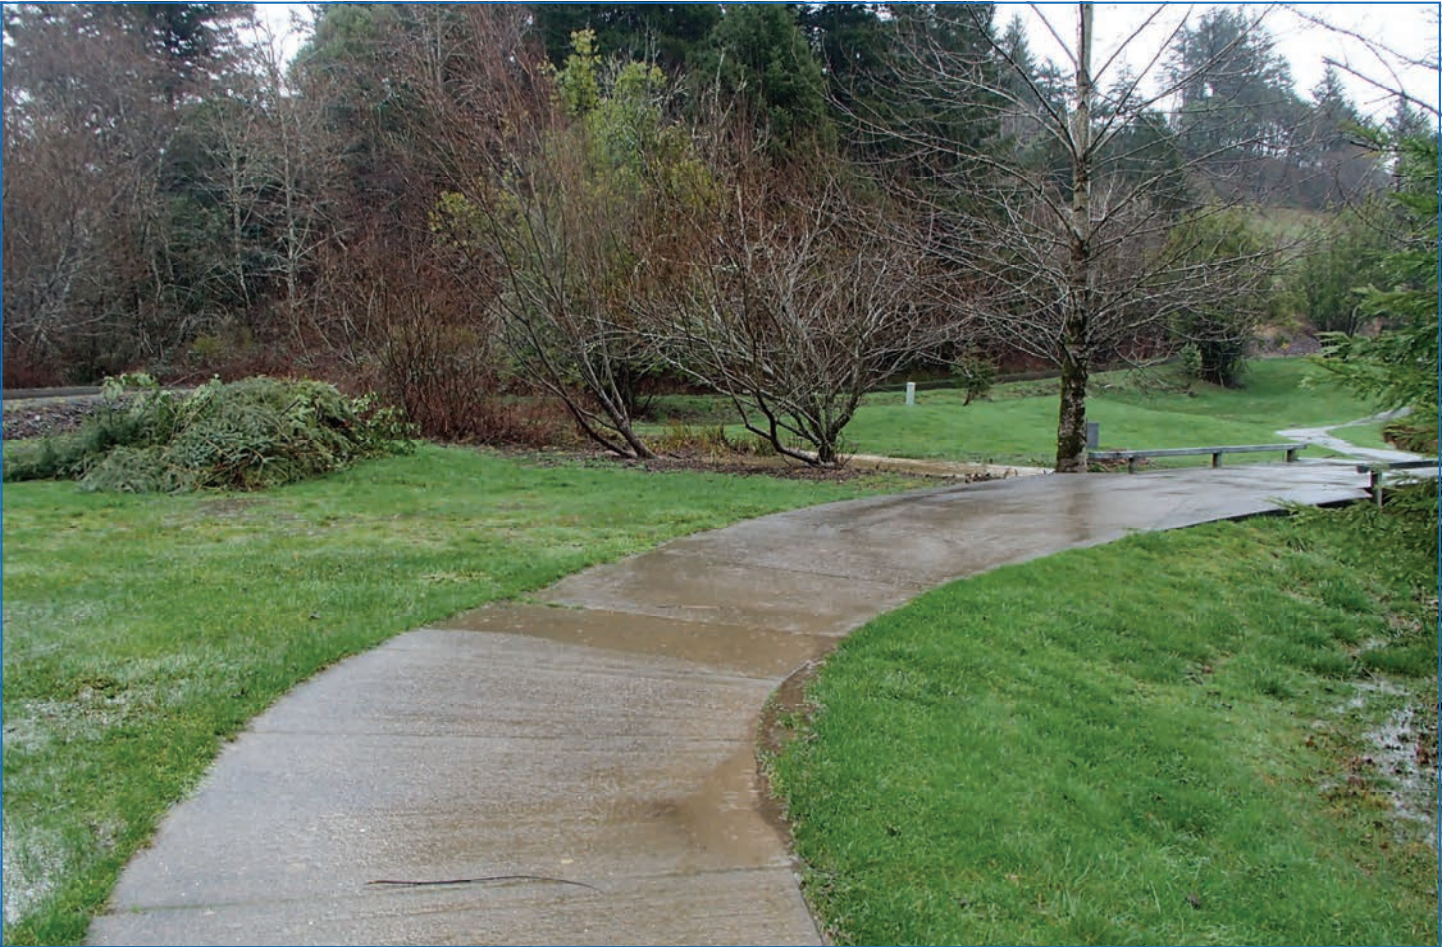
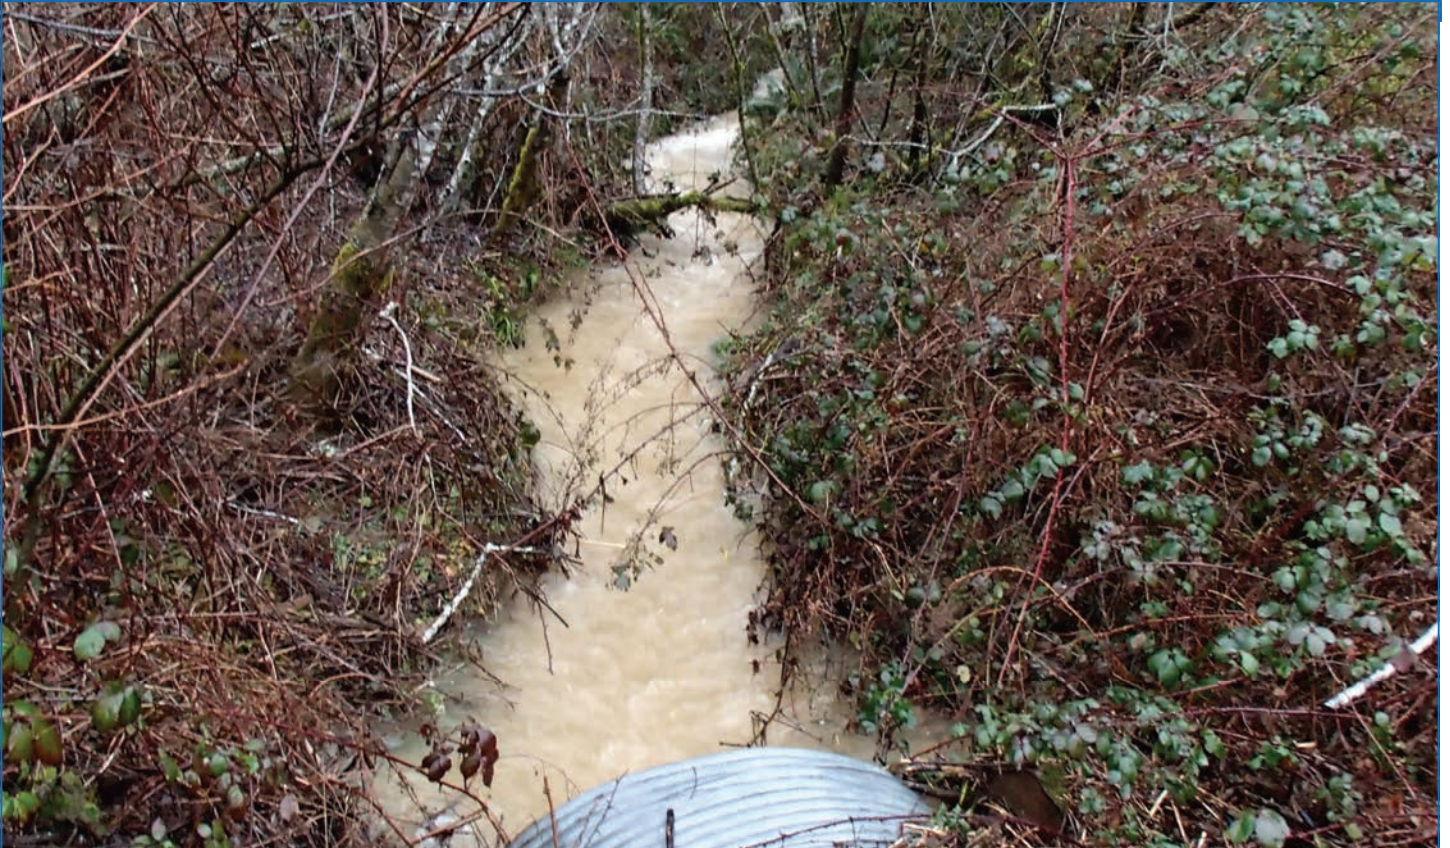
Salmon Run Hole 3 Restoration: The top photo shows the proposed new channel alignment from the driveway crossing downstream to the top of the existing wetland — the cart path will be relocated to make adequate room for the new channel and to maximize wetland habitat. The bottom photo shows the tributary channel upstream of the golf course driveway—wood placements and riparian enhancement would improve instream habitat within this reach.
