Salmon Run G.C. – Hole 4: Fish Passage & Wetland Restoration

Preliminary Project Design

June 5, 2014

Prepared By: Curry Soil and Water Conservation District, South Coast Watershed Council,
& Swanson Ecological Services, LLC

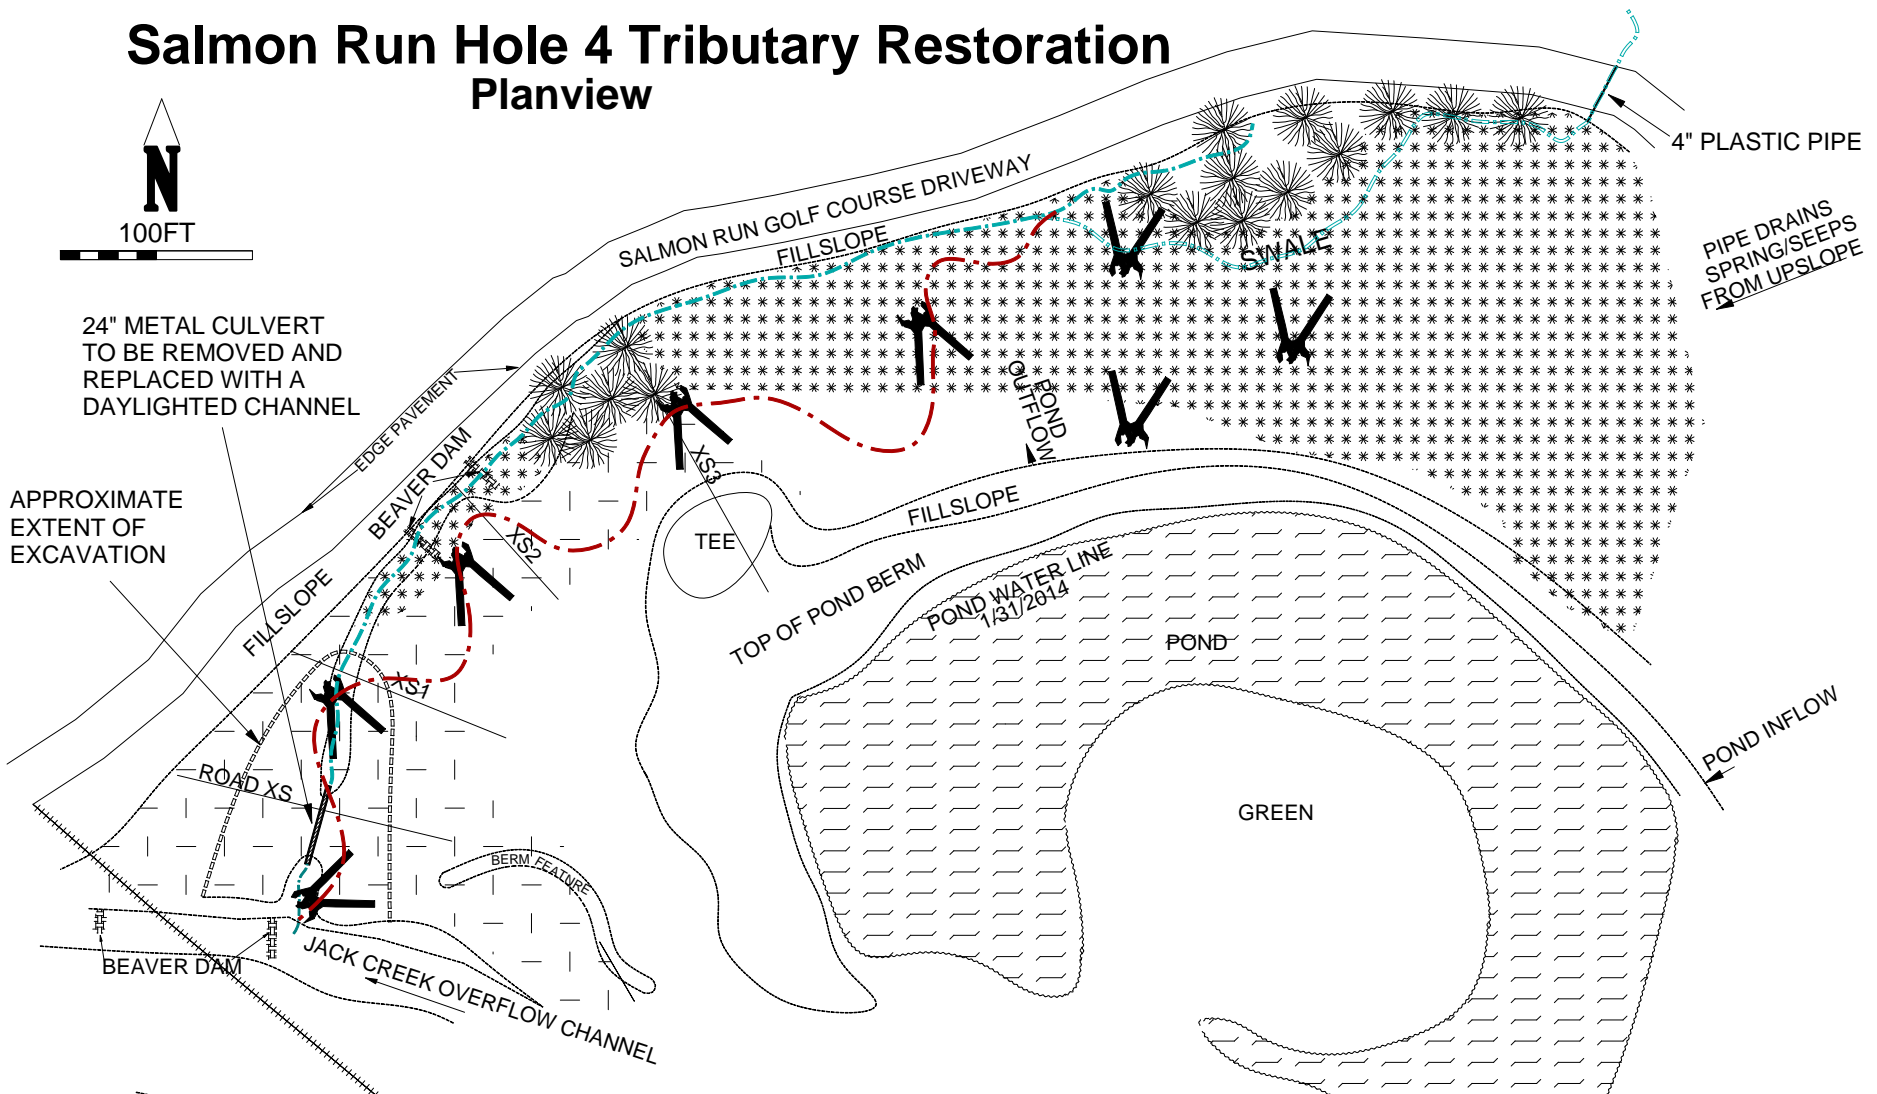
Salmon Run Hole 4 Tributary Restoration Planview

24" METAL CULVERT TO BE REMOVED AND REPLACED WITH A DAYLIGHTED CHANNEL

APPROXIMATE EXTENT OF EXCAVATION

ESTIMATED LENGTH OF NEW CHANNEL = 745FT. LENGTH OF CHANNEL TO BE ABANDONED = 530FT

Removal of the Orphaned Road Crossing: The existing road-stream crossing culvert will be removed to restore a free-flowing stream channel through the orphaned road alignment, and excess fill will be excavated downstream of the road alignment to restore a broader confluence of the wetland tributary stream and the Jack Creek overflow channel. This will increase winter rearing habitat, and improve upstream migration through the lowest reach of the tributary stream by converting the existing, artificially confined and incised channel, into a wider, lower gradient channel that is inset within a functional floodway. Total excavation is estimated at 800 cubic yards. This material should be end-hauled off-site and disposed of outside the 100-yr floodplain of Jack Creek. The gradient of the restored tributary channel will be approximately 0.34% through the decommissioned crossing, and the floodway will be approximately 20 feet in width.

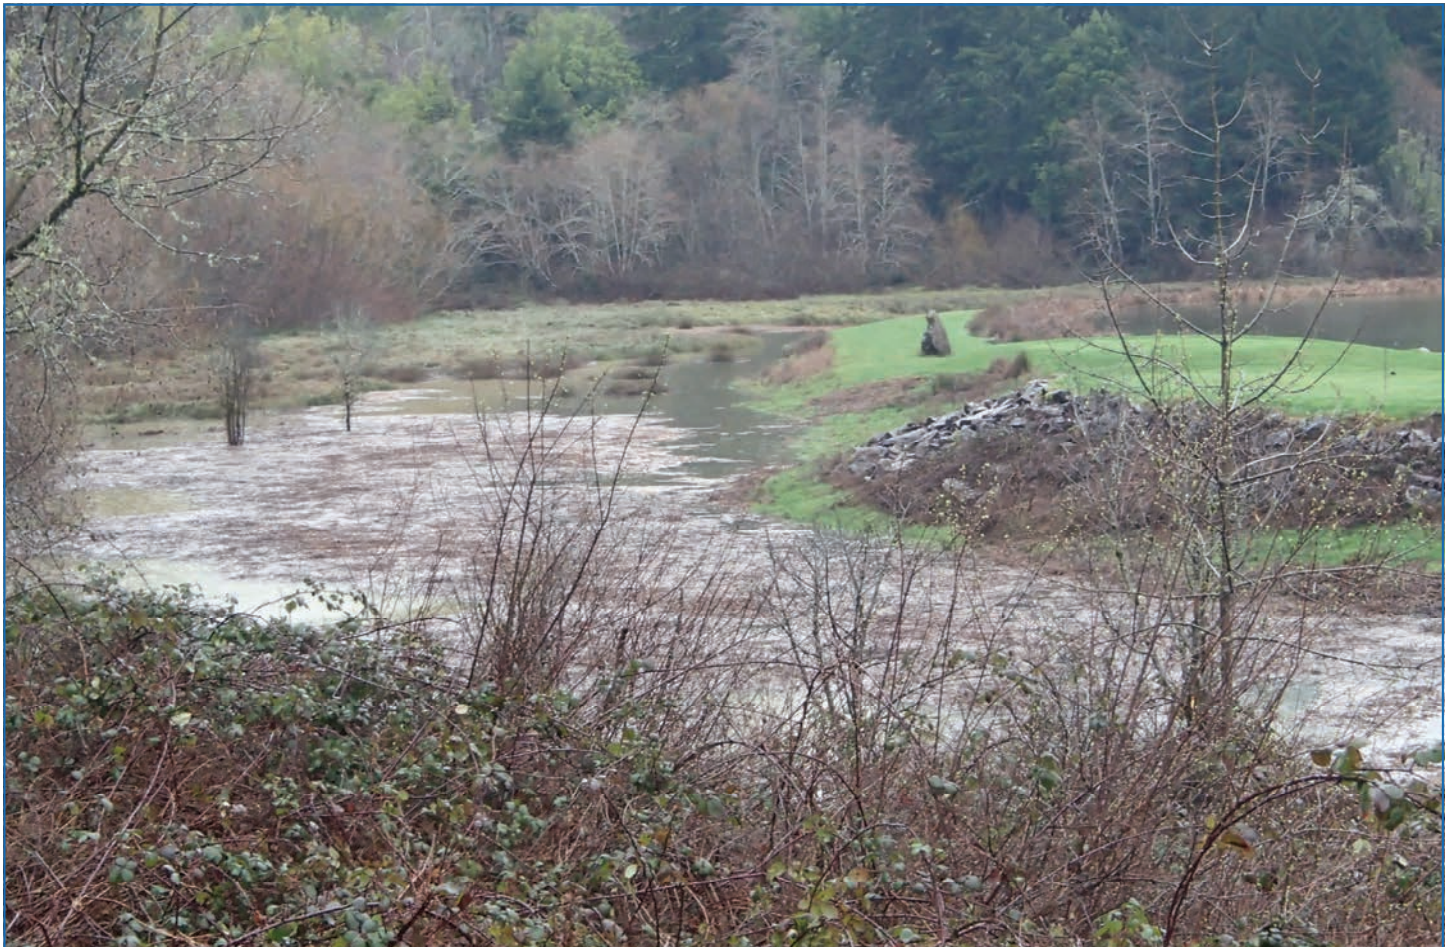
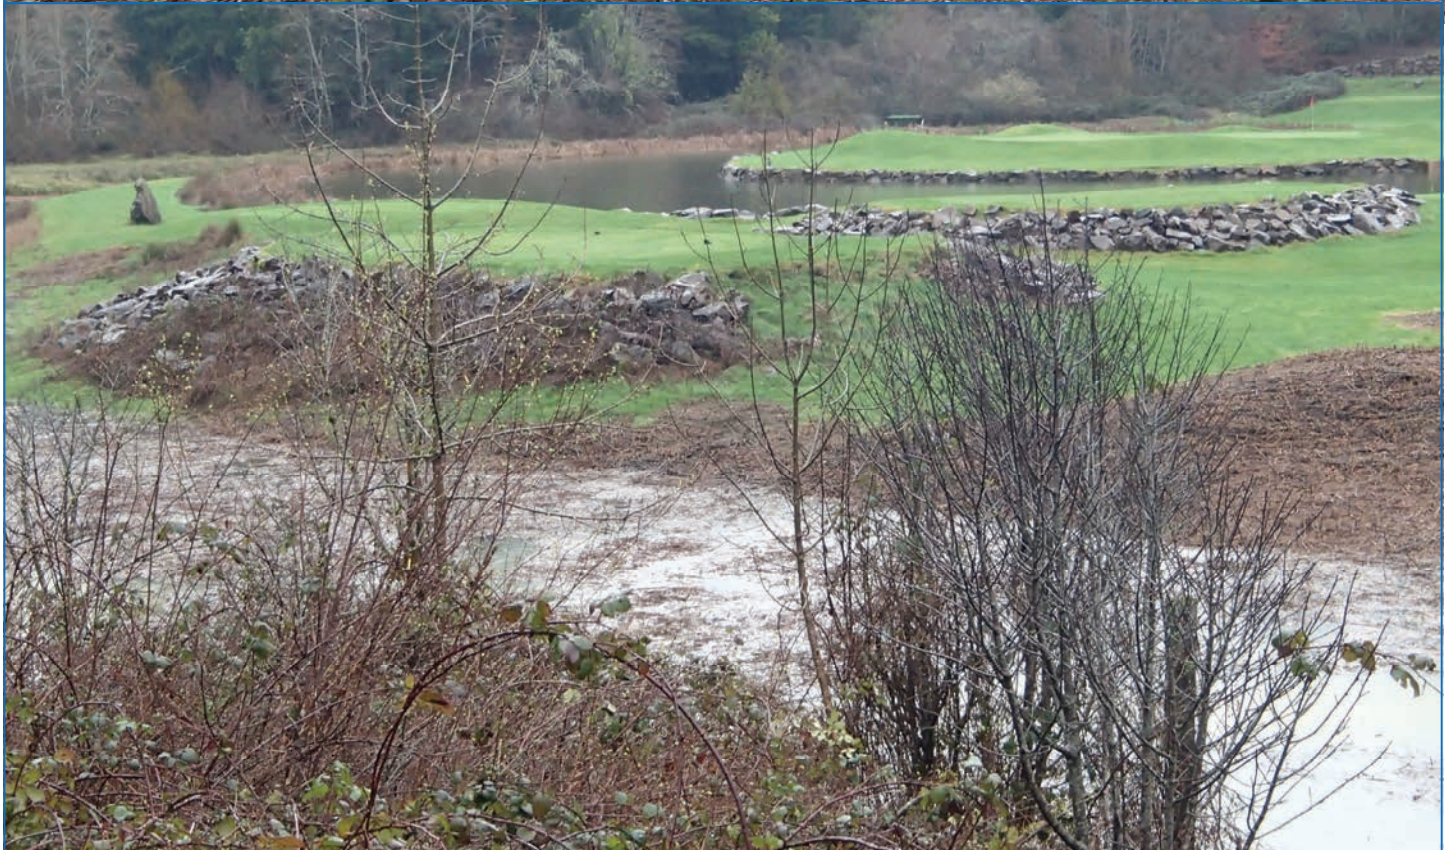
Salmon Run Hole 4 Restoration: Top photo shows the greater Hole 4 wetland during a moderate flood event. Notice the extent of ponding in the wetland, which represents potential high quality wintering rearing habitat for coho salmon pre-smolts; also notice the golf course pond and other infrastructure to the right of the wetland. The bottom photo shows the wetland as it narrows immediately upstream of the orphaned road crossing.

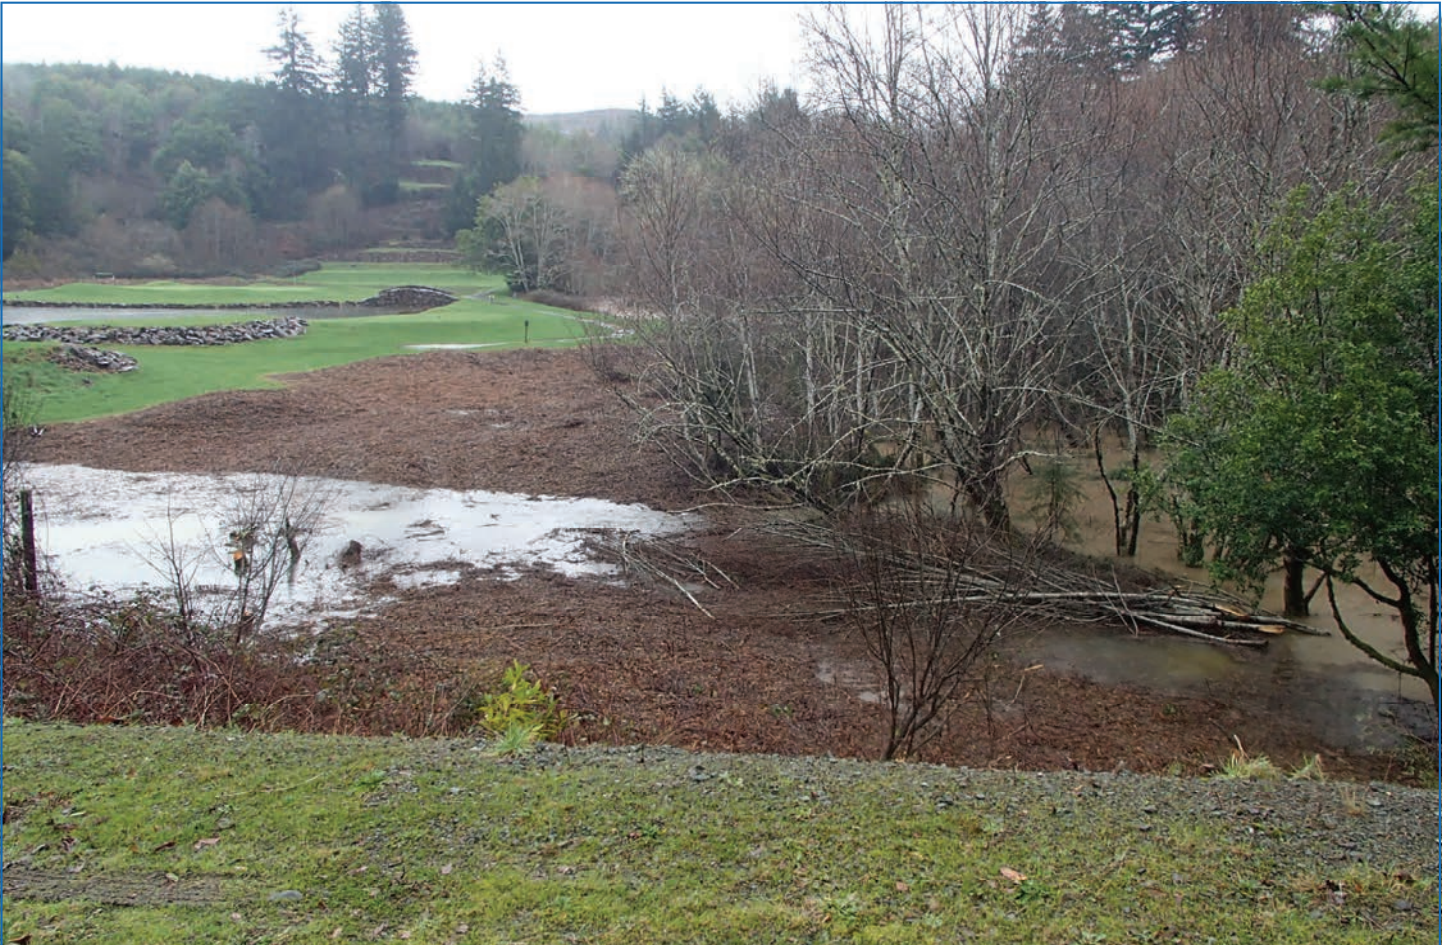
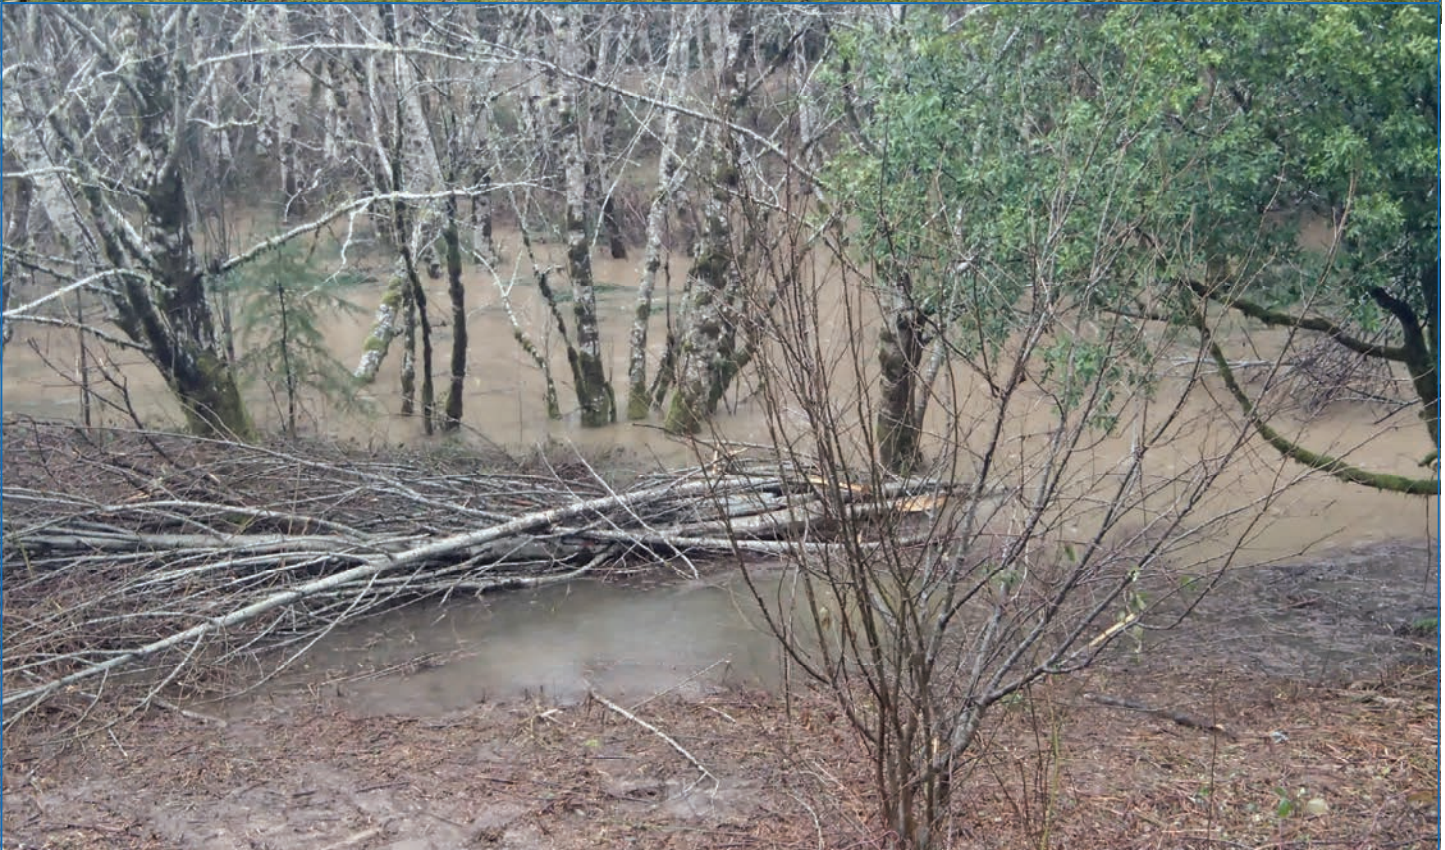
Salmon Run Hole 4 Restoration: Top photo shows the orphaned road crossing, which is underwater in this photo, and the confluence of the wetland stream channel and the floodway of Jack Creek. Also notice the extent of Himalayan blackberry that was mowed to facilitate our investigations — some of this area would be regraded to restore backwater habitat. Bottom photo shows a close up of the confluence and a greater extent of the Jack Creek floodway.

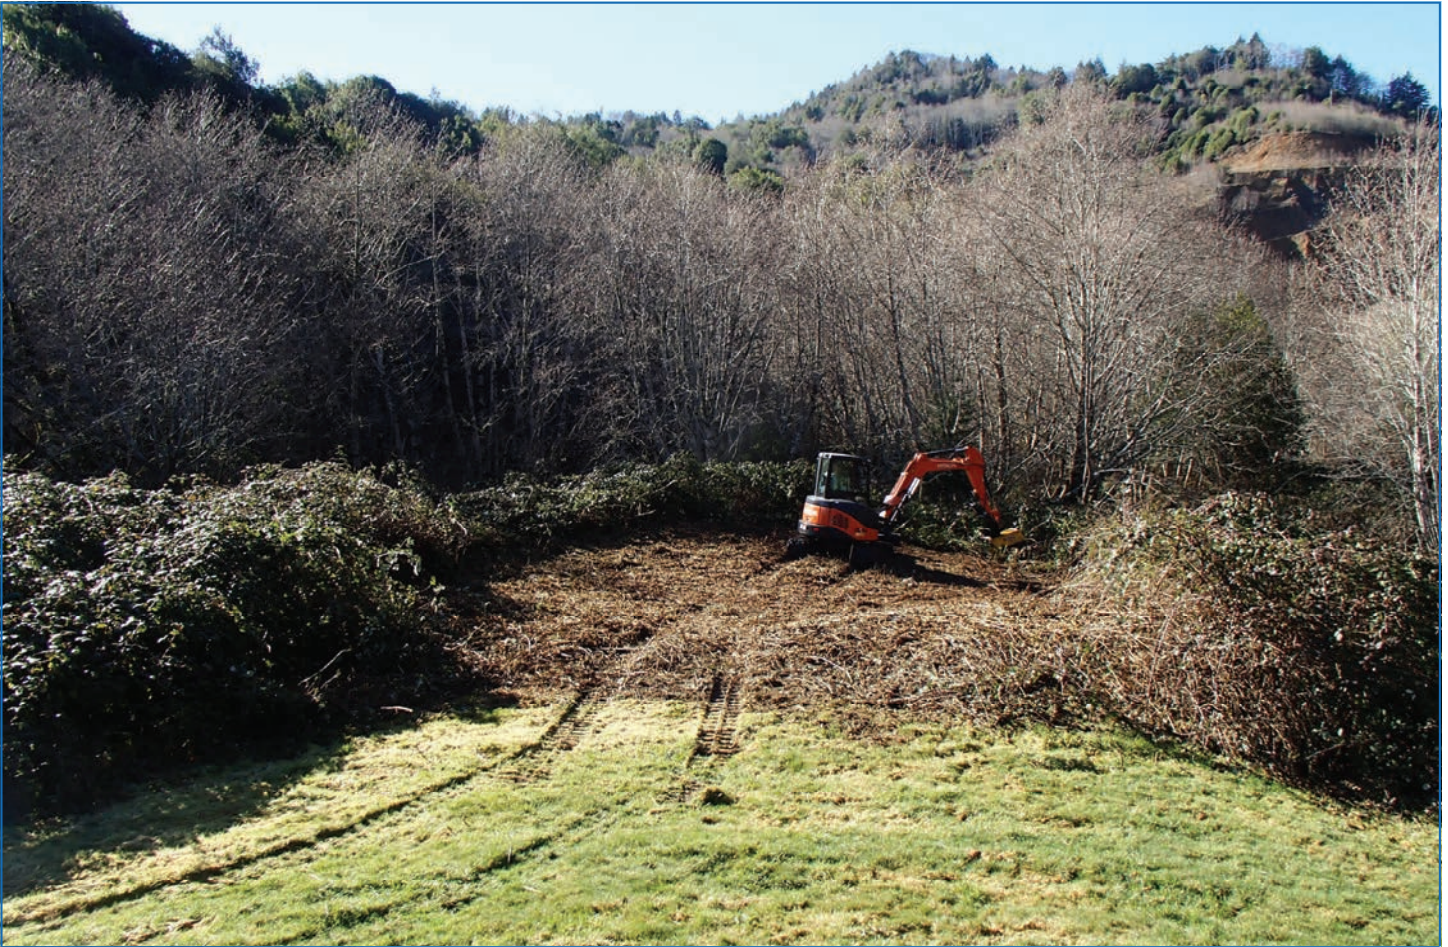
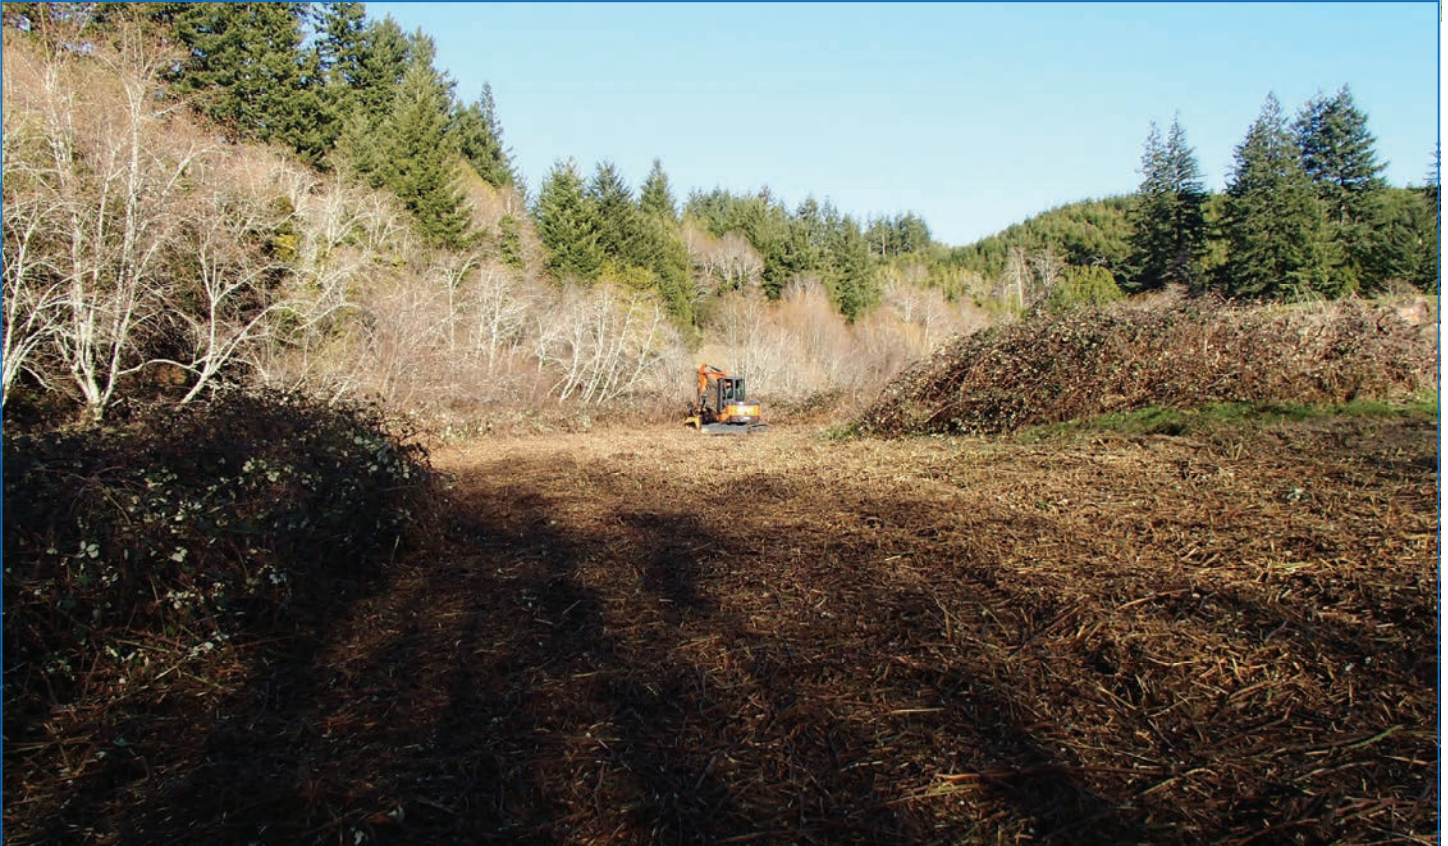
Salmon Run Hole 4 Restoration: Both photos show the magnitude of Himalayan blackberry encroachment on the wetland and greater project area. In the top photo the contractor is mowing the orphaned road grade that leads to the road-stream crossing — some of this area will be regraded and restored to backwater habitat when the road crossing is removed. In the bottom photo the contractor is mowing the interface between the course and the wetland.

Invasive Weed Management: The management of invasive plants at Salmon Run Golf Course should be a priority of the restoration community given the importance of the greater Jack Creek stream network. This objective, however, would take a substantial effort up front, and require a long-term commitment. Management of invasive plants around the Hole 4 wetland would be a good starting point, and is necessary to achieving the objectives of this project. Specifically, herbicide treatment of English ivy and Himalayan blackberry should be a short-term strategy that is included in the riparian revegetation plan, and the development of competing vegetation should be a long-term strategy for continued suppression of the blackberry; long-term management of the English ivy will require diligent monitoring and continued use of herbicides since shade is not an effective suppression method for this species.
