*Lateral Channel Migration, Downcutting and Restoration Potential
of
the North Fork Siuslaw River*

A report prepared for the Siuslaw River Watershed Council

*Barbara Ellis-Sugai, PhD
Forest Hydrologist
Siuslaw National Forest*

July 2002

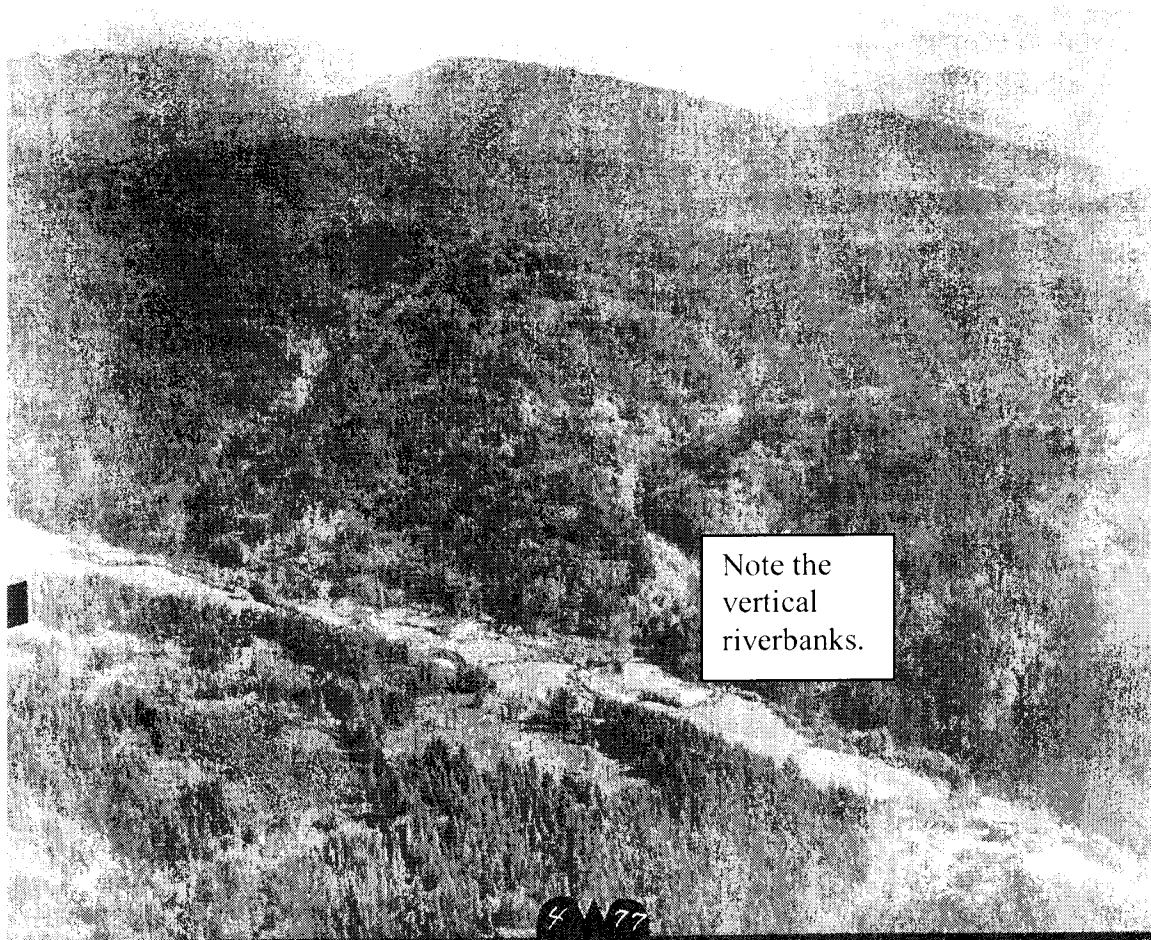
Figure 5: Oblique 1930 aerial photo.

No reference to the height of the riverbanks is made in the GLO notes. The 1930 oblique aerial photo of the valley seem to show some incision of the river channel (Figure 5); however, when the downcutting may have occurred is unknown. Incision of the river channel into the valley floor may have increased since settlement and the removal of large wood from the channel, but the evidence is circumstantial: Settlers considered the head of tide to be the downstream side of the Portage. Today, there is an average of one foot of tidal fluctuation at the upstream bridge of the Portage, approximately 2.8 miles from farther upstream. The fact that the tidal influence seems to reach farther up the river channel than it did a century ago may indicate downcutting of the river channel (Charlie Dewberry, pers. comm.).

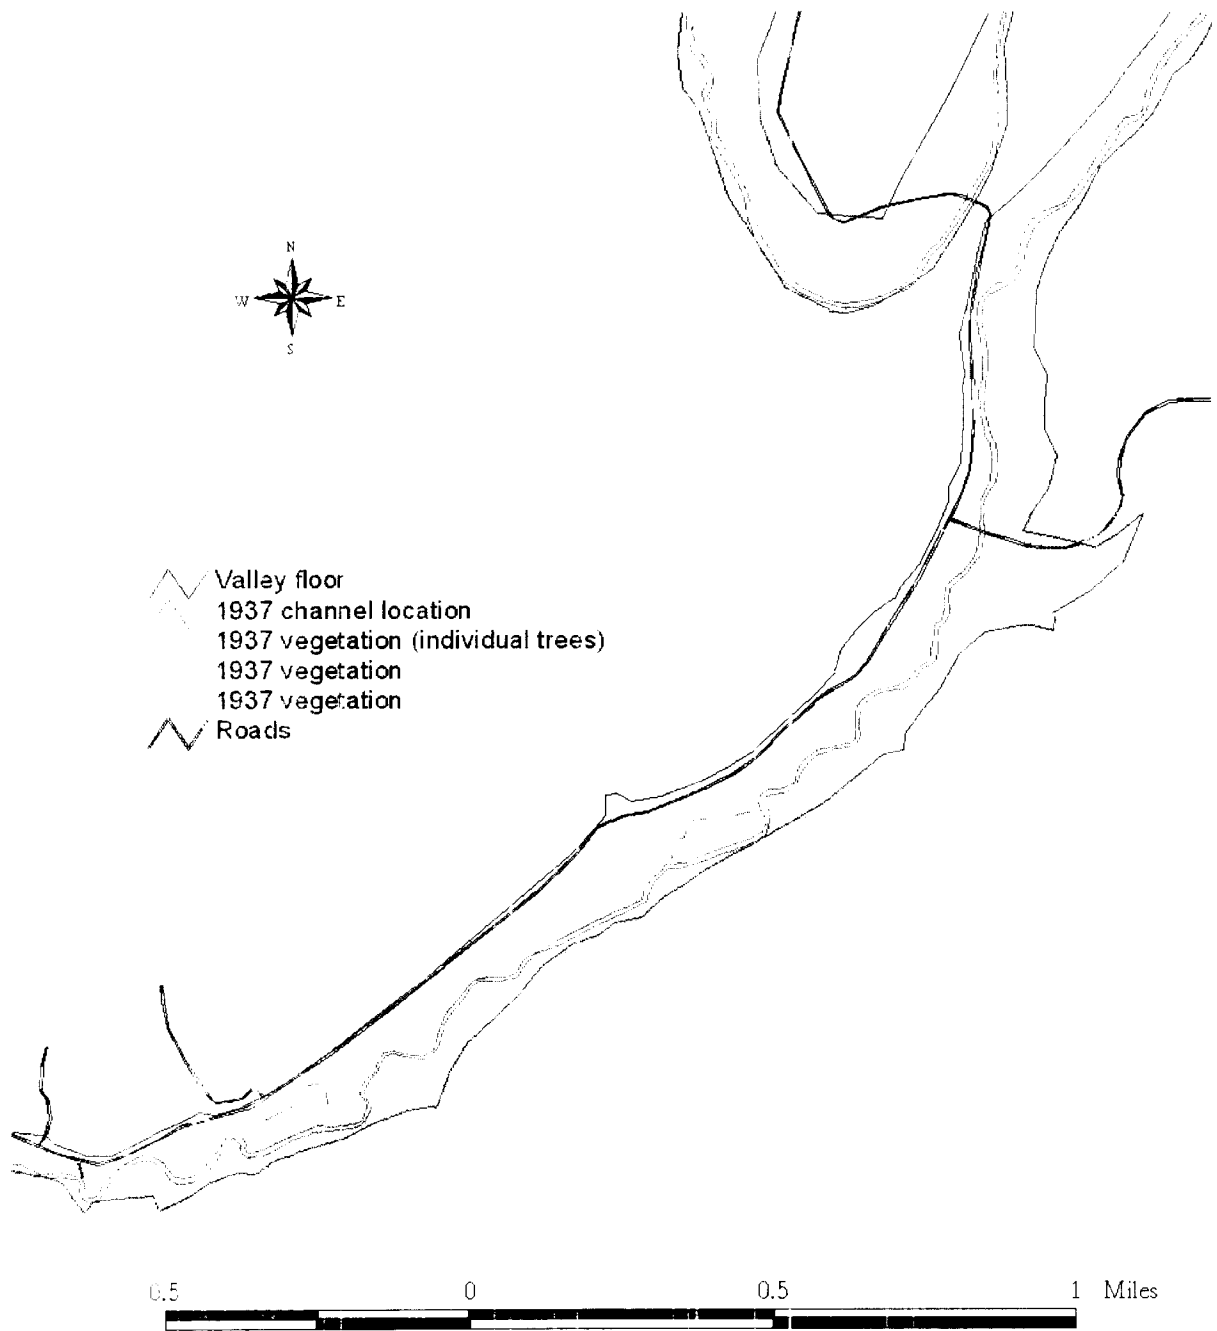
The GLO survey notes imply that woody vegetation, mostly vine maple, alder and some willow, covered much of the valley bottom prior to homesteading. By the time aerial photographs were taken in the late 1930's, much of the valley bottom had been cleared and converted to farms and pastures. Only a thin, sometimes one tree wide, strip of brush and trees were left along the riverbank. This condition has remained much the same to the present day. Figures 7a, 7b, and 7c compare the 1930's vegetation coverage with the 1994 vegetation on a section of the North Fork Siuslaw River downstream from McLeod Creek. To see the entire study area, refer to *Plate 1: Comparison of Vegetation along the North Fork Siuslaw River between the years of 1937 and 1994*.

Figure 7a: Vegetation along the North Fork Siuslaw River in 1937. By 1937, much of the valley floor had been cleared of trees and brush.

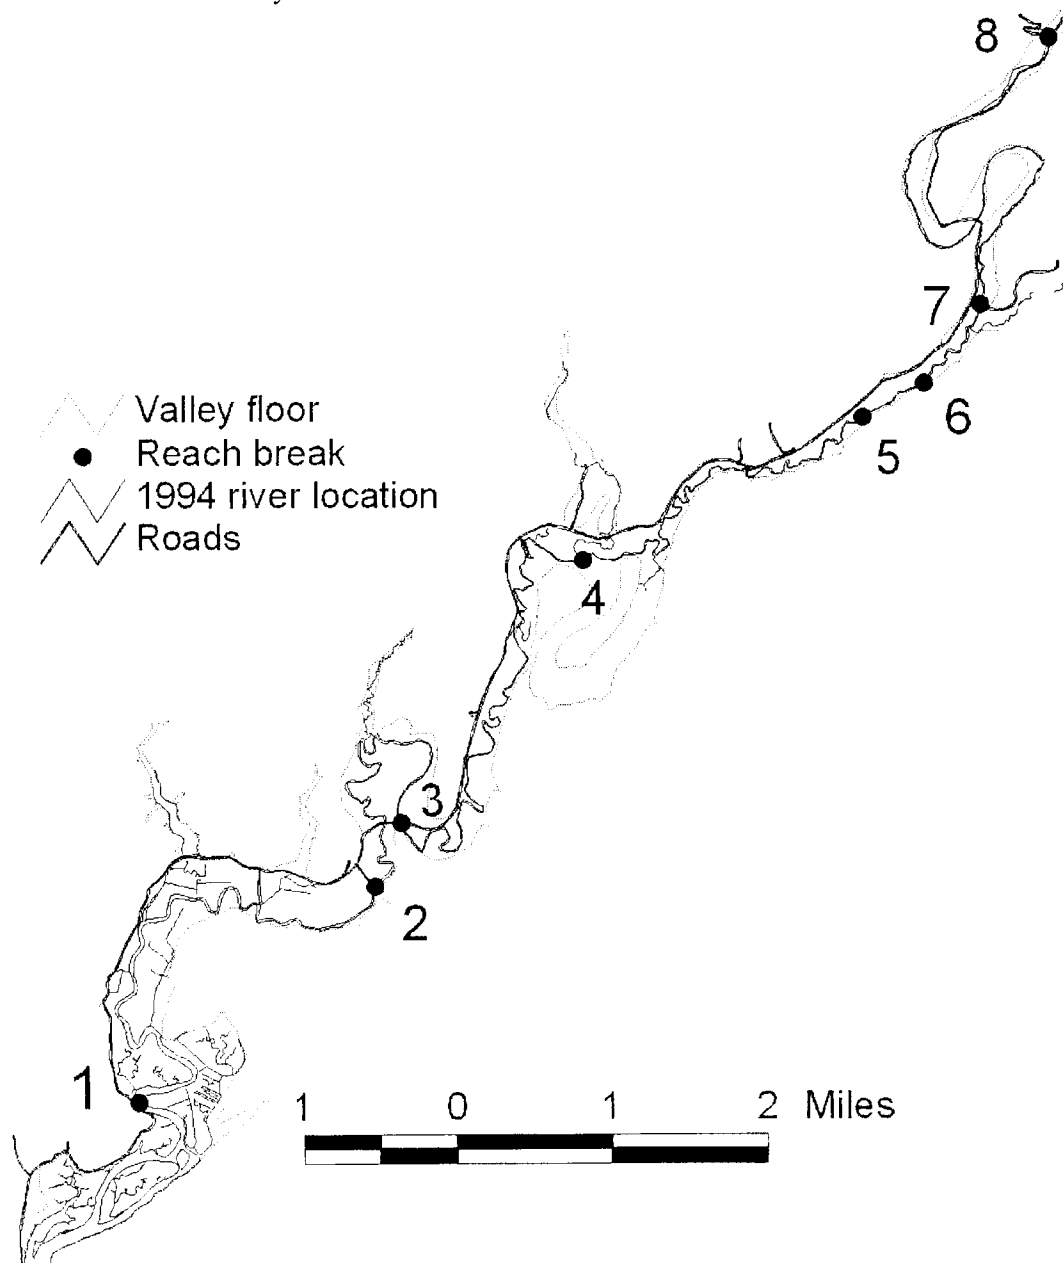
Figure 8: Map of reach breaks.

The reaches between points 1 and 3 are in the tidal influence zone, where the river was extensively diked between 1910 and 1915. The river reach between points 1 and 2 has the lowest gradient, and as expected, the highest sinuosity. The sinuosity between points

2 and 3, the river around the Portage, is quite low. The map from the 1879 GLO survey shows the river in the same location, so the unusually low sinuosity appears to be a natural feature. There is a gap in coverage between the 1937 and 1939 air photos between points 3 and 4, so the late 1930's sinuosity could not be measured. The reaches above point 4 show a very slight increase in sinuosity between 1937 and 1994. Above point 7, the valley becomes narrow and confined, and the sinuosity of the river reflects that. A comparison of the results is shown in Table 1.

Most of the bank erosion and lateral channel migration has taken place upstream from Condon Creek (point 4 on Figure 8) (see Plates 2 and 3, and Table 2). The river in the tidally influence lands has been diked since the 1910's (see Plate 2); and hasn't been allowed to migrate. The area just downstream from McLeod Creek has experienced the most lateral migration of the stream channel (Plate 3), possibly because of an influx of sediment, and deposition of sand and gravel bars just downstream from McLeod Creek. Slightly more stream length was affected by bank erosion and lateral migration between 1952 and 1962 in the reaches between points 4 and 5, and points 6 and 7 than in other years.

An unusually straight section of river channel exists between points 5 and 6 for a distance of almost half a mile (Plate 3). The straight section doesn't appear to be controlled by riprap or hard bedrock, and the banks are sandy (Johan Hogervorst, pers. comm.) In addition, no lateral migration appears to have taken place over the time period covered by aerial photography (1937 to the present). This straight segment of river channel is bracketed by channel segments that have been actively migrating and maintaining their sinuosity. The reason for this unusually straight and immobile segment is unclear, and puzzling.

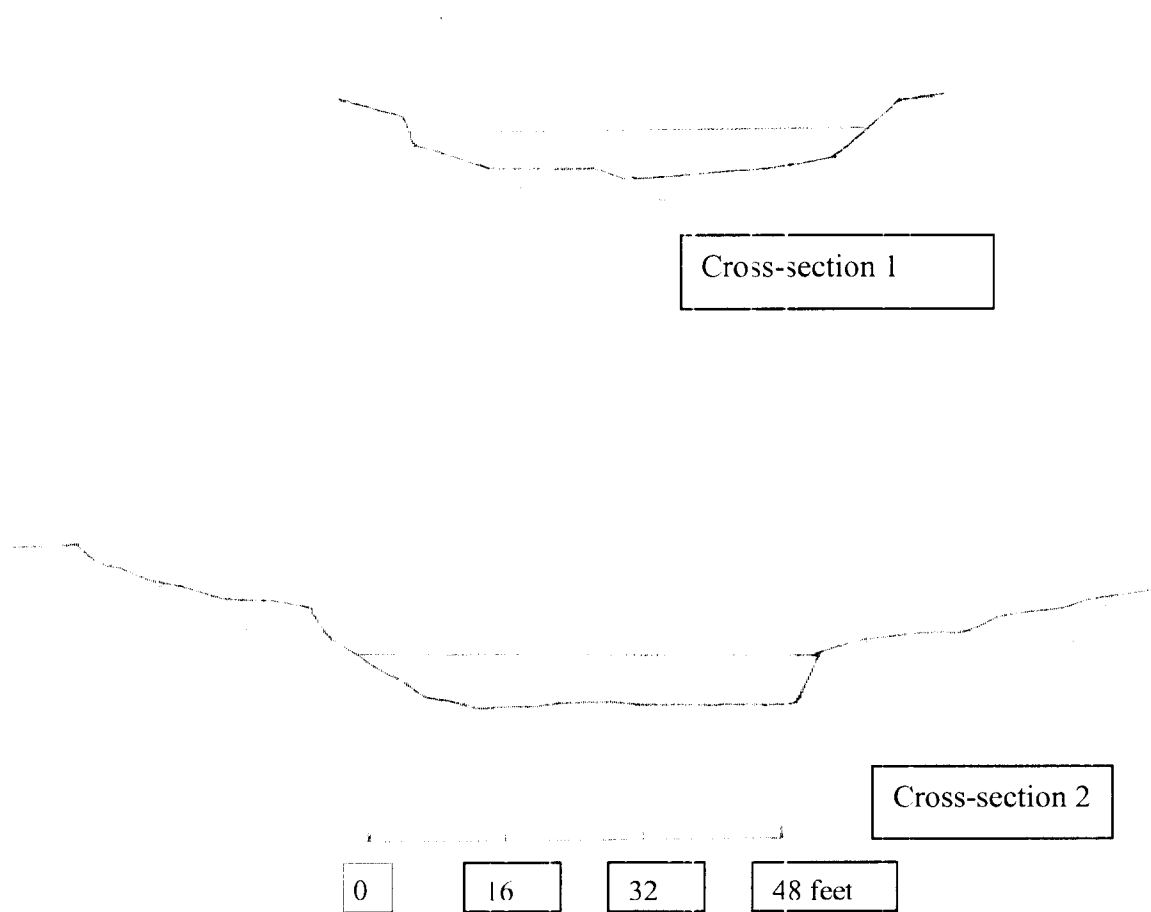
Figure 11: Cross-sections on the North Fork Siuslaw River.

The North Fork Siuslaw does not fit neatly into any one stream type. This lack of correlation suggests the stream channel may be evolving from one stream type to another. Cross-section 2 measures an abandoned channel (not shown), as well as the active channel. Assuming the abandoned channel has not been modified or filled in, the bottom of the channel is approximately 5-6 feet below the valley floor. The active channel, on the other hand, is downcut approximately 16-18 feet below the valley floor. Comparing the depths of the two channels suggests considerable downcutting into the floodplain has taken place. Based on the numerical data from the cross-sections, and the qualitative

descriptions of the channel types, the North Fork Siuslaw River seems to be between a “C5” and an “F5” channel. For example, the entrenchment ratio of 1.73 is between the values given for a “C” channel and an “F” channel. The cross-section data, including comparing the abandoned channel with the active channel, suggest the North Fork Siuslaw may have started as a “C” channel, then evolved into an “F” channel as it downcut into its floodplain. It may be starting to revert back to a “C” channel at a lower base level.

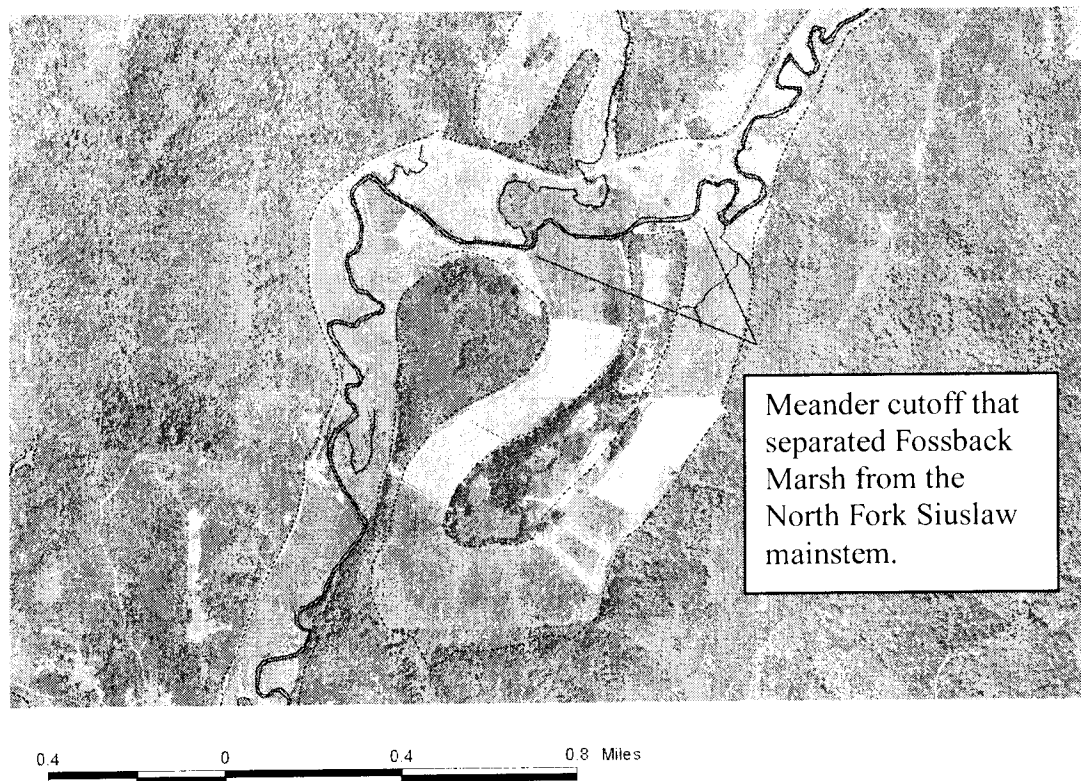
Figure 12: The abandoned meander at Fossback Marsh

The pre-settlement meander cut-off at Fossback Marsh may have been another contributing factor to the downcutting in the river channel. When the river abandoned the large meander through Fossback Marsh, the length of the channel was shortened by 17,500 feet (assuming a sinuosity of 1.5) (Figure 12). As a result, the gradient across the

meander cut-off increased. Assuming the original gradient was 0.03%, the gradient could have increased to 0.13%. The increased gradient in a local area could have caused a step in the gradient profile of the river. Removing the woody debris from the river could have removed a grade control, and allowed the headcutting to propagate upstream.
