PROJECT COMPLETION REPORT
CLOVER CREEK RIPARIAN RESTORATION
OWEB Project # 99-304

Glen Brady
Umpqua Basin Watershed Council
December 11, 2001

Clover Creek Riparian Restoration

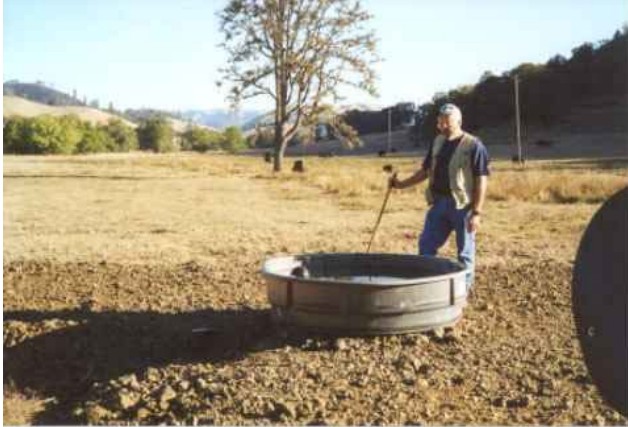
Figure 2
Completed stock water tank on Sandberg's – Oct. 2000.

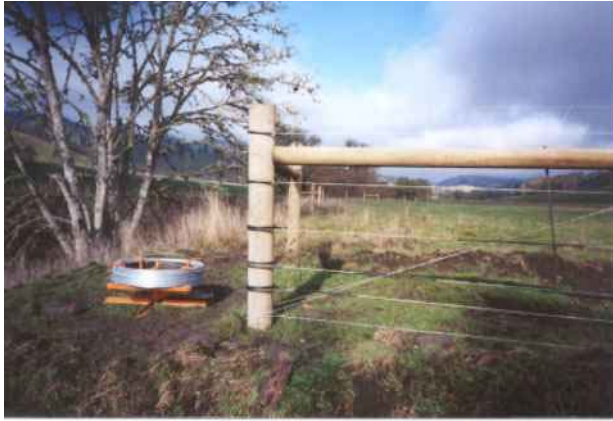
Figure 5
Corner of Sandberg high tensile riparian fence next to Clover Creek. Photo Point. March 2001.

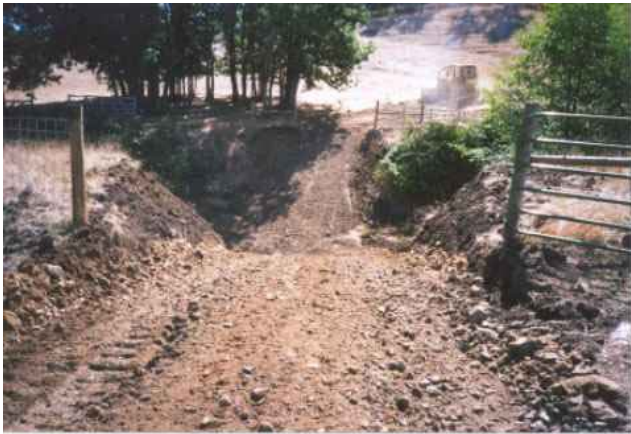
The last crossing, called the 3-way crossing because it accessed 3 pastures, required less excavation than originally planned and since much of one side was already shale rock, we left that side alone after excavation to proper slope (3:1). Fence construction left no access from the 3-way crossing to the south end of the hilly third pasture, so the contractor built about 300 feet of low impact tractor/4-wheeler road across the hillside to connect with the original road. Portions of this road were surfaced with shale to improve traction and reduce runoff.

Figure 6
Completed Kahn "3-way crossing". September 2001.

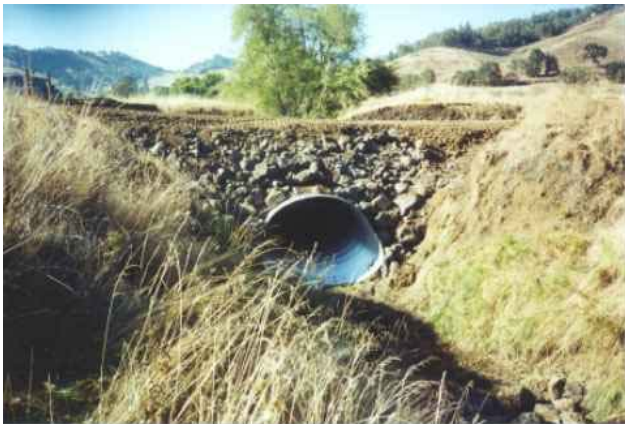
After a short turnaround permit application (see below) for installing the main culvert, a 137" x 87" pipe arch (114" round) 56 feet long, was delivered to the installation site on September 10, 2001. Upon receipt of the permit on September 11, the contractor, Rod Lower Trucking, proceeded with excavation of the site. To keep costs at a minimum he used shale rock as compacted bedding material, then placed the culvert. At the recommendation of Civil Engineer Don Porior the contractor used a concrete slurry around the bottom half of the culvert. The advantage of slurry is that it is a less expensive and faster way to compact around the culvert. The time saved was important since we were very close to the September 15 instream deadline. The slurry was poured on September 13 and 14 and let cure for one day as recommended, then fill was placed over the culvert and compacted. Rip rap was placed on both fill slopes and the fill was surfaced with shale rock on September 16. The next day the landowner moved a 13 foot wide seed drill across the completed crossing to demonstrate it's effectiveness.

Figure 6
Completed culvert installation with riprap visible at the inlet end of the pipe.
