Ecola Creek Watershed Assessment: A Living Document

May, 2001

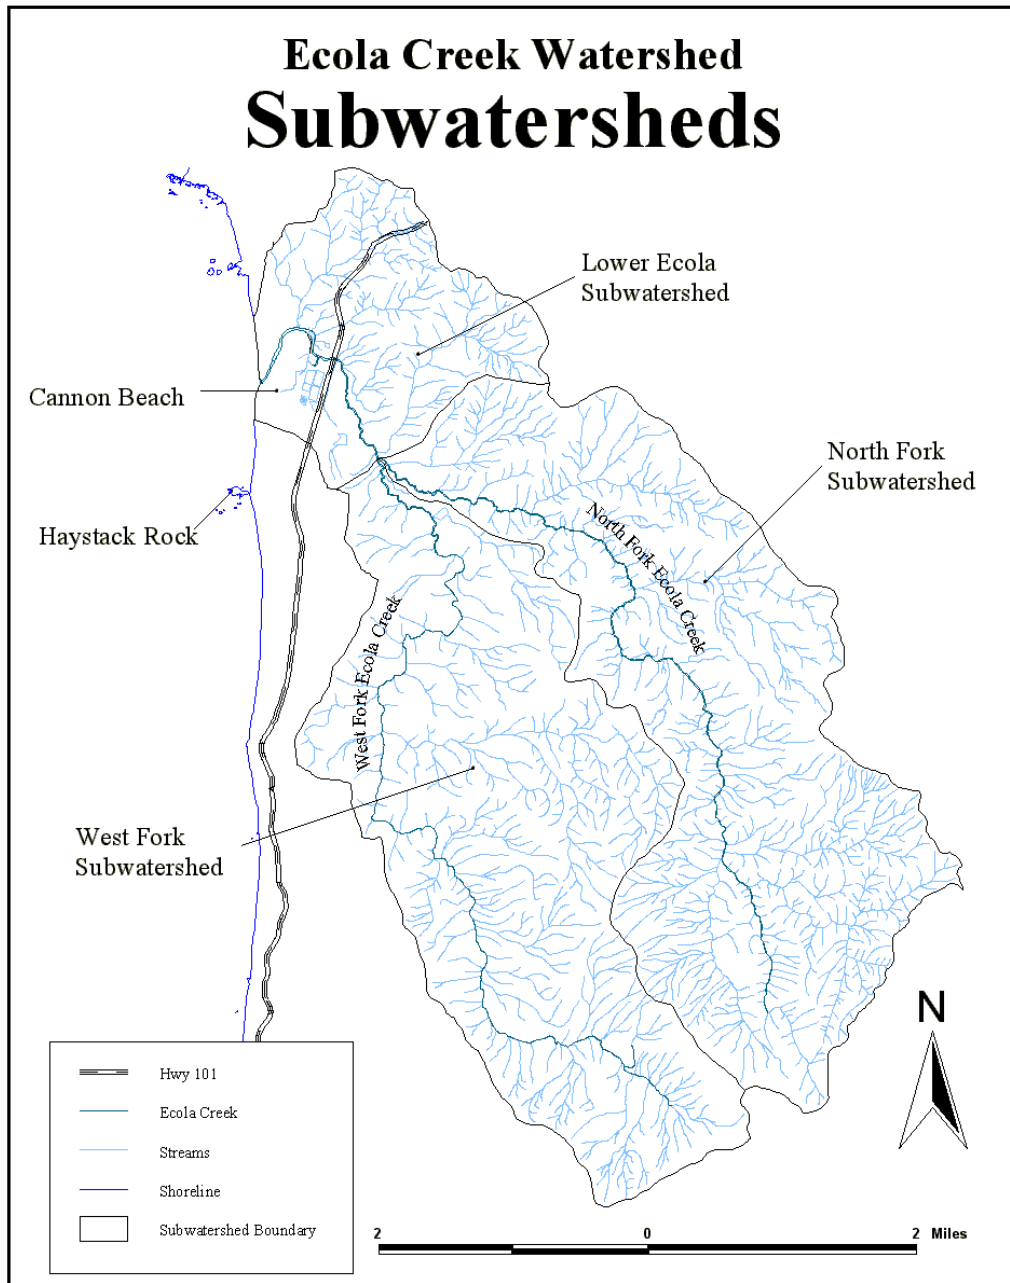
Figure 1.1 The three subwatersheds in the Ecola Creek basin: Lower Ecola, West Fork and North Fork subwatersheds. Also illustrated are major landmarks in the region.

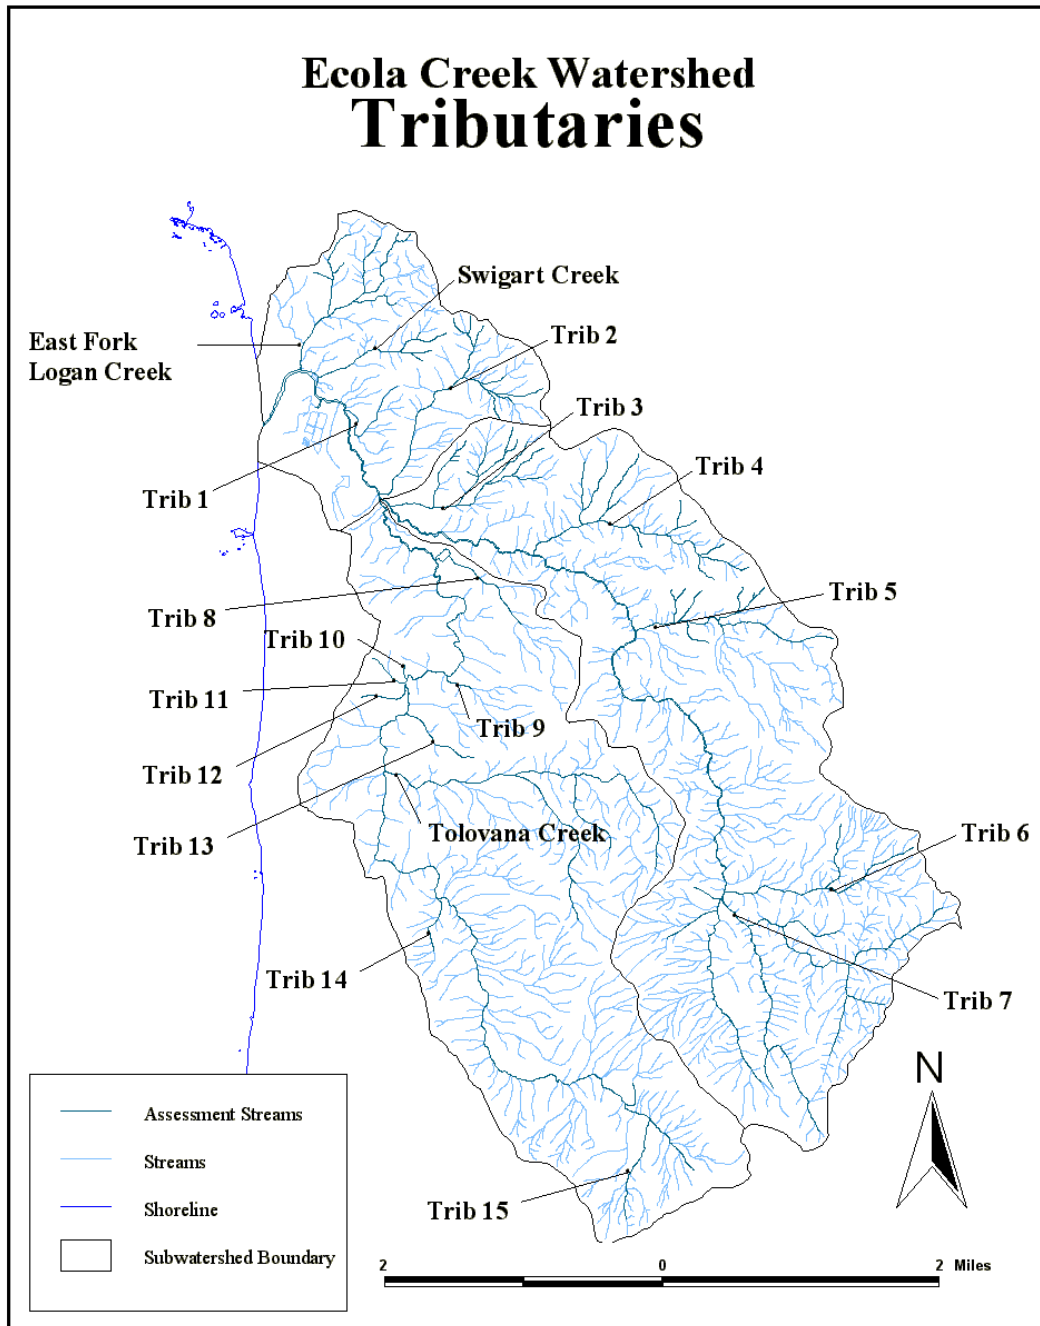
Figure 1.2 Tributaries included in the Ecola Creek watershed assessment.

Tributaries to Ecola Creek that were included in the assessment are presented in Figure 1.2. The name Swigart Creek is the unofficial name used throughout the assessment for the unnamed tributary whose confluence with the mainstem of Ecola Creek is just east of the Elm Street bridge on the north bank. Most tributaries are unnamed in the watershed and designating names for the creeks could be the focus of a future ECWC project. In addition, Trib 2 is incorrectly mapped. The tributary flows north by northwest and semi-parallel to Ecola Creek to combine with Trib 1. The combined waters of Tribs 1 and 2 empty into the mainstem of Ecola Creek approximately 3/4 of a mile downstream from where Trib 2 is shown to flow into Ecola Creek on the map. Channel meandering of this nature is common in low gradient, unconstrained areas.

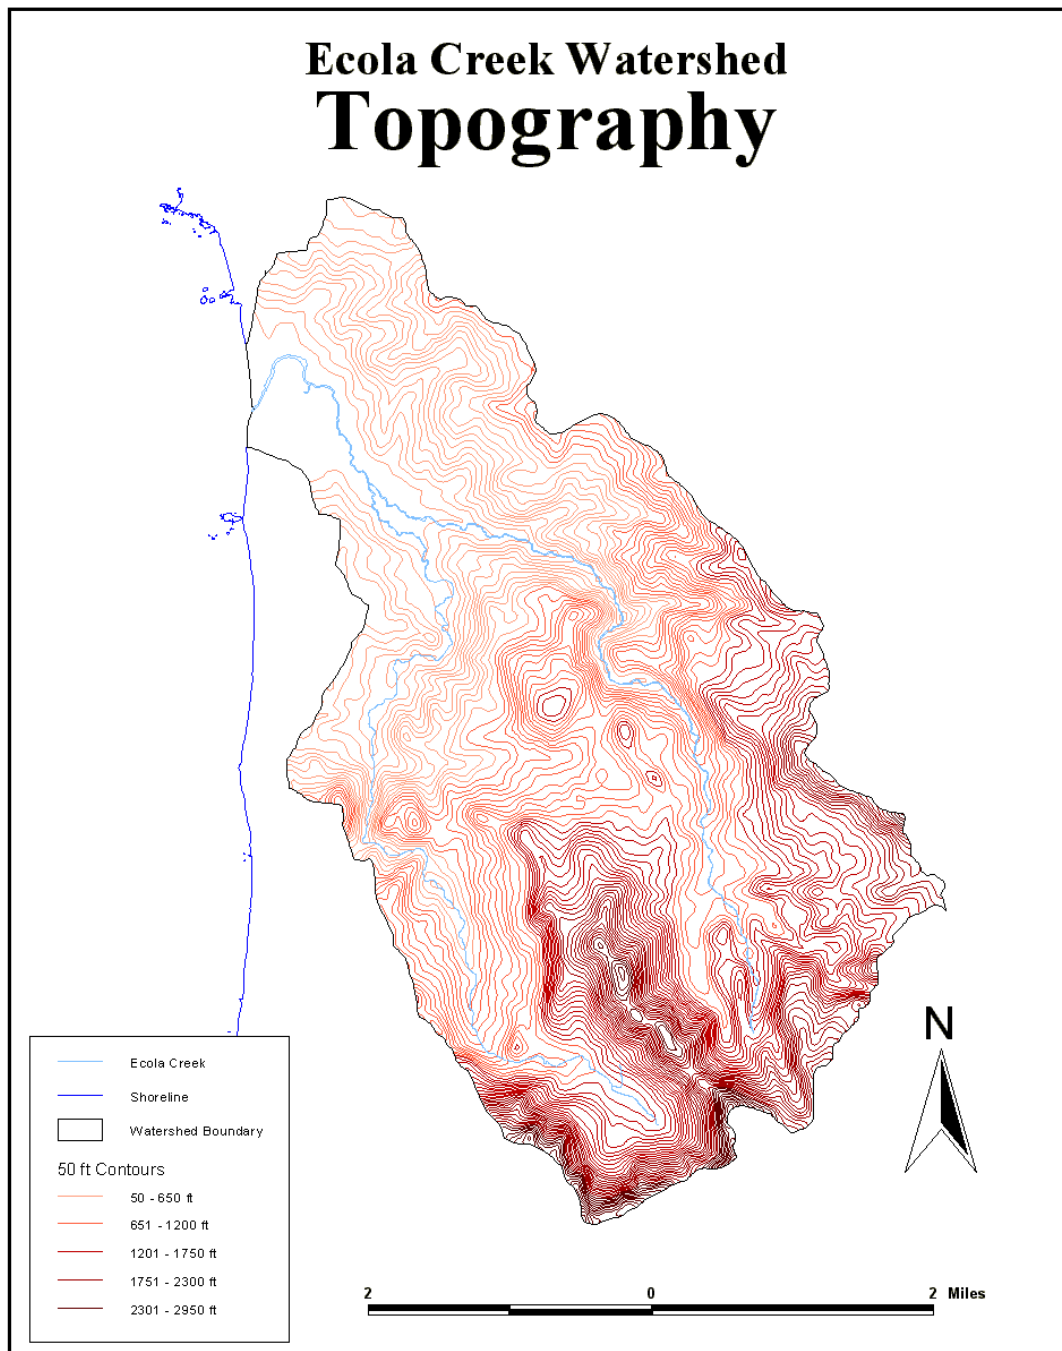
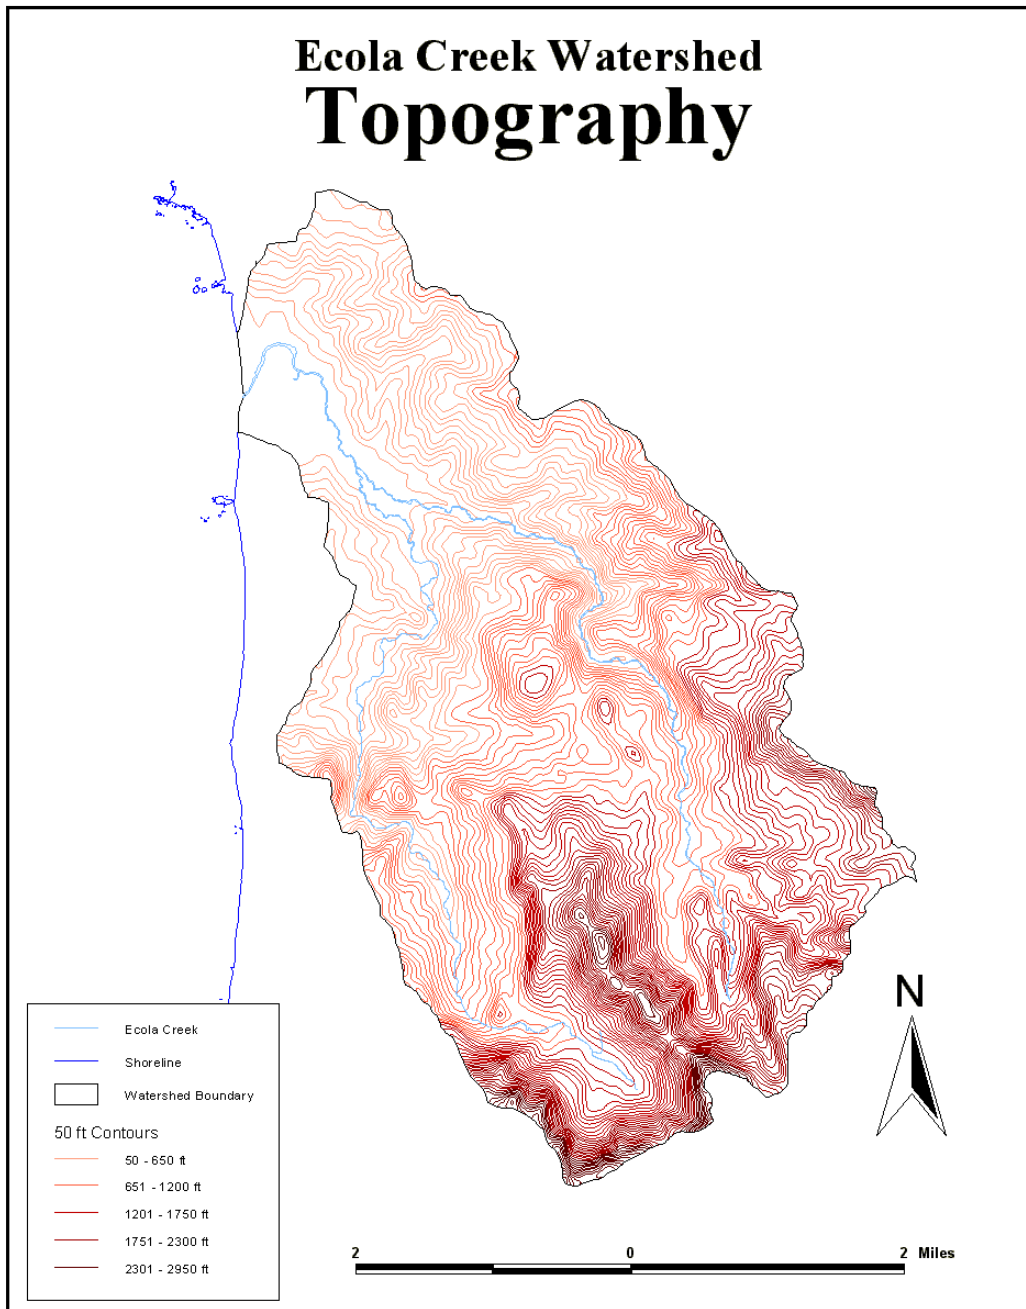
Figure 1.3 50 foot contours illustrating the steep terrain in the Ecola Creek watershed.

The Ecola Creek watershed is a north to northwest facing drainage with headwaters that drain steep and mountainous narrow valleys, often breaking abruptly to more gentle slopes below (Figure 1.3). The West Fork and North Fork of Ecola Creek converge approximately 1.4 stream miles above Highway 101 in a large valley bottom and floodplain and drain to the sea.

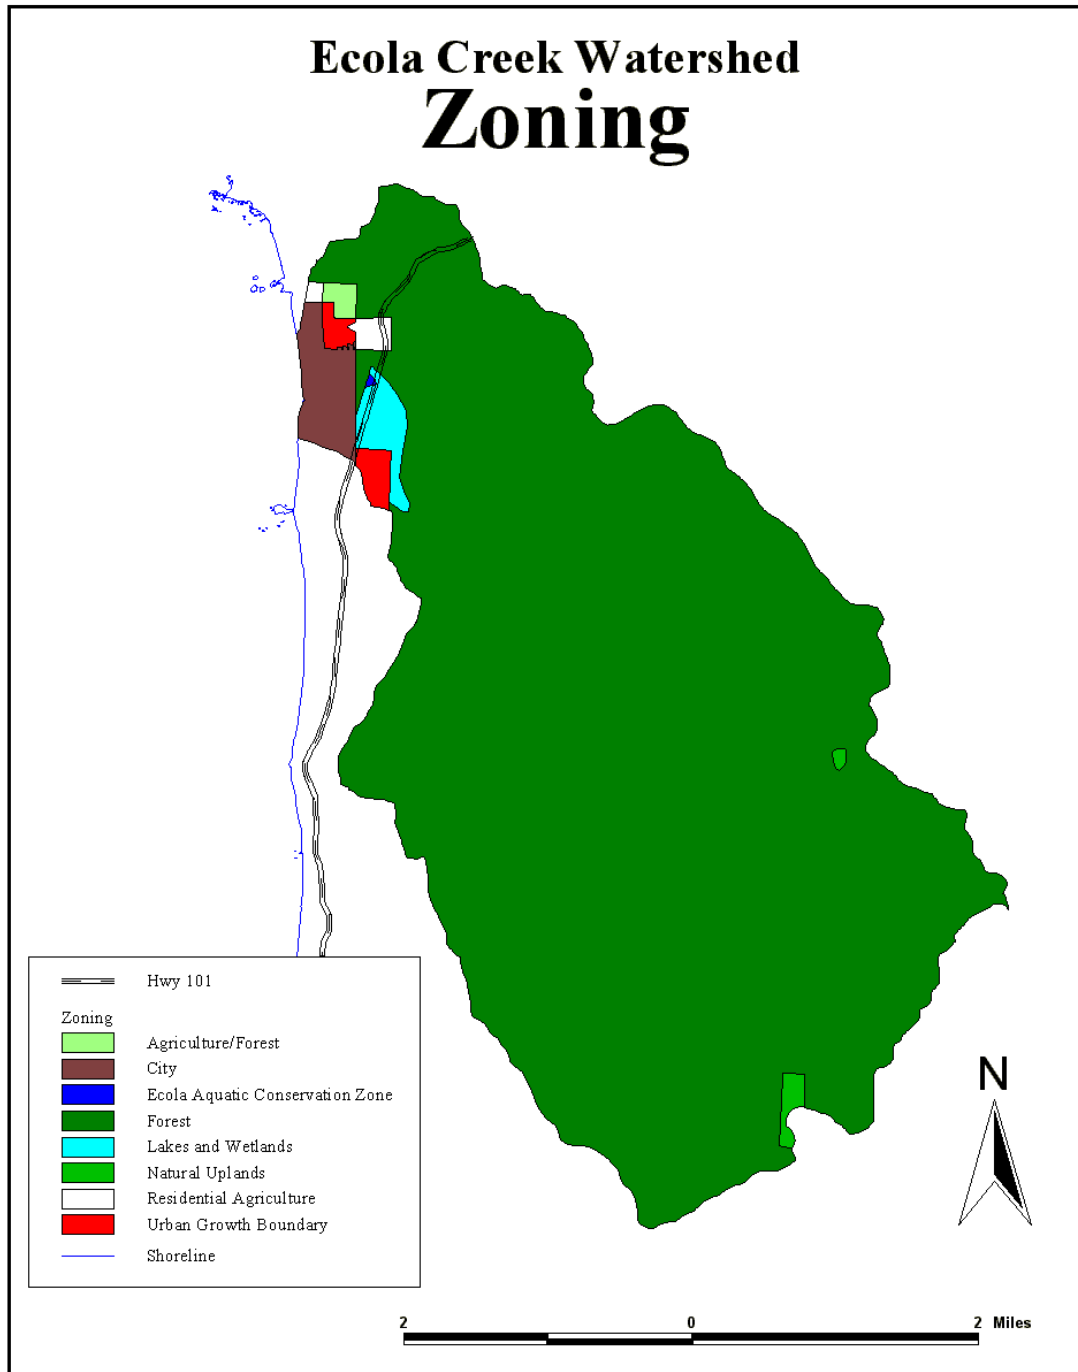
Figure 1. 4 Zoning in the Ecola Creek watershed.

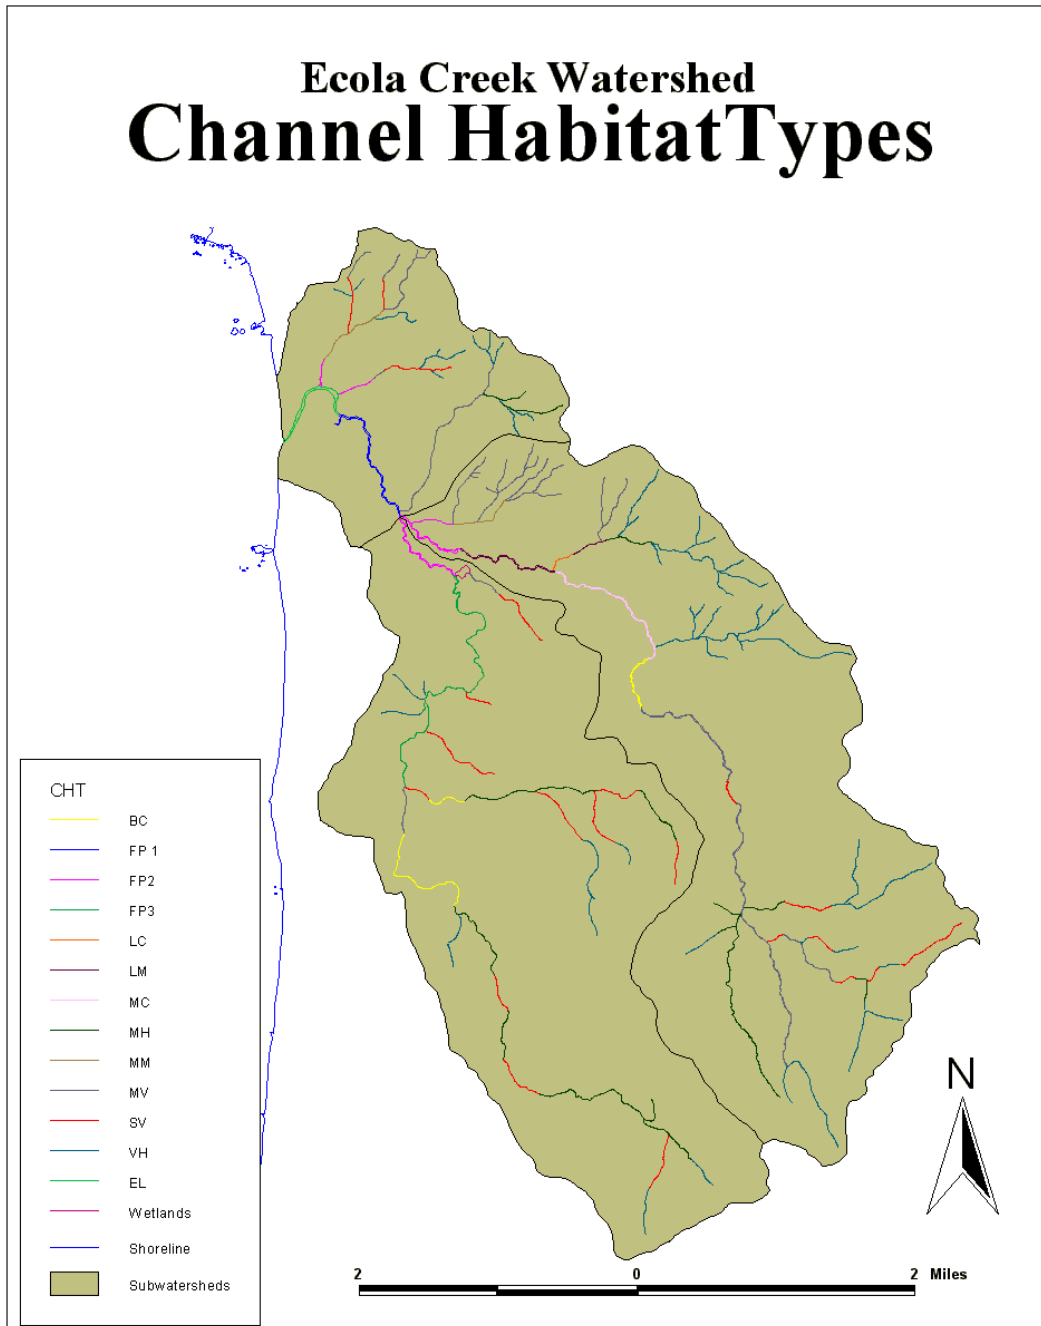
Figure 2.1 Distribution of Channel Habitat Types in the Ecola Creek watershed.

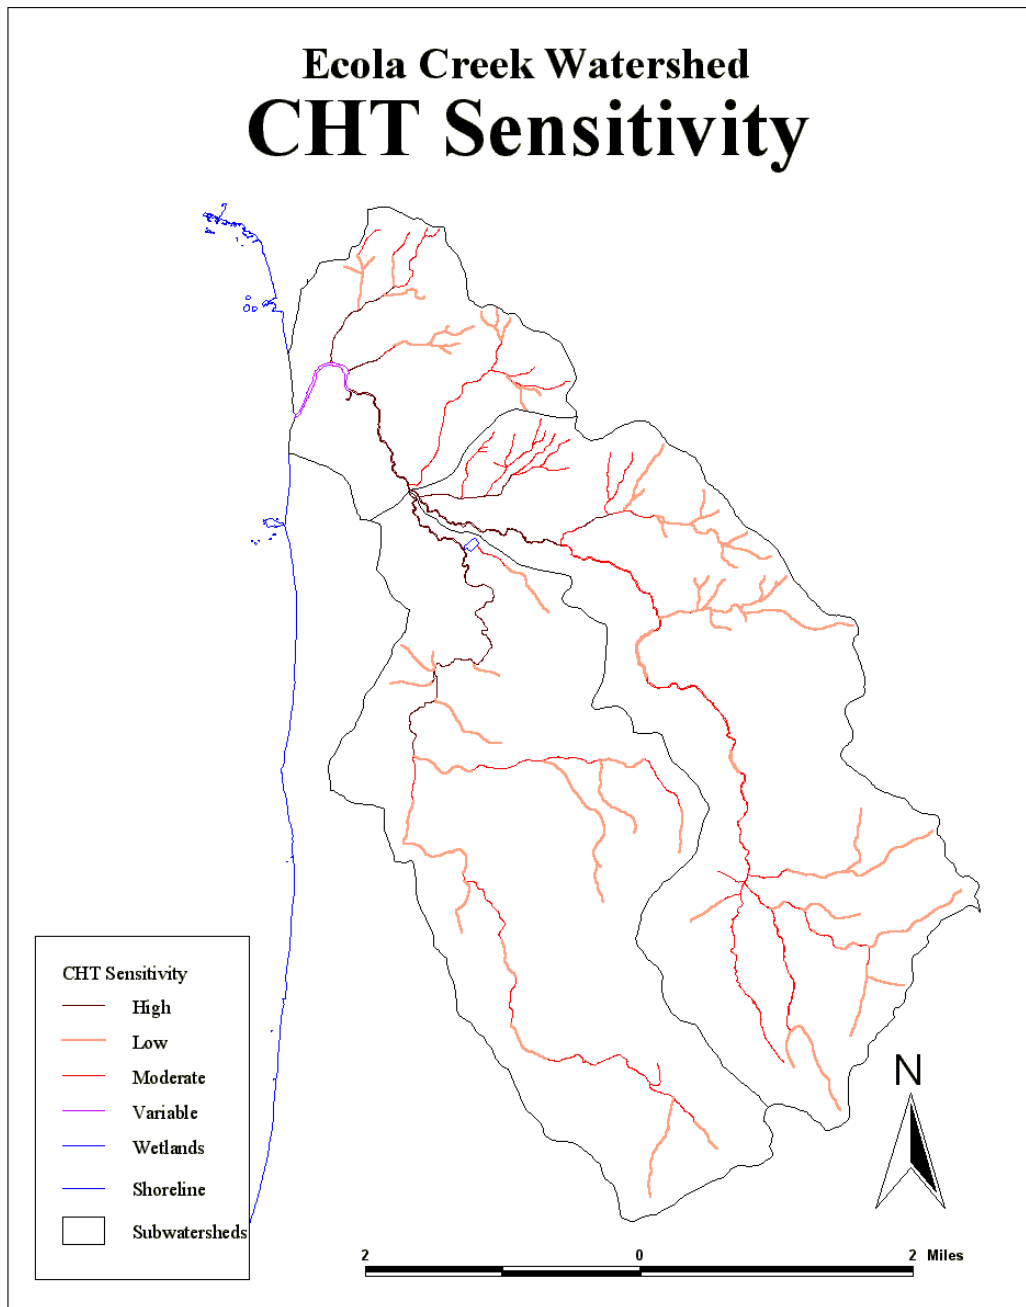
Figure 2.2 Channel Habitat Types in the Ecola Creek watershed grouped according to their sensitivity to changes in the factors that impact channel development. The more sensitive areas are most likely to exhibit physical changes from land management activities, as well as restoration efforts.

characteristics when flow, sediment supply, or in-stream structures (such as large woody debris) are altered. Highly sensitive reaches in the Ecola Creek watershed make up approximately 14% of the CHTs designated. Highly sensitive streams generally have low gradients and extensive to limited floodplains. As would be expected, map 2.2 illustrates that most of the highly sensitive reaches are located in the Lower Ecola subwatershed and the lower reaches of the West and North Fork subwatershed. Most of the highly sensitive reaches are the FP1 and FP2 areas located on the mainstems. In addition, highly sensitive areas are located in the lower reaches of several tributaries in the same region of the watershed.

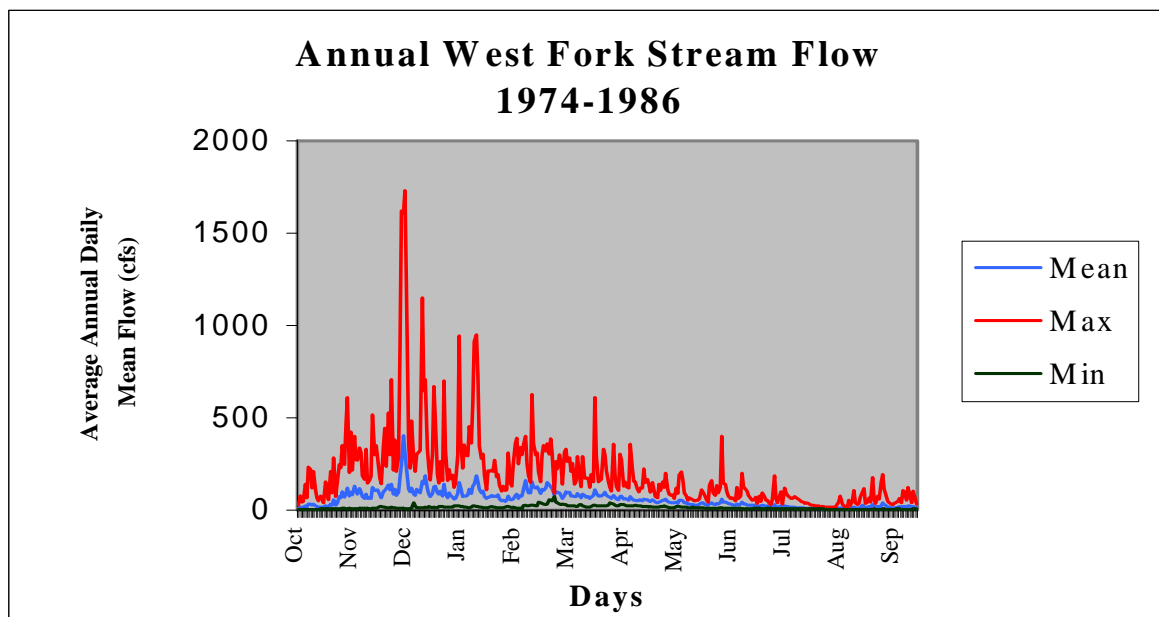
Figure 3.1. Average Annual Daily Mean Stream discharge for the West Fork stream gauge based upon daily mean records for the period of 1974-1986.

The West Fork subwatershed is the municipal watershed for the City of Cannon Beach and the historic stream gauge was located approximately .5 miles downstream from the city's point of diversion. The West Fork drains approximately 8.55 square miles of land and the North Fork subwatershed drains approximately 9.36 square miles of land. Stream flow patterns for both subwatersheds are typical of Oregon coastal watersheds with the majority of high flows and storm events occurring between the months of October and May (Figure 3.1 and Figure 3.2). The dramatic sharp peaks in Figures 3.1 and 3.2 are indicative of watersheds

with steep slopes as is the case with Ecola Creek. The graphs illustrate how quickly both subwatersheds move water during storm events. The summer months consist of base flow conditions with very few storm events. Average annual maximum daily mean flows for the West Fork subwatershed range between 117 cubic feet per second (cfs) and 1730 cfs, with the largest event occurring in December of 1975. Average annual maximum daily mean flows for the North Fork subwatershed range between 165 cfs and 1420 cfs with the largest event occurring in December of 1977. It should be noted that stream gauge data on the West Fork had multiple periods of data gaps. A comparison between Figures 3.1 and 3.2 indicate that the missing data is most likely masking high flows throughout the year for the West Fork subwatershed.

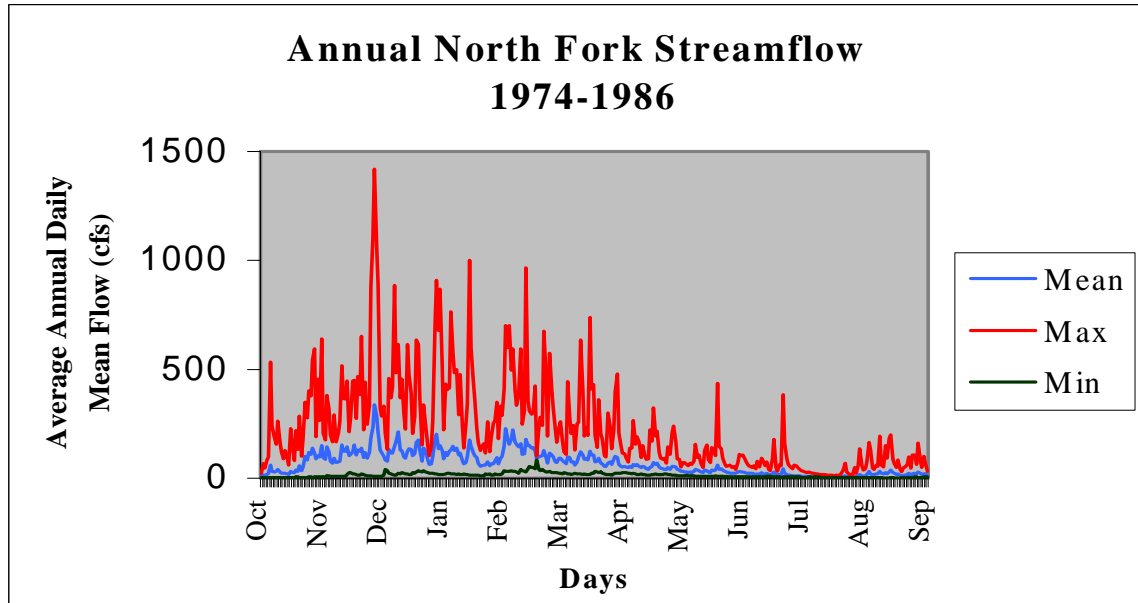
Figure 3.2. Average Annual Daily Mean Stream discharge for the North Fork stream gauge based upon daily mean records for the period of 1974-1986.

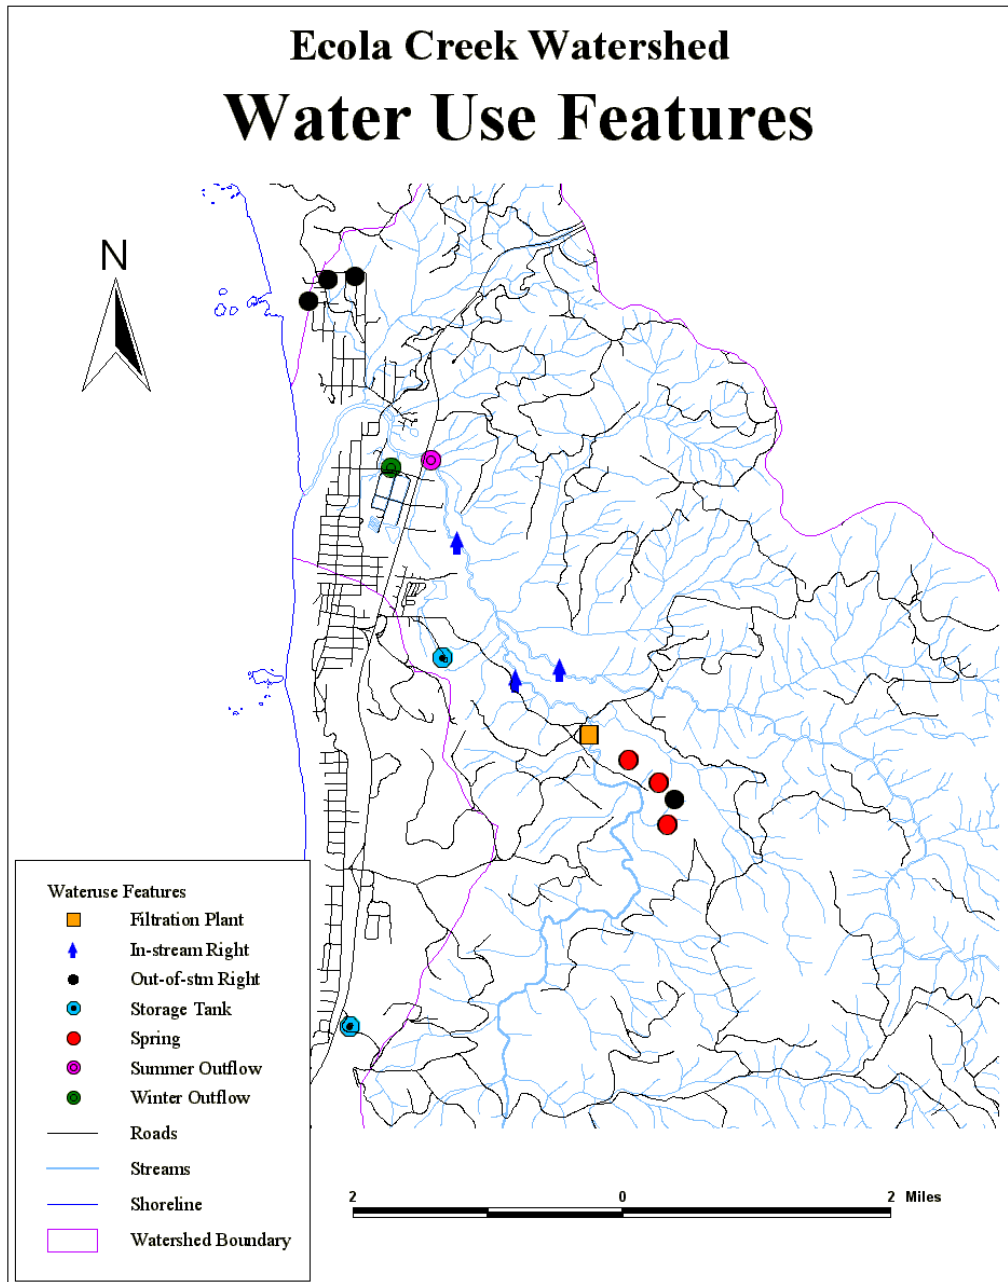
Figure 4.1 Water Use features in the Ecola Creek watershed. Out-of-stream rights are those with known locations other than the municipal water rights. Municipal water rights are depicted as the springs and filtration plant.

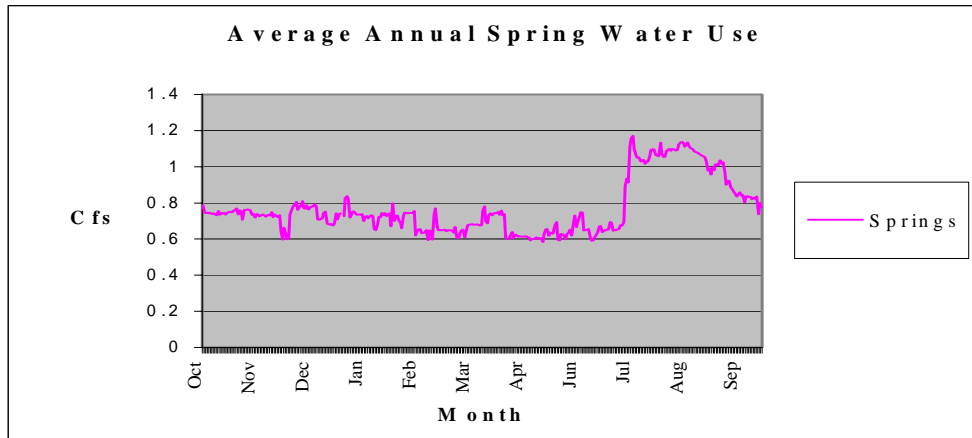
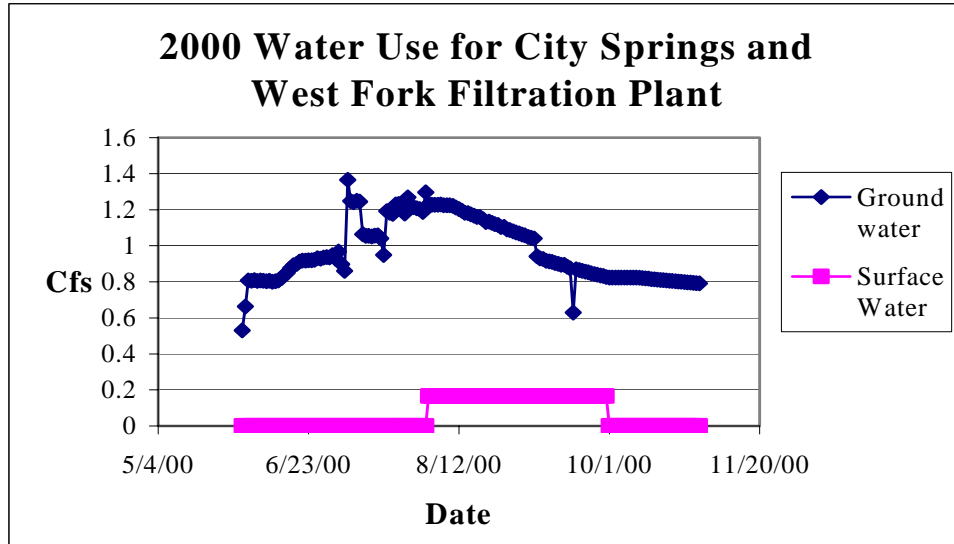
Daily city water use values from 1995-2000 were obtained from the Public Works Director for the City of Cannon Beach. Both demand and supply data were provided, but only supply data was used for the assessment because it was found to most closely measure the amount of water withdrawn from the springs and creek. While the water rights for the springs and the creek are instantaneous rights, due to the design of the water system it is not possible to measure the amount of water being withdrawn at any given moment. Instead, daily supply readings were used to get an idea of how much water is being withdrawn and how much of the water rights the City is using.

The greatest amount of water withdrawn from the basin is from the West Fork Ecola Creek for municipal use. The municipal rights total 3.1cfs with two of the rights for springs that feed the West Fork and the third on the West Fork itself. The City of Cannon Beach uses the West Fork subwatershed as its primary source of water. Further inquiry should be made concerning the amount of water the city is consuming. It appears the city comes close to using their 1.6 cfs total water right on the springs, but they only use a very small portion of their conditional use permit right of 1.5 cfs on the West Fork.

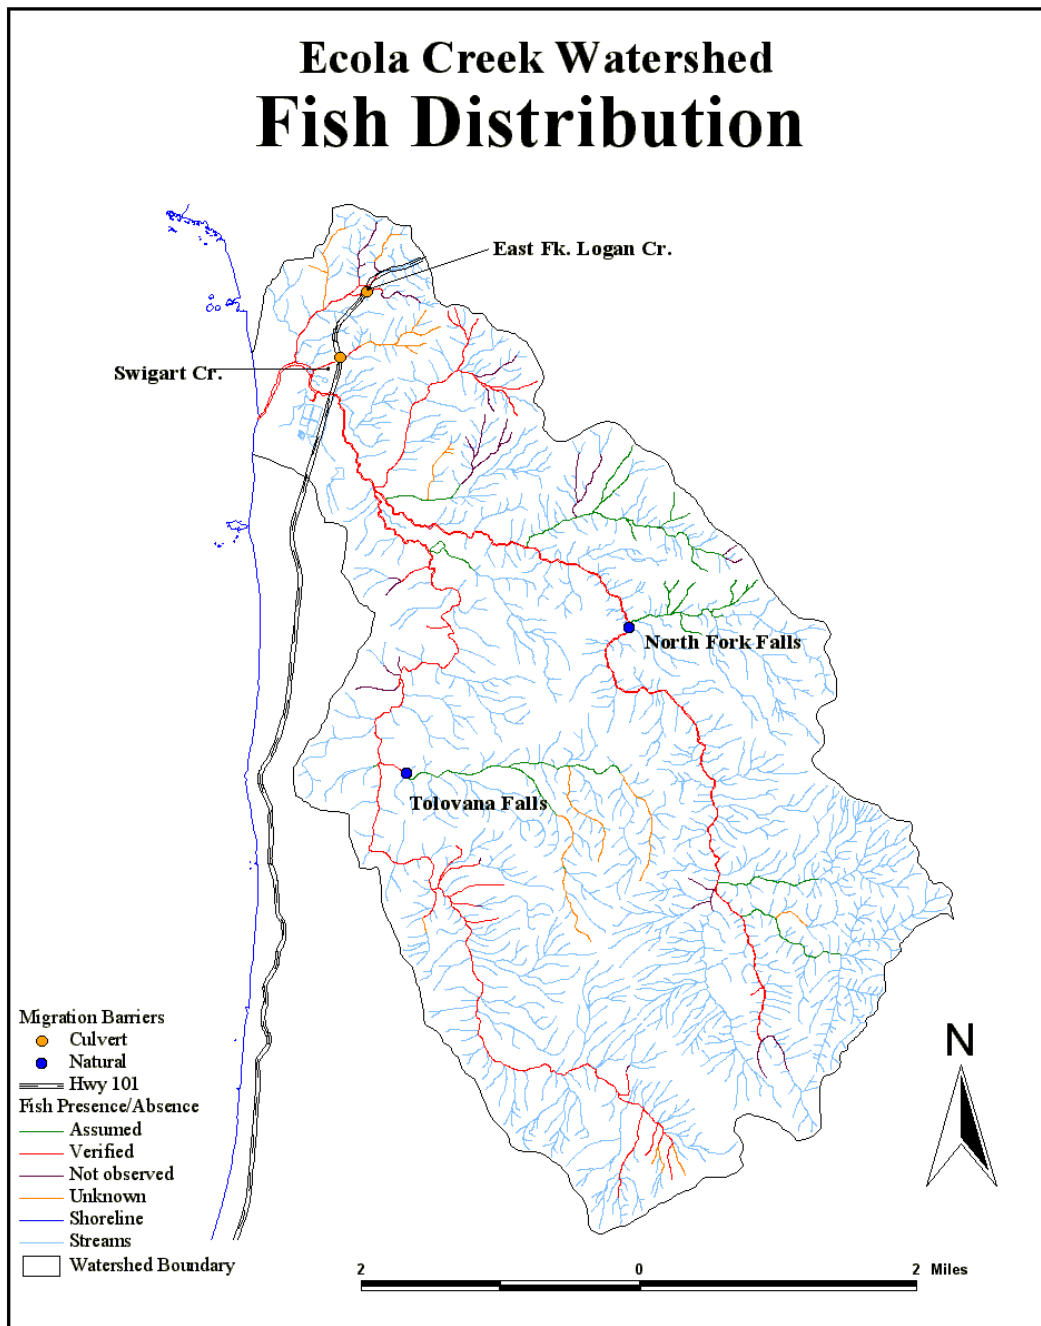
Figure 5.1 Fish distribution in the Ecola Creek watershed based upon ODF Fish Presence/Absence surveys. The map identifies areas within streams where fish were found, where they were absent, where they were assumed to be and where it is unknown. In addition, ODFW verified fish migration barriers are illustrated.

Fish distribution is presented in Figure 5.1 and is derived from the Oregon Department of Forestry (ODF) Fish Presence/Absence survey maps. The fish distribution map illustrates streams surveyed for fish and the portions of the stream where fish were observed or not

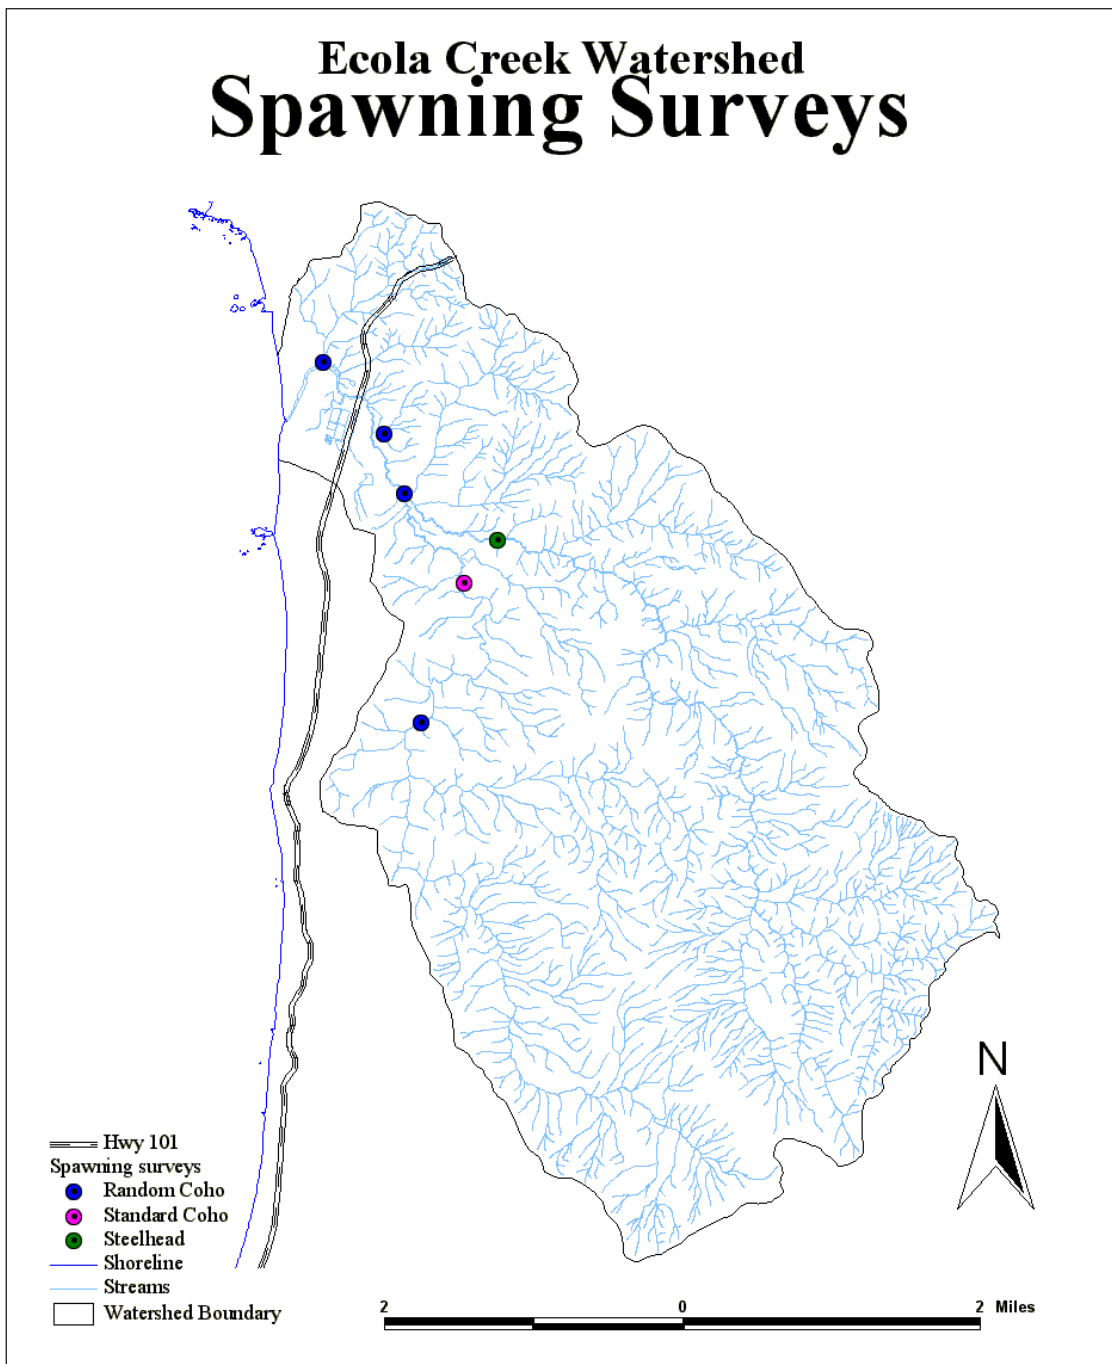
Figure 5.2 The location of ODFW random and standard coho spawning surveys and the steelhead spawning survey in the Ecola Creek watershed.

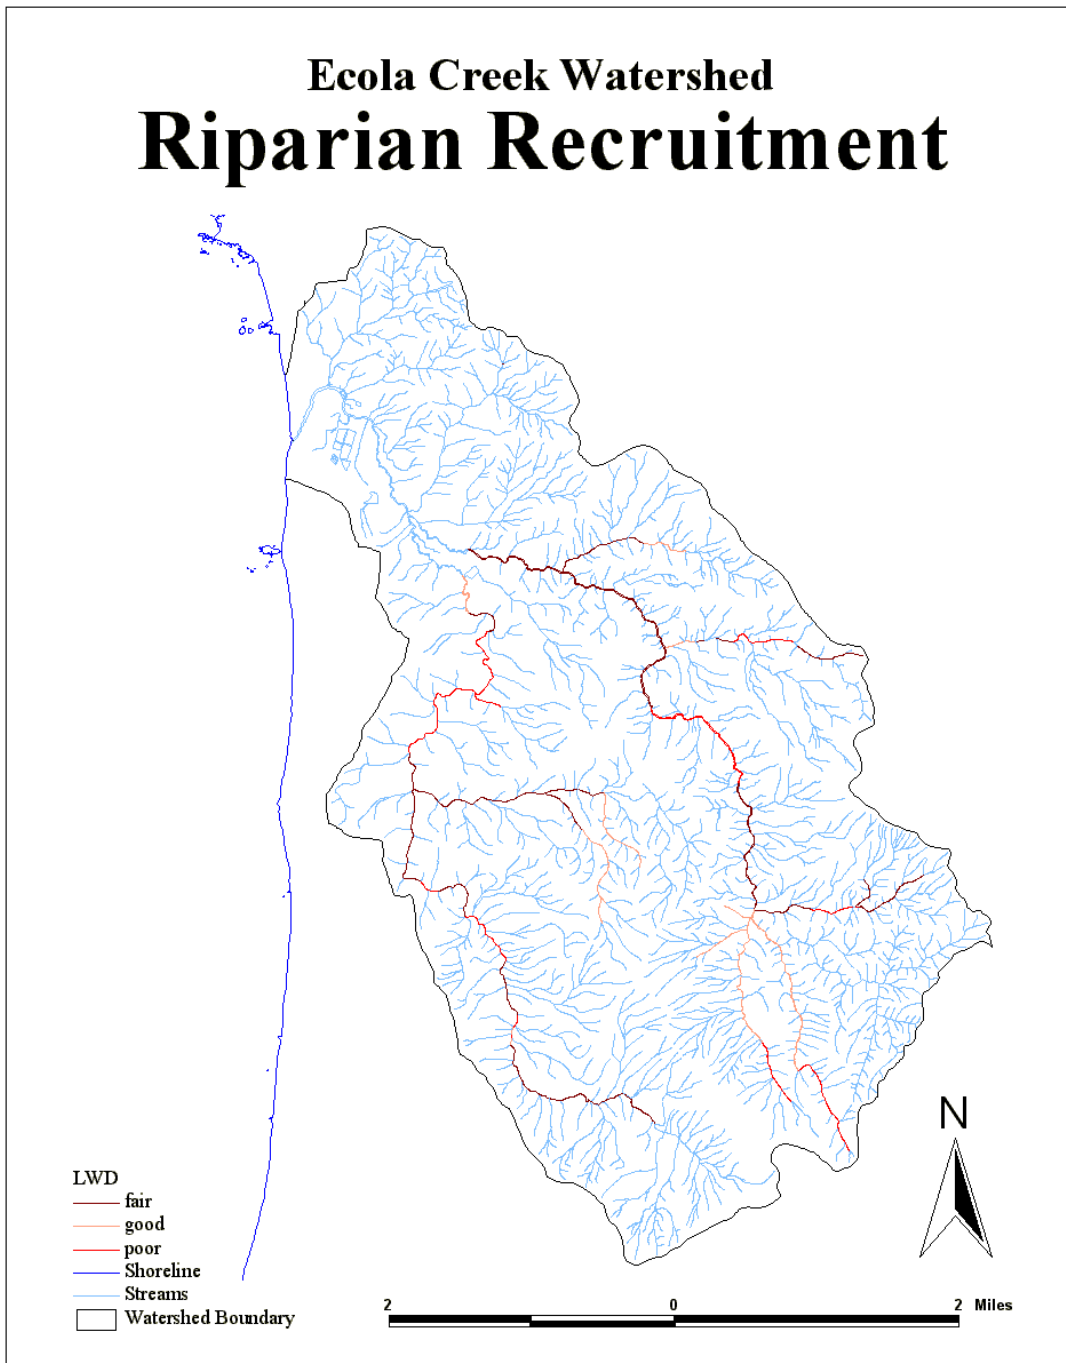
Figure 6.2 Riparian recruitment of large woody debris (LWD) based upon data obtained from Willamette Industries.

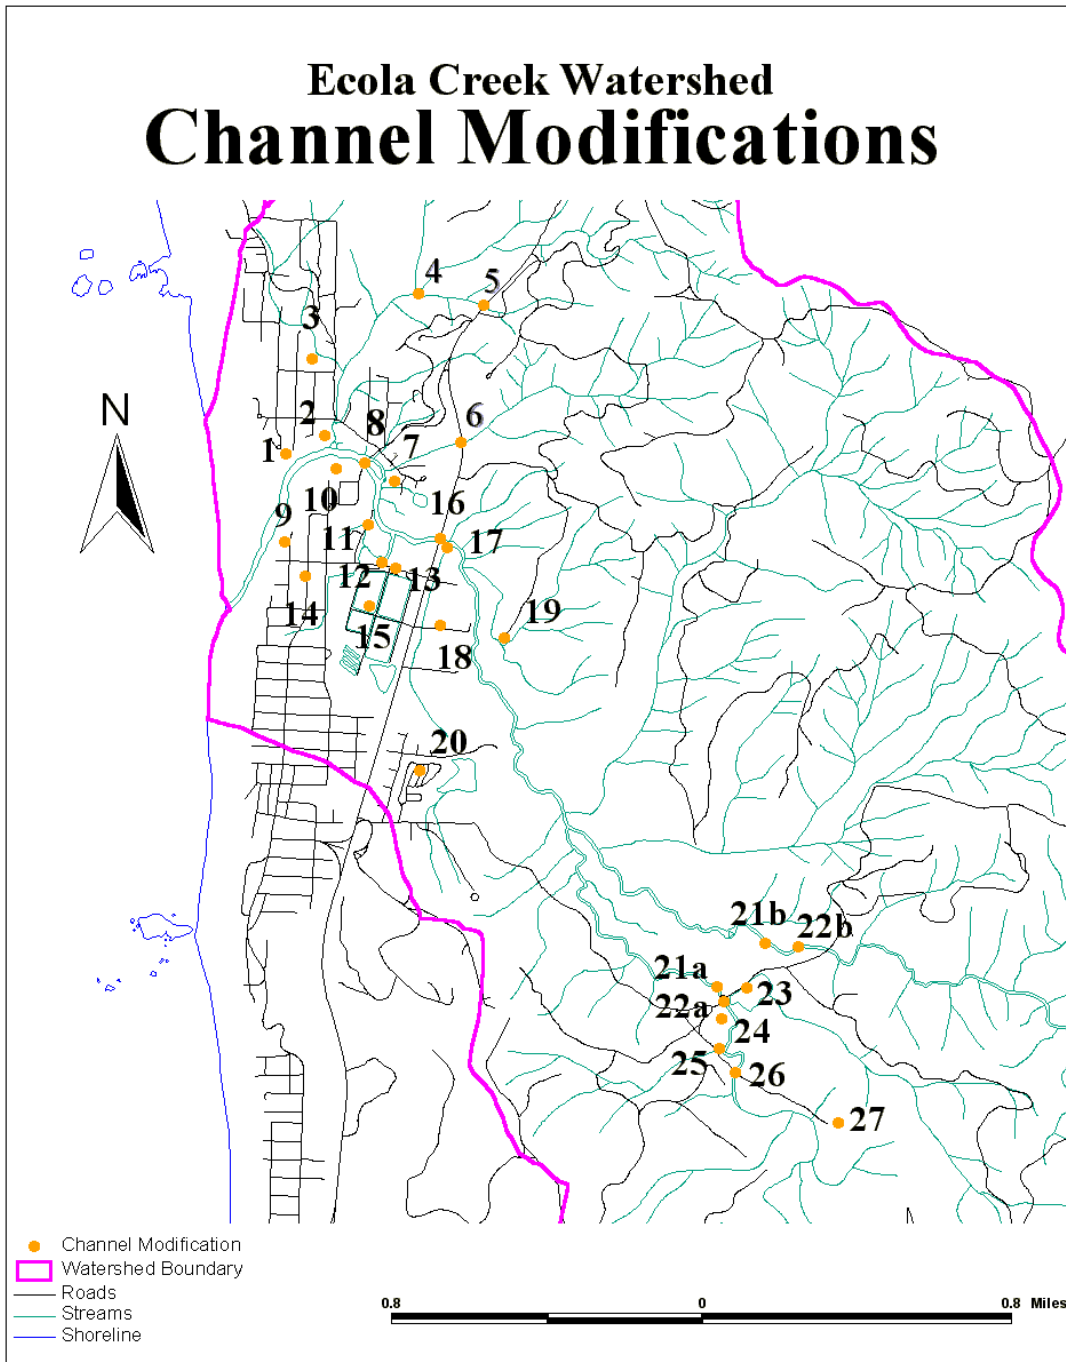
Figure 6.3 Channel modifications in the Ecola Creek watershed. Table 6.7 describes each location, the type of impact and the degree of potential impact. Not shown are the Tolovana Mainline road crossings on the West Fork and North Fork of Ecola Creek.

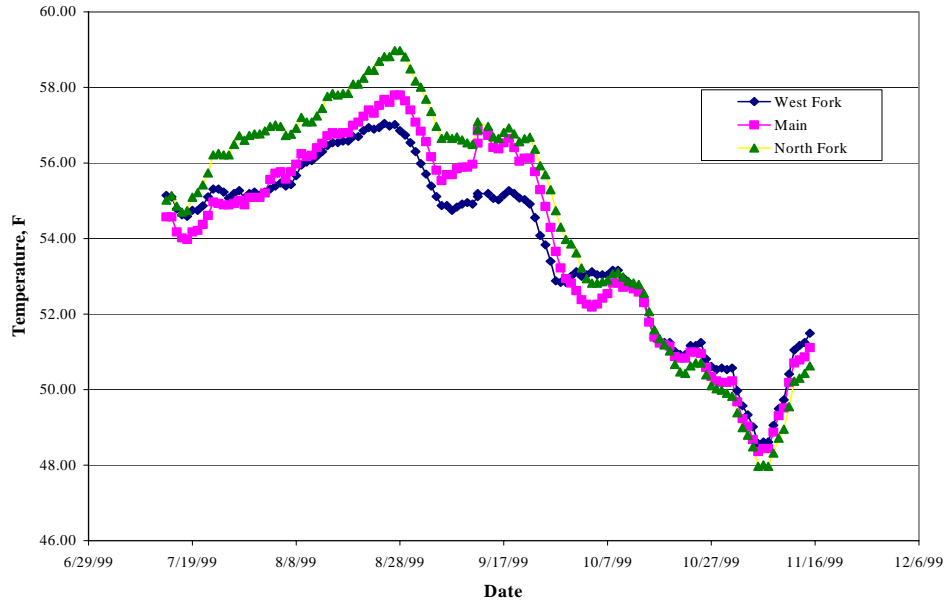
Figure 8.1 Ecola Creek - 7-Day Moving Average Maximum Temperature - 1999

day moving average of daily maximum temperature does not exceeded the 64°F limit for the two years.

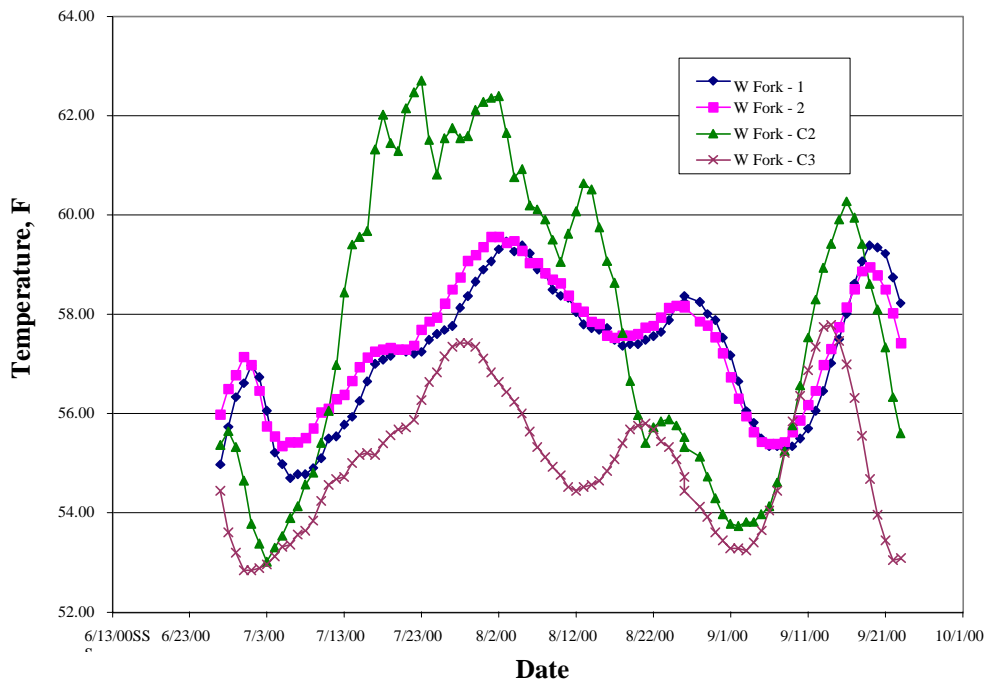
Figure 8.2 7-Day Moving Average Maximum Temperature West Fork Ecola Cr --2000

- West Fork 1 is located 3.4 miles up-stream from Highway 101 bridge)
- West Fork 2 is located 1.8 miles up-stream from Highway 101 bridge)
- West Fork C2 is located 5.2 miles up-stream from Highway 101 bridge)
- West Fork C3 is located 5.4miles up-stream from Highway 101 bridge)

Temperature data from the West Fork monitors C2 and C3 do not appear to be consistent. These are new monitors located near the Willamette Industries Rock Crusher Road. Further checking of these monitors will be done in the future.
