Ecola Creek Watershed Assessment: A Living Document

May, 2001

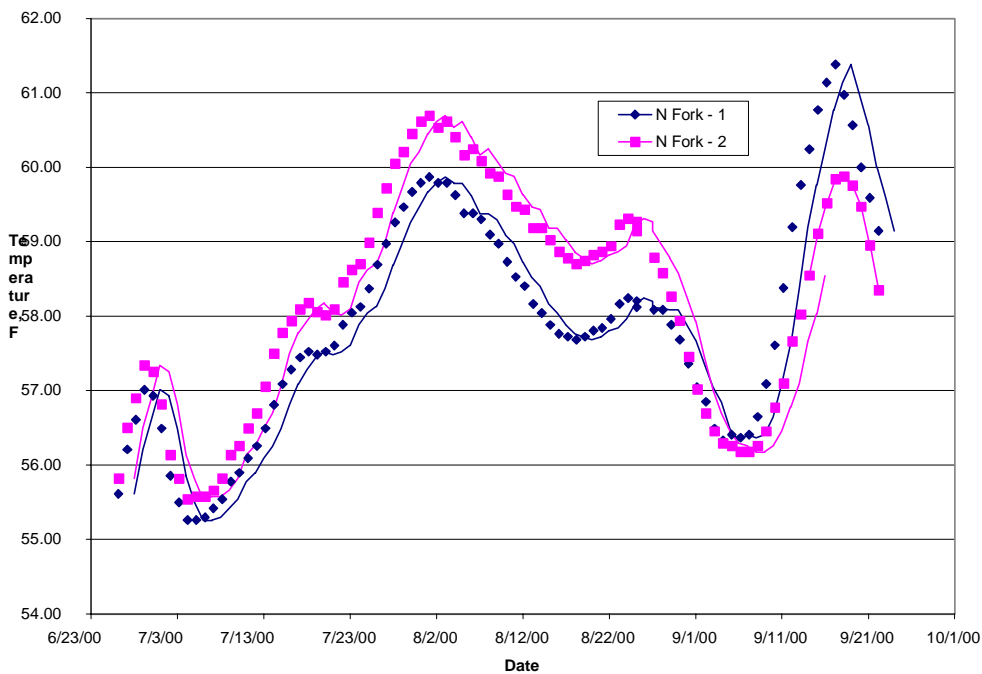
**Figure 8.3 Ecola Creek - North
7-Day Moving Average Maximum Temperature - 2000**

- North Fort 1 is located 1.8 miles up-stream from Highway 101 bridge)
- North Fork 2 is located 1.6 miles up-stream from Highway 101 bridge)

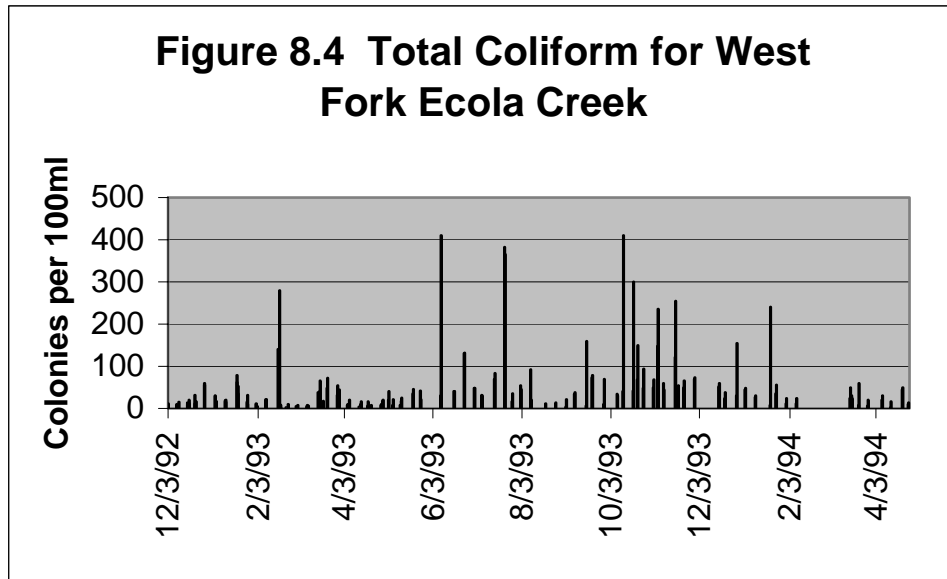
TNTC (Too Numerous To Count) is plotted as 410 on Figure 8.4 for illustration only. Maximum Total Coliform colony actual count was 366 on 7/22/93, plus there are two listed TNTC, on 6/8/93 and 10/11/93, presumably having counts higher than 366. Assuming TNTC > 366, it might be concluded that from 10/11/93 to 11/04/93, the 126/100 ml (30 day log mean: 5 samples), criteria, may have been exceeded. But, as will be seen in the conclusion for fecal coliform testing, the West Fork coliform tests were in compliance for E. Coli bacteria.

OWAM criteria for bacteria are as shown in Table 8.14 and test results are shown in Figures 8.4 and 8.5. The tests done were for fecal coliform and total coliform.

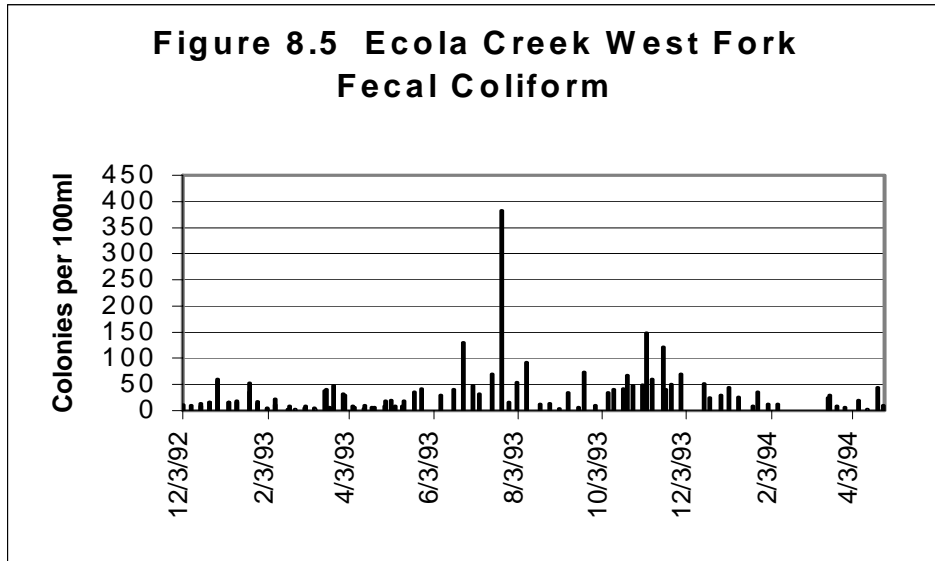
The maximum fecal coliform colony count was 382/ml on 7/22/93. No fecal coliform samples exceeded the screening criteria for E. Coli. Because E. Coli would show up as part of the fecal coliform colony count, it is concluded that the West Fork of Ecola Creek was in compliance each time it was tested.
