Chum Salmon Spawning Habitat Report
for the Clatskanie River and Scappoose Creek Populations

Oregon Department of Fish and Wildlife

November 2017

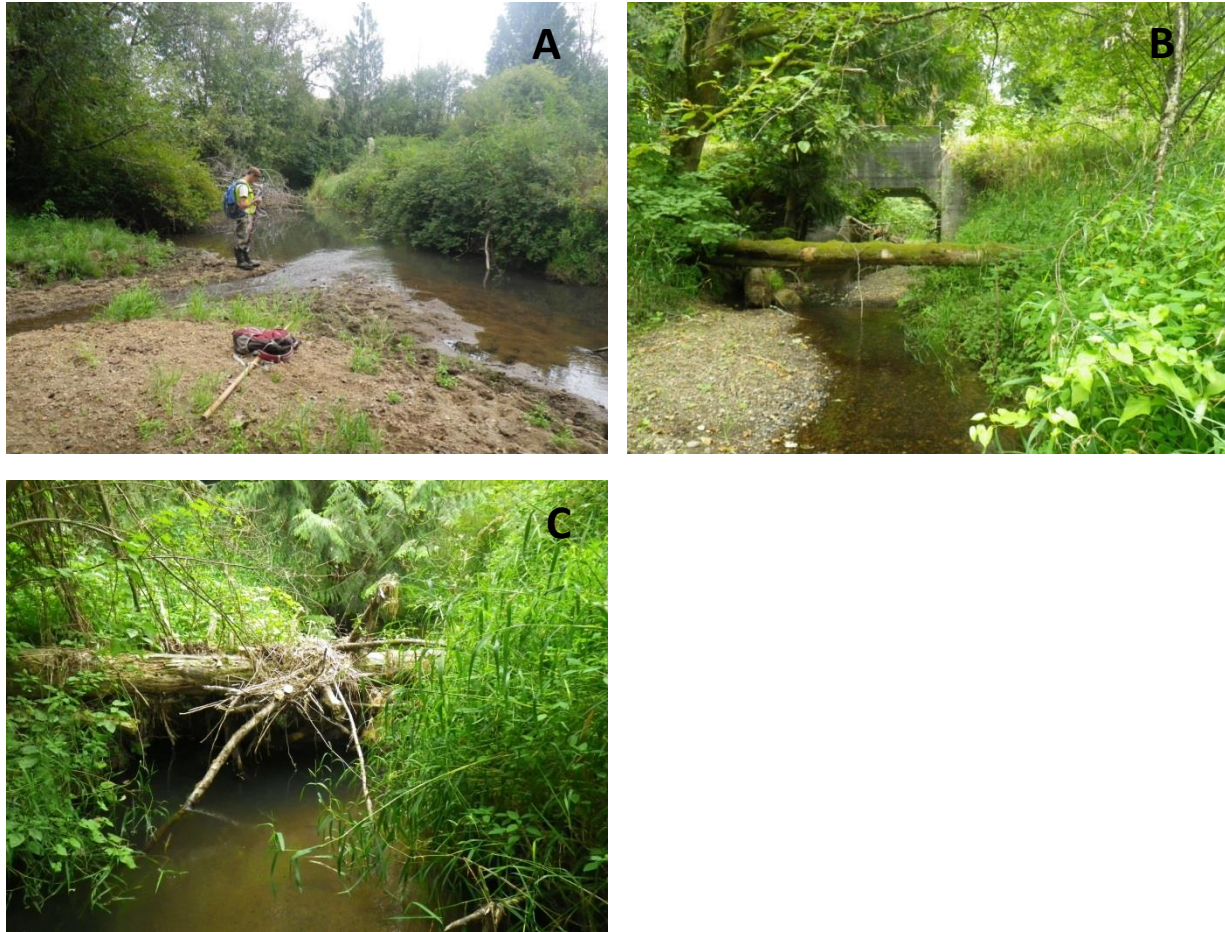
Figure 4. Survey pictures of Cox Creek reach 1.1 showing evidence of grazing at the confluence of Cox and Milton Creeks (panel A), the Kappler Road bridge at the upstream end of the reach (panel B), and a channel-spanning log jam barrier (panel C).

There were no gravel patches that met the established criteria. One cold-water patch was identified near the upstream end of the reach (0.9 m²); temperature in the patch was 13.1° C and temperature adjacent to the patch was 14.4° C. The dominant substrate type within this cold-water patch was fine sediment (< 4 mm diameter). There was one potential barrier to Chum Salmon *Oncorhynchus keta* migration, classified as a channel-spanning log jam (Figure 3; Table 1; Figure 4, panel C).

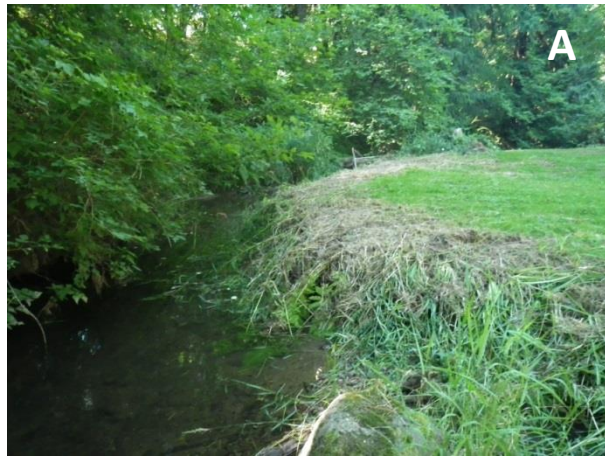
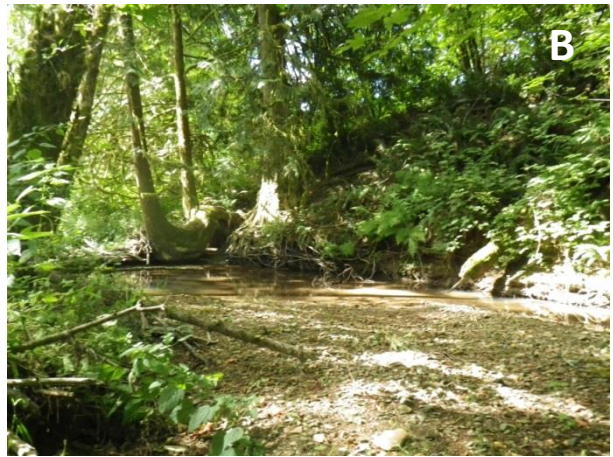
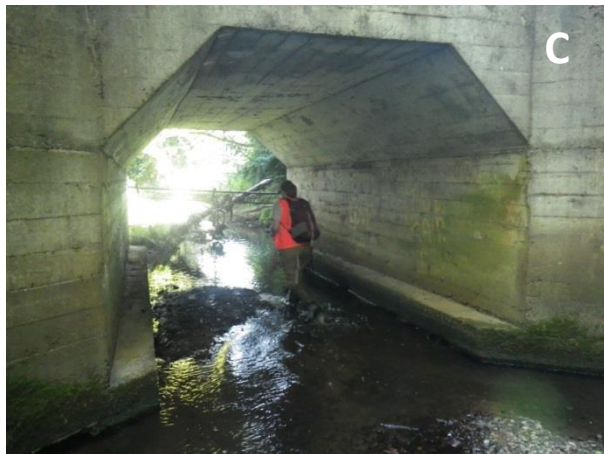
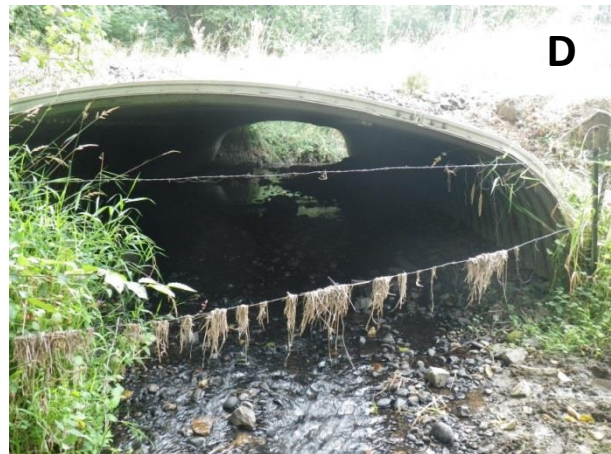
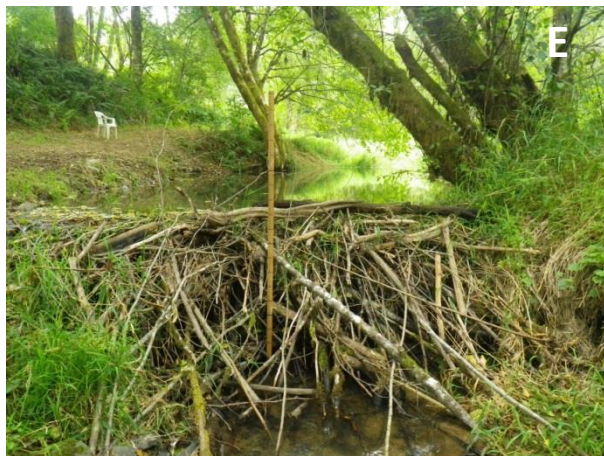
Figure 6. Survey pictures of Cox Creek reach 1.2 showing a mowed lawn in the riparian zone (panel A), a section of the riparian zone with cedar trees (panel B), the downstream end of the Kappler road bridge (panel C), a culvert bridge at Brooks Road near the upper end of the reach (panel D), and a beaver dam (panel E).

“low” quality because of excess fine sediment (11–20% of patch area), but substrate consisted of large gravel and small cobble (Table 2). One cold-water patch was identified, measuring 0.5 m² (Figure 6); temperature in this patch was 13.9° C and temperature adjacent to the patch was 14.9° C. The dominant substrate within this cold-water patch was fine sediment (<4 mm diameter). There were three potential barriers to Chum Salmon migration in this reach (Figure 5). The first was a box culvert under Kappler Road, located at the downstream end of the reach (Figure 6, panel C; Table 3). The second was a semicircular culvert under Brooks Road (Figure 6, panel D; Table 3) and the third was a beaver dam located near the upstream end of the reach (Figure 6, panel E; Table 3).

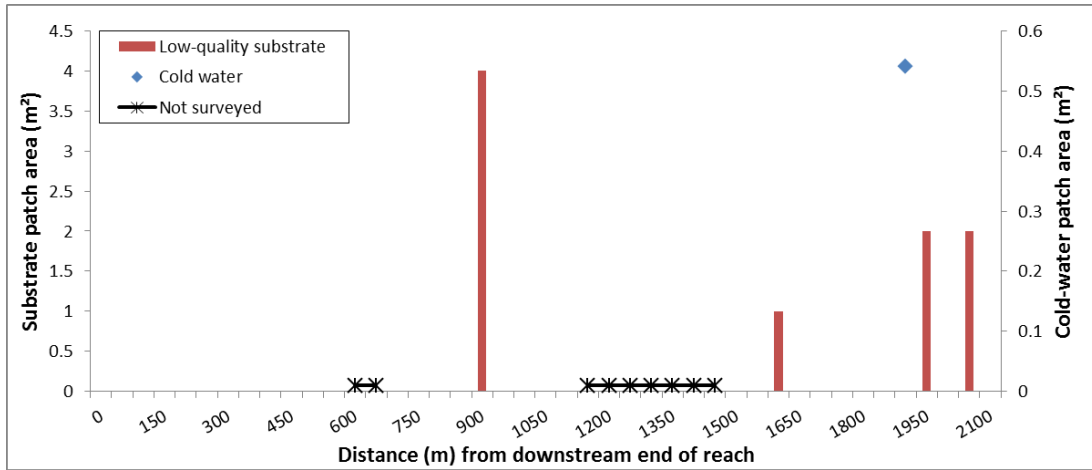
Figure 7. Location of substrate and cold-water patches measured as distance from downstream end of survey in reach 1.2 of Cox Creek, OR, in August 2012. For cold water and substrate quality, patch area was summed into 50 m units. Cold-water patches were at least 1.0° C colder than the temperature in the main channel.

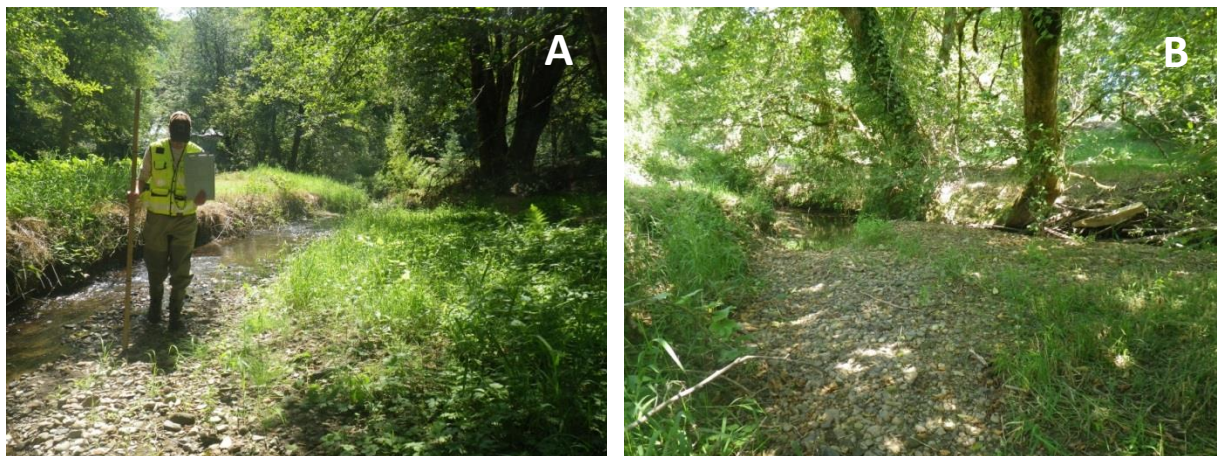
Figure 9. Survey pictures of reach 1.0 on Cox Creek showing a riparian zone dominated by grass near the downstream end of the reach (panel A), and a large gravel bar (panel B).

Forty-three patches of suitable spawning substrate that met established criteria were found in Cox Creek reach 1.0 (Table 4; Figure 10), measuring a total of 249 m². None were categorized as “high” quality, seven patches were of “moderate” quality, and 33 patches were of “low” quality (Table 4; Figure 10). All but two patches consisted of large gravel and small cobble (Table 4; Figure 9, panel B). One cold-water patch was identified (18.0 m²; Figure 10);

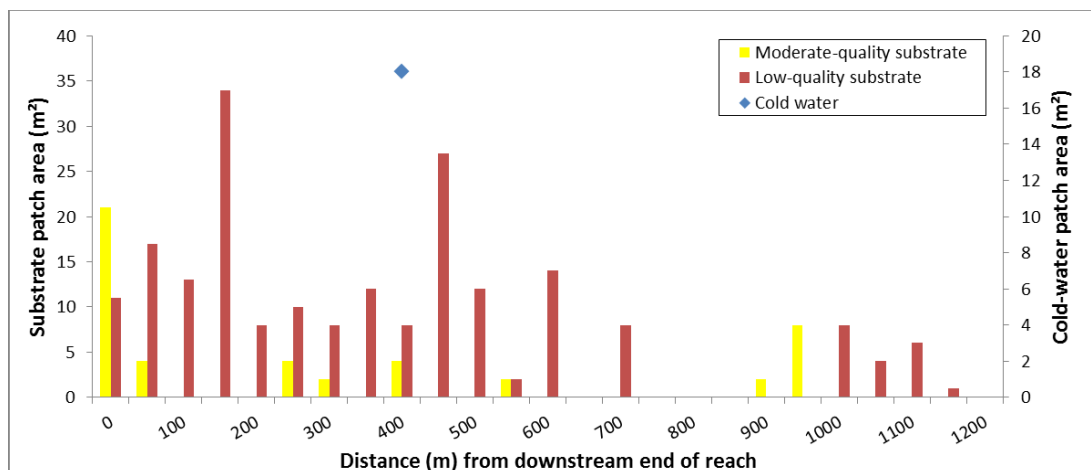
Figure 10. Location of substrate and cold-water patches measured as distance from downstream end of survey in reach 1 of Cox Creek, near St. Helens, OR, in August 2012. For cold water and for each category of substrate quality, patch area was summed into 50 m units. Cold-water patches were at least 1.0° C colder than the temperature in the main channel.

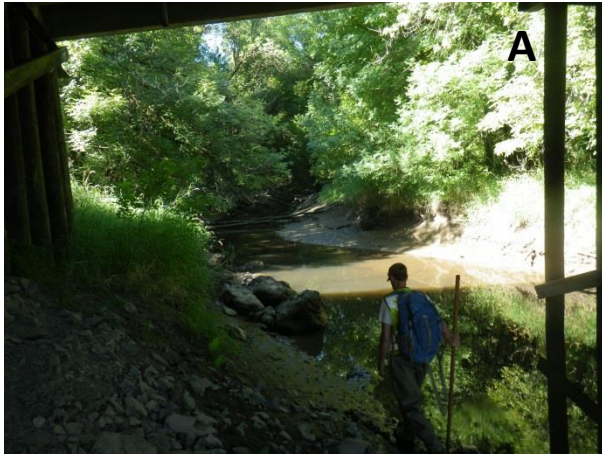
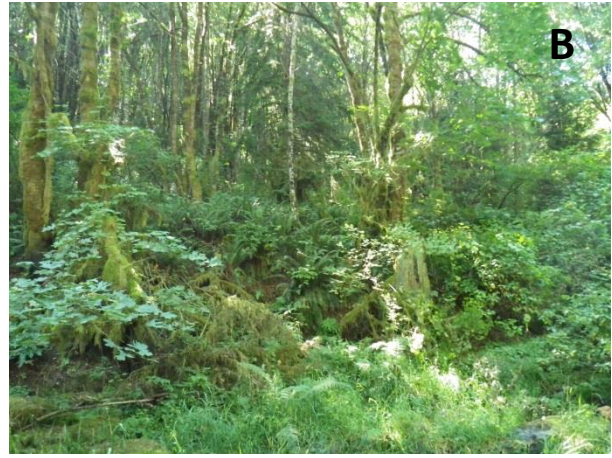
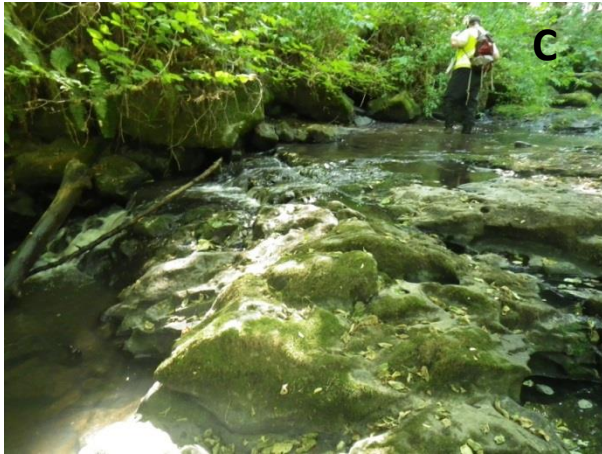
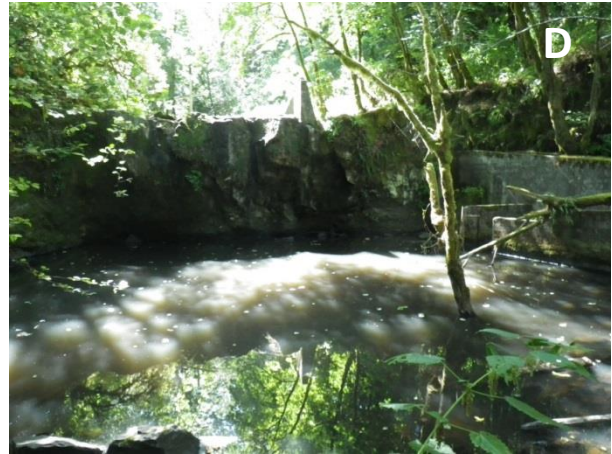
Figure 12. Survey pictures of Goble Creek showing a tidal area under Highway 30 (panel A), dense riparian vegetation (panel B), a gradient barrier (panel C), and a waterfall with a fish ladder, located at the upstream end of the reach (panel D).

Small substrate was present at the downstream end of the reach, however because fine sediment levels were > 20%, little suitable spawning habitat was identified. Substrate size increased in the upstream direction, and several areas of bedrock were present throughout the reach. Two patches of suitable spawning substrate that met established criteria were found in Goble Creek (Figure 13), measuring a total of 2 m². Both patches were designated as “low” quality because of elevated levels of fine sediment (11–20% of patch area); one patch was entirely comprised of small cobble and the other was comprised of 25% large gravel and 75% small cobble. There were three cold-water patches observed, measuring a total of 10.8 m² (Figure 12); average temperature in these patches was 13.3° C and average temperature adjacent to these patches was 14.7° C. The dominant substrate types within these cold-water patches were fine sediment (n = 1) and bedrock (n = 2). There were two potential barriers to Chum Salmon migration in this reach (Figure 11; Table 5): one was a high gradient bedrock cascade with a calculated slope of 29%, and the other was a waterfall with a fish ladder, both located at the upstream end of the survey (Table 5; Figure 11; Figure 13, panels C and D).

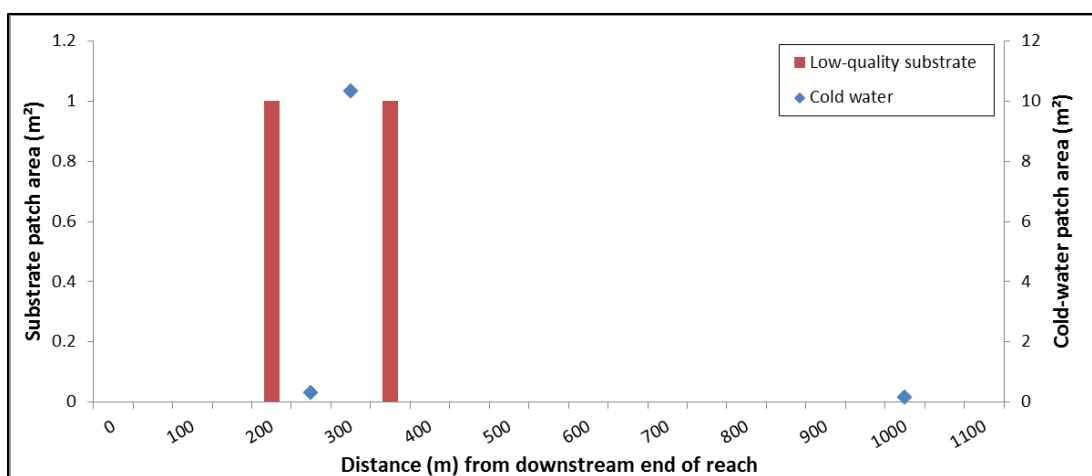
Figure 13. Location of substrate and cold-water patches measured as distance from downstream end of survey in Goble Creek, near Goble, OR, in September 2012. Cold water and substrate patch areas were summed into 50 m units. Cold-water patches were at least 1.0° C colder than the temperature in the main channel.

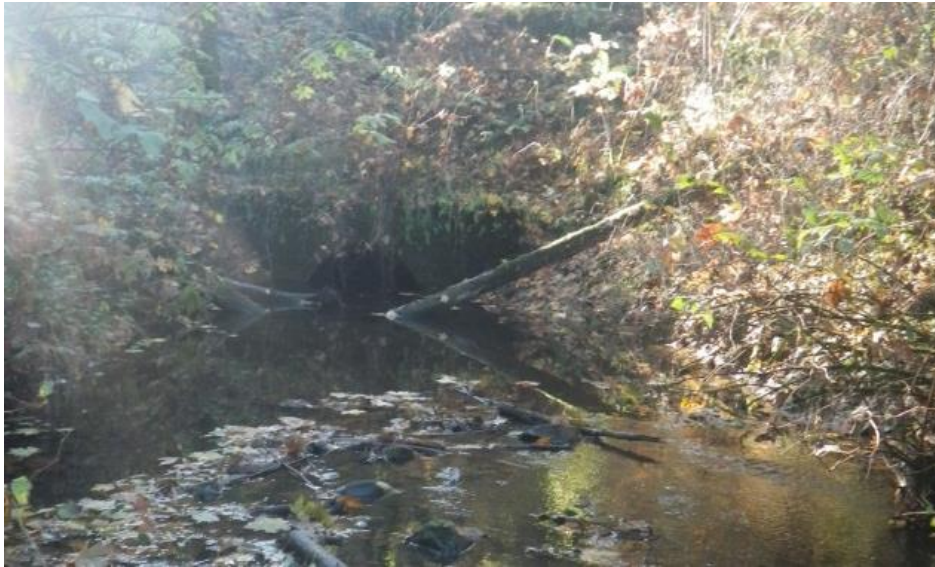
Figure 15. A semicircular culvert located under Highway 30 at the upstream end of reach 1 of McBride Creek, near Columbia City, OR, in December 2012.

Substrate sizes within the range suitable for Chum Salmon (4 mm–128 mm) were observed in this reach of McBride Creek; however, fine sediment exceeded 20%. There were no gravel patches or cold-water patches that met minimum established criteria. There was one potential barrier to Chum Salmon migration in this reach, a semicircular culvert located under Highway 30 (Figure 14; Table 6; Figure 15).

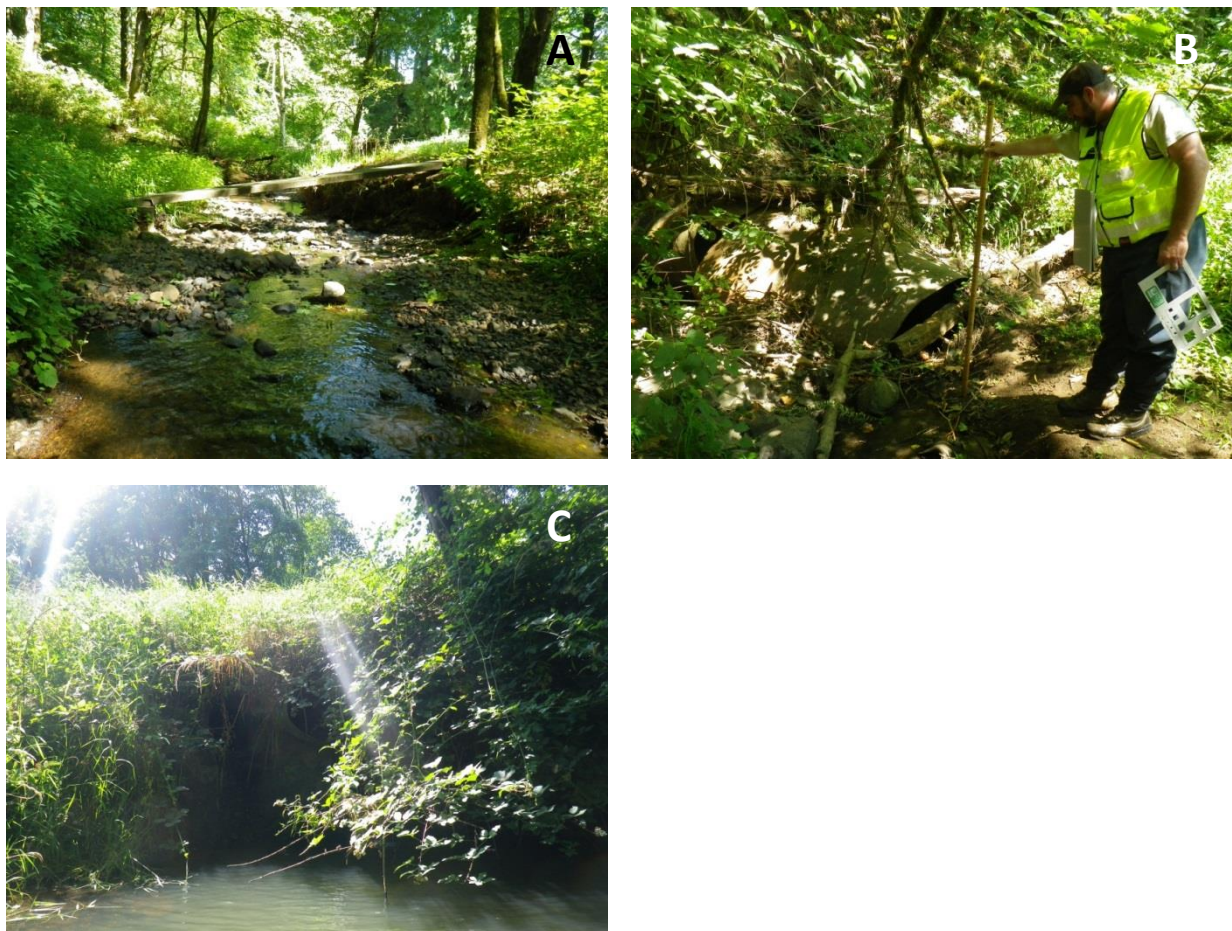
Figure 16. Survey pictures on reach 2 of McBride Creek showing a small footbridge (panel A), the lower culvert (panel B), and the downstream end of the double culvert at the top of the reach (panel C).

Substrate sizes within the range suitable for Chum Salmon (4–128 mm) were observed in reach 2 of McBride Creek; however, fine sediment levels were typically > 20%, and little substrate was suitable for spawning. Three patches of suitable spawning substrate met established criteria (Table 7; Figure 17), measuring a total of 6 m². All substrate patches were of “low” quality (Table 7) because of excess fine sediment (11–20% of patch area), but substrate consisted of large gravel and small cobble (Table 7). Four cold-water patches totaling 21.7 m² were observed (Figure 17). Average temperature in these patches was 17.4° C and average temperature adjacent to these patches was 19.3° C. The dominant substrate types within these cold-water patches were fine sediment (n = 3) and large gravel (n = 1). There were two potential barriers to Chum Salmon migration in this reach (Figure 14; Table 8). The first barrier was a partially crushed culvert and the second was a set of two perched culverts (Figure 16, panels B and C).

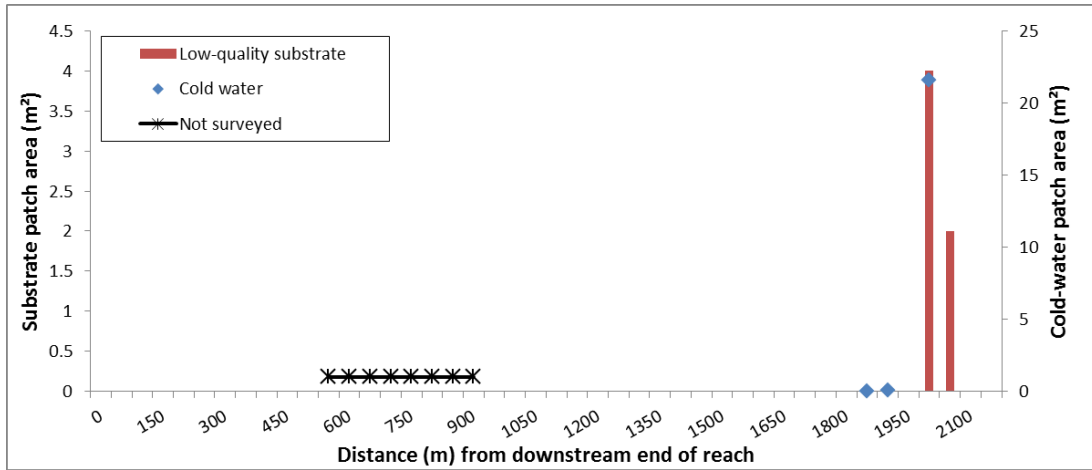
Figure 17. Location of substrate and cold-water patches measured as distance from downstream end of survey in reach 2 of McBride Creek, near Columbia City, OR, in August 2012. Cold water and substrate patch areas were summed into 50 m units. Cold-water patches were at least 1.0° C colder than the temperature in the main channel.

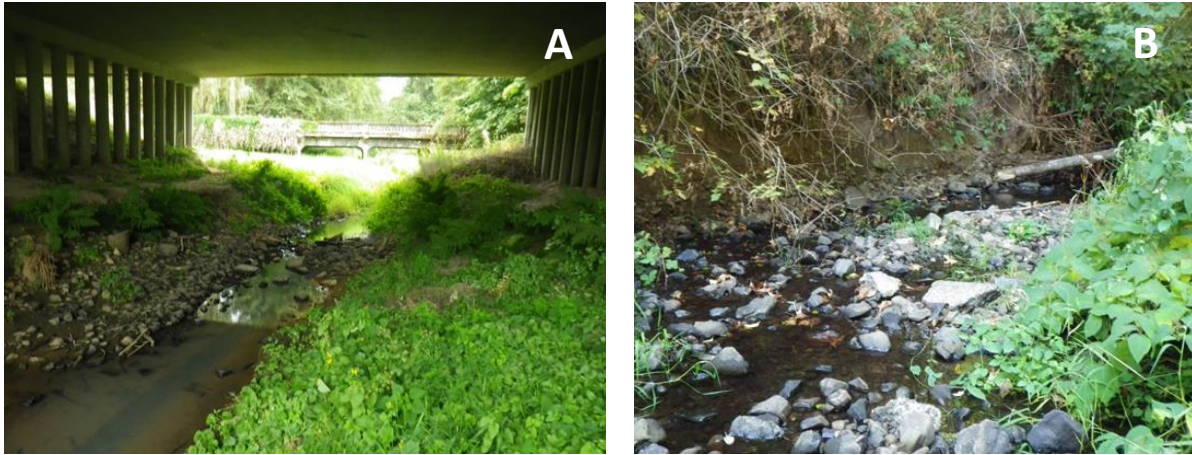
Reach 2 started at the Highway 30 bridge (Lat: 45.651157, Long: -122.851415; Figure 19, panel A) and continued upstream to a house with a fence adjacent to the creek (Lat: 45.639951, Long: -122.860161). The mainstem thalweg length of this reach was 506 m and there were no side channels. Through this reach, the creek flowed through a narrow canyon confined by Cornelius Pass Road and a railroad. Signs of beaver activity, including small dams, were observed in the lower half of the reach. The riparian zone was dominated by big leaf maple, with several small clusters of invasive knotweed also observed (Figure 19, panel B). Land use was rural residential.

Figure 19. Survey pictures on reach 2 of McCarthy Creek showing the Highway 30 bridge at the downstream end of the reach (panel A) and invasive knotweed growing along the bank in the upper section of the reach (panel B).

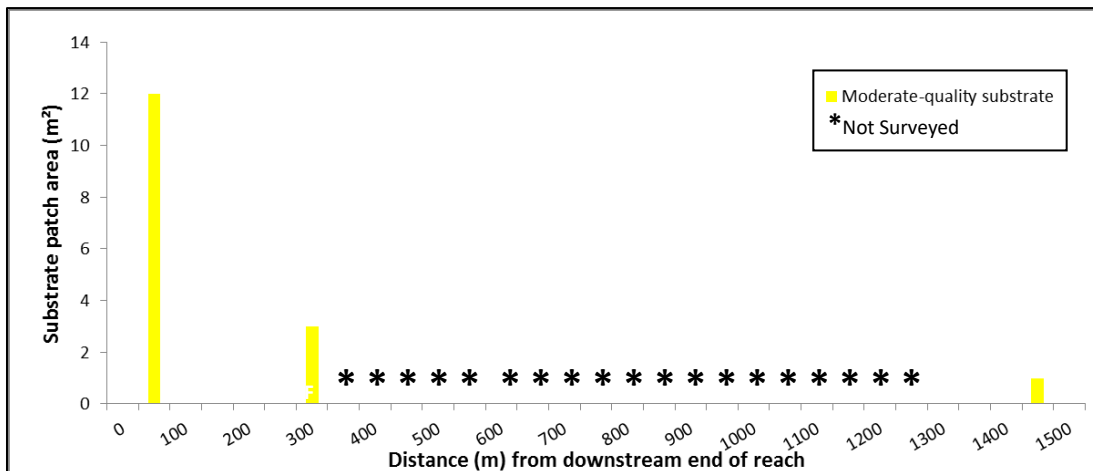
Three patches of suitable spawning substrate met established criteria in McCarthy Creek reach 2 (Figure 20; Table 9), measuring a total of 16 m² in surface area. All patches were categorized as “moderate” quality (Figure 20; Table 9), and contained both excess levels of fine sediment (11–20% of patch area) and elevated proportions of large gravel (> 50% of patch area). No cold-water patches were observed. There were also no potential barriers to Chum Salmon migration in this reach.

Figure 20. Location of substrate patches measured as distance from downstream end of survey in reach 2 of McCarthy Creek, near Linnton, OR, in September 2012. Substrate patch area was summed into 50 m units.

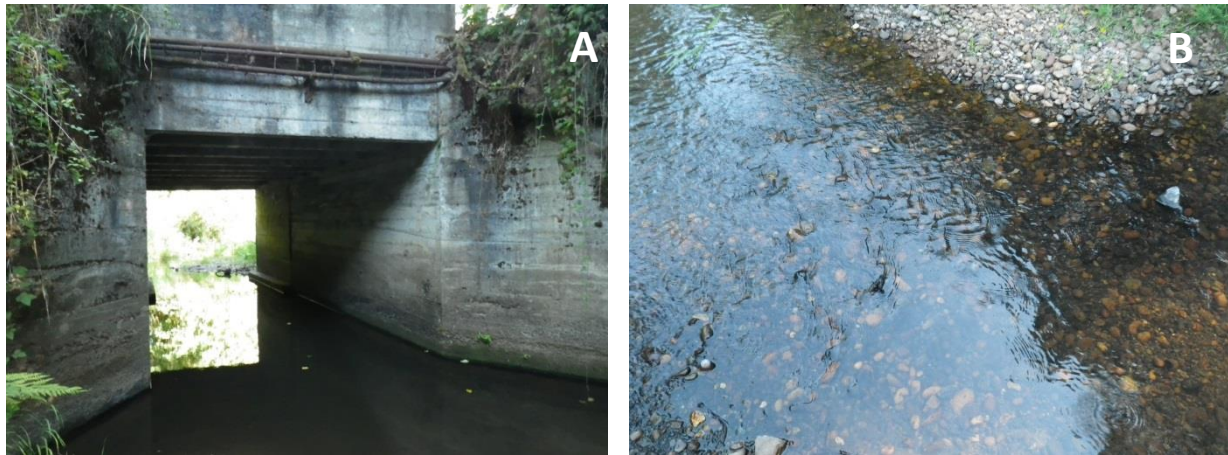
Figure 22. Survey pictures on reach 1 of Merrill Creek showing Canaan Road bridge at the downstream end of the reach (panel A) and gravel substrate interspersed with fine sediment (panel B).

Substrate suitable for Chum Salmon spawning was observed in this reach (Figure 22, panel B); however, there were elevated levels of fine sediment interspersed within this substrate (> 20% of patch area) and that limited the number of suitable substrate patches. Six patches of suitable spawning substrate that met established criteria were found in Merrill Creek reach 1 (Table 10; Figure 23), measuring a total of 8 m². One patch was designated as “high” quality, no patches were categorized as “moderate” quality, and five patches were of “low” quality (Table 10; Figure 23). One cold-water patch was observed, measuring 0.1 m² (Figure 23); temperature in this patch was 12.8° C and temperature adjacent to this patch was 14.0° C. The dominant substrate type within this cold-water patch was fine sediment (< 4 mm diameter). There was one potential barrier to Chum Salmon migration in this reach, classified as a box culvert located under Canaan Road (Figure 21; Table 11; Figure 22, panel A).

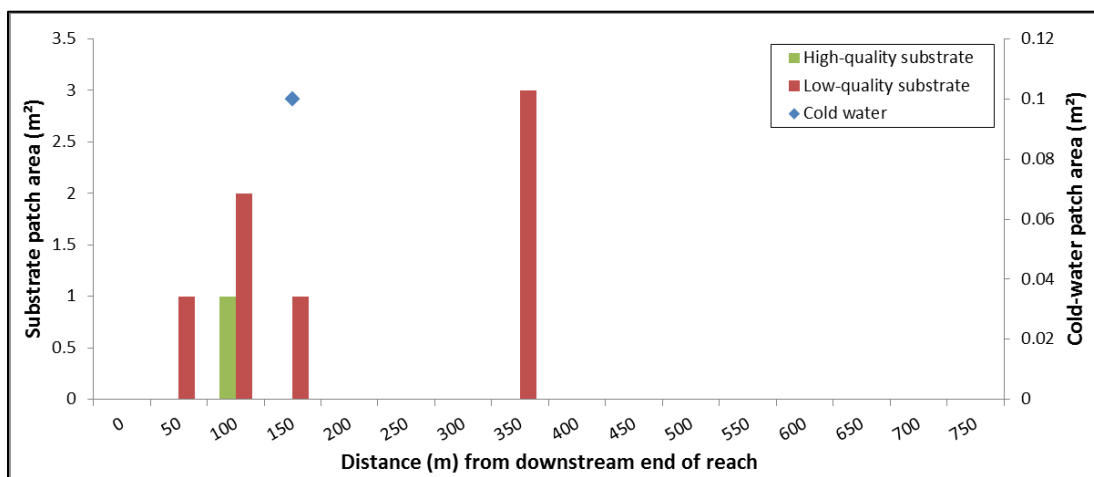
Figure 23. Location of substrate and cold-water patches measured as distance from downstream end of survey in reach 1 Merrill Creek, west of Dear Island, OR, in September 2012. For cold water and for each category of substrate quality, patch area was summed into 50 m units. Cold-water patches were at least 1.0° C colder than the temperature in the main channel.

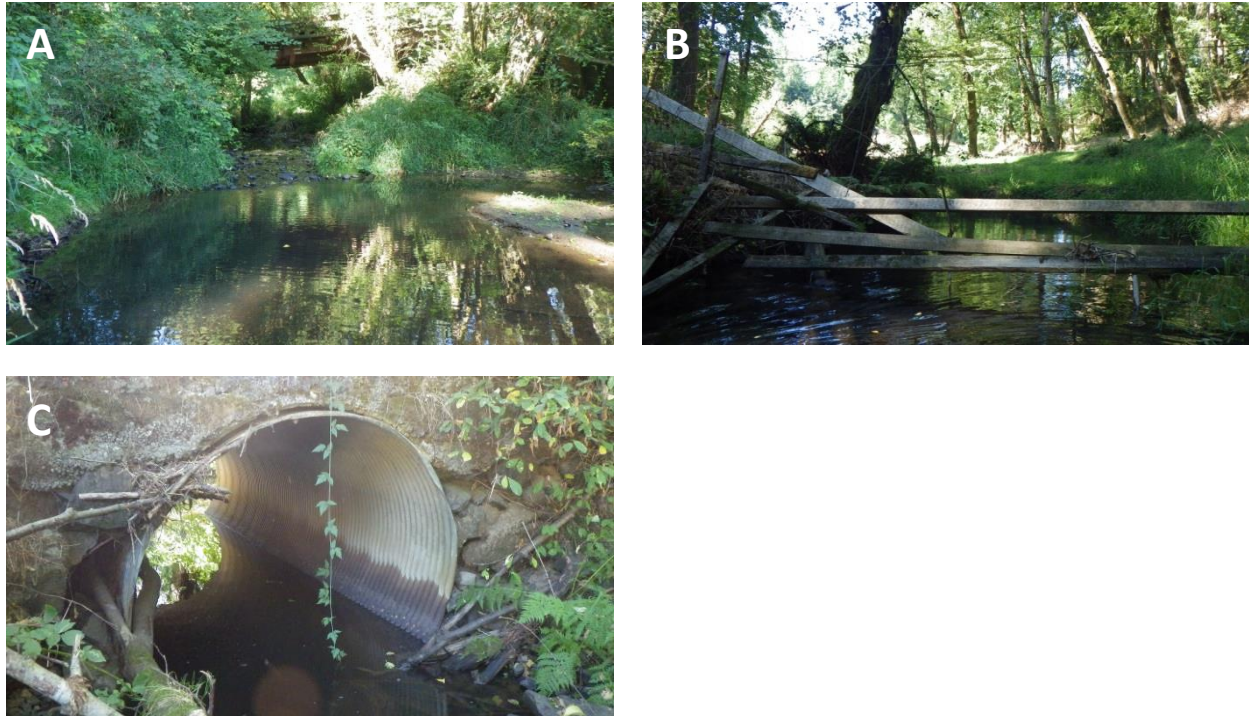
Reach 2 started at the Hills Haven Road bridge (Lat: 45.931451, Long: -122.879359; Figure 21; Figure 24, panel A) and continued upstream to a fence line along the creek (Lat: 45.93119, Long: -122.879359; Figure 24, panel B). The mainstem thalweg length of this reach was 485 m, and there were no side channels. Channel form was confined with meanders observed throughout. Signs of livestock activity (e.g., hoof prints and feces) were observed along the creek, indicating an overall land use of light grazing mixed with rural residential. The riparian zone primarily consisted of alders, maples, cedars and firs.

Figure 24. Survey pictures on reach 2 of Merrill Creek showing a private bridge (panel A), a broken cattle fence near the upstream end of the reach (panel B), and a circular culvert located under Hills Haven Road (panel C).

Substrate within the range suitable for Chum Salmon (4–128 mm) was observed in reach 2 of Merrill Creek; however, there was excess fine sediment (> 20%) and the substrate was unsuitable for spawning. There were also no cold-water patches that were $\geq 1^\circ$ C colder than the main channel water temperature found. There was one potential barrier to Chum Salmon migration in this reach, classified as a circular culvert located under Hills Haven Road (Figure 21; Table 12; Figure 24, panel C).

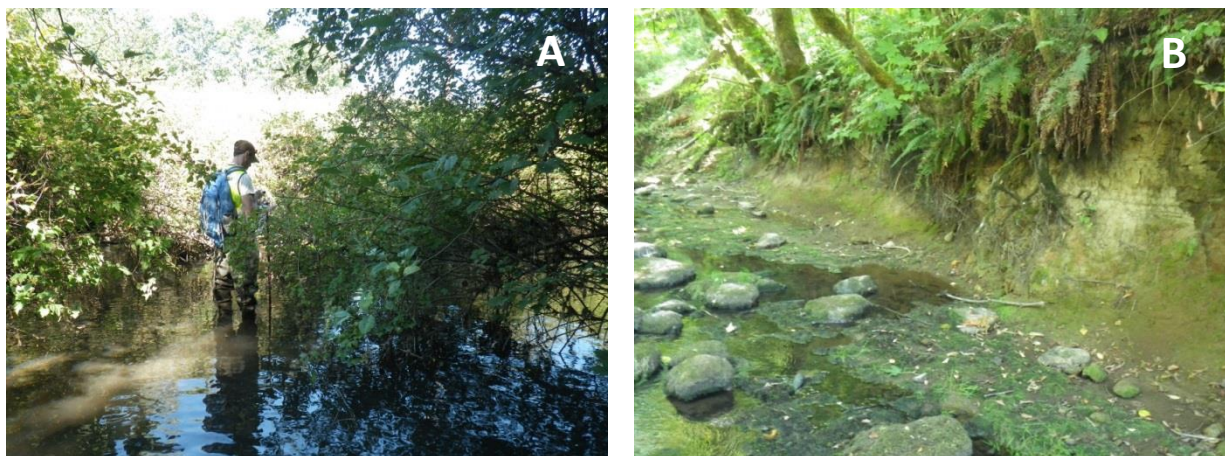
Figure 27. Survey pictures on reach 3.1 of Milton Creek showing dense brush (panel A) and a stream section with hardpan-clay (panel B).

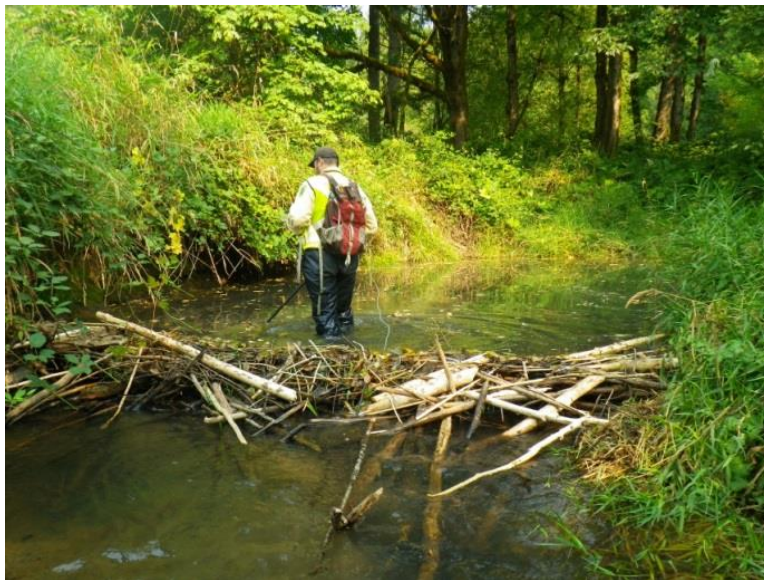
Figure 31. Survey picture of reach 3.5 on Milton Creek showing a beaver dam and pool.

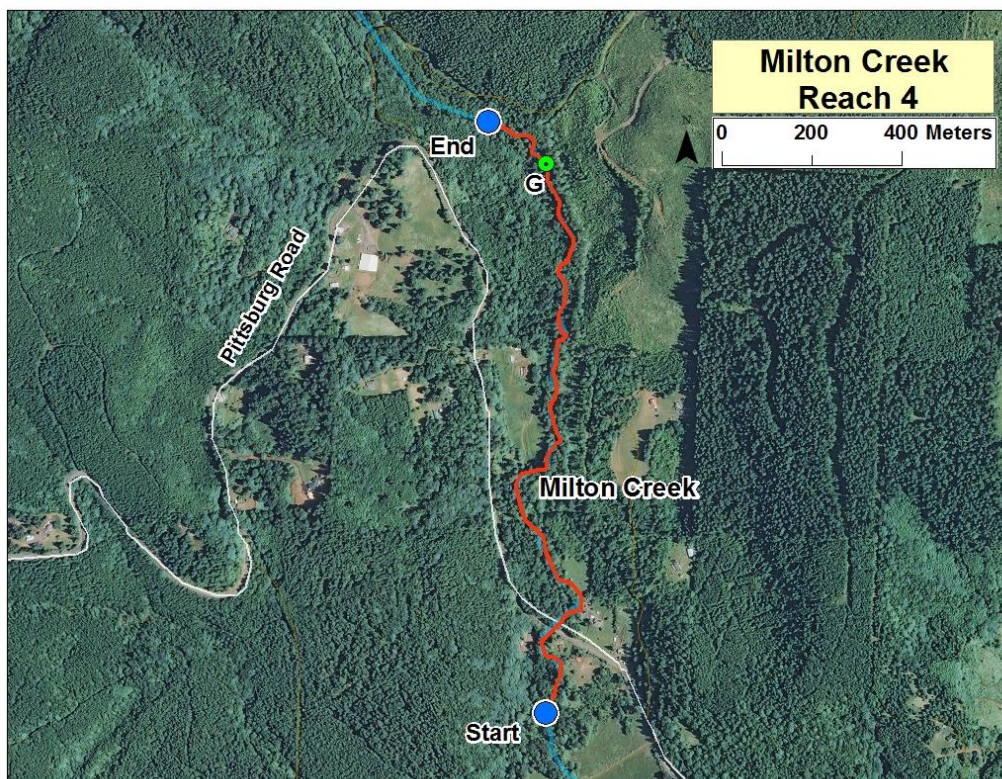
Figure 32. Map of reach 4 (red line) on Milton Creek, including start and end points (blue dots) and one location with increased gradient (not considered a barrier).

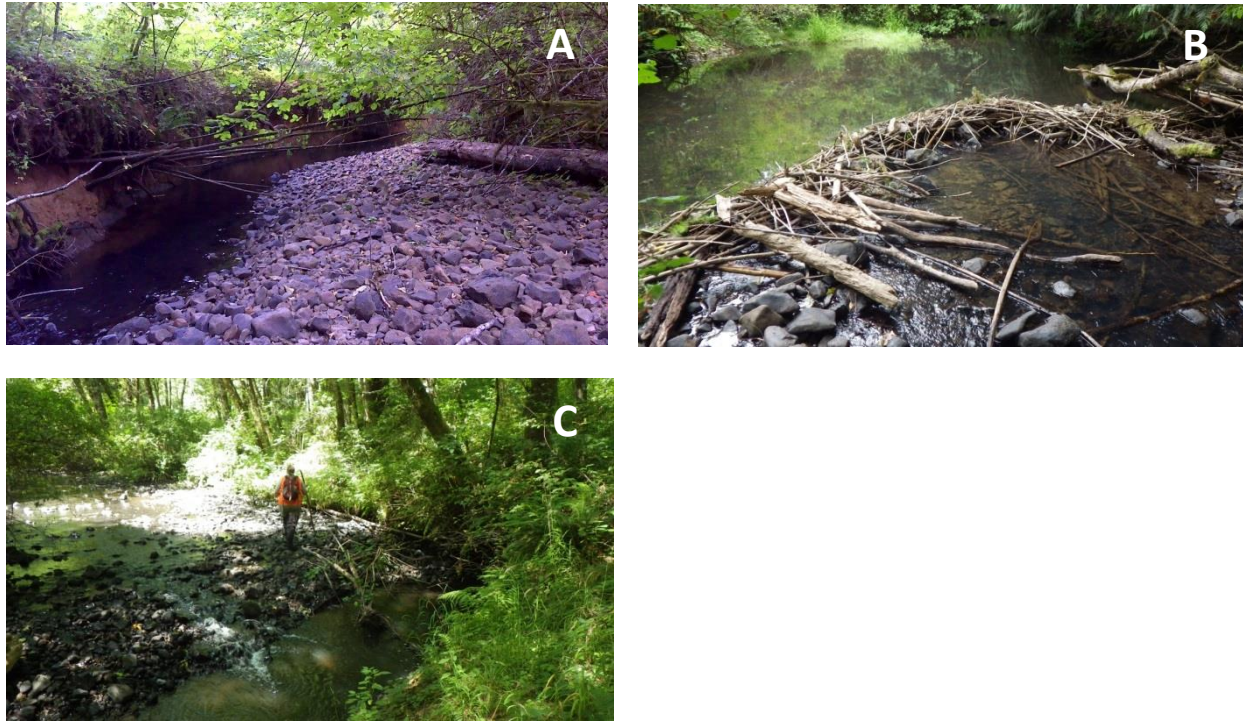
Reach 4 started at a log jam 250 m downstream from where Pittsburg Road crosses Milton Creek for the third time (Lat: 45.891675, Long: -122.92763) and continued upstream to a small tributary 300 m downstream from the Pinkney logging road bridge (Lat: 45.903515, Long: -122.929833; Figure 32). The mainstem thalweg length of this reach was 1,664 m. There were nine side channels with a combined thalweg length of 224 m. The channel was entrenched and several seeps and springs were observed. Channel form was confined, with multiple channels and meanders throughout. The riparian zone consisted of alders, cedars, and firs. Land use was a combination of young and mature timber. Beaver activity was observed throughout this reach, and there were several small beaver dams that were < 1 m in height (Figure 33, panel B).

Figure 33. Survey pictures on reach 4 of Milton Creek showing gravel typical of the size observed throughout the reach (panel A), a small beaver dam (panel B), and increased gradient over a gravel bar (panel C).

Substrate in reach 4 of Milton Creek was primarily large cobble and boulders (> 128 mm, diameter), but a small amount of suitable spawning habitat was observed as well (Figure 33, panel A). Ten patches of suitable spawning substrate met minimum established criteria (Table 13; Figure 34), measuring a total of 37 m² in surface area. All patches were designated “low” quality (Table 13; Figure 34). There were 15 cold-water patches in the reach, with a combined surface area of 122.0 m² (Figure 34); average temperature in these patches was 13.5° C and average temperature adjacent to these patches was 15.8° C. The dominant substrate types within these cold-water patches were fine sediment (n = 9) and small cobble (n = 6). There were also four patches with temperatures between 0.5° C and 0.9° C colder than that of the adjacent stream. There was one location with increased gradient where the stream flowed over a gravel bar, but it was not considered a barrier (Figure 32; Figure 33, panel C).

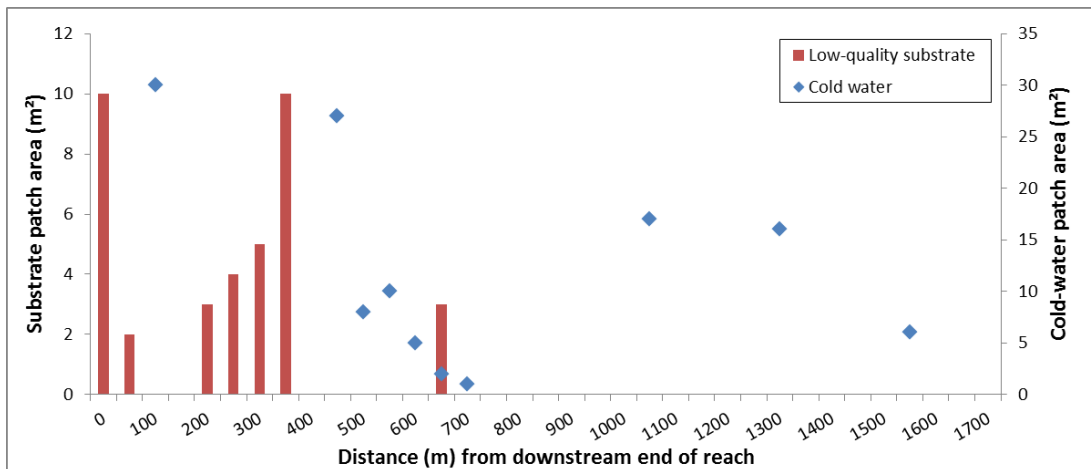
Figure 34. Location of substrate and cold-water patches measured as distance from downstream end of survey in reach 4 of Milton Creek, west of St. Helens, OR, in July 2013. Cold water and substrate patch areas were summed into 50 m units. Cold-water patches were at least 1.0° C colder than the temperature in the main channel.

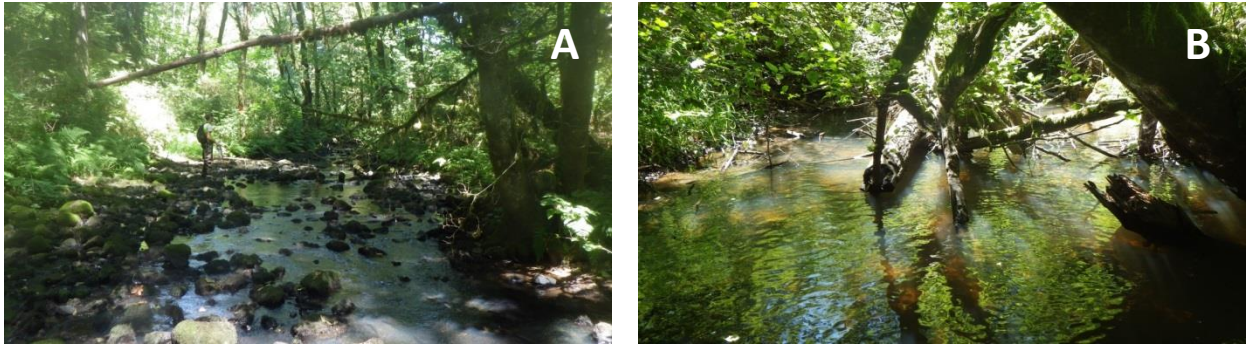
Figure 36. Survey pictures on reach 5.1 of Milton Creek showing a riffle section with large cobble and boulders (panel A) and a large pool (panel B).

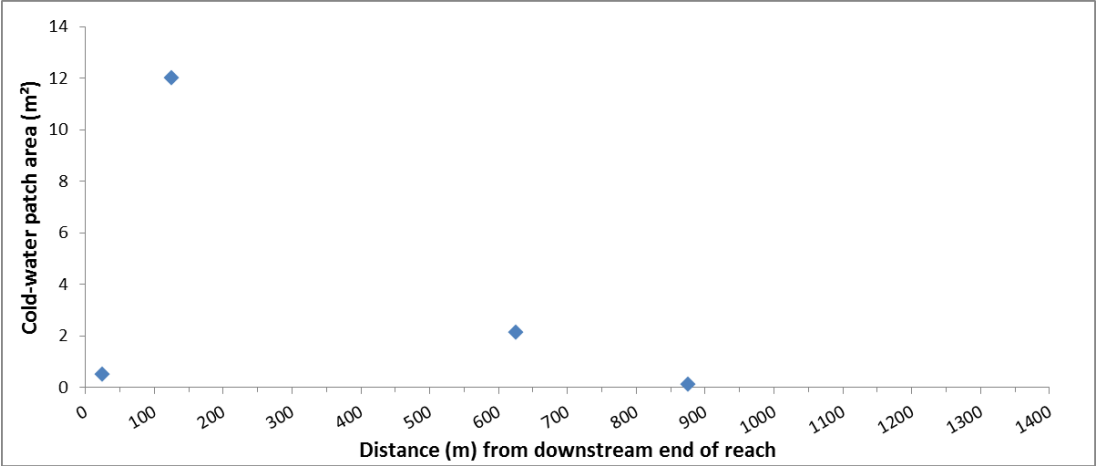
Figure 37. Location of cold-water patches measured as distance from downstream end of survey in reach 5.1 of Milton Creek, west of St. Helens, OR, in August 2013. Cold-water patches were at least 1.0° C colder than the temperature in the main channel and patches were summed into 50 m units

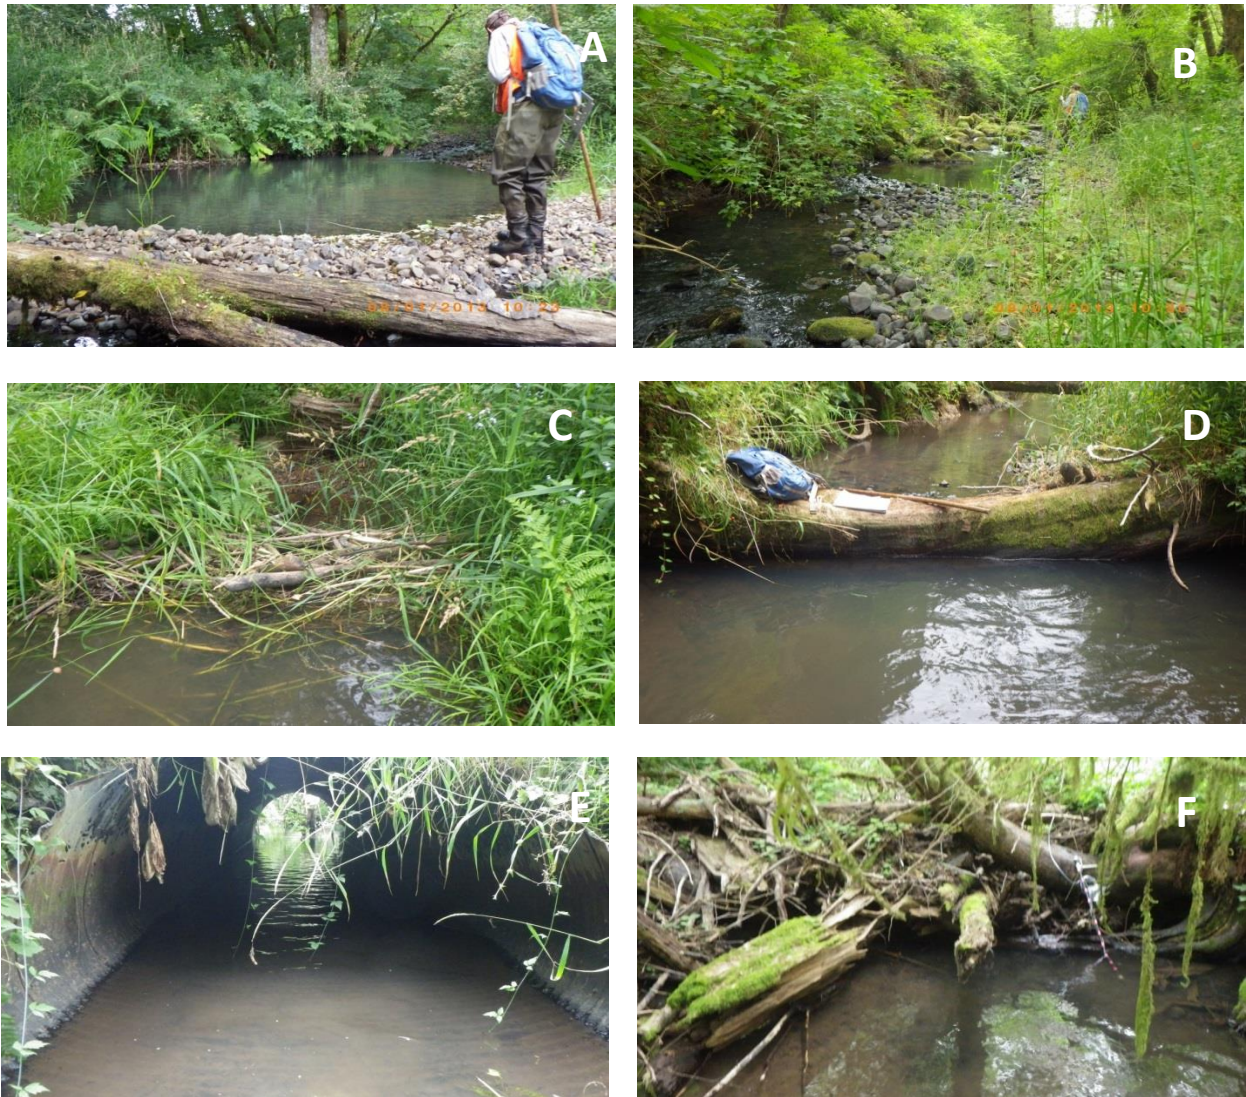
Figure 39. Survey pictures on reach 5.2 of Milton Creek showing a suitable gravel patch (panel A), a stream section with boulders and large cobble substrate (panel B), a small beaver dam near the middle of the reach (panel C) a large log jam across the stream (panel D), a culvert under South Canaan road (panel E), and a log jam (panel F).

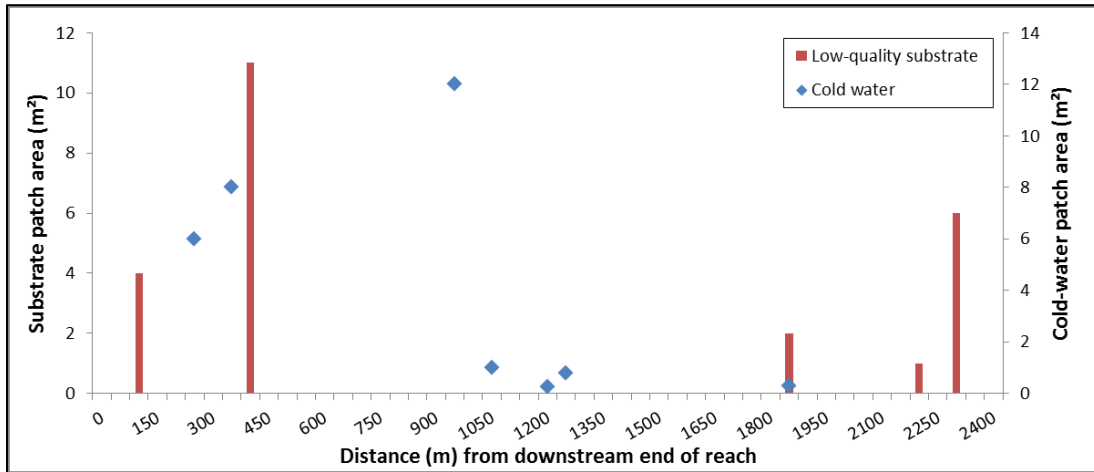
Figure 40. Location of substrate and cold-water patches measured as distance from downstream end of survey in reach 5.2 of Milton Creek, west of St. Helens, OR, in July 2013. Cold water and substrate patch areas were summed into 50 m units. Cold-water patches were at least 1.0° C colder than the temperature in the main channel.

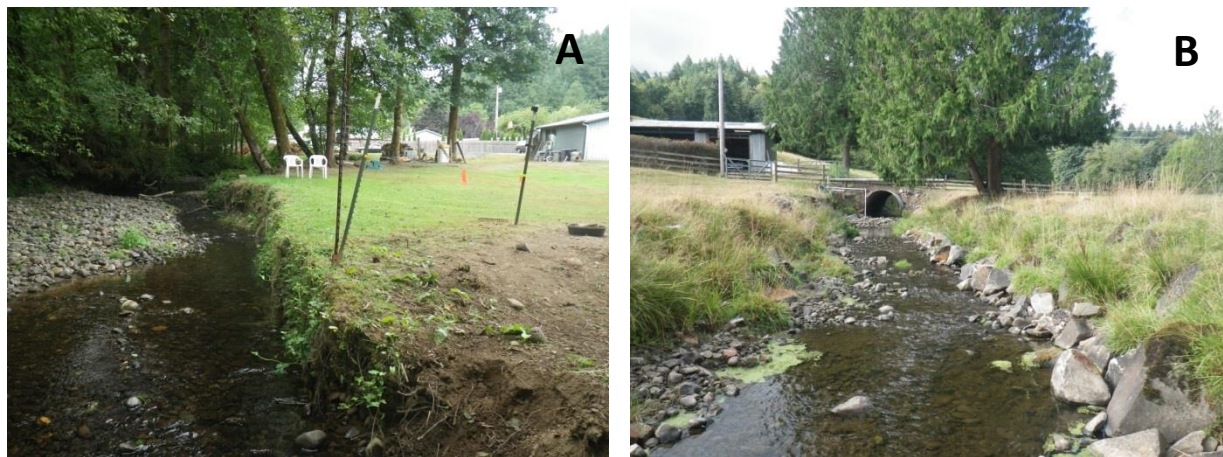
Figure 42. Survey pictures on Raymond Creek showing a maintained lawn extending to the stream bank (panel A) and a culvert underneath a small bridge (panel B).

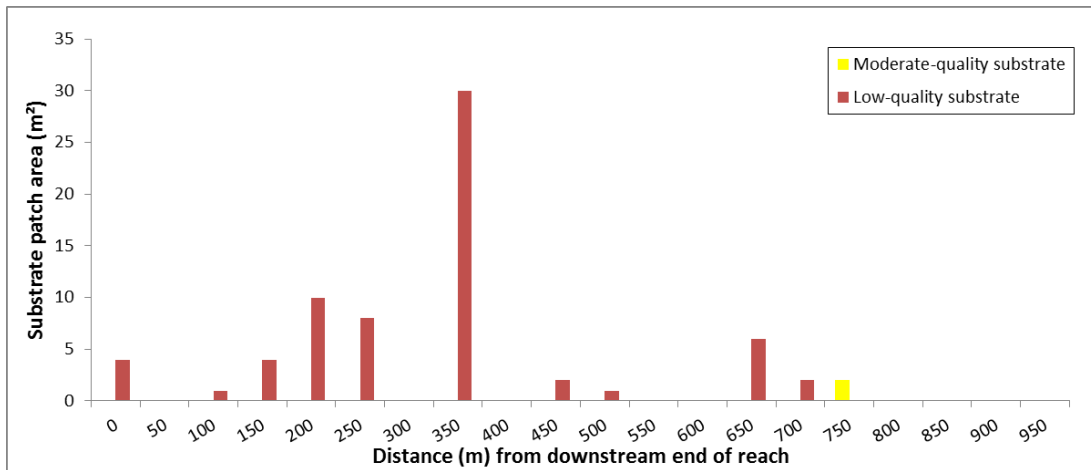
Figure 43. Location of substrate patches measured as distance from downstream end of survey in Raymond Creek, southwest of Scappoose, OR, in August 2012. For each category of substrate quality, patch area was summed and binned into 50 m units.
