Chum Salmon Spawning Habitat Report
for the Clatskanie River and Scappoose Creek Populations

Oregon Department of Fish and Wildlife

November 2017

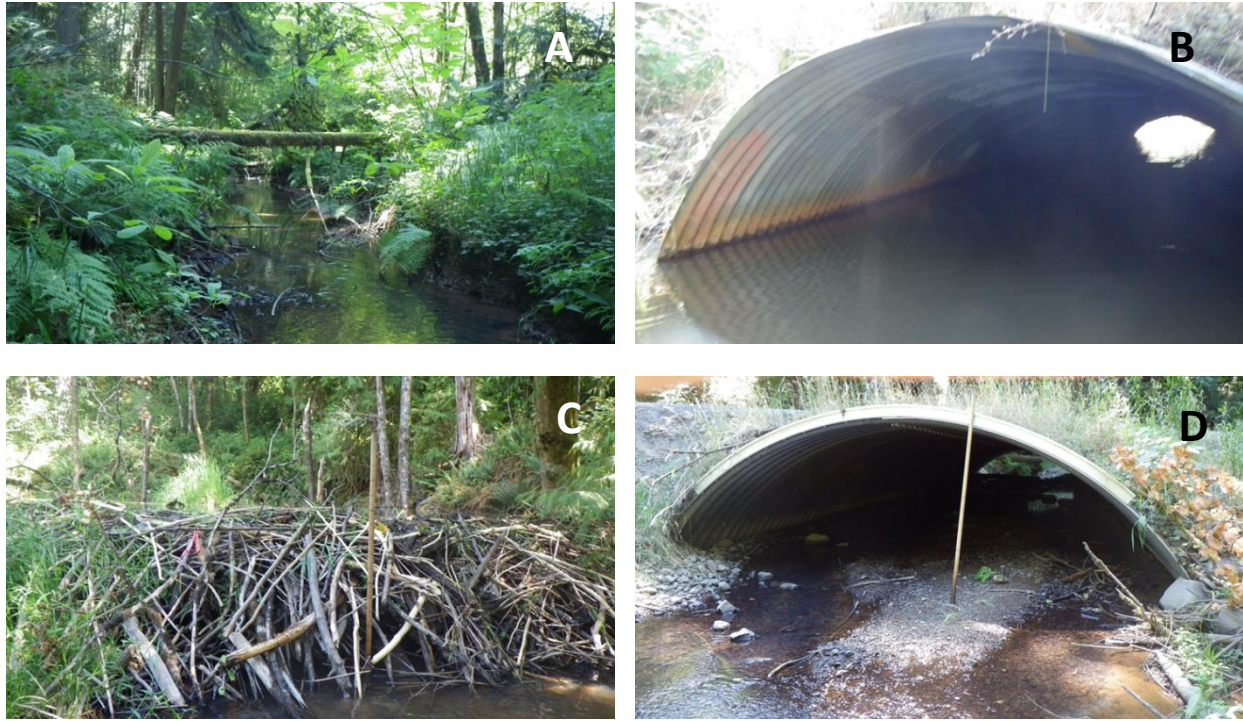
Figure 45. Survey pictures on Salmon Creek showing the dense riparian vegetation in the upstream end of the reach (panel A), a circular culvert at the second Brinn Road bridge (panel B), a large beaver dam (panel C), and a semicircular culvert at the third Brinn Road bridge near the upstream end of the reach (panel D).

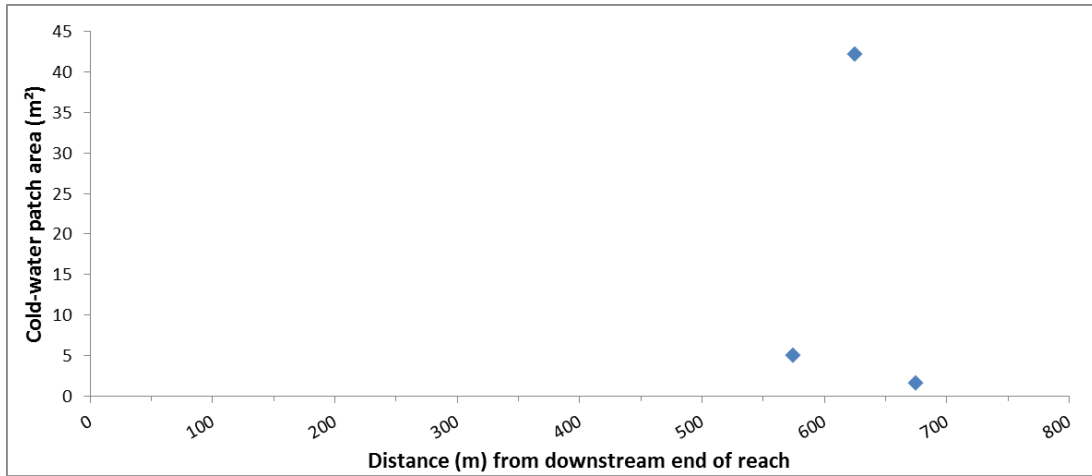
Figure 46. Location of cold-water patches measured as distance from downstream end of survey in Salmon Creek, west of St. Helens, OR, in August 2012. Cold-water patches were $\geq 1.0^{\circ}\text{C}$ colder than the main channel temperature and patch area was summed and binned into 50 m units.

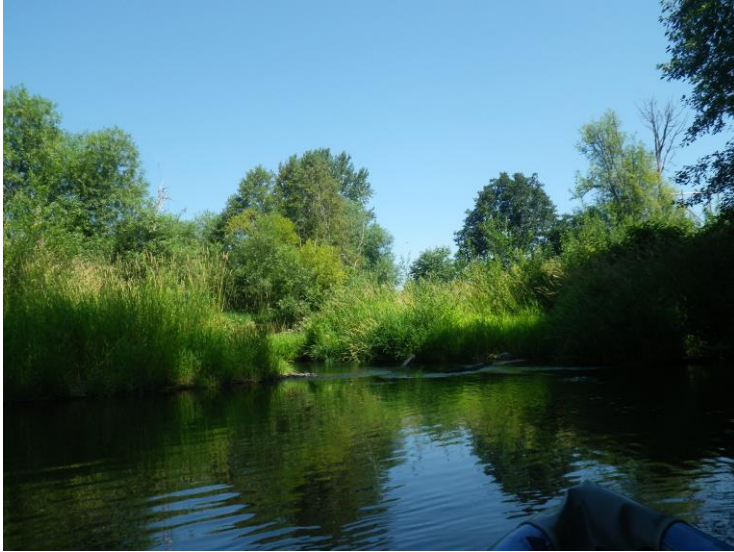
Figure 49. Survey picture in reach 1 of Scappoose Creek showing vegetated banks and deep pools, with limited gravel.

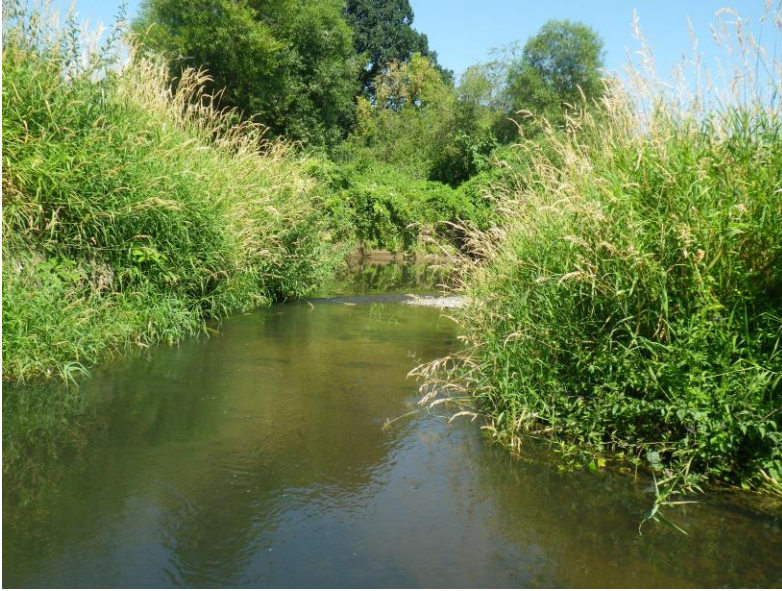
Figure 50. Survey picture in reach 2 of Scappoose Creek showing vegetated banks and deep pools, with limited gravel.

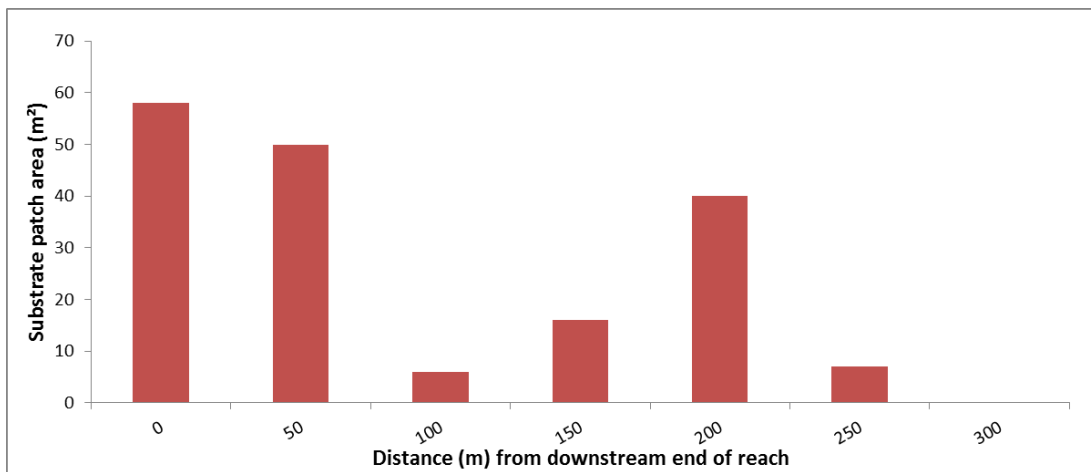
Figure 53. Location of low quality substrate patches (red bars) measured as distance from downstream end of survey in reach 1 of North Fork Scappoose Creek, northwest of Scappoose, OR, in August 2012. Substrate patch area was summed and binned into 50 m units.

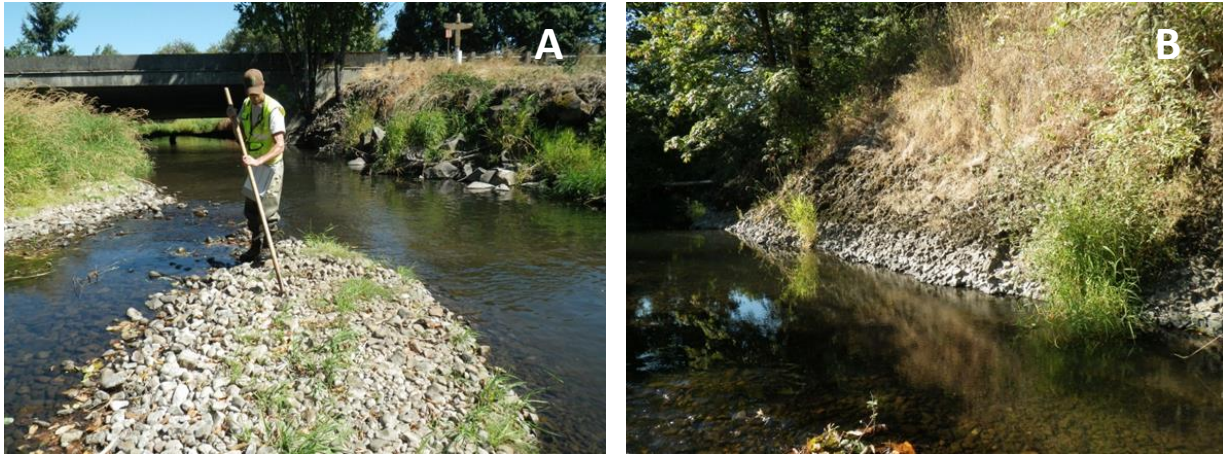
Figure 55. Survey pictures in reach 2 of North Fork Scappoose Creek showing a gravel bar near the downstream end of the reach (panel A), and a bedrock shelf and pool near the middle of reach (panel B).

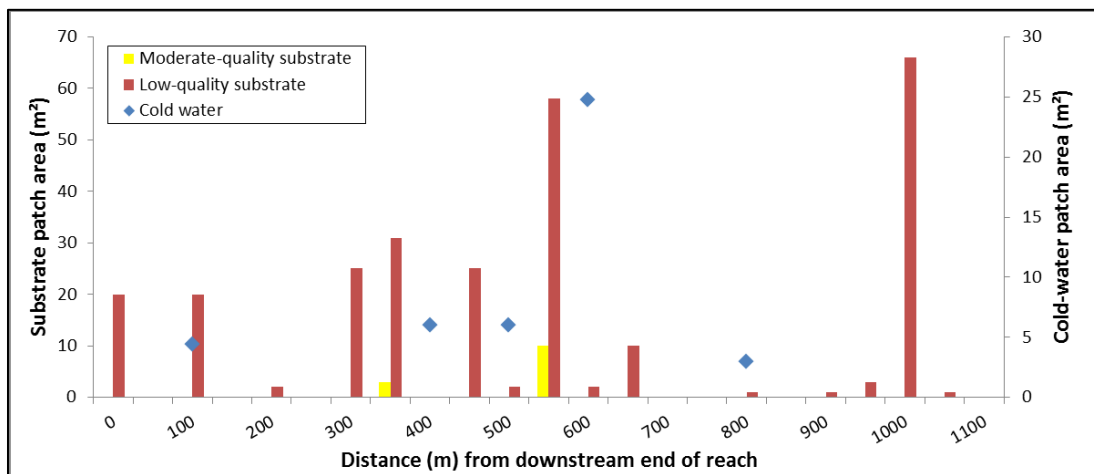
Figure 56. Location of substrate and cold-water patches measured as distance from downstream end of survey in reach 2 of North Fork Scappoose Creek, northwest of Scappoose, OR, in September 2012. For cold water and for each category of substrate quality, patch area was summed and binned into 50 m units. Cold-water patches were $\geq 1.0^{\circ}$ C colder than the temperature in the main channel.

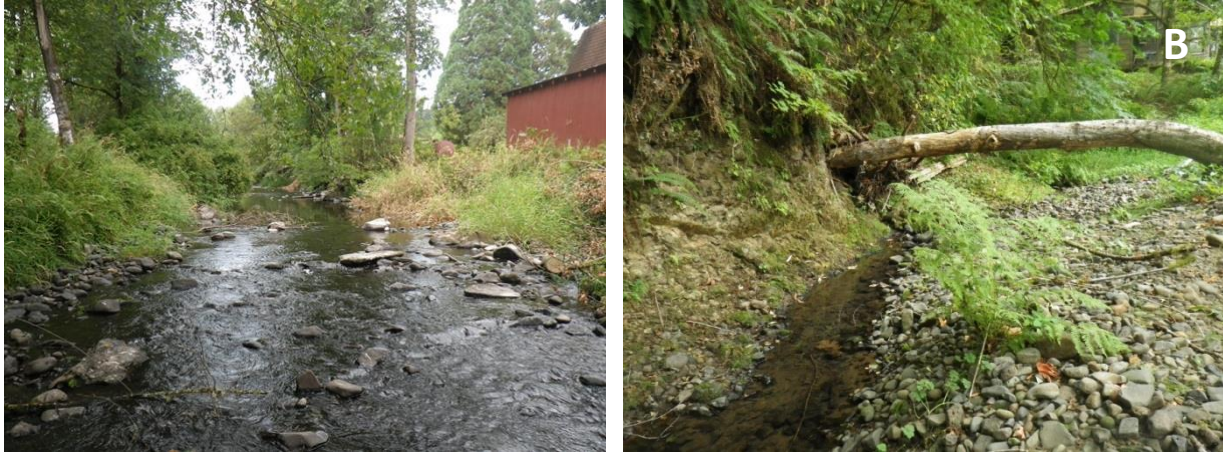
Figure 58. Survey pictures in reach 3 of North Fork Scappoose Creek showing an upstream view of Scappoose Creek at the downstream end of the survey (panel A), and a side channel with several cold-water patched (panel B).

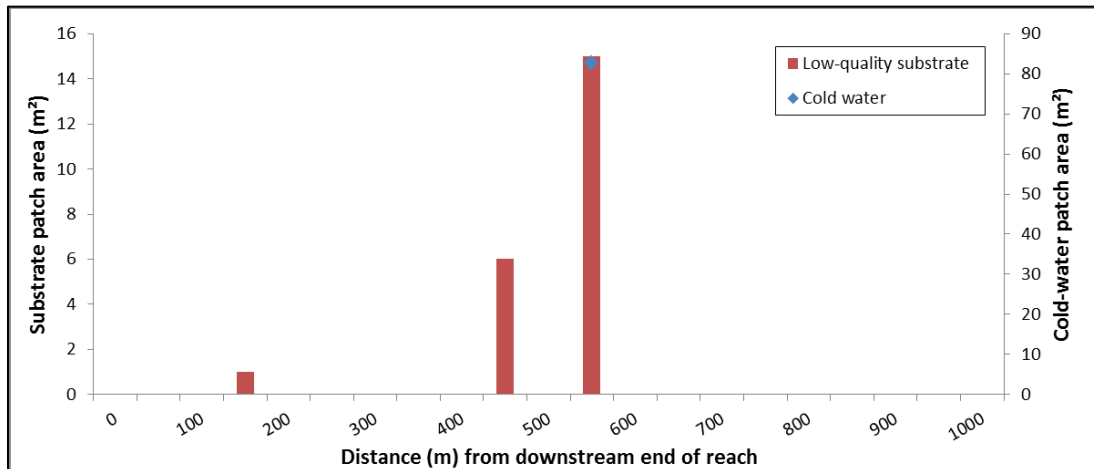
Figure 59. Location of substrate and cold-water patches measured as distance from downstream end of survey in reach 3 of North Fork Scappoose Creek, northwest of Scappoose, OR, in September 2012. Cold water and substrate patch areas were summed and binned into 50 m units. Cold-water patches were $\geq 1.0^{\circ}$ C colder than the temperature in the main channel.

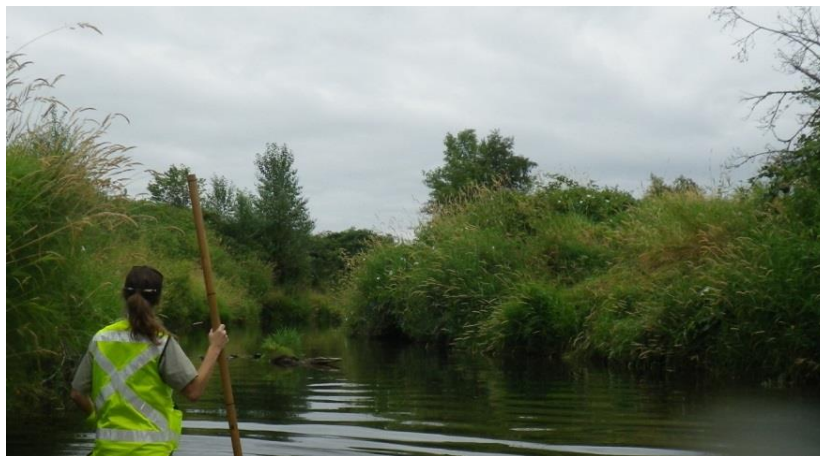
Figure 61. Survey picture in reach 0.1 of South Fork Scappoose Creek showing a long pool near the upstream end of the reach.

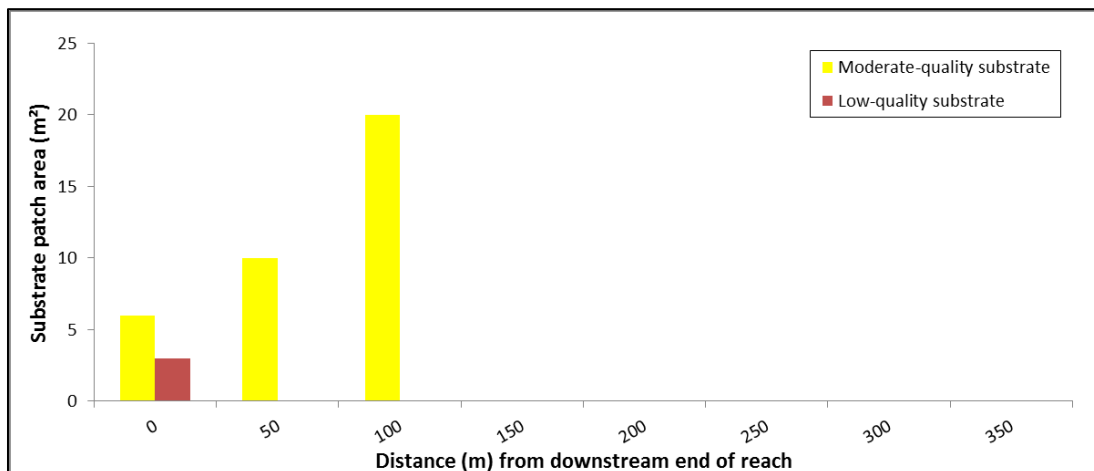
Figure 62. Location of substrate patches measured as distance from downstream end of survey in reach 0.1 of South Fork Scappoose Creek, north of Scappoose, OR, in August 2012. For each category of substrate quality, patch area was summed and binned into 50 m units.

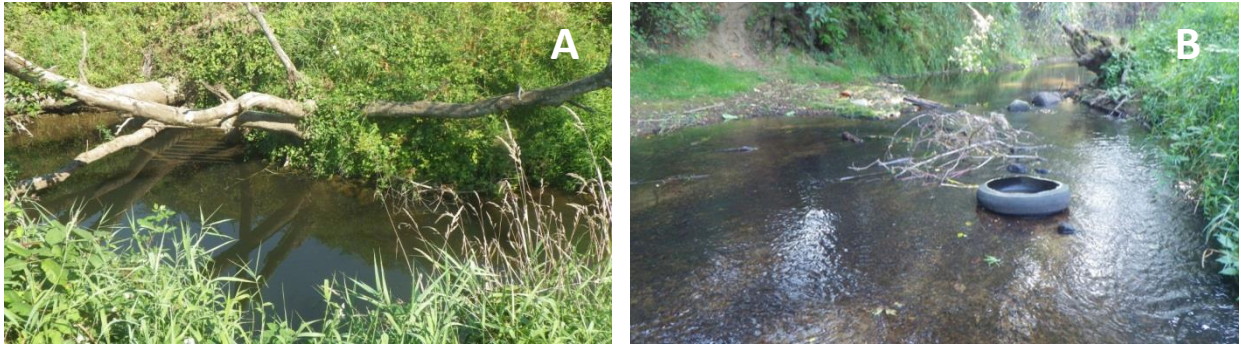
Figure 64. Survey pictures in reach 0.3 of South fork Scappoose Creek showing a deeply entrenched pool with woody debris (panel A), and section of stream with gravel, excess fine sediment, and garbage (panel B).

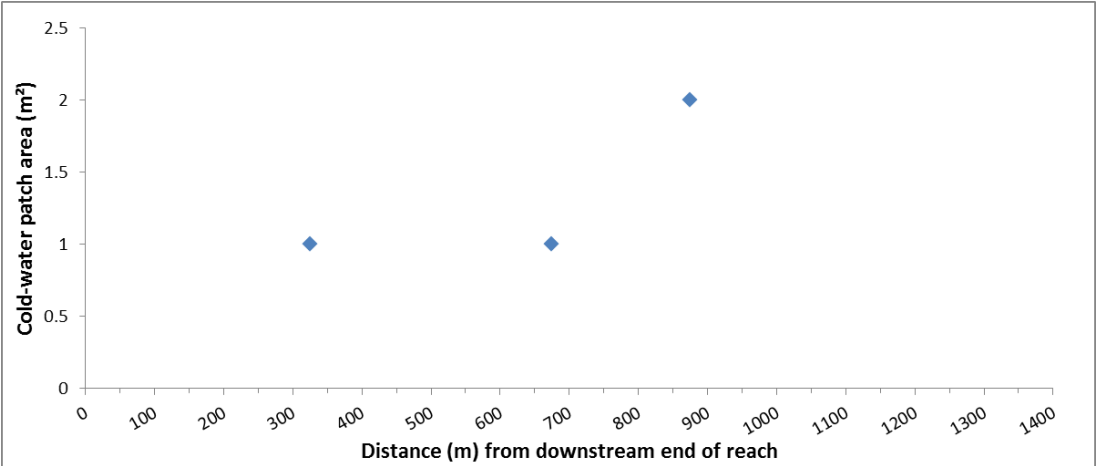
Figure 65. Location of cold-water patches measured as distance from downstream end of survey in reach 0.3 of south Fork Scappoose Creek, near Scappoose, OR, in September 2012. Cold-water patches were ≥ 1.0° C colder than the temperature in the main channel and patch area was summed and binned into 50 m units.

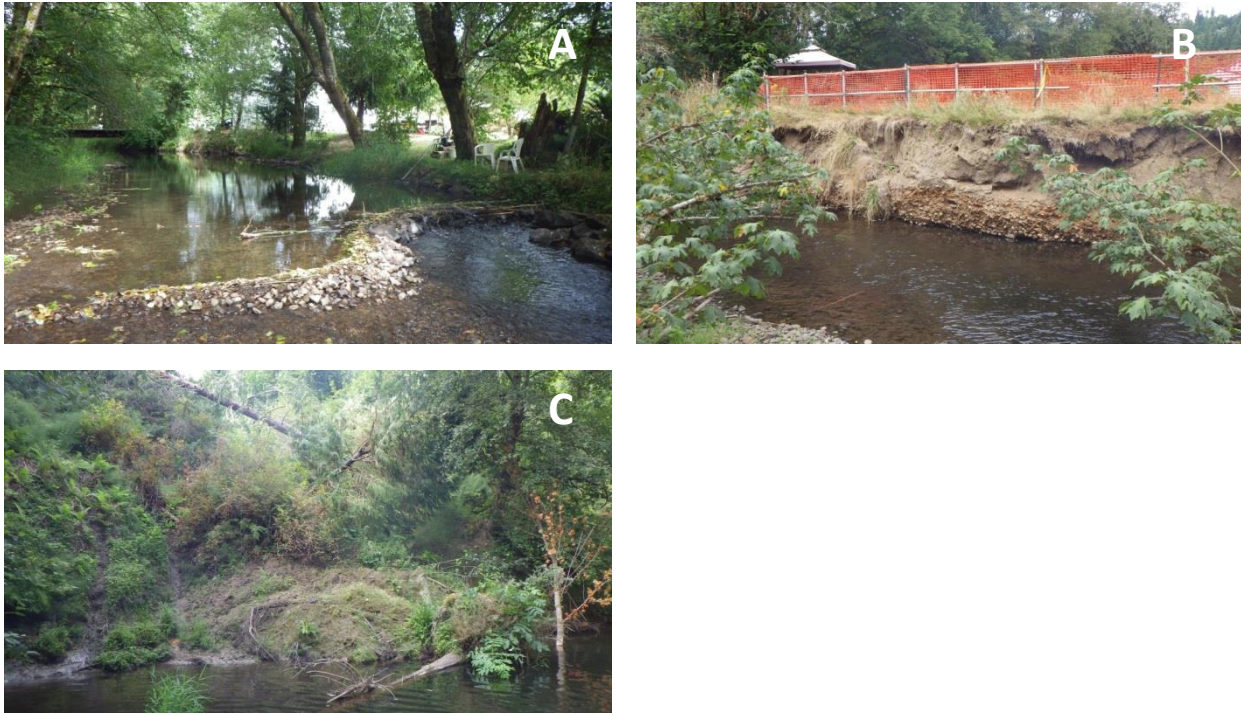
Figure 67. Survey pictures in reach 1 of South Fork Scappoose Creek showing a residential irrigation withdrawal pipe and man-made dam in middle of reach (panel A), bank erosion (panel B), and a large landslide located 30 m upstream from the Branch Drive bridge (panel C).

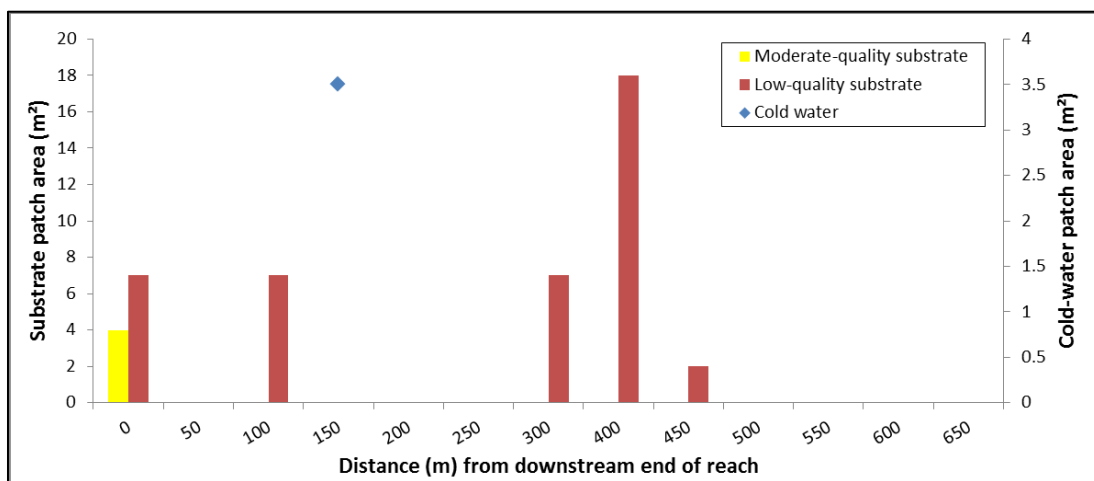
Figure 68. Location of substrate and cold-water patches measured as distance from downstream end of survey in reach 1.0 of South Fork Scappoose Creek, west of Scappoose, OR, in August 2012. For cold water and for each category of substrate quality, patch area was summed and binned into 50 m units. Cold-water patches were $\geq 1.0^{\circ}$ C colder than the temperature in the main channel.

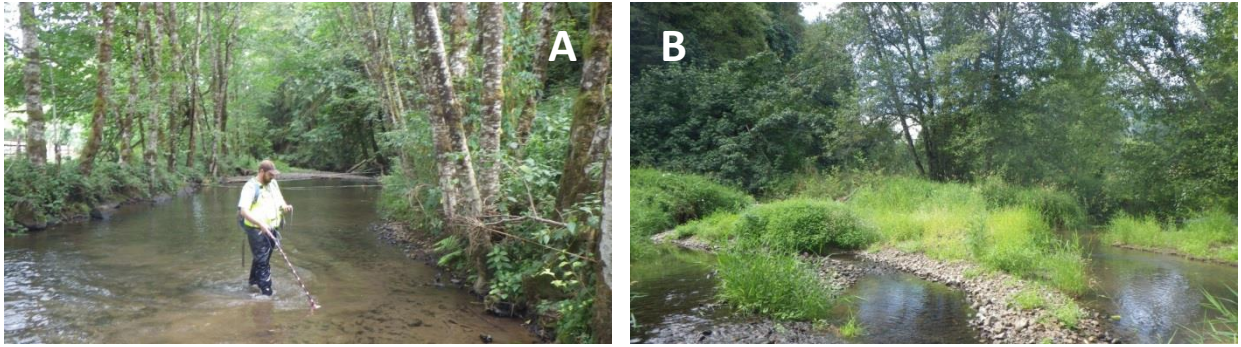
Figure 70. Survey pictures in reach 1.1 of South Fork Scappoose Creek showing collection of water temperature data in a silty section of channel with a riparian zone dominated by alders (panel A), and a gravel bar near the middle of the reach (panel B).

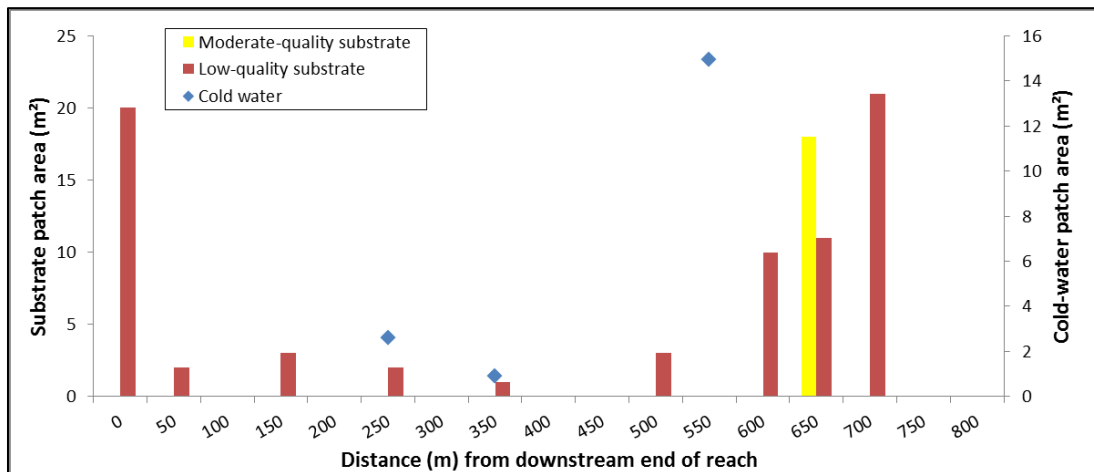
Figure 71. Location of substrate and cold-water patches measured as distance from downstream end of survey in reach 1.1 of South Fork Scappoose Creek, west of Scappoose, OR, in August 2012. For cold water and for each category of substrate quality, patch area was summed and binned into 50 m units. Cold-water patches were $\geq 1.0^{\circ}$ C colder than the temperature in the main channel.

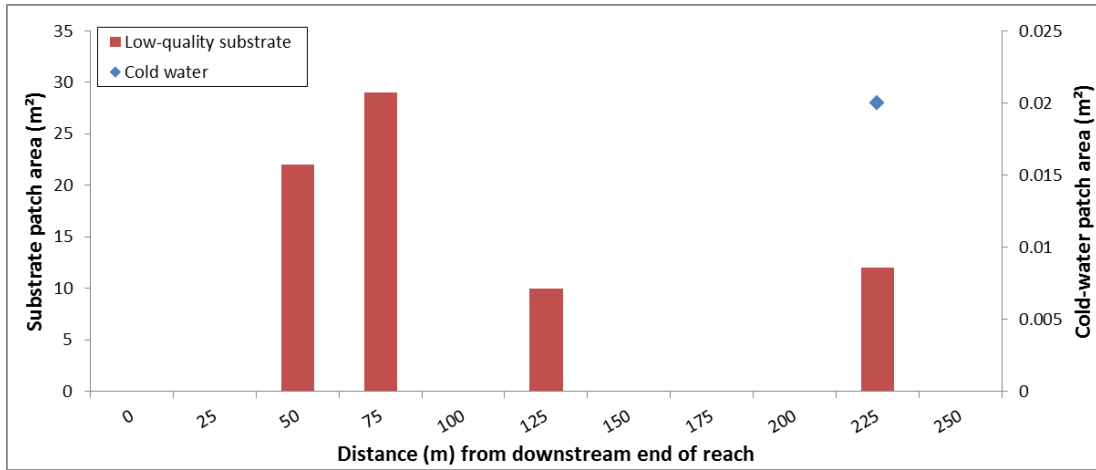
Figure 73. Location of substrate and cold-water patches measured as distance from downstream end of survey in reach 2 of South Fork Scappoose Creek, west of Scappoose, OR, in August 2012. Cold water and substrate patch areas were summed and binned into 50 m units. Cold-water patches were $\geq 1.0^{\circ}$ C colder than the temperature in the main channel.

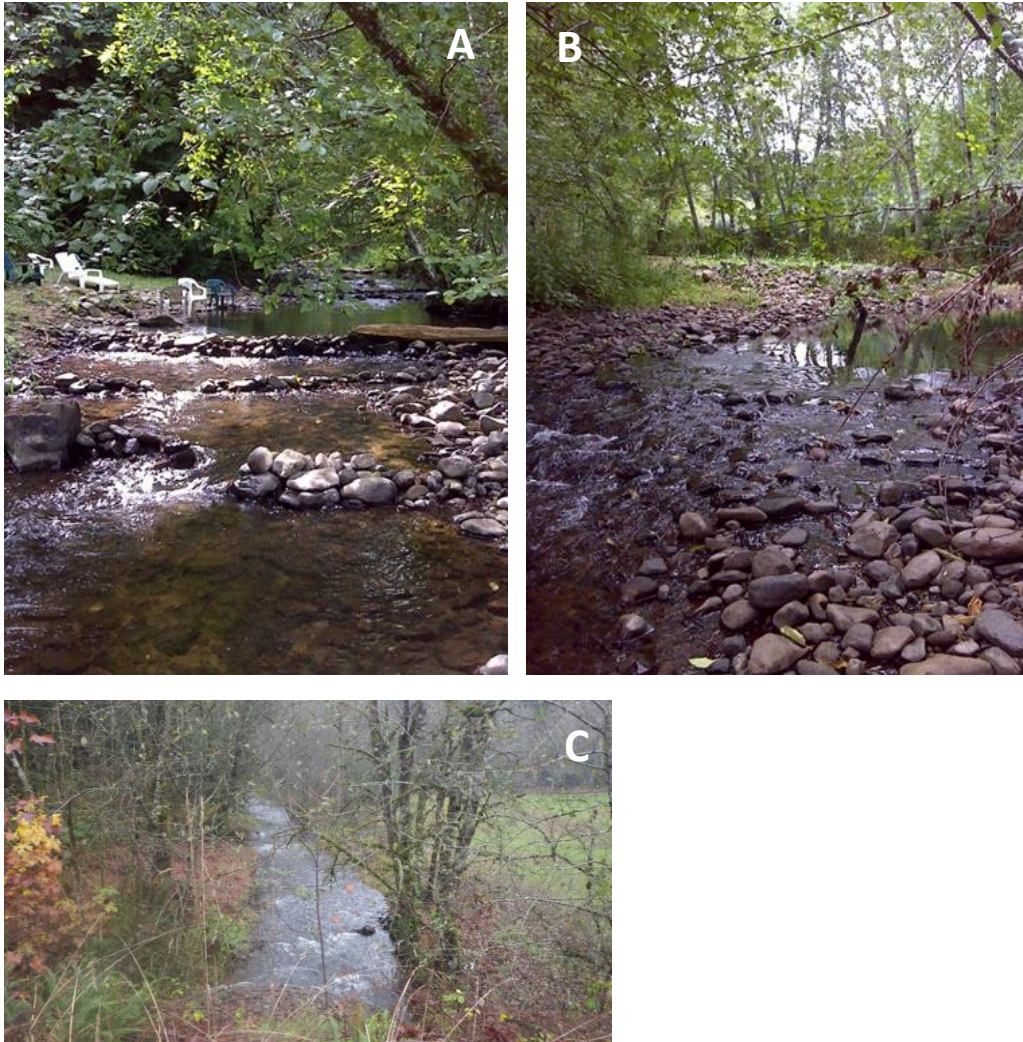
Figure 75. Survey pictures in reach 4 of South Fork Scappoose Creek showing several man-made pools located upstream of Bankston Road (panel A), a streambed with large cobble substrate and limited riparian vegetation (panel B), and a semicircular culvert under Bankston Road (panel C).

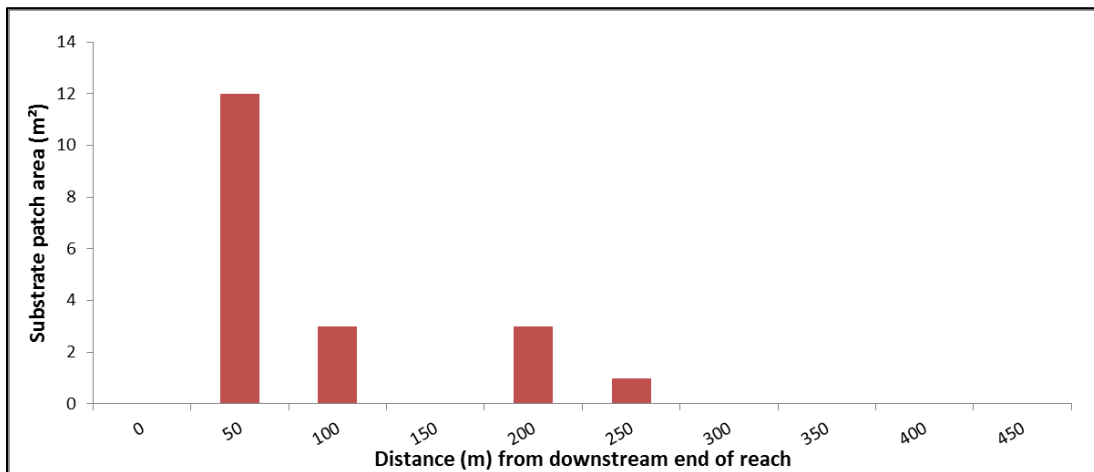
Figure 76. Location of low-quality substrate patches (red bars) measured as distance from downstream end of survey in reach 4 of South Fork Scappoose Creek, west of Scappoose, OR, in August 2012. Substrate area was summed and binned into 50 m units.

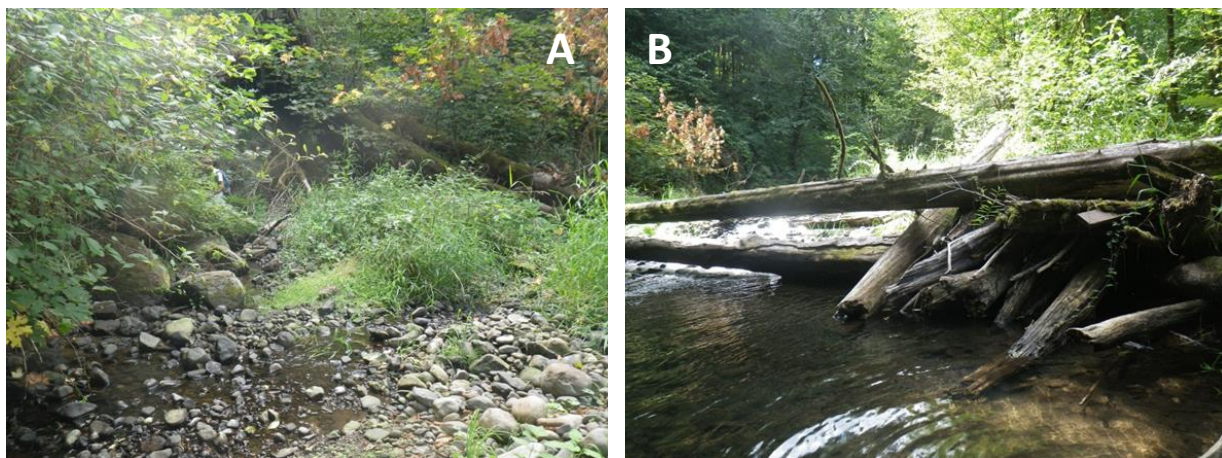
Figure 78. Survey pictures in reach 5 of South Fork Scappoose Creek showing a small landslide adjacent to a cold-water seep (panel A), and an accumulation of large woody debris (panel B).

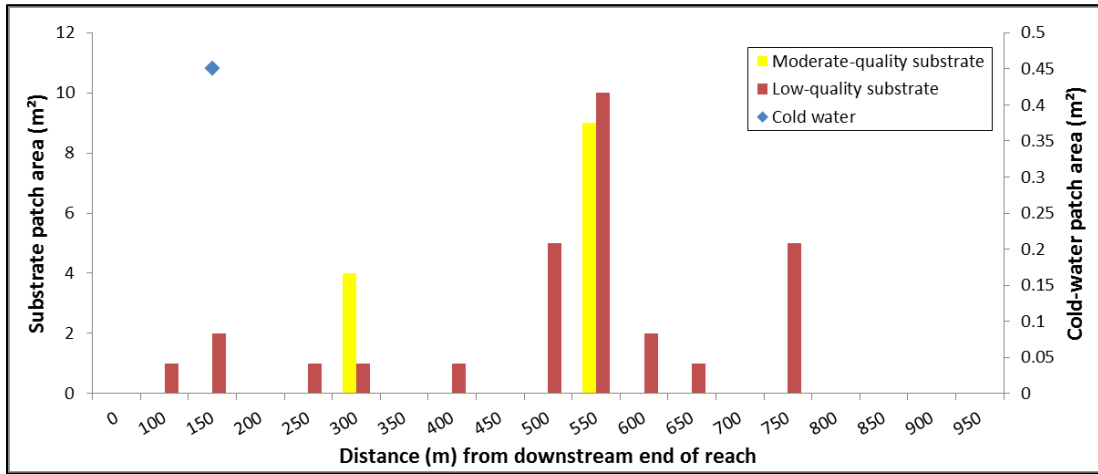
Figure 79. Location of substrate and cold-water patches measured as distance from downstream end of survey in reach 5 of South Fork Scappoose Creek, west of Scappoose, OR, in August 2012. For cold water and for each category of substrate quality, patch area was summed and binned into 50 m units. Cold-water patches were $\geq 1.0^{\circ}$ C colder than the temperature in the main channel.

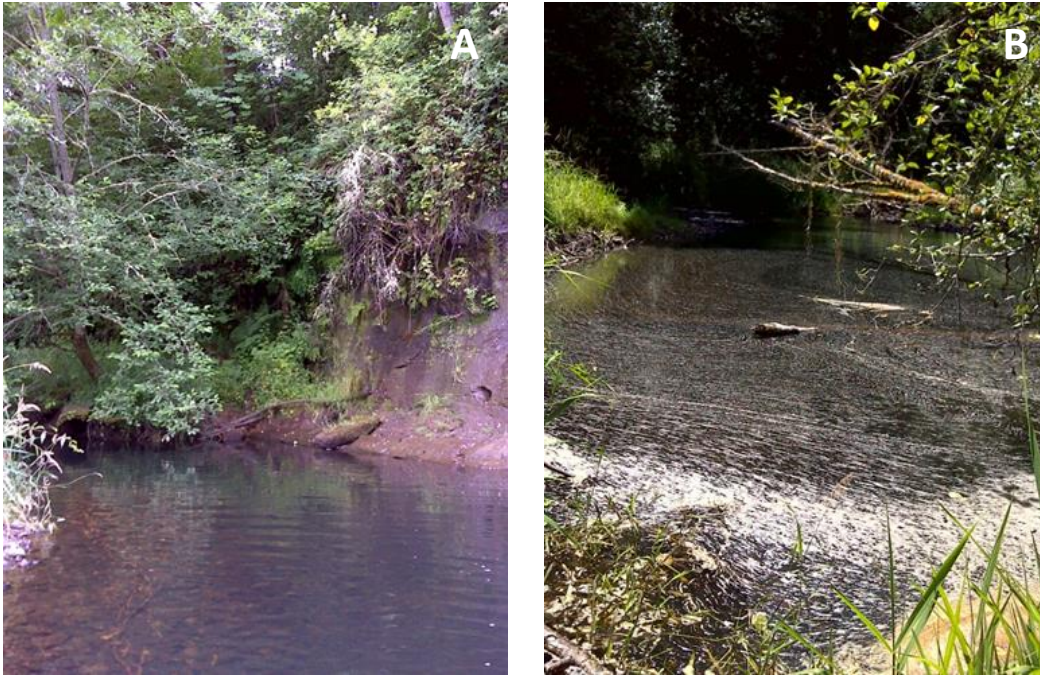
Figure 83. Survey pictures of Beaver Creek reach 1 show a deep pool and adjacent bedrock shelf (panel A), and a pool created by a beaver dam (panel B).

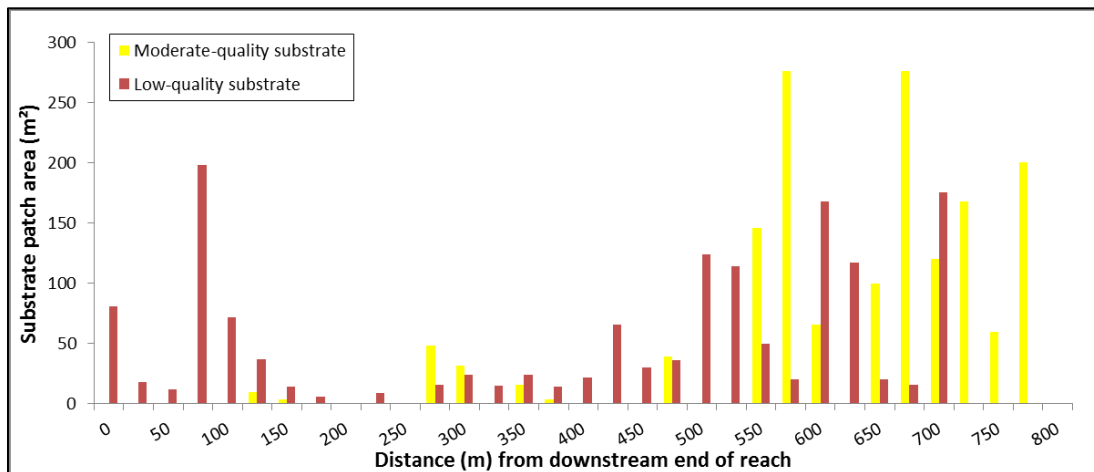
Figure 84. Location of substrate patches measured as distance from downstream end of survey in reach 1 of Beaver Creek, OR, in July 2012. For each category of substrate quality, patch area was summed and binned into 25 m units.

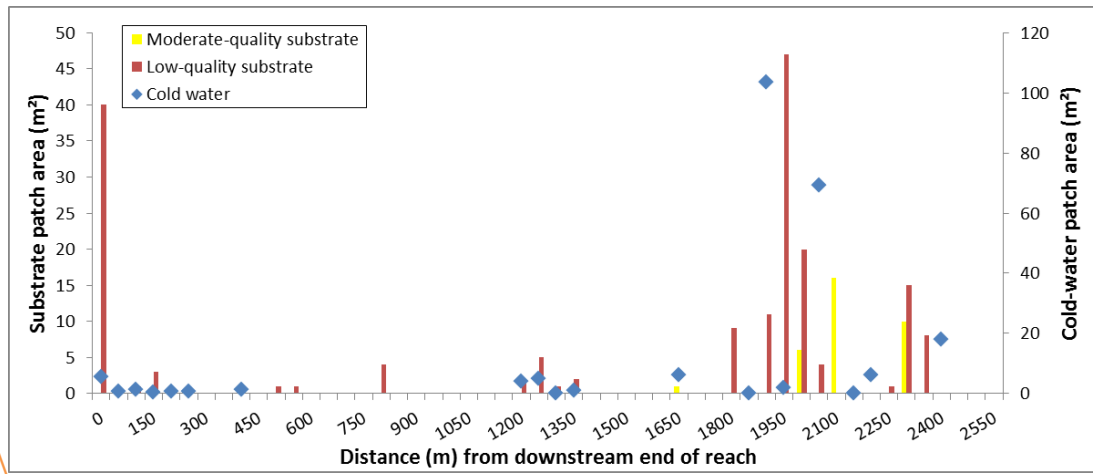
Figure 87. Location of substrate and cold-water patches measured as distance from downstream end of survey in reach 2 of Beaver Creek, OR, in July 2013. For cold water and for each category of substrate quality, patch area was summed and binned into 50 m units. Cold-water patches were $\geq 1.0^{\circ}$ C colder than the temperature in the main channel.

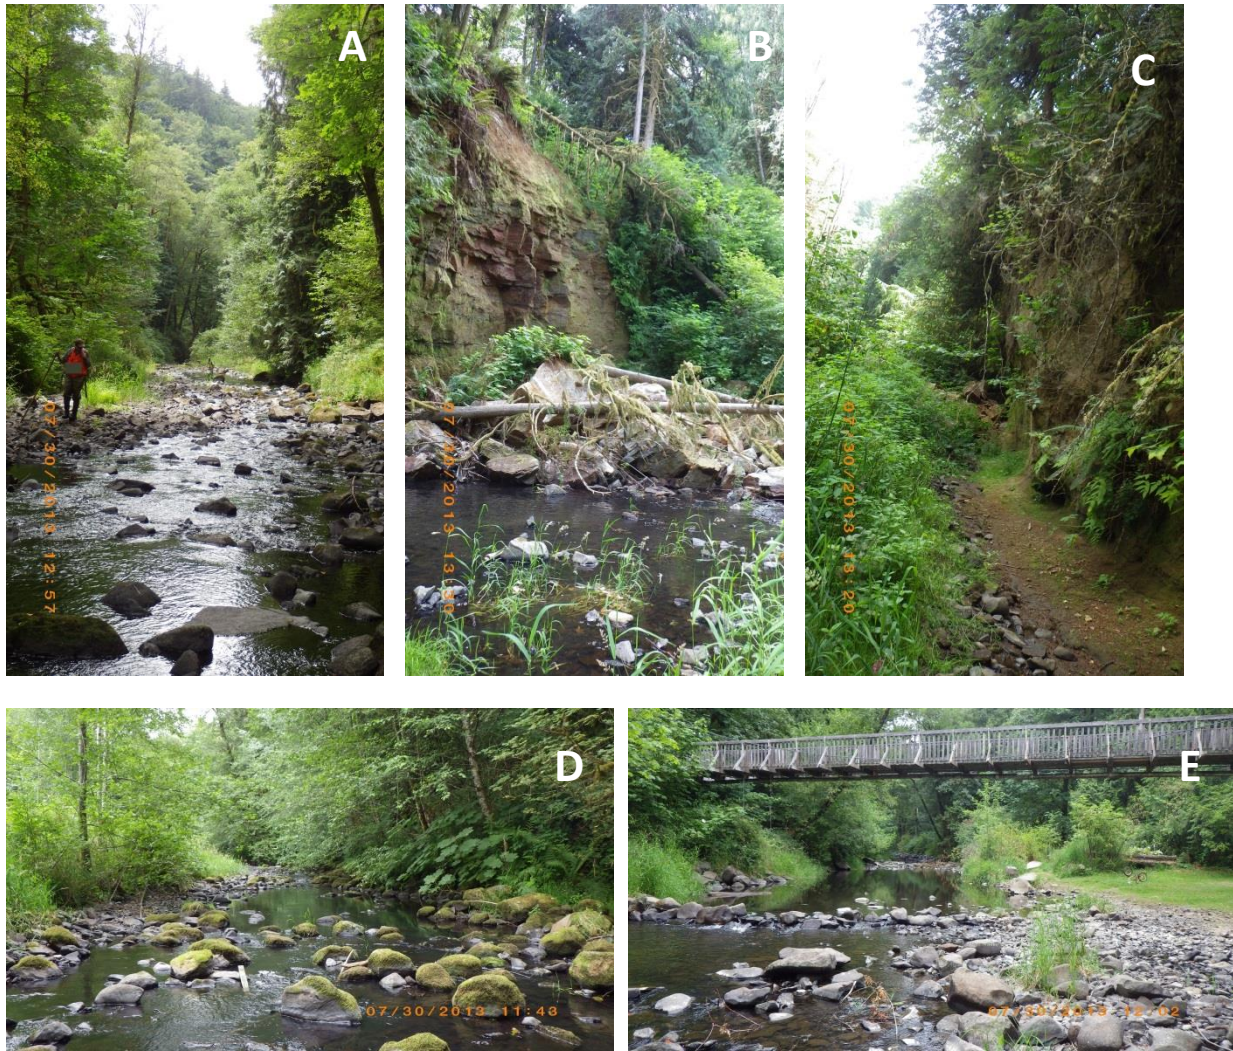
Figure 89. Survey pictures of Beaver Creek reach 3, showing a densely-vegetated riparian zone (panel A), a rock slide along the creek (panel B), a dry side channel section (panel C), substrate consisting of large cobble and boulders (panel D), and a footbridge near the middle of the reach (panel E).

Boulder and large cobble (129–256 mm, diameter) substrate was common throughout reach 3 of Beaver Creek (Figure 89, panel D). Thirteen patches of suitable spawning substrate were found (Table 33; Figure 90), measuring a total of 36 m². None of these patches were categorized as “high” quality, one was of “moderate” quality, and 12 were of “low” quality (Table 33; Figure 90). All but one of these patches contained ≥ 50% small cobble (Table 33). Fourteen cold-water patches totaling 23.9 m² were observed (Figure 90); average temperature in these patches was 13.0° C and average temperature adjacent to these patches was 15.2° C. The dominant substrate types within these cold-water patches were fine sediment (n = 3), small cobble (n = 2), large cobble (n = 1), and bedrock (n = 8). There were also six patches with temperatures 0.5–0.9° C colder than that of the adjacent stream, but these did not meet our temperature criteria to be considered cold-water patches. There were no potential barriers to

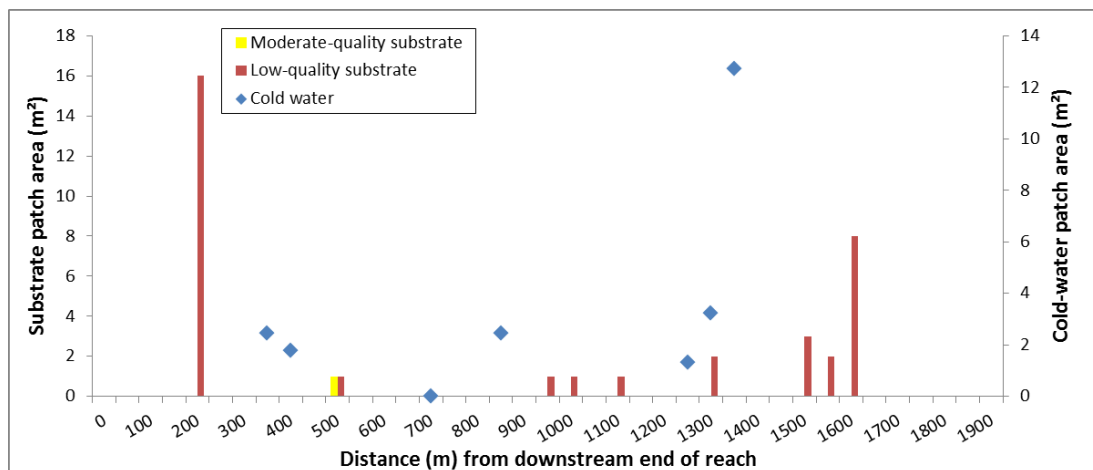
Figure 90. Location of substrate and cold-water patches measured as distance from downstream end of survey in reach 3 of Beaver Creek, OR, in July 2013. For cold water and for each category of substrate quality, patch area was summed and binned into 25 m units. Cold-water patches were $\geq 1.0^{\circ}$ C colder than the temperature in the main channel.

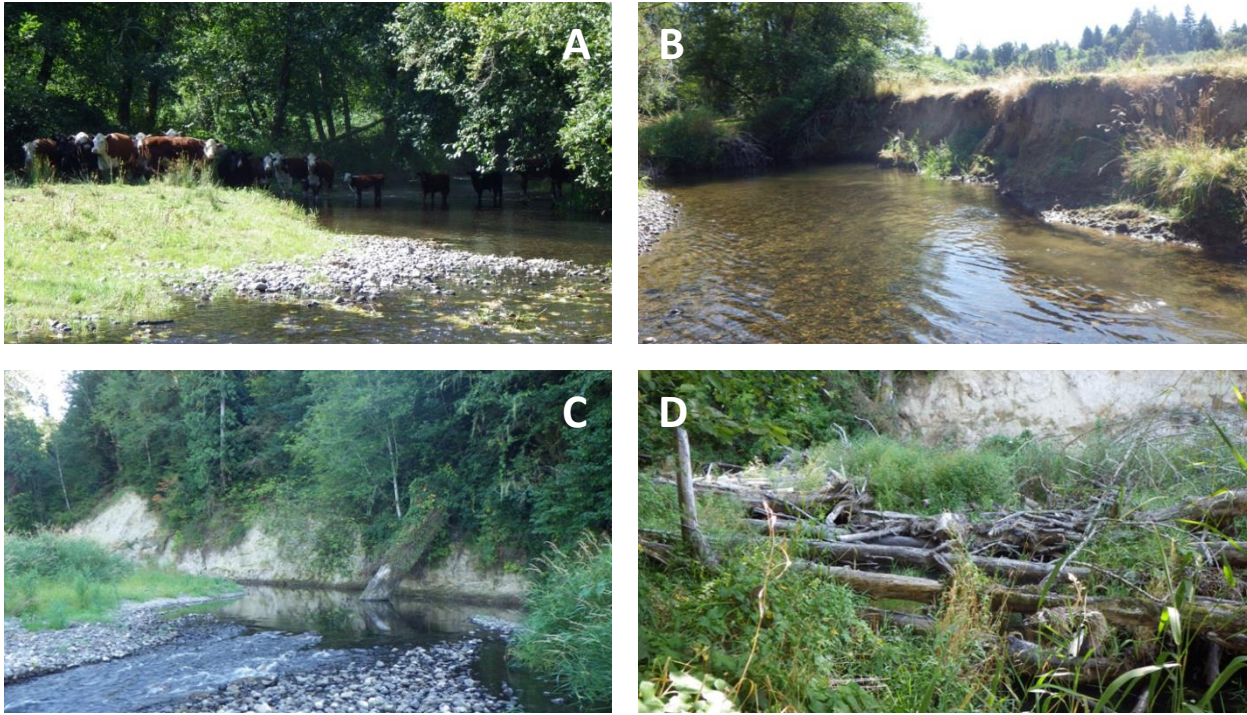
Reach 2 started at tidewater 0.8 km upstream from Olson Road (Lat: 46.099988, Long: -123.176779) and continued upstream to the confluence with Merrill Creek (Lat: 46.094339, Long: -123.170627; Figure 92). The mainstem thalweg length of this reach was 1,090 m. There were three side channels with a combined thalweg length of 217 m. The channel was unconfined, with multiple side channels and meanders. The riparian vegetation in this reach consisted of grasses and sparse alders. Cattle were observed walking through the stream channel during the survey and signs of heavy grazing were evident throughout the reach (Figure 93, panel A), as such land use was heavy grazing. One side-channel complex was partially surveyed due to dense vegetation and lack of water or spawning substrate in the channel. Active erosion was observed on the river-right stream bank throughout much of this reach (Figure 93, panel B). At the upstream end of the reach there was a channel-spanning log jam (> 10 m long; Figure 93, panel D).

Figure 93. Survey pictures on reach 2 of the Clatskanie River show cattle crossing the river (panel A), a large, eroded bank on a ranch (panel B), a cliff and large pool near the upstream end of the reach (panel C), and a channel-spanning log jam (panel D).

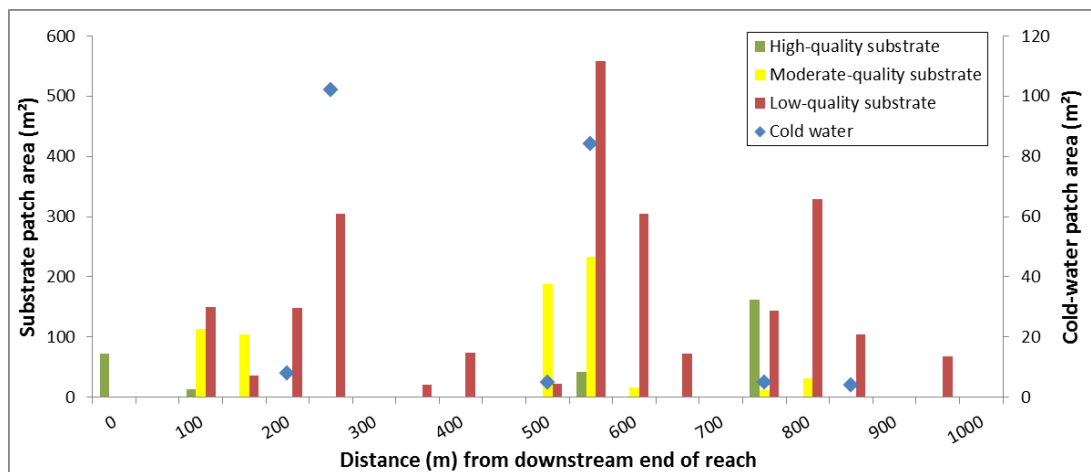
Figure 94. Location of substrate and cold-water patches measured as distance from downstream end of survey in reach 2 of the Clatskanie River, OR, in September 2012. For cold water and for each category of substrate quality, patch area was summed and binned into 50 m units. Cold-water patches were $\geq 1.0^{\circ}$ C colder than the temperature in the main channel.

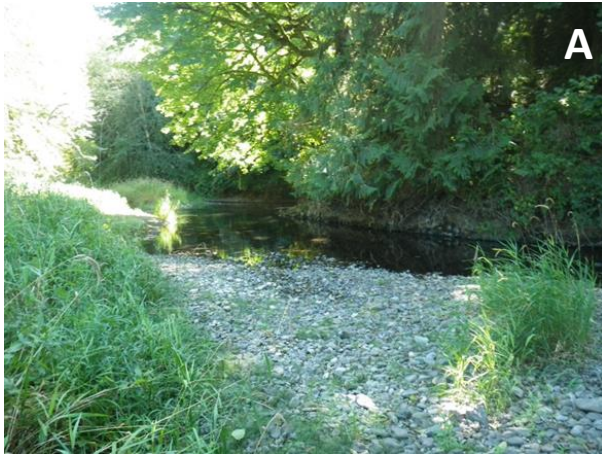
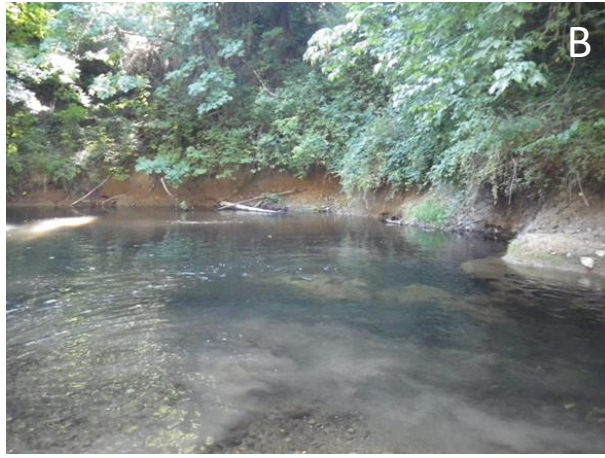
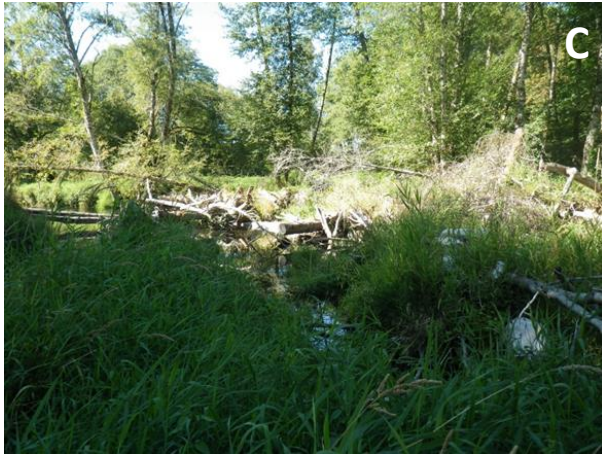
Reach 3 started at the confluence with Merrill Creek (Lat: 46.093894, Long: -123.170068) and continued upstream to the confluence with Perkins Creek (Lat: 46.086261, Long: -123.166217; Figure 95). The mainstem thalweg length of this reach was 1,174 m. There were three side channels with a combined thalweg length of 474 m. The channel was unconfined, with multiple channels and meanders. The riparian zone consisted of alders and grass, and land use was heavy grazing. Evidence of livestock use within the stream channel was observed throughout this reach including hoof prints in the stream, bank erosion at access points, and feces. Several of the substrate patches in this reach were located outside of the wetted channel, but still within the active channel (Figure 96, panel A). Several instances of major bank erosion were observed within the channel (Figure 96, panel B). In the upstream half of the survey, discharge was evenly split between two channels, one of which occurred below a large log jam (Figure 96, panel C).

Figure 96. Survey pictures on reach 3 of the Clatskanie River showing dry gravel within the active channel (panel A), an eroded bank at a sharp river bend (panel B), and a large log jam next to a side channel (panel C).

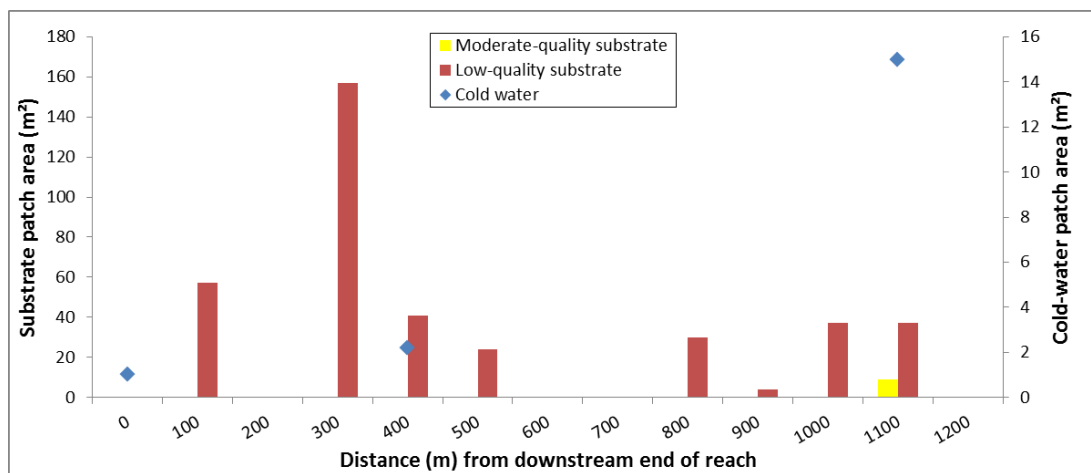
Figure 97. Location of substrate and cold-water patches measured as distance from downstream end of survey in reach 3 of the Clatskanie River, OR, in September 2012. For cold water and for each category of substrate quality, patch area was summed and binned into 100 m units. Cold-water patches were $\geq 1.0^{\circ}$ C colder than the temperature in the main channel.
