Chum Salmon Spawning Habitat Report
for the Clatskanie River and Scappoose Creek Populations

Oregon Department of Fish and Wildlife

November 2017

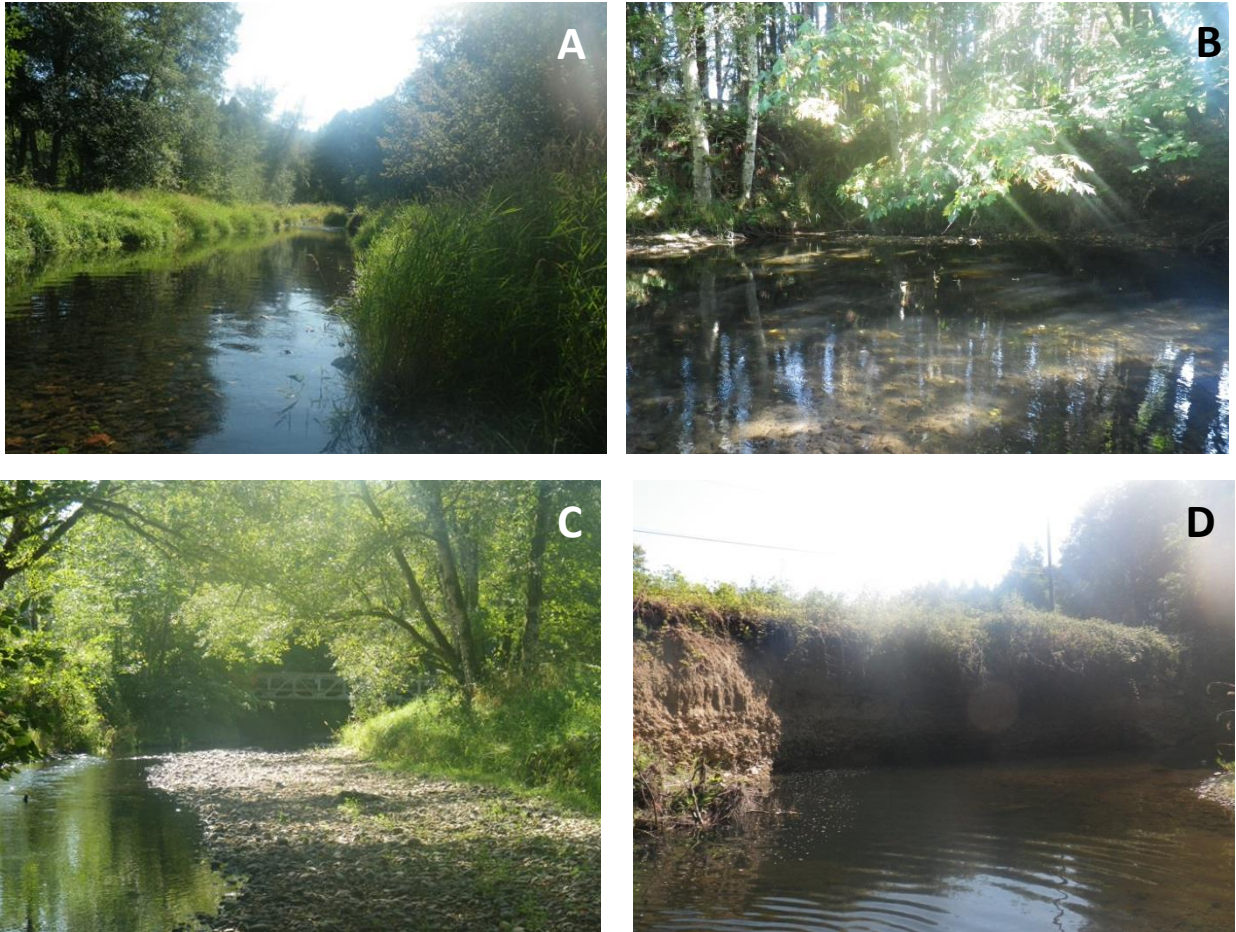
Reach 4 started at the confluence with Perkins Creek (Lat: 46.086261, Long: -123.166217) and continued upstream to the confluence with Keystone Creek (Lat: 46.083407, Long: -123.162801; Figure 98). The mainstem thalweg length of this reach was 501 m, and there were no side channels. Channel form was unconfined and braided, with multiple meanders. The riparian zone was dominated by alders and grasses (Figure 99, panel A). No signs of livestock were observed in this reach. Land use was rural residential and young timber. There were several deep pools (depth > 2 m), including one long pool (length > 25 m; Figure 99, panel B) located 100 m downstream from the Perkins Creek Campground bridge (Figure 99, panel C). There was one instance of severe bank erosion, the hillside was actively eroding and cutting under Swedetown Road (Figure 99, panel D).

Figure 99. Survey pictures on reach 4 of the Clatskanie River showing a long pool near the downstream end of the reach (panel A), a deep pool along a sharp bend in the river (panel B), Perkins Creek Campground bridge (panel C), and an eroded bank near the upstream end of the reach (panel D).

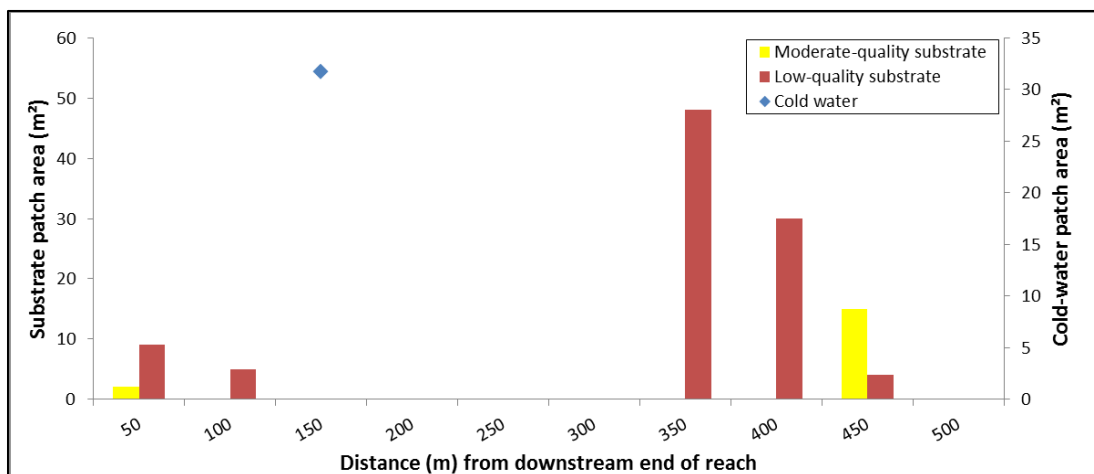
Figure 100. Location of substrate and cold-water patches measured as distance from downstream end of survey in reach 4 of the Clatskanie River, OR, in September 2012. For cold water and for each category of substrate quality, patch area was summed and binned into 50 m units. Cold-water patches were $\geq 1.0^{\circ}$ C colder than the temperature in the main channel.

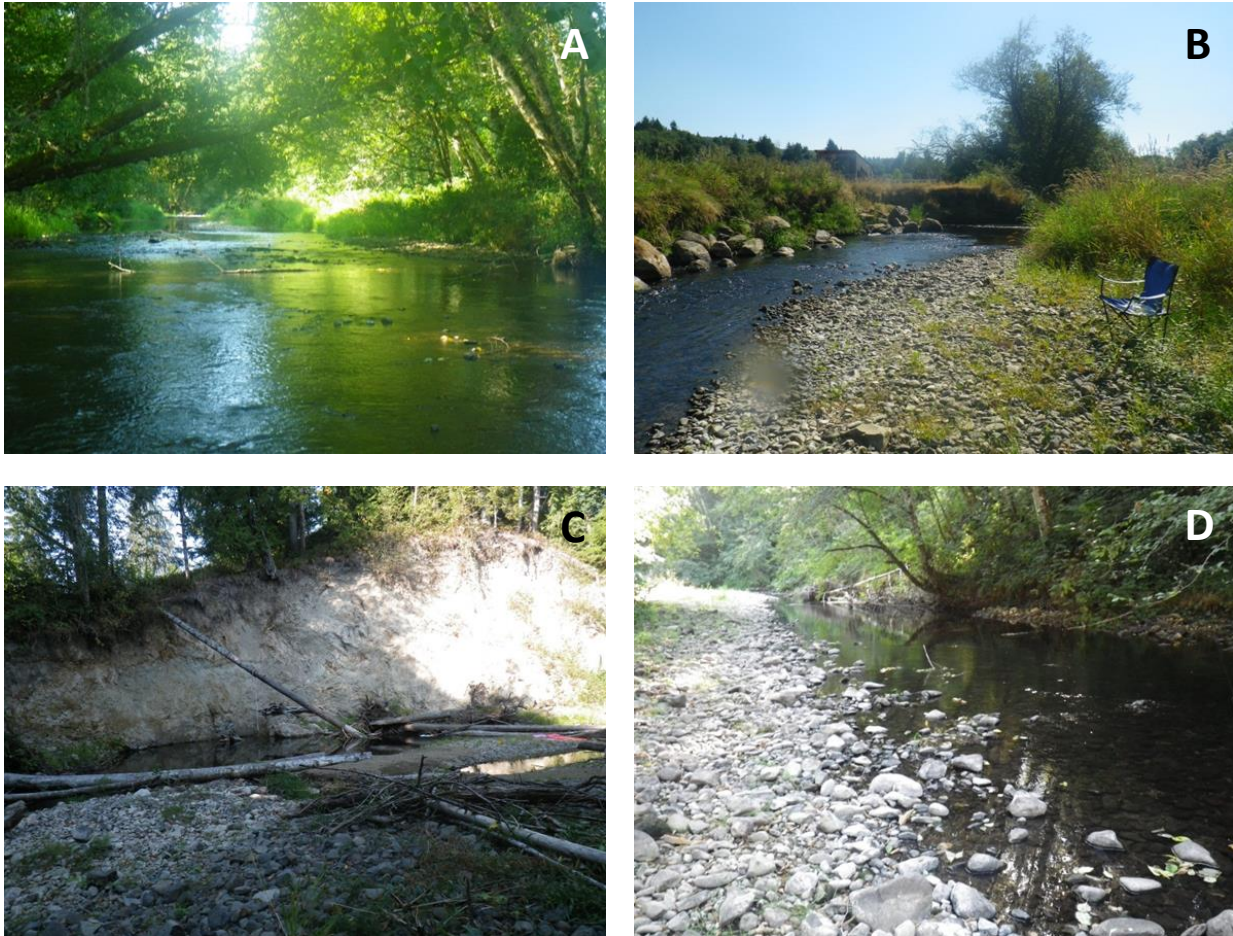
Reach 5 started at the confluence with Keystone Creek (Lat: 46.083407, Long: -123.162801), and continued upstream to a point adjacent to a house on county tax lot 7N4W2700 302 (Lat: 46.067691, Long: -123.1641; Figure 101). The mainstem thalweg length of this survey was 1,342 m. There were two side channel sections in this reach with a combined thalweg length of 81 m. One side channel and two main channel sections with thalweg lengths of 50 m and 650 m respectively, were not surveyed due to landowner denials. Riparian vegetation was dominated by alders along the river-left bank, and grass along the river-right bank (Figure 102, panel A). In one section of stream there was limited riparian vegetation and the stream temperature increased. Alterations to the stream channel were common throughout this reach and included large holes (depth > 2 m), areas where substrate was removed, and banks that were stabilized by the placement of boulders (Figure 102, panel B). Land use was rural residential and light grazing. Several sandstone cliffs were actively eroding into the stream channel, depositing fine sediment (< 4 mm, diameter), which reduced substrate quality (Figure 102, panel C).

Figure 102. Survey pictures on reach 5 of the Clatskanie River show alders in the riparian zone near the downstream end of the reach (panel A), boulders stabilizing a bank along residential properties (panel B), an eroded bank (panel C), and large cobble substrate at the upstream end of the reach (panel D).

Large cobble substrate (129–256 mm, diameter) was common throughout this reach (Figure 102, panel D), but suitable spawning substrate was observed as well. Thirty-one patches of suitable spawning substrate were found in reach 5 of the Clatskanie River (Table 37; Figure 103), measuring a total of 656 m². None of these patches were categorized as “high” quality, six were of “moderate” quality, and twenty-five were of “low” quality (Table 37; Figure 103). Small gravel (4–11 mm, diameter) was present in five of these patches. Nine cold-water patches totaling 57.6 m² were observed (Figure 103); average temperature in these patches was 12.1° C and average temperature adjacent to these patches was 13.7° C. The dominant substrate types within these cold-water patches were fine sediment (n = 5), large gravel (n = 2), and large cobble (n = 2). There were no potential barriers to Chum Salmon migration in this reach.

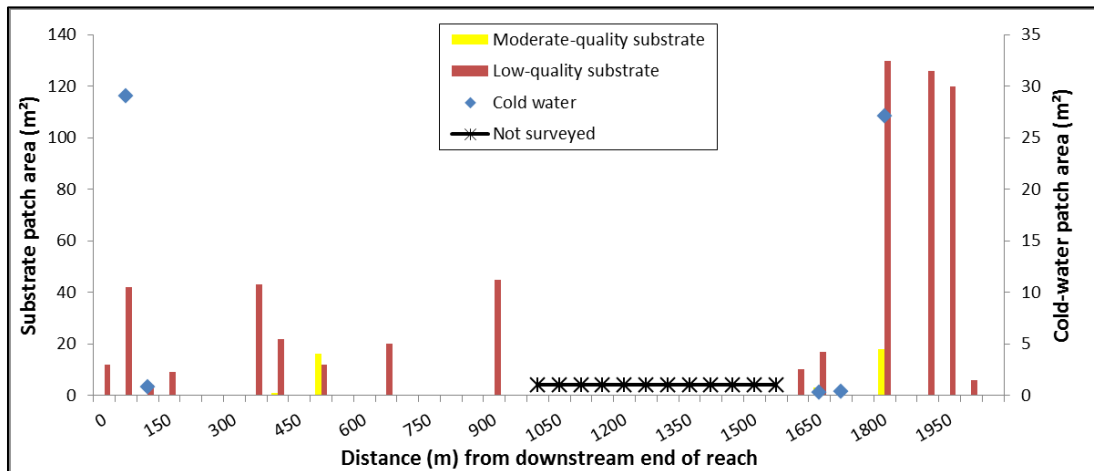
Figure 103. Location of substrate and cold-water patches measured as distance from downstream end of survey in reach 5 of the Clatskanie River, OR, in September 2012. For cold water and for each category of substrate quality, patch area was summed and binned into 50 m units. Cold-water patches were $\geq 1.0^\circ$ C colder than the temperature in the main channel.

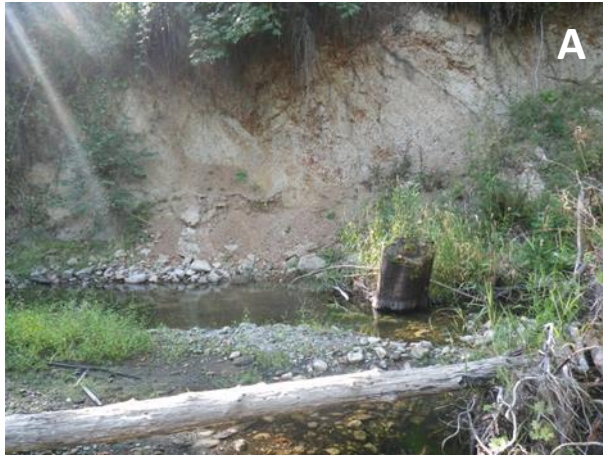
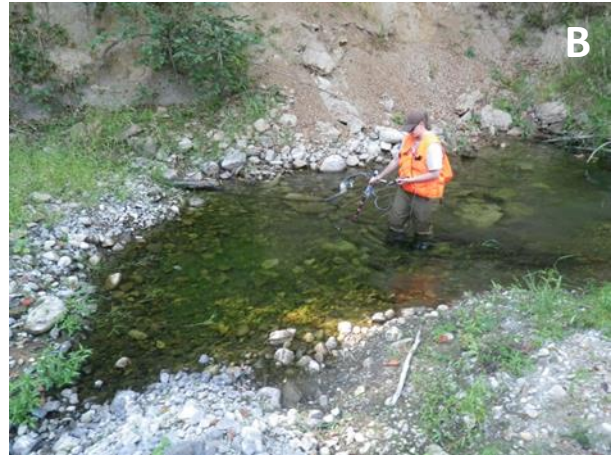
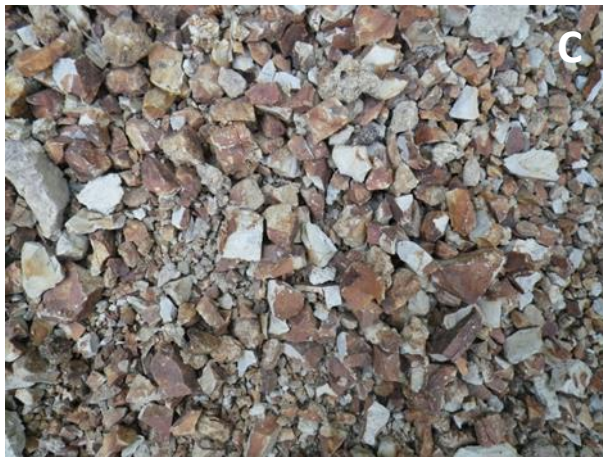
Reach 6 started adjacent to a house on county tax lot 7N4W2700 302 (Lat: 46.070484, Long: -123.163268) and continued upstream to a small farm at Lat: 46.067691, Long: -123.1641. The mainstem thalweg length of this reach was 508 m. There were two side channels with a combined thalweg length of 93 m. The channel was primarily unconfined, with multiple meanders. A large section of the river measuring 1.7 km, stretching from the upstream end of reach 6 to the downstream end of reach 7, was not surveyed due to several landowner denials. The riparian zone was dominated by trees along both banks, and land use was a mix of mature timber and rural residential. A large sandstone cliff on the river left bank was actively eroding into the stream channel (Figure 105, panel A).

Figure 105. Survey pictures on reach 6 of the Clatskanie River show a large, eroded, sandstone cliff (panel A), a cold-water patch in an isolated pool (panel B), and sandstone substrate throughout the river (panel C).

Five patches of suitable spawning substrate were found in reach 6 of the Clatskanie River (Table 38; Figure 106), measuring a total of 44 m². All patches were categorized as “low” quality (Table 38; Figure 106) and they all contained $\geq 75\%$ small cobble (Table 38). Several of the substrate patches in this reach consisted of sandstone rock (4–128 mm, diameter; Figure 105, panel C). One cold-water patch was observed, measuring 13.9 m² (Figure 106). The temperature in this patch was 13.9° C and temperature adjacent to this patch was 15.5° C. The dominant substrate type within this cold-water patch was large cobble (46–128 mm, diameter), and the patch was in an isolated pool in an otherwise dry side channel (Figure 105, panel B). There were no potential barriers to Chum Salmon migration in this reach.

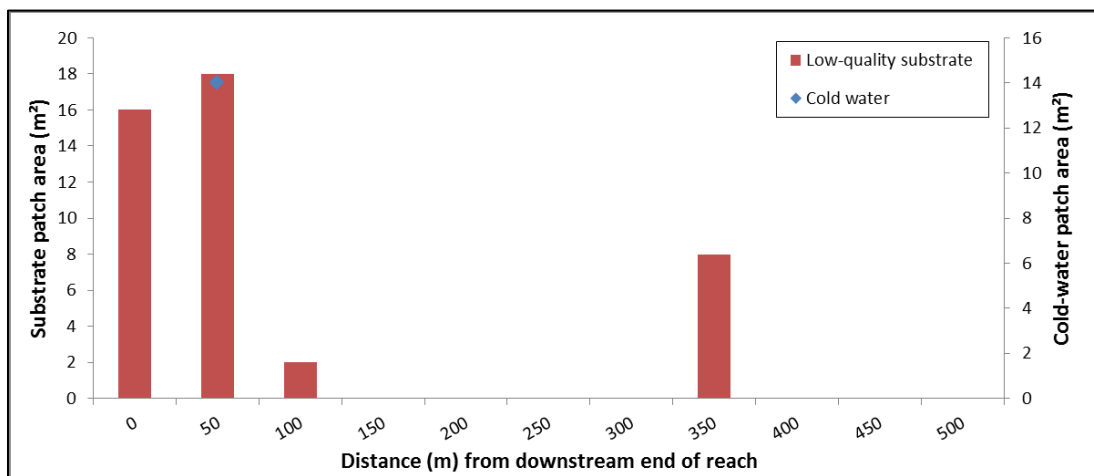
Figure 106. Location of substrate and cold-water patches measured as distance from downstream end of survey in reach 6 of the Clatskanie River, OR, in September 2012. For cold water and for low-quality substrate, patch area was summed and binned into 50 m units. Cold-water patches were $\geq 1.0^{\circ}$ C colder than the temperature in the main channel.

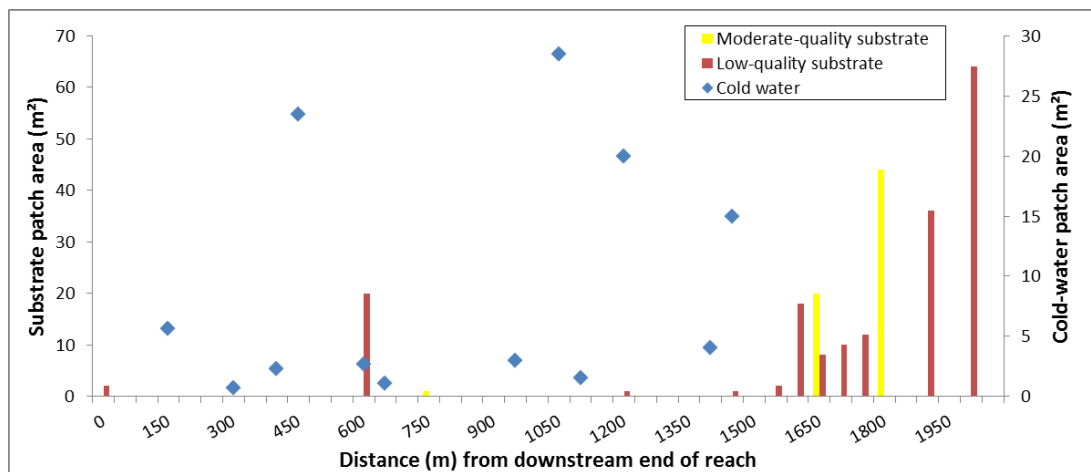
Figure 109. Location of substrate and cold-water patches measured as distance from downstream end of survey in reach 7 of the Clatskanie River, OR, in September 2012. For cold water and for each category of substrate quality, patch area was summed and binned into 50 m units. Cold-water patches were $\geq 1.0^{\circ}$ C colder than the temperature in the main channel.

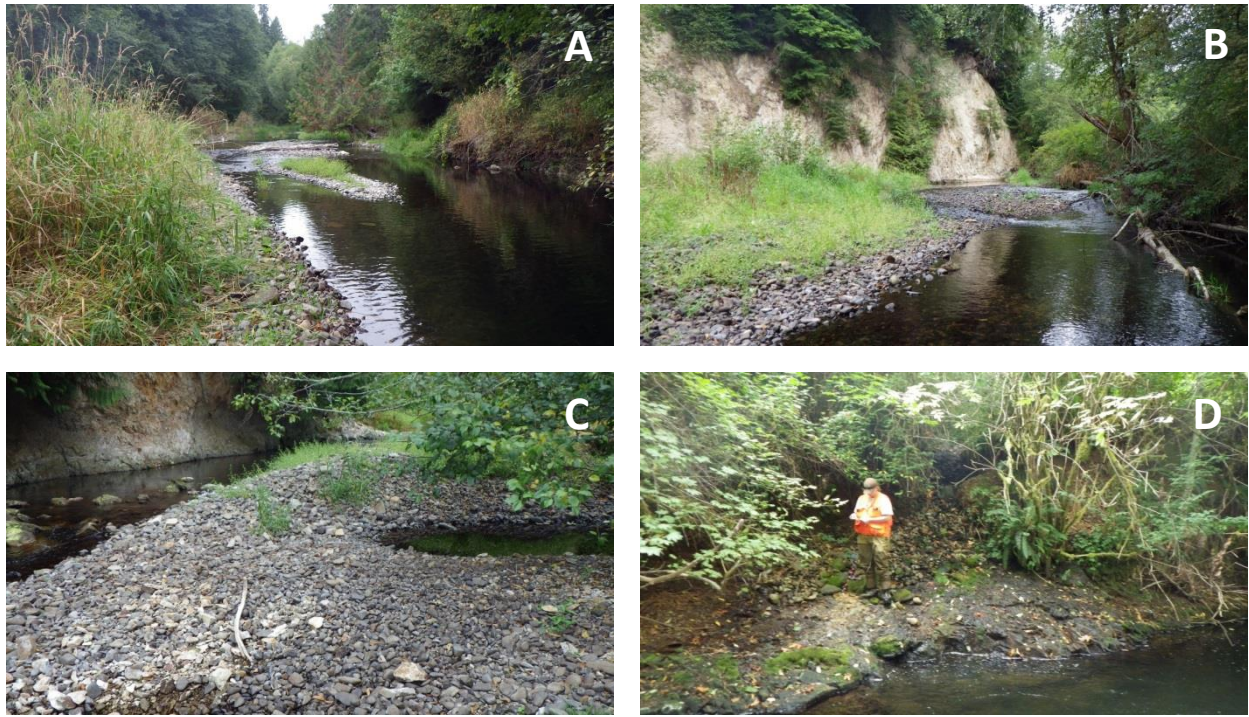
Reach 8 started at the confluence with Miller Creek (Lat: 46.04778, Long: -123.144593) and continued upstream to the confluence with Adams Creek (Lat: 46.048399, Long: -123.131204; Figure 110). The mainstem thalweg length of this reach was 1,405 m. There was one side channel with a thalweg length of 43 m, and multiple meanders were observed throughout. Channel form was unconfined and braided. The riparian zone was dominated by with grasses, alders, firs, and cedars (Figure 111, panel A), but there were also several sandstone cliffs in the riparian zone (Figure 111, panel B). Land use was primarily mature timber.

Figure 111. Survey pictures on reach 8 of the Clatskanie River show a riparian zone with a mix of grass, alder, Western Red Cedar and Douglas Fir (panel A), a large sandstone cliff along the river (panel B), a dry side channel with multiple substrate patches (panel C), and a cold-water seep flowing over a bedrock shelf (panel D).

Forty-eight patches of suitable spawning substrate were found in reach 8 of the Clatskanie River (Table 40; Figure 112), measuring a total of 2,362 m². Several substrate patches were found in dry side channel sections (Figure 111, panel C). One of these patches was categorized as “high” quality, six patches were of “moderate” quality, and 41 patches were of “low” quality (Table 40; Figure 112). Forty-two of these patches contained $\geq 50\%$ small cobble (Table 40). Four cold-water patches were observed, totaling 30.2 m² (Figure 112); average temperature in these patches was 12.4° C and average temperature adjacent to these patches was 13.9° C. The dominant substrate types within these cold-water patches were fine sediment (n = 1), small gravel (n = 1), small cobble (n = 1), and bedrock (n = 1). One of the cold-water patches was a seep flowing out of a bedrock shelf (Figure 111, panel D). There were no potential barriers to Chum Salmon migration in this reach.

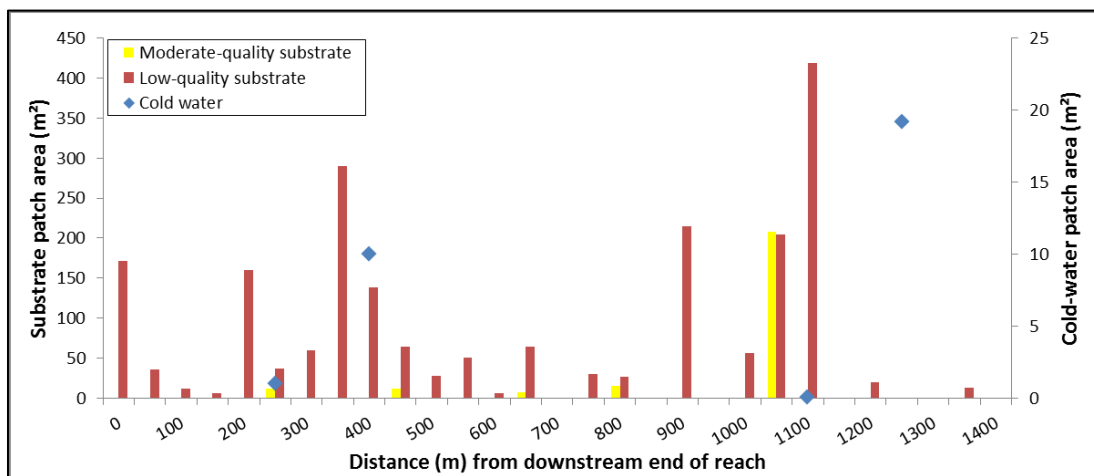
Figure 112. Location of substrate and cold-water patches measured as distance from downstream end of survey in reach 8 of the Clatskanie River, OR, in September 2012. For cold water and for each category of substrate quality, patch area was summed and binned into 50 m units. Cold-water patches were $\geq 1.0^{\circ}$ C colder than the temperature in the main channel.

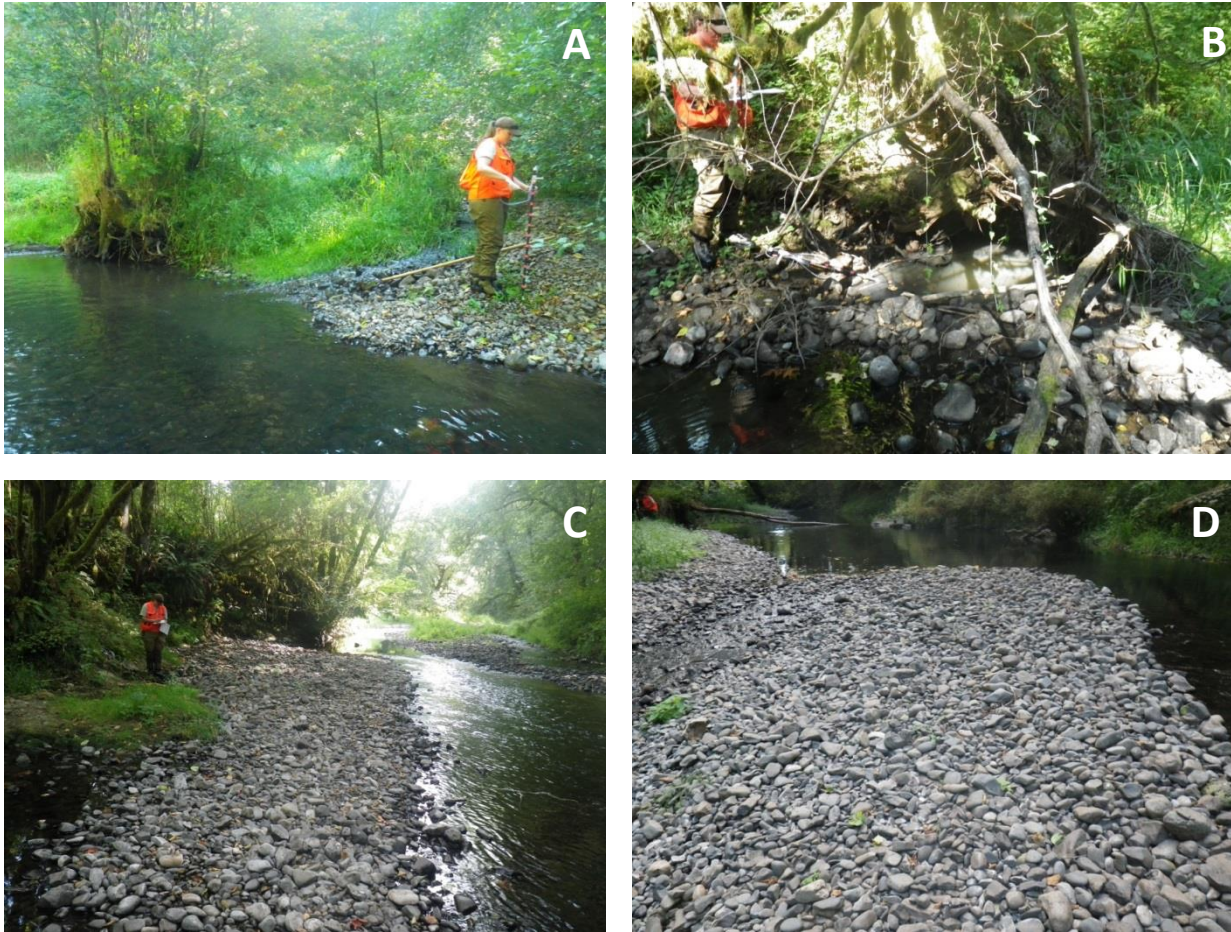
Reach 9 started at the confluence with Adams Creek (Lat: 46.048399, Long: -123.131204; Figure 114, panel A) and continued upstream to a small unnamed tributary 1 km upstream from the Swedetown Road bridge (Lat: 46.045236, Long: -123.110811; Figure 113). The mainstem thalweg length of this reach was 1,953 m, with no side channels. The channel was unconfined and braided. The riparian zone was dominated by grasses and older alders, firs, and cedars (Figure 114, panels A and B). Land use was a mix of young and mature timber.

Figure 114. Survey pictures on reach 9 of the Clatskanie River show the confluence with Adams Creek at the downstream end of the reach (panel A), a grey colored cold-water patch at the base of a tree (panel B), a substrate patch adjacent to a cold-water patch (panel C), and a large substrate patch (panel D).

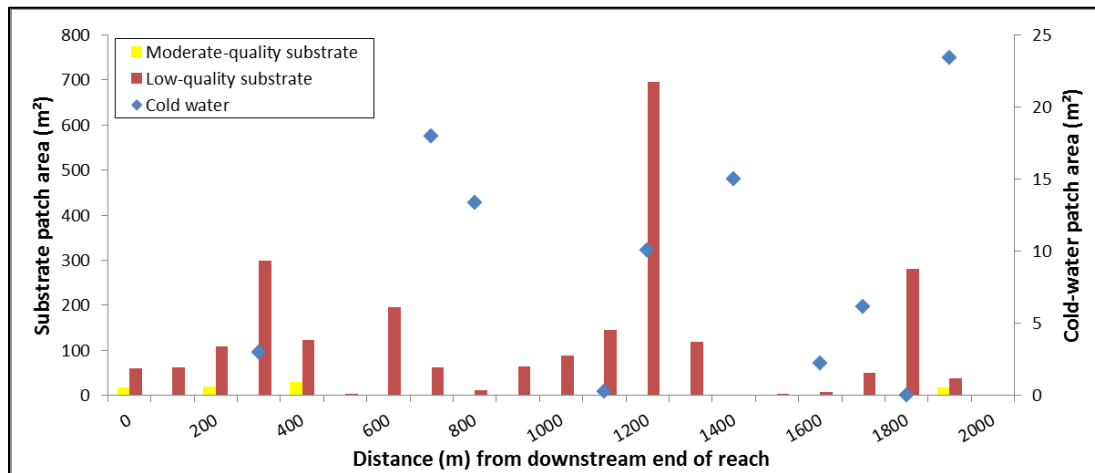
Figure 115. Location of substrate and cold-water patches measured as distance from downstream end of survey in reach 9 of the Clatskanie River, OR, in September 2012. For cold water and for each category of substrate quality, patch area was summed and binned into 100 m units. Cold-water patches were $\geq 1.0^\circ\text{C}$ colder than the temperature in the main channel.

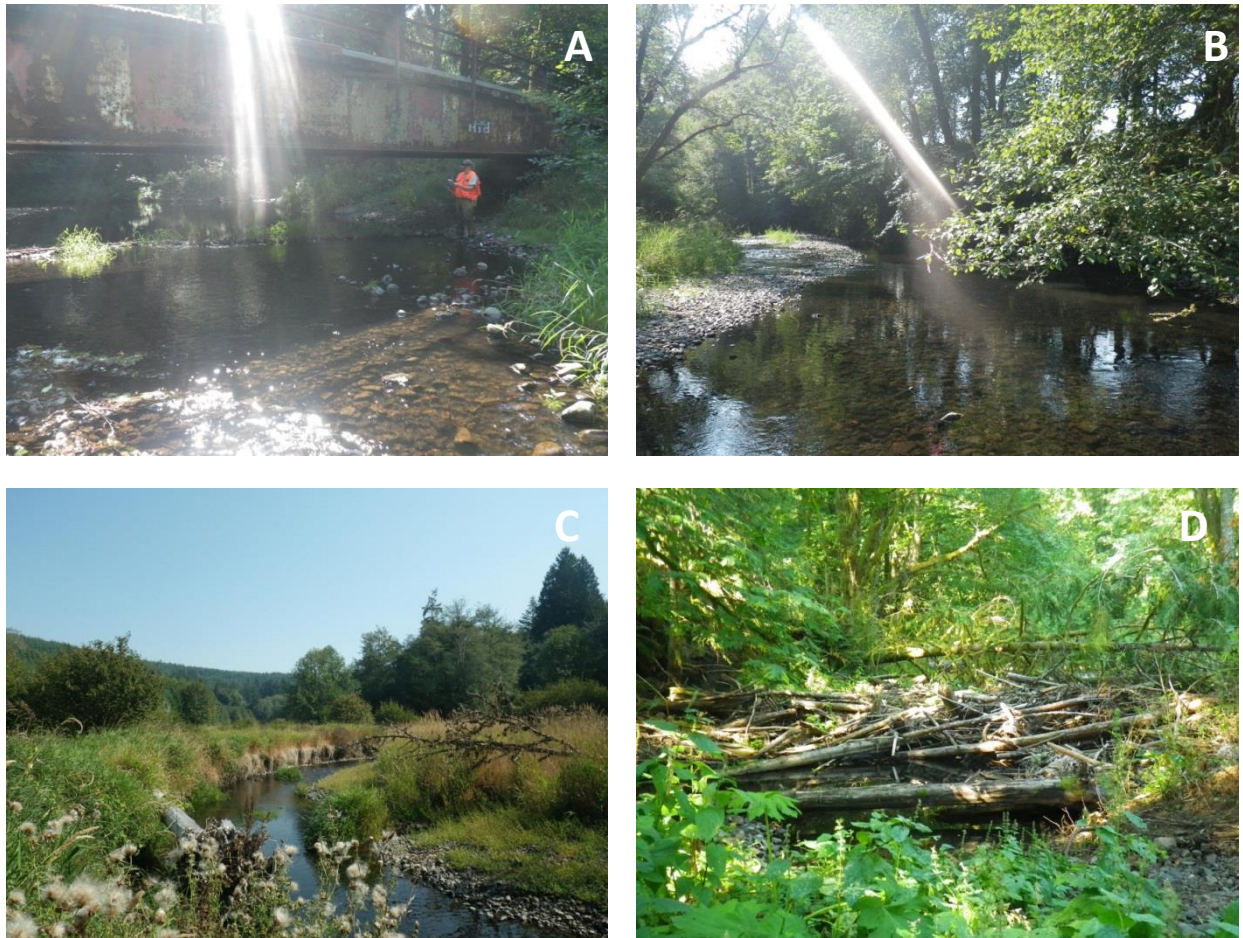
Figure 117. Survey pictures on reach 10 of the Clatskanie River show a bridge at the upstream end of reach (panel A), an alder-dominated riparian zone near the downstream end of the reach (panel B), a grass-dominated riparian zone at the middle of the reach (panel C), and a log jam in a dry side channel (panel D).

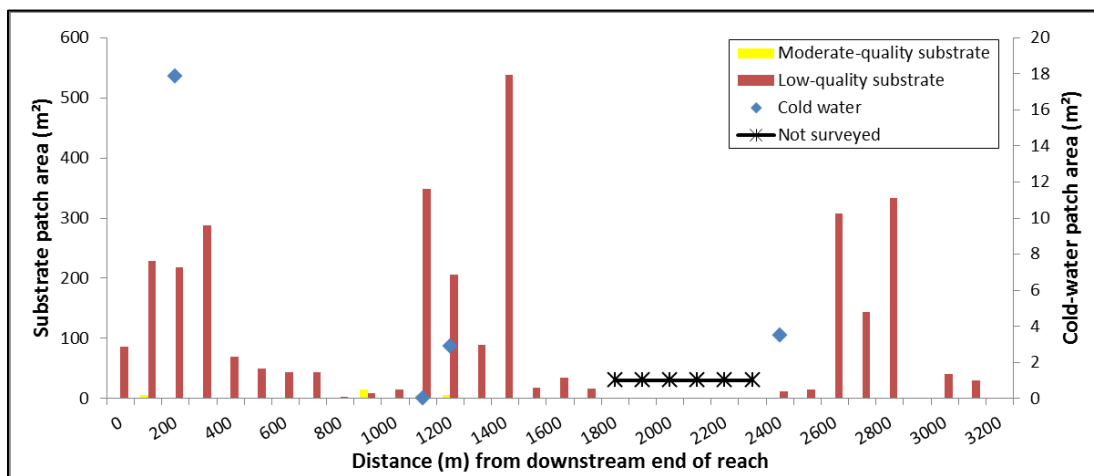
Figure 118. Location of substrate and cold-water patches measured as distance from downstream end of survey in reach 10 of the Clatskanie River, OR, in September 2012. For cold water and for each category of substrate quality, patch area was summed and binned into 100 m units. Cold-water patches were $\geq 1.0^{\circ}$ C colder than the temperature in the main channel.

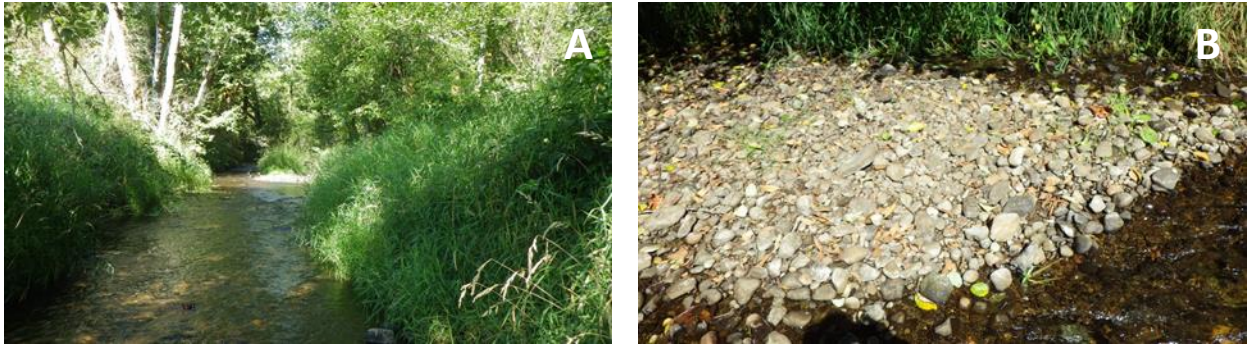
Figure 121. Survey pictures of reach 2 of Conyers Creek show a section of stream with a grass-dominated riparian zone (panel A) and a “low” quality substrate patch with large gravel and elevated levels of fine sediment (panel B).

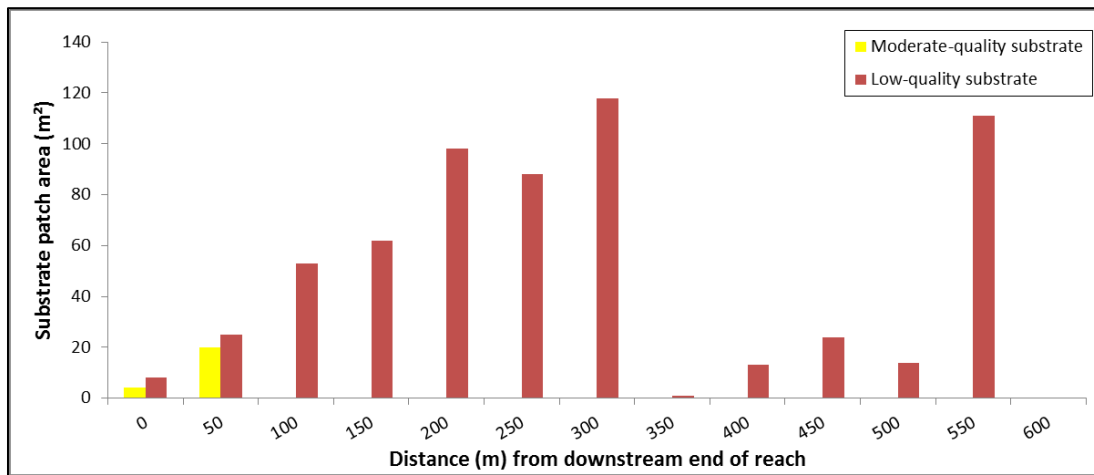
Figure 122. Location of substrate patches measured as distance from downstream end of survey in reach 2 of Conyers Creek, OR, in September 2012. For each category of substrate quality, patch area was summed and binned into 50 m units.

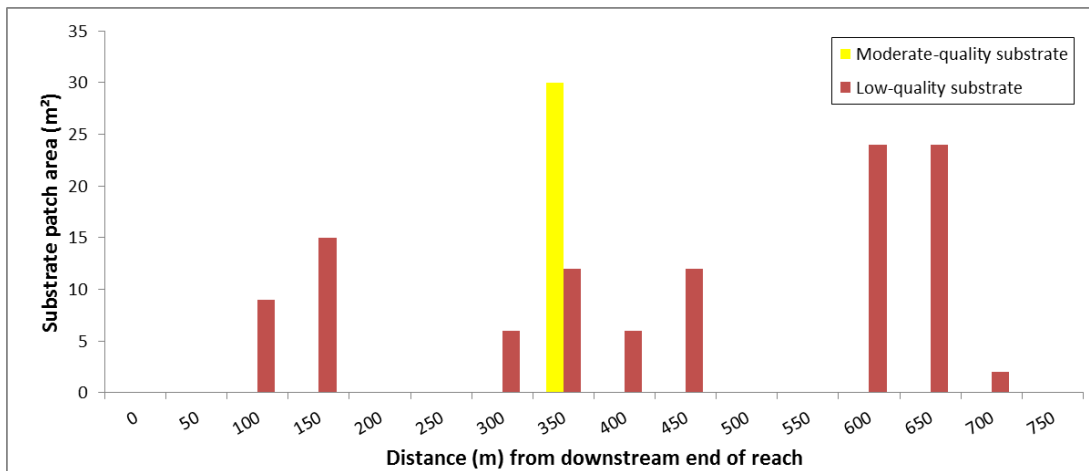
Figure 125. Location of substrate and cold-water patches measured as distance from downstream end of survey in reach 3 of Conyers Creek, OR, in September 2012. For each category of substrate quality, patch area was summed and binned into 50 m units.

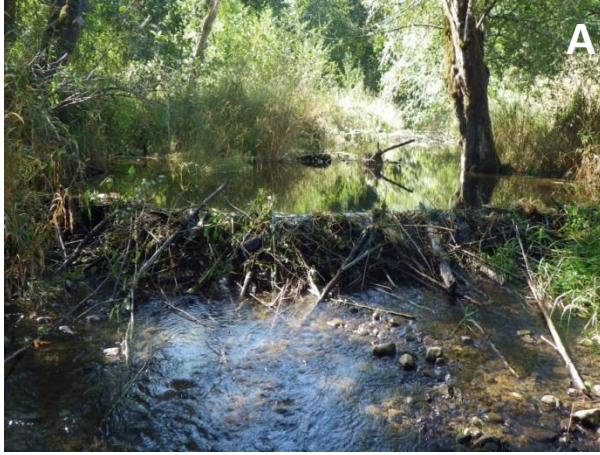
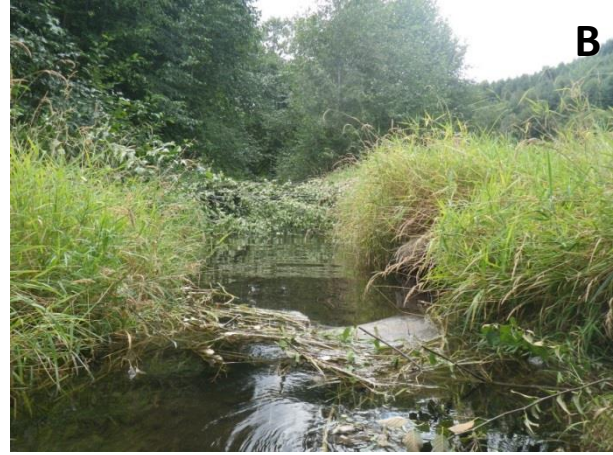
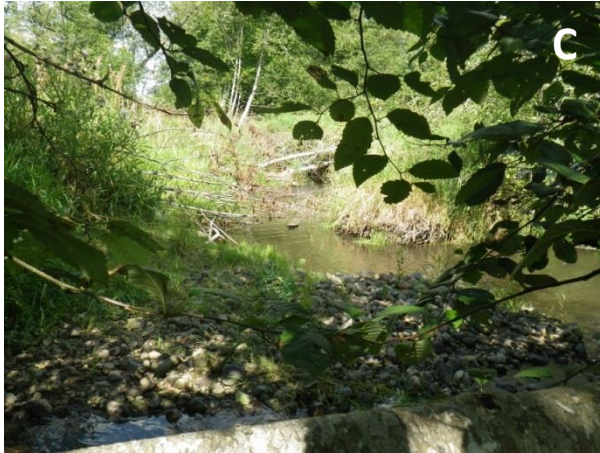
Figure 127. Survey pictures of reach 4 on Conyers Creek show several beaver dams near the downstream end of the reach (panels A and B), and gravel accumulation upstream of a large log jam (panel C).

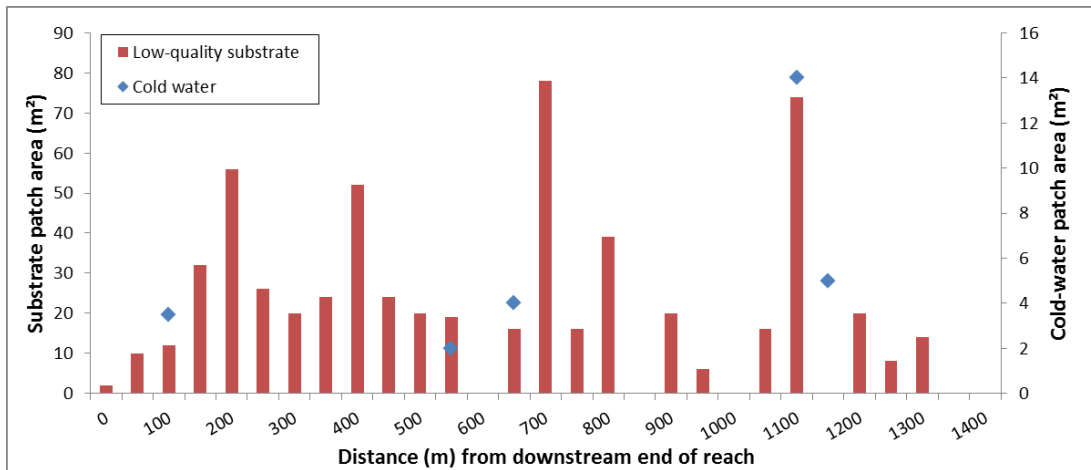
Figure 131. Location of substrate and cold-water patches measured as distance from downstream end of survey in reach 5 of Conyers Creek, OR, in July 2013. For cold water and for low-quality substrate, patch area was summed and binned into 50 m units. Cold-water patches were $\geq 1.0^{\circ}$ C colder than the temperature in the main channel.

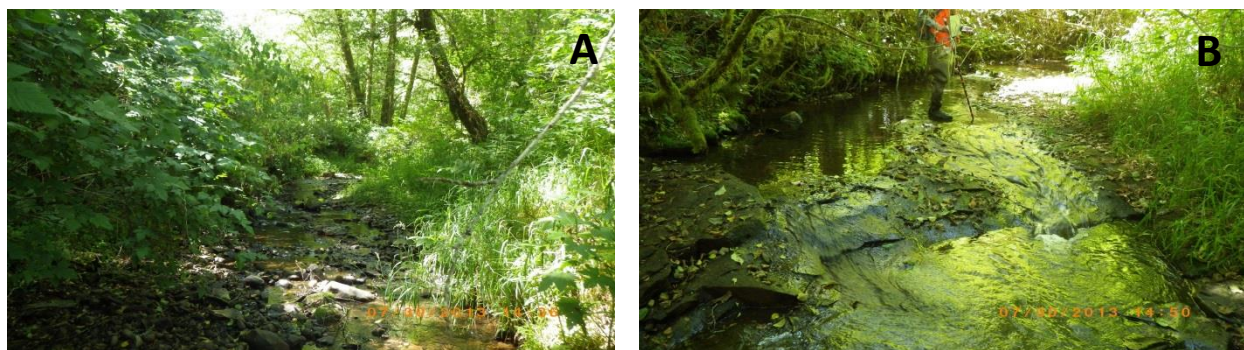
with shrubs and alders (Figure 133, panel A), and land use was rural residential. Gravel was present in the downstream end of this reach; however, bedrock was observed throughout the reach (Figure 133, panel B).

Figure 133. Survey pictures of reach 1 on Conyers Creek tributary show a riparian zone with shrubs and alders (panel A) and the creek flowing over bedrock (panel B).

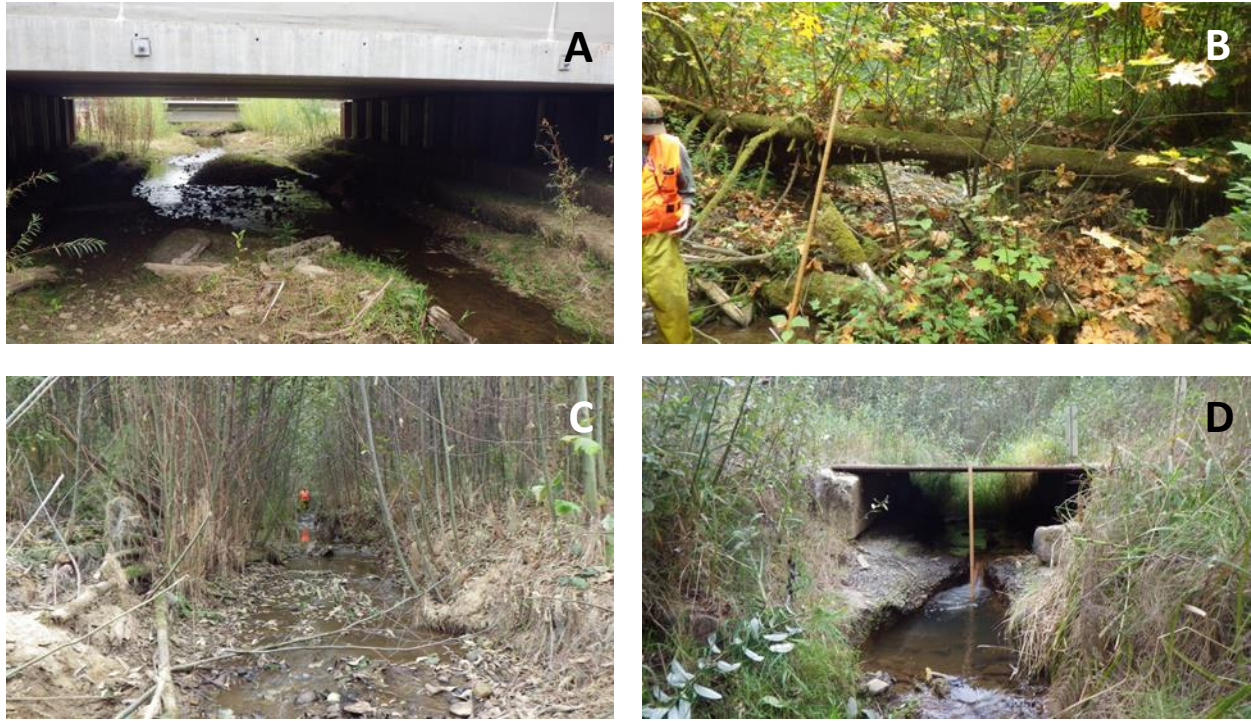
Figure 135. Survey pictures on Eilertsen Creek show the Highway 30 bridge (panel A), large woody debris at the upstream end of the reach (panel B), a section of stream where young alders dominate the riparian zone (panel C), and a temporary bridge (panel D).

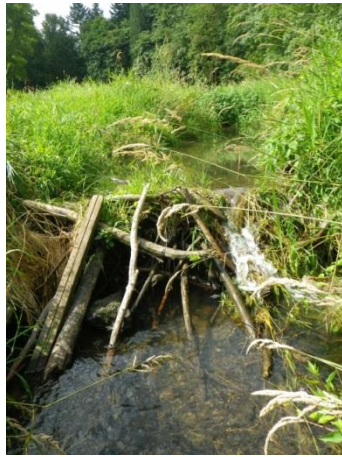
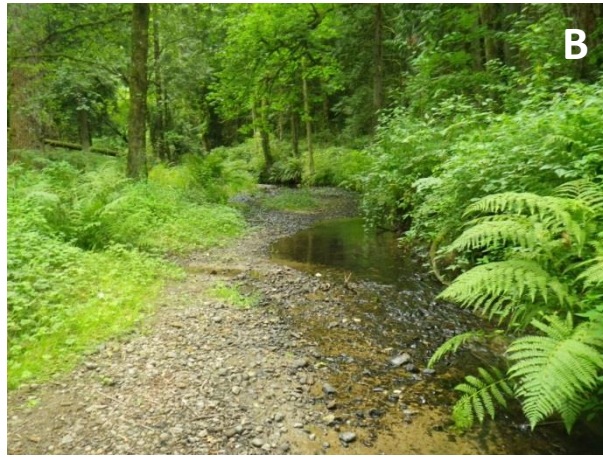
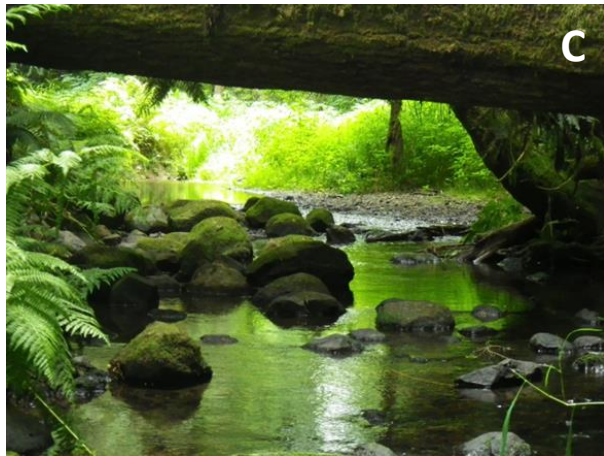
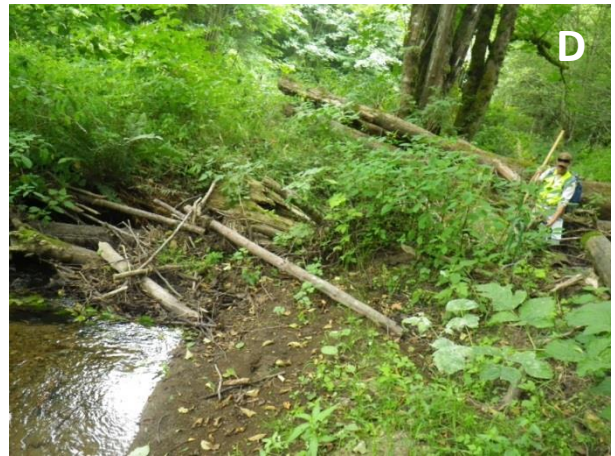
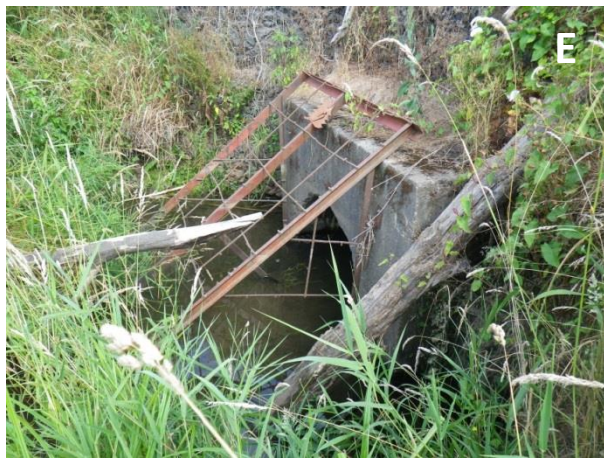
Figure 140. Survey pictures on Fox Creek show a beaver dam and a grass-dominated riparian zone (panel A), dense riparian vegetation near the middle of the reach (panel B), a section of stream with large boulders (panel C), a log jam located in the upstream quarter of the reach (panel D), a semicircular culvert that runs under the town of Rainier (panel E), and one of two box culvert barriers located in the upper half of the reach (panel F).

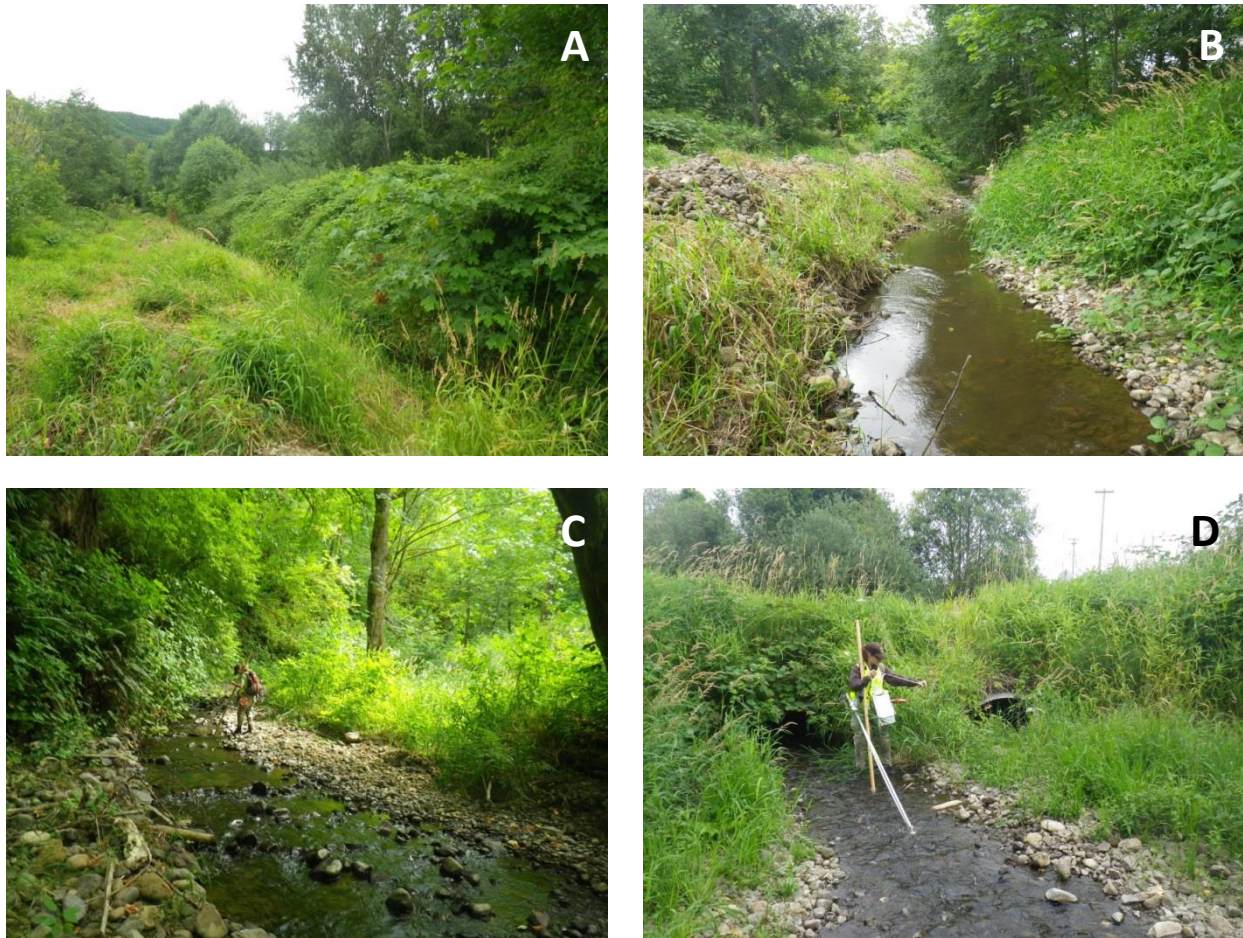
Figure 143. Survey pictures on Graham Creek show a riparian zone dominated by grass and shrub in the lower half of the reach (panel A), an artificially straightened section of stream with piles of substrate on the river-right bank (panel B), a section of stream upstream of Colvin Road (panel C), and two adjacent circular culverts under Highway 30 (panel D).

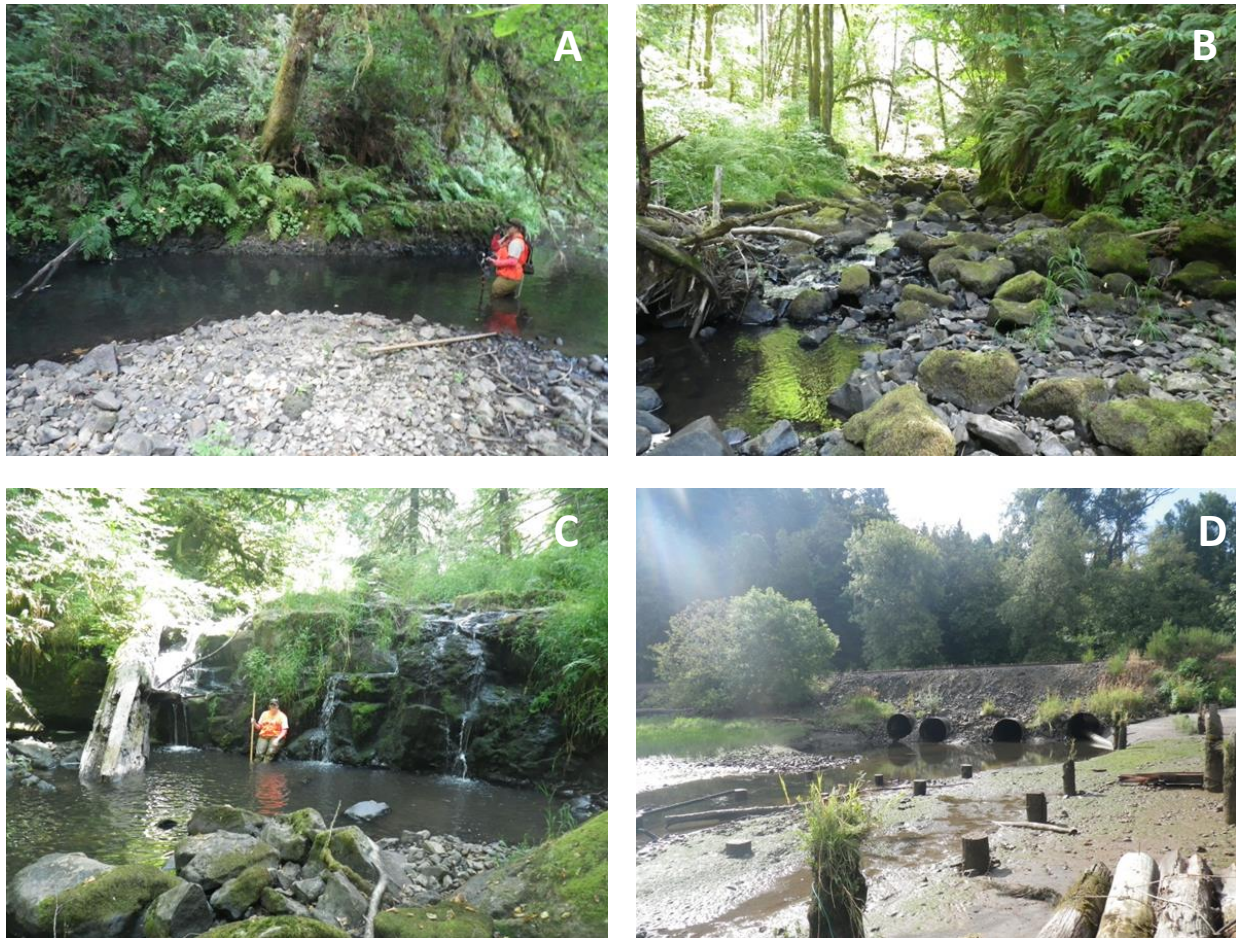
Figure 146. Survey pictures on Green Creek show a deep bedrock pool near the downstream end of the reach (panel A), a high gradient section of stream with numerous boulders (panel B), a waterfall at the upstream end of the reach (panel C), and a set of four adjacent circular culverts located under a railroad bridge in tidewater (panel D).

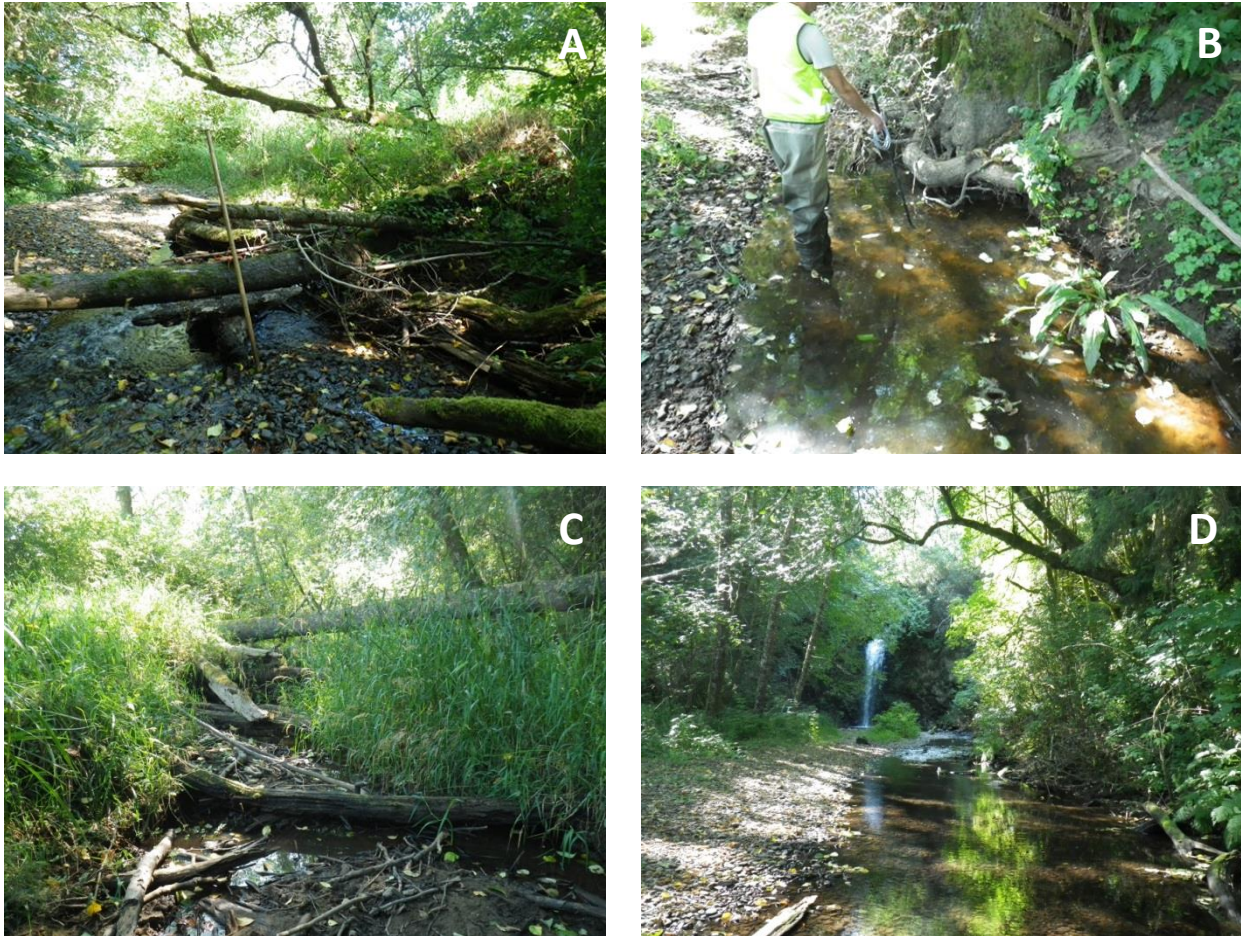
Figure 149. Survey pictures on Hunt Creek show a log jam separating a dry side channel (left) and the main channel (right; panel A), an isolated cold-water patch located in the otherwise dry side channel (panel B), woody debris and mud in the dry side channel (panel C), and the waterfall at the upstream end of the reach (panel D).
