Chum Salmon Spawning Habitat Report
for the Clatskanie River and Scappoose Creek Populations

Oregon Department of Fish and Wildlife

November 2017

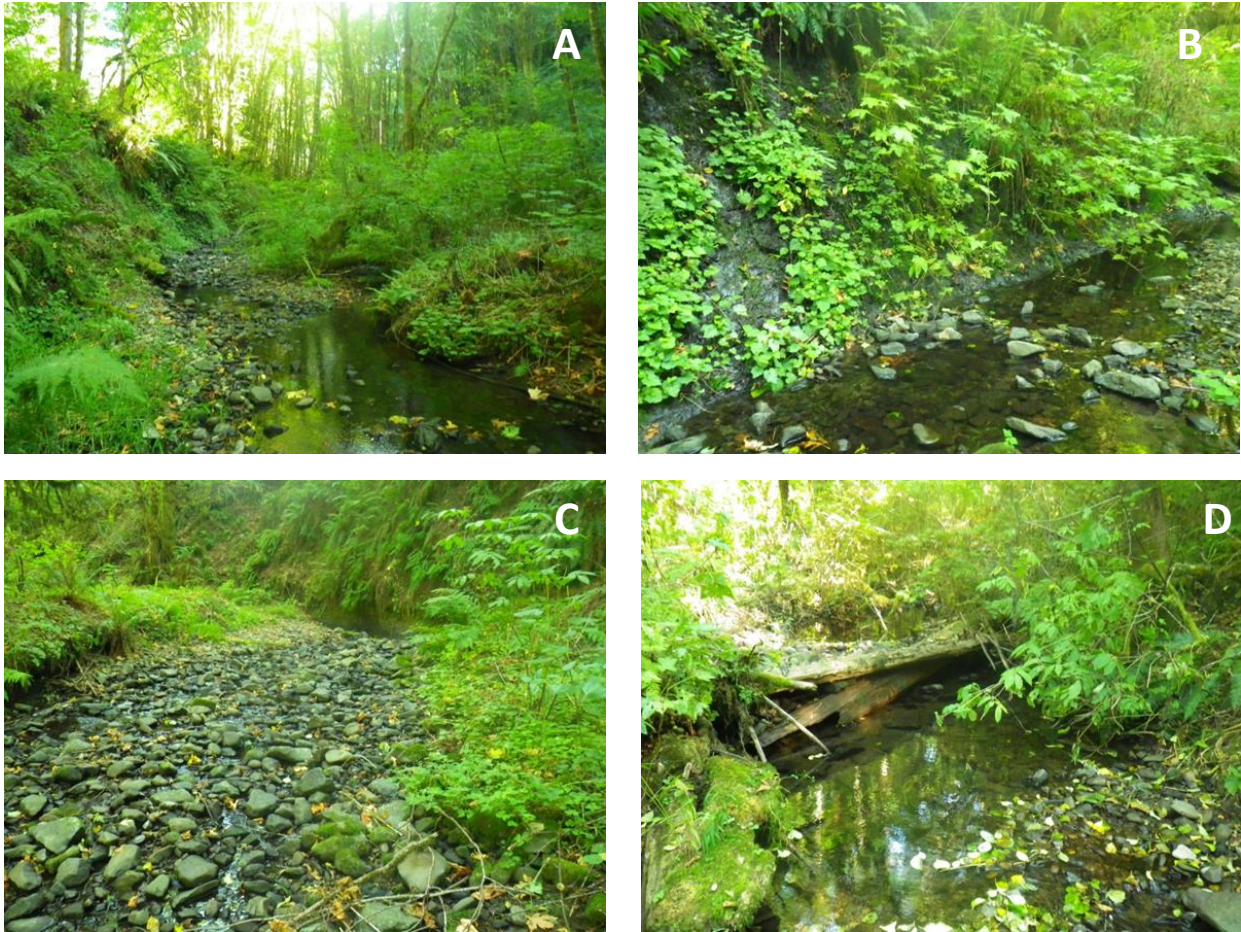
Figure 152. Survey pictures in reach 1 of Keystone Creek show dense riparian vegetation (panel A), a bedrock shelf along the creek (panel B), a section of stream with large cobble substrate (panel C), and a step pool near the upstream end of the reach (panel D).

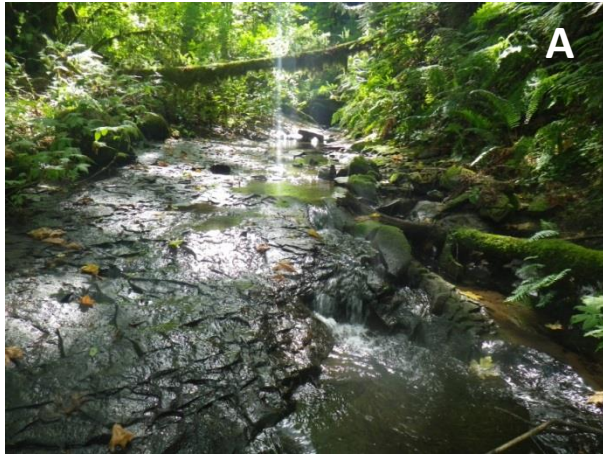
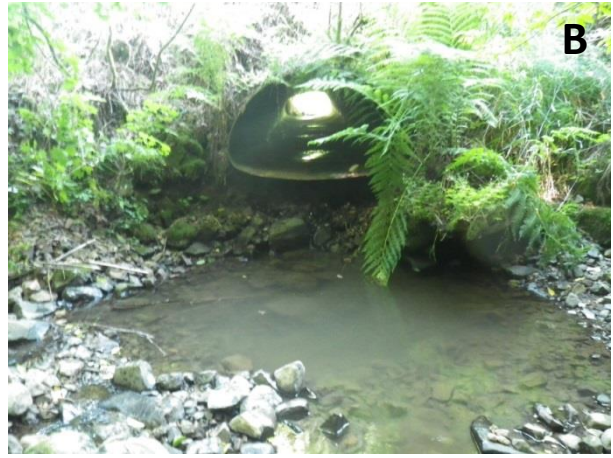
Figure 155. Survey pictures of Keystone Creek reach 2 show the creek flowing over bedrock (panel A), a semicircular culvert located at the upstream end of the reach (panel B), a waterfall barrier over bedrock (panel C), and a cascading section of stream in the upper quarter of the reach (panel D).

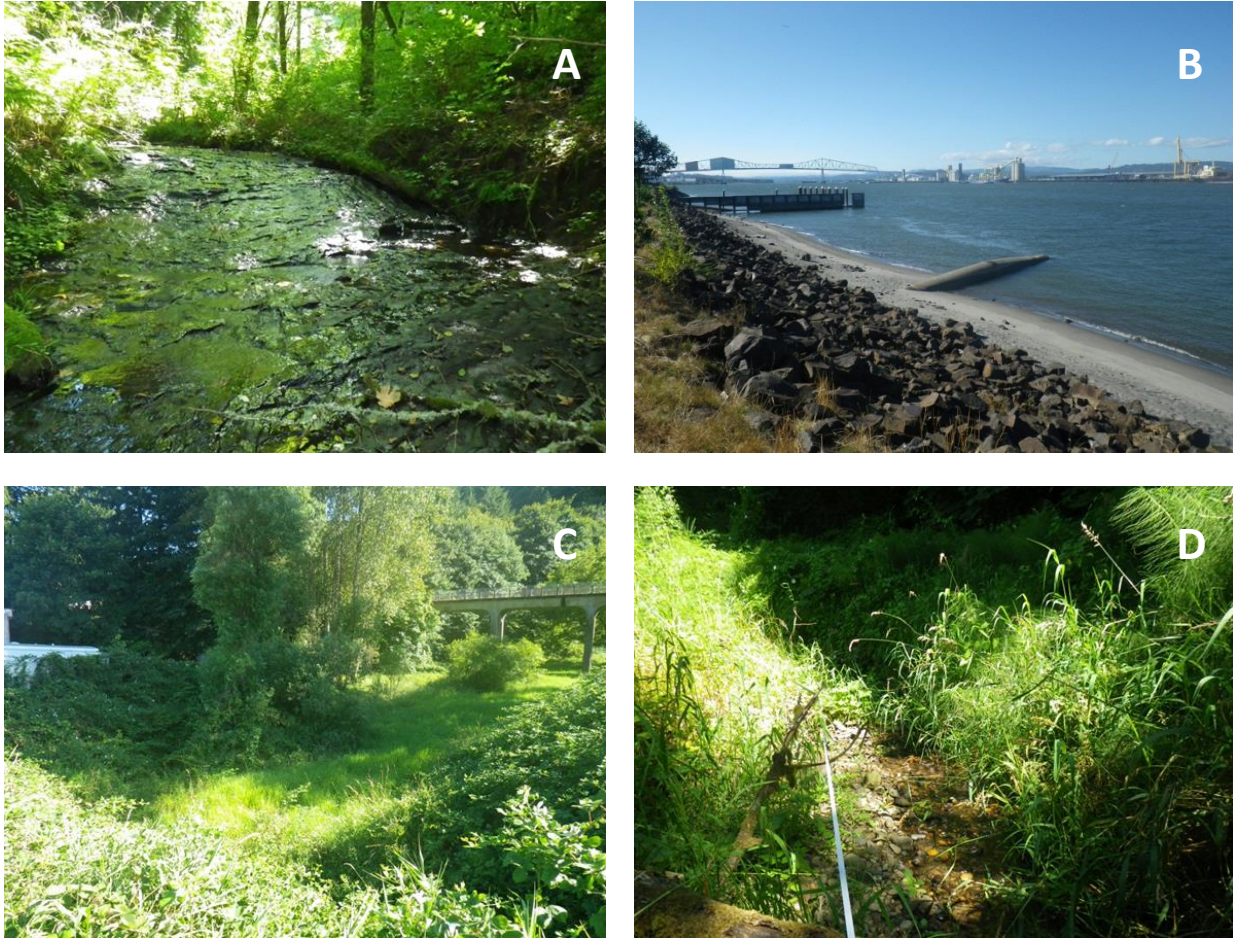
Figure 158. Survey pictures on Nice Creek show a bedrock cascade at the upstream end of the reach (panel A), the downstream end of the culvert where Nice Creek flows into the Columbia River (panel B), a view from the downstream end of the reach showing a riparian zone dominated by grass and blackberry (panel D), and an area of small and large gravel substrate (panel D).

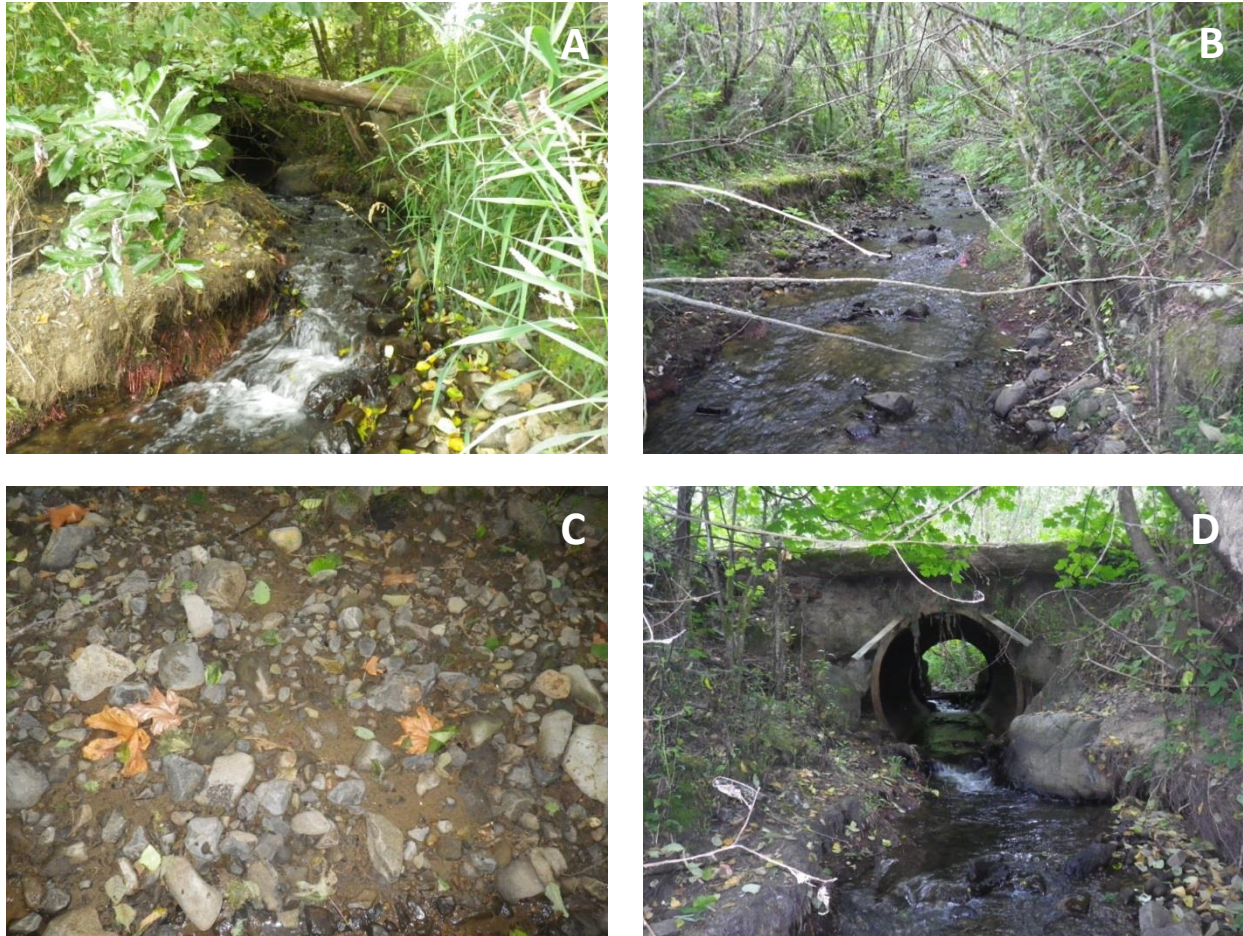
Figure 161. Survey pictures on OK Creek show a riffle (panel A), entrenched channel along the stream banks (panel B), substrate section with > 50% fine sediment (panel D), and a circular culvert under Colvin Road (panel D).

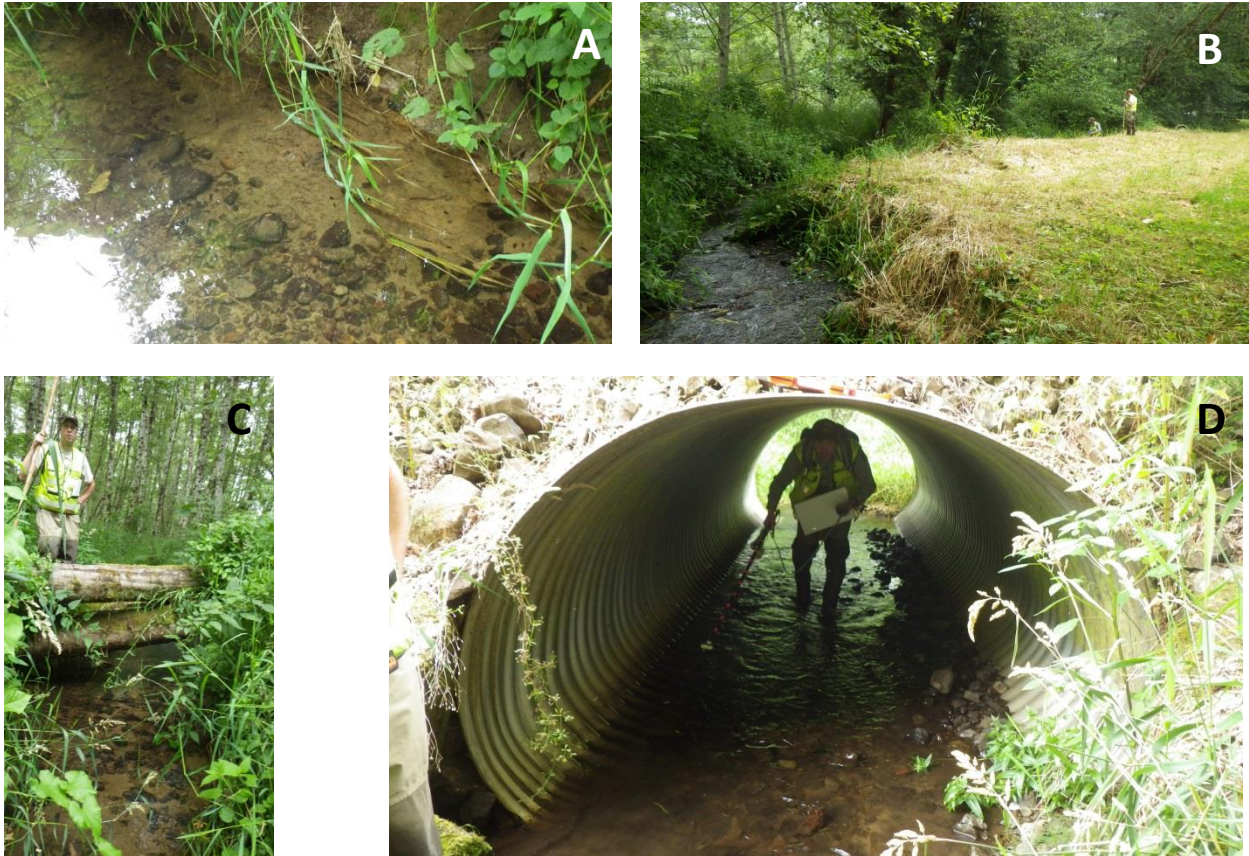
Figure 163. Survey pictures on Perkins Creek show hardpan clay along streambed (panel A), a maintained yard in the riparian zone (panel B), alder-dominated riparian zone in downstream half of the reach (panel C), and a circular culvert under a gravel road (panel D).

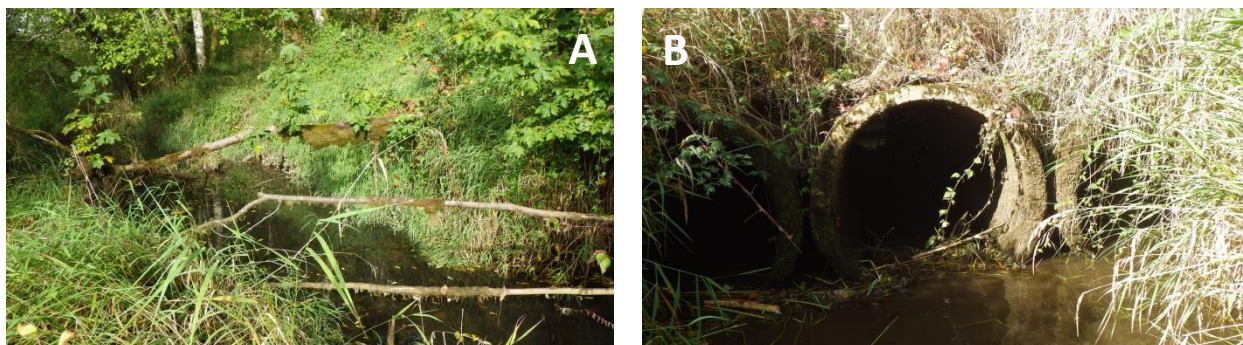
Figure 167. Survey pictures of Stewart Creek show a tidal channel downstream from the reach (panel A) and three adjacent circular culverts under Rutter Road (panel B).

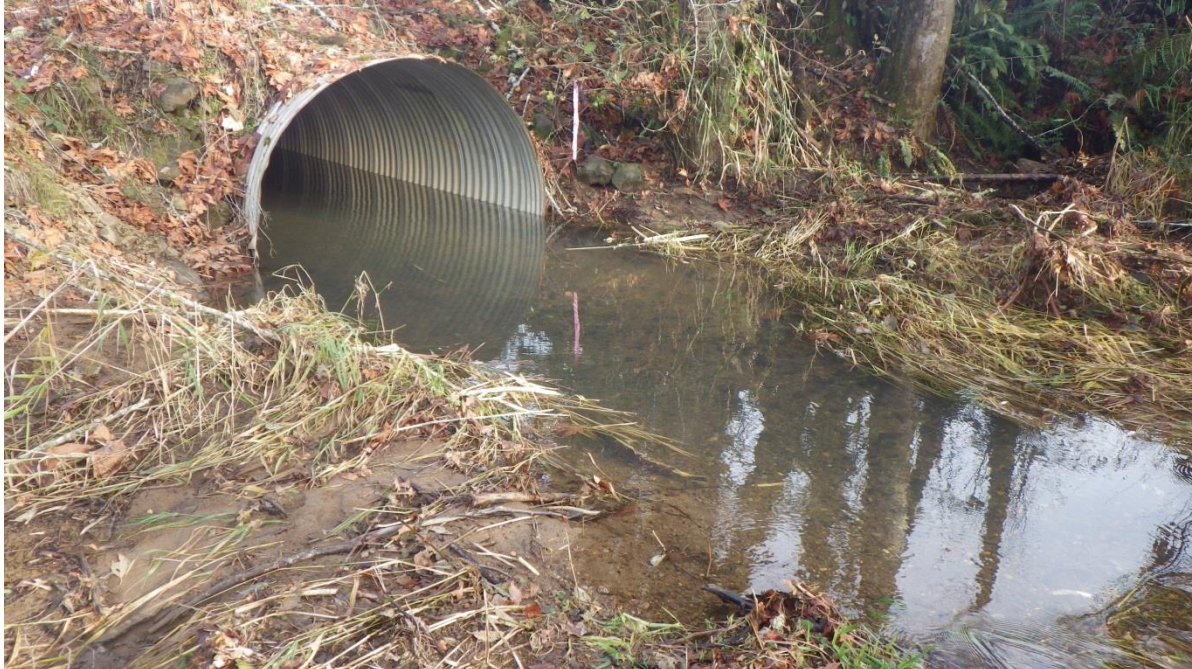
Figure 169. A circular culvert, under a logging road, located at the upstream end of the reach on North Fork Stewart Creek (picture taken in the fall 2012).

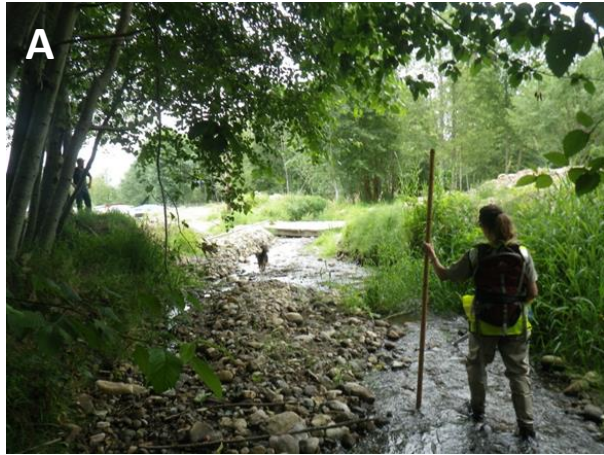
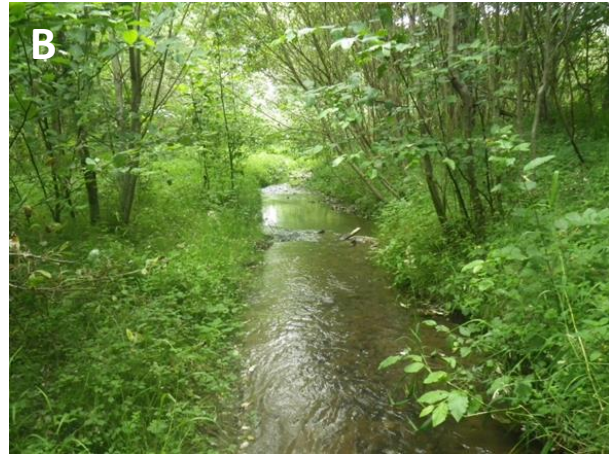
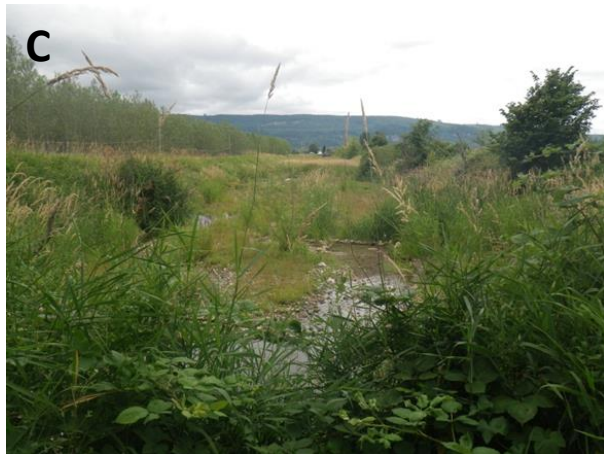
Figure 173. Survey pictures on Tandy Creek showing the creek immediately downstream of Colvin Road (panel A) and a section of creek upstream (panel B) and downstream (panel C) of Highway 30.

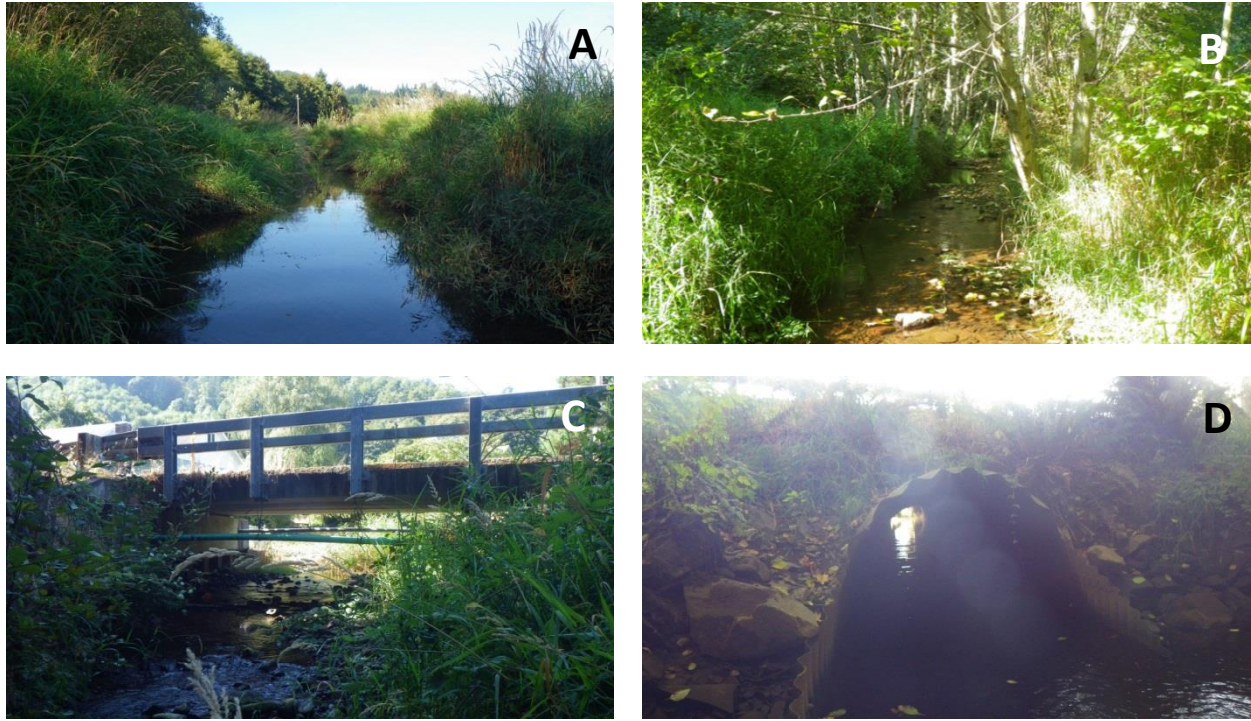
Figure 175. Survey pictures on West Creek show a tidally-influenced section of stream at the downstream end of the reach (panel A), a riparian zone dominated by young alders and grass (panel B), a bridge on Hungry Hollow Loop at the upstream end of the reach (panel C), and a circular culvert under Highway 30 (panel D).

The West Creek habitat survey (Township: 7N Range: 6W Section: 1A) started at the Burlington Northern railroad bridge adjacent to Highway 30 (Lat: 46.12638, Long: -123.365352; Figure 174), and continued upstream to the first Hungry Hollow Loop bridge (Lat: 46.128403, Long: -123.372035; Figure 175, panel C). The survey consisted of one reach with a mainstem thalweg length of 592 m, few meanders, and no side channels. In the section between the railroad and Highway 30 the stream channel was tidally influenced with several large pools and the riparian vegetation was dominated by grasses (Figure 175, panel A). The section upstream from

Highway 30 was characterized by an increase in riffle habitat and a decrease in pools, as well as a riparian zone that was densely vegetated with alders (Figure 175, panel B). Land use was urban, and a portion was considered rural residential.

Substrate suitable for chum spawning was observed in this reach of West Creek, however because fine sediment levels were > 20%, no suitable spawning habitat was identified. No cold-water patches were found. There was one potential barrier to Chum Salmon migration in this reach, classified as a semicircular culvert located under Highway 30 in the middle of the reach (Figure 174; Table 72; Figure 175, panel D).
