Chum Salmon Spawning Habitat Report for the Youngs Bay and Big Creek Populations

Oregon Department of Fish and Wildlife

November 2017

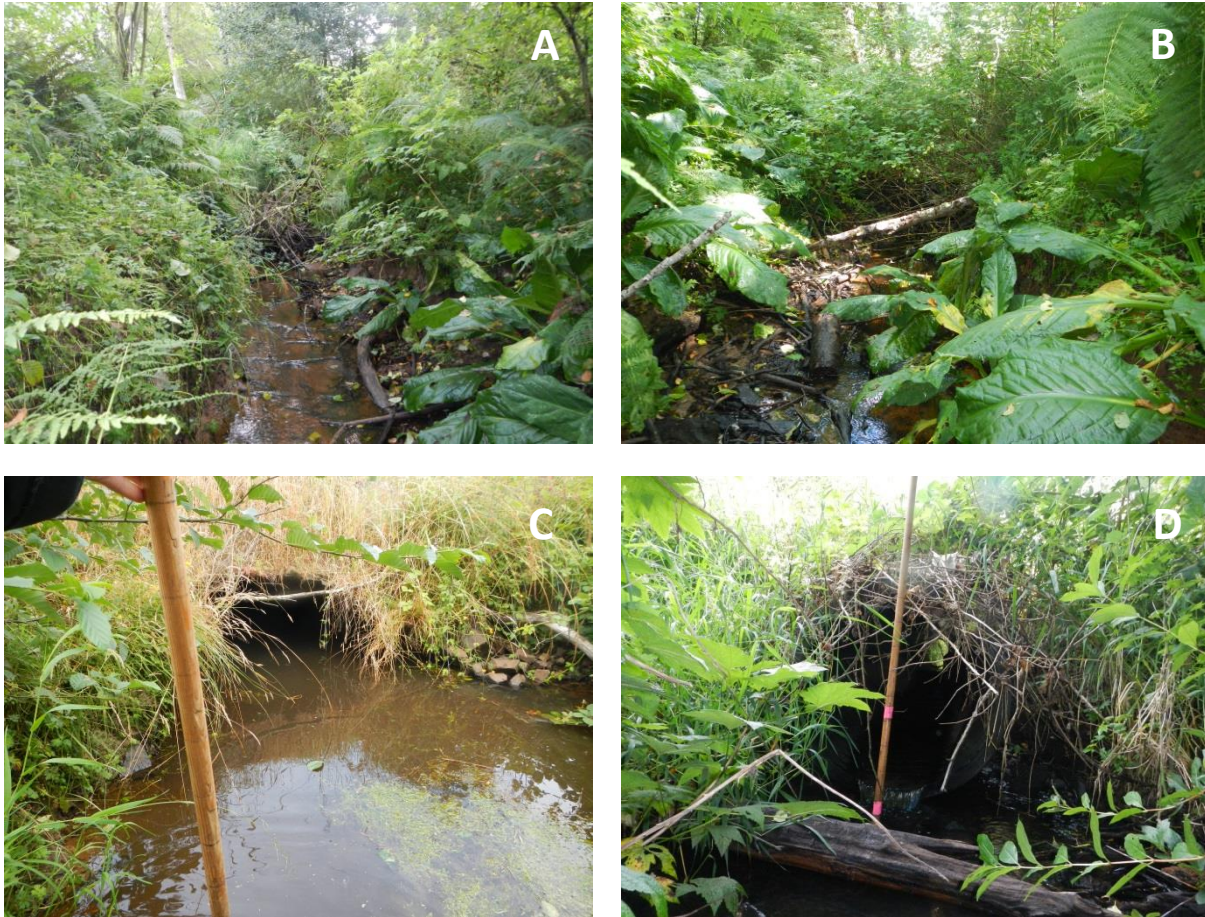
Figure 3. Survey pictures on Barrett Creek show a riparian zone dominated by alder and shrub (panel A), substantial quantities of woody debris within the stream channel (panel B), a semicircular culvert under Lewis and Clark Road located at the downstream end of the reach (panel C), and a circular culvert under Conifer Lane located at the upstream end of the reach (panel D).

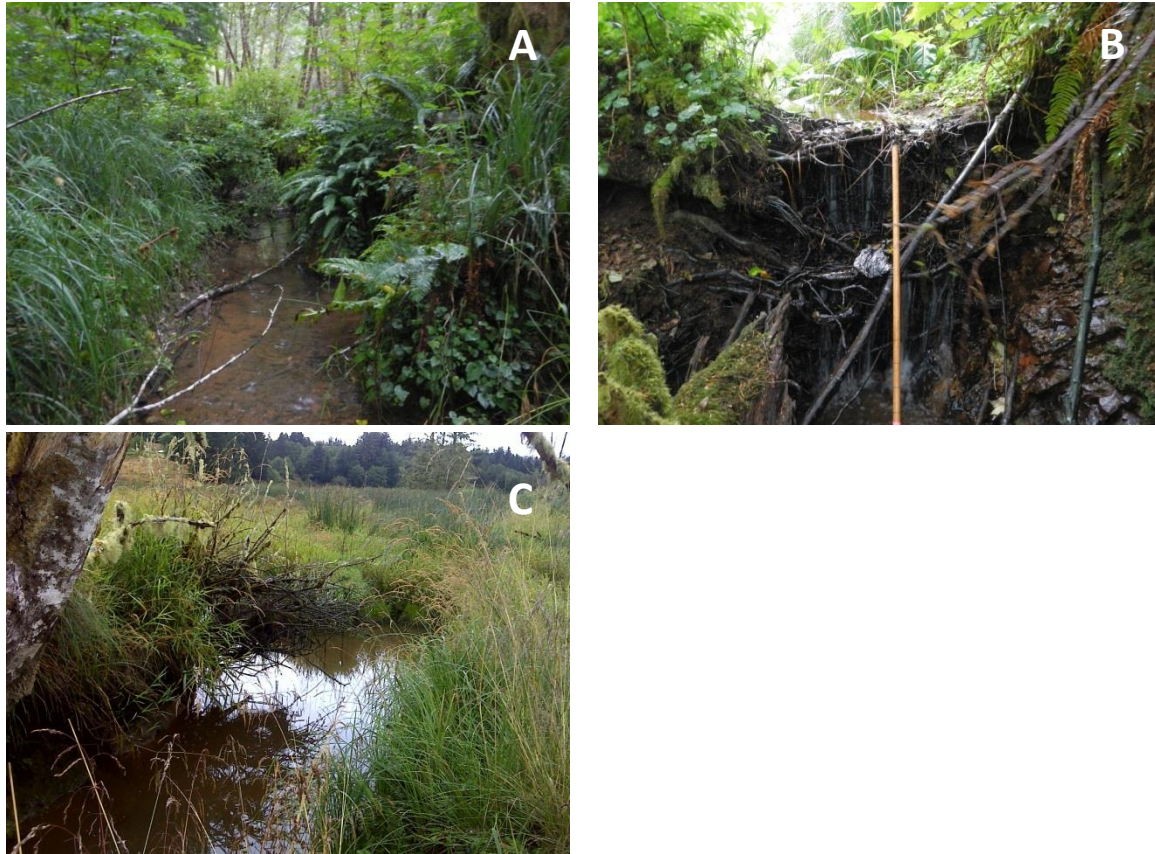
Figure 5. Survey pictures on Colewort Creek showing an alder and shrub dominated riparian zone (panel A), a waterfall located upstream from the end of the reach (panel B), and tidal channel downstream of the reach (panel C).

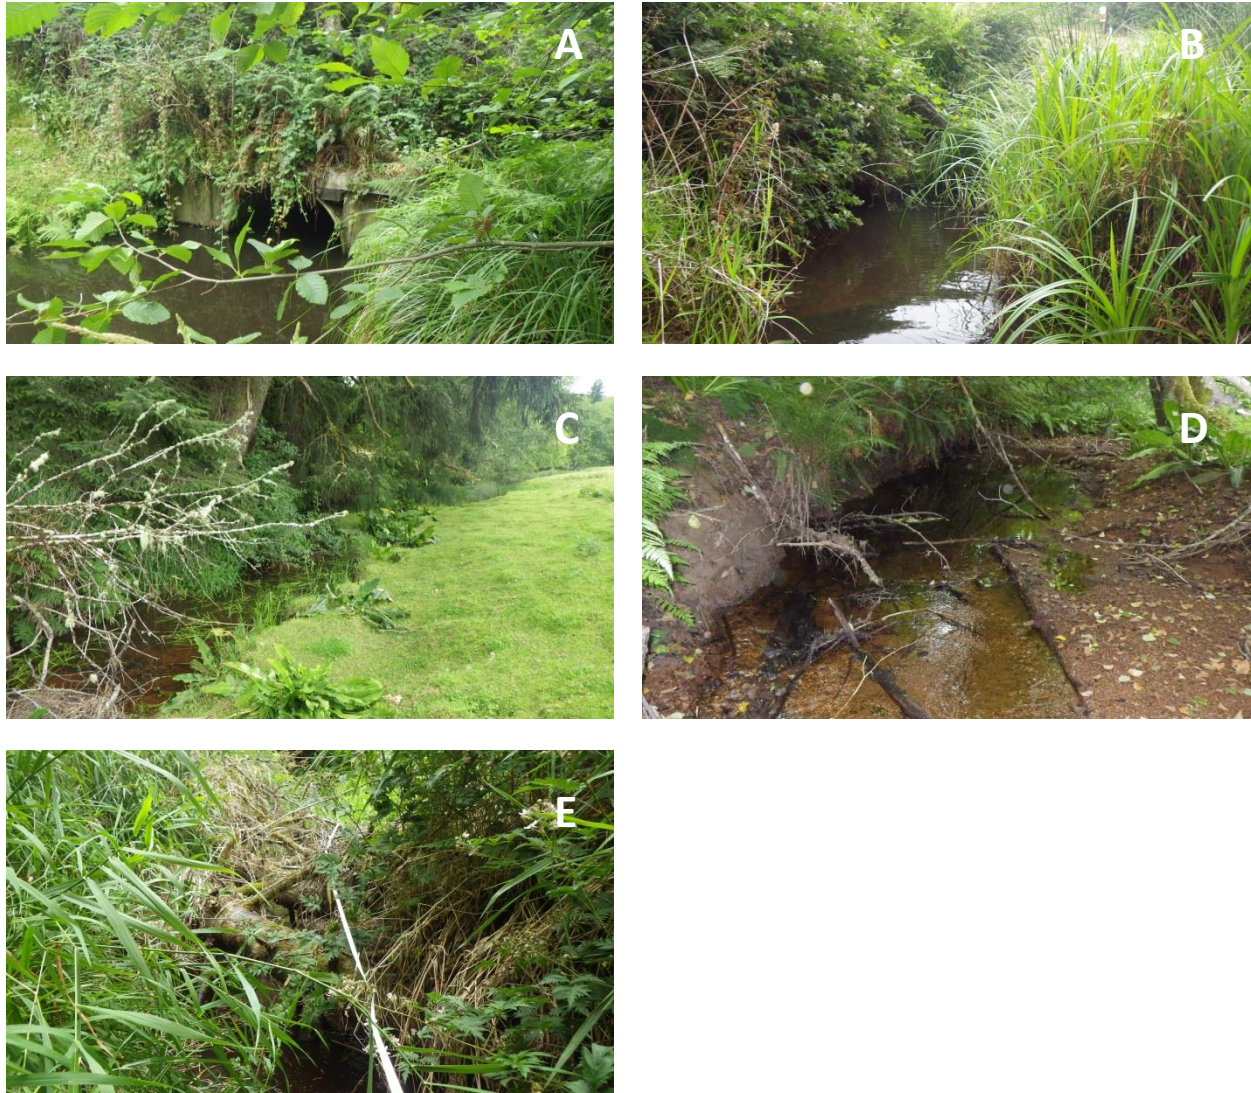
Figure 7. Survey pictures on Johnson Creek showing a circular culvert downstream of the reach start under Loukas Lane (panel A), a slough channel downstream from reach 2 (panel B), dense brush and grass along the stream channel in reach 2 (panel C), a streambed consisting of silt and mud (panel D), and dense woody debris within the stream channel (panel E).

The streambed in Johnson Creek consisted of mud and fine sediment (<4 mm diameter) with limited substrate in larger size classes (Figure 7, panel D). There were no gravel patches observed that met minimum the criteria established. There were also no cold-water patches that were $\geq 0.5^{\circ}$ C colder than the main channel water temperature. There were no potential barriers to Chum Salmon migration in this reach; however, there was one potential barrier observed downstream of the reach start, a circular culvert (Table 3; Figure 7, panel A).

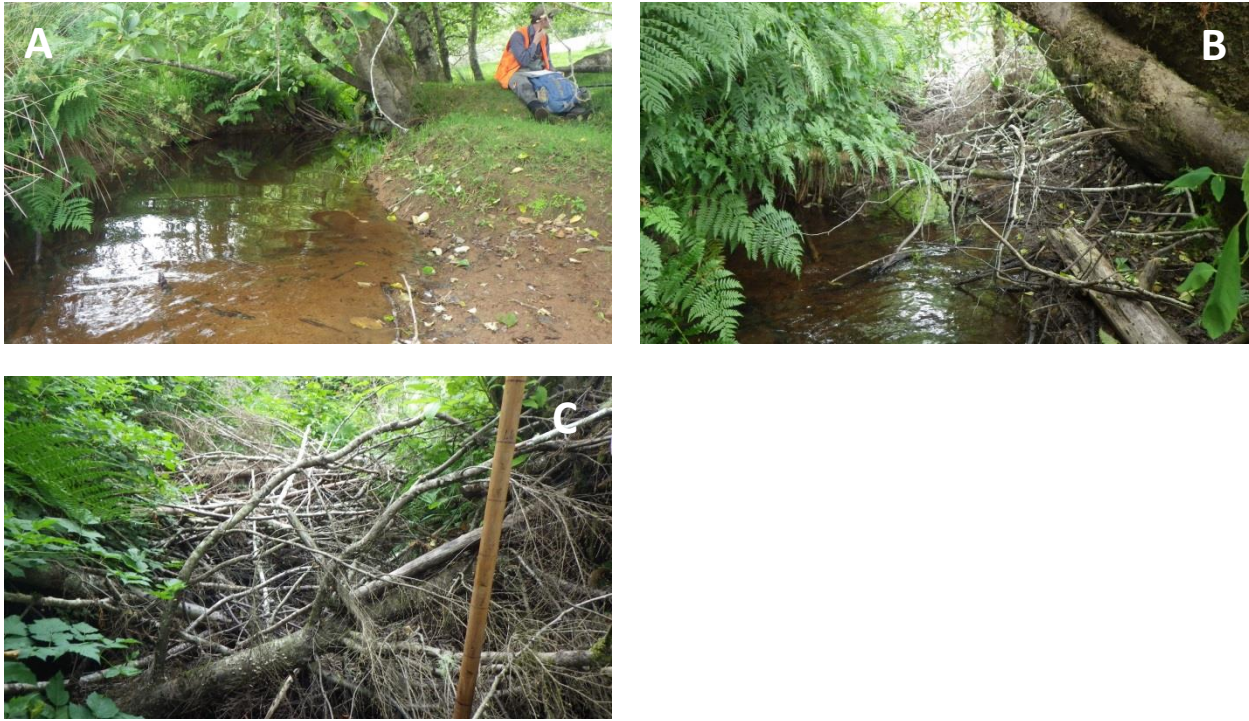
Figure 8. Survey pictures on Abercrombie Creek showing the streambed dominated by fine sediments and a grass-covered bank (panel A) and dense woody debris within the stream channel (panels B and C).

Substrate in Abercrombie Creek consisted of small and large gravel (4–45 mm, diameter); however, fine sediment levels were > 20%, so no suitable spawning habitat that met the minimum criteria were observed. No cold-water patches were found. There were no potential barriers to Chum Salmon migration in this reach.

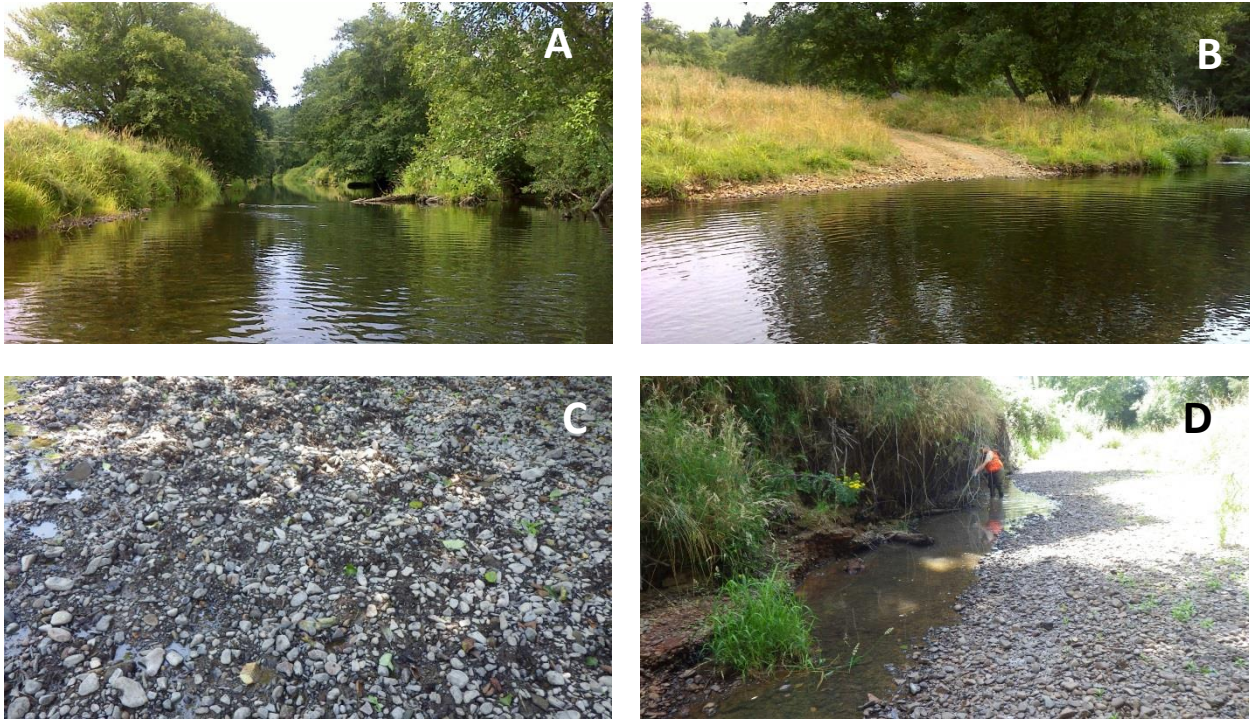
Figure 11. Survey pictures on reach 1 of the Lewis and Clark River showing a long pool section of stream with grass and alder dominated riparian vegetation (panel A), a farm road bridge along the streambed (panel B), hoof depressions from cattle in the stream channel (panel C), and an isolated cold-water patch in a side channel (panel D).

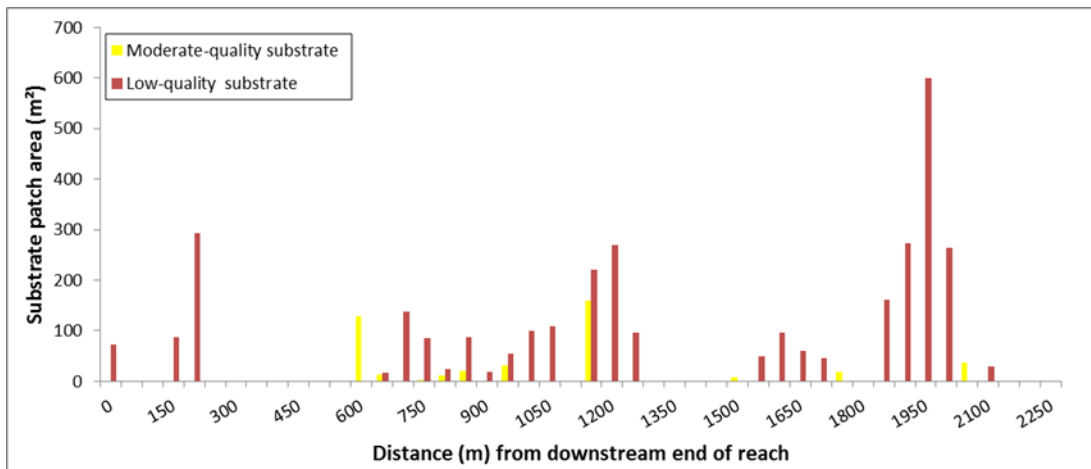
RESULTS: Forty-five patches of suitable spawning substrate were found in reach 1 of the Lewis and Clark River (Table 4; Figure 12), measuring a total of 3,681 m². None of these patches were categorized as “high” quality, 12 patches were of “moderate” quality, and 33 patches were of “low” quality (Table 4; Figure 12). Several of these substrate patches were observed in the creek near an instream road crossing (Figure 11, panel B). Twenty-two cold-water patches measuring a total of 242.8 m² were observed (Figure 12). Average temperature in these patches was 17.4° C, while average temperature adjacent to these patches was 19.5° C. Several of these cold-water patches were found in isolated pools located in predominantly dry side channels, however GPS data location was not collected (Figure 11, panel D). The dominant substrate types within these cold-water patches were fine sediment (n = 4), large gravel (n = 17), and small cobble (n = 1). There were no potential barriers to Chum Salmon migration in this reach.

Figure 12. Location of substrate patches measured as distance from downstream end of survey in reach 1 of the Lewis and Clark River, south of Astoria, OR, in July 2014. For each category of substrate quality, patch area was summed and binned into 50 m units. No location data was collected for cold-water patches in this reach due to a GPS device malfunction.

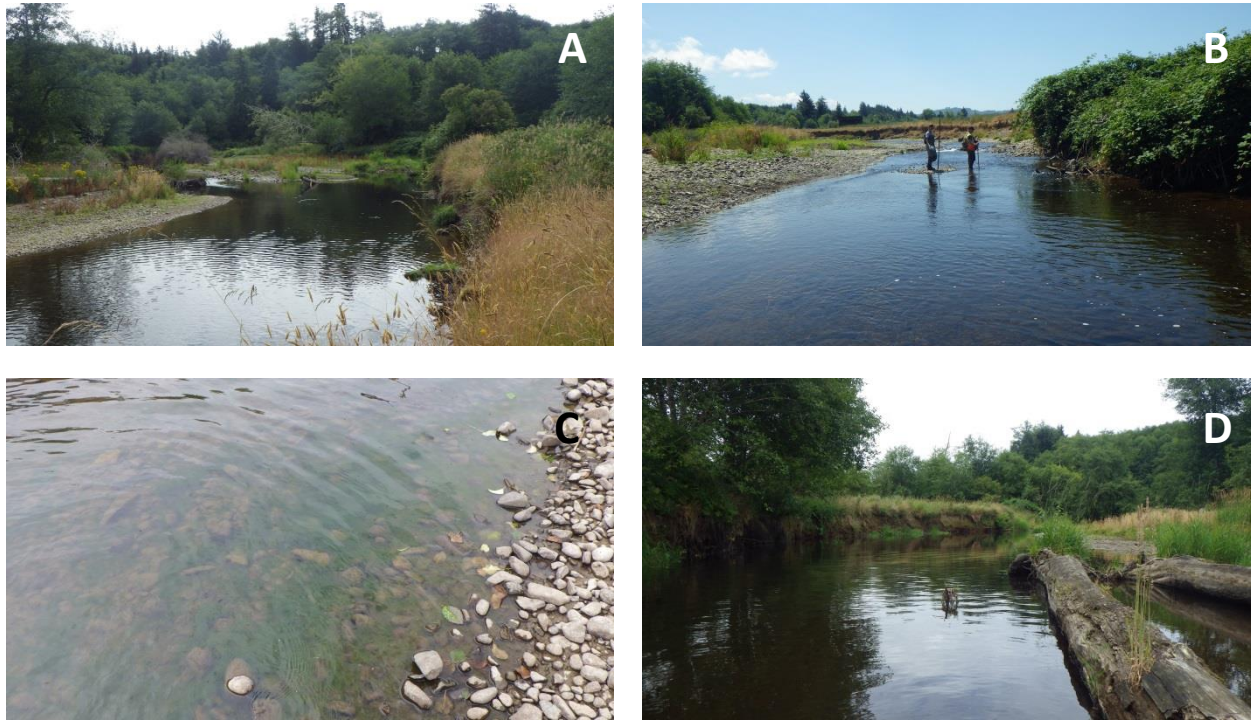
Figure 14. Survey pictures on reach 2 of the Lewis and Clark River showing a riparian zone dominated by grass, blackberry, and alder (panels A and B), algal growth within the active stream channel (panel C), and several pieces of artificially placed large woody debris (panel D).

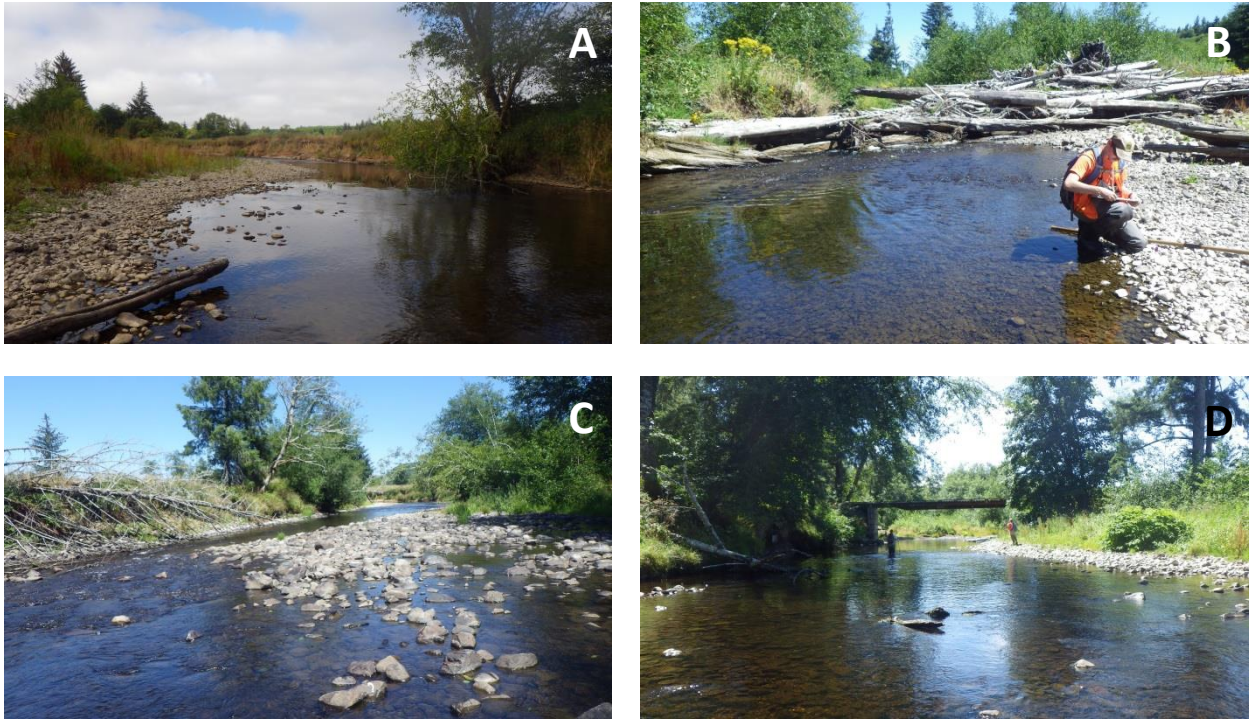
Figure 17. Survey pictures on reach 3 of the Lewis and Clark River showing a riparian zone with sparse trees and grass fields (panel A), a channel-spanning log jam (panel B), large cobble substrate within the channel (panel C), and a residential bridge (panel D).

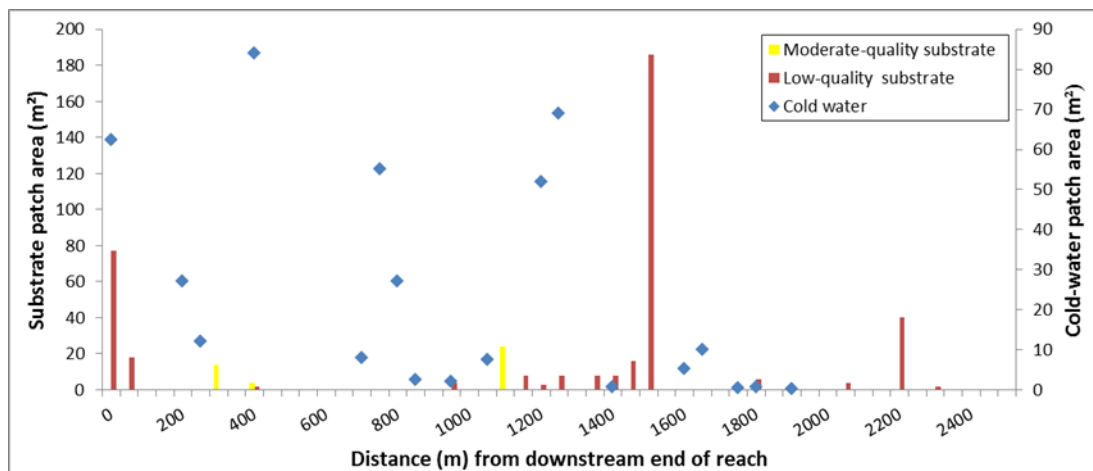
Twenty-six patches of suitable spawning substrate were found in reach 4 of the Lewis and Clark River (Table 7; Figure 21), measuring a total of 432 m². None of these patches were categorized as “high” quality, three patches were of “moderate” quality, and 23 patches were of “low” quality (Table 7; Figure 21). The remainder of substrate was dominated by large cobble and boulders (Figure 20, panel C). Twenty-eight cold-water patches measuring a total of 501.3 m² were observed (Figure 21). Average temperature in these patches was 15.0° C and average temperature adjacent to these patches was 17.0° C. The dominant substrate types within these cold-water patches were fine sediment (n = 5), large gravel (n = 7), small cobble (n = 8), large cobble (n = 7), and boulder (n = 1). There were no potential barriers to Chum Salmon migration in this reach.

Figure 21. Location of substrate and cold-water patches measured as distance from downstream end of survey in reach 4 of the Lewis and Clark River, south of Astoria, OR, in July 2014. For cold water and for each category of substrate quality, patch area was summed and binned into 50 m units. Cold-water patches were $\geq 1.0^{\circ}$ C colder than the temperature in the main channel. No location data were recorded for cold-water patches from 1,950 m to 2,550 m due to a GPS device malfunction.

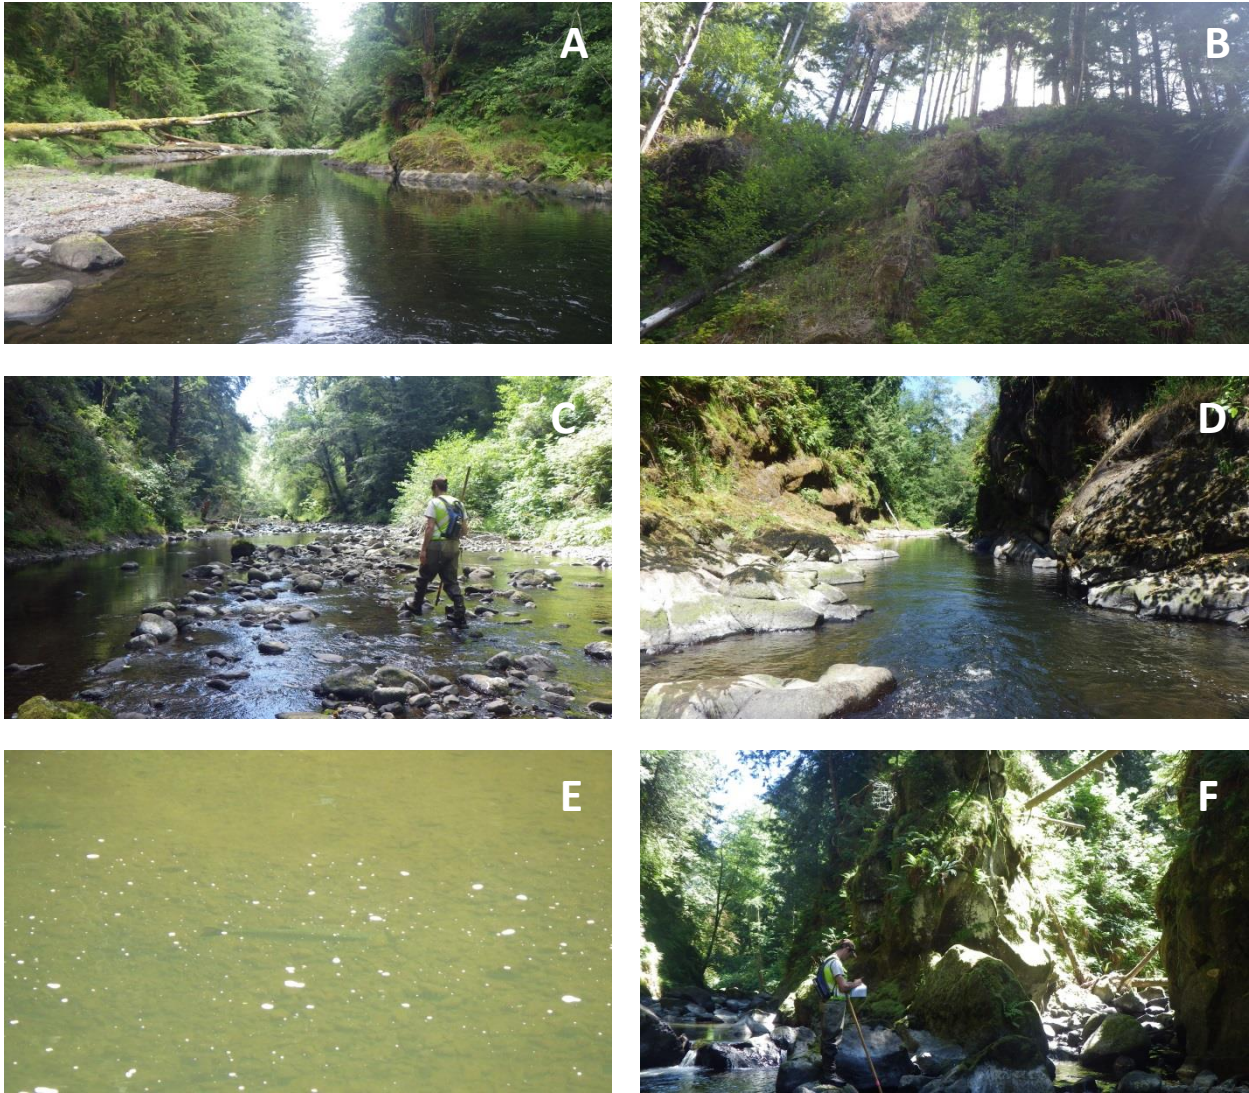
Figure 26. Survey pictures on reach 6 of the Lewis and Clark River showing dense riparian vegetation in a lower section of the reach (panel A), a narrow riparian zone resulting from adjacent timber harvest (panel B), large cobble substrate (panel C), a trench pool in a narrow canyon (panel D), an adult salmonid of unknown species swimming in a deep pool (panel E), and the confluence with the North Fork of the Lewis and Clark River (right) at the upstream end of the reach (panel F).

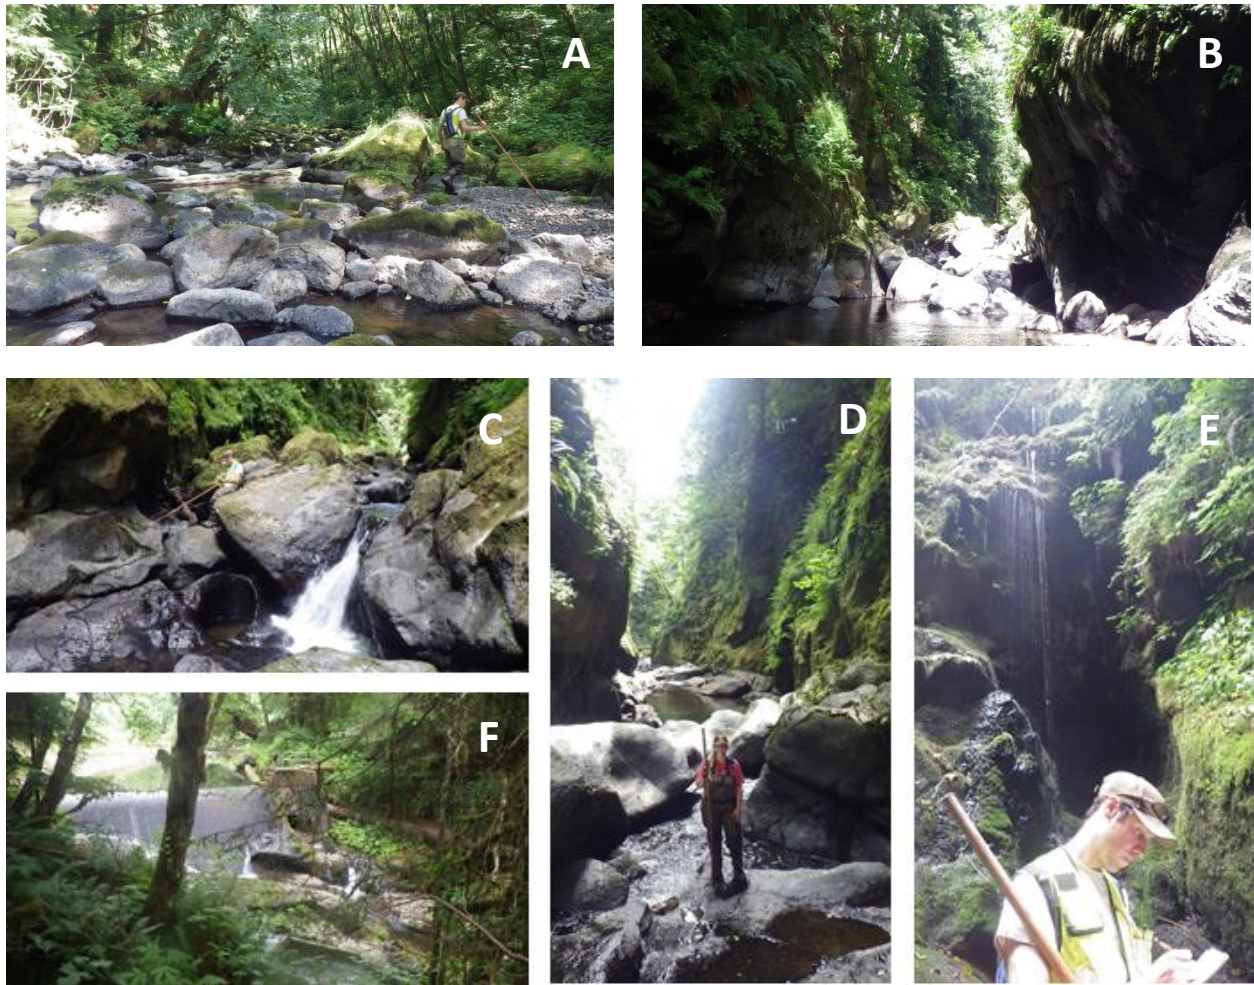
Figure 27. Survey pictures on reach 7 of the Lewis and Clark River showing a patch of small gravel downstream from a large boulder (panel A), a section of stream with steep canyon walls and boulders (panel B), a cascade over bedrock and boulders (panel C), narrow canyon, characteristic of this reach (panel D), water seeping out of canyon walls (panel E), and a dam with a fish ladder marking the upstream end of the reach (panel F).

The substrate in reaches 6 and 7 of the Lewis and Clark River was predominantly large cobble, boulders (several > 2 m in diameter), and bedrock, with very limited substrate that met the established criteria for Chum Salmon spawning (4–128 mm, diameter; Figure 26, panel C; Figure 27, panel A). Throughout both reaches there were areas where water was seeping from the top and sides of the canyon walls (Figure 27, panel E). Due to the high gradient stream features found in this reach, this entire section of the Lewis and Clark River is potentially a barrier to Chum Salmon migration. Additionally, the dam with the fish ladder is a potential barrier to Chum Salmon migration (Table 11).

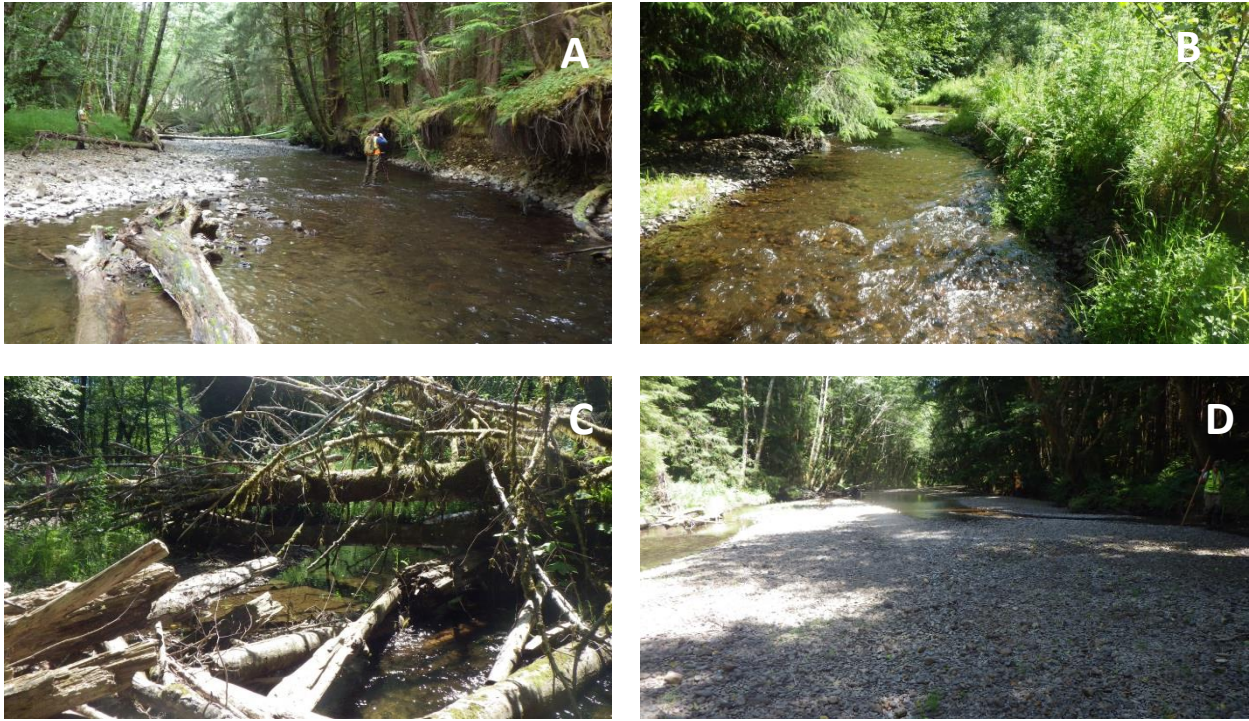
Figure 29. Survey pictures on reach 8 of the Lewis and Clark River showing a densely-vegetated riparian zone (panel A), a long side channel near the downstream end of the reach (panel B), a large log jam (panel C), and an extensive substrate patch (panel D).

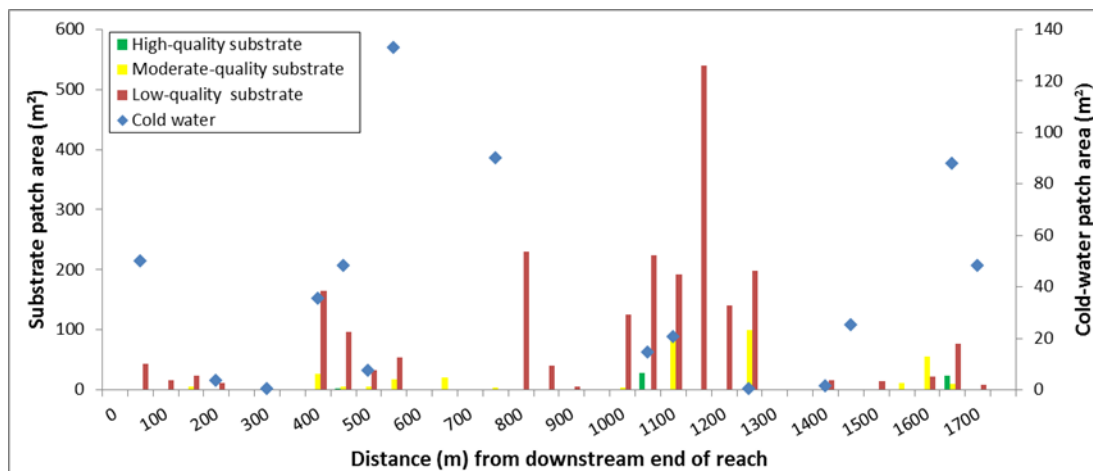
Sixty-eight patches of suitable spawning substrate that met established criteria were found in reach 8 of the Lewis and Clark River (Table 12; Figure 30), measuring a total of 2,692 m². In a section of stream in the upper half of the reach, extensive patches of suitable spawning substrate were discovered, with some patches > 100 m in length (Figure 29, panel D). Four of these patches were categorized as “high” quality, 21 patches were of “moderate” quality, and 43 patches were of “low” quality (Table 12; Figure 30). Twenty-one cold-water patches (measuring a total of 565.0 m²) were observed (Figure 30). Average temperature in these patches was 13.2° C, and average temperature adjacent to these patches was 15.4° C. The dominant substrate types within these cold-water patches were fine sediment (n = 12), large gravel (n = 7), small cobble (n = 1), and large cobble (n = 1). There was one potential barrier to Chum Salmon migration in this reach, the dam with fish ladder at the downstream start of the reach (Table 13).

Figure 30. Location of substrate and cold-water patches measured as distance from downstream end of survey in reach 8 of the Lewis and Clark River, south of Astoria, OR, in July 2014. For cold water and for each category of substrate quality, patch area was summed and binned into 50 m units. Cold-water patches were $\geq 1.0^{\circ}$ C colder than the temperature in the main channel.

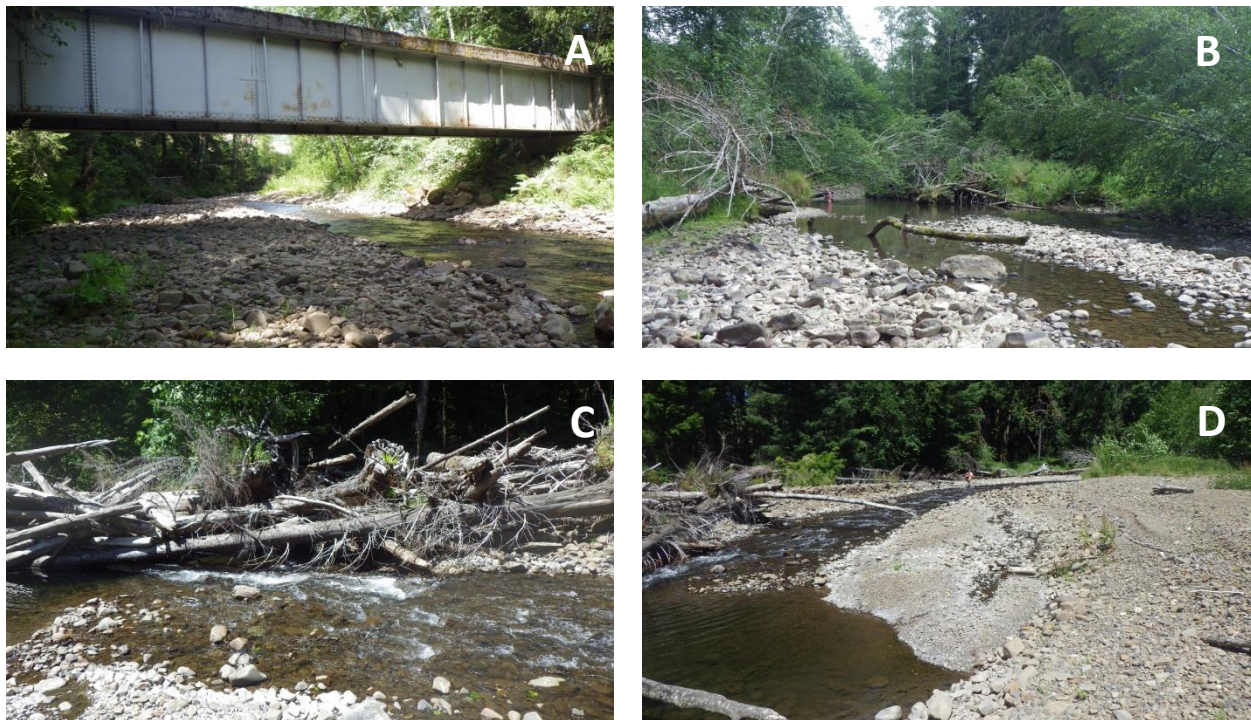
Figure 32. Survey pictures on reach 9 of the Lewis and Clark River showing the mainline bridge marking that upstream end of the reach (panel A), dense riparian vegetation (panel B), a channel-spanning log jam (panel C), and a gravel bar located downstream of a log jam (panel D).

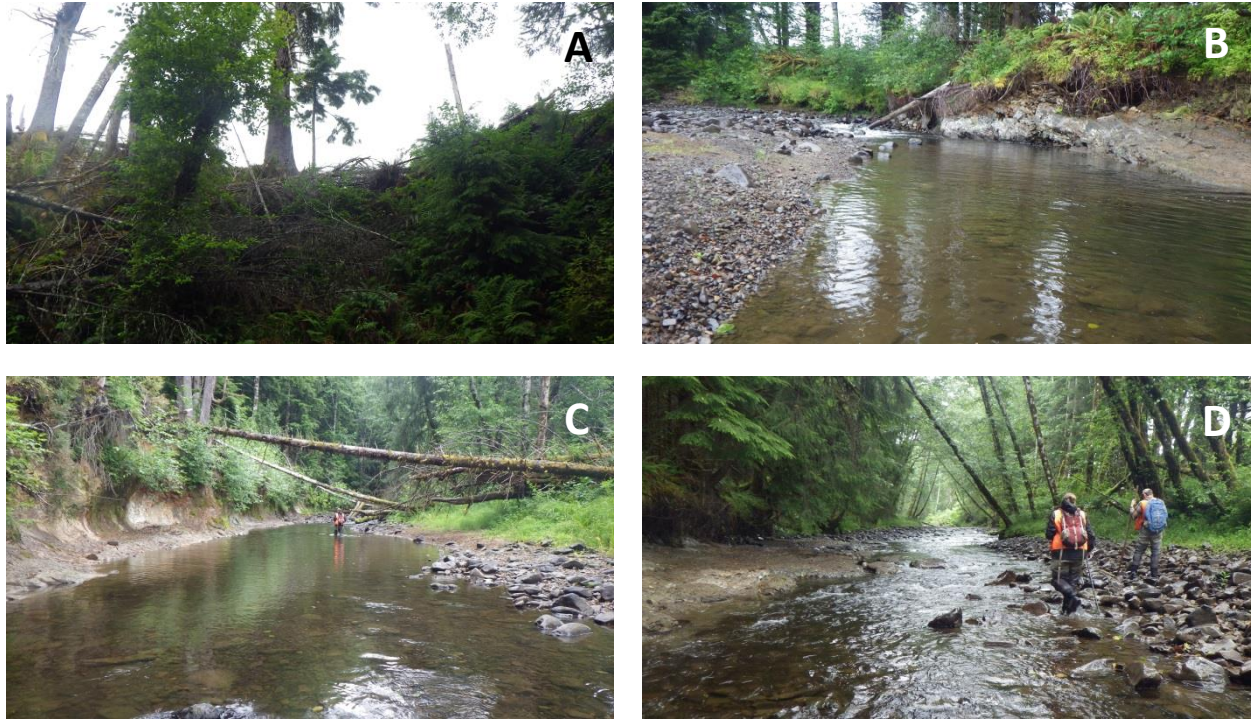
Figure 35. Survey pictures on reach 10 of the Lewis and Clark River showing a section of riparian vegetation with sparse trees (panel A), bedrock (panel B) and hardpan (panel C) banks, and large cobble substrate (panel D).

The substrate was predominantly large cobble (129–256 mm, diameter; Figure 35, panel D), however 30 patches of suitable spawning substrate that met established criteria were found in reach 10 of the Lewis and Clark River measuring a total of 217 m² (Table 15; Figure 36). None of these patches were categorized as “high” quality, but 16 patches were of “moderate” quality, and 14 patches were of “low” quality (Table 15; Figure 36). Bedrock and hardpan clay were also observed throughout the reach (Figure 35, panel B and C). Twenty-seven of these patches contained ≥ 50% large gravel (12–45 mm, diameter; Table 15). Six cold-water patches were detected, measuring a total of 25.7 m² (Figure 36). Average temperature in these patches was 12.8° C and average temperature adjacent to these patches was 14.1° C. The dominant substrate types within these cold-water patches were large gravel (n = 1), small cobble (n = 1), large cobble (n = 2), and bedrock (n = 2). There were no potential barriers to Chum Salmon migration in this reach.

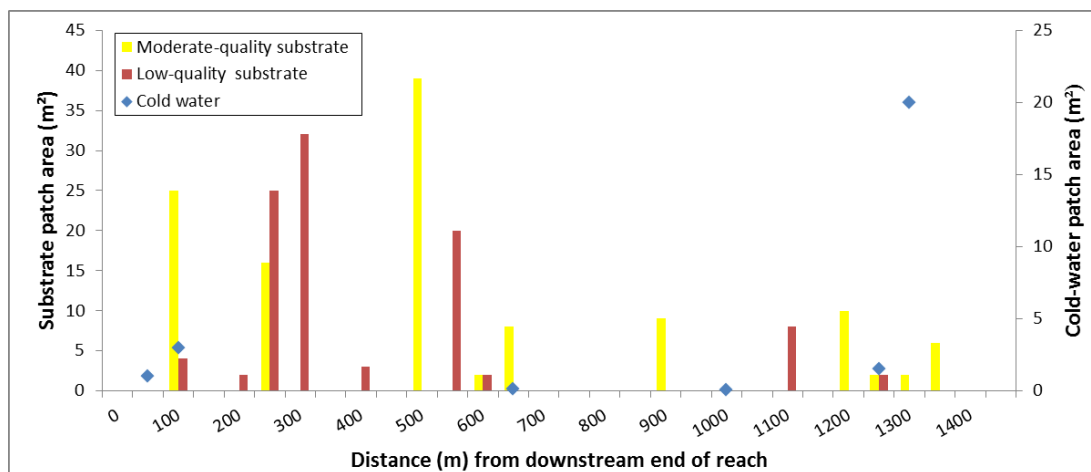
Figure 36. Location of substrate and cold-water patches measured as distance from downstream end of survey in reach 10 of the Lewis and Clark River, south of Astoria, OR, in July 2014. For cold water and for each category of substrate quality, patch area was summed and binned into 50 m units. Cold-water patches were $\geq 1.0^{\circ}$ C colder than the temperature in the main channel.

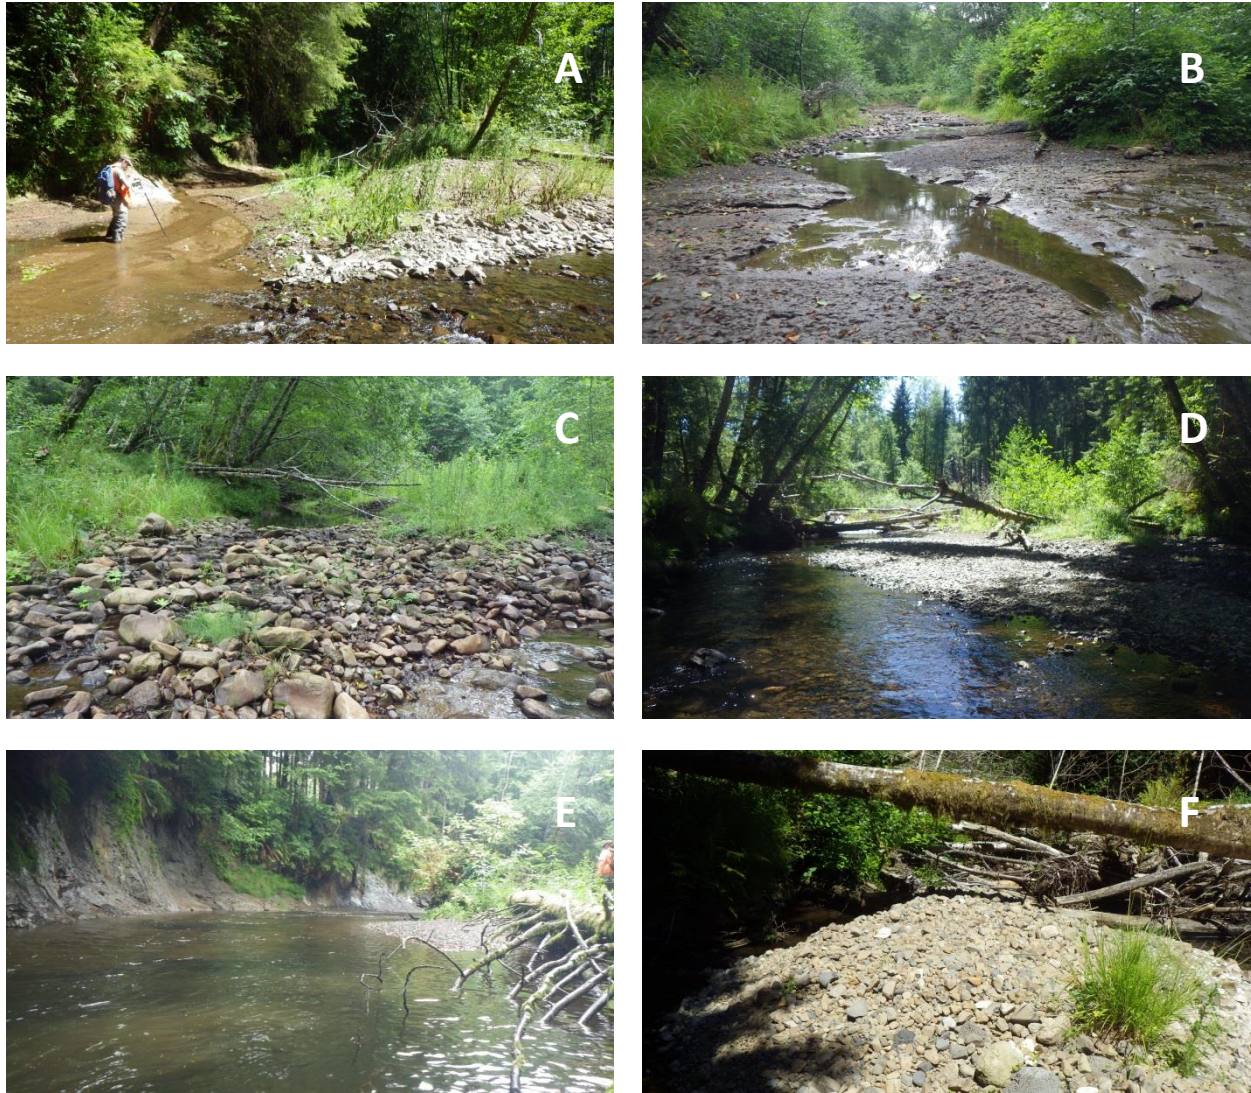
Figure 38. Survey pictures on reach 11 of the Lewis and Clark River showing three different large side channels (panels A–C), a riparian zone dominated by alder and spruce along a side channel (panel D), a hardpan shelf along the river-right bank (panel E), and an accumulation of gravel downstream of a log jam in a dry side channel (panel F).

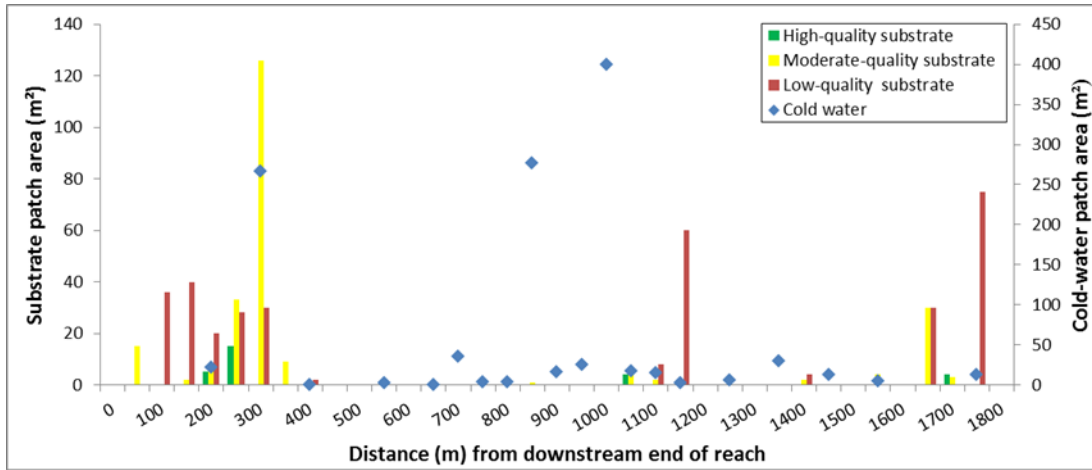
Thirty-eight patches of suitable spawning substrate were found in reach 12 of the Lewis and Clark River (Table 17; Figure 42), measuring a total of 600 m². Substrate outside of side-channel complexes consisted predominantly of large cobble (129–256 mm, diameter) and boulders (Figure 41, panel D). Five of these patches were categorized as “high” quality, 17 patches were of “moderate” quality, and 16 patches were of “low” quality (Table 17; Figure 42). Thirty-three of these patches contained ≥ 50% large gravel (12–45 mm, diameter; Table 17). Thirty-nine cold-water patches were detected, measuring a total of 1,151.5 m² (Figure 42). Average temperature in these patches was 13.3° C and average temperature adjacent to these patches was 15.8° C. The dominant substrate types within these cold-water patches were fine sediment

Figure 42. Location of substrate and cold-water patches measured as distance from downstream end of survey in reach 12 of the Lewis and Clark River, south of Astoria, OR, in July 2014. For cold water and for each category of substrate quality, patch area was summed and binned into 50 m units. Cold-water patches were $\geq 1.0^{\circ}$ C colder than the temperature in the main channel.

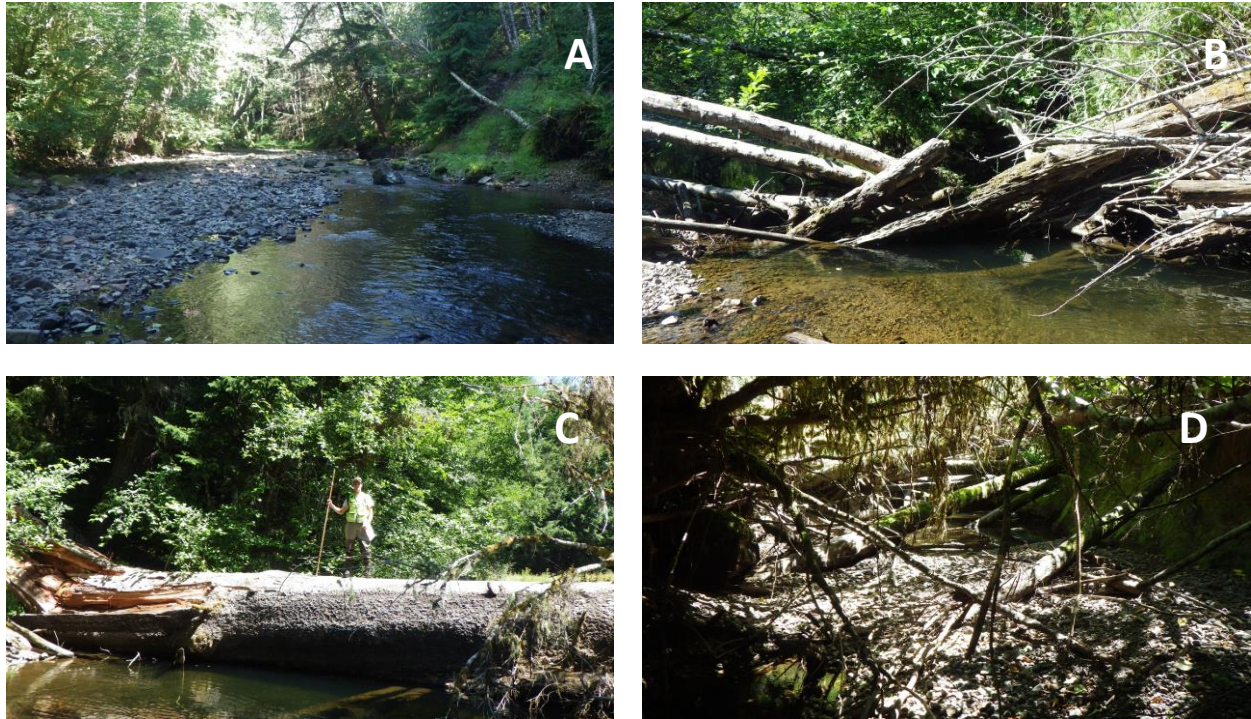
Figure 44. Survey pictures on reach 13 of the Lewis and Clark River showing a riparian zone with a variety of tree species (panel A), a channel-spanning log jam (panel B), a large Douglas fir log (panel C), and a log jam in a dry side channel (panel D).

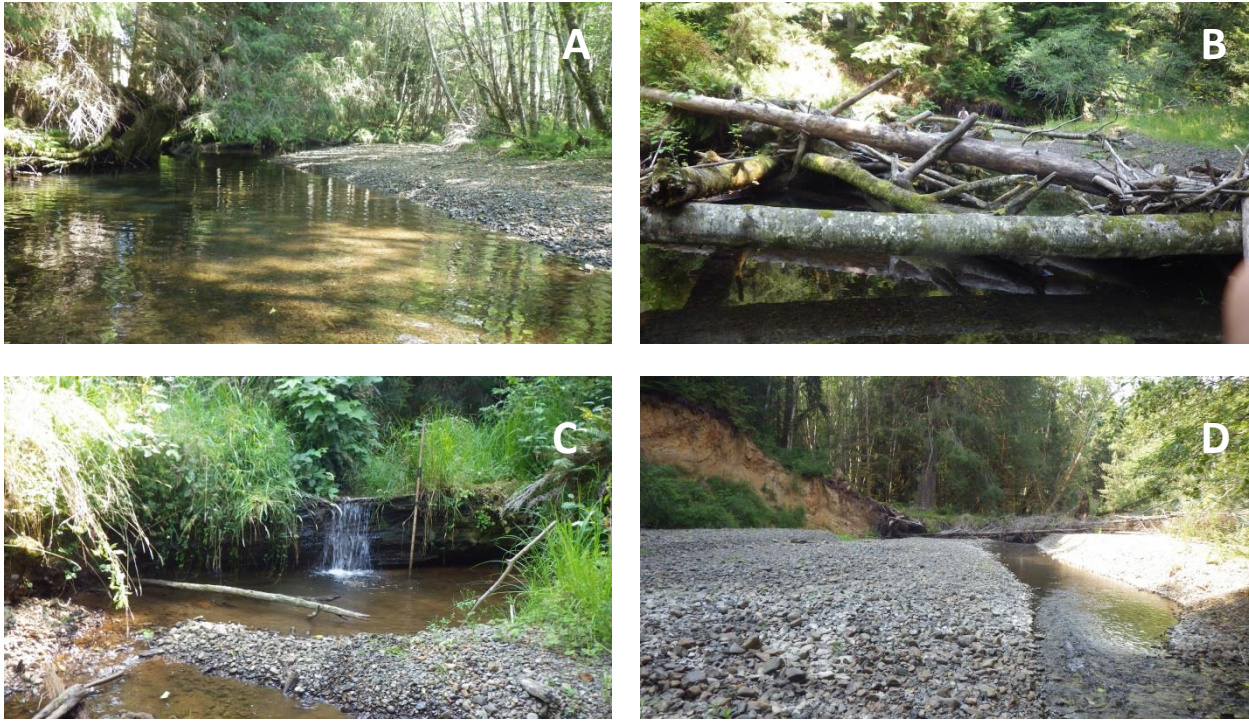
Reach 14 started at a small tributary 200 m upstream from the Bridge Road bridge (Lat: 45.964135, Long: -123.752255) and continued upstream to Lat: 45.959734, Long: -123.745148 (Figure 46). The mainstem thalweg length of this reach was 954 m. There were five side channel sections with a combined thalweg length of 178 m. Channel form was unconfined with multiple side channels and meanders. Riparian vegetation in this reach was dense, consisting of alders, firs, and cedars (Figure 47, panel A). Land use was a mix of mature timber and timber harvest. Log jams were common throughout the reach (Figure 47, panel B). Several unnamed tributaries entered the river from the river-left bank, with most having colder water than the main channel (Figure 47, panel C).

Figure 47. Survey pictures on reach 14 of the Lewis and Clark River showing dense riparian vegetation (panel A), a log jam (panel B), an unnamed tributary entering from river-left (panel C), and a large substrate patch (panel D).

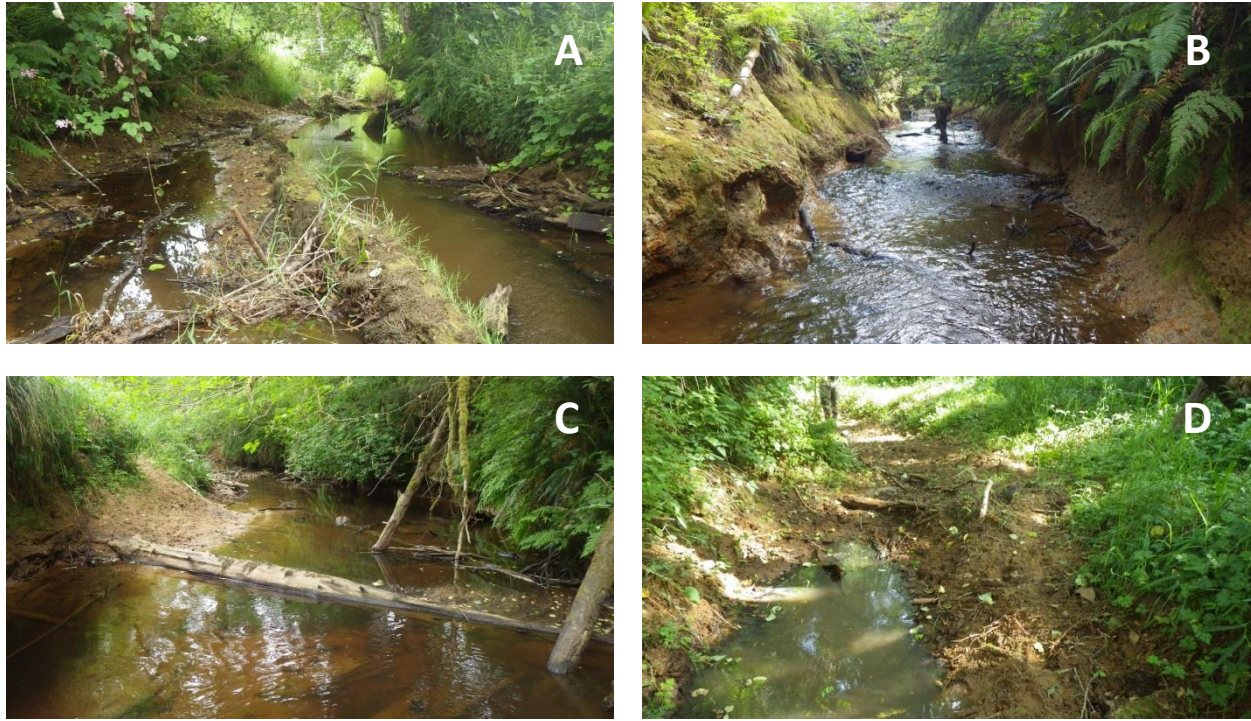
Figure 51. Survey pictures on reach 1 of the Wallooskee River showing an alder-dominated riparian zone (panel A), a deeply entrenched channel (panel B), several pieces of large woody debris in the stream channel (panel C), and an isolated pool in a predominantly dry side channel (panel D).
