Chum Salmon Spawning Habitat Report for the Youngs Bay and Big Creek Populations

Oregon Department of Fish and Wildlife

November 2017

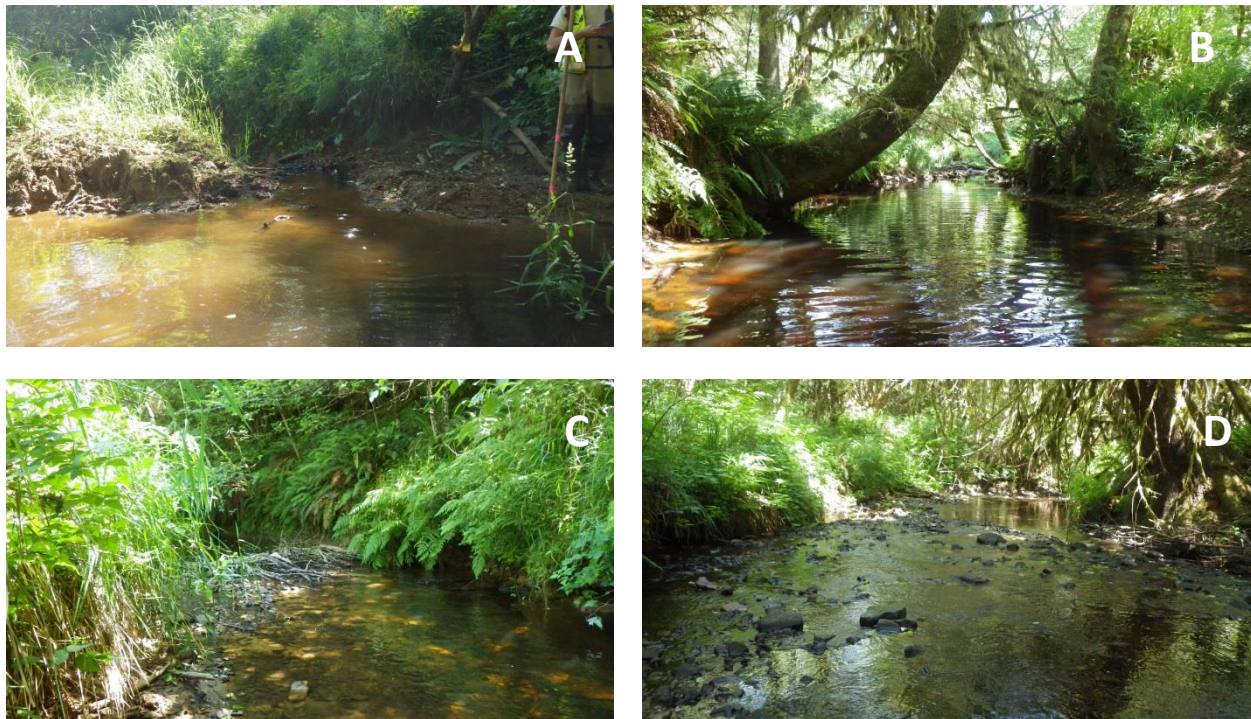
Reach 2 started at the confluence with the second unnamed tributary 500 m downstream from Palmer Road (Lat: 46.117881, Long: -123.756185; Figure 54, panel A) and continued upstream to the Labiske Road bridge (Lat: 46.128326, Long: -123.74887; Figure 53). The mainstem thalweg length of this reach was 2,489 m, including two side channels with a combined thalweg length of 36 m. Riparian vegetation consisted of alders, firs, cedars, ferns, and shrubs (Figure 54, panel B). Land use was agriculture and timber harvest. The stream channel form was confined with multiple channels and extensive meanders. Beaver activity, including several small dams, was observed throughout the reach (Figure 54, panel C).

Figure 54. Survey pictures on reach 2 of the Wallooskee River showing the confluence with an unnamed tributary marking the downstream end of the reach (panel A), riparian vegetation consisting of firs, alders, ferns, and shrubs (panel B), a small beaver dam (panel C), and gravel and small cobble substrate (panel D).

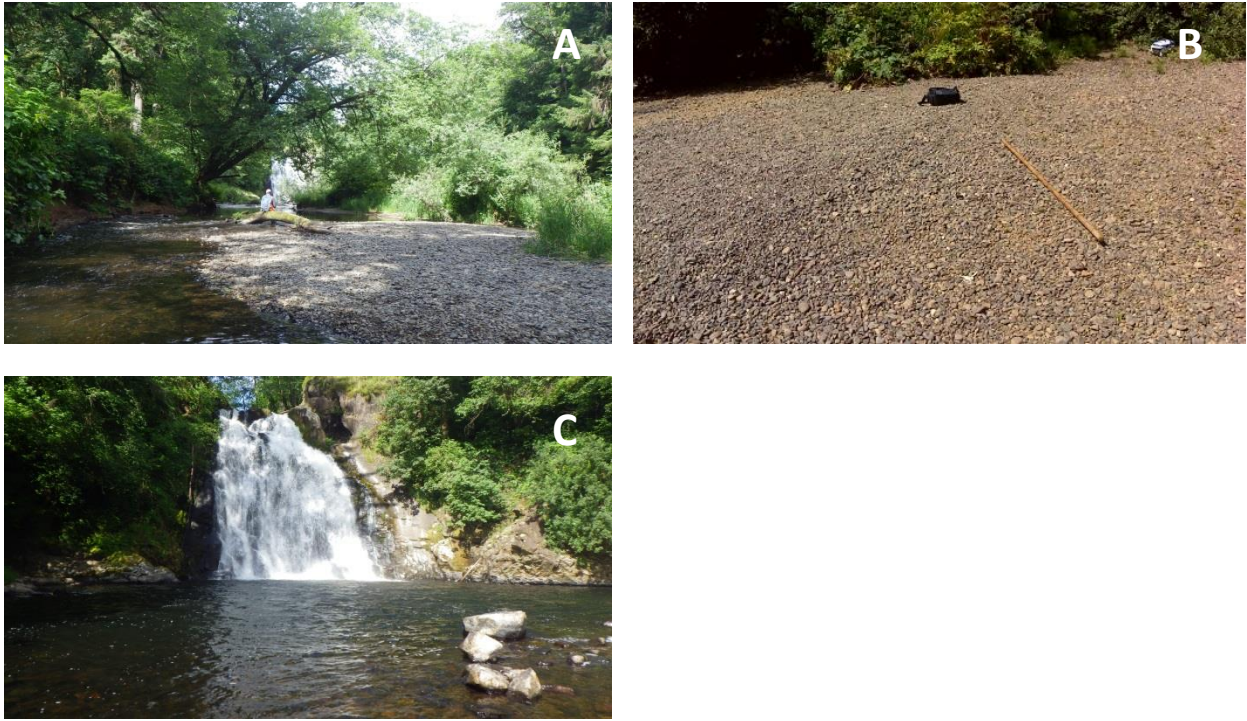
Figure 57. Survey pictures on the Youngs River showing riparian vegetation consisting of a wide variety of species (panel A), a substrate patch located in a dry side channel (panel B), and the Youngs River Falls marking the upstream end of the reach (panel C).

Suitable spawning substrate for Chum Salmon (4–128 mm, diameter), was observed throughout the Youngs River reach (Figure 57, panel B). Thirteen patches of suitable spawning substrate were found (Table 21; Figure 58), measuring a total of 328 m². Six of these patches were categorized as “high” quality, four patches were of “moderate” quality, and three patches were of “low” quality (Table 21; Figure 58). Ten of these patches consisted of ≥ 75% large gravel (12–45 mm diameter; Table 21). No cold-water patches were detected. The reach ended at Youngs River Falls, (height = 16.5 m; width = 13.7 m), which is a permanent barrier to Chum Salmon migration (Figure 56; Figure 57, panel C; Table 22).

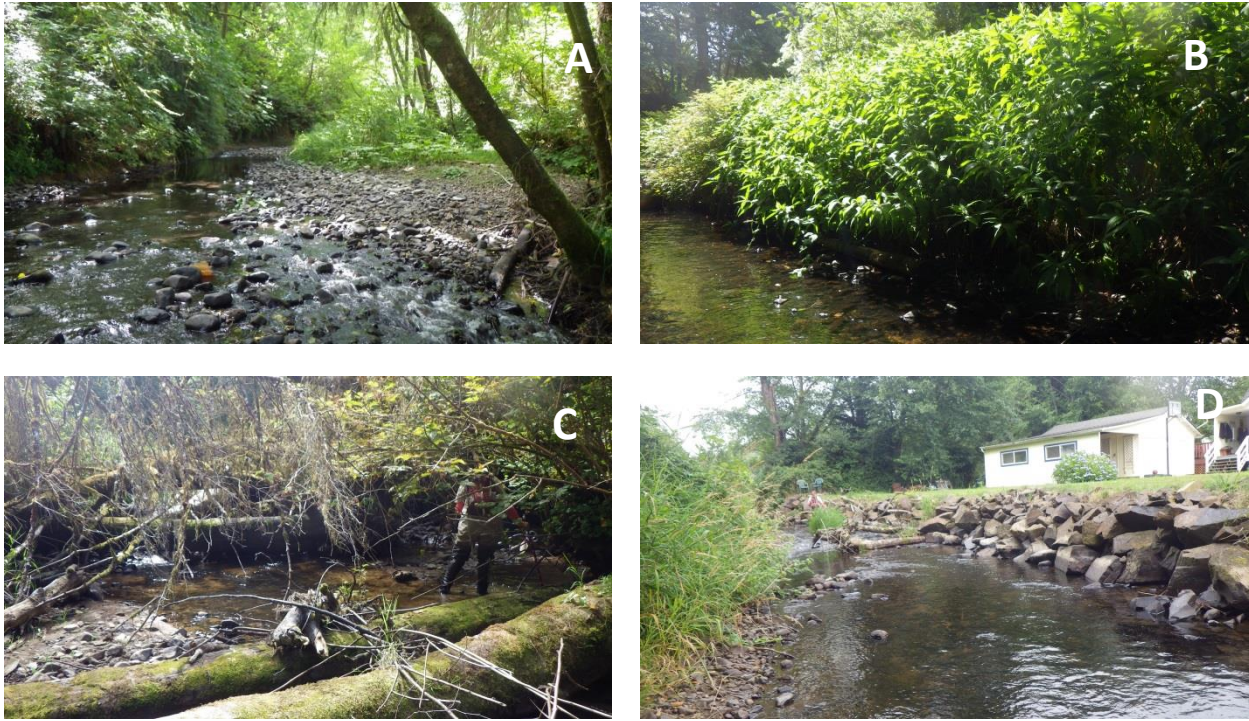
Figure 62. Survey pictures on reach 1 of Bear Creek showing a sparsely-vegetated riparian zone with alders and shrubs (panel A), a dense area of knotweed along the stream bank (panel B), a channel-spanning log jam (panel C), and large boulder rip rap (panel D).

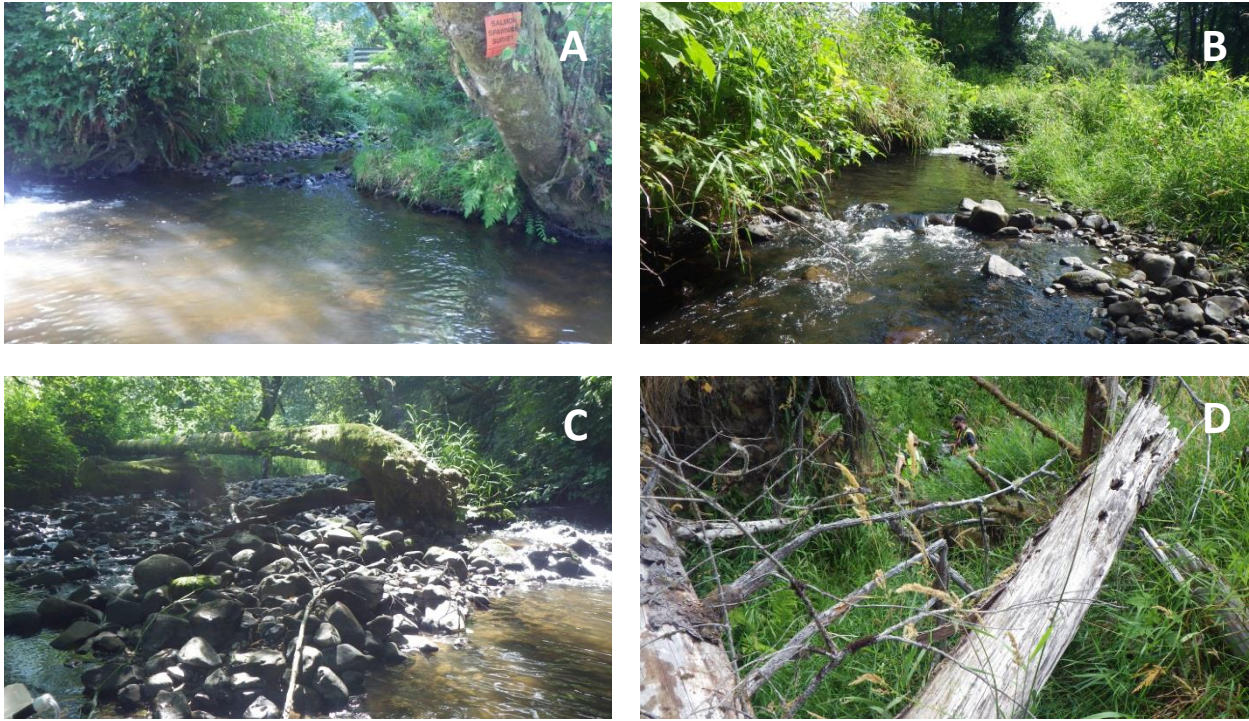
Figure 65. Survey pictures on reach 2 of Bear Creek showing the confluence with Little Bear Creek at the downstream end of the reach (panel A), a riparian zone dominated by grass and including some trees (panel B), large cobble substrate (panel C), and a log jam (panel D).

Thirteen patches of suitable spawning substrate were found in Bear Creek reach 2 (Table 24; Figure 66), measuring a total of 40 m². None of these patches were categorized as “high” quality, three patches were of “moderate” quality, and ten patches were of “low” quality (Table 24; Figure 66). Eleven of these patches contained $\geq 50\%$ small cobble (46–128 mm, diameter; Table 24). The substrate in this reach was predominantly small and large cobble (45–256 mm, diameter; Figure 65, panel C). Six cold-water patches were detected, measuring a total of 17.5 m² (Figure 66). Average temperature in these patches was 14.2° C and average temperature adjacent to these patches was 16.3° C. The dominant substrate types within these cold-water patches were fine sediment (n = 2), small cobble (n = 1), large cobble (n = 2), and bedrock (n = 1). There was one potential barrier to Chum Salmon migration in this reach, classified as a channel-spanning log jam located in the downstream half of the reach (Figure 64; Table 25; Figure 65, panel D).

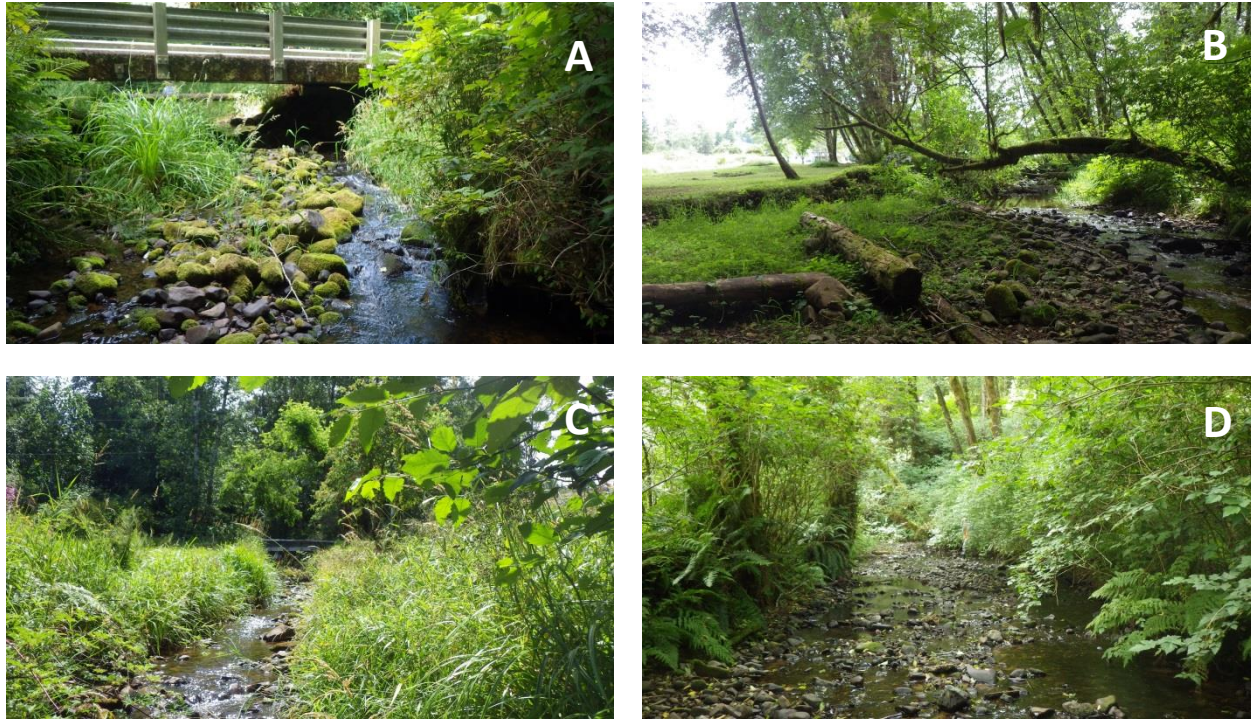
The Little Bear Creek habitat survey (Township: 8N Range: 8W Section: 27D) started at the confluence with Bear Creek (Lat: 46.1544, Long: -123.66732; Figure 68, panel A), and continued upstream to a point in the middle of county tax lot 8N8W27C 1001 (Lat: 46.144471, Long: -123.665579); Figure 67). The mainstem thalweg length of this reach was 1,434 m. There were seven side channels with a combined thalweg length of 158 m. Channel form was unconfined, with multiple side channels and meanders. The riparian zone in the downstream half of the reach consisted of dense trees on the river-left bank and grassy vegetation on the river-right bank (Figure 68, panels B and C). In the upstream half of the reach, the riparian vegetation consisted of alders, shrubs, ferns, and firs (Figure 68, panel D). Land use in the surveyed portion of these creeks was rural residential. Large woody debris was abundant throughout the reach, but more so in the upstream half.

Figure 68. Survey pictures on reach 1 of Little Bear Creek showing the Maki Road bridge viewed from the downstream end of the survey (panel A), a field located in the downstream half of the reach (panel B), a grass-dominated riparian zone located adjacent to the residential road bridge (panel C), and a densely-vegetated riparian zone consisting of alders, shrubs, and ferns located in the upstream half of the reach (panel D).

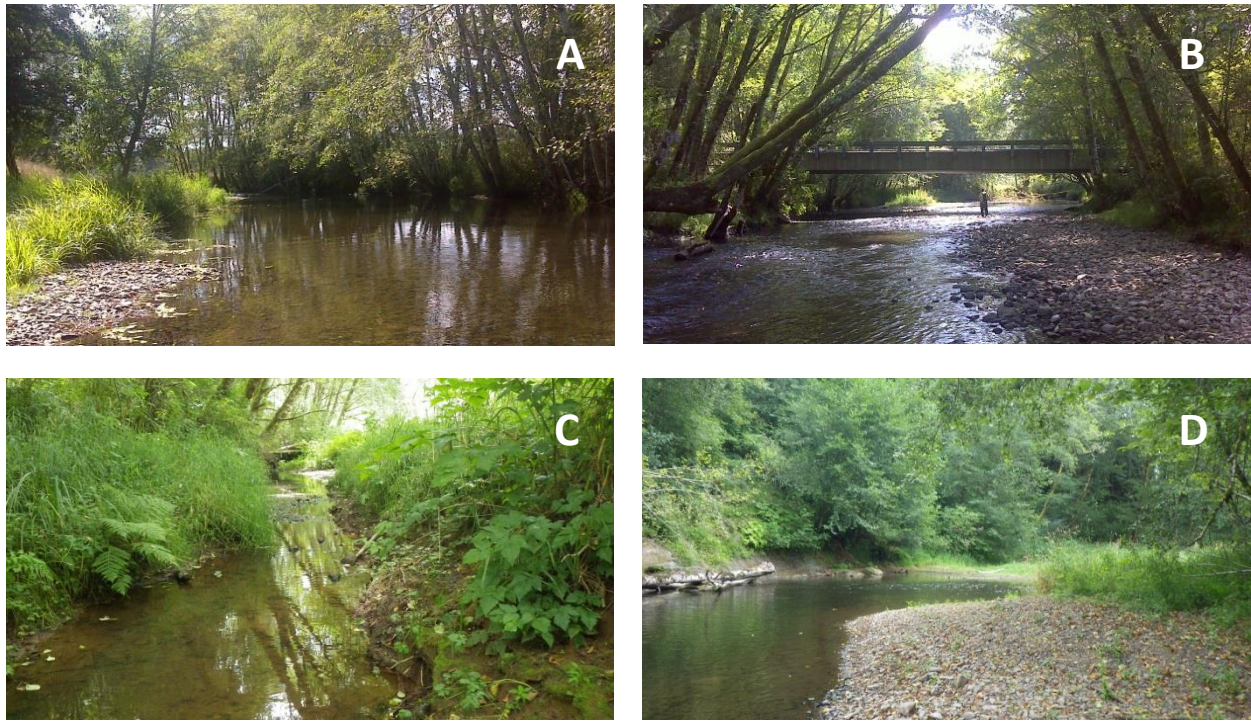
Figure 71. Survey pictures on reach 1 of Big Creek showing a thin strip of alders along the river-left bank (panel A), the Old Highway 30 bridge (panel B), a side channel with isolated pools located upstream of the Old Highway 30 bridge (panel C), and a sharp bend in the stream with a deep pool (panel D).

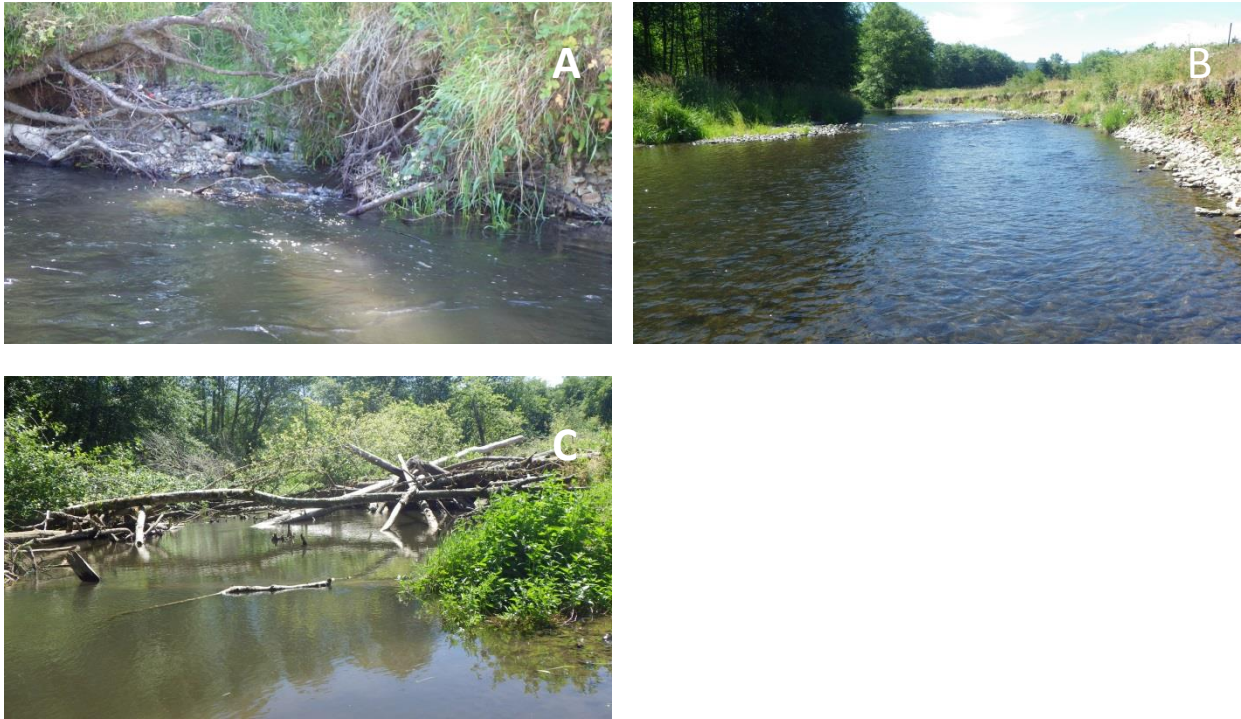
Reach 2 started at the Old Highway 30 bridge (Lat: 46.167321, Long: -123.592351) and ended at the confluence with Little Creek (Lat: 46.16267, Long: -123.596573; Figure 73; Figure 74, panel A). The mainstem thalweg length of this reach was 759 m. There were six side channels with a combined thalweg length of 277 m. Channel form was unconfined with multiple channels and meanders. In one very long side channel, crews surveyed 130 m before encountering heavy brush, which prevent any further surveying. Riparian vegetation was limited in the downstream half of the reach especially on the river-left bank (Figure 74, panel B); however, in the upstream half the riparian zone consisted of more alders and maples. Land use was a mix of rural residential and agriculture. The creek flowed through a county park near the middle of this reach. Power lines crossed the creek at this park and there was limited vegetation under the lines. Adjacent to the side channel, there was a large log jam with a deep pool on the downstream end and substantial gravel accumulation on the upstream end (Figure 74, panel C).

Figure 74. Survey pictures on reach 2 of Big Creek showing the confluence with Little Creek (panel A), an eroded stream bank with with no trees in the riparian zone (panel B), and a log jam located in the upstream half of the reach (panel C).

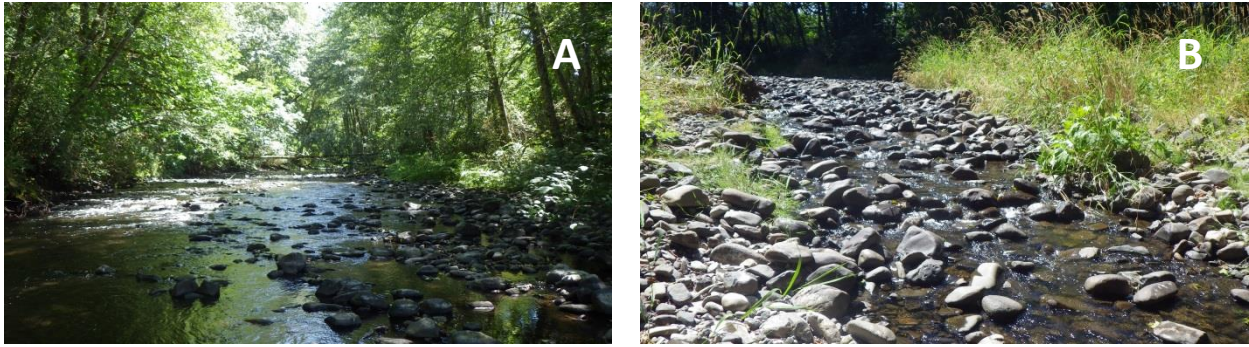
Reach 3 started at the confluence with Little Creek (Lat: 46.16267, Long: -123.596573) and continued upstream to the Hillcrest Loop Road bridge (Lat: 46.154726, Long: -123.588493; Figure 76). The mainstem thalweg length of this reach was 1,200 m. There were four side channels with a combined thalweg length of 195 m. Channel form was unconfined with multiple channels and meanders. The riparian zone was more densely vegetated on the river-right bank than on the river-left and this vegetation was dominated by alders (Figure 77, panel A). Land use was a mix of rural residential and agriculture.

Figure 77. Survey pictures on reach 3 of Big Creek showing an alder-dominated riparian zone (panel A), and small and large cobble substrate throughout the stream channel (panel B).

Substrate in this reach was predominantly small and large cobble (46–256 mm, diameter; Figure 77, panel B). Sixteen patches of suitable spawning substrate were found in Big Creek reach 3 (Table 28; Figure 78), measuring a total of 76 m². None of these patches were categorized as “high” quality, four patches were of “moderate” quality, and 12 patches were of “low” quality (Table 28; Figure 78). Four cold-water patches were detected, totaling 17.3 m² (Figure 78). Average temperature in these patches was 14.5° C and average temperature adjacent to these patches was 15.6° C. The dominant substrate types within these cold-water patches were small cobble (n = 2), large cobble (n = 1), and bedrock (n = 1). There were no potential barriers to Chum Salmon migration in this reach.

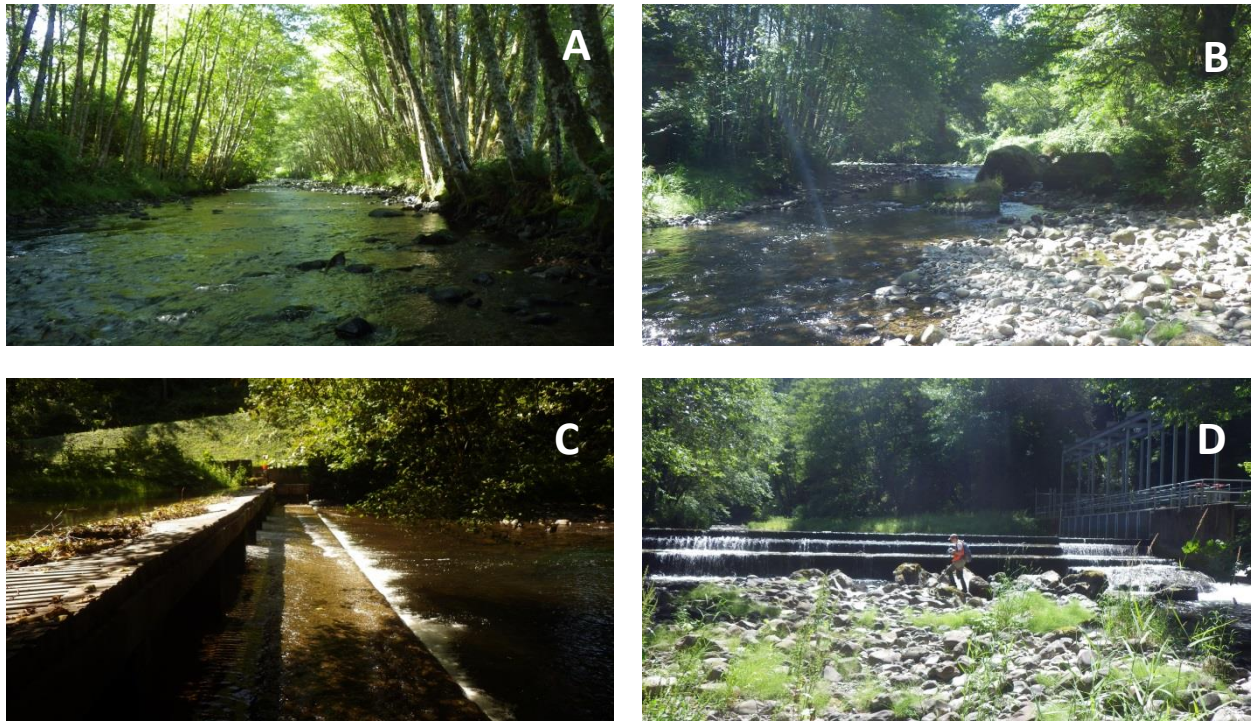
Figure 80. Survey pictures on reach 4 of Big Creek showing an alder-dominated riparian zone (panel A), large cobble and boulder-sized substrate (panel B), the dam at Big Creek Hatchery (panel C), and the dam at the intake for Big Creek Hatchery (panel D).

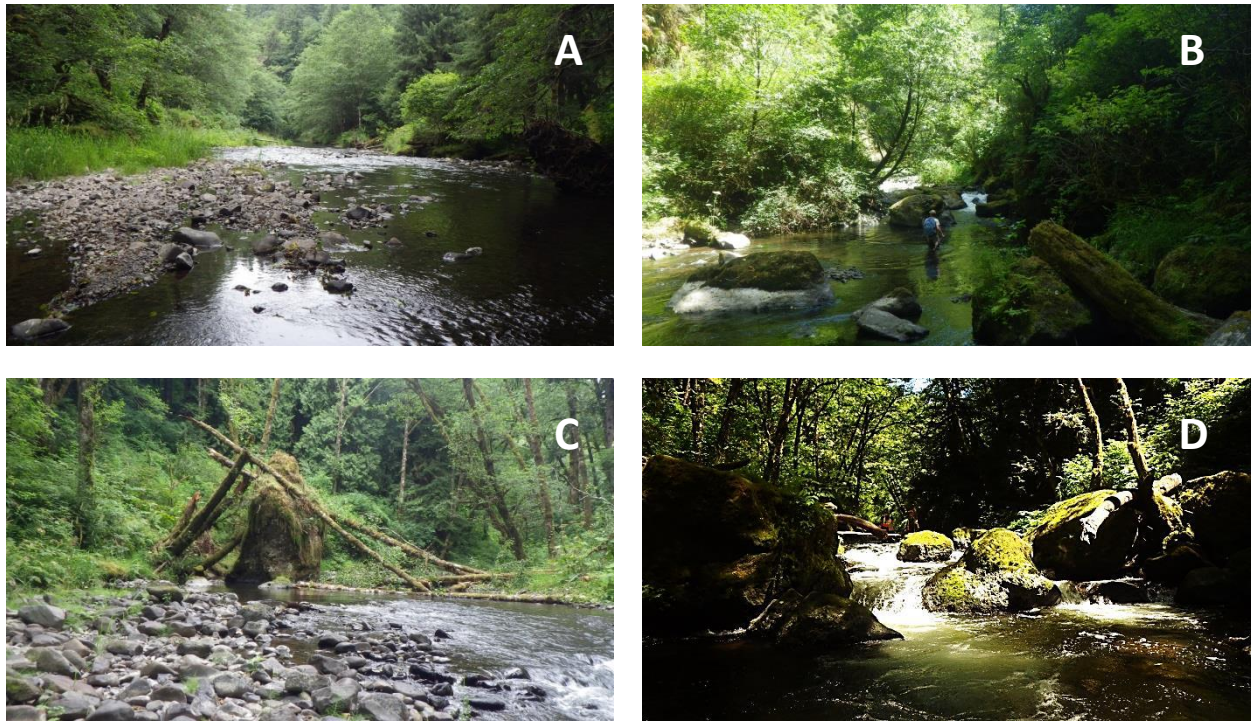
Figure 83. Survey pictures on reach 5 of Big Creek showing dense riparian vegetation consisting of alders, fir, maple, and cedars (panel A), the creek flowing through a canyon section (panel B), large cobble substrate (foreground) and a large boulder (background; panel C) and increased gradient where the stream cascades over large boulders (panel D).

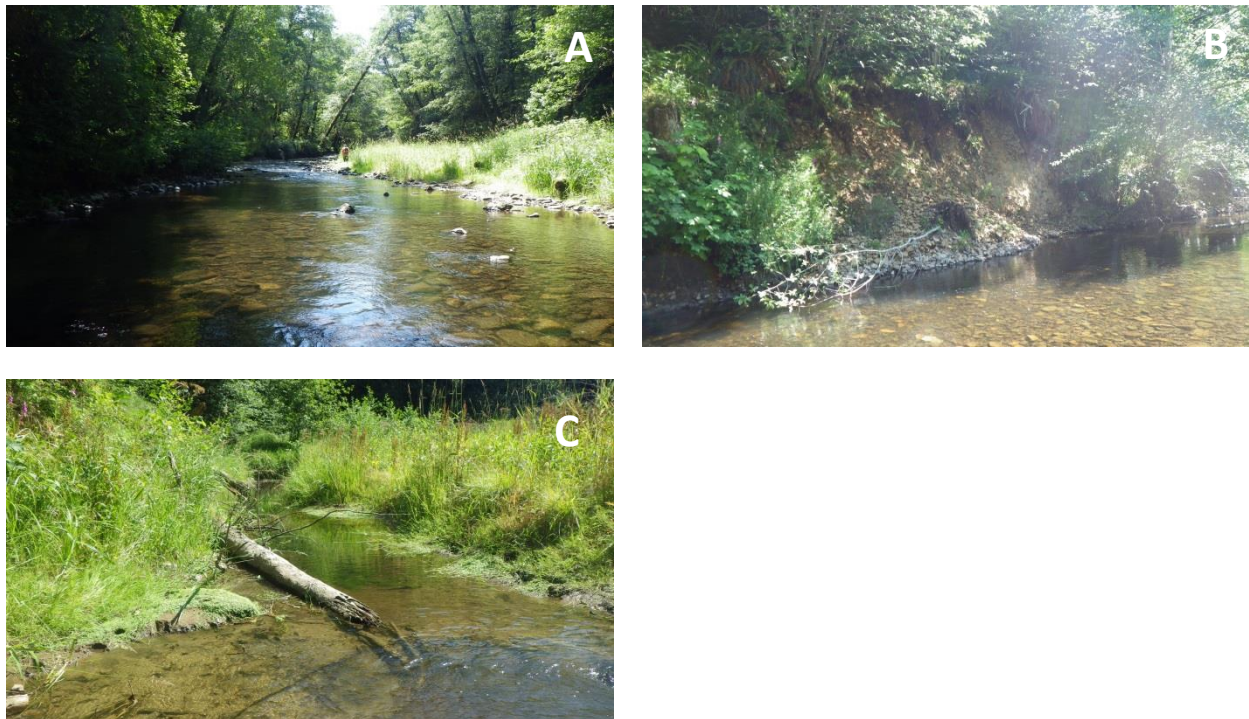
Figure 89. Survey pictures on reach 7 of Big Creek showing a dense riparian zone consisting of alders and firs (panel A), a hill slope constraining the stream on the river-right bank (panel B), and a side channel (panel C).

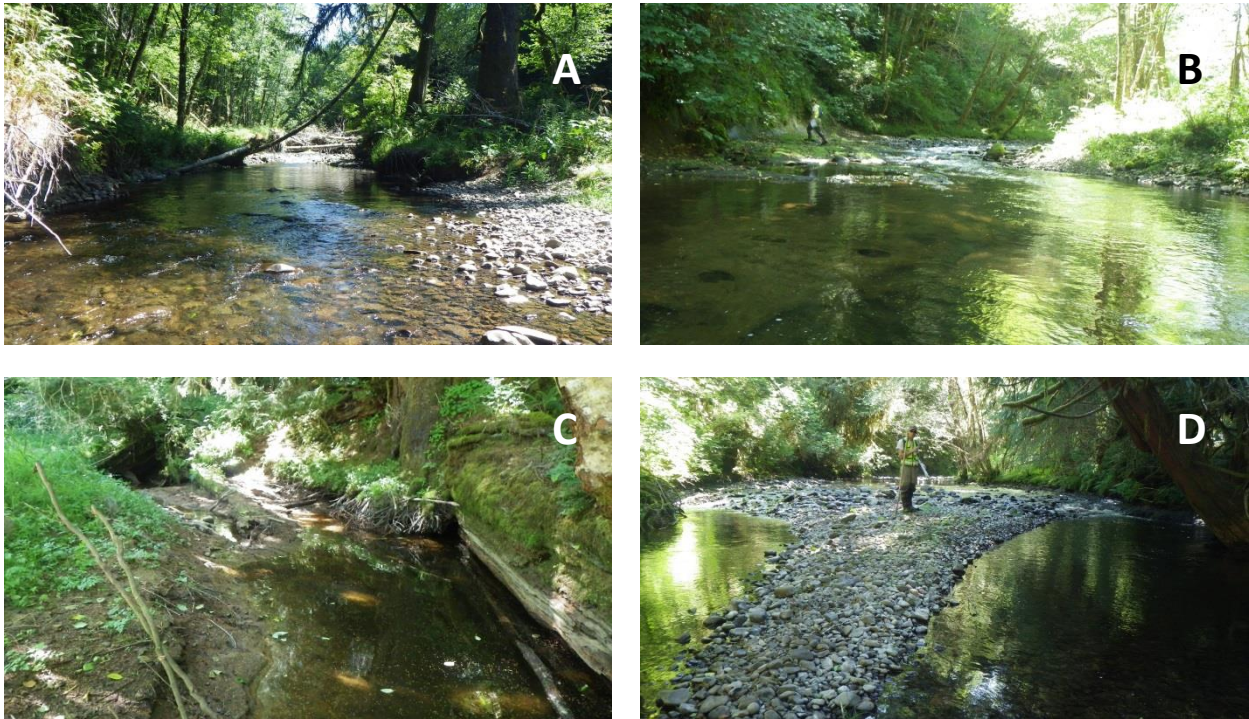
Figure 92. Survey pictures on reach 8 of Big Creek showing a densely-vegetated riparian zone comprised of alder, fir, cedar, hemlock, and spruce (panel A), a bedrock shelf at a bend in the creek (panel B), a side channel (< 100 m) with large woody debris (panel C), and a substrate patch on a gravel bar (panel D).

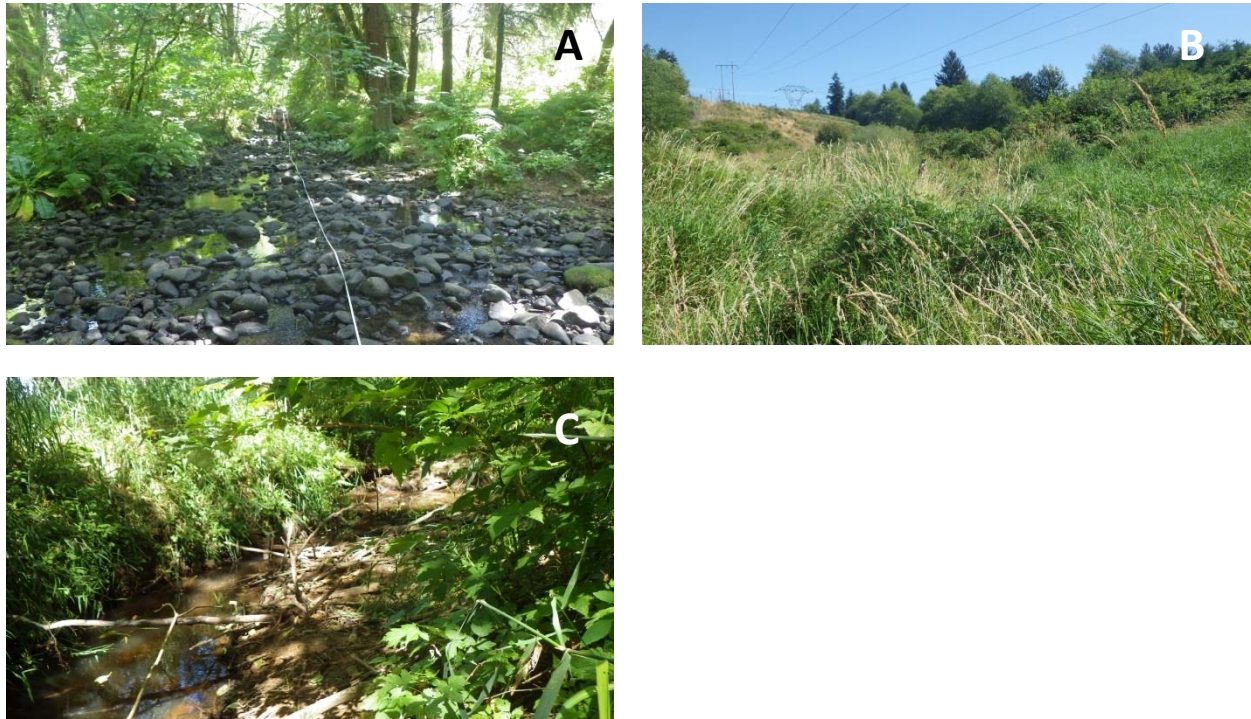
Figure 96. Survey pictures on reach 1 of Ferris Creek showing dense riparian vegetation consisting of alders, shrubs, and ferns (panel A), a section of stream at the upstream end of the reach where power lines cross the creek and the riparian vegetation is dominated by grass (panel B), and a short side channel next to a log jam (panel C).

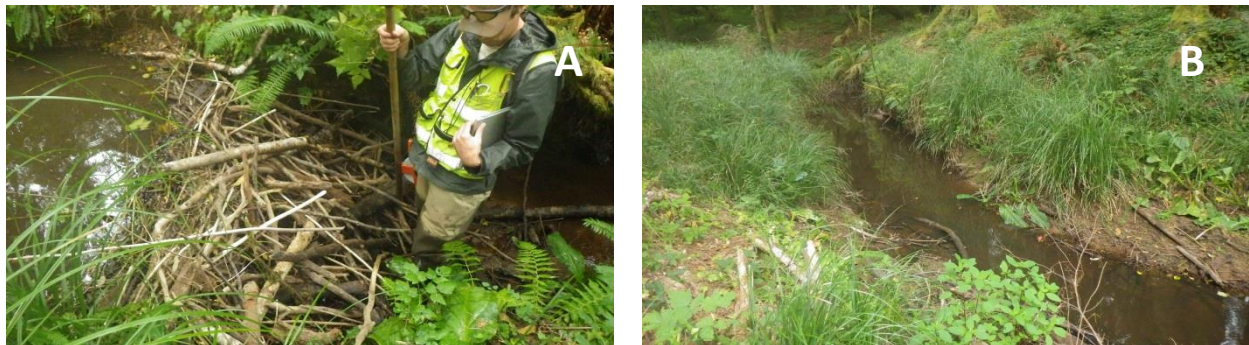
The reach on Little Ferris Creek started at the end of Schoolhouse Road (Lat: 46.15744900, Long: -123.62401000) and ended 75 m upstream at a small beaver dam (Lat: 46.15725700, Long: -123.62320200; Figure 98; Figure 99, panel A); Mainstem thalweg length was 75 m, and there were no side channels. The stream flowed through a low gradient area that appeared to be regularly inundated. The riparian vegetation consisted of large firs, spruces, and cedars, with land use being determined as rural residential and young timber. The creek was stagnant, with numerous pieces of small woody debris and a silt laden streambed (Figure 99, panel B).

Figure 99. Survey pictures on Little Ferris Creek showing a beaver dam barrier marking the upstream end of the reach (panel A) and a stagnant channel with fine sediment (panel B).

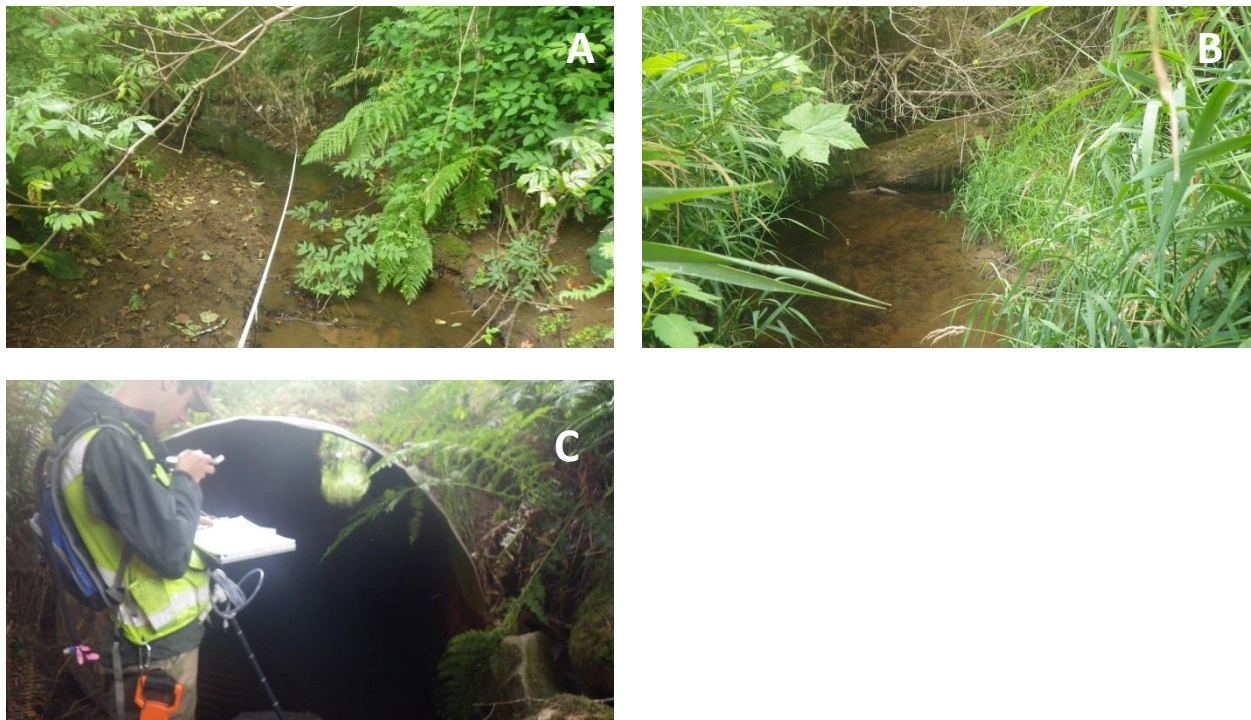
Reach 1 started at a culvert under a small farm road 450 m upstream from the Old Highway 30 bridge (Lat: 46.15873, Long: -123.644642) and ended 150 m upstream from the first Hillcrest Loop Road bridge (Lat: 46.155549, Long: -123.643871; Figure 101). The mainstem thalweg length of this reach was 436 m, and there were no side channels and few meanders. The riparian zone was densely vegetated with shrubs, grass, ferns, and several large fir trees (Figure 102, panel A). Land use was rural residential and young timber.

Figure 102. Survey pictures on reach 1 of Hillcrest Creek showing dense riparian vegetation consisting of shrubs, grass, ferns and sparse trees (panel A), the streambed filled with mud and silt (panel B), and a semicircular culvert located near the upstream end of the reach (panel C).

Stream channel consisted of mud, silt (< 4 mm diameter) and a small amount of gravel-sized substrate (4–45 mm, diameter; Figure 102, panel B). No gravel patches that met established minimum criteria were found in reach 1 of Hillcrest Creek. Two cold-water patches were detected, with a combined surface area of 4.9 m². Average temperature in these patches was 15.4° C, and average temperature adjacent to these patches was 16.2° C. The dominant substrate type within these cold-water patches was fine sediment (< 4 mm diameter). One of these cold-water patches was located between 50 m and 75 m and another between 350 m and 375 m from the downstream end of the reach. There were two potential barriers to Chum Salmon migration in this reach (Figure 102; Table 36). These barriers were semicircular culverts located at Hillcrest Loop Road bridges (Table 36; Figure 102, panel C).

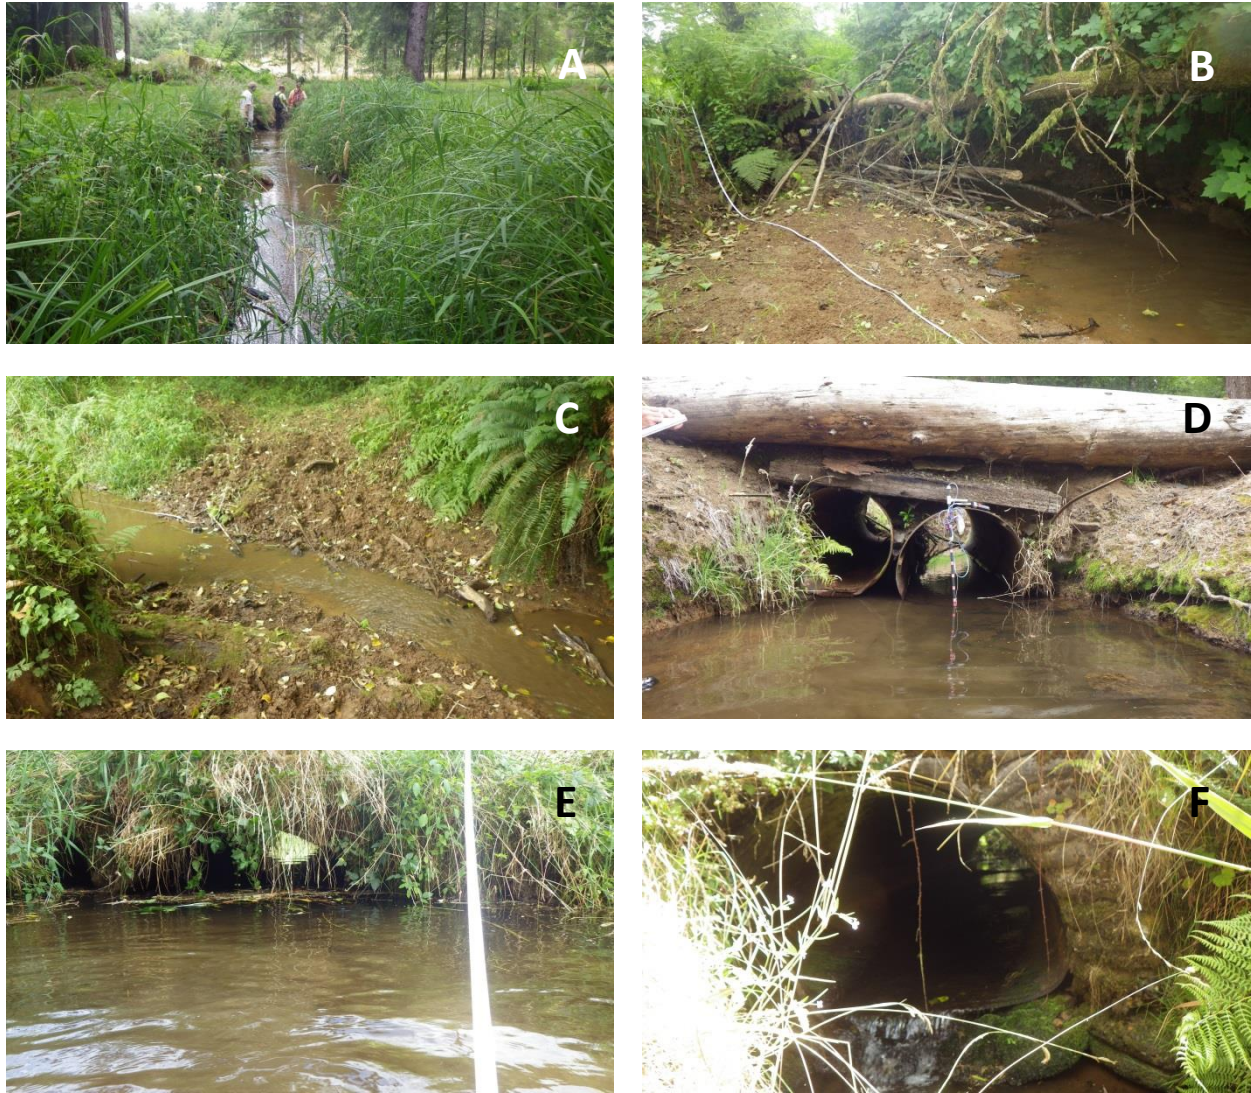
Reach 2 started at the confluence with a small, unnamed tributary 250 m upstream from the first Hillcrest Loop Road bridge (Lat: 46.153603, Long: -123.643382) and ended at a point 300 m upstream from the third Hillcrest Loop Road bridge. (Lat: 46.148787, Long: -123.632979; Figure 103). The mainstem thalweg length of this reach was 1,688 m, and there were no side channels. The stream channel meandered as it flowed through a residential area, and the primary land use was a mix of rural residential and light grazing. The riparian vegetation was highly variable with some areas that were densely vegetated with shrubs, firs, and alders, and other areas that were grass-dominated (Figure 104, panel A). Channel-spanning large woody debris was abundant throughout the reach (Figure 104, panel B), as was broken glass and trash.

Several livestock or wildlife crossing were observed in the downstream half of the reach (Figure 104, panel C).

Figure 104. Survey pictures on reach 2 of Hillcrest Creek showing section of stream with a grass-dominated riparian zone (panel A), large woody debris spanning the stream channel (panel B), signs of livestock crossing the creek (panel C), a double circular culvert barrier located under a small residential road (panel D), a triple circular culvert barrier located under the second Hillcrest Loop Road bridge (panel E), and a semicircular culvert barrier located under the third Hillcrest Loop Road bridge (panel F).

residential road, (2) three adjacent circular culverts located under the second Hillcrest Loop Road bridge, and (3) a semicircular culvert located under the third Hillcrest Loop Road bridge (Table 37; Figure 104, panels D–F).

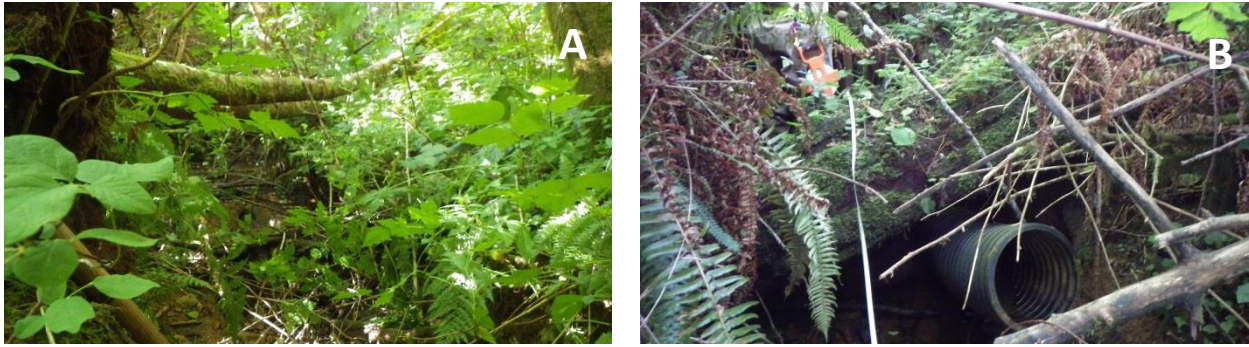
Reach 1 started at the confluence with Hillcrest Creek (Lat: 46.153625, Long: -123.64333) and continued upstream to an old farm road bridge (Lat: 46.15176, Long: -123.64543; Figure 106). The mainstem thalweg length of this reach was 337 m, with no side channels and multiple meanders. The confluence of this tributary with Hillcrest Creek has moved 50 m upstream from where it is surveyed on the map. The riparian vegetation was a dense thicket of salmonberry, ferns and small alders (Figure 107, panel A), and land use was rural residential. The survey ended at a crushed culvert located under an old logging road (Figure 107, panel B). The upstream end of this culvert was not visible due to heavy sediment accumulation.

Figure 107. Survey pictures of an unnamed tributary of Hillcrest Creek show a densely-vegetated riparian zone with shrubs, ferns, alders, and maples (panel A) and a crushed circular culvert at the upstream end of the reach (panel B).

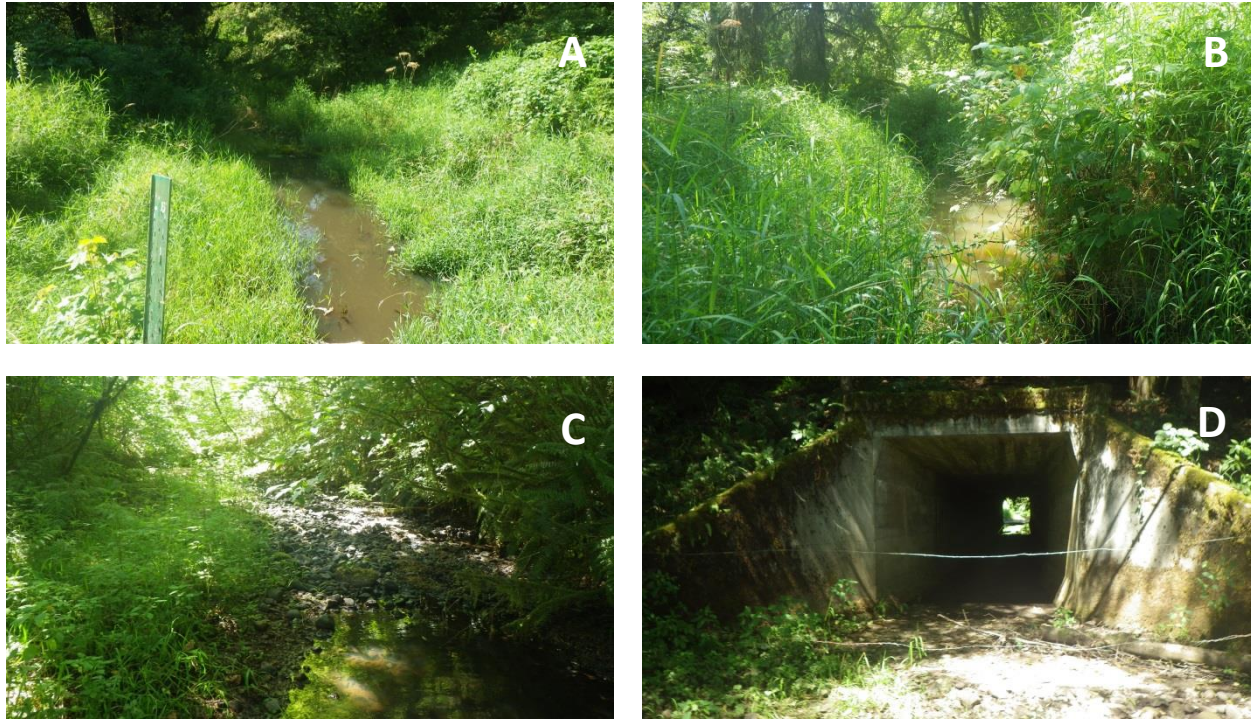
Figure 110. Survey pictures on reach 1 of Little Creek showing a tidal slough downstream from Old Highway 30 (panel A), riparian vegetation consisting of dense grass, shrubs and some sparse trees (panel B), an isolated pool with adjacent gravel substrate (panel C), and a box culvert under the Highway 30 bridge (panel D).

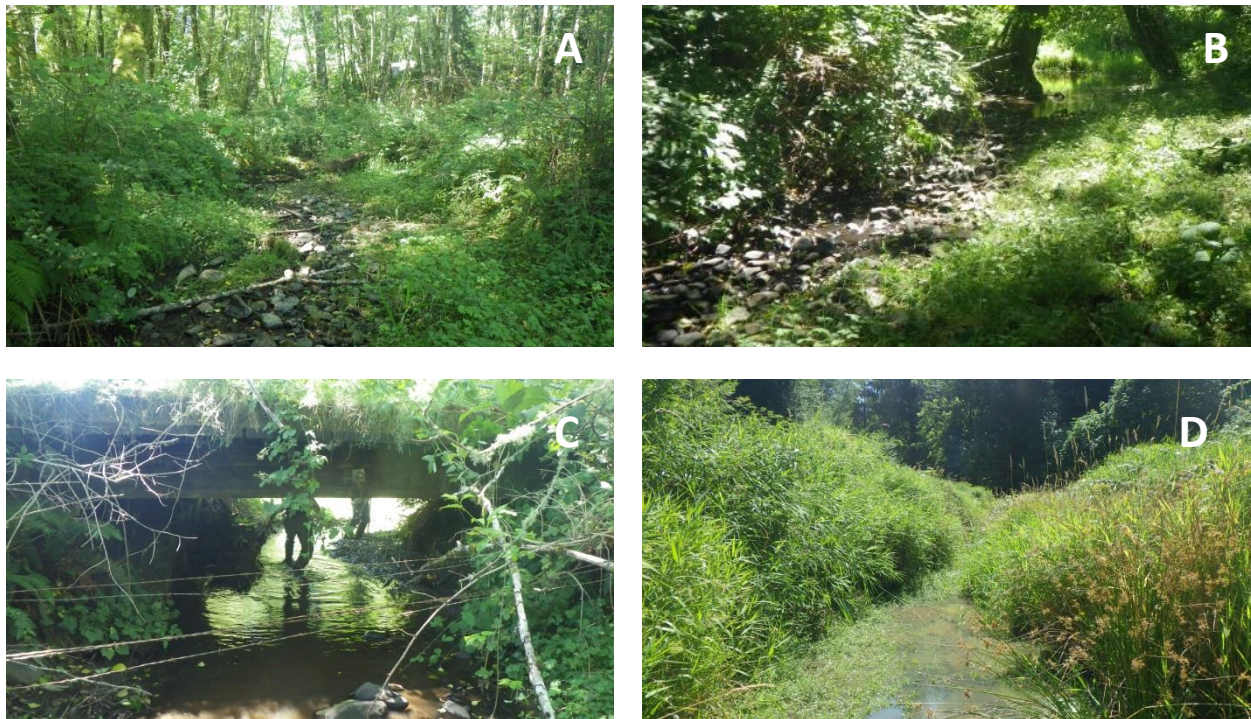
Reach 2.1 started at the Highway 30 bridge (Lat: 46.167522, Long: -123.595896) and continued upstream to where Little Creek now connects with Big Creek (Lat: 46.16262, Long: -123.596682; Figure 112). The thalweg length of this reach was 666 m, with no side channels and multiple meanders. The riparian zone was sparsely vegetated with young alders and grass (Figure 113, panel A), and land use was rural residential. Much of the stream channel in this reach was dry, however some isolated pools were also present (Figure 113, panel B). There was a small farm bridge in the downstream half of the reach (Figure 113, panel C). Power lines crossed near the middle of the reach, with this riparian area consisting of grasses (Figure 113, panel D).

Figure 113. Survey pictures on reach 2.1 of Little Creek showing a riparian zone dominated by alders, shrubs, and grass (panel A), a short riffle connecting two pools (panel B), a small bridge (panel C), and a section of stream where the riparian zone is dominated by dense grass underneath powerlines (panel D).

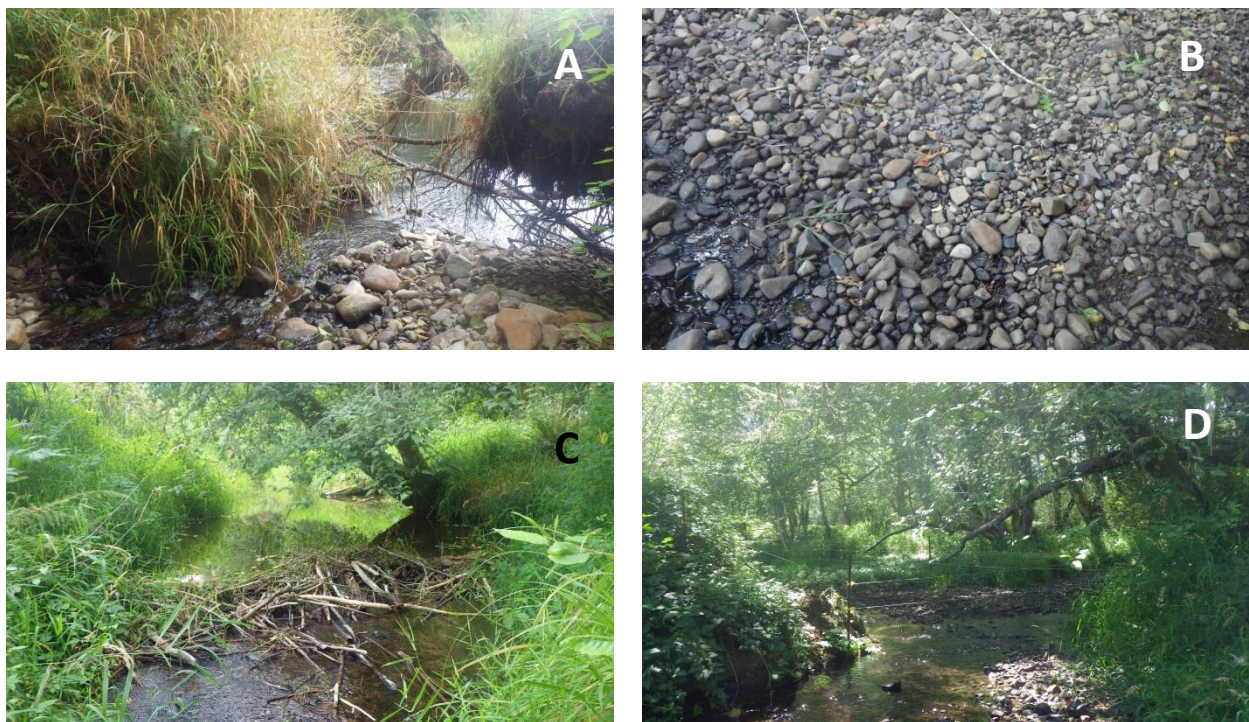
Figure 116. Survey pictures on reach 2.2 of Little Creek showing the confluence of Little and Big Creeks at the downstream end of the reach (panel A), a substrate patch with large gravel and small cobble (panel B), a small beaver dam with a pool upstream (panel C), and a livestock fence across the stream channel (panel D).
