# **Aquatic Inventory Project (AIP) Habitat Surveys: Morton Creek – 2008 & 2012**

Survey conducted by  
**Aaron Fitch & Erin Minster**  
**Curry Soil and Water Conservation District**

Report by  
**Erin Minster – Curry SWCD**  
**Matt Swanson – Swanson Ecological Services, LLC**

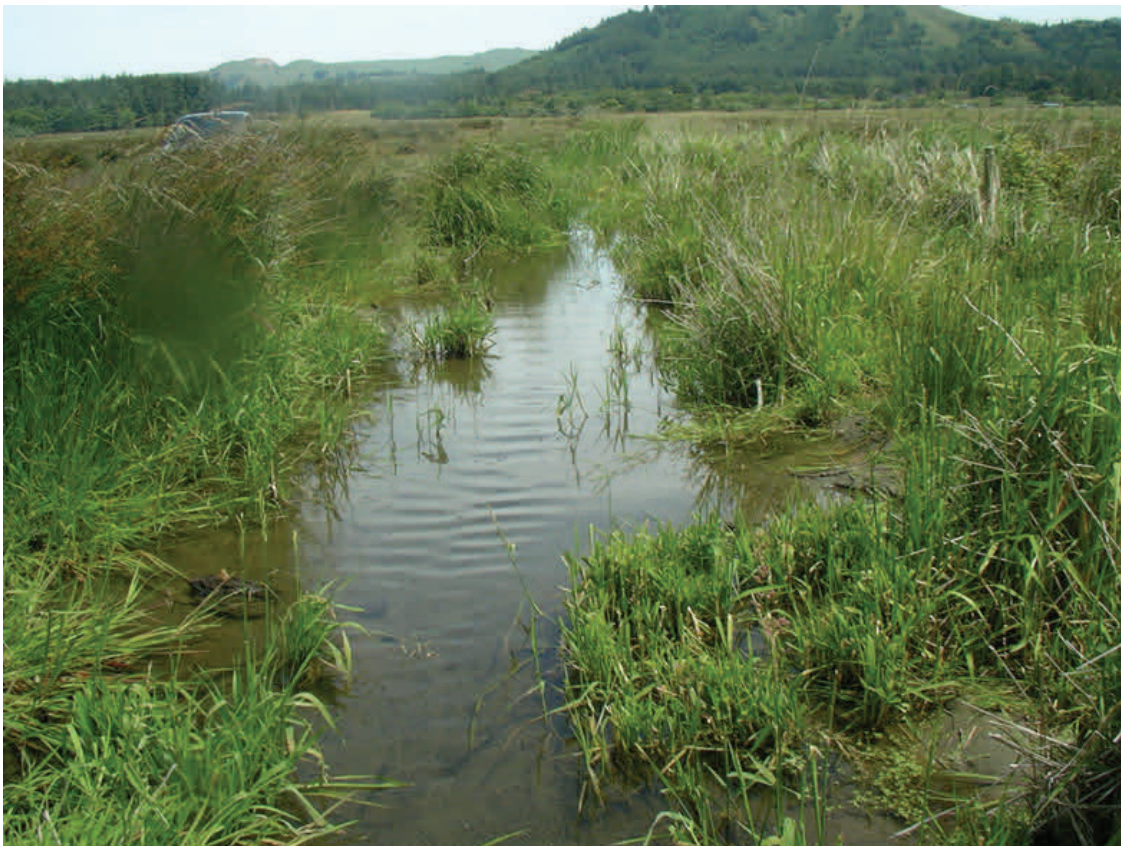
**Figure 1**

2008—Start of AIP survey on the ditch channel; which had not been “cleaned out” in more than a decade, and had subsequently filled with sediment by 2008.

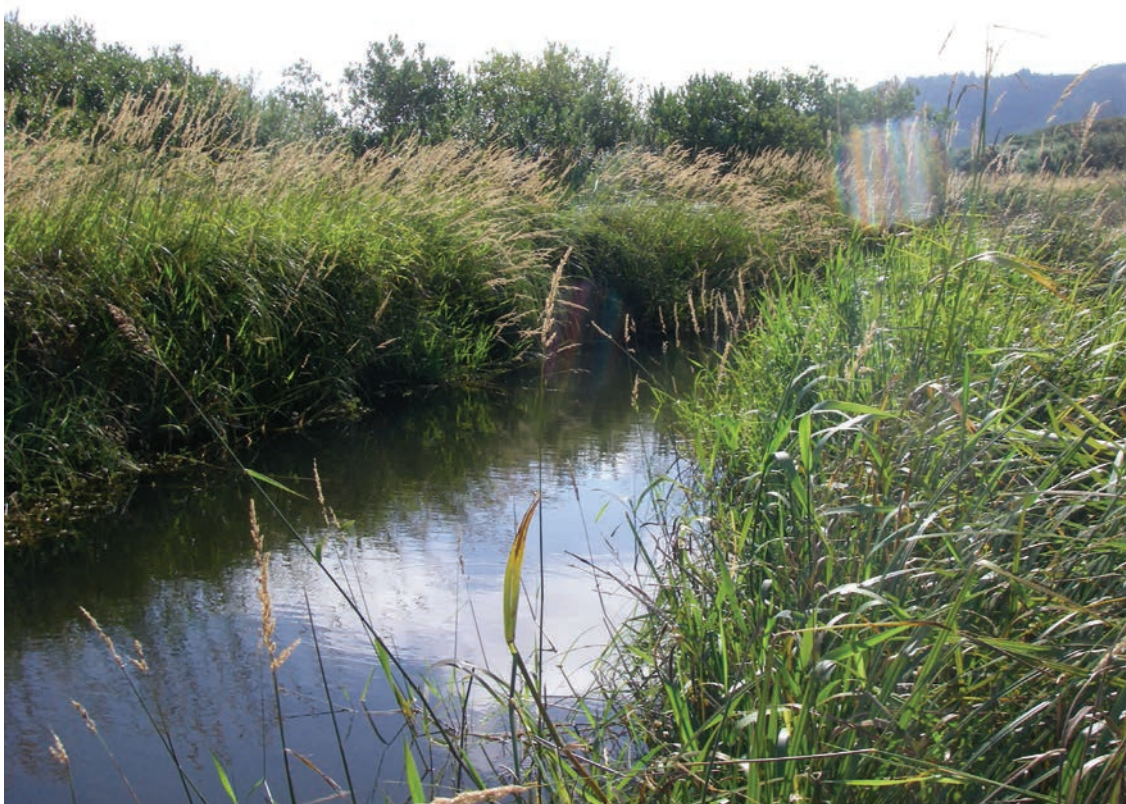
**Figure 2**

2012—Start of AIP survey on the new Morton Creek channel.

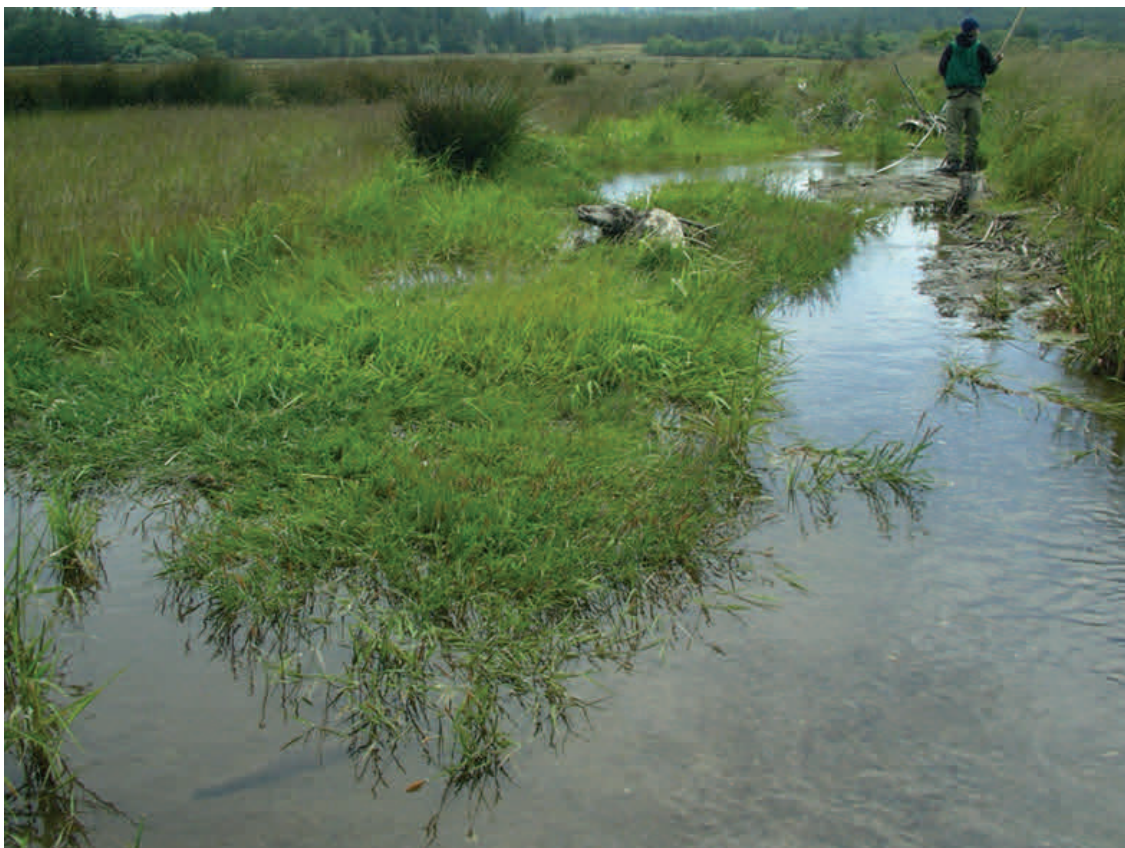
**Figure 3**

2008—Reach 1, units 20-26: Looking upstream where deposition had filled the ditch channel and was forcing the stream to fan out across the adjacent pastureland.

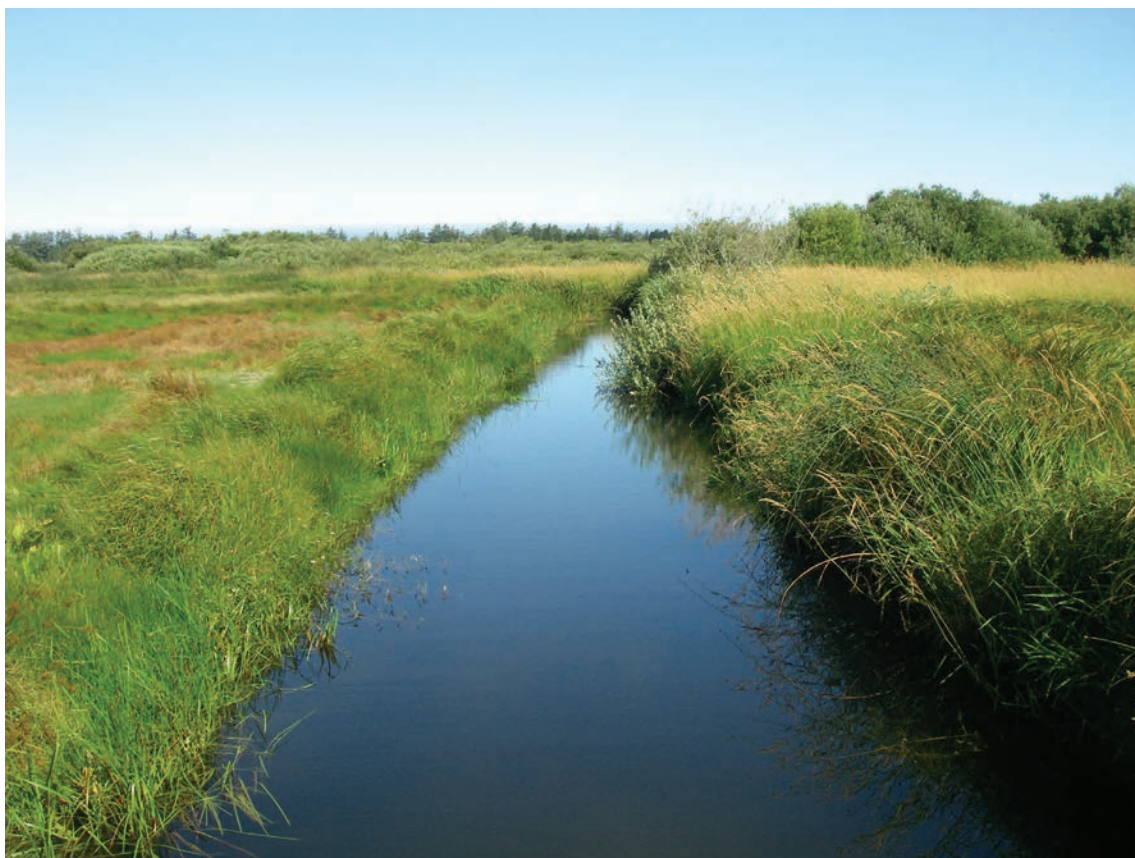
**Figure 4**

2012—Reach 1, unit 2: Looking downstream at the lower end of the new channel, which is being backwatered by New Lake via an abandoned segment of the original Bono Ditch channel.

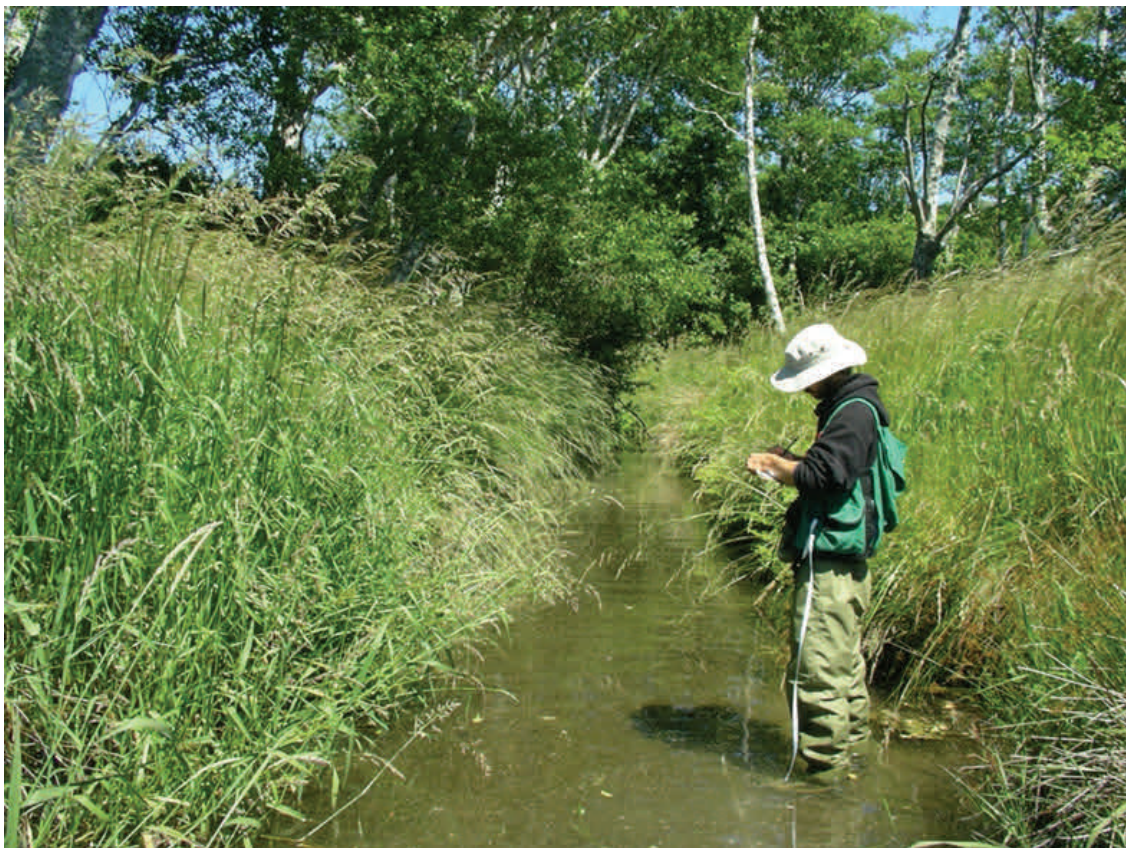
**Figure 5**

2008—Start of Reach 2, unit 82: Looking upstream.

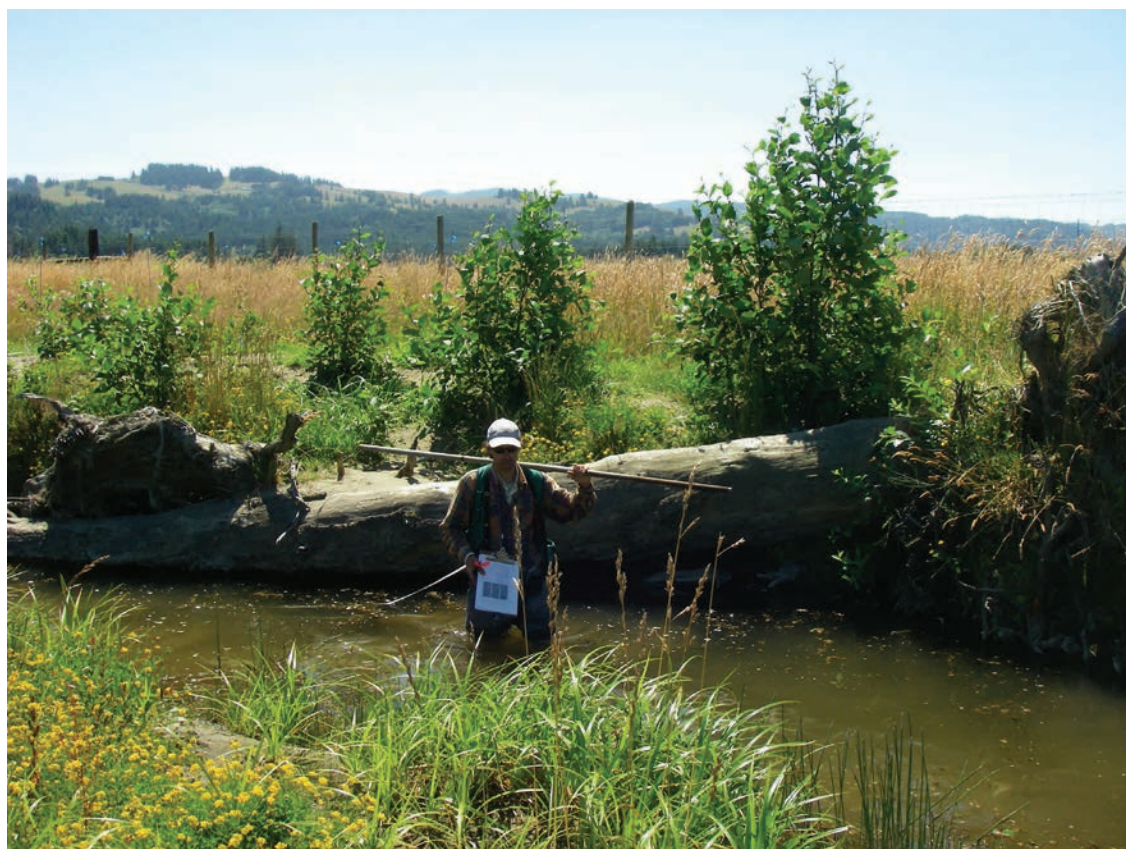
**Figure 6**

2012—Near the start of Reach 2, unit 15: Looking upstream on the new channel at a lateral scour pool and log structure.

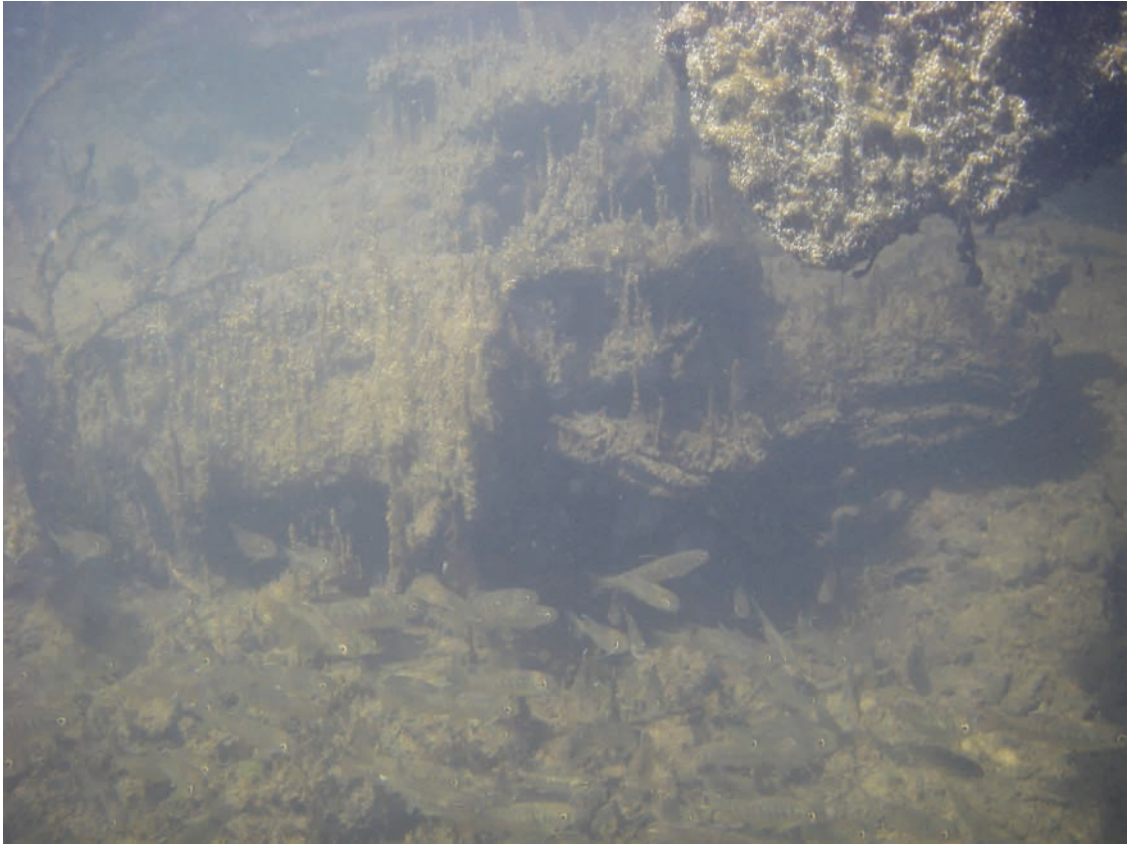
**Figure 7**

2012—Reach 2, unit 15: Coho were abundant in pool habitat on the new channel.

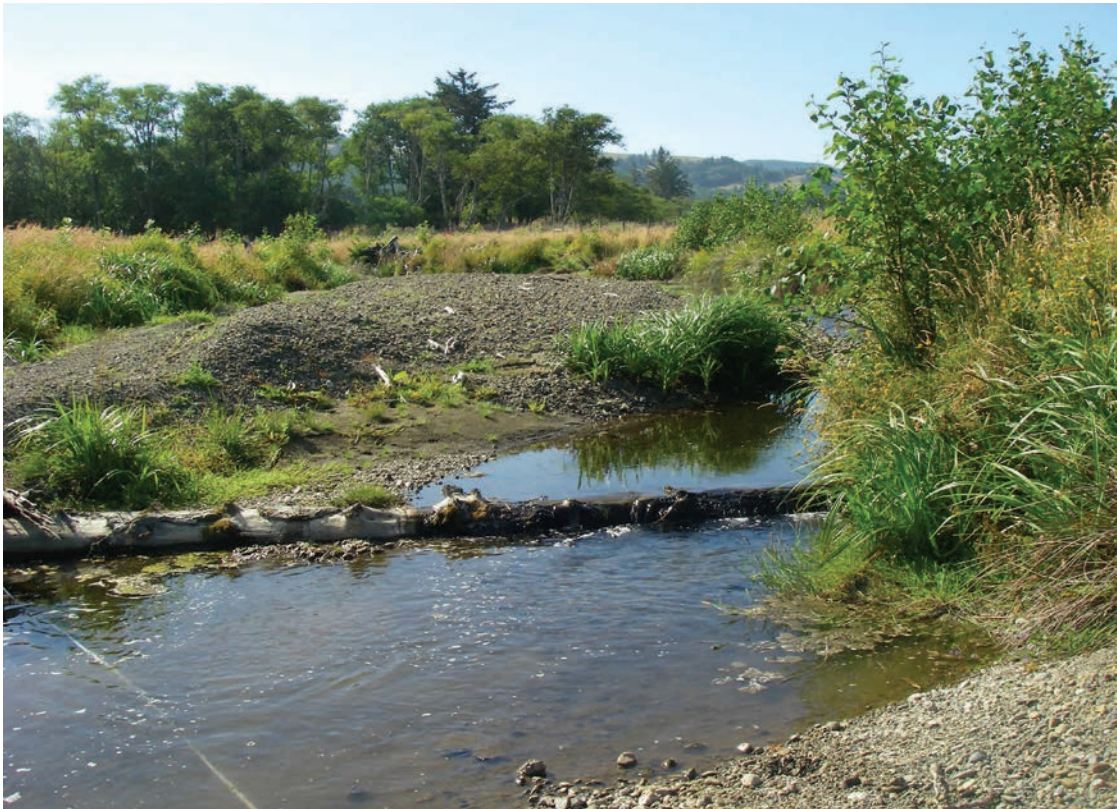
**Figure 8**

2012—Reach 2, unit 53: Looking upstream at the in-line sediment retention pond that was designed as a “sacrifice area” where incoming bedload could be removed to prevent the downstream channel from filling with sediment. In Year 1 ~200 cubic yards were removed, but no material has been removed since because USACE erroneously omitted bedload removal from the removal-fill permit authorization.

During the first winter post-implementation the inline pond filled with bedload after high flows in November and December, and a headcut developed near RM 0.46 because of modifications to the design that shortened the channel, which subsequently increased the slope. In summer 2010 approximately 200 cubic yards of sediment were removed from the inline pond, which indirectly aggravated the headcut by depriving the downstream channel of bedload. No sediment was removed in the summer of 2011 (nor any year since), and log weirs were built for grade control to arrest and reverse the headcut. The channel responded quickly during the winter of 2011-12, and by summer 2012 the headcut was no longer noticeable.

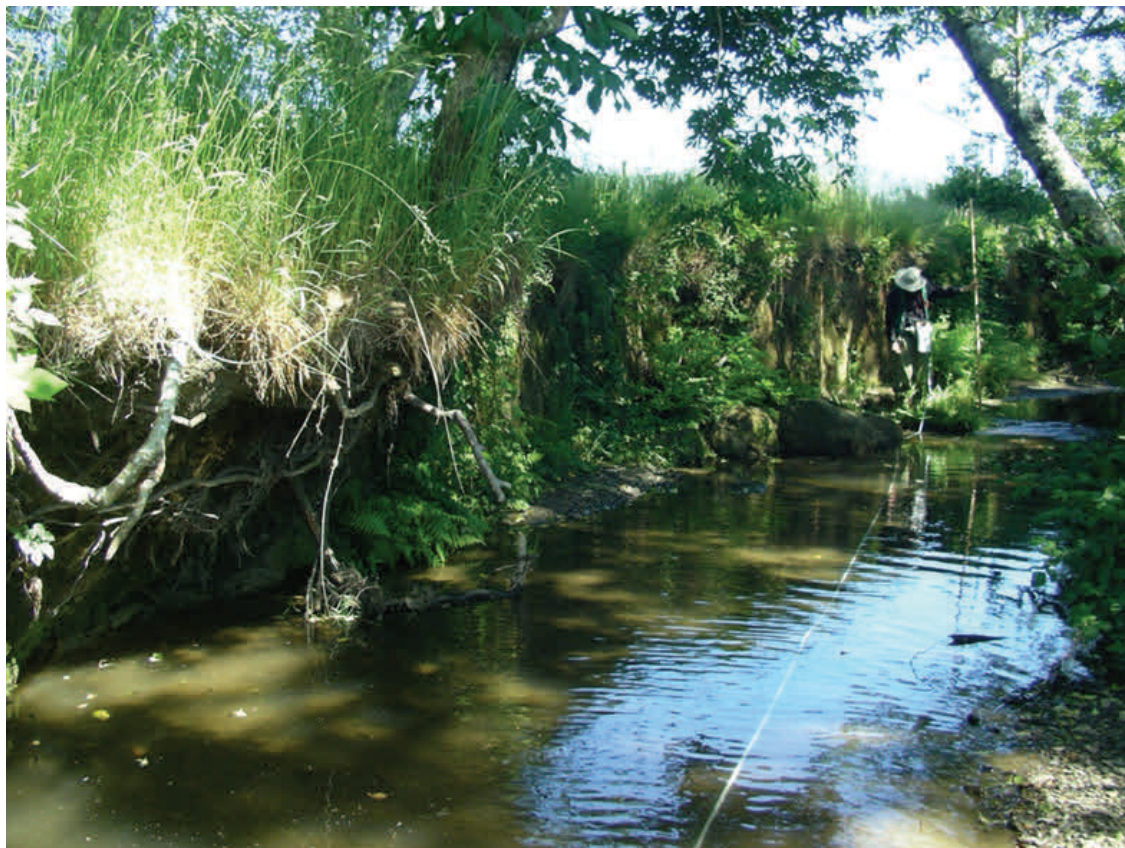
**Figure 9**

2008—Reach 2, unit 87: Looking upstream at a segment of incised channel that was modified in 2009 through the construction of inset floodplain terraces and bank sloping.

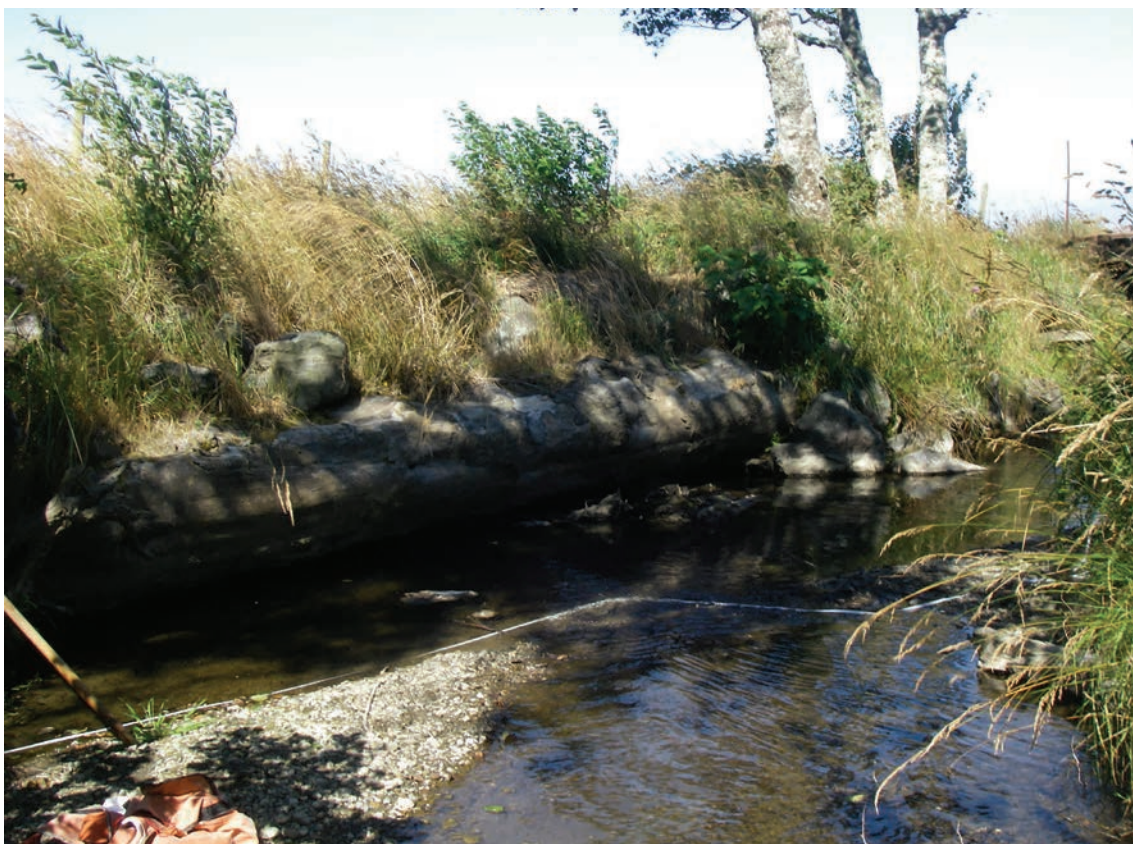
**Figure 10**

2012—Reach 2, unit 65: Looking downstream at the “cutoff” where the old channel was abandoned and filled — the log and rocks were used to seal off the old channel.

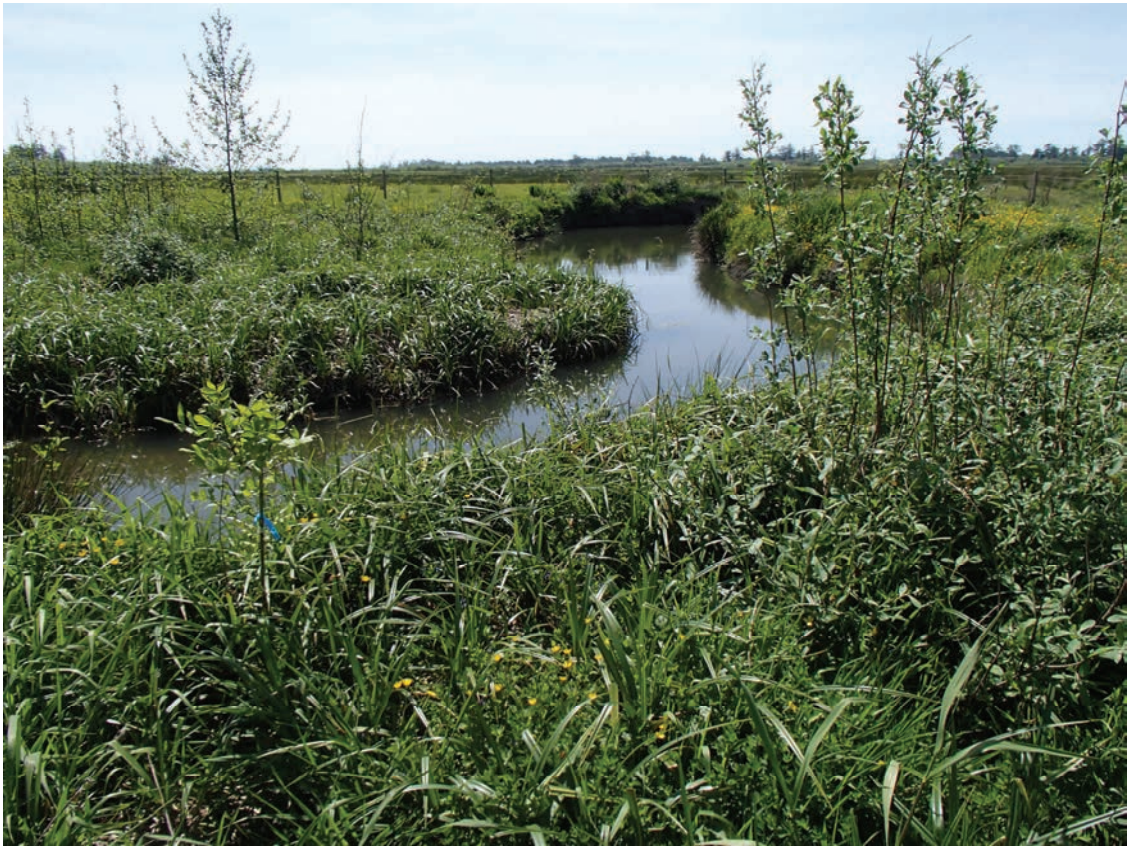
**Figure 11**

April 2014—Looking downstream at the new channel near the break between Reach 1 & 2, where the gradient decreases and the stream transforms into a “meadow-trench” channel.

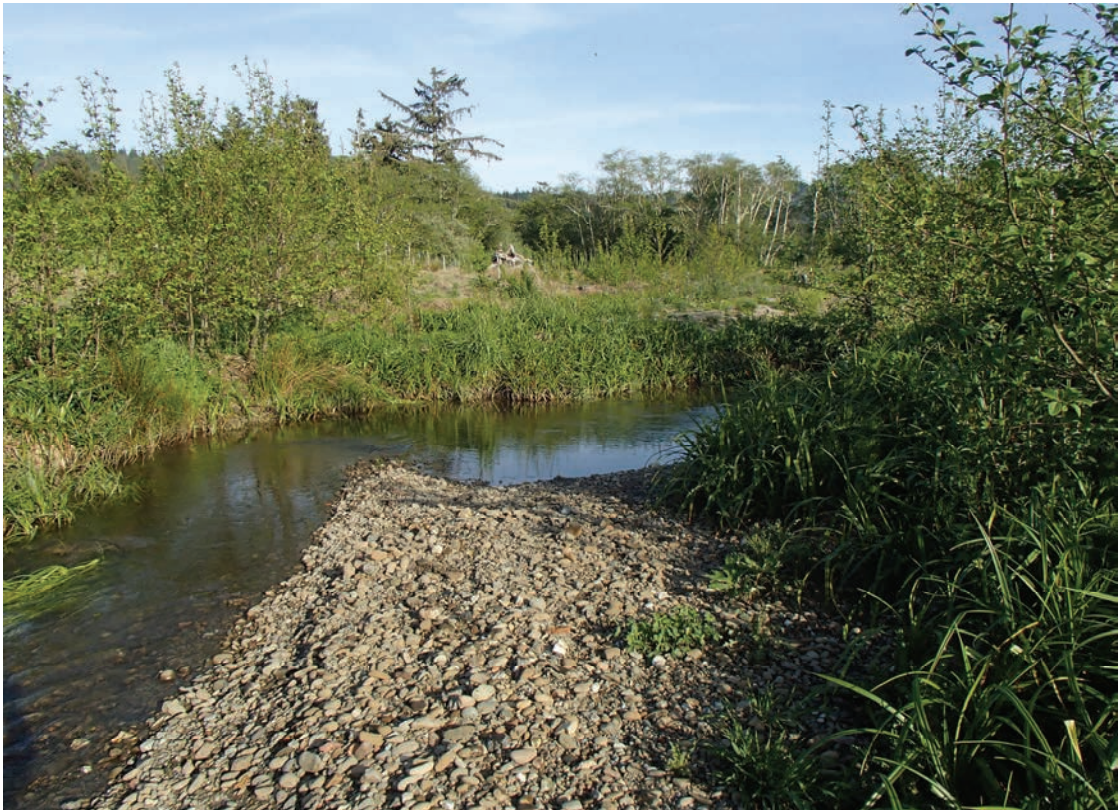
**Figure 12**

April 2014—Looking upstream at a lateral scour pool in Reach 2. Notice the point bar development and the colonization of riparian vegetation, including sedge.

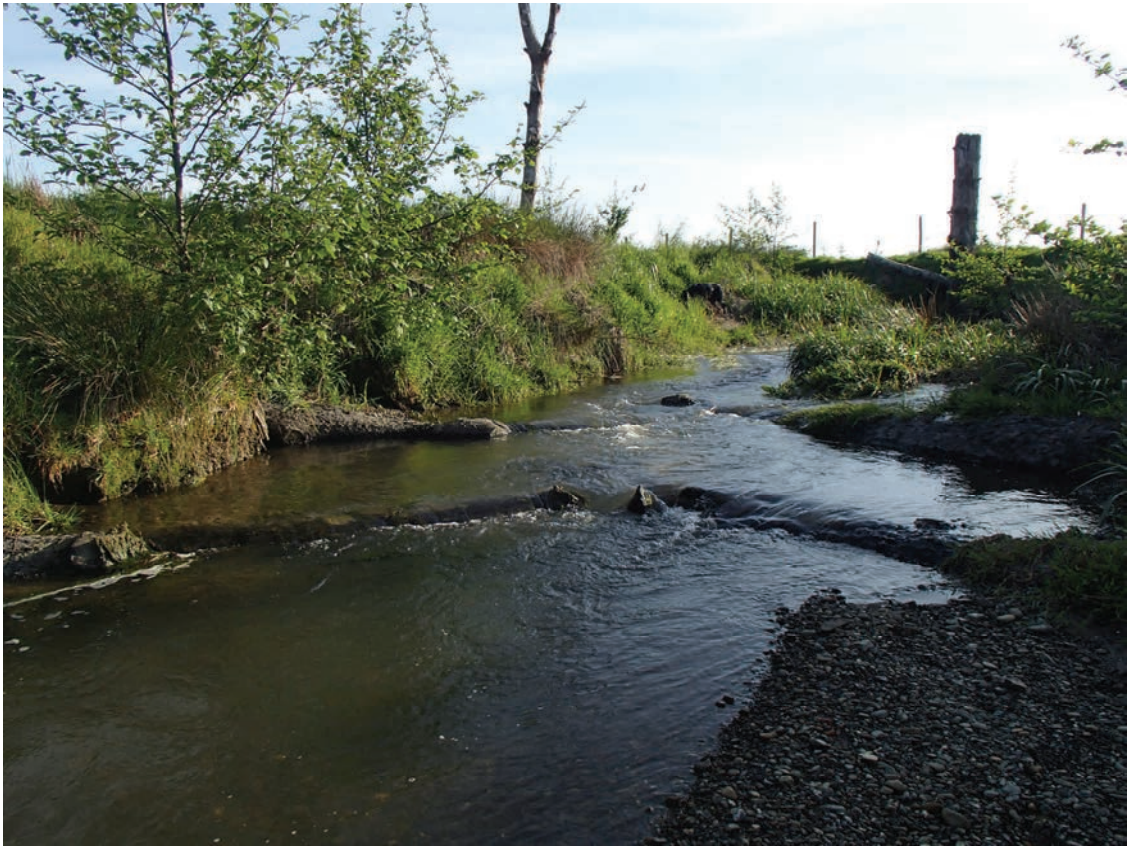
**Figure 13**

April 2014—Looking upstream at one of three log weirs constructed in 2011 for grade control to arrest and reverse the upstream migration of a headcut.

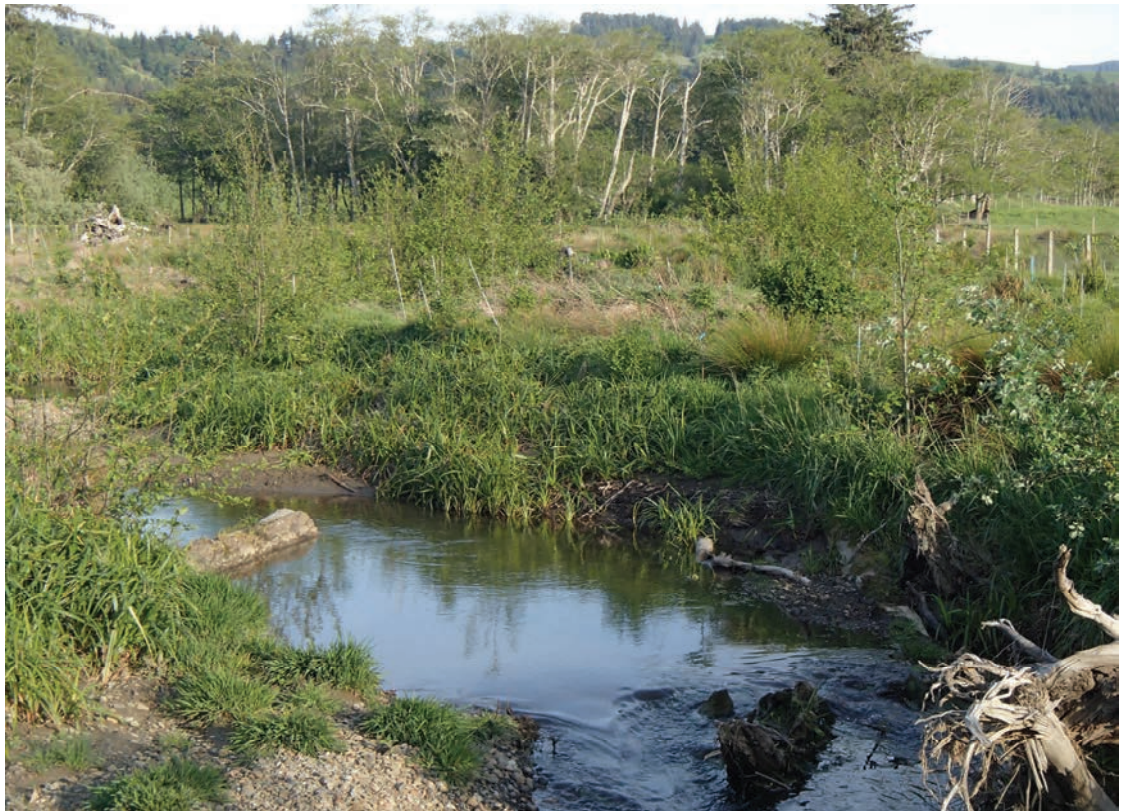
**Figure 14**

April 2014—Looking upstream at the new Morton Creek channel in Reach 2, where log structures and channel sinuosity have formed “complex pools”.

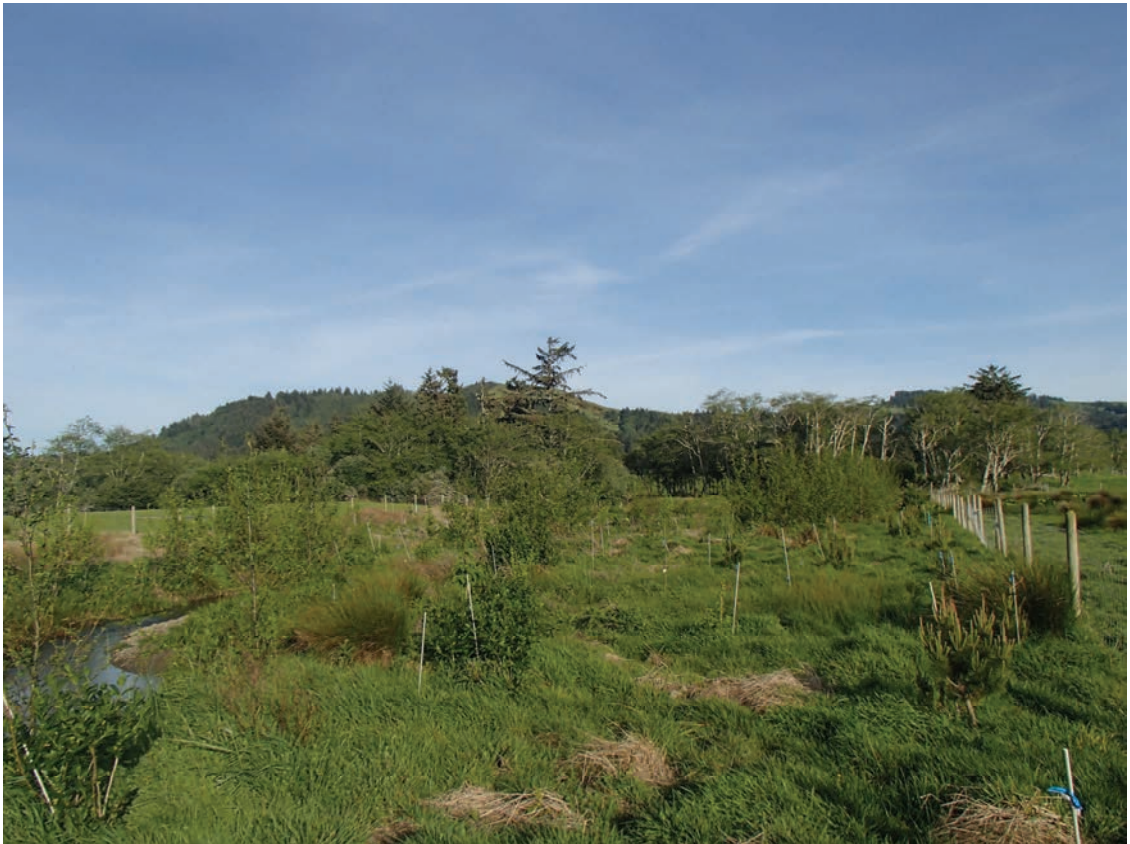
**Figure 15**

April 2014—Reach 2 on the new channel was enrolled in CREP to fence livestock from the stream and revegetation the area with native trees and shrubs.

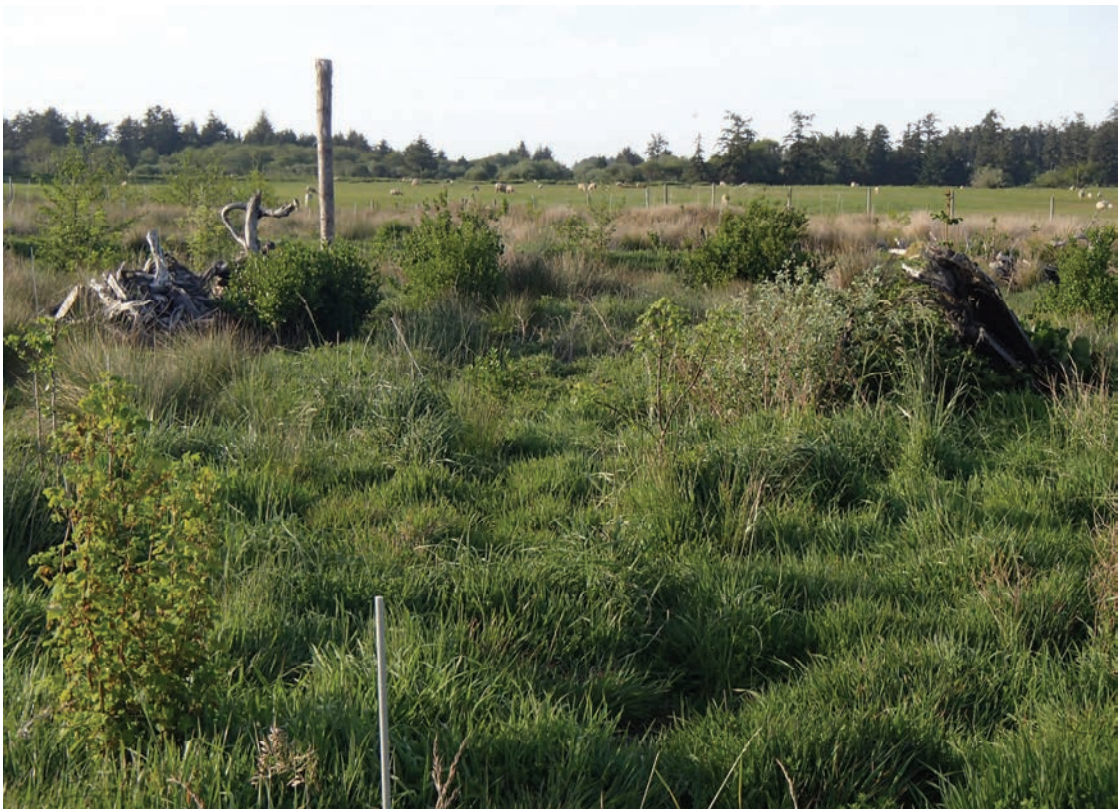
**Figure 16**

April 2014—The earliest plantings were free-to-grow as of spring 2014, but the project continued to be interplanted and maintained in order to reach a desirable stocking density.
