Limiting Factors Analysis and Restoration Plan

Mosby Creek Combined 6th Fields
of Coast Fork Willamette River

May 2014

Prepared by
Bio-Surveys, LLC
P.O. Box 65
Alsea, OR 97324
541-487-4338
Contact: Steve Trask

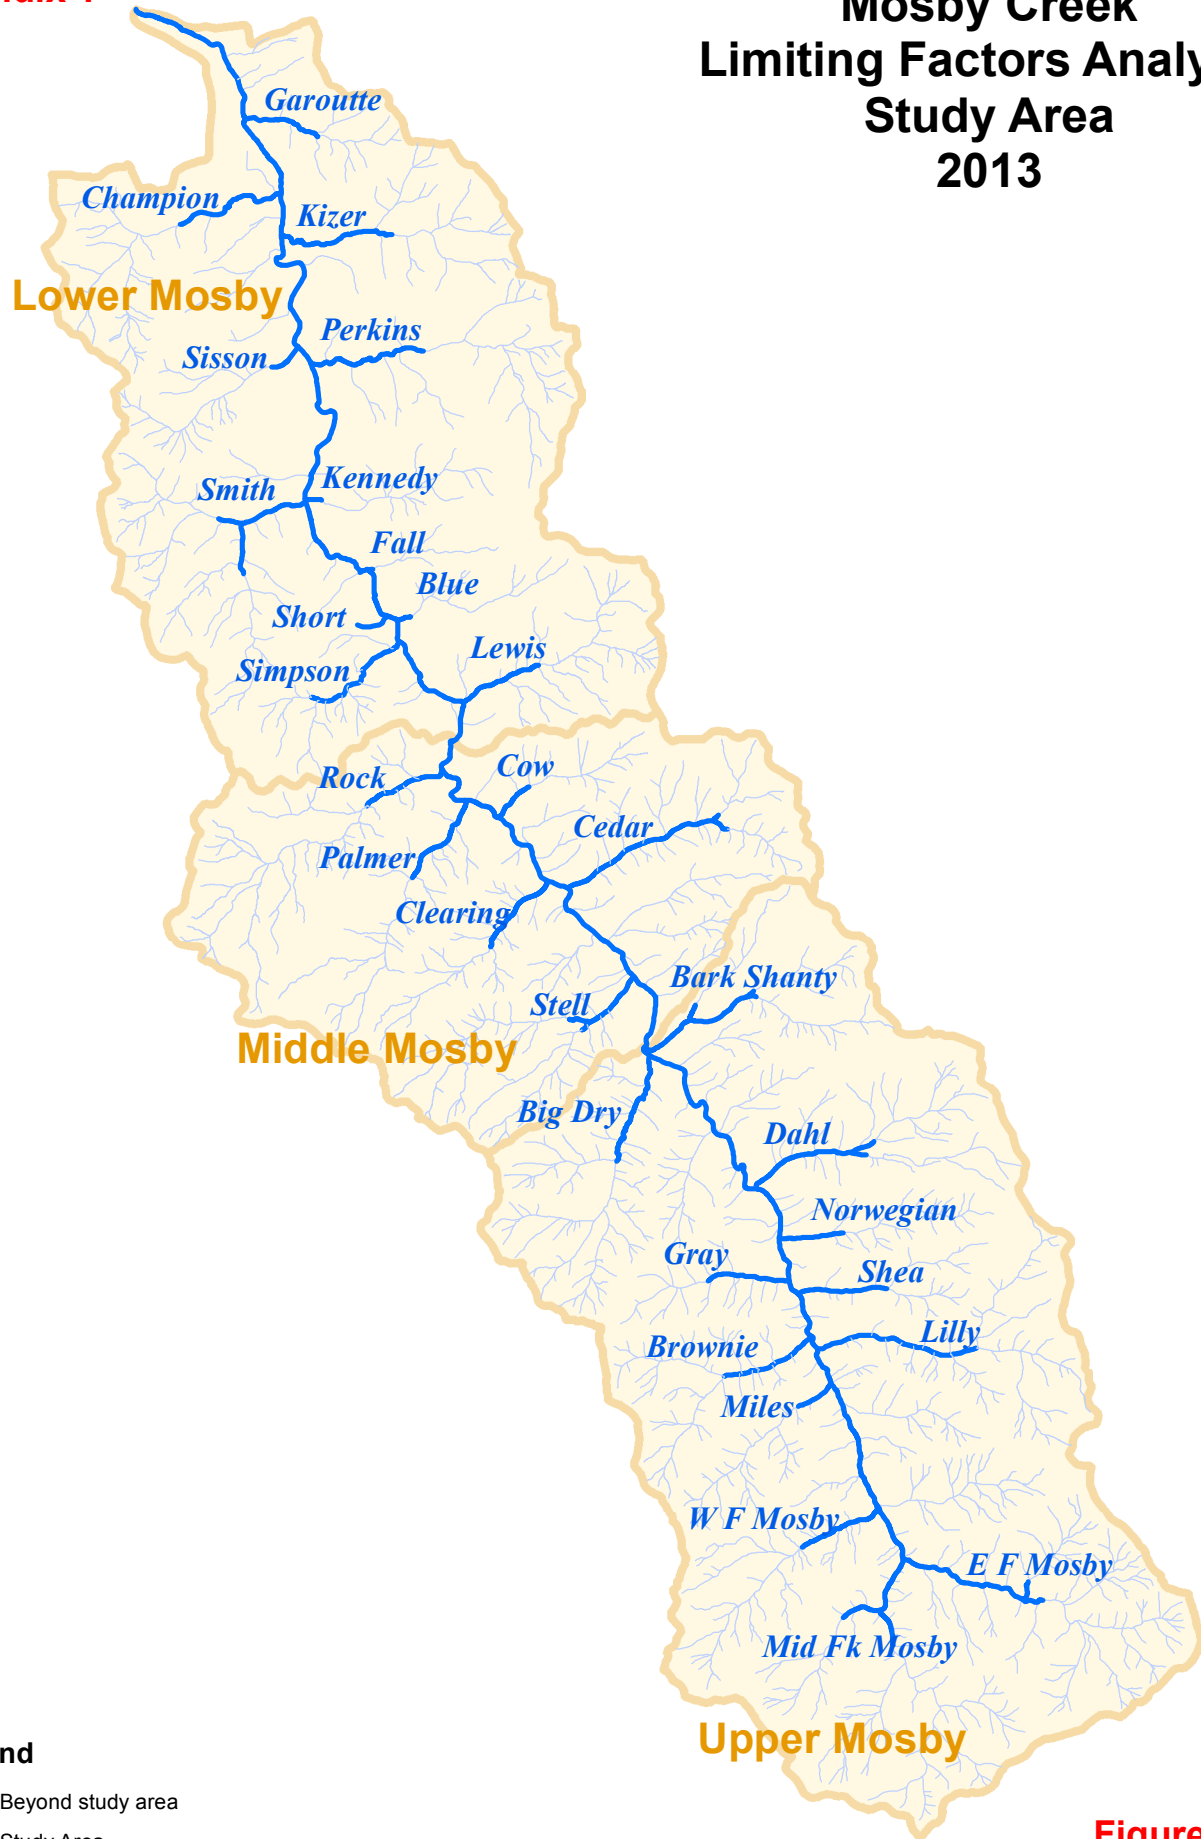
Figure 1

Mosby Creek Limiting Factors Analysis Study Area 2013

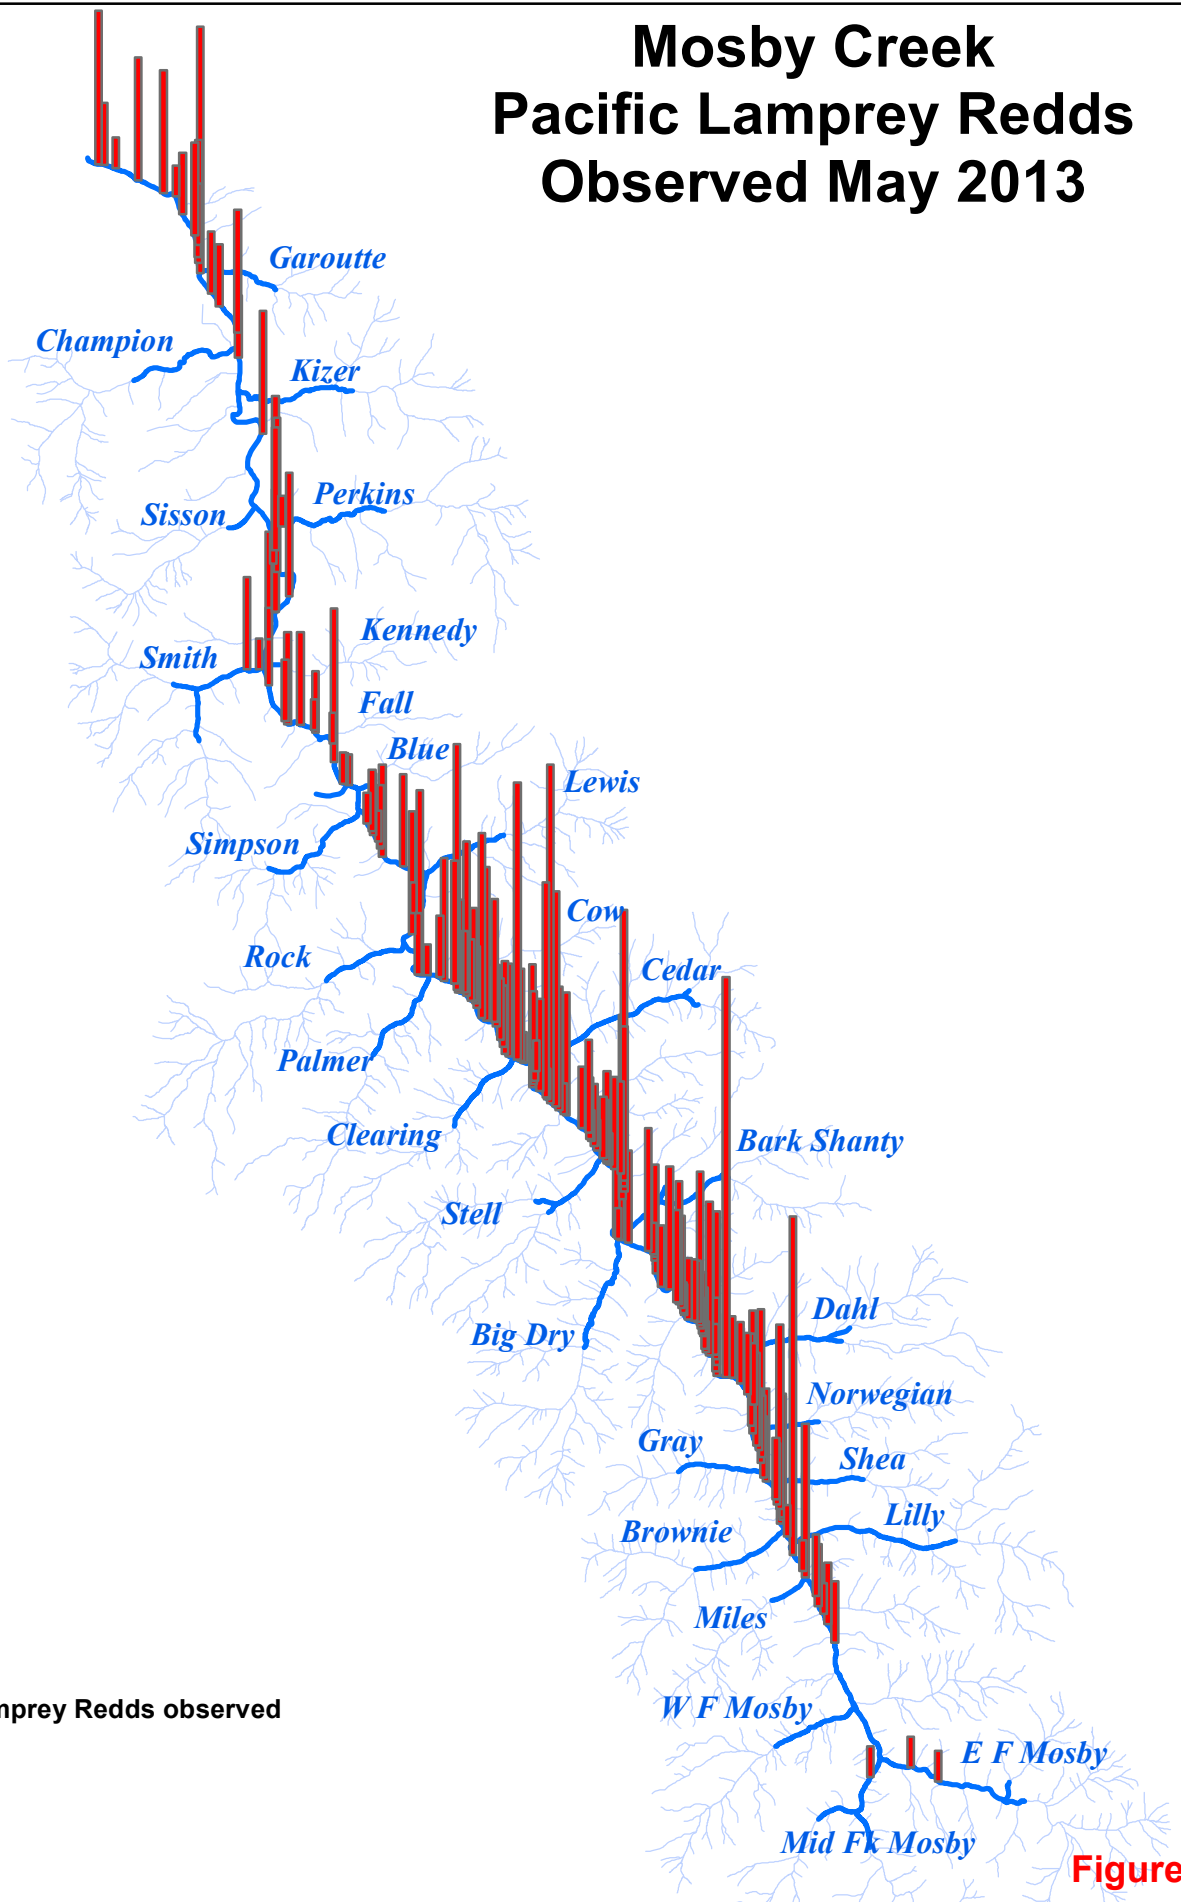
Figure 11

Mosby Creek Pacific Lamprey Redds Observed May 2013

There were 473 Pacific lamprey redds documented in the 22.2 miles inventory of the mainstem of Mosby Cr mainstem in 2013 (Figure 11). Nine lamprey redds were observed in the 30 tributaries combined. This was a 100% census during a period where only one live pair of spawning lamprey was observed. This suggests that the number of redds observed is likely to represent the bulk of the spawning that occurred in the system. The count included a broad range of redd age classes but surveyors noted that almost all redds regardless of age class were still visible and not inundated by deposition from late winter storm events.

There were 473 Pacific lamprey redds documented in the 22.2 miles inventory of the mainstem of Mosby Cr mainstem in 2013 and 9 in all 30 tributaries inventoried (Figure 11). This was a 100% census during a period where only one live pair of spawning lamprey was observed. A video of this activity can be viewed at:

Redds were distributed throughout 20 miles of mainstem Mosby Cr with the highest concentration of redds within the middle 6th field reach, where mainstem spawning gravels are highest in abundance. It is assumed that Pacific lamprey adults, utilizing the same high quality spawning gravels utilized by winter steelhead are not compromising the egg-to-fry survival rates of the few observed winter steelhead redds (N=7). Restoration prescriptions identified within this document that consequently provide for the storage and sorting of spawning gravels would simultaneously benefit the Pacific lamprey.

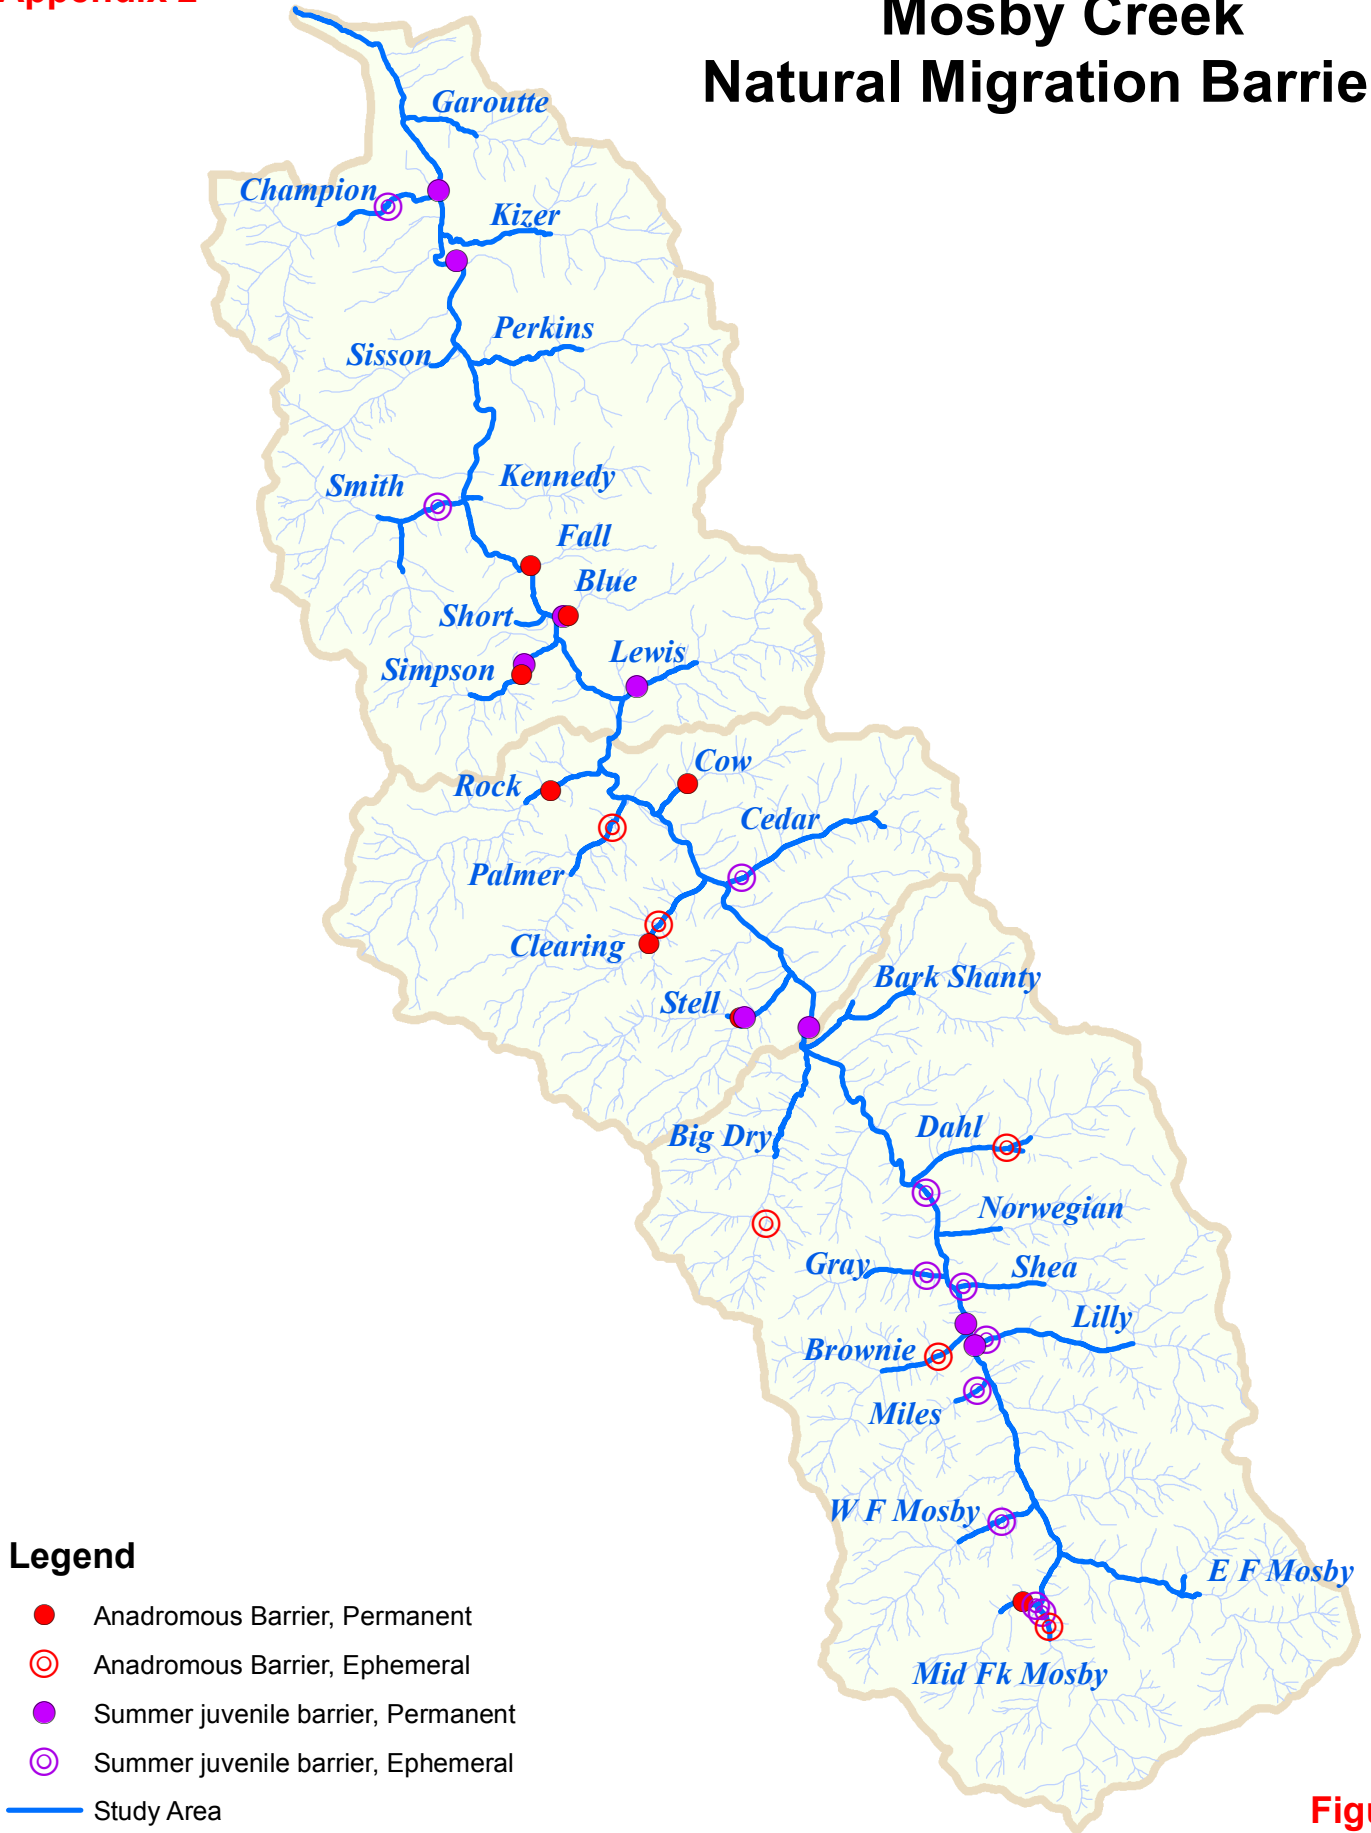
Figure 12

Mosby Creek Natural Migration Barriers

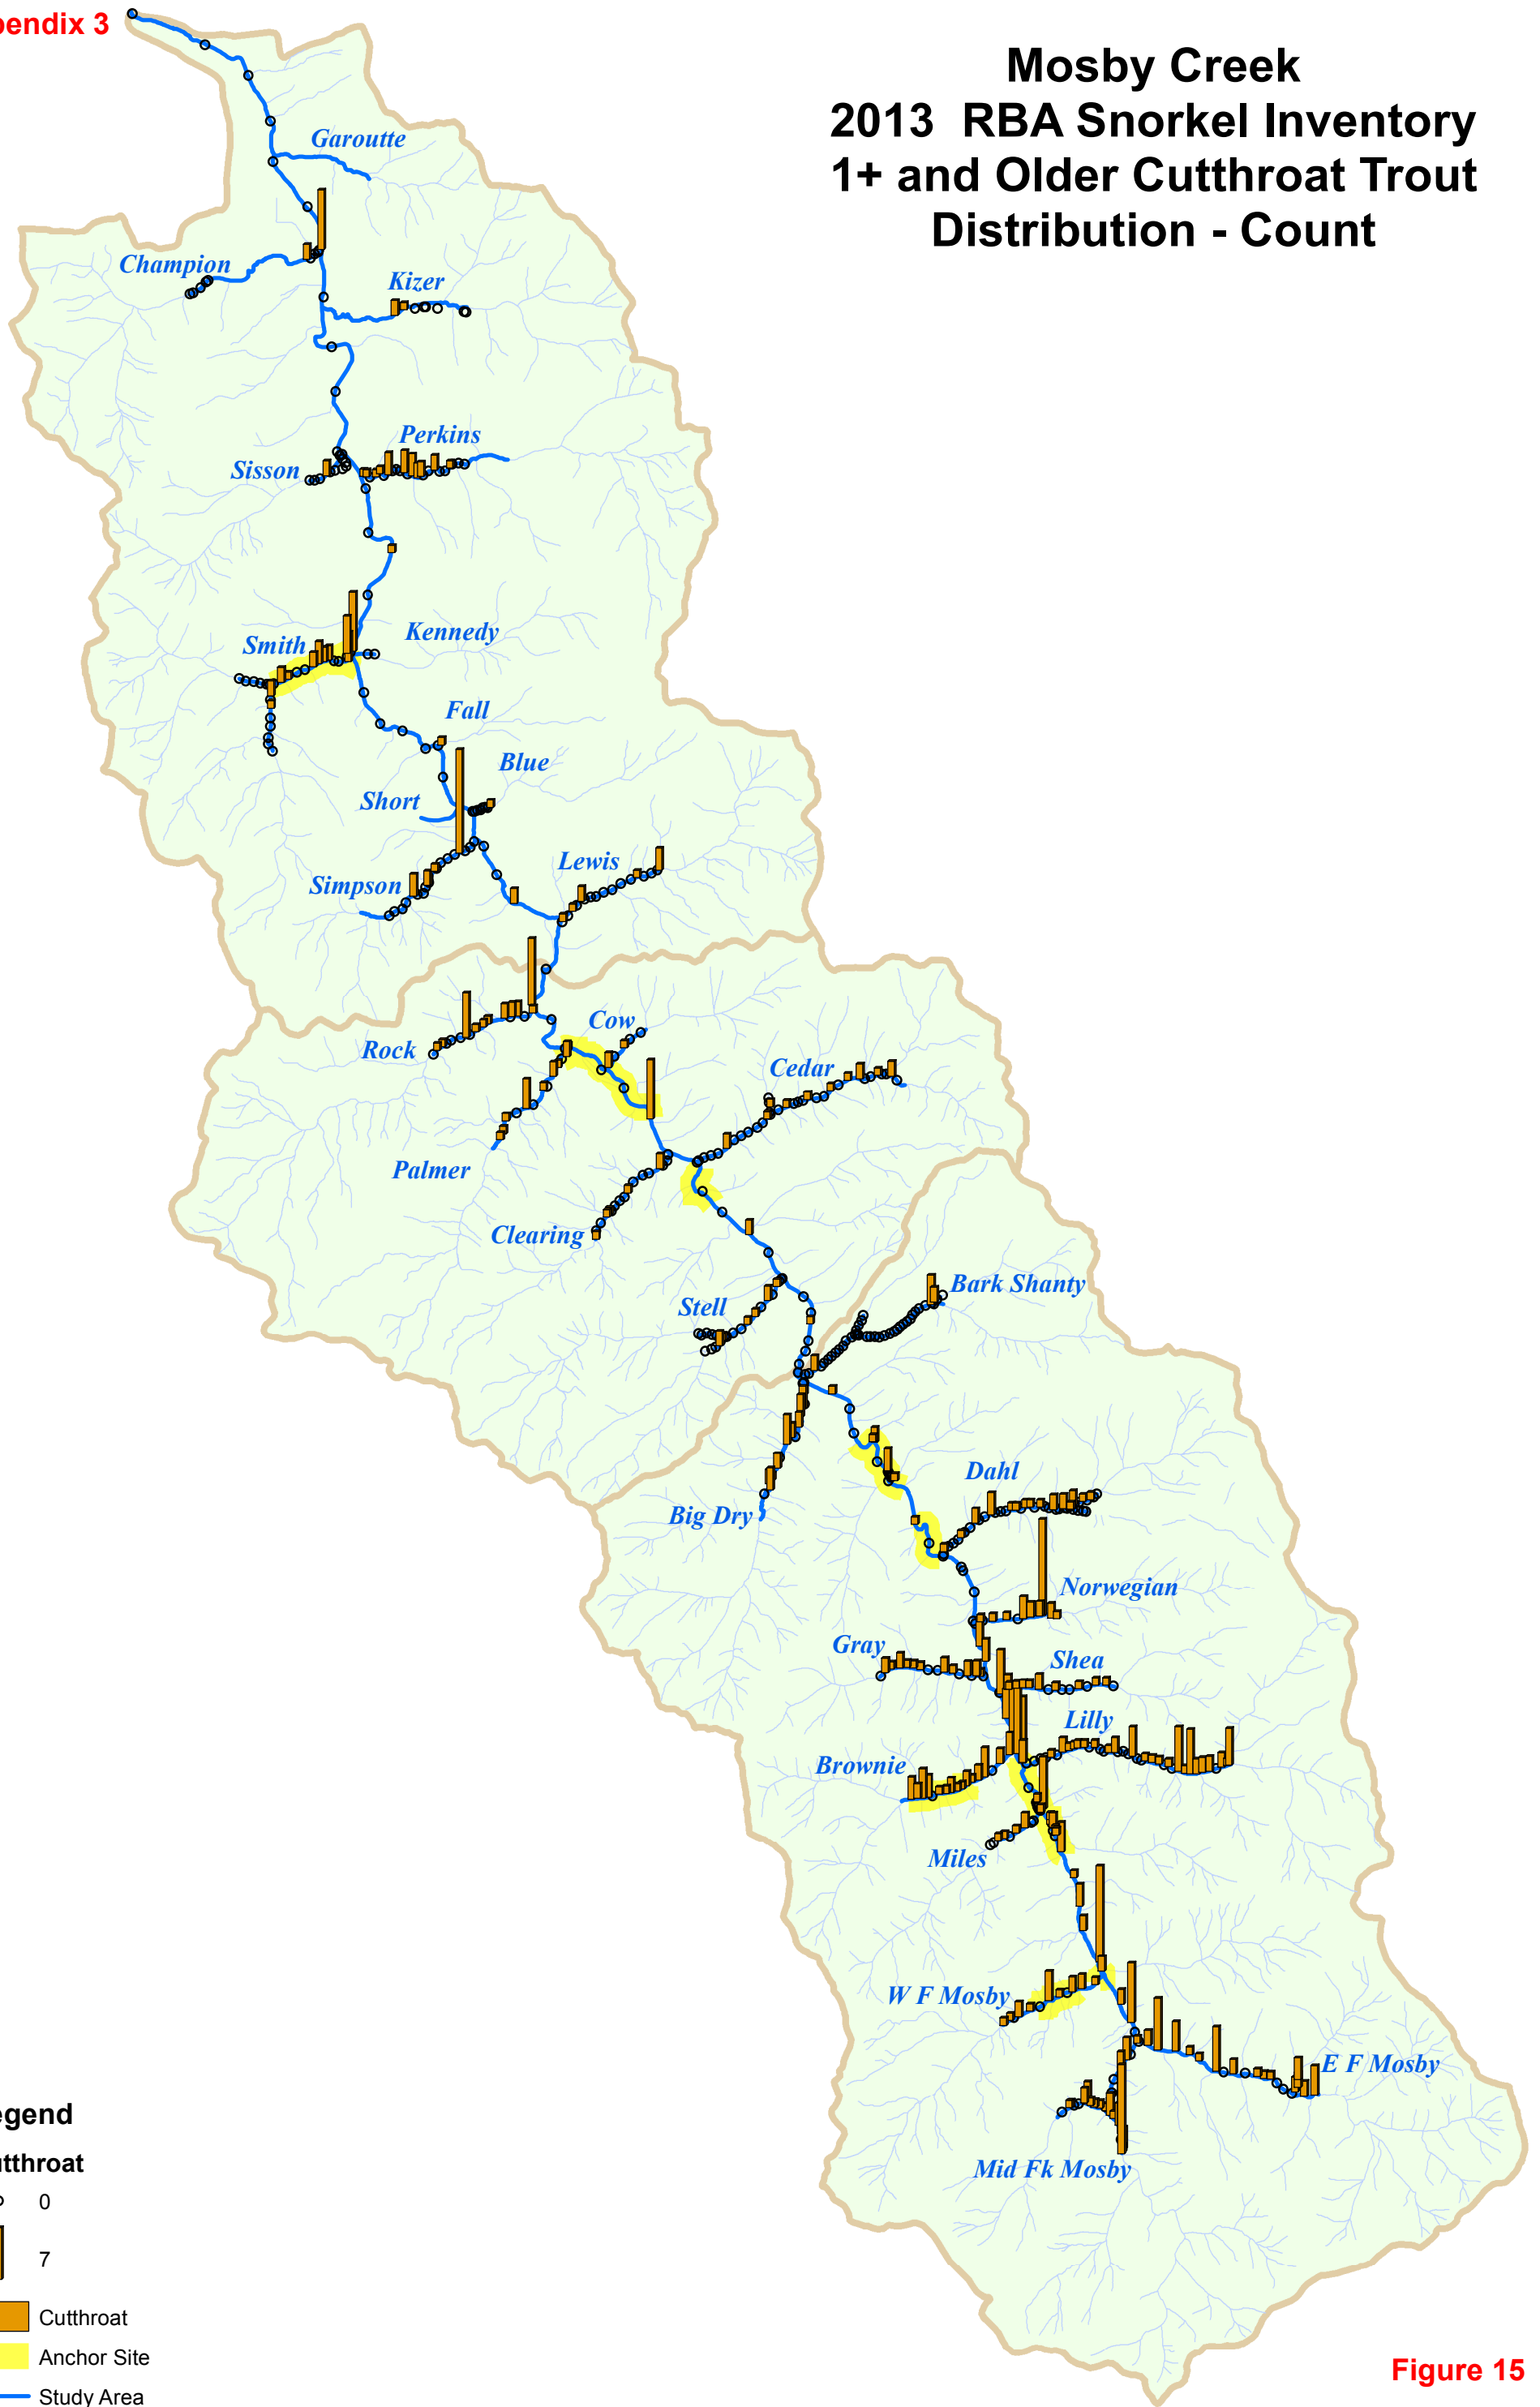
Figure 15

Mosby Creek 2013 RBA Snorkel Inventory 1+ and Older Cutthroat Trout Distribution - Count

The absolute numbers of cutthroat rearing in the 50.4 miles of the Mosby Cr system (mainstem and tributaries), would however be considered extremely low when compared to other east side tributaries of the Willamette River (Figure 15). With densities of 73 pool rearing cutthroat /mile for tributary habitats and 39 cutthroat / mile for the Mosby Cr mainstem, we are looking at what would be classified as low rearing densities. Compare the Mosby Cr densities to the range observed in the Molalla River system with 43-192 fish / mile for mainstem reaches and 250 – 617 fish / mile in high quality tributary reaches without intraspecific competition with *O.mykiss*.

The absolute numbers of cutthroat rearing in the 50.4 miles of the Mosby Cr system (mainstem and tributaries), would however be considered extremely low when compared to other east side tributaries of the Willamette River (Figure 15). With densities of 73 pool rearing cutthroat /mile for tributary habitats and 39 cutthroat / mile for the Mosby Cr mainstem, we are looking at what would be classified as low rearing densities. Compare the Mosby Cr densities to the range observed in the Molalla River system with 43-192 fish / mile for mainstem reaches and 250 – 617 fish / mile in high quality tributary reaches without interspecific competition with *O.mykiss*.

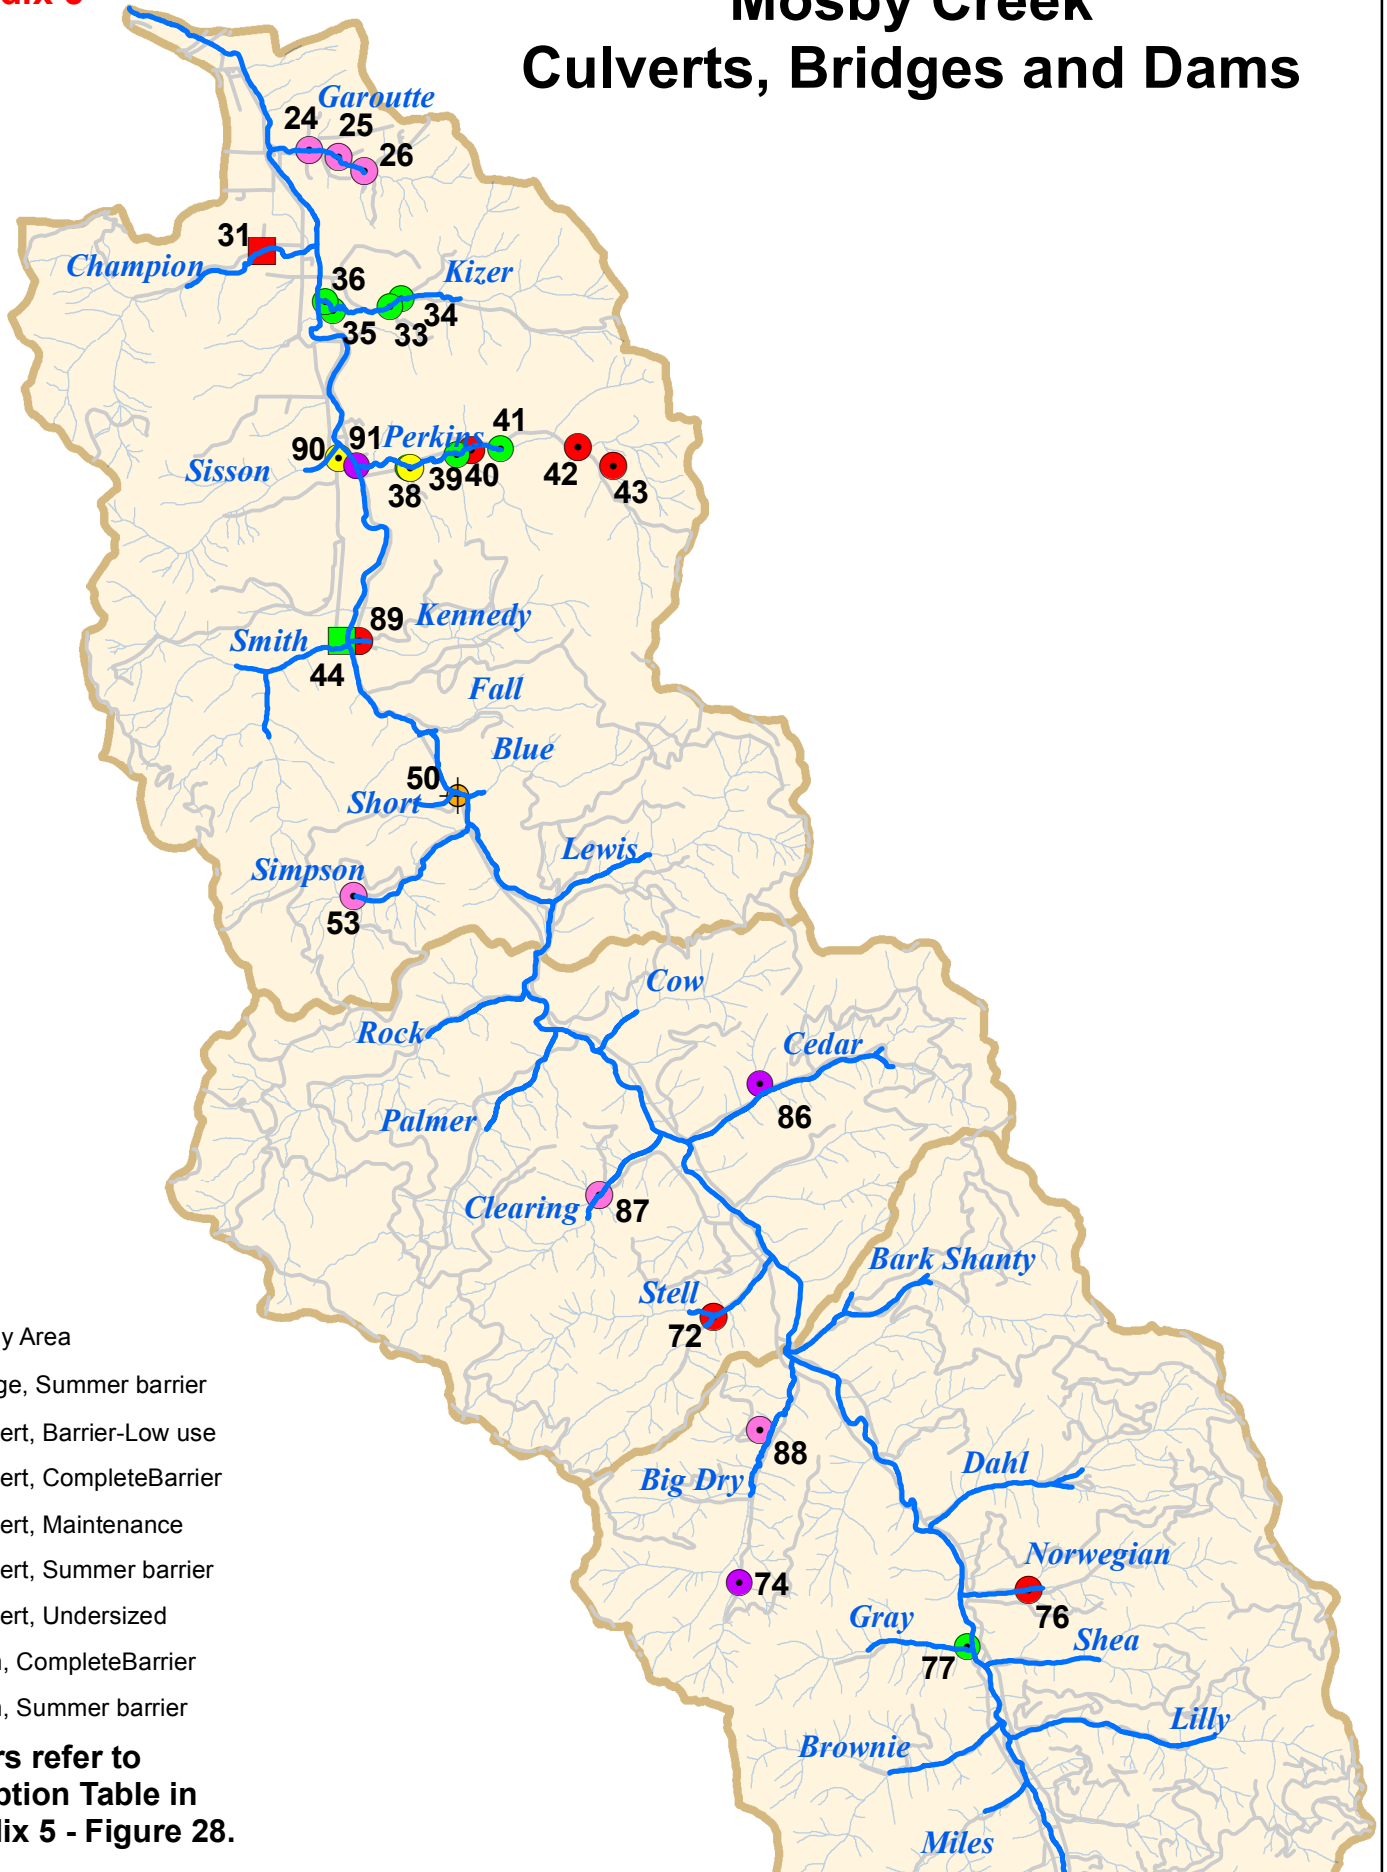
Mosby Creek Culverts, Bridges and Dams
