# **Applegate River Systems Analysis**

**Completed by:  
The Applegate River Watershed Council  
1999**

**Historical and Current Floodplain Function along  
the Lower Applegate River (River Mile 14-25)  
1850-1999**

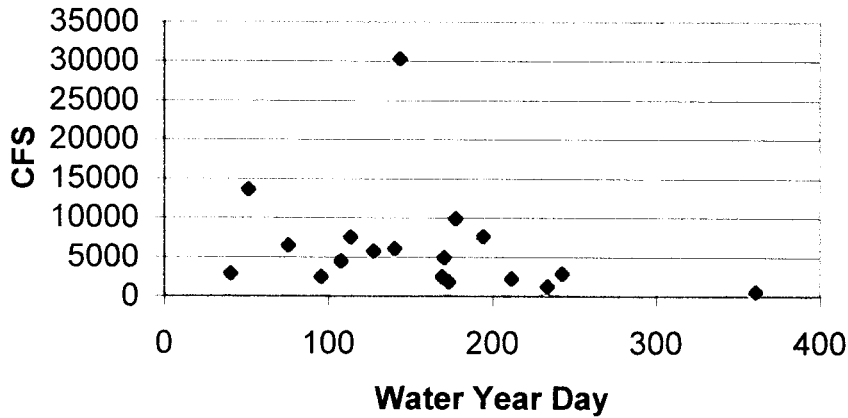
**Flood Peaks by Water Year Day  
(1912-1939)**

A) Note very few flood peaks above 10,000 CFS. This graph represents relatively dry climatic conditions.

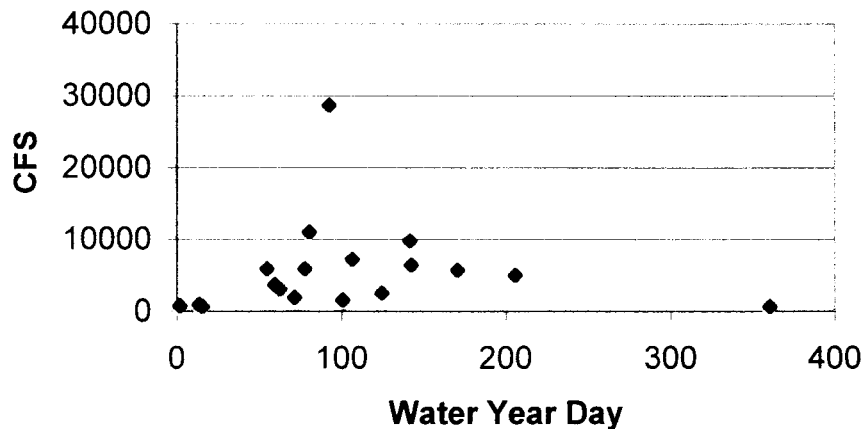
**Flood Peaks by Water Year Day  
(Following 1980 Dam Closure)**

C) Note few peaks above 10,000 CFS. This graph manifests the low flows created by Applegate Dam operations.

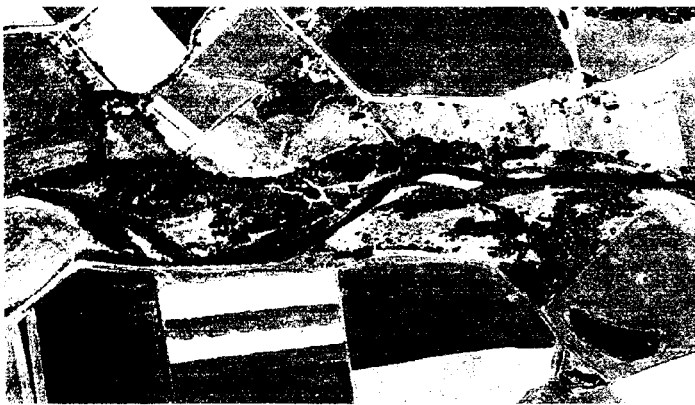
Pre-flood 1996 Aerial Photograph

Floodplain encroachment and development have reduced the river's ability to both store and transport floodwater in this photograph. Most mature vegetation has been removed at this point, and mature floodplain vegetation has been replaced by cropland. In addition, channelization and encroachment have straightened the river channel.

*Sinuosity=1.01*

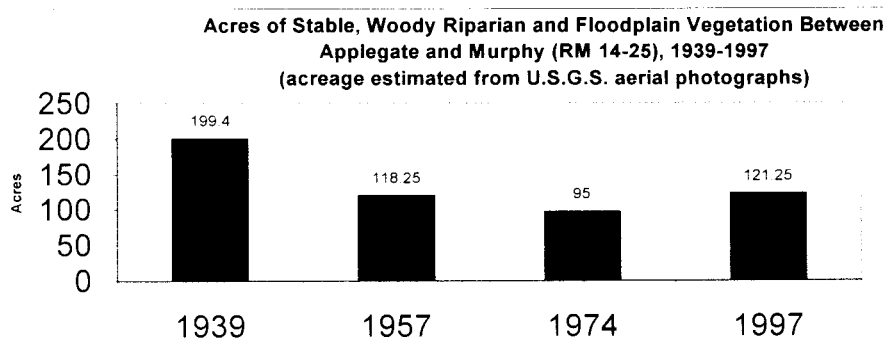
Figure 13.5

Between 1939 and 1957, roughly 80 acres of natural floodplain vegetation were cleared from floodplain areas. By 1960 large-scale agricultural clearing appears complete, and changes in the amount of undisturbed riparian and floodplain vegetation at this point are likely linked to aggregate operations and flood disturbances (Figure 13.5).

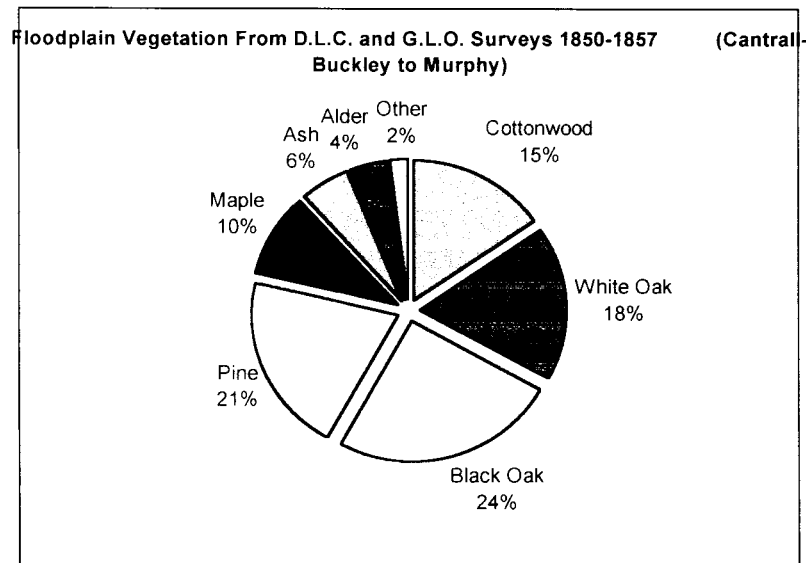
Figure 14

Surveyors selected healthy, representative trees, which were close to survey corners, for bearing trees, and as a result, G.L.O. and D.L.C. vegetation information provides a valuable random sample of species and size information on the lower river floodplain (McKinley and Frank 1996).

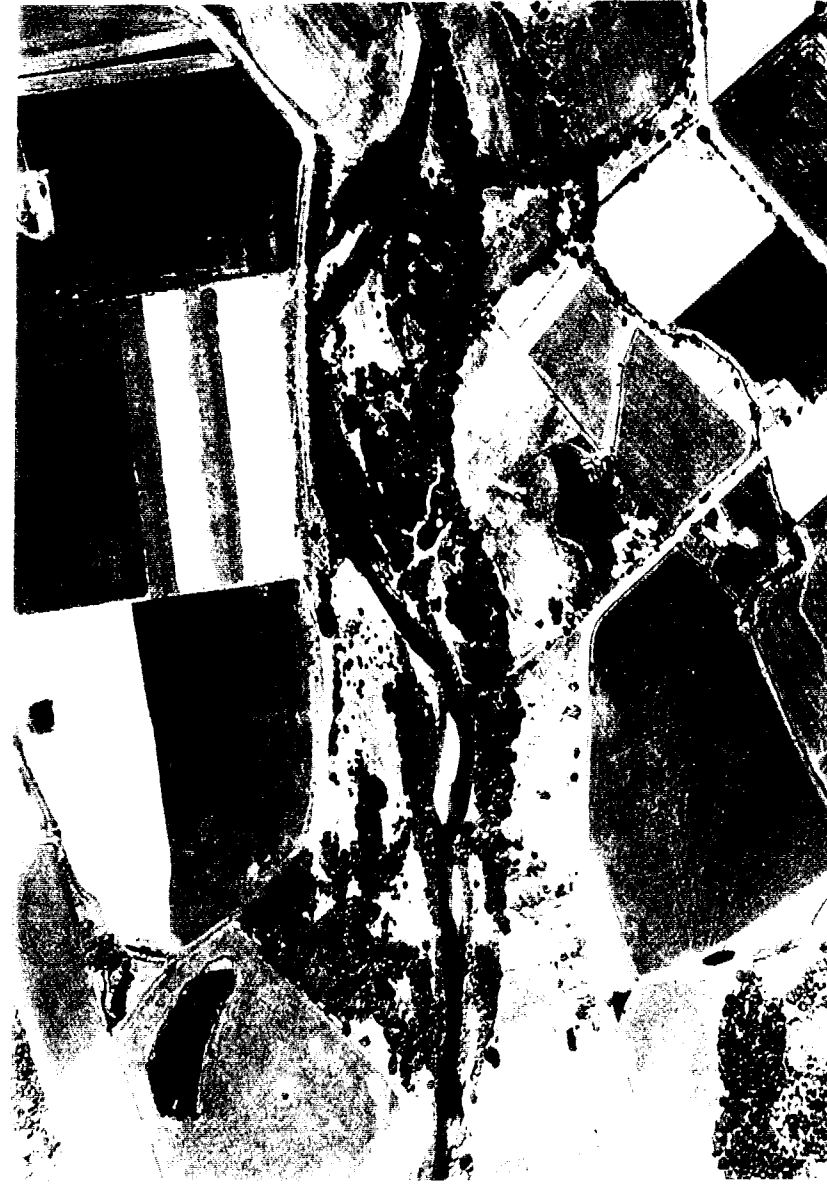
1996 aerial photograph

Floodplain encroachment and the impact of levees reduce the river's capacity to both store and transport floodwater. When mature vegetation has been removed, and riparian floodplain vegetation has been replaced by cropland, channel erosion and encroachment have straightened the river channel.

Sinuosity = 1.17

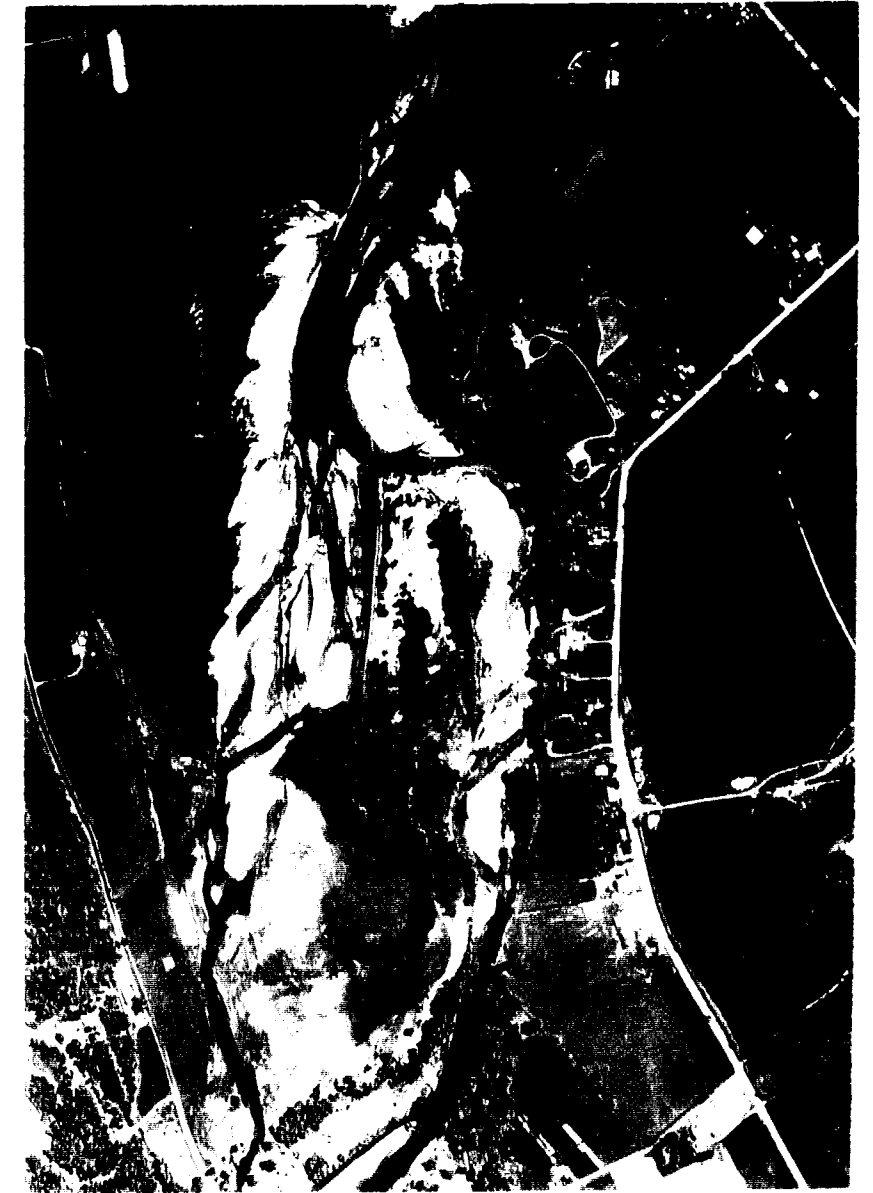
1997 photograph

In 1997, a flood destroyed the levee that floodplains are protected, and only floodplain areas with mature trees remained intact. During floods, the river occupies an area equal to the forested area in the 1939 photograph. When trees are cleared to increase arable acreage, excessive floodwater strips away valuable agricultural land. In many locations, in fact, no loss of arable land follows tree clearing, and floodplain encroachment affects. In addition, the lack of stable floodplain vegetation has allowed the river to carve a new channel, creating an island. This denies landowner access to valuable agricultural land. Note that the river regained much of the sinuosity present in the 1939 photograph.
