FINAL
*Upper Klamath Lake
Watershed Assessment*

June 2010

Prepared for
Klamath Watershed Partnership

Prepared by
David Evans and Associates, Inc.

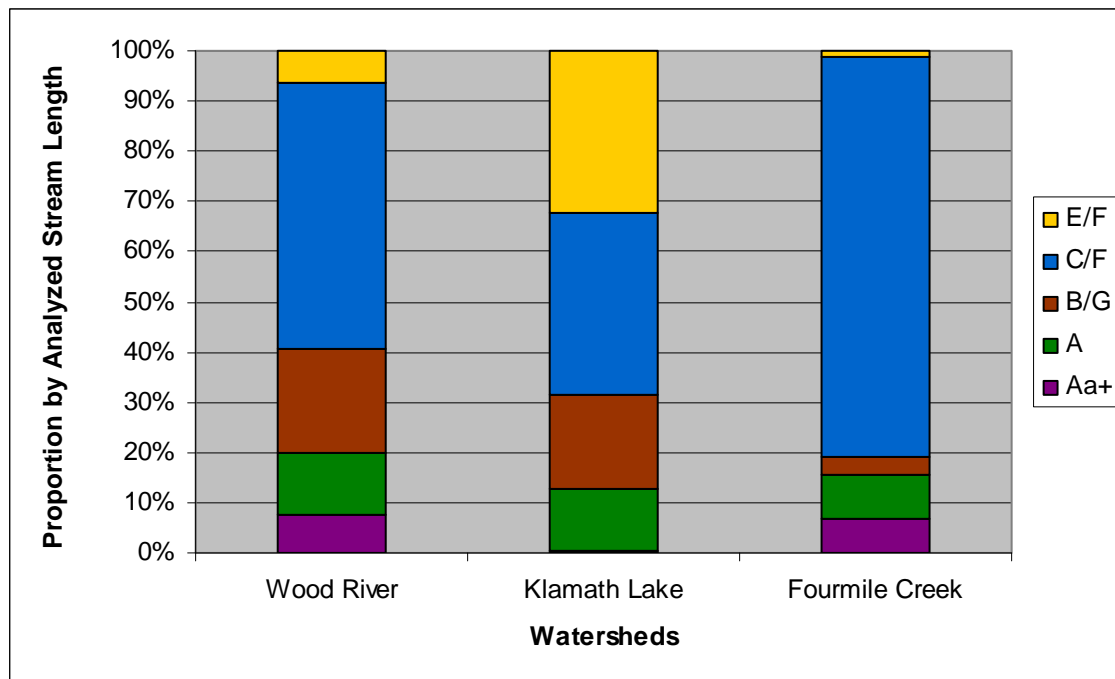
Figure 3-1. Summary of Rosgen Channel Types in the Upper Klamath Lake Subbasin

The Aa+ stream types are very steep streams (>10 percent channel gradient) located primarily near the headwaters within the assessment area. Type Aa+ streams occur on the slopes of the Cascade Mountains to the west, and at a few small, discreet locations in the middle of stream reaches (Figure 3-1). Transport processes dominate in these reaches, as they are often source areas for downstream deposition. Type Aa+ channels are found within all three watersheds, making up 5 percent of the total channel length analyzed within the assessment area. The

Klamath Lake watershed has less than 1 percent of total channel length, the Fourmile Creek watershed has just over 1 percent and the Wood River watershed has 4 percent (Figure 3-1).

Type B/G channels are the second most common type found within the assessment area (17 percent of total channel length overall), the Fourmile Creek watershed containing just 1 percent of the total channel length, 5 percent in the Klamath Lake watershed and 11 percent in the Wood River watershed (Figure 3-1). Although the Fourmile Creek watershed had few channels designated as B/G in this assessment, the USFS watershed analysis from 1996 found nearly 70 percent of the channels in the Fourmile Creek watershed (this includes Lost, Horse, and upper Fourmile Creeks) to be B-type channels (USFS 1996). This assessment and the USFS analysis both define Lost Creek as a B-type channel, however the categorization of upper Fourmile Creek is different. This difference may be attributed to the overlap of characteristics between A and B-type channels which have the same channel sinuosity ratio, except A channels are steeper (Table 3-1, General Stream Type Descriptions). In addition, field verification performed by USFS may have been able to locate small sections of more gradual slopes, whereas the GIS analysis for this assessment took an average of the slope for the whole section and found that it was steeper than 4 percent, and, therefore, an A-type channel.

Type C/F channels are the predominant type within the subbasin, and are found within all watersheds, making up 53 percent of all streams that were analyzed. These channel types occur primarily in the lower reaches of many stream channels (Figure 3-2, Aerial Photo of Crystal Creek, a Rosgen C/F Channel) but can also be found in the gently sloping reaches below headwater channels. Based upon descriptions in various USFS watershed analyses, some of these lower reaches have characteristics more typical of type F channels, including entrenchment and potential for bank erosion, where channels have been modified by dredging or for agricultural use. Type C/F channels make up 10 percent of the total analyzed channel length in the Klamath Lake watershed, 16 percent in the Fourmile Creek watershed and 27 percent in the Wood River watershed (Figure 3-1).

Type E/F channels are only found in significant quantity within the Wood River and Klamath Lake watersheds, and occur in the lower stream reaches of the Wood River and Sevenmile Creek (as shown in Map 3-1 and Figure 3-3, Aerial Photo of a Meandering Rosgen E/F in the Wood River Valley). These channels predominantly occur in areas of intensive agriculture or grazing. Type E/F channels make up 13 percent of the total analyzed channel length, with less than 1 percent located in the Fourmile watershed, 3 percent in the Wood River watershed, and 9 percent in the Klamath Lake watershed (Figure 3-1).

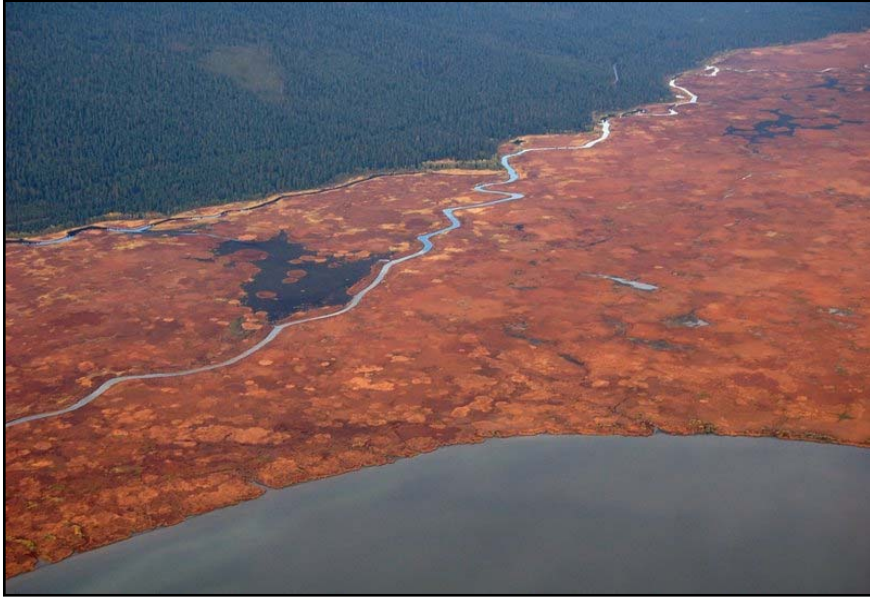
Figure 3-2. Aerial Photo of Crystal Creek, a Rosgen C/F channel (DEA 2009).

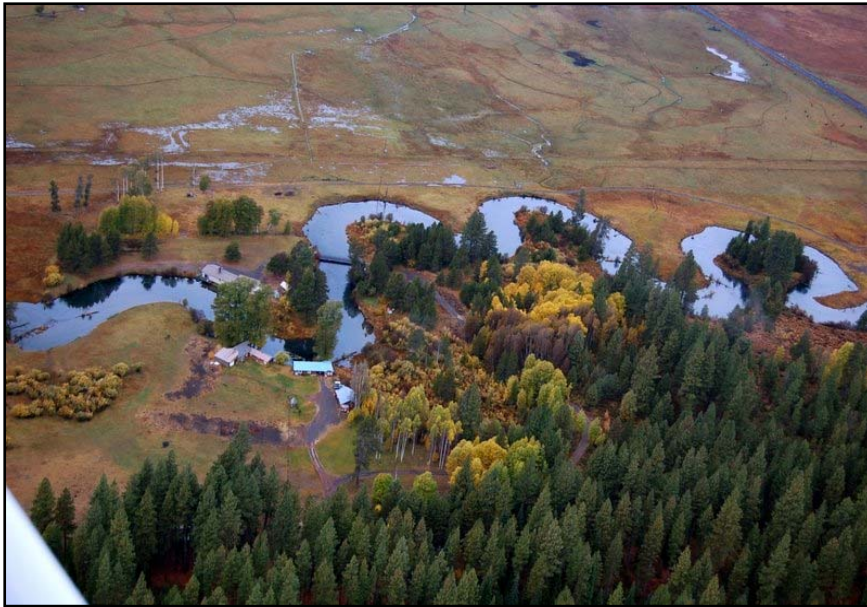
Figure 3-3. Aerial photo of a meandering Rosgen E/F channel in the Wood River Valley (DEA 2009).

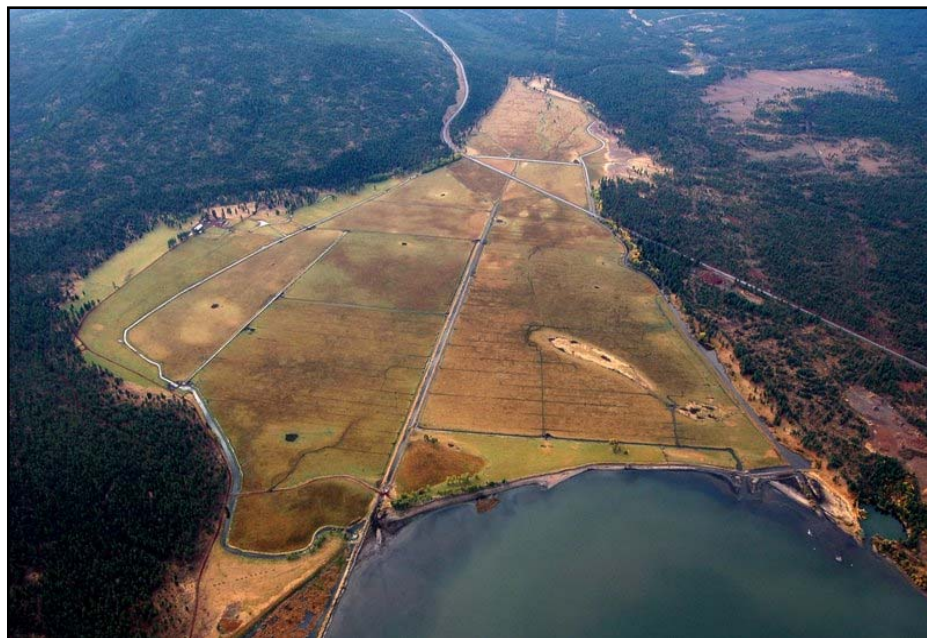
During the course of the assessment, it became apparent that there is a significant group of channels that are so highly modified that they are not considered by the Rosgen channel classification system (and, therefore, not included in Figure 3-1). These channels occur primarily in the vicinity of Upper Klamath and Agency lakes (Map 3-1), and consist of either natural streams that have been excavated and straightened for drainage, or constructed drainage ditches (Figure 3-4, Aerial Photo of Ditched Portion of Denney Creek). Significant quantities of these channels are found within the Klamath Lake and Wood River watersheds, with the most ditched channels occurring in the Klamath Lake watershed, totaling 56 percent of all ditched channels in the subbasin. The Wood River watershed has 44 percent of all the ditched channels within the subbasin. While available digital data do not identify any canals or ditches in the Fourmile Creek watershed, the last two miles of Fourmile Creek, before it enters Upper Klamath Lake, have been channelized (USFS 1996a) (Map 3-1).

Figure 3-4. Aerial photo of Ditched portion of Denney Creek (DEA 2009).

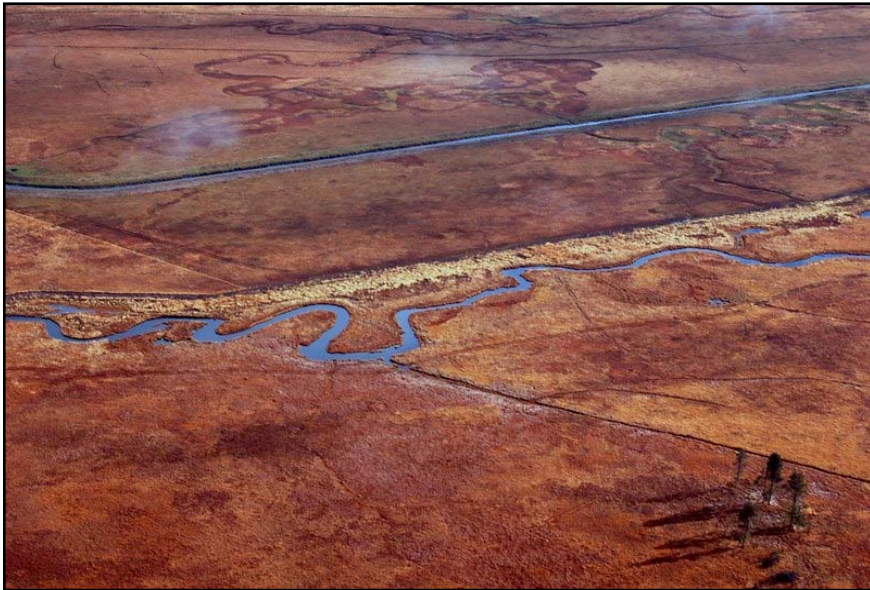
Several streams have been diverted into ditches, consequently de-watering their historic channel. In locations where the historic channel has not been completely wiped out, re-directing water back into the channel will help restore floodplain function. An example of such a project, Figure 3-5 (Aerial Photo of Crane Creek Following Restoration To Re-direct Flows From an Irrigation Ditch to the Historic Channel), was completed in 2007 on Crane Creek, a tributary to Sevenmile Creek (Peterson, pers. comm. 2009). This project successfully restored redband trout fish habitat, as they were recorded using the area for spawning the winter following construction (KBRT 2009).

Figure 3-5. Aerial photo of Crane Creek following restoration to re-direct flows from an irrigation ditch to the historic channel (DEA 2009)

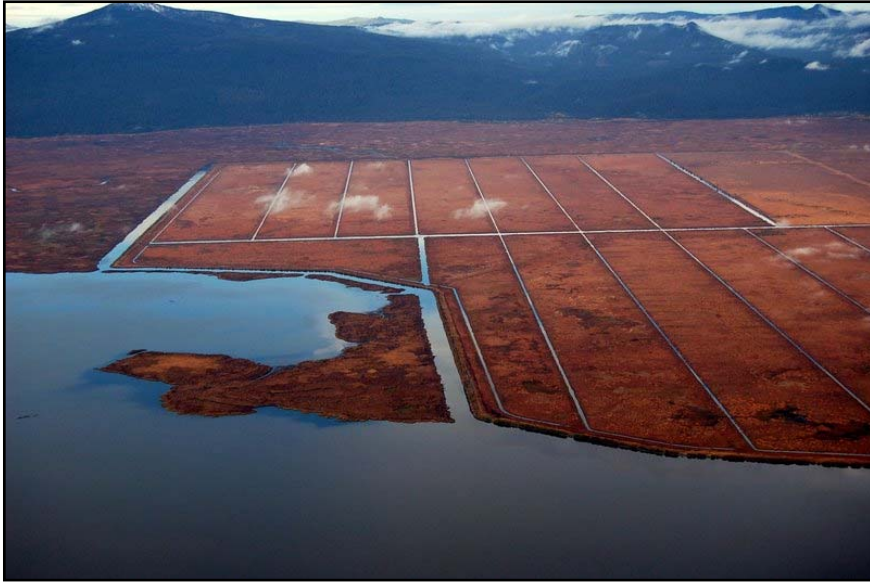
Figure 3-6. Aerial photo of an example of channelization adjacent to Agency Lake (DEA 2009).

Channelization has a direct effect on habitat conditions in the affected reach. The primary impact is simplification of aquatic habitat because the stream structure that produced pools, riffles, and steps is removed. In addition, downstream reaches can be affected as flow velocities increase and sediment delivery rates and timing are altered. This can result in increased peak flows and a lowered water table, reducing the duration and volume of base flows. Channelization and channel simplification can also cause significant bank erosion.

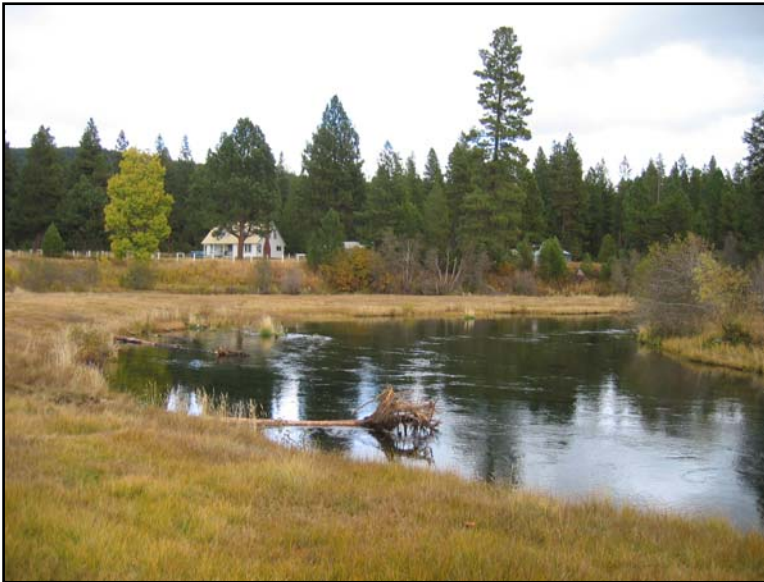
modifications. Monitoring activities, such as those performed in the Wood River CEAP, have shown improvements in water quality and quantity once channel modifications are reversed (NRCS 2009).

Figure 3-7. Photo of habitat enhancement project along the Wood River (DEA 2009).

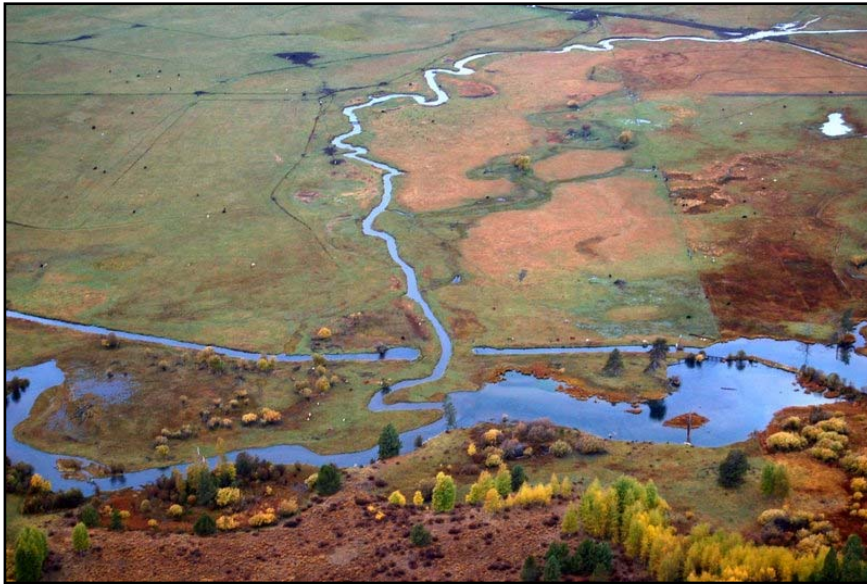
Figure 4-1. Aerial Photo of irrigation diversions, common throughout the subbasin (DEA 2009).

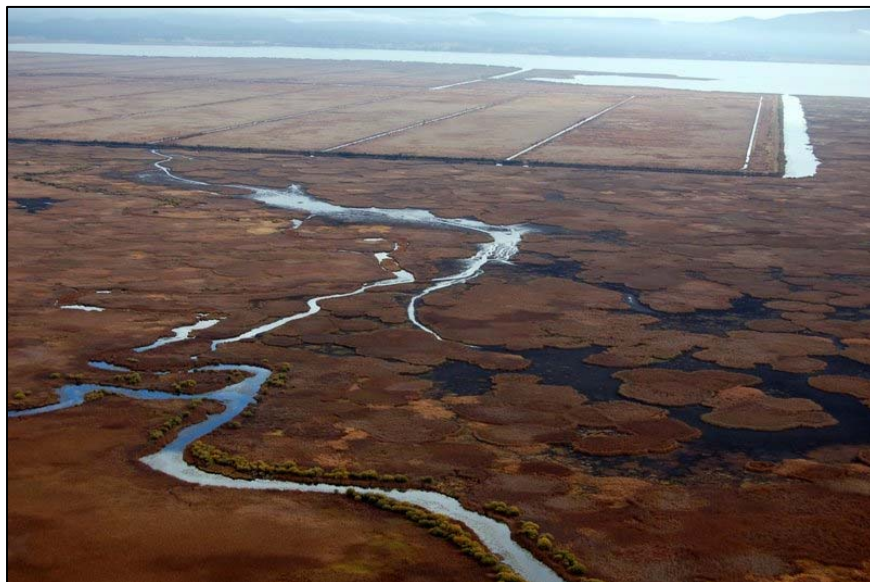
melt has infiltrated, it then discharges at lower elevations in the form of spring or seep flow. Two of these springs, Malone and Crystal Springs, feed Crystal and Recreation Creeks before they flow into Pelican Bay of Upper Klamath Lake. Crystal and Recreation Creeks have a very low gradient in their lower reaches, connecting with Upper Klamath Lake as a wetland rather than through a defined channel (USFS 2003c). At summer low flow, Recreation Creek has an average width ranging between 50 to 75 feet (USFS 2003c). Figure 4-2 (Aerial Photo of Channels Altered for Drainage and Irrigation) shows a loss of channel connectivity between Crystal and Thomason Creeks.

Figure 4-2. Aerial Photo of channels altered for drainage and irrigation (DEA 2009).

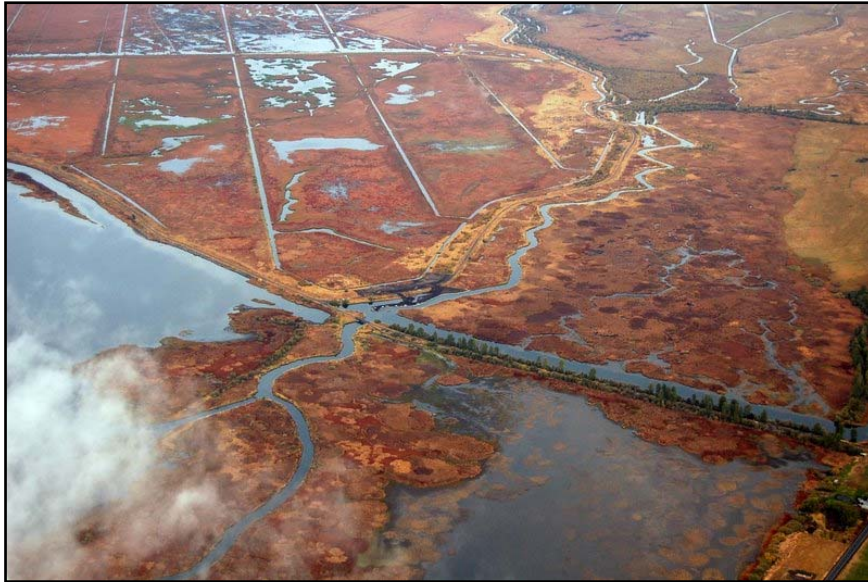
Figure 4-10. Aerial Photo of the Wood River Wetland, the site of many restoration activities (DEA 2009).
