## **Results**

### **Current Riparian Conditions**

## Existing Conditions by Watershed

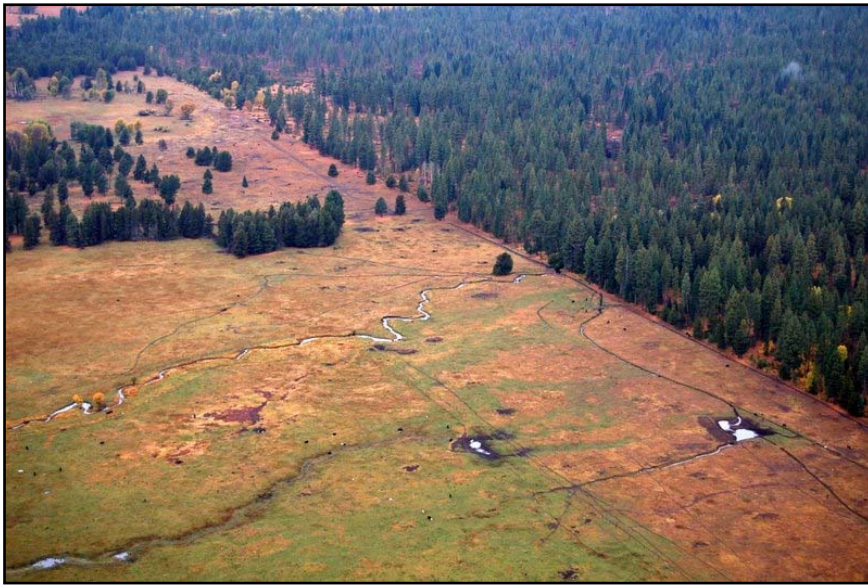
*Figure 6-1. Aerial photo of a channel lacking overhead canopy adjacent to forested land (DEA 2009).*

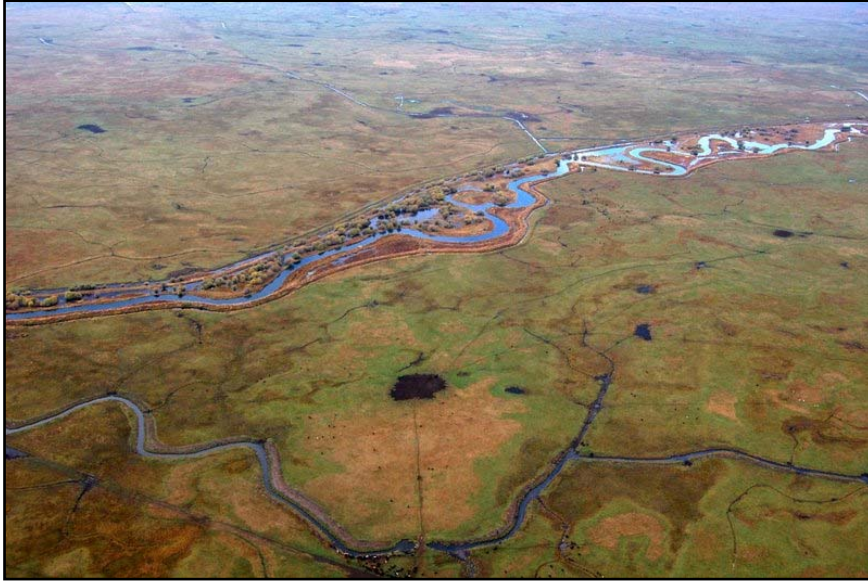
Figure 6-3. Aerial photo of an example of scattered riparian cover along channels located on agricultural lands (DEA 2009).

minimal shading (Figure 6-3, Aerial Photo of an Example of Scattered Riparian Cover Along Channels Located on Agricultural Lands). While there is some willow corridor present, minimal woody riparian vegetation decreases the opportunities for large wood recruitment. In addition, channelization and bank instability are common in these reaches.

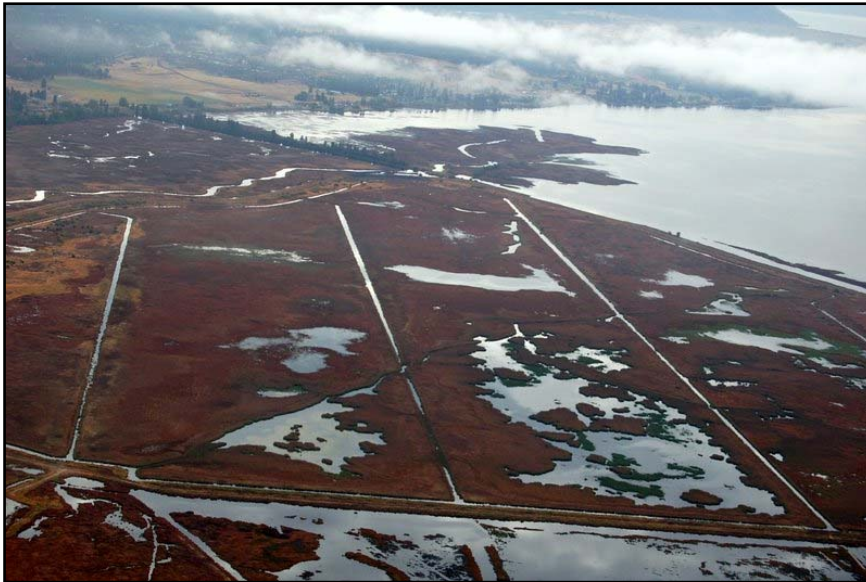
Figure 6-4. Aerial photo of the Wood River Wetland in the foreground and the Wood River in the background (DEA 2009).

At the mouth of the Wood River, at Agency Lake, shown in Figure 6-4 (Aerial Photo of the Wood River Wetland in the Foreground and the Wood River in the Background) restoration efforts have been underway on the Wood River Wetland since 1995 (Shapiro 2000). The BLM purchased private pasturelands, formerly called Wood River Ranch, with restoration efforts currently aimed at restoring wetland function and riparian conditions along the Wood River.

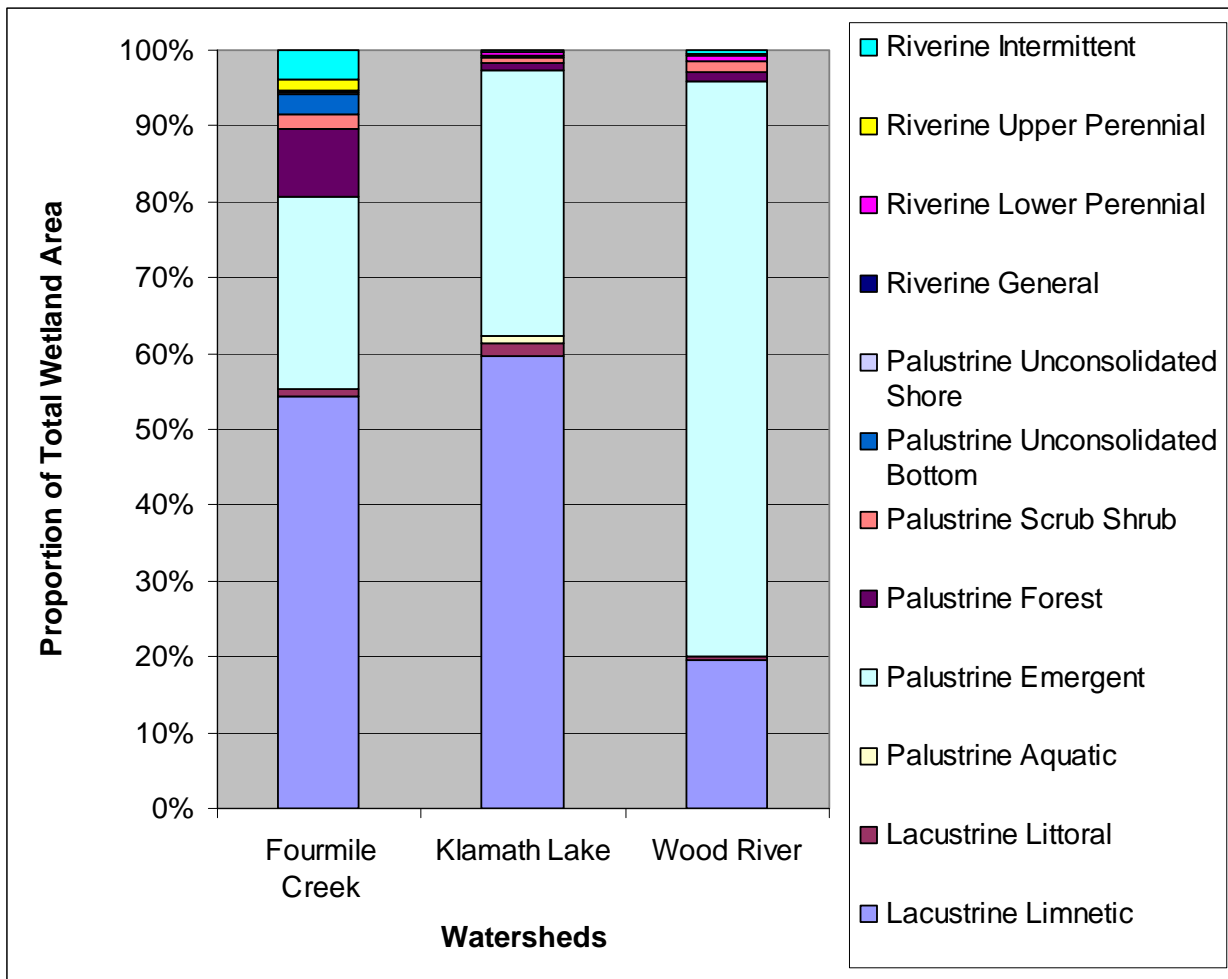
Figure 7-1. Types and Prevalence of Wetlands in the Watersheds

Lacustrine limnetic wetlands are a subsystem of the lacustrine wetland system. Lacustrine wetlands consist of at least 20 acre-large deep-water habitats lacking vegetation over 30 percent of its area (Cowardin 1992). Examples of lacustrine wetlands include permanently flooded lakes and reservoirs. Water depth further categorizes a lacustrine wetland as limnetic or littoral - lacustrine limnetic wetlands are deepwater habitat (Cowardin 1992) and lacustrine littoral wetlands are located from the shore to a depth of 6.6 feet below water, or to the maximum extent of nonpersistent emergent vegetation (Cowardin 1992). Lacustrine limnetic wetlands make up an average of 48 percent of the total wetlands within the subbasin whereas lacustrine littoral wetlands make up just 1 percent.

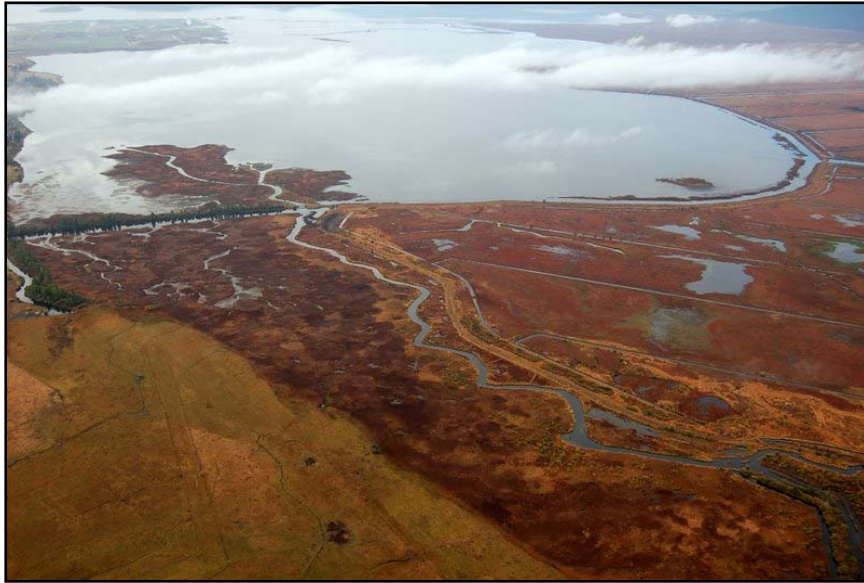
Figure 7-2. Aerial photo of the lower Wood River and Wood River Wetland, adjacent to Agency Lake (DEA 2009).

Most of the 45,700 acres of wetlands in this watershed are found along the valley bottom, starting in the mid to lower reaches of Annie and Sun Creeks, continuing south to Agency Lake (Figure 7-2, Aerial Photo of the Lower Wood River and Wood River Wetland, Adjacent to Agency Lake).

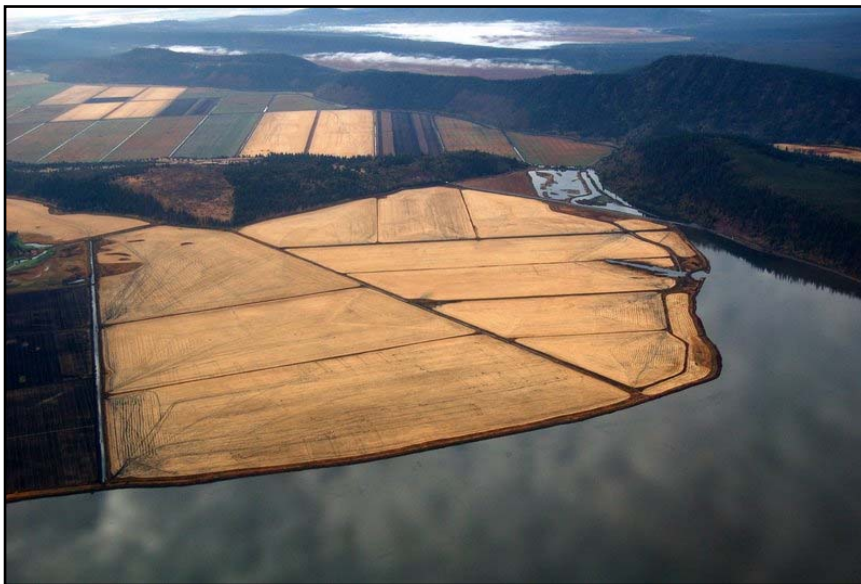
*Figure 7-3. Aerial photo of Caledonia Marsh, adjacent to Upper Klamath Lake (DEA 2009).*

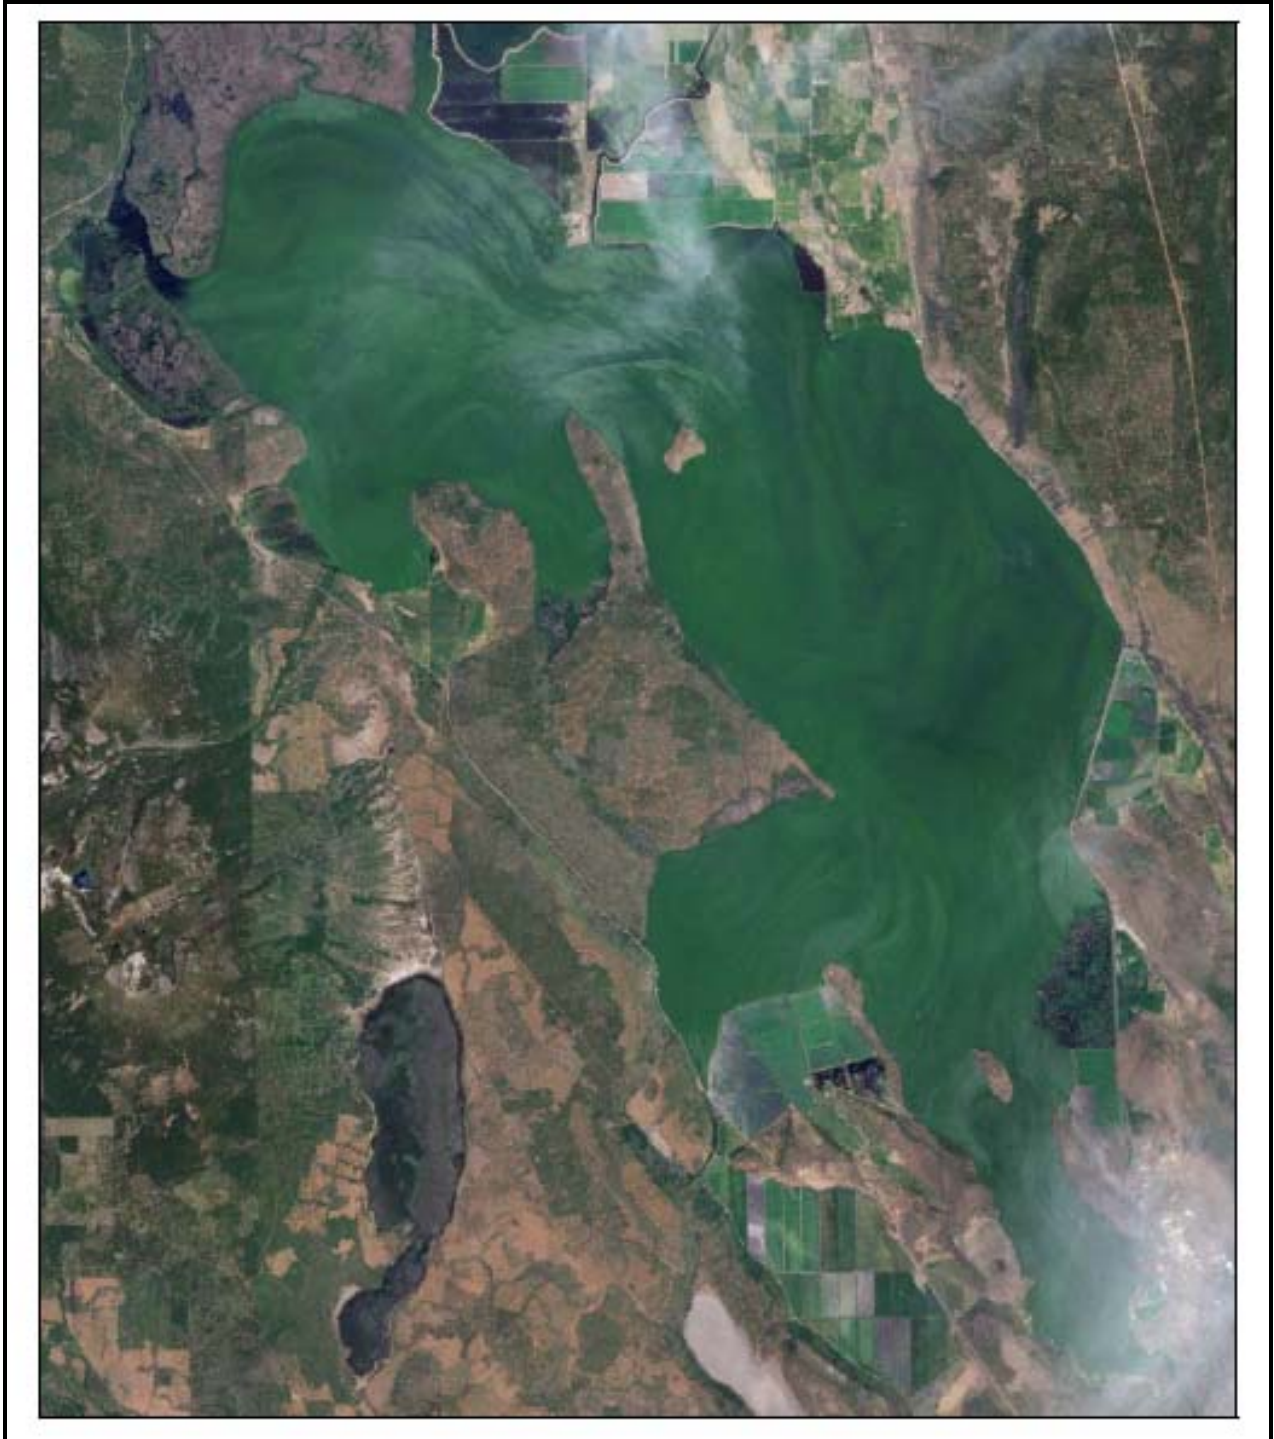
Figure 8-1. Photo of algal bloom (*Aphanizomenon flos-aquae*) in Upper Klamath Lake (DEQ 2002).

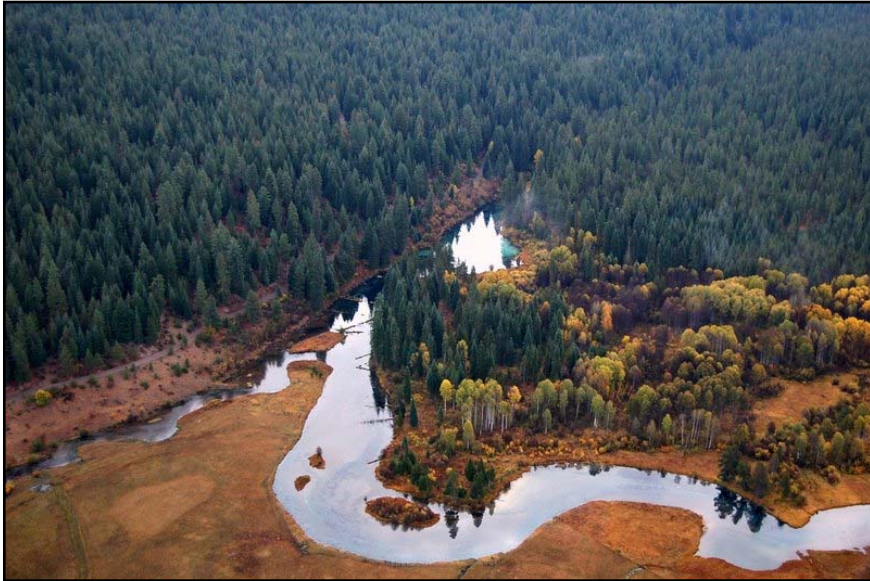
Figure 9-2. Aerial Photo of source spring for the Wood River (DEA 2009).

A spring emanating from the escarpment at Kimball State Park is the source of the Wood River (ODF 1995) (Figure 9-2, Aerial Photo of source spring for the Wood River). It flows for slightly more than 15 miles before entering Agency Lake. Tributaries to the river include Annie Creek, Fort Creek, and Crooked Creek. Sun Creek is a tributary to Annie Creek, with the two creeks combining roughly 1.75 miles prior to Annie Creek's confluence with the Wood River (Figure 9-3, Aerial Photo showing Annie Creek). There are several diversions located along the river, some of which may require screening to prevent entrainment of fish.

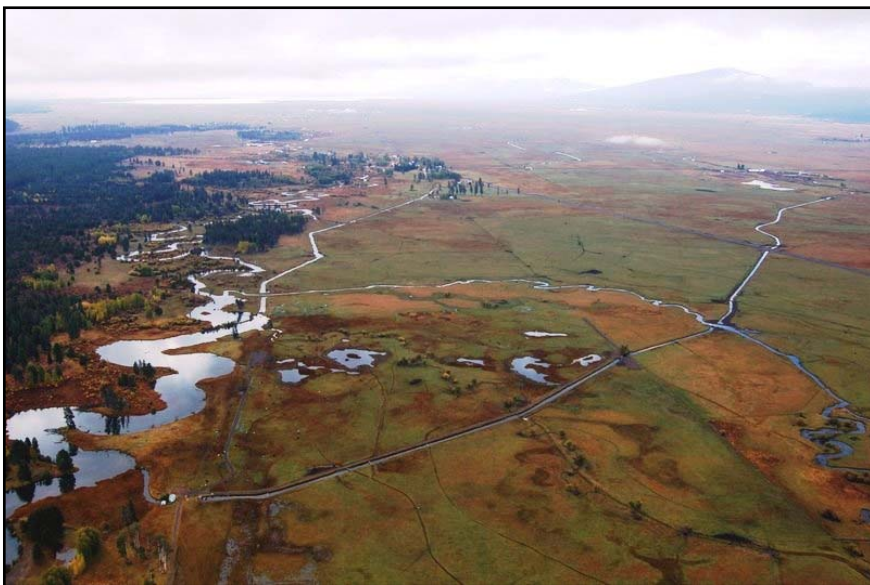
Figure 9-3. Aerial Photo showing Annie Creek flowing from right side of photo east to its confluence with the Wood River. Several water diversions flow westward from the Wood River (DEA 2009).

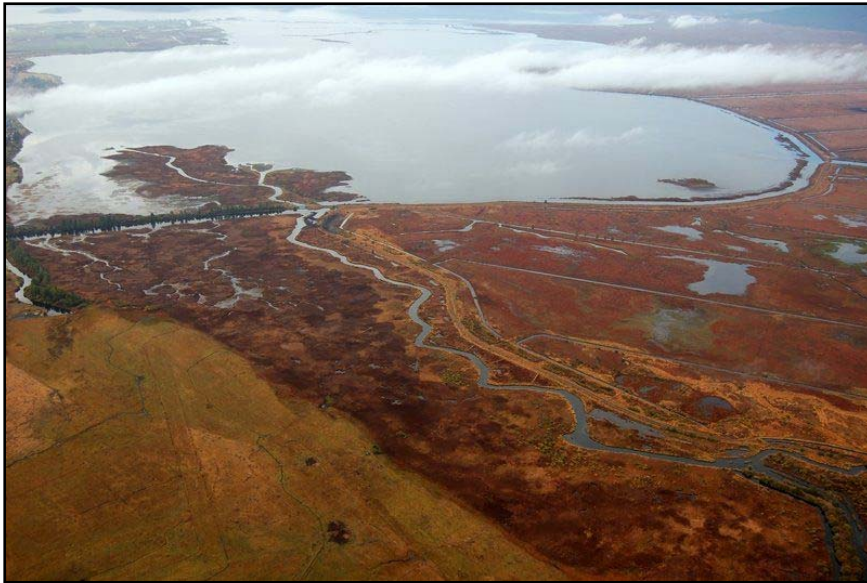
*Figure 9-4. Aerial Photo looking south towards mouth of Wood River entering into Agency Lake (DEA 2009).*

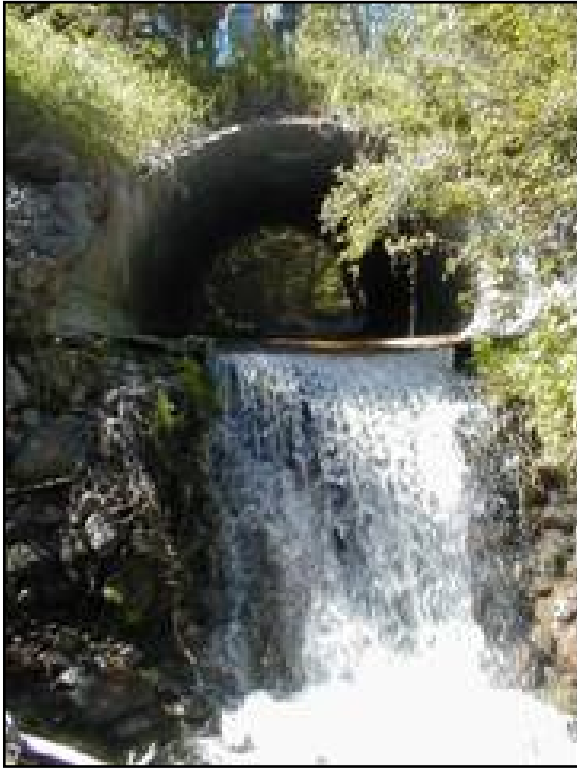
*Figure 9-7. Photo of Impassable Fish Barrier at Forest Road 3413-110 (USFS 2007)*

An existing fish migration barrier is found at the intersection of FR 3413 and FR 3413/110 roads (Figure 9-7, Photo of Impassable Fish Barrier at Forest Road). This barrier was first observed in

1992 and high flows in 1996 and lack of LWD caused additional downcutting which created a migration barrier (USFS 2007).

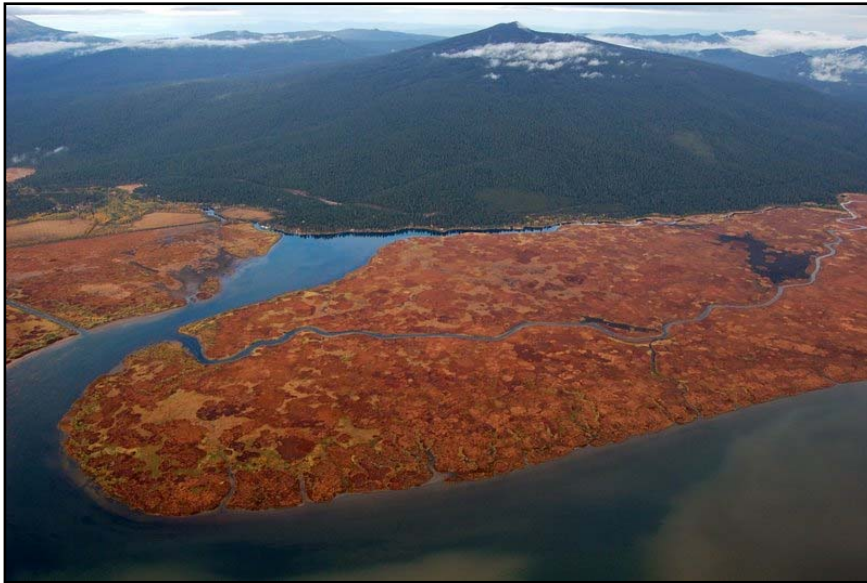
*Figure 9-8. Aerial photo of Recreation and Crystal creeks with Pelican Butte in background. Recreation Creek flows along base of the hillside, while Crystal Creek flows completely through emergent marsh area (DEA 2009).*

Recreation and Crystal Creeks are spring-fed systems. These marsh creeks are better characterized as palustrine wetlands, with little observable gradient or flow (Figure 9-8, Aerial photo of Recreation and Crystal Creeks with Pelican Butte in background. Recreation Creek flows along base of the hillside, while Crystal Creek flows completely through emergent marsh area). Fish use in Recreation and Crystal Creeks appears to be limited to migration, holding, refuge and rearing by redband trout and suckers. The lack of suitable spawning substrate eliminates spawning potential for most species.

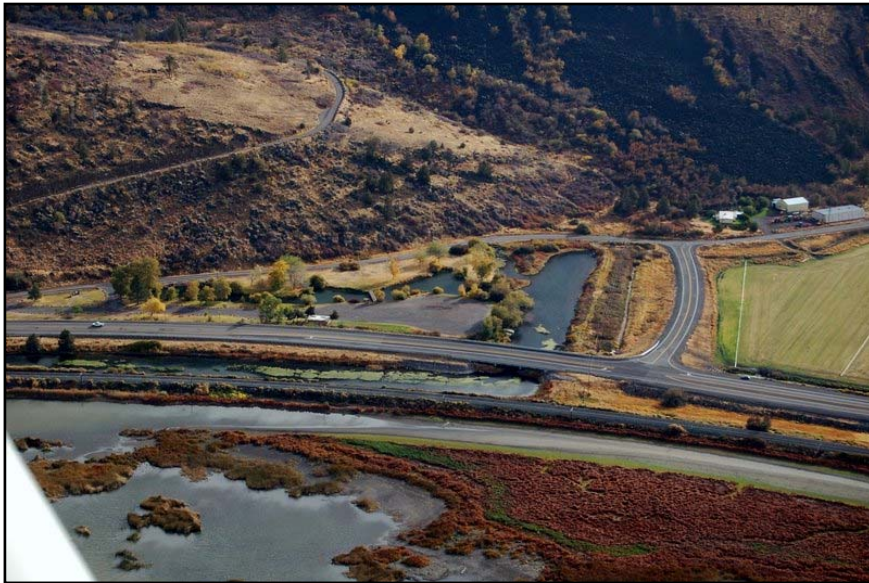
Figure 9-10. Aerial photo of Barkley Springs feeds into irrigation canal on far side of Highway-97. Upper Klamath Lake and Hanks Marsh in foreground, October 2009.

- Large-scale wetland restoration around the lakes
- Restoration of some of the historic spring spawning areas including Barkley Springs, near Algoma (see Figure 9-10, Aerial photo of Barkley Springs).
- ODFW coordinating with landowners to install fish screens on irrigation water diversion intakes from the lakes. Figure 9-11 (Photo of Fish screen/irrigation diversion under construction at Running Y Ranch, October 2009) provides photos of a fish screening site under construction at the Running Y Ranch (former Wocus Marsh area).

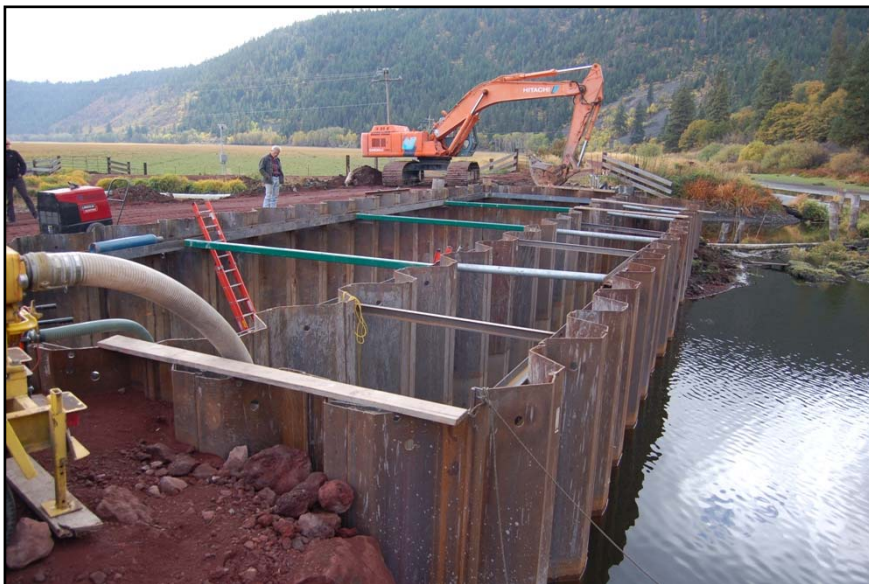
Figure 9-11. Photo of Fish screen/irrigation diversion under construction at Running Y Ranch, October 2009.
