TRYON CREEK ENVIRONMENTAL BASELINE CONDITIONS;

Prepared for:
West Multnomah Soil and Water Conservation District
2115 SE Morrison Street, Room 104
Portland, OR 97214

Prepared by:
Bernard Klatte, Fisheries Biologist &
Robert Ellis, Ph.D., Fisheries Biologist
Ellis Ecological Services, Inc.
4 January 2002

Overview of Existing Conditions, Data Gaps and Recommendations for the Protection and Restoration of Aquatic Resources

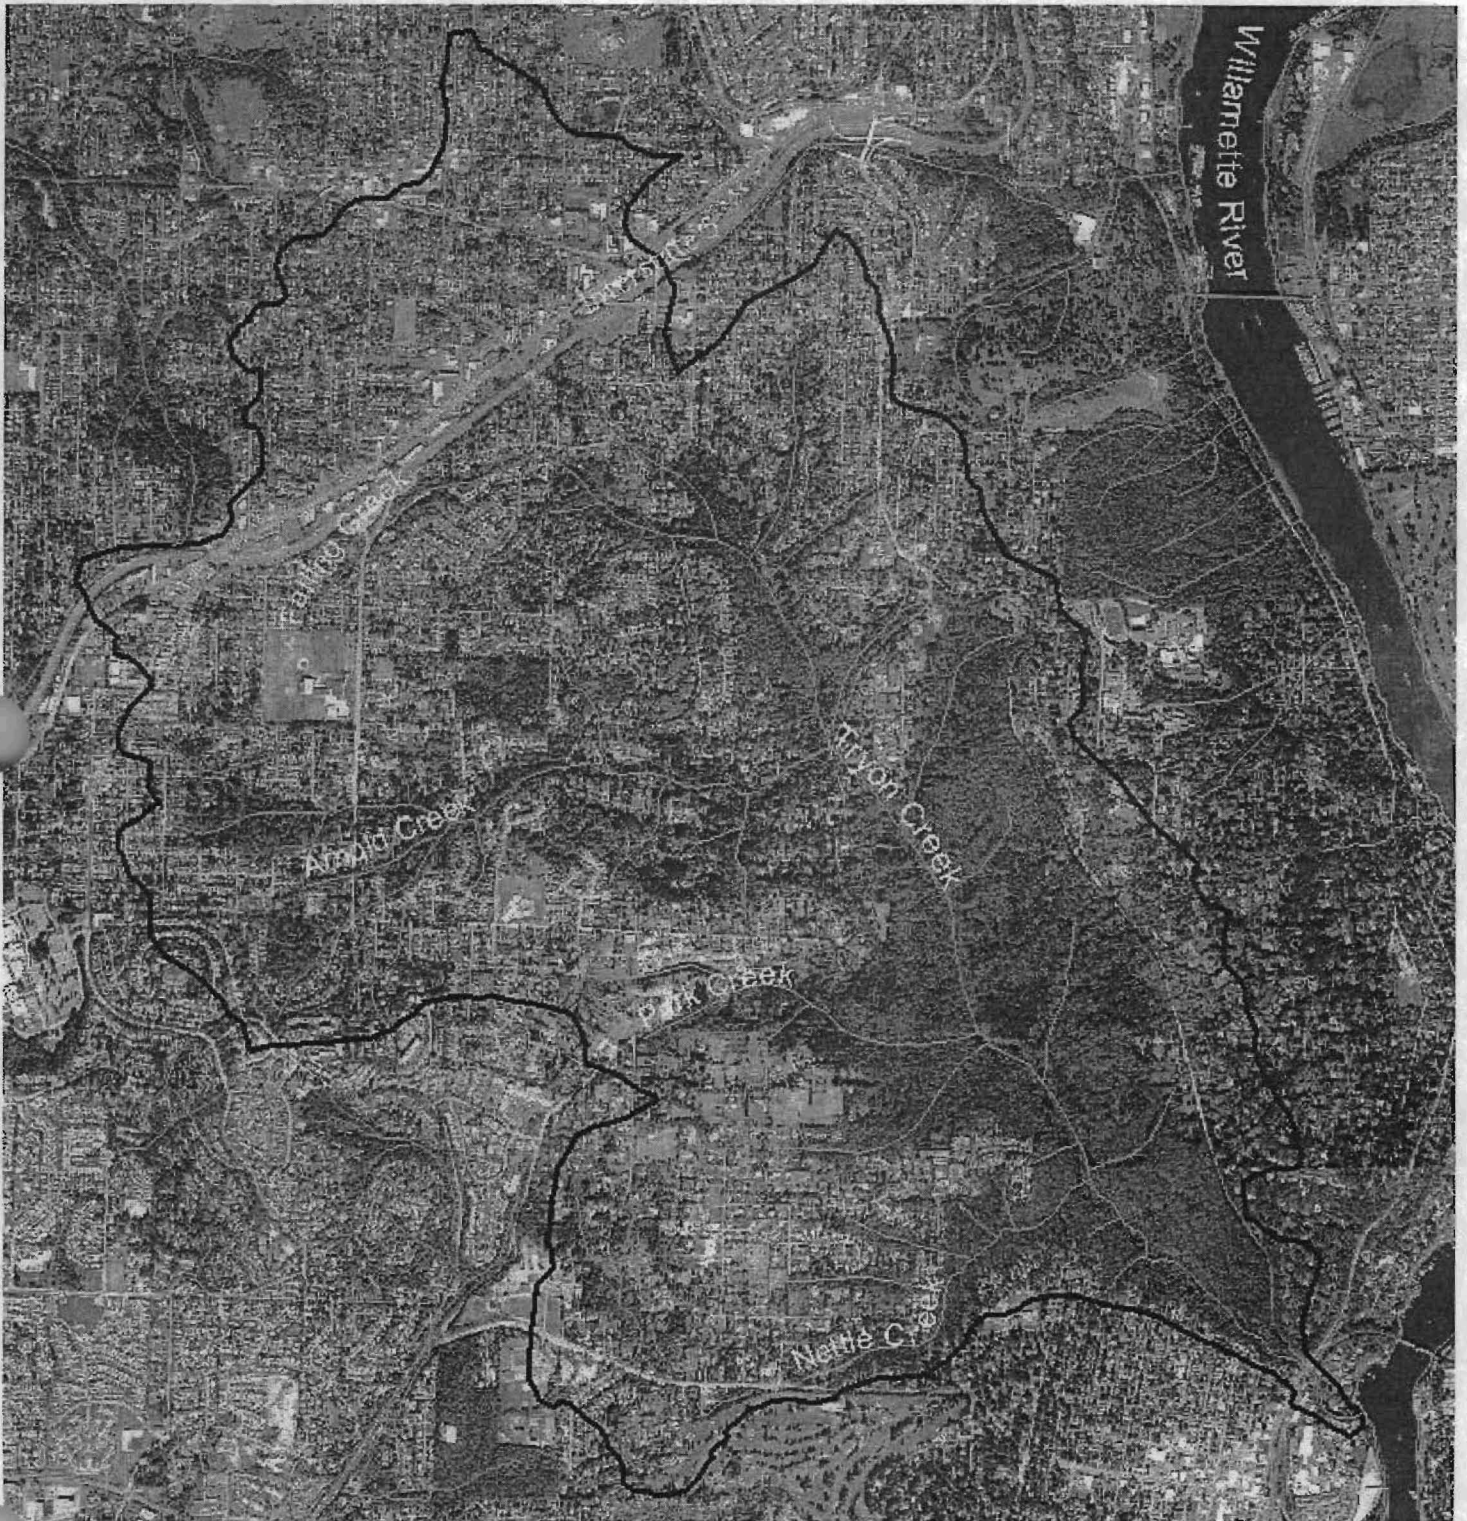
Map 1--Tryon Creek Watershed

Source: Stream centerline is from METRO RLIS data, 2001. Watershed boundary--black outline; stream centerline--blue line. Tributaries highlighted: Falling, Arnold, Park and Nettle.

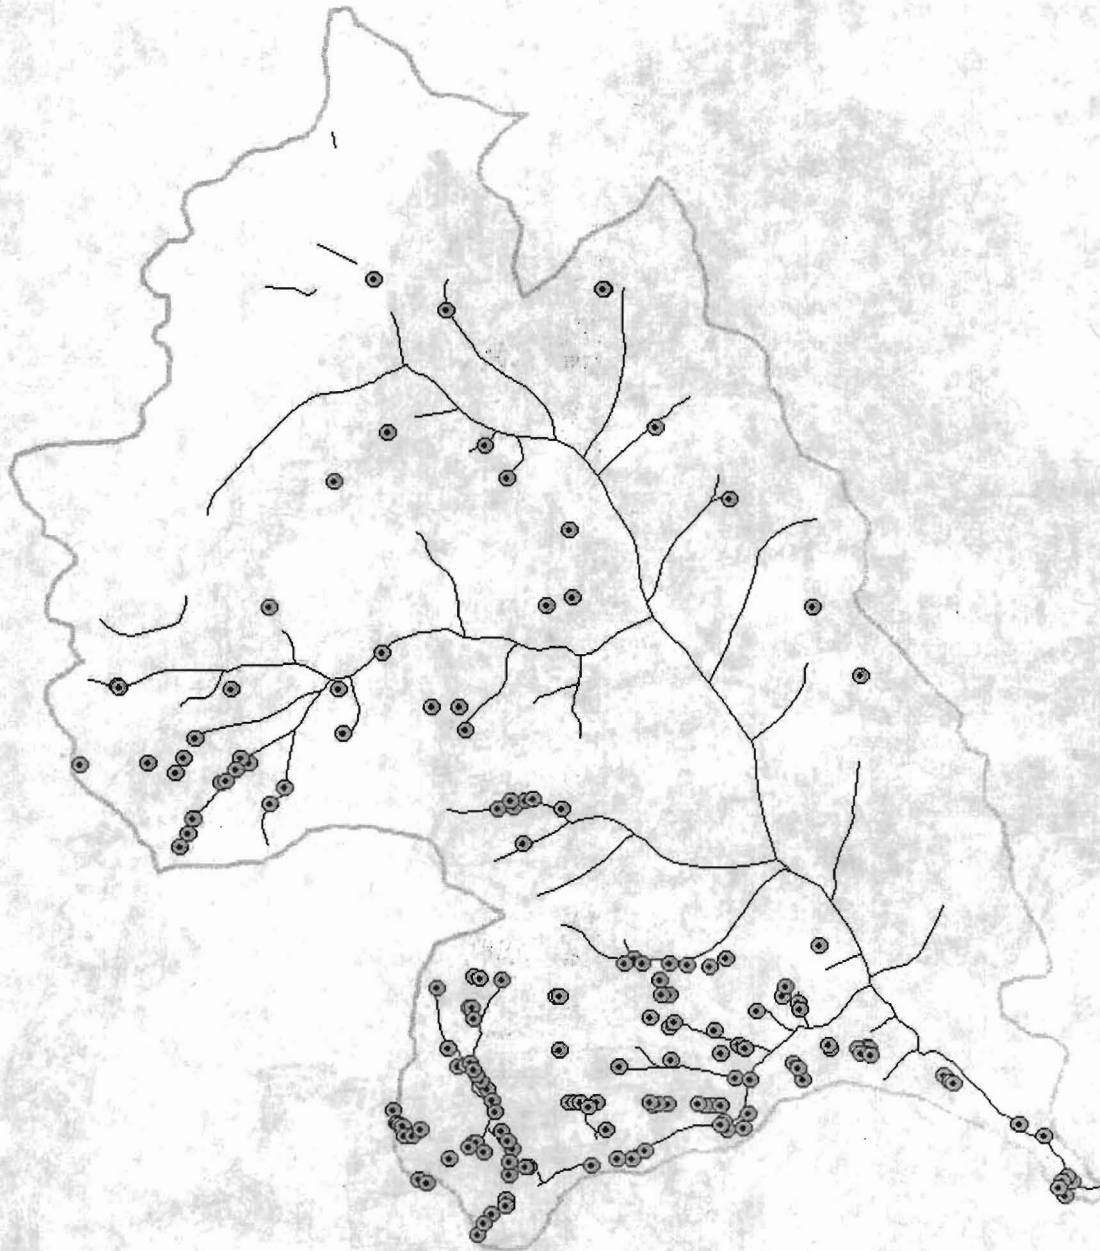
Map 3 Tryon Creek Composite: Streams and Municipal Storm Drain Outfalls;
Dots indicate municipal storm drain outfalls within 50 feet of mapped streams. All data need field checking.

Data Sources: Cities of Portland and Lake Oswego, 2001.

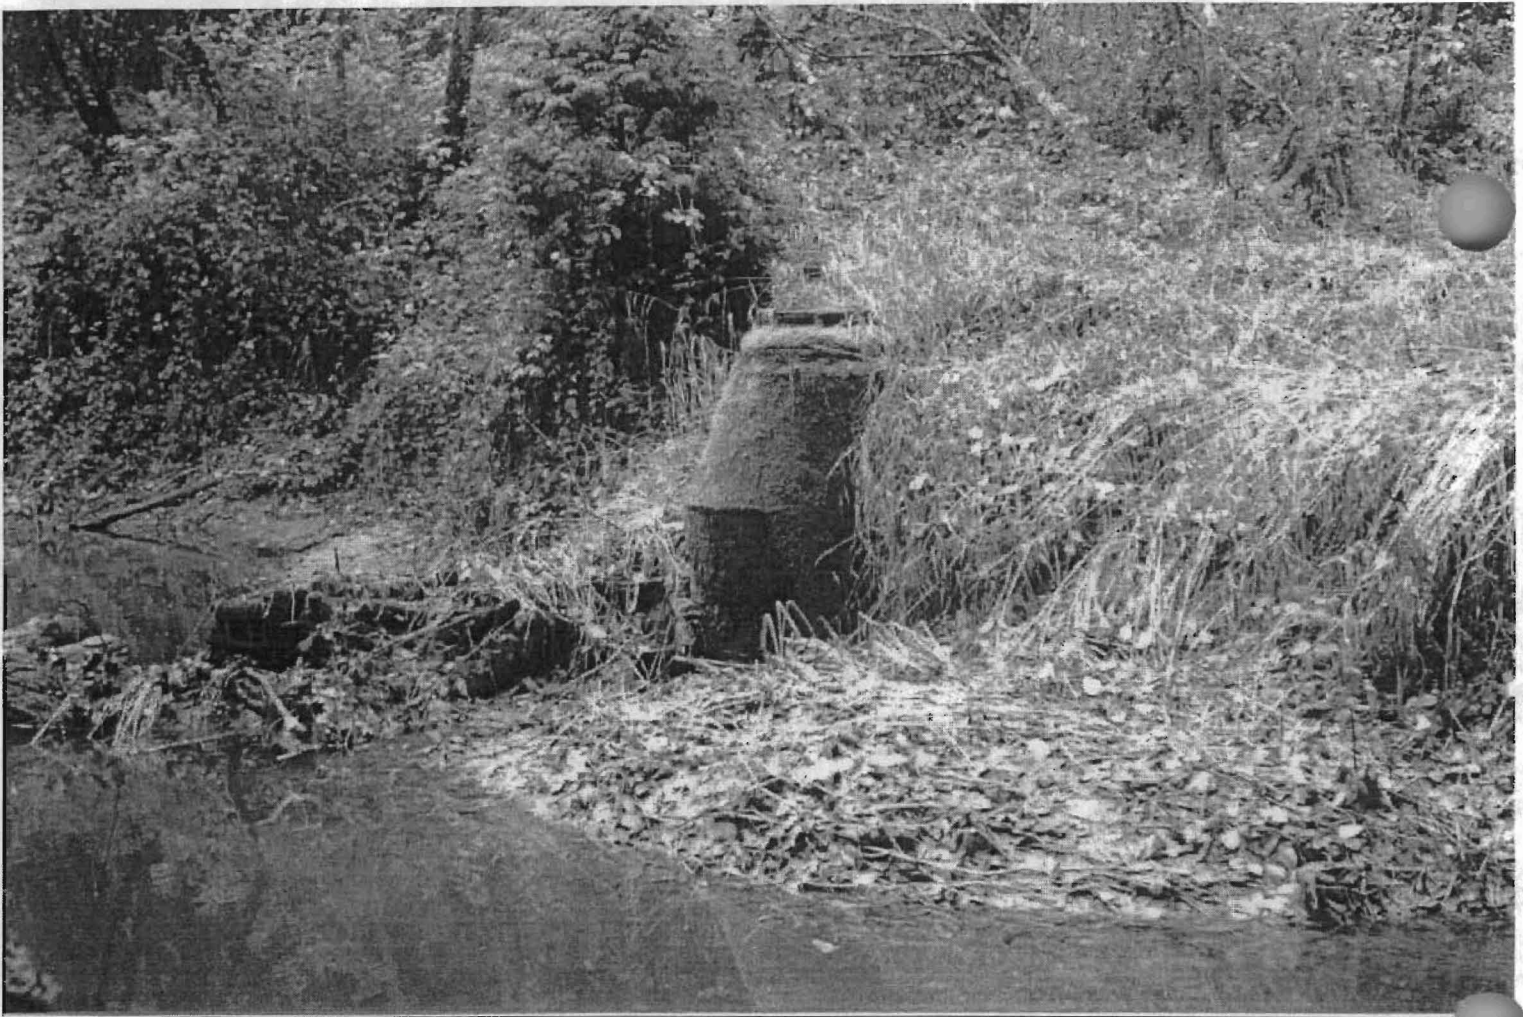
Photo: Frequent flooding of storm water runoff erodes stream banks and exposes sewer pipes. This moss-covered sewer pipe and manhole are located in lower Tryon Creek State Natural Area--formerly named Tryon Creek State Park. First installed during the period of 1968-70, the cement sewer-mains are approx. 4 ft. in diameter and run along the creek to the Tryon Creek Wastewater Treatment Plant in the Lake Oswego portion of the watershed.

When blocked with roots or other debris, these pipes may surcharge raw sewage into the creeks, given their proximity. Occasionally Portland also utilizes a toxic chemical foam to dissolve tree roots that have worked their way into the pipes. Some pipe protection/bank-anchoring was funded by USDA Natural Resources Conservation Service under its EWP (Emergency Watershed Protection Program) between 1997-99, as a result of severe 1996-97 flooding. Portland BES was the local sponsor and recipient of NRCS-EWP funds
