CHAPTER TEN: CONDITION SUMMARY

**LOWER MOLALLA RIVER & MILK CREEK
WATERSHED ASSESSMENT**

APPENDIX OF PHOTOGRAPHS

MOLALLA RIVERWATCH, INC.
MOLALLA, OREGON

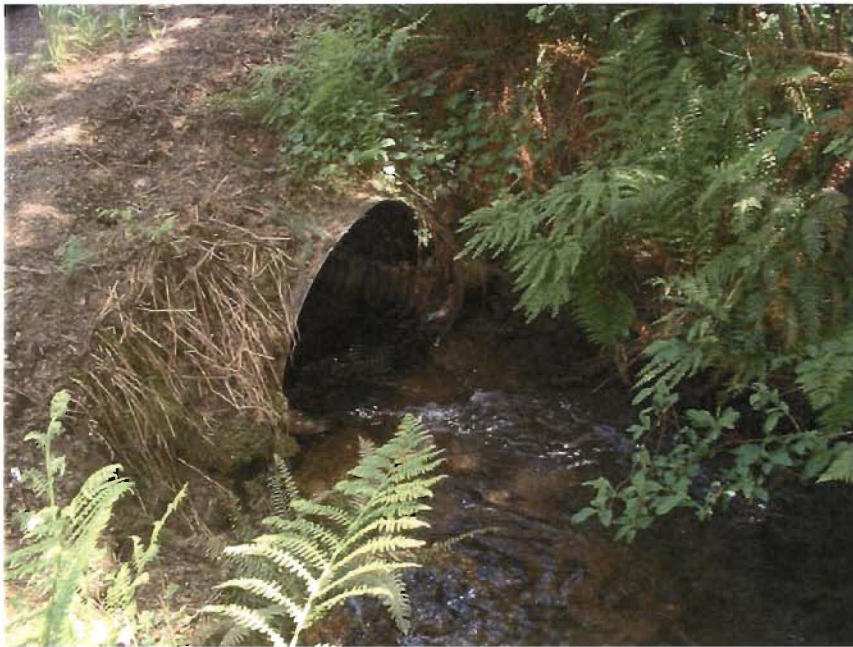
43	5/22/2003	Dorn Creek	Culvert outlet
44	5/22/2003	Bittner Creek	Cow tracks
45	5/22/2003	Bittner Creek	Downstream
46	5/22/2003	Bittner Creek	Upstream
47	5/22/2003	Bittner Creek	Land use adjacent to creek
48	5/22/2003	Nate Creek	Upstream from Unger road crossing
49	5/22/2003	Nate Creek	Downstream from Unger road crossing
50	5/22/2003	Randall Road Creek	Upstream from Unger road crossing
51	5/22/2003	Randall Road Creek	Stream restoration sign
52	5/22/2003	Randall Road Creek	Downstream from Unger road crossing

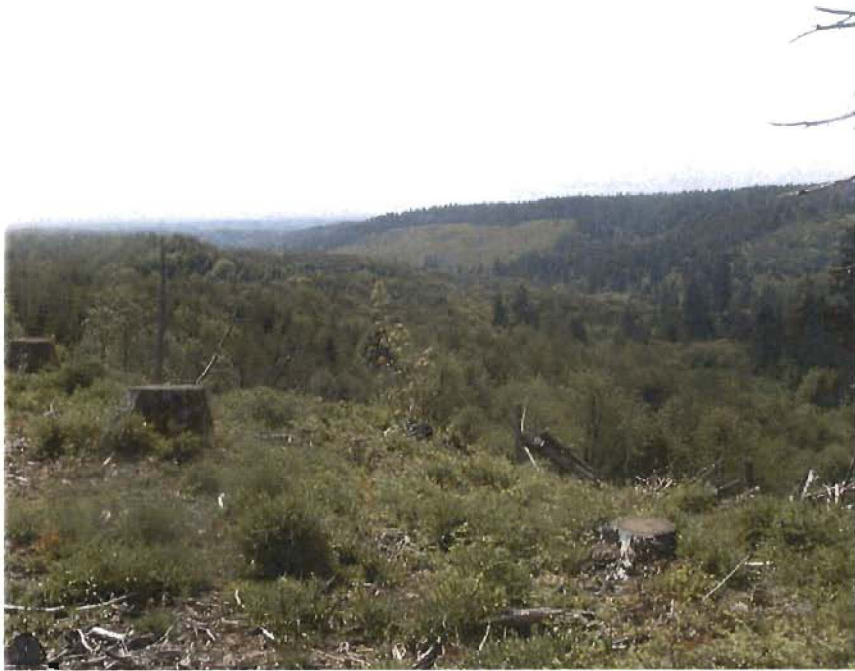
53	5/22/2003	Randall Road Creek	Culvert upstream
54	5/22/2003	Cedar Creek	Watershed from Windy City road crossing
55	5/22/2003	Milk Creek	Downstream from Windy City road crossing
56	5/22/2003	Milk Creek	Upstream from Windy City road crossing
57	5/22/2003	Milk Creek	Downstream from Graves road crossing
58	5/22/2003		Upstream
59	5/22/2003		Stream restoration sign
60	5/22/2003		Down through culvert
61	5/22/2003		Up through culvert
62	6/11/2003	Molalla mainstem	Temp Recorder Site - behind Gymkowski's
63	6/11/2003	Molalla mainstem	Temp Recorder Site - behind Gymkowski's
64	6/11/2003	Molalla mainstem	Temp Recorder Site - behind Gymkowski's
65	6/11/2003	Molalla mainstem	bank erosion from 96 flood - behind Gymkowski's
69	6/11/2003	Milk Creek	Temp recorder Site - at Bonney Road Bridge
70	6/11/2003	Molalla mainstem	Temp recorder Site - Molalla R behind Milk Ck tree farm
71	6/11/2003	Molalla mainstem	Temp recorder Site - Molalla R behind Milk Ck tree farm

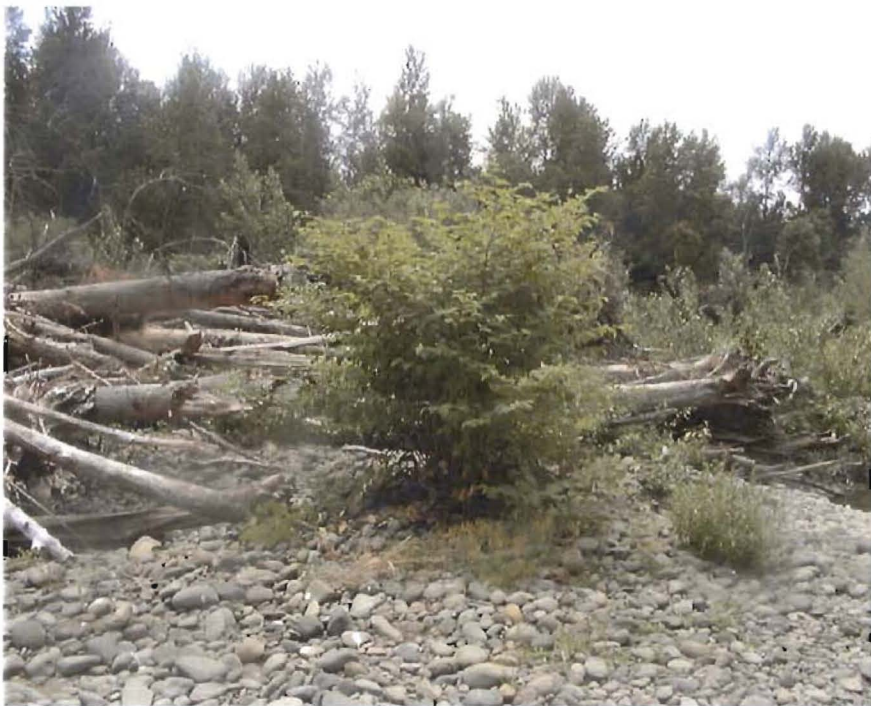
72	6/11/2003	Molalla mainstem	Japanese knotweed along Molalla R
73	6/11/2003	Woodcock Creek	at Callahan Road
74	6/11/2003	Woodcock Creek	at Callahan Road
75	6/11/2003	Bull Creek	riparian zone along 211
76	6/11/2003	Bull Creek	at 211 (above box culvert)
77	6/11/2003	Milk Creek	at Hult Road - facing down
78	6/11/2003	Nate Creek	at Hult Road - facing up
79	6/11/2003	Nate Creek	at Hult Road - facing bridge
80	6/11/2003	Milk Creek	watershed from upper Hult Road
81	6/11/2003	Milk Creek	watershed from upper Hult Road
82	6/11/2003	Milk Creek	watershed from upper Hult Road
83	6/11/2003	Milk Creek	watershed from upper Hult Road
84	6/11/2003	Randell Creek	at Hult Road
85	6/11/2003	Randell Creek	at Hult Road
