# Upper Deschutes Subbasin Assessment August 2003

## EXECUTIVE SUMMARY

The Upper Deschutes Subbasin Assessment began work in 2002 as a project of the Upper Deschutes Watershed Council. From its inception, the assessment has been a cooperative venture with multiple partners, participants, and advisors. Funding for the project came from grants received from the Oregon Watershed Enhancement Board and the National Fish and Wildlife Foundation. In-kind donations of time, technical assistance, contract services, and equipment were generously contributed to the project by the Oregon Department of Environmental Quality, Deschutes National Forest, the Deschutes Resources Conservancy, the Oregon Department of Fish and Wildlife, the Bureau of Land Management, OSU-Cascades, the Nature Conservancy, the Oregon Water Resources Department, Deschutes County Soil and Water Conservation District, and GeoSpatial Solutions among many others.

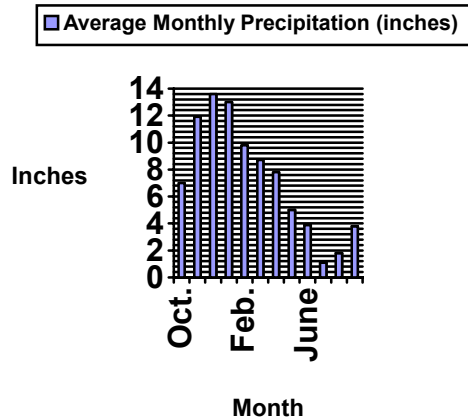
Figure 1: High Elevation Precipitation in the Cascade Subalpine/ Alpine and Cascade Crest Montane Forest Ecoregions of the Upper Deschutes Subbasin

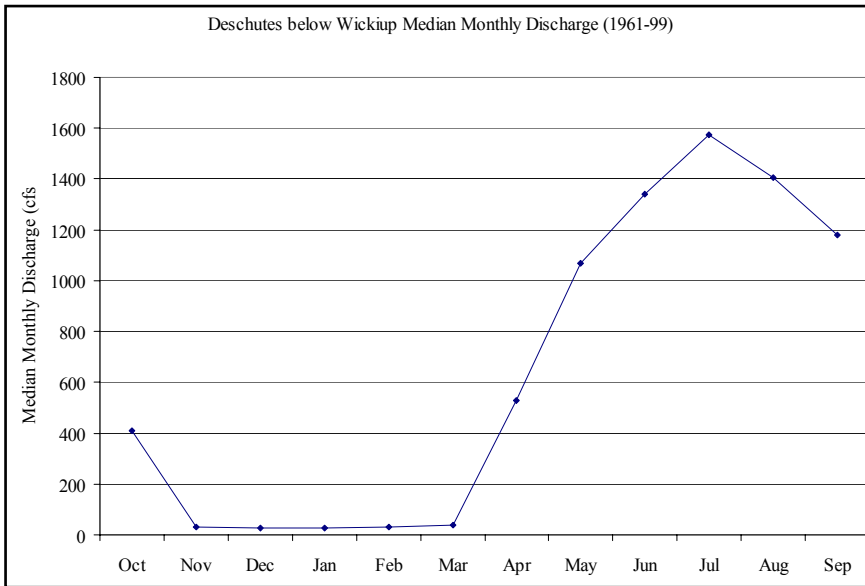
Figure 6: Median Monthly Discharge Below Wickiup Reservoir

The median ratio of summer to winter flows from 1961 through 1999 is 1500 to 30 cfs below Wickiup reservoir (Figure 6) and roughly 30 to 600 cubic feet per second (cfs) below Bend (Figure 7). The swing between the maximum and minimum flows in these sections of the Deschutes is dramatic when compared to the natural stable hydrograph of the river. As currently managed, the minimum flows are substantially lower than they were historically. According to the Oregon Water Resources Department, “increasing flows in these reaches during low flow periods would benefit both the aesthetics and ecology of the river.” (OWRD 2001).

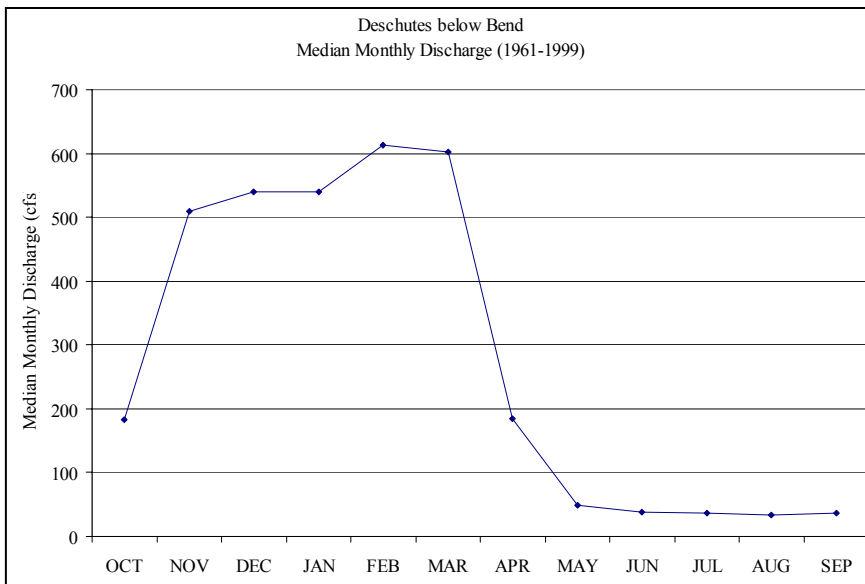
Figure 7: Median Monthly Discharge Below Bend

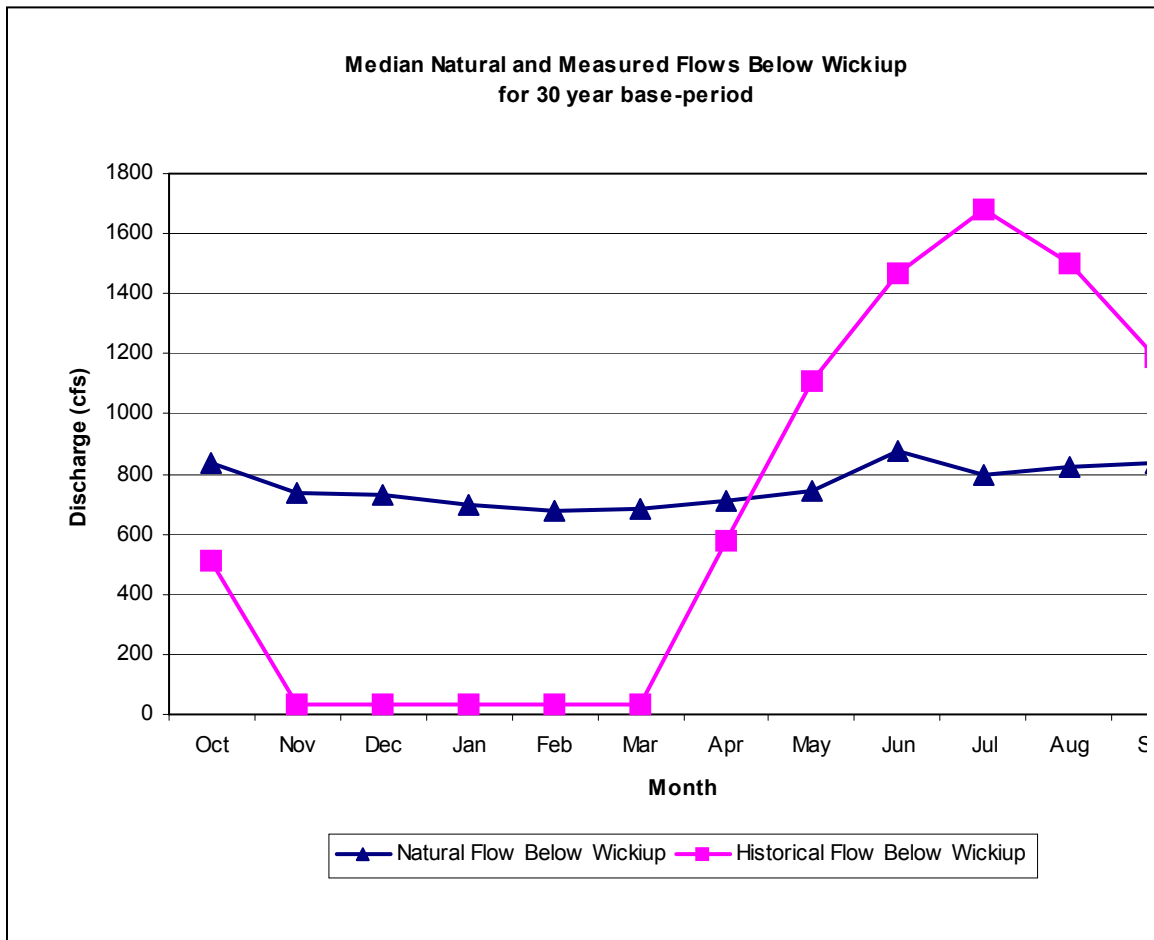
Figure 1: Median Natural and Regulated Flows Below Wickiup Reservoir (OWRD 2002)

Minimum Daily Flow (winter)	Maximum Daily Flow (summer)
Regulated Flow (1943-1987)	20 cfs	2280 cfs
Natural (unregulated) flow (1925-1941)	419 cfs	1400 cfs
Comparison between	95% decrease in flow under regulated	162% increase in flow under regulated

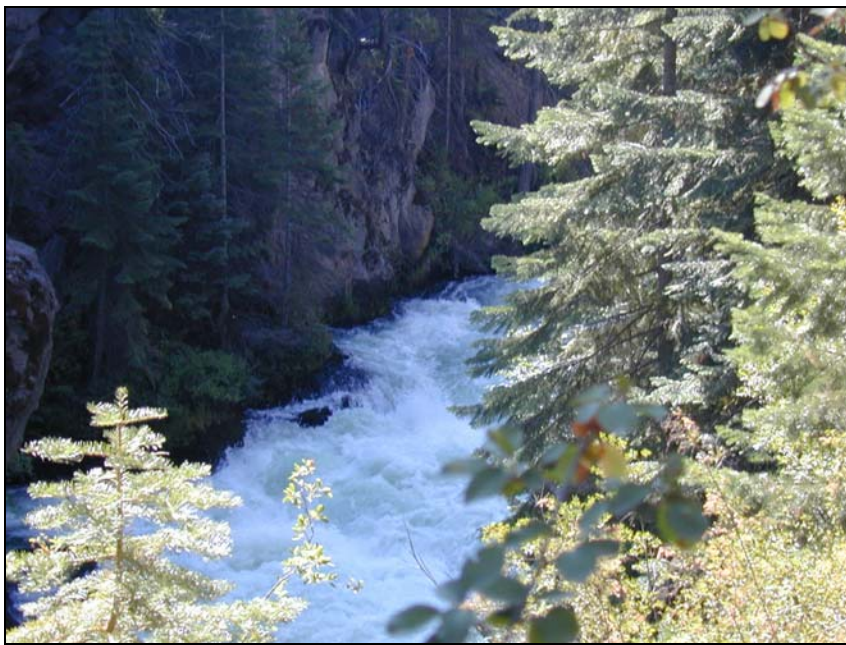
Photograph 1: Reach 104, Benham Falls

As mentioned in the introduction, some sections of the Upper Deschutes are naturally resistant to erosion due to the geology of the area. Taken from the overlook at Benham Falls, photograph 1 displays the bedrock that is remnant from the Lava Butte Flow from the eruption of Newberry Volcano. The lava rock remains and lines the channel at Benham Falls. Although the gradient and velocity are high in this reach, the erosion potential is very low.

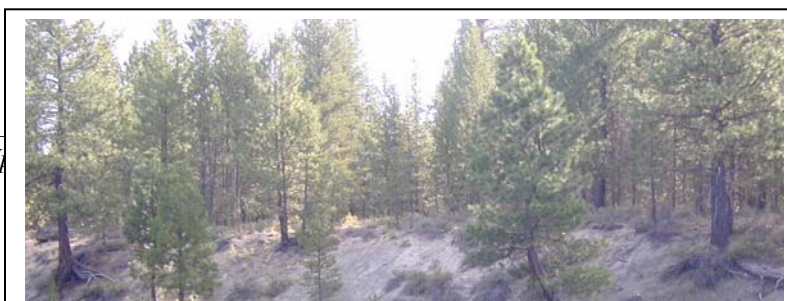
Photograph 2: Reach 51, La Pine State Park

Distinctly different from the banks at Benham Falls, the stream reach in photograph 2 consists of primarily silt and clay fine sediments. This reach is located at river mile 209 near La Pine State Park. The bank received a BEHI rating of moderate due to the combination of loose bank materials, moderate vegetation, and a 45 degree bank angle. The sedges and other herbaceous material at the water's edge combined with some surface protection from the pine roots to prevent a higher erosion rating.

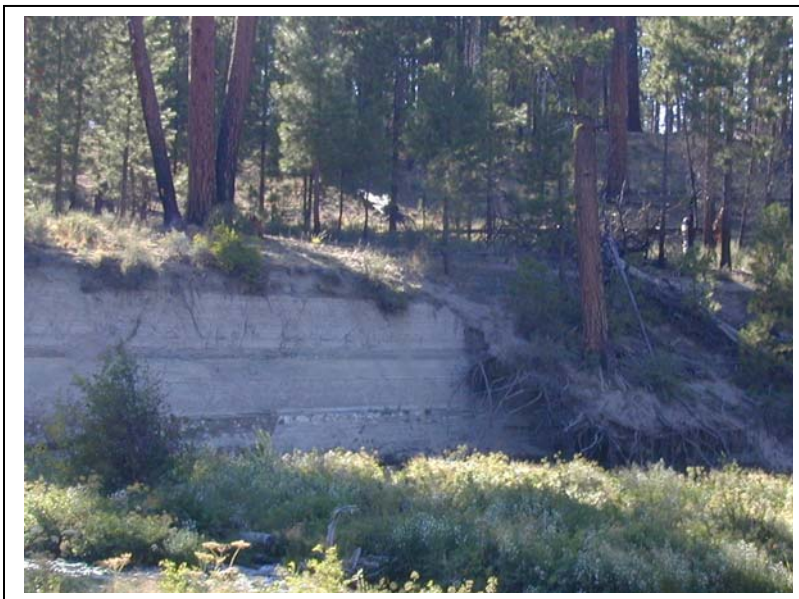
Photograph 3: Reach 30, Tetherow Log Jam

Taken just below river mile 213, photograph 3 presents a stream bank that received a BEHI rating of extreme. On this bank there is vegetation at the top portions of the bank but it is serving no protective service to the erosion or erodability of the bank at the water's edge.

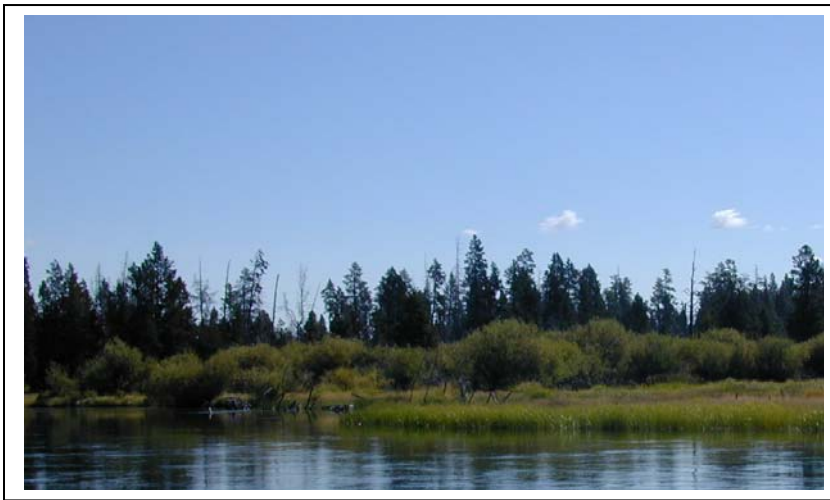
Photograph 4: Reach 62, Fall River Area

The relatively small number of banks receiving a very low BEHI rating is due to the fact that a large percentage of the banks that appeared to have no erosion problem were not included in the assessment. Reach 62 shown in photograph 4 is a bank that was assessed in order provide a representative sample of banks that, due to high levels of surface protection and low height, have very low or no erodability potential. Photograph 4 is representative of the majority of inside meander bends on the Upper Deschutes. As in the photo, the inside of meanders were typically deposition areas that had well established sedge meadow and willow vegetation.

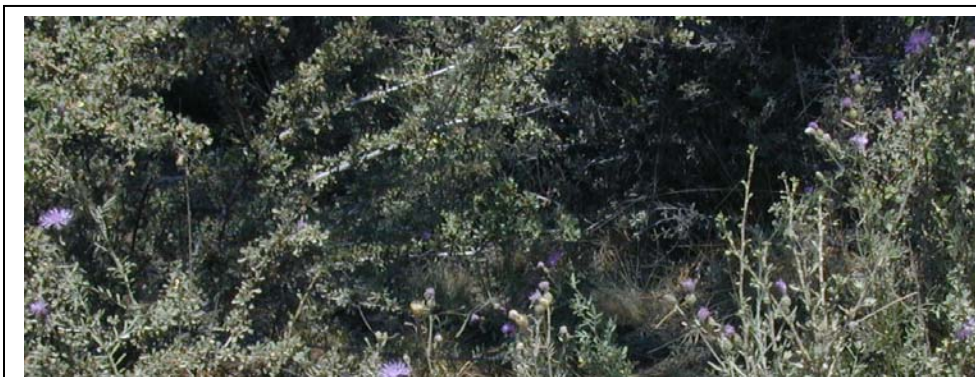
Photograph 5: Reach 108, ¼ mile downstream from Slough campground

Photograph 5 shows a substantial patch of knapweed located right on the river trail. This patch of knapweed is between the trail and the water's edge. As knapweed sends down a single deep taproot, the weed can exacerbate erosion but edging out other native riparian vegetation that would more effectively hold soil in place.
