# LITTLE

# NESTUCCA

## Watershed Analysis

June, 1998

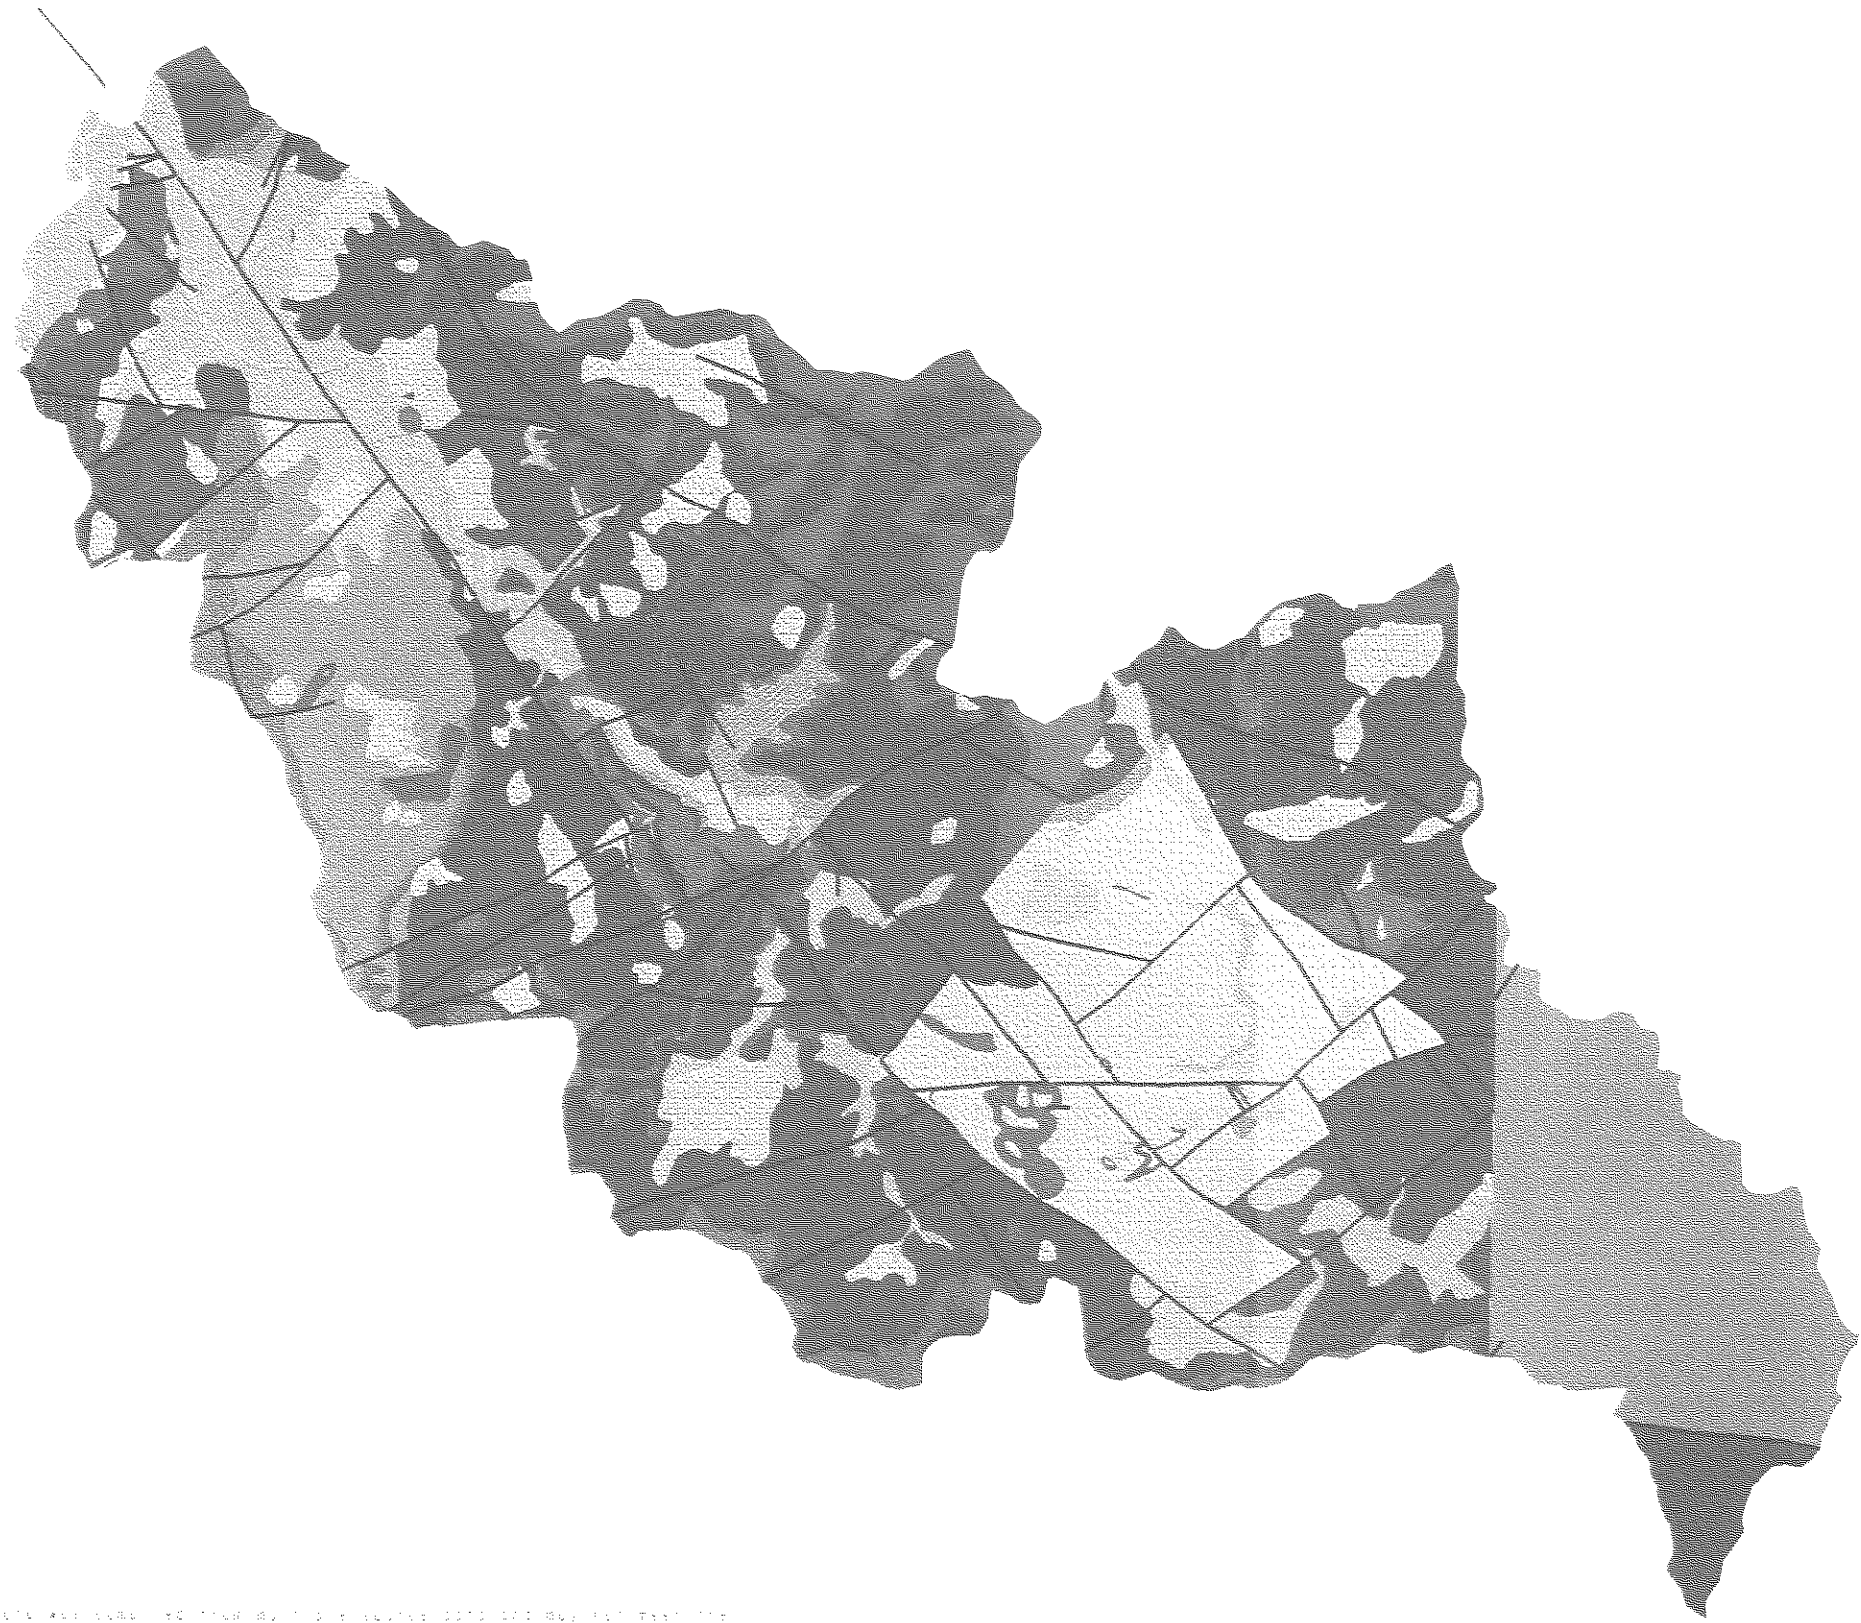
## Map 3

- Water
- Oal: Quaternary alluvial deposit
- Obs: Quaternary beach sand
- Ods: Quaternary dune sand
- Ols: Landslide debris
- Otr: Quaternary river terrace deposit
- Talbs: Basaltic Sandstone Member, Alsea Formation
- Tchb: Basalt of Cascade Head
- Tcsbc: Conglomerate and sandstone of Cannery Hill Unit
- Tcsbm: Mudstone and siltstone of Cannery Hill Unit
- Tcsbv: Basalt of Cannery Hill Unit
- Tiao: Olivine-Augite-Phyric Basalt
- Tid: Diabase
- Tidb: Intrusive Depoe Bay Basalt
- Titb: Basalt sill
- Tiu: Basaltic intrusive rocks - undivided
- Tn: Nestucca Formation
- TSAR: Salmon River Formation
- Tsr: Siletz River Volcanics
- Tt: Tyea Formation
- Tts: Tyea Formation - Siltstone Member
- Ty: Yamhill Formation
- TYT
- Faults

eastern half of the watershed. The Salmon River Formation is a basaltic sandstone that contains scattered locations of seashell fragments. In this watershed it is only found along the bottom of Bear Creek and “the gorge” of the Little Nestucca River (Snaveley, et al., 1996). Map 3 shows the geology of the watershed.

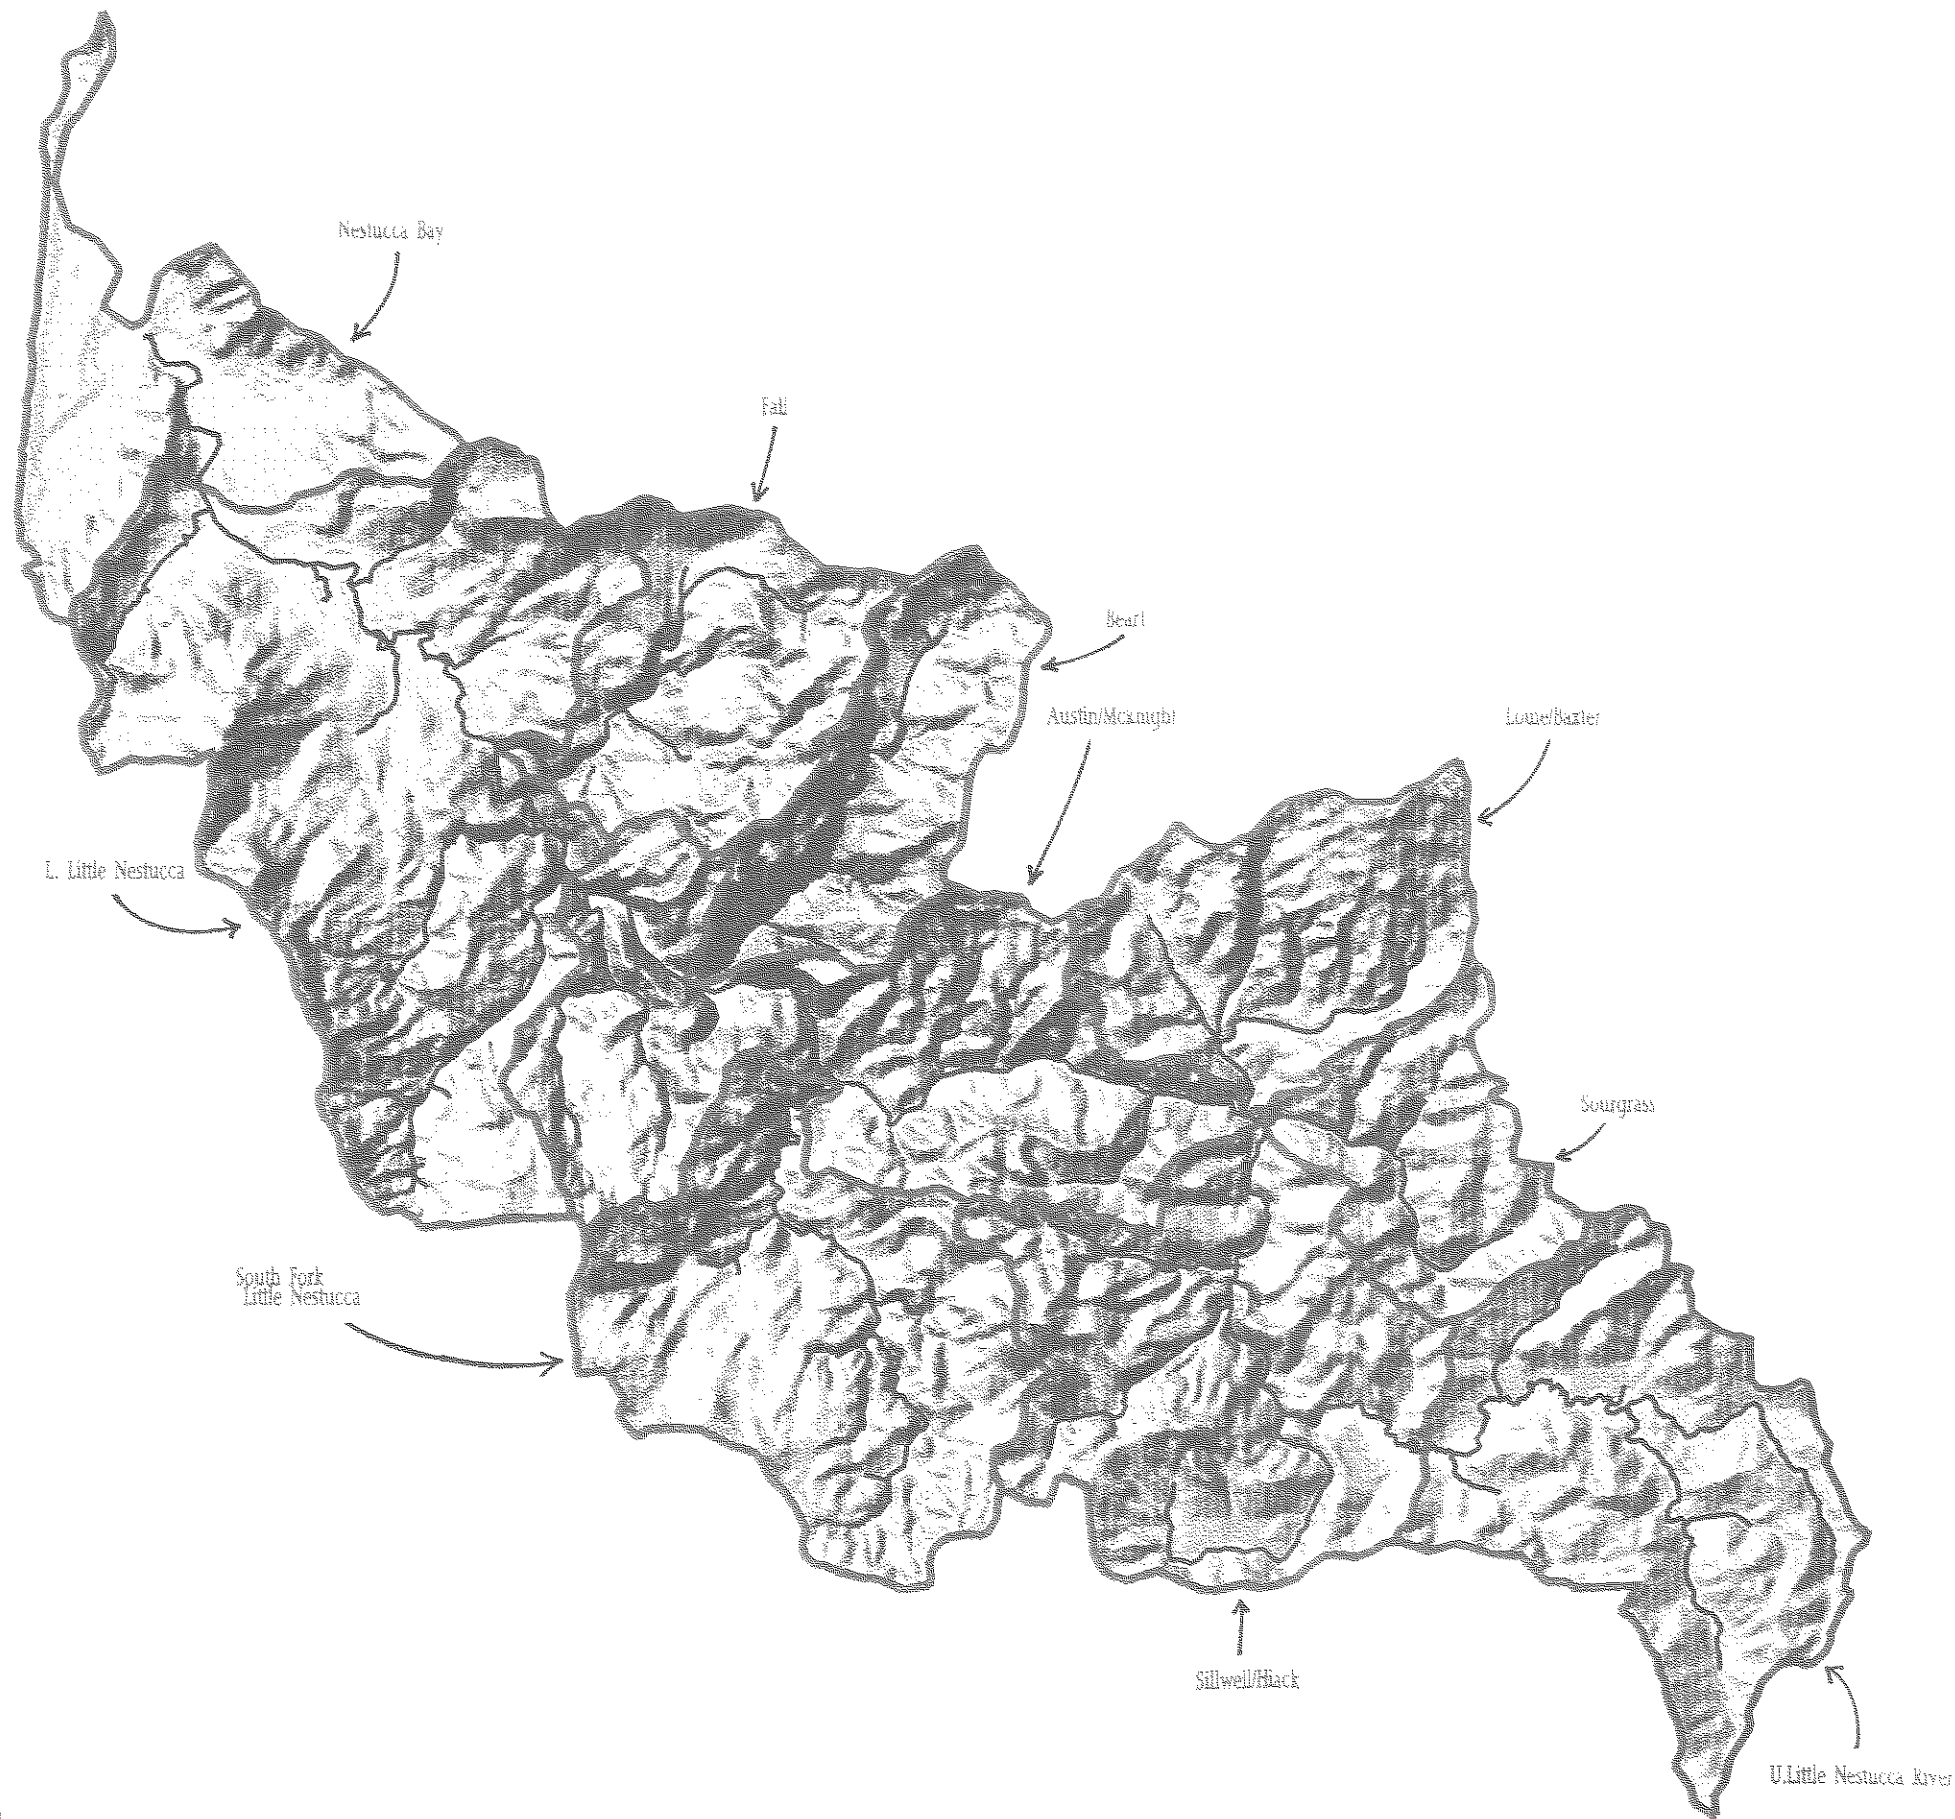
## Map 4

Shaded Relief

Bedrock has an obvious influence on landforms in this watershed. The more erodable siltstone of the Yamhill Formation underlies gently rounded hills and short, gentle slopes. The Tyee Formation underlies more pronounced, sharper ridges. This picture is complicated by the presence of the basaltic dikes and sills, which are more resistant to erosion. Basalt is found at the top of the higher ridges and peaks, such as Gauldy Ridge, Neskowin Ridge on the southern border of the watershed and the unnamed ridge west of Bear Creek. Resistant sills of basalt that are found on the midslope along Bear Creek impede the hillslope from eroding back, and create an incised canyon in the Salmon River Formation at the bottom of the canyon. The interbedded basalt within more erodable sedimentary rock has created resistant steps in streams, leading to the development of numerous waterfalls within this watershed. Map 4 is a shaded relief map of the watershed, and shows landforms.

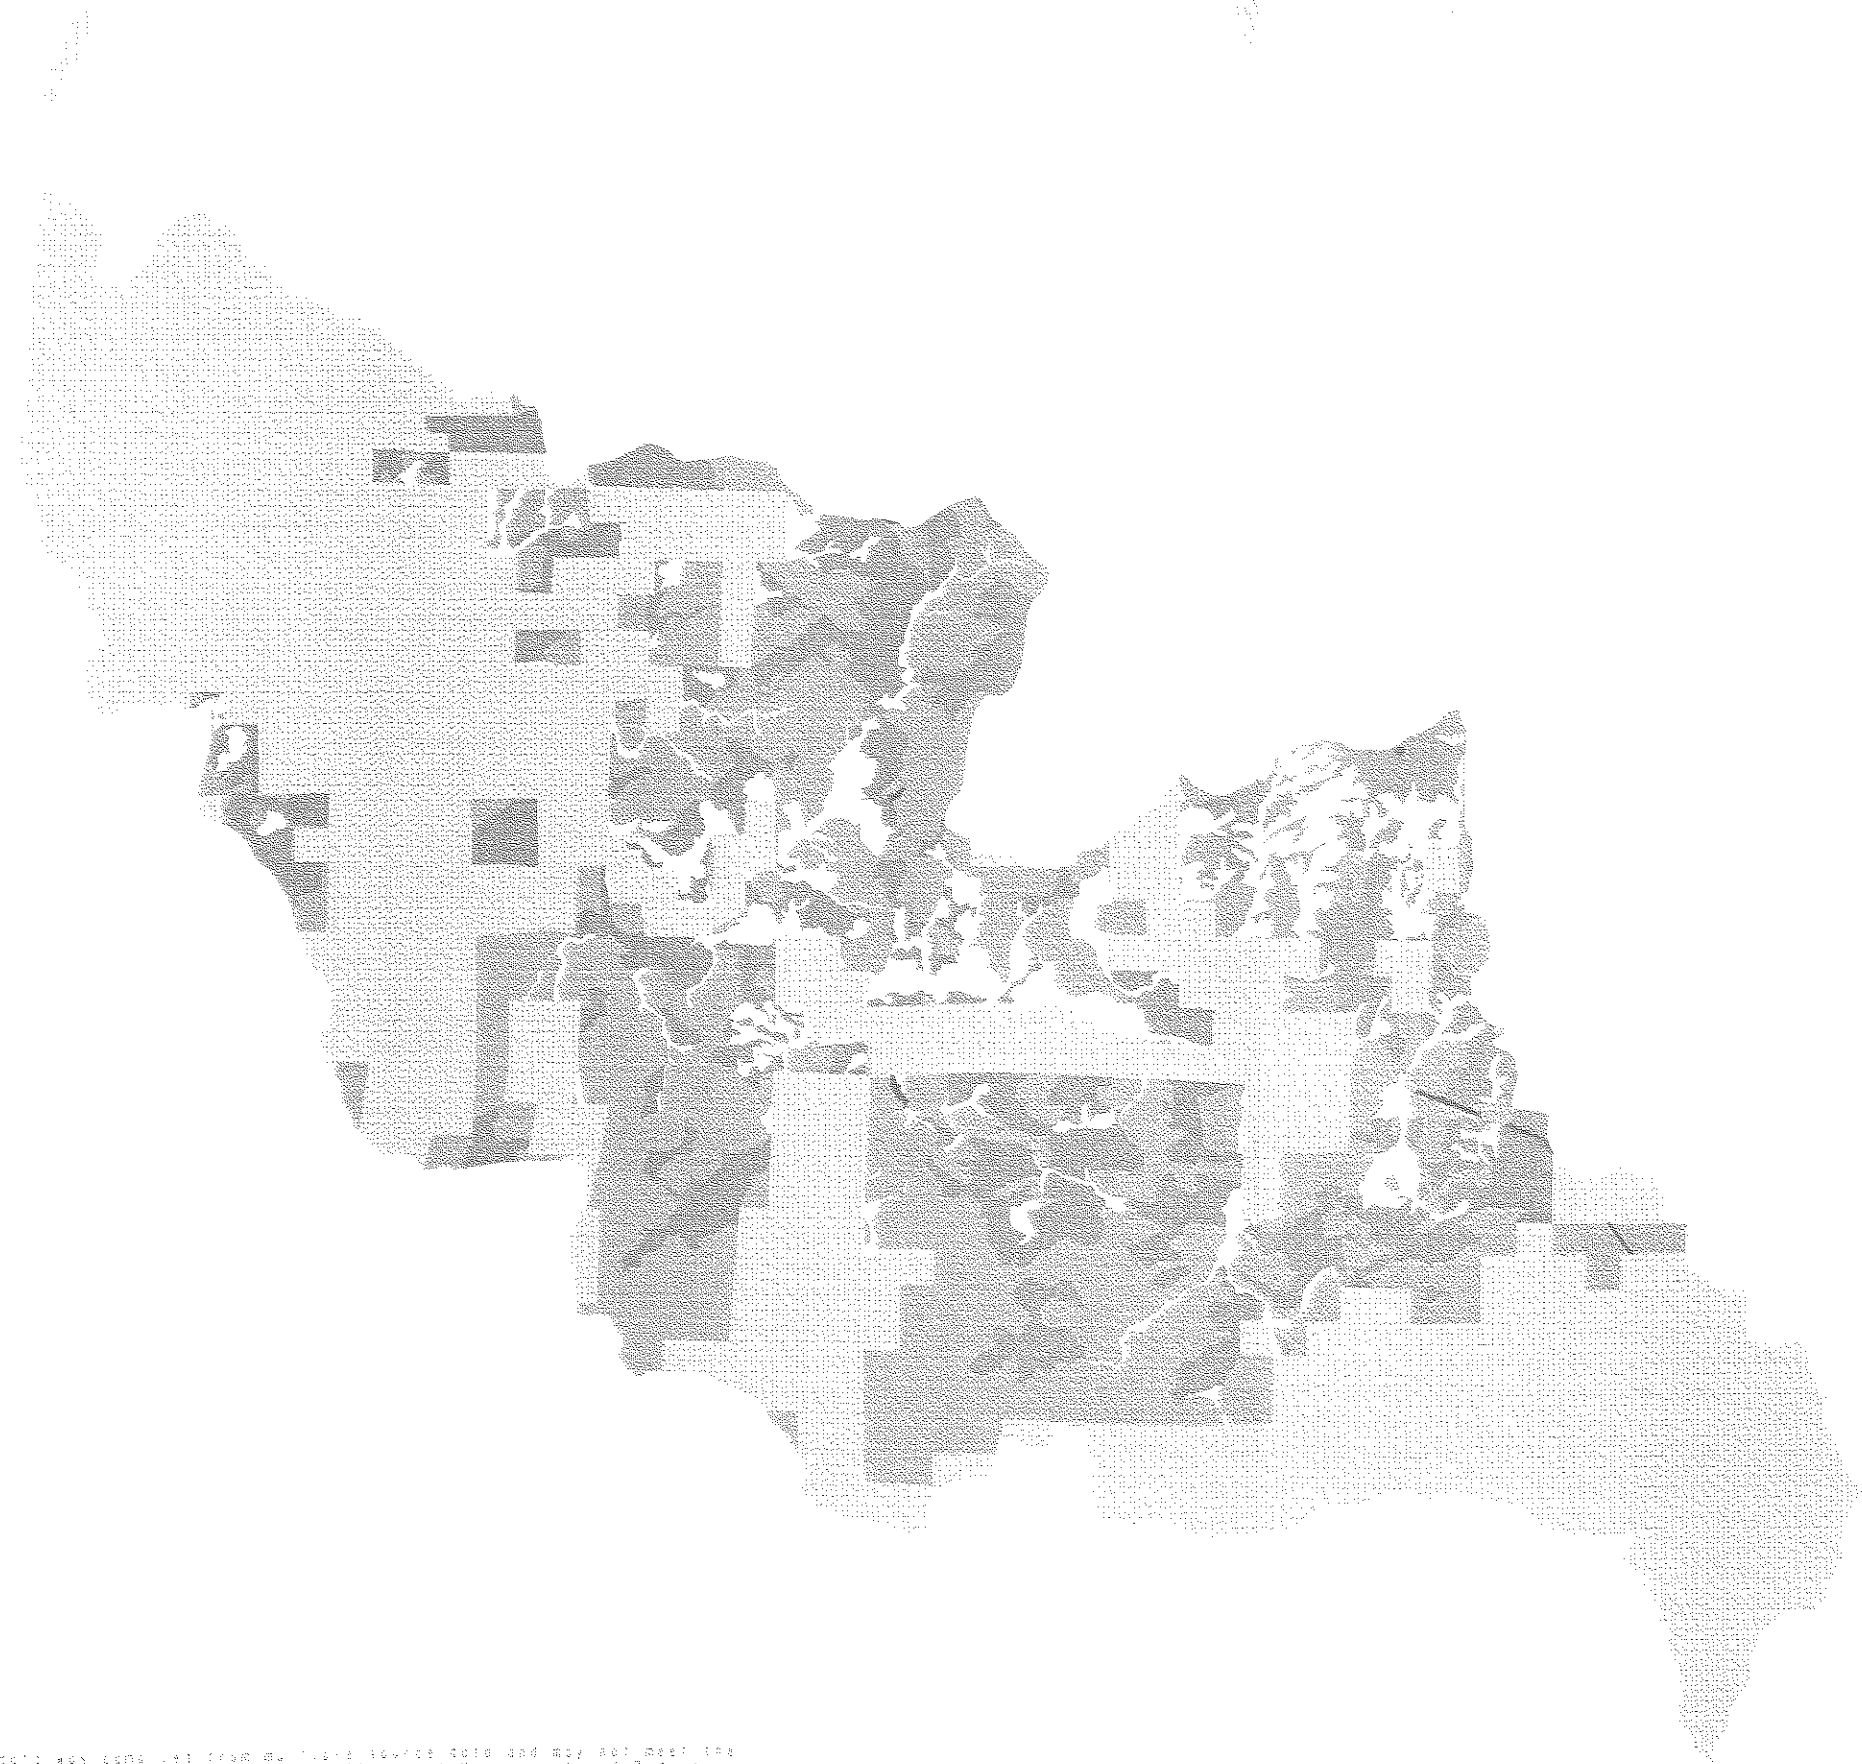
## Map 9

Analysis Area  
Roads shown with  
risk of failure
