OWEB Project # 210-1023-8076

Elk Flats Restoration & Effectiveness Monitoring

This report details three years of effectiveness monitoring conducted by CREST at the Elk Flats restoration project site. CREST conducted fish community, vegetation, and water quality post-project implementation monitoring from 2012 - 2014. Effectiveness monitoring details the habitat conditions and fish use of restored habitat.

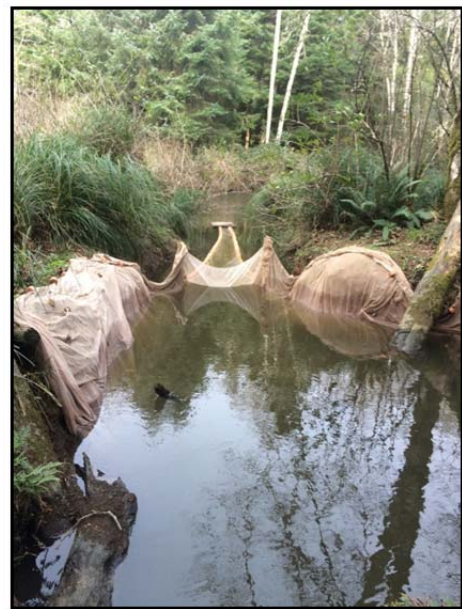
FIGURE 1. Trapnet and livebox set up at confluence of Elk Flats channel and Ecola Creek mainstem.

The trapnet was set at the mouth of the created channel where it converges with the Ecola Creek main stem, at slack tide, just before the ebb, and remained deployed until low water. This method employs a passive technique in which the ebb tide encourages fish into the net and livebox as the water recedes from the channel. The livebox provides a shaded holding area for fish, continual water exchange from the channel, and low water velocity to reduce stress to fish. All species observed in the nets and livebox were collected into black buckets using dip nets. Water was collected from the channel at the time of each catch to maintain consistent water quality conditions with the channel. Portable aerators were inserted into the buckets to maintain static dissolved oxygen levels. All juvenile salmonids were measured, weighed, and checked for tags and markings prior to being placed in the recovery buckets. All non-salmonid fish were identified to species and measured. All fish were allowed ample recovery time and then released.

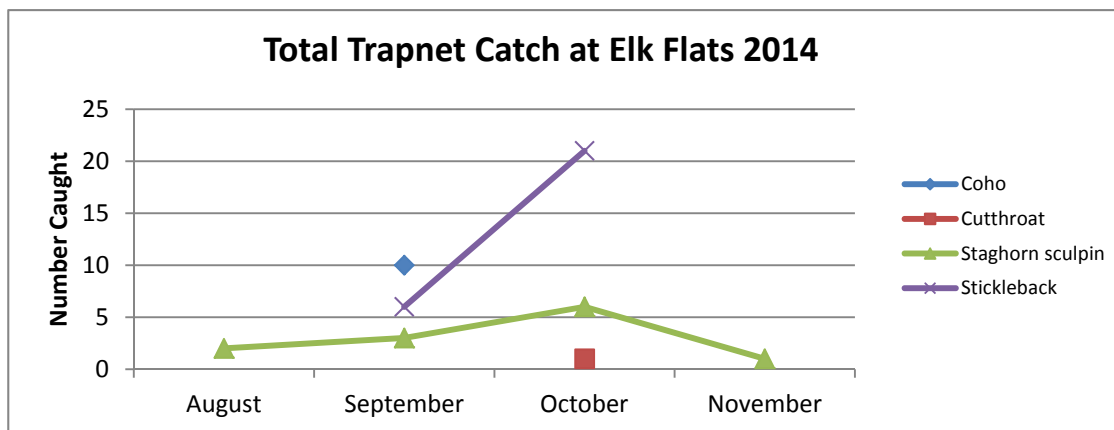
Coho were only caught in September of the 2014 field sampling season. Several factors may contribute to the low observance of Coho at Elk Flats, including water level, low velocity, and natural variations in migration behavior. At very low-tide/low-water events the channel is disconnected from the mainstem Ecola Creek inhibiting fish passage. This was only observed at the bottom of low tides in drier months in prior years. During fishing events from August to November 2014 the channel did not lose connectivity to Ecola Creek. Moderately sized pools hold water even during low tide/water events. These pools are well shaded and have large woody debris in them providing cover. Salmon were observed in the pools during low tide, demonstrating that fish were actively avoiding the trapnet and remaining in the channel. This behavior would result in catch numbers being lower than the

FIGURE 2. Total number of fish caught and sampled at Elk Flats in 2014 by species.

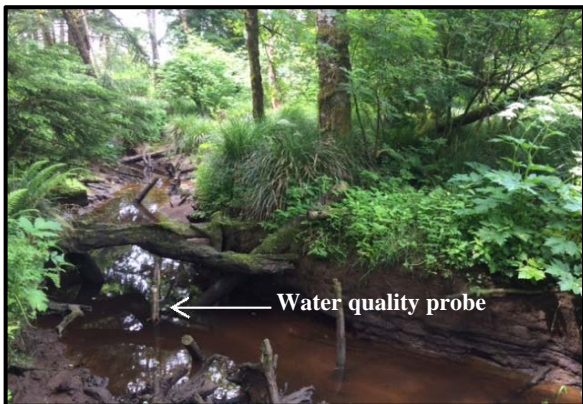
Two In-situ LevelTROLL 300 series probes were installed, one in the created tidal channel at Elk Flats and another in Ecola Creek outside the project site. The probes were set in a perforated PVC housing secured to a T-post that was buried two to three feet into the substrate. The probes were set in November of 2013 and data collected hourly until November of 2014, providing a full year of water surface elevation and temperature data. Water level and temperature were recorded every hour. The probes were surveyed using an auto level and stadia rod, and the elevation data was corrected using atmospheric data also collected by CREST.

FIGURE 6. Water quality probe in Elk Flats channel.

Two probes measuring pressure, temperature, and depth were deployed for a full year (November 2013 to November 2014) in the created channel at Elk Flats and in the mainstem Ecola Creek. The mainstem probe was placed approximately 50 yards up river from the restoration site, close enough that water surface elevation data should be identical. A longer distance would create a delay in the tidal signature between the two sites. The probes were surveyed and depth data corrected using survey data, as well as atmospheric data collected at the CREST office in Astoria. Daily temperature and water level data were graphed to demonstrate the tidal hydrology

The almost identical temperatures and water depths inside and outside the project site demonstrate the success of restored tidal hydrology at the restoration site. The data indicates that the channel opening was designed in a manner that allows for unrestricted tidal access, not being too shallow or narrow enough to restrict hydrologic processes which would result in greater differences in water depths. The created channel did maintain higher water levels throughout the year, however. This is the result of lower elevation pockets of water within the channel. In order to maintain the probe below the water surface during low water events the probe was placed in such a pocket.

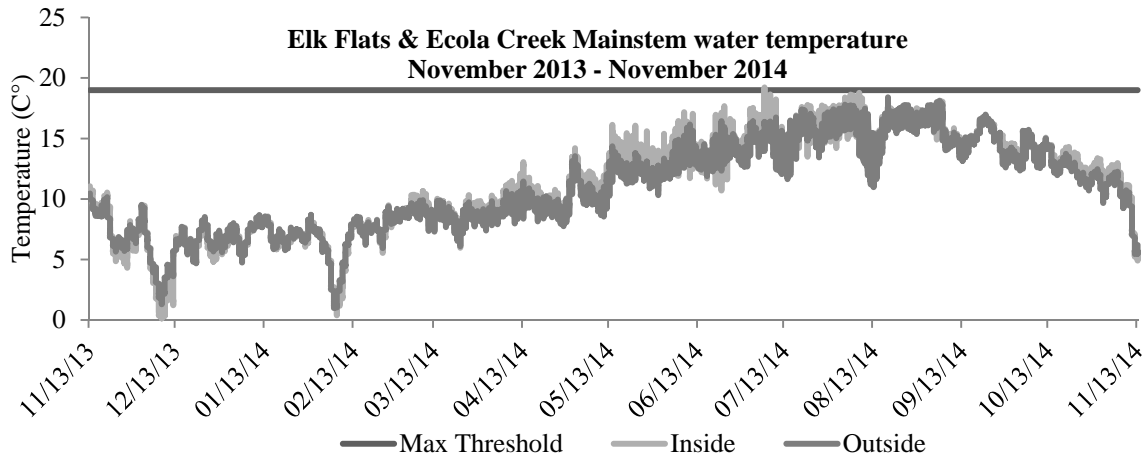
and similar conditions inside and outside the project site; the 7-Day moving average for water temperature was calculated and compared to the maximum ideal temperature for juvenile salmonid growth and survival. Water temperatures were slightly higher in the created off channel than in the mainstem Ecola Creek. These higher temperatures occurred between March and July; and occurred again in the fall between the months of October and November of 2014.

FIGURE 7. Hourly water temperatures inside Elk Flats and in the Ecola Creek mainstem.

The maximum temperature inside Elk Flats was 19.2°C, which is 0.8 degrees less than the maximum temperature measured in the mainstem Ecola Creek (18.4°C). The minimum temperature inside Elk Flats was 0.13°C, which was actually 0.85 degrees warmer than the mainstem whose lowest measured temperature was 0.98°C. This less than one degree difference in temperature attests to the congruous conditions inside and outside the restoration site. The average temperature difference was 0.9 degrees. The maximum ideal temperature for juvenile salmonids, above which growth rates are poor to none, is 19°C (U.S. Environmental Protection Agency. 1999). The mainstem Ecola Creek never reached this temperature, and the restoration channel only had one single reading during the entire year that was 19°C or higher; this occurred in July.

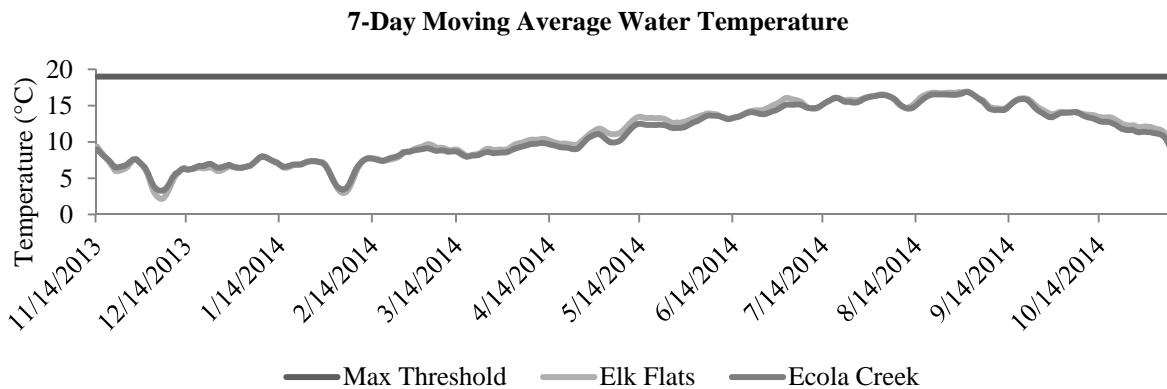
FIGURE 8. 7-Day moving average water temperature inside Elk Flats and outside the project site in the Ecola Creek mainstem.

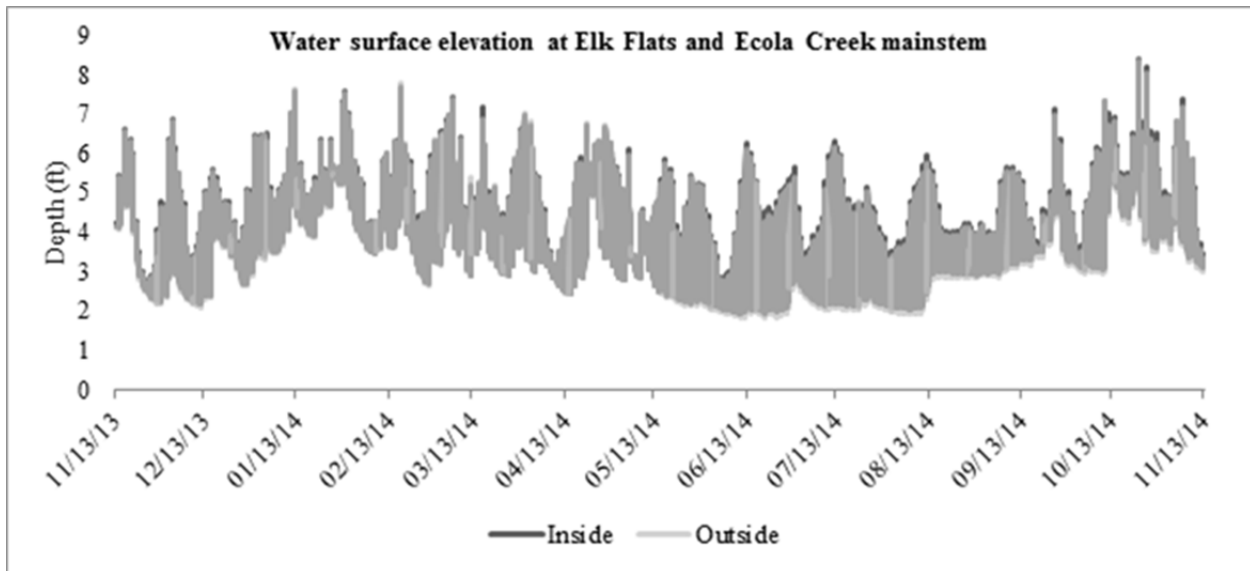
Water surface elevation was remarkably similar inside and outside the restoration site. The maximum recorded depth was 8.28 feet inside the created channel and 8.34 feet in the mainstem, for a difference of only 0.06 feet in maximum depth. The lowest recorded depth inside the created channel was 1.817 feet and outside was 1.844 feet, for a difference of 0.027 feet. The average depth was 3.5 feet inside and 3.6 feet outside.

Figure 9. Water surface elevation and temperature inside Elk Flats and outside the project site in the Ecola Creek mainstem.

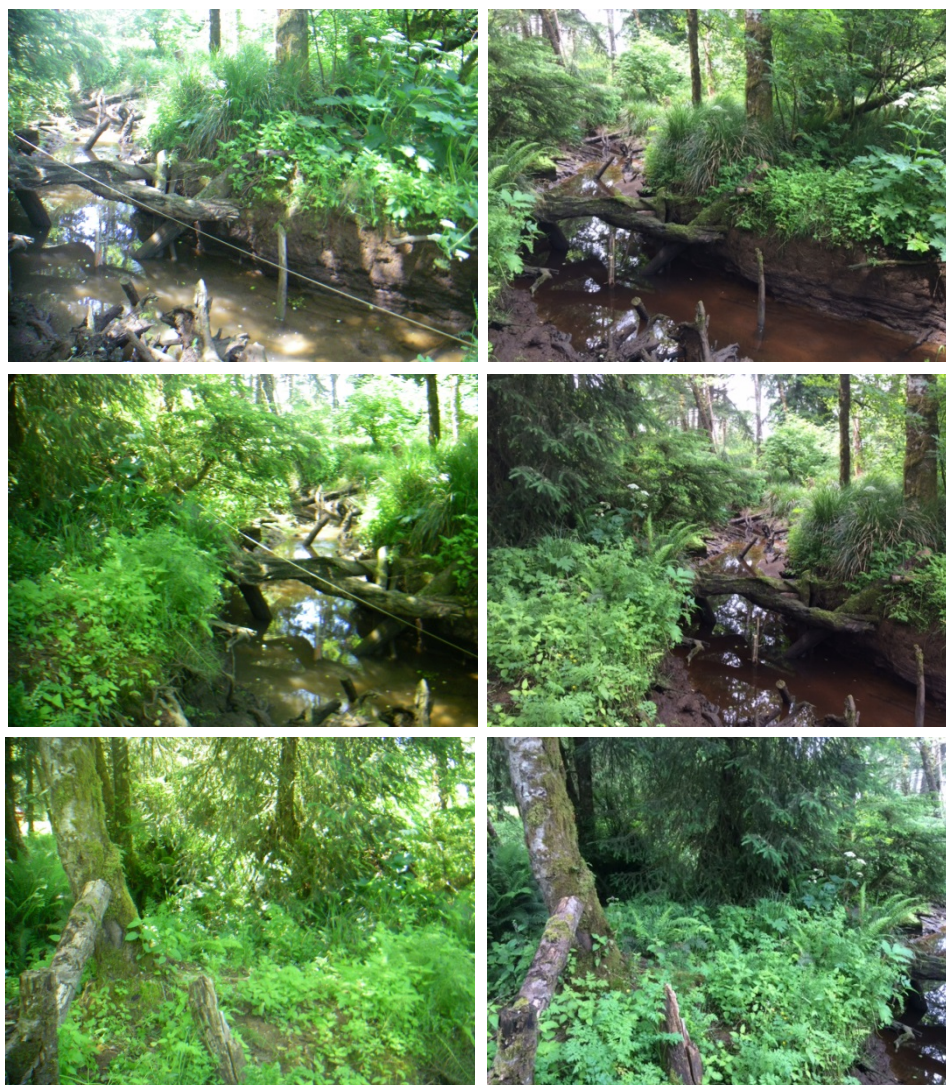
A series of six photos were taken at two photo point locations during the summers of 2013 and 2014. The photos were taken on the east side of the channel where restoration activities were staged. The project was completed in 2012 allowing almost a year for vegetation to recover from construction impacts, and planting to become established. The photos display a native emergent plant community, with a healthy forested canopy. Very little difference is noticeable in the vegetation or channel shape between the two years. The site shows little to no signs of impact, and the abundance of native plant cover leaves very little open or disturbed areas for non-native species to persist.

FIGURE 12. Photo Point 1: near mouth of channel at start of vegetation transect 1. The three photos on the left are from 2013 and the three photos on the right are from 2014. Photo Point 1.1 is shown in the top two photos. Photo Point 1.2 is shown in the middle two photos. Photo Point 1.3 is represented in the bottom set of photos.

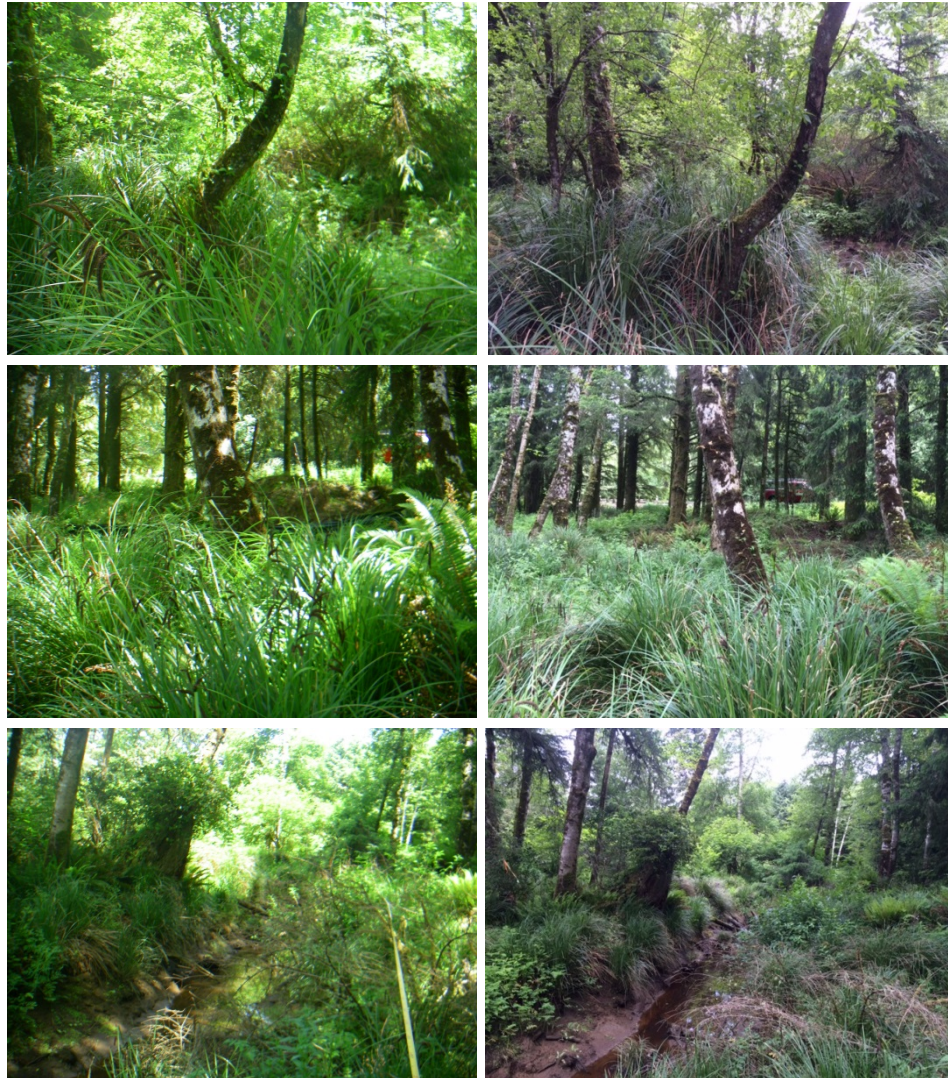
FIGURE 13. Photo Point 2: at start of vegetation transect 2. The three photos on the left are from 2013 and the three photos on the right are from 2014. Photo Point 2.1 is represented in the top two photos. Photo Point 2.2 is shown in the middle set of photos. Photo Point 2.3 is shown in the bottom two photos.
