Oregon South Coast Estuaries: Hunter Creek, Pistol River, Chetco River, & Winchuck River Tidal Wetlands Assessment

September 30, 2015

Prepared for the South Coast Watershed Council

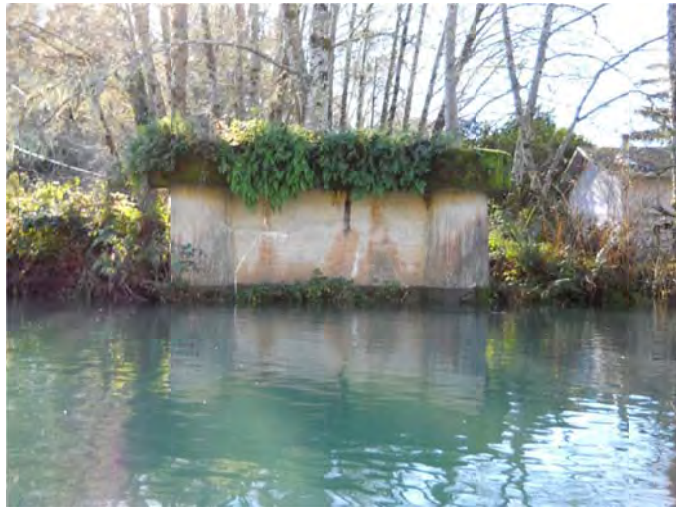
* it is uncertain whether Bill refered to the current bridge at RM 2.2 (figure 8) which would was probably lower at the time, or possibly more likely to the old crossing abutment at RM 0.6, shown to the right

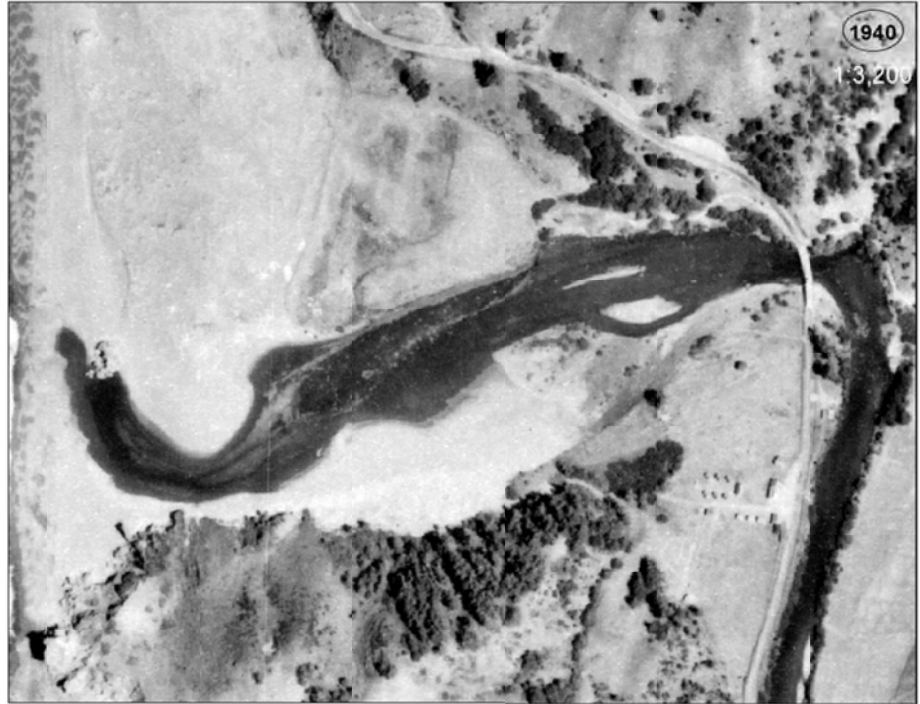
Compare the historic photograph from the north side of old bridge, of Hunter's Creek Auto Park (provided by Allen Wilson) to the 1940 aerial photo, prior to mill development and fill.

The 1951 aerial photo lacks resolution, but fill had been placed at the current Turtle Rock development site, resulting in the main channel migrating laterally to the north around the island and straightening. By 1965, south bank armoring was evident, protecting a mill pond that had been excavated. The abutments for Highway 101 had been placed and constricted the channel by ~275-300', and was aligned with the armored south bank.

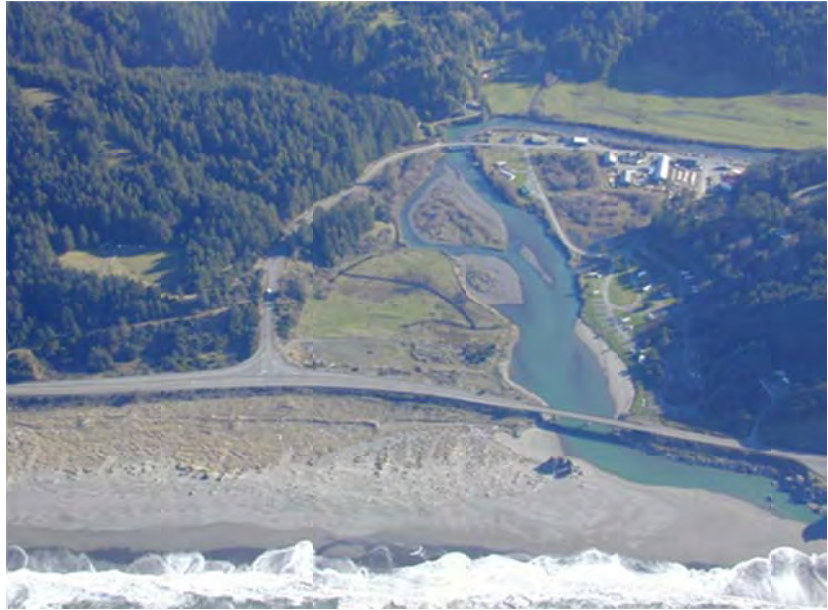
Turtle Rock RV Park was open as of the 2002 photo, which was taken when the mouth of the estuary was restricted enough to fill the estuary. Vegetation was well developed on the island. The oblique overflight photo to the right was taken on 1/16/2002. In 2014, the wet area on the east side pasture was much larger than before for an unknown reason (perhaps it had just rained?).

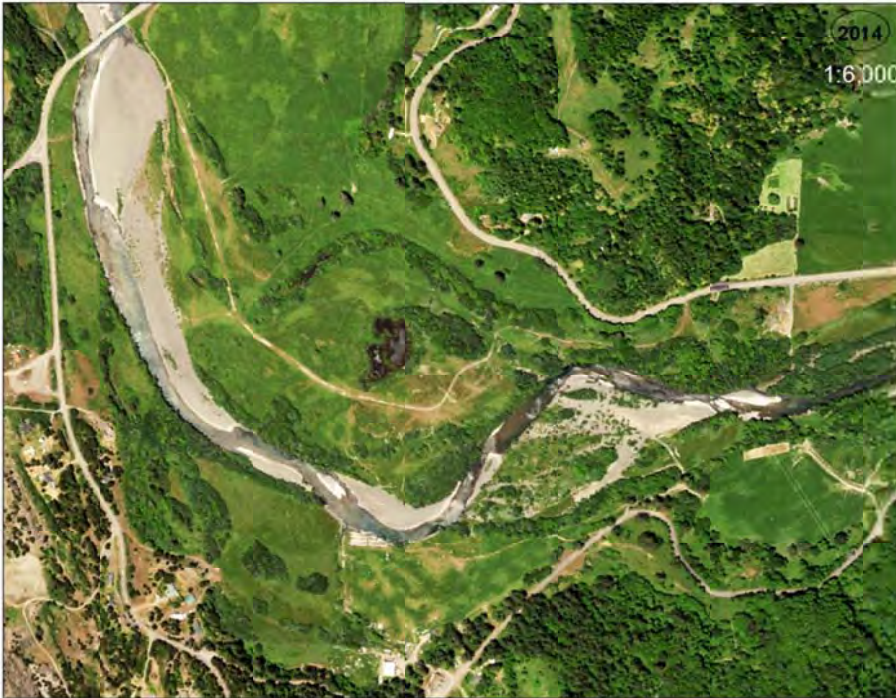
As of 1940, the bridge at Pistol Loop Road had already been constructed and constricted channel width. Upstream, the main channel flowed across the pasture in a large meander on the north side. Today there is a narrow remnant channel along this location (a surveyed HGM wetland). Although the 1951 aerial photo lacks resolution, it is apparent that the northerly jog of the mainstem was abandoned for a broad turn on the southern pasture.

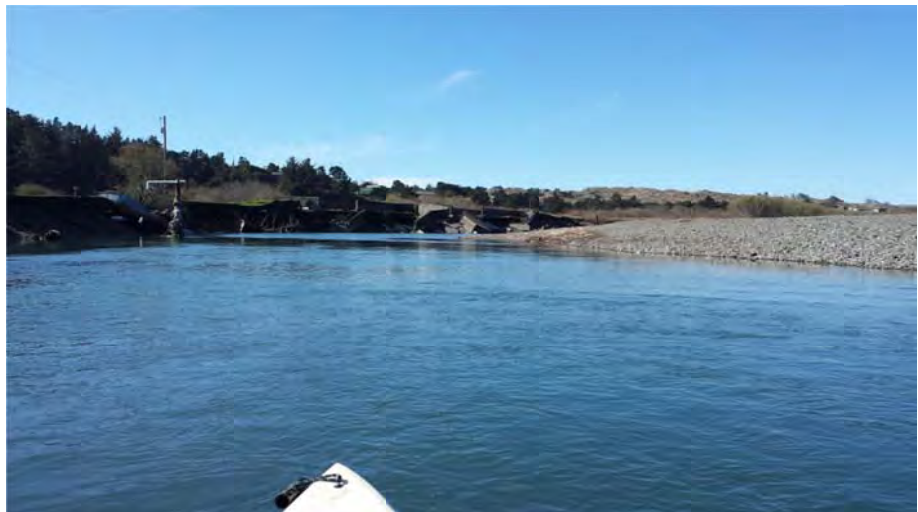
During field surveys along the north bank where an overflow channel cuts into the floodplain, it was observed that construction materials (concrete, rip rap, soil) had been placed to form a plug to prevent the river from flowing into the former channel. Extra flow likely contributes to bank erosion, resulting in old fish hatchery structures dropping into channel (photo to the right). Higher water surface elevations probably also explain the active deposition of a gravel/cobble bar over the south bank.

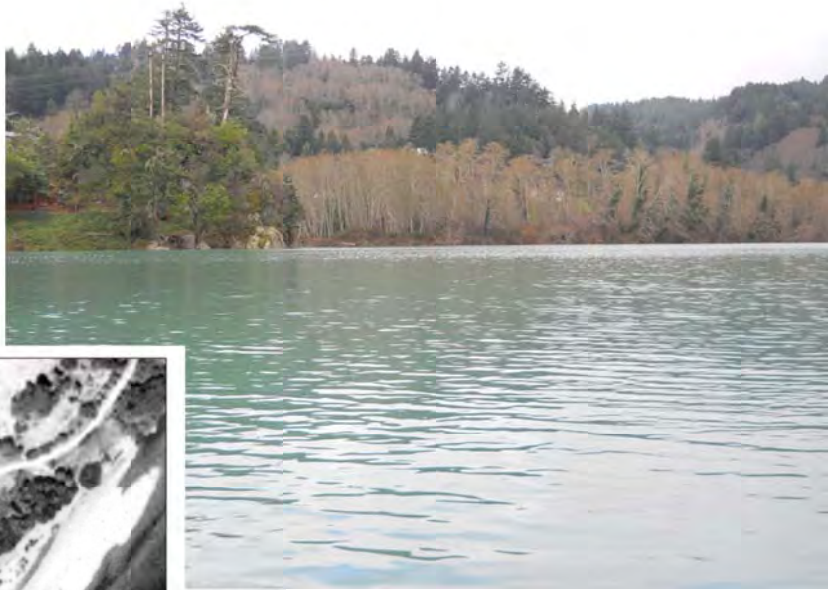
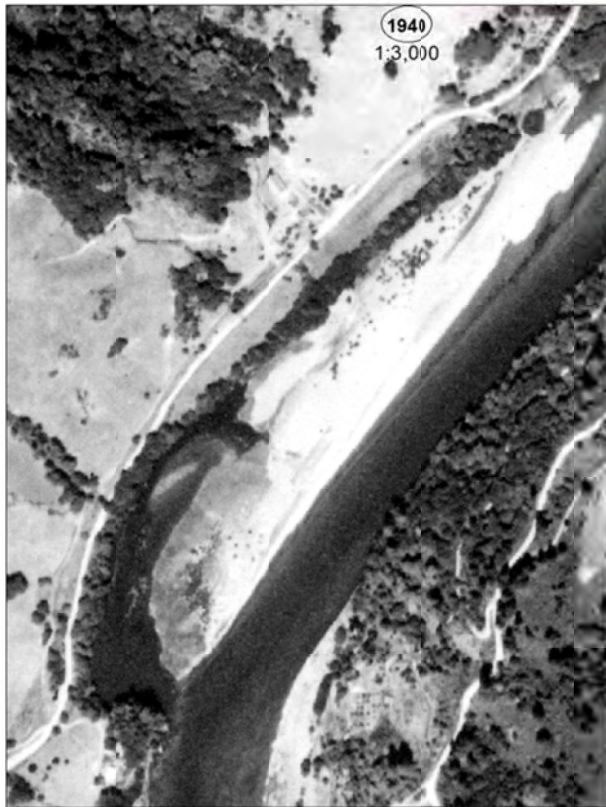
The bar at the mouth of Ferry Creek was more active in 1940 (below), appearing to be occupied regularly by the Chetco River and with side-channel flow scouring against the north bank. This is the process that maintained Snug Harbor, an alcove upstream of a rock on the north bank (right).

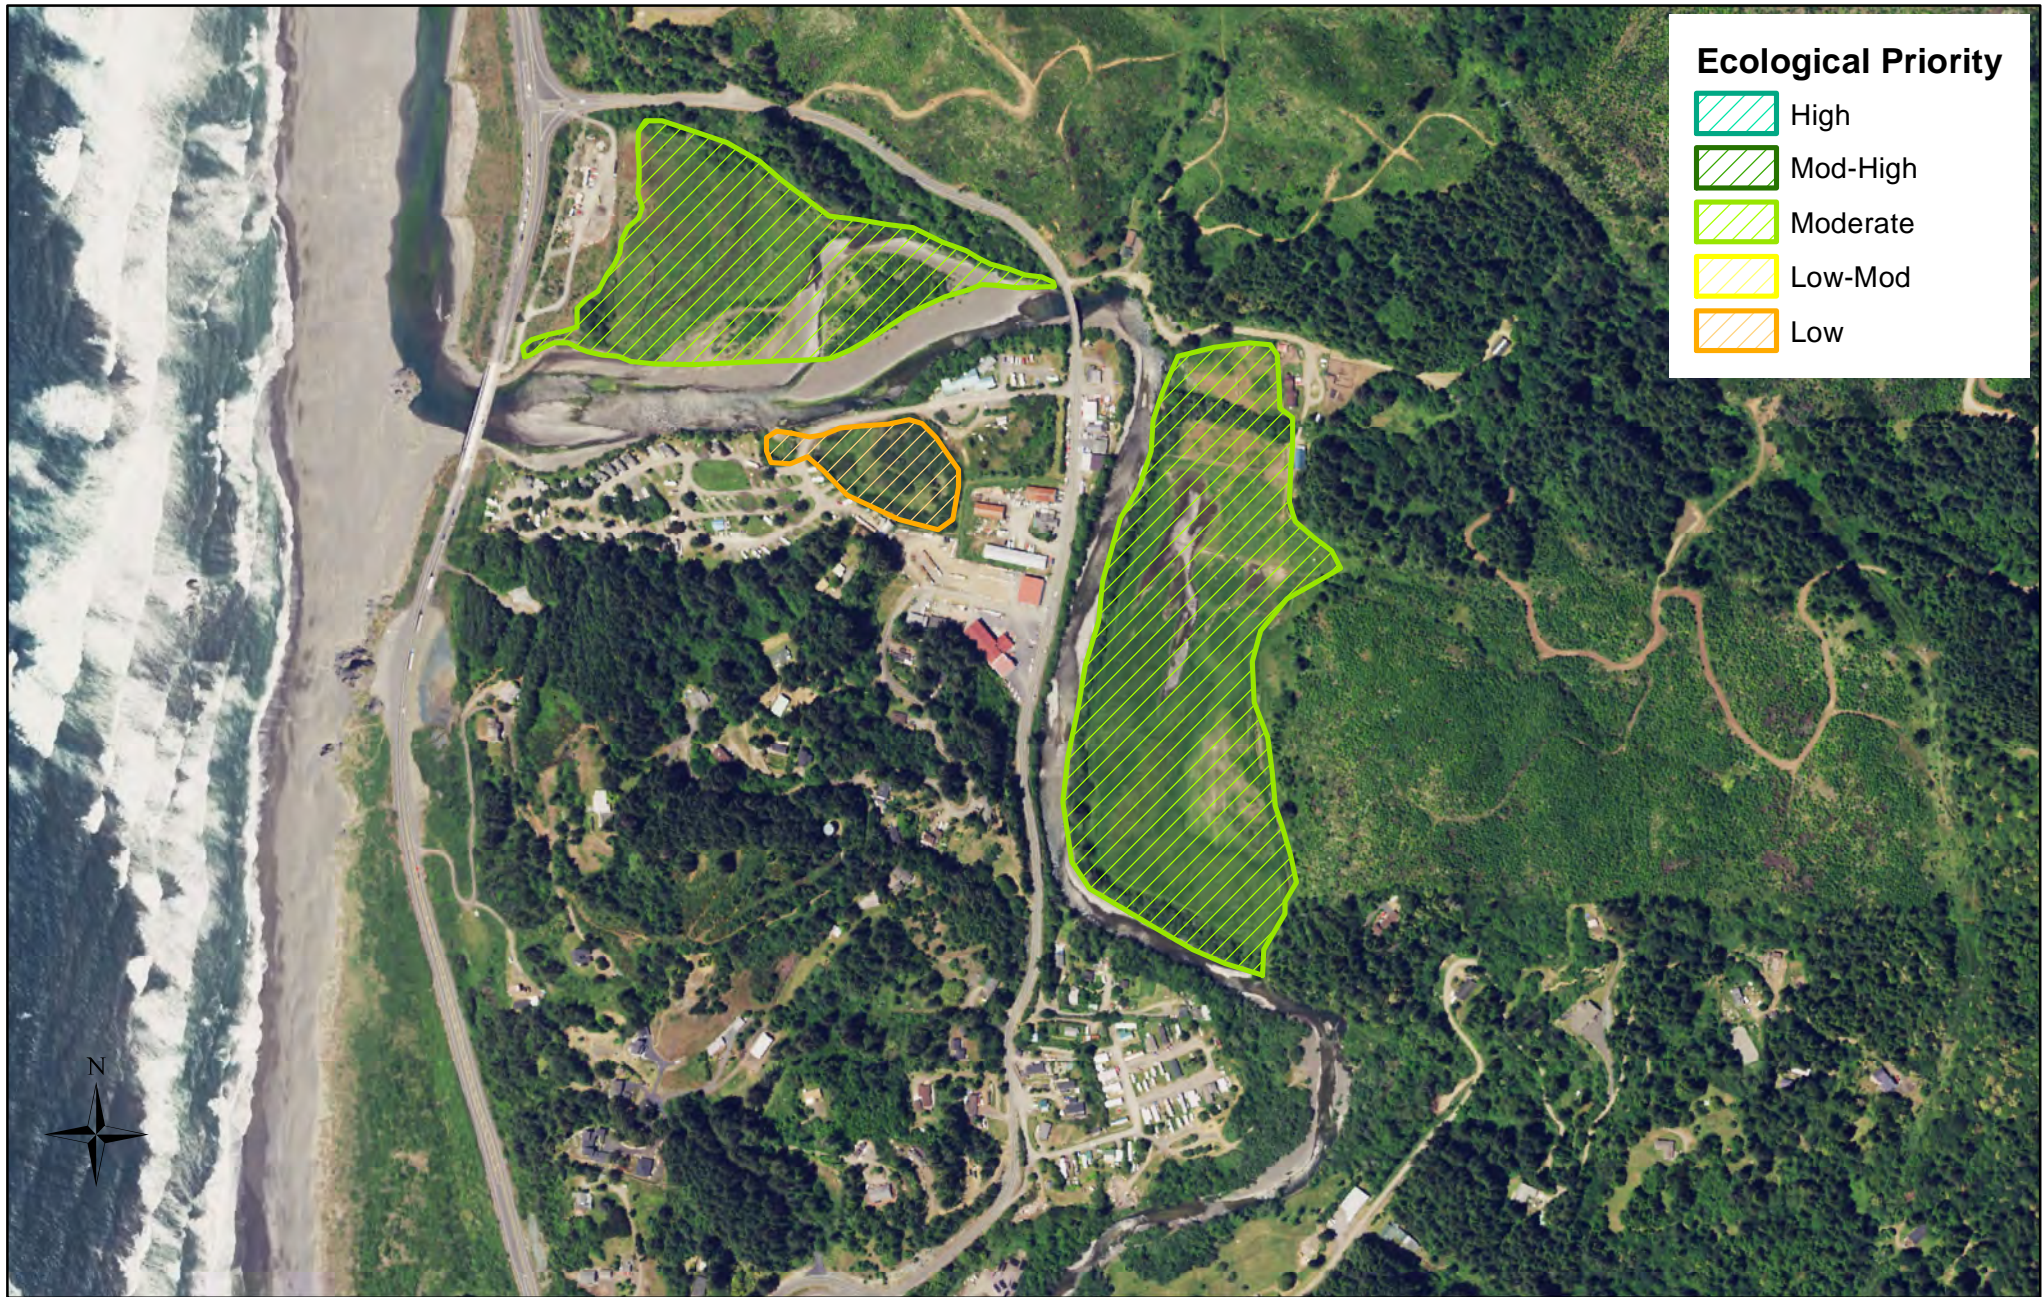
Figure 9: Ecological Priority for Hunter Creek Tidal Wetlands

The six Ecological Criteria were proportionally converted to a 1-5 scale and summed. Since the tidal channel condition score is doubled, the ecological scores can range from 7 to 35. South Coast tidal wetland ecological scores range from 13.5 to 25.0 (table 1). In order to map sites by ecological priority, natural breaks were used to separate the ranks (Figures 9-12).

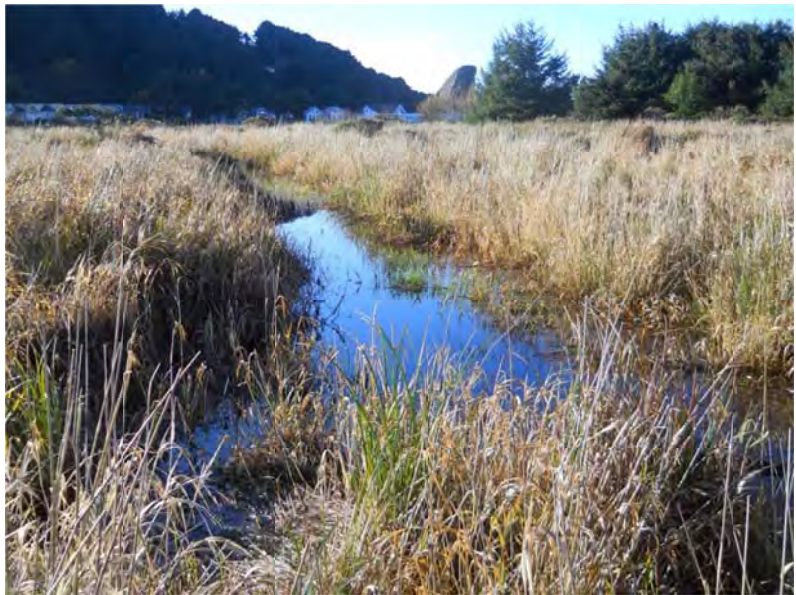
Transect 2 (Quadrats #11-#20) begins at the fence and crosses the largest tidally influenced ditched channel (shown to the right during December 2012 King Tide), ending at an open area composed of sandy soils. The total distance was 55 meters, spaced at five meters between plots. This transect was more uniformly vegetated, except for plots in the ditch channel. Sixteen species were identified on this transect, and only five species exceeded 5% cover, including 39% cover of *Phalaris arundinacea* (present in all plots, ranging from 7-73% cover). *Potentilla anserina* (15%), *Eleocharis palustris* (13%) and *Juncus balticus* (12%), all perennial native obligate or FACW species, covered 40% of plots.

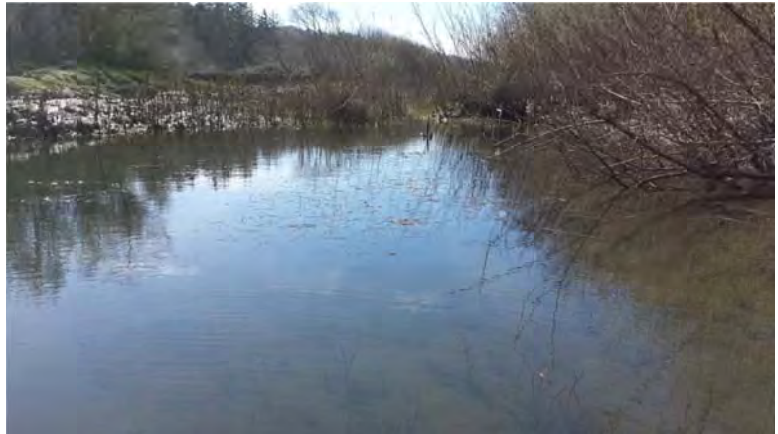
Most of the quadrats were located across a shallow pond on the downstream end of an overflow channel (right). This wetland is located upstream of tidal influence (based on observations during a King Tide).

Another set of quadrats cross a former channel of Pistol River (evident in the 1940's historic aerial photographs). The transect location may be tidally influenced

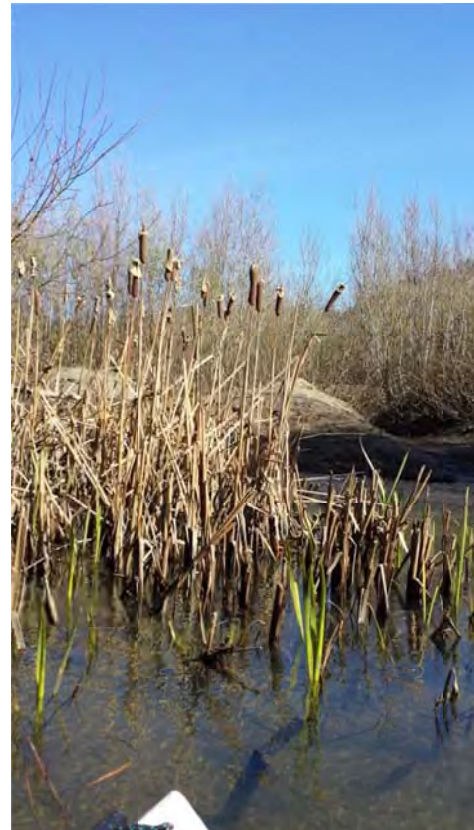
Transect 1 (Quadrats #1-#17) is actually a series of three transects across a scour pond in an overflow channel of Pistol River. Quadrats #1-#4 cross the upstream end of the pond, quadrats #5-#10 cross the downstream end, and quadrats #11-17 cross an alcove adjacent to the river on the downstream-most end of the overflow channel. This transect was spaced with one meter between each plot, for a total distance of 32 meters. *Eleocharis palustris* (common spikerush) dominated this transect, at 43% overall (but ranging from 0-100% in each plot). Patches of *Salix spp* (willow) covered 15%, with individual plots up to 40%. A patch of *Typha latifolia* (broadleaf cattail), was concentrated at the upstream end of the scour pond (up to 86% cover, right)

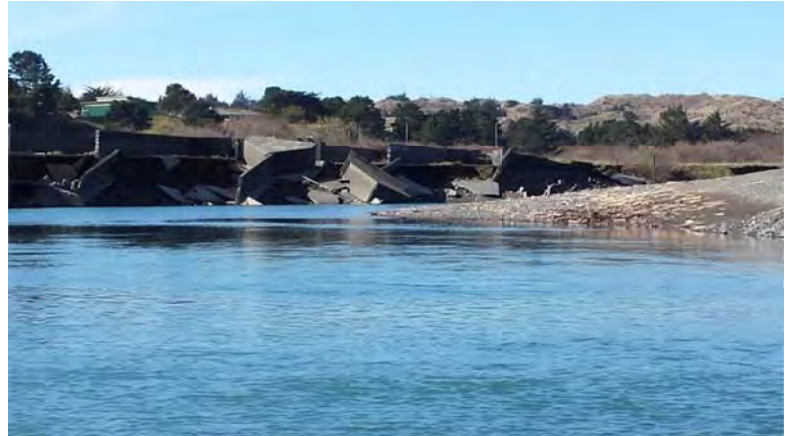
- Treat non-native species, particularly bull thistle, Canadian thistle, scotch broom, tansy ragwort, and Himalayan blackberry. Although *Crocsmia* is not on priority weeds list, it is an introduced species that persists and spreads, often from old gardens.
- Vegetate “upland” or buffer with native shrubs and trees, including Oregon ash, Sitka spruce, and red alder.
- Investigate hillslope drainage and provide technical assistance for wetland reserves on spruce swamp in wall base locations.
- Investigate the effects of a constructed barrier at the head of an overflow channel on erosion on opposite bank of Pistol River.
- Address effects of old fish hatchery facility falling into Pistol River due to bank erosion (right).

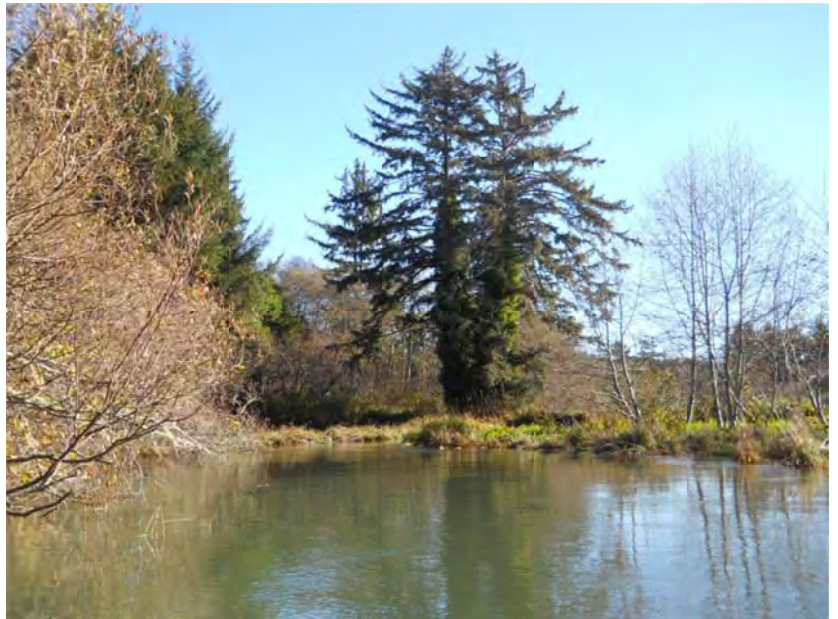
begins at the Winchuck River bank and continues across the widest part of the island, toward the large spruce west of the home located upslope. *Deschampsia caespitosa* dominates the first two quadrats, and then again on the last quadrat in the slough (shown to the right). Overall, *Crocoshmia* covers 33% of the transect, although four of the plots do not contain the wetland indicator species, *Potentilla*. Excluding these plots from the transect, the wetland is covered primarily by 27% *Deschampsia*, 22% *Schedonorus*, 19% *Crocoshmia*, 13% *Potentilla*, and 9% *Lotus*.

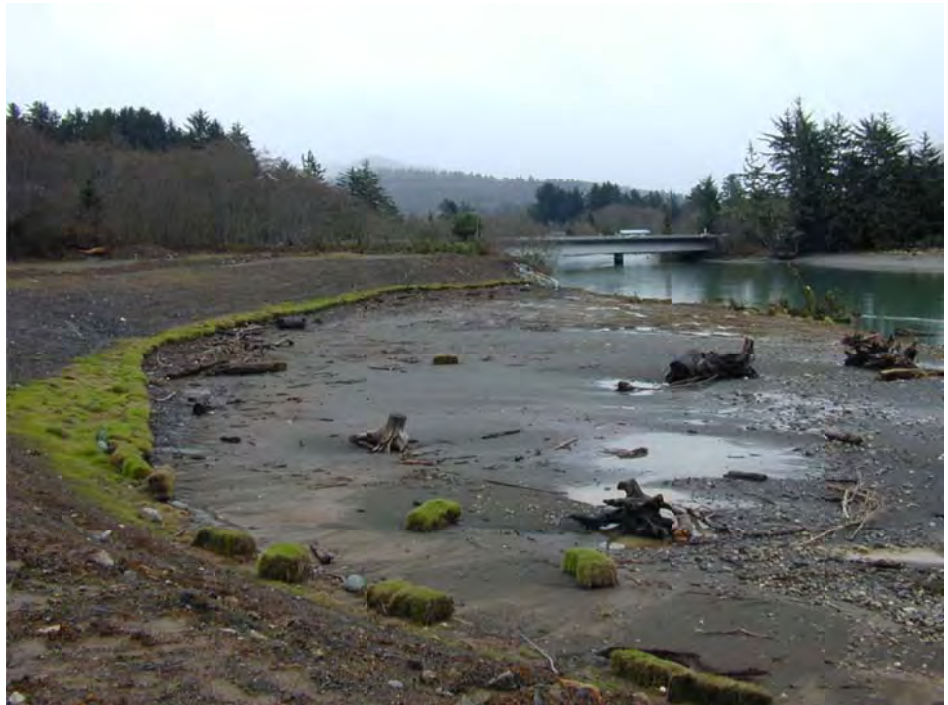
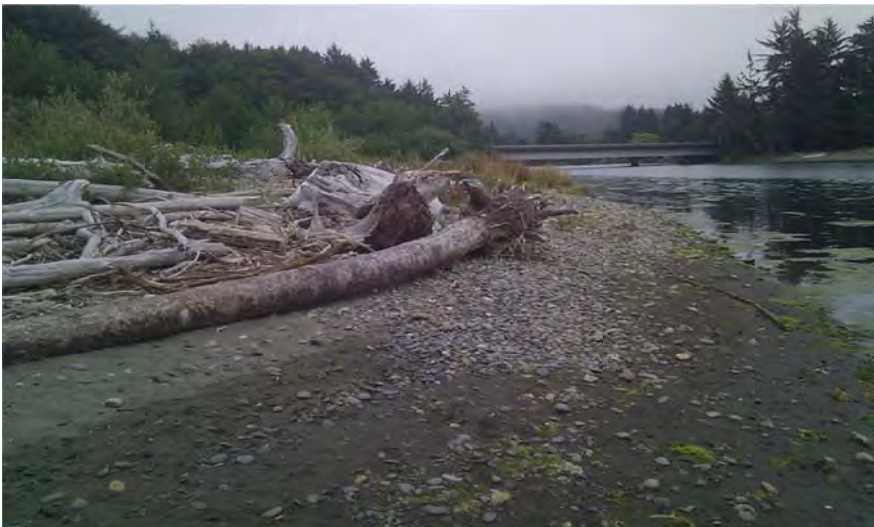
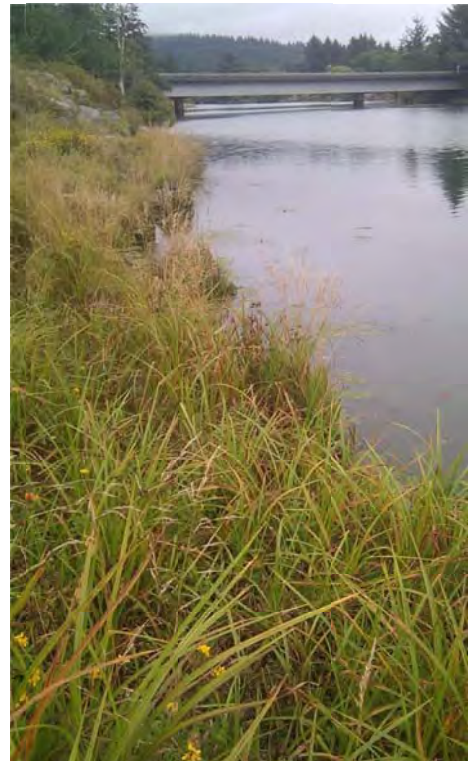
This wetland was created in 2001 by excavating a portion of the fill which was deposited here in ~1965, during construction of the Hwy 101 bridge. Photo above right taken in December, 2001 following fill removal (H. Hoogesteger). Photos below taken August 2012.

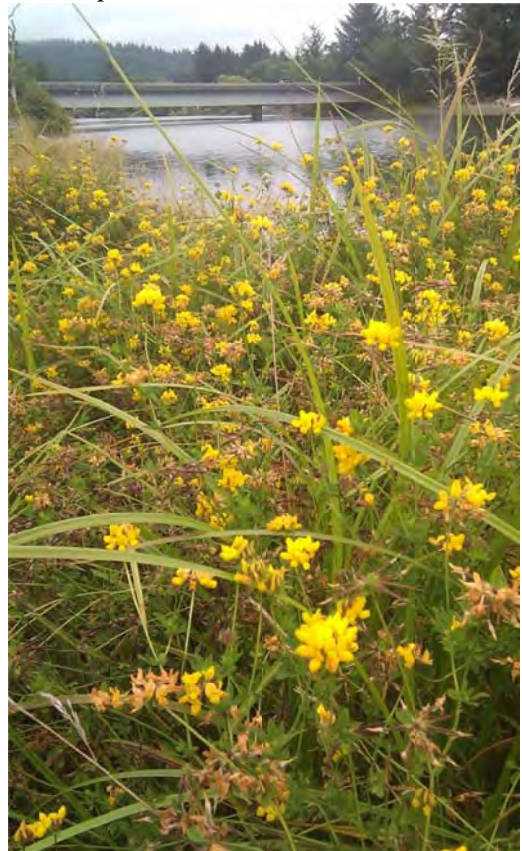
Non-native perennial *Lotus corniculatus* (bird's-foot trefoil) is the dominant cover for the wetland at 39% (photo to the right). Other FAC non-native perennials include grasses: *Holcus lanatus*, *Agrostis stolonifera*, *Schedonorus arundinaceus*, and *Agrostis gigantea* covering 9% of plots. *Trifolium repens* (white clover) and *Parentucellia viscosa* (yellow glandweed) are also FAC non-natives, and have smaller percent cover along with FACU non-natives *Tanacetum vulgare*, *Ammophila arenaria*, *Medicago lupulina*, and *Hypochaeris* spp. *Spergularia salina* (saltmarsh sandspurry), a non-native wetland obligate that is brackish-tolerant, was present.

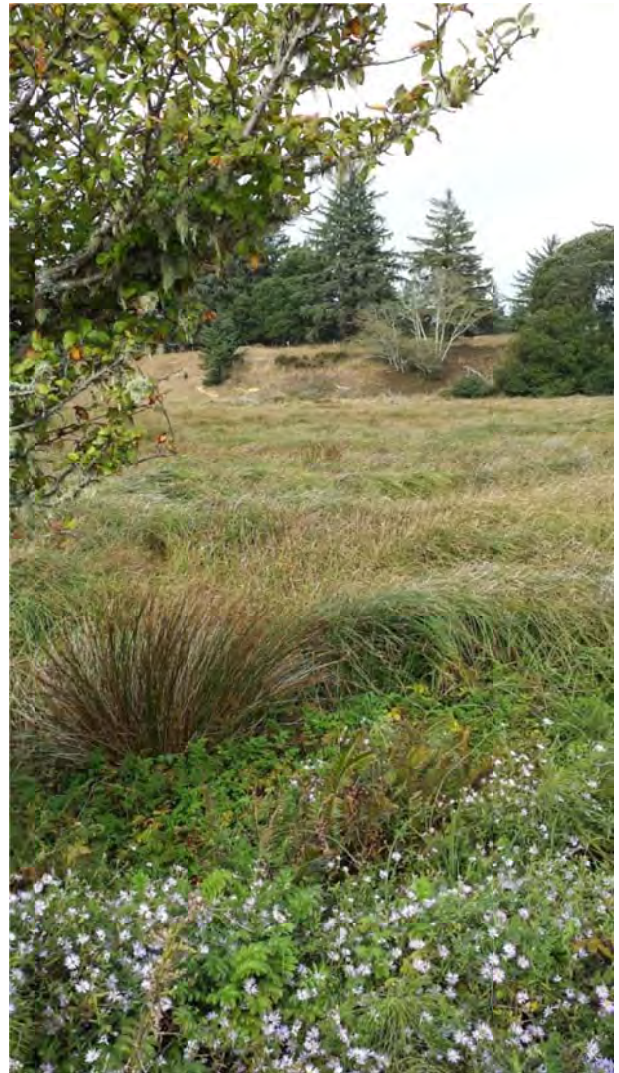
The photo on the right is the view along Transect 2, from the end on Cape Blanco Road to the beginning at the base of the hill. Wetland obligate, *Carex obnupta* dominates most of the quadrats, while *Juncus hesperius* is also abundant. In more open areas, *Oenanthe sarmentosa* comprises up to 35% and *Potentilla anserina* up to 40%. In less than half of the quadrats, *Lotus corniculatus* is present and covers up to 15%.

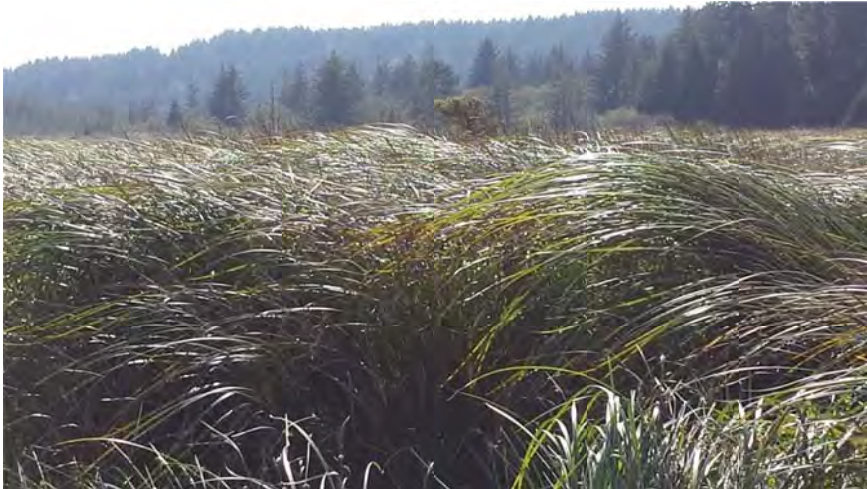
The photo to the left is taken from a quadrat dominated by *Carex obnupta*.

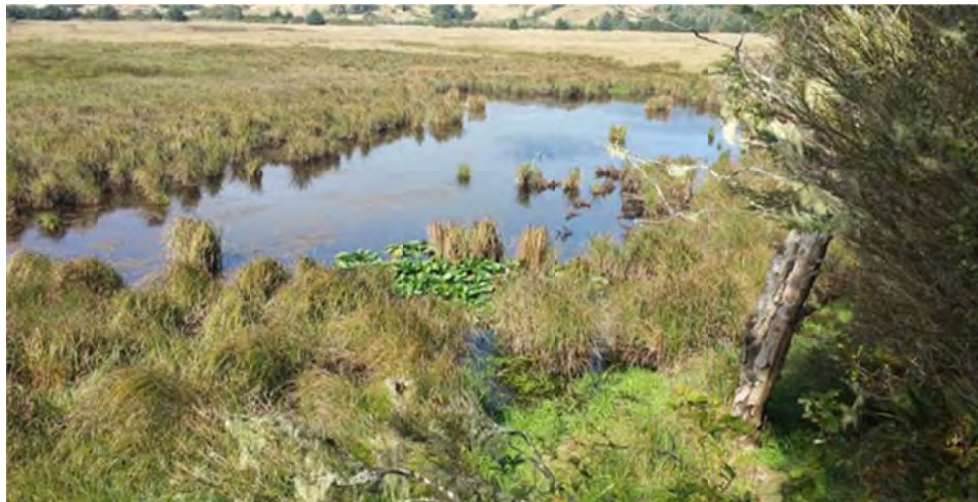
Along the margin of the ponded area to the east of the oxbow, near the hill, both wetland and upland species are in close proximity. Native wetland obligates include *Lysichiton americanus* (skunk cabbage), *Oenanthe sarmentosa* (water parsley), and *Potentilla anserina* (silverweed). Additional observations and plant collections would be required to determine whether the bur reed, *Sparganium*, is the native *S. eurycarpum* (broadfruit bur reed) or the introduced *S. emersum* (European bur reed). Also to be determined is whether the *Persicaria spp* (smartweed) is native, among 5-7 species in Curry County. From a distance, the pond lily (shown in the photo below) was tentatively identified as the invasive *Nuphar lutea*.

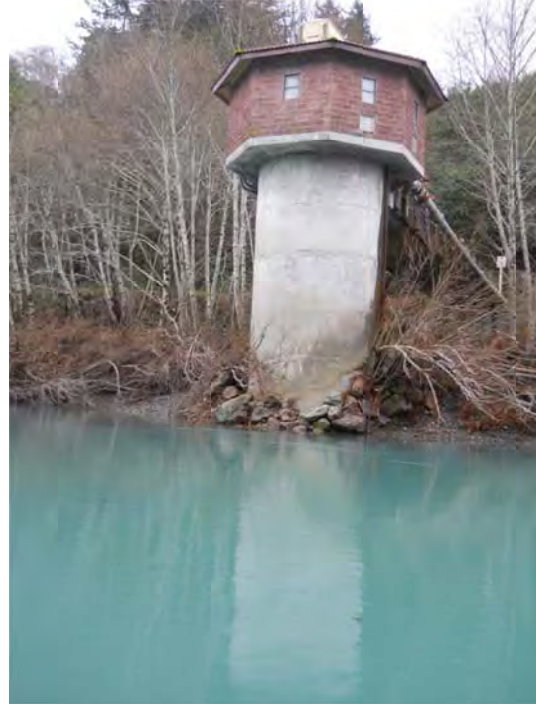
Past episodes of salinity intrusion at former City of Brookings drinking water (DW) intake, resulted in relocating the intake from river mile 3.1 to 5.4 in 1989 (HGM, 2007 Water Systems Master Plan Update). During high tides in late summer, the upstream extent of salinity has penetrated as far upstream as the Harbor Water P.U.D. drinking water intake on the south bank at river mile 3.35 (shown at right). During the summers of 2014 and 2015, drinking water was periodically contaminated.

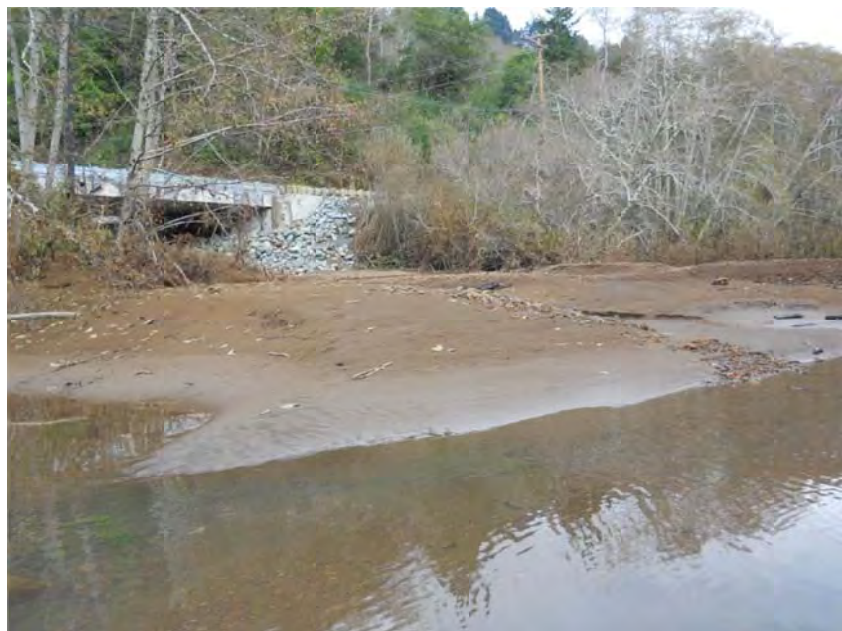
To the right: mouth of Joe Hall Creek (RM 2.2) photographed on 12/14/12 after an 8.7 foot high King Tide. Discharge at the USGS Chetco River gage was 2,080 cfs.

Tidal exchange is also lacking at the mouth of Ferry Creek.

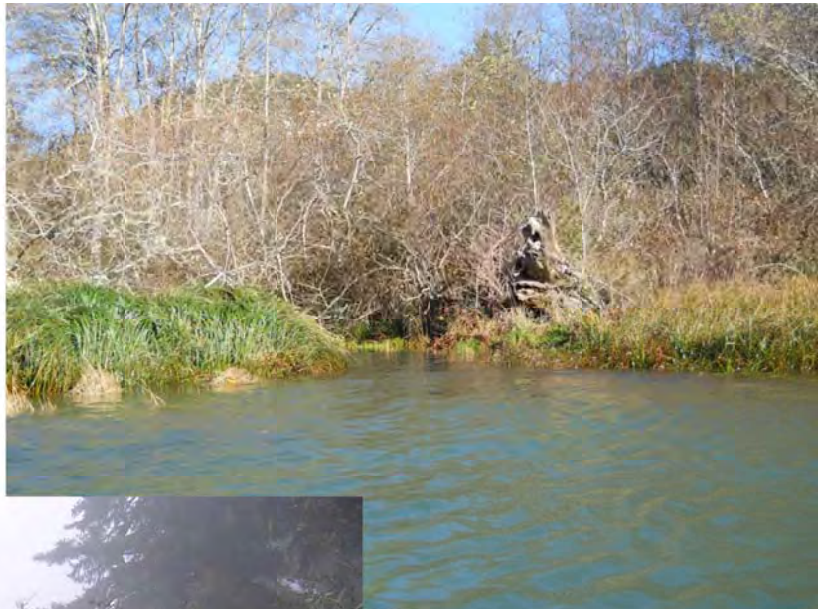
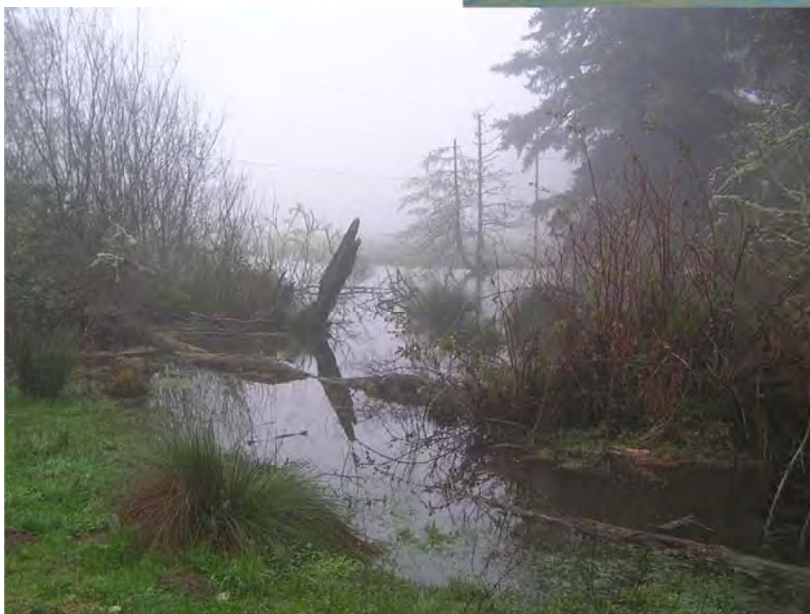
Tidal exchange with mouth of the tributary flowing on the east margin of Winchuck Wayside State Park (RM 0.27) was photographed on 12/13/12 after an 8.8 foot-high King Tide. Discharge at the USGS Chetco River gage was 2,330 cfs.

tributary (where the livestock bridge was later installed) was inundated when the photo above was taken on 12/4/2007, at a discharge of 17,200 cfs at the USGS Chetco River gage.
