Calapooia Watershed Fish Passage Assessment

February 2004

*BioSystems
&
Alsea Geospatial*

For the
The Calapooia Watershed Council

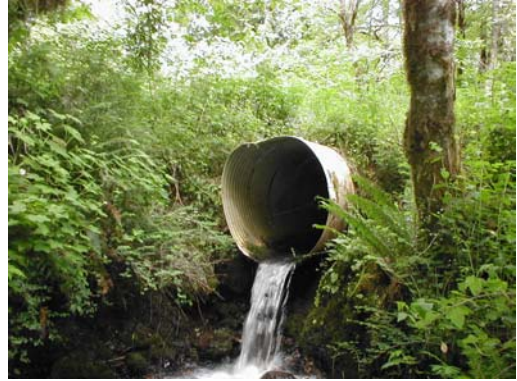
Photo 1. Outlet drop from a culvert located in the headwaters of Brush Creek. This outlet drop is greater than the jumping ability of fish.

Culverts commonly block fish passage by creating high water velocities within the culvert and creating a significant drop at their outlet. At the outlet of culverts, the stream bed is scoured, creating a pool (outlet pool) and a drop from the culvert (Photo 1). In addition, the slope of the culvert contributes significantly to increasing stream velocities, often producing currents greater than a fish's ability to swim (Photo 2).

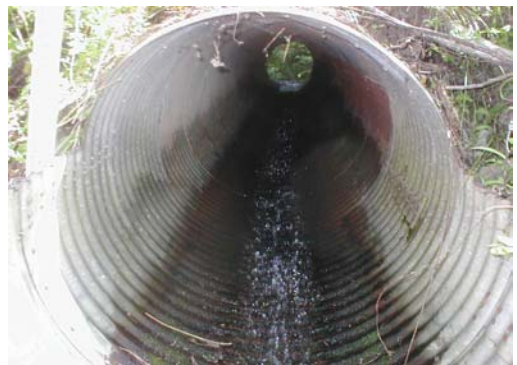
Photo 2. The inlet to a culvert located in the headwaters of Courtney Creek. This culvert has a steep gradient (12%) and shallow water that prevent fish passage.

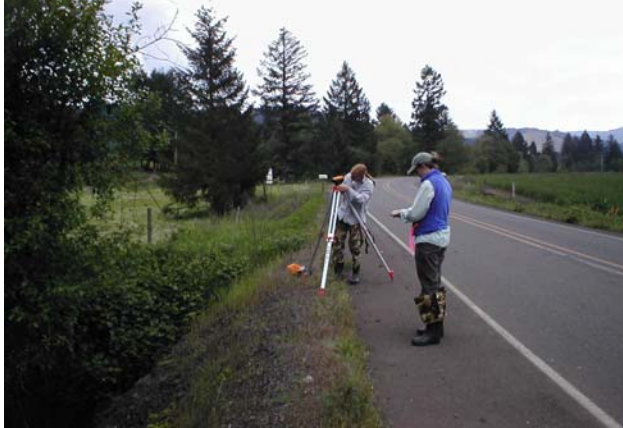
Photo 3. Culvert 435B where Brush Creek Road crosses West Fork Brush Creek. Setting up the transit for the field survey and recording location information with the GPS.

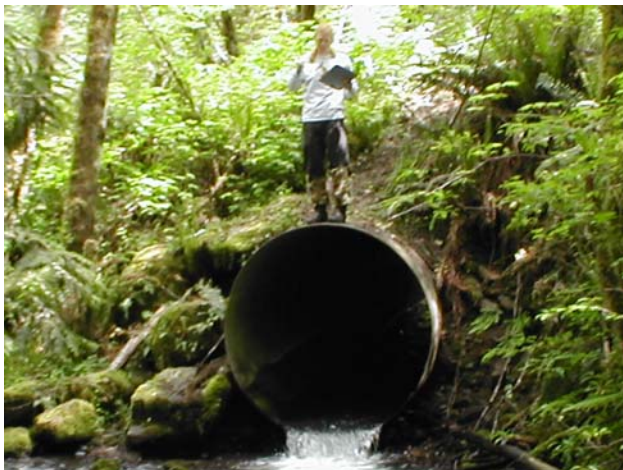
Photo 4. Culvert 323 in the headwaters of Brush Creek. Below the culvert outlet collecting maximum scour pool depth measurements.

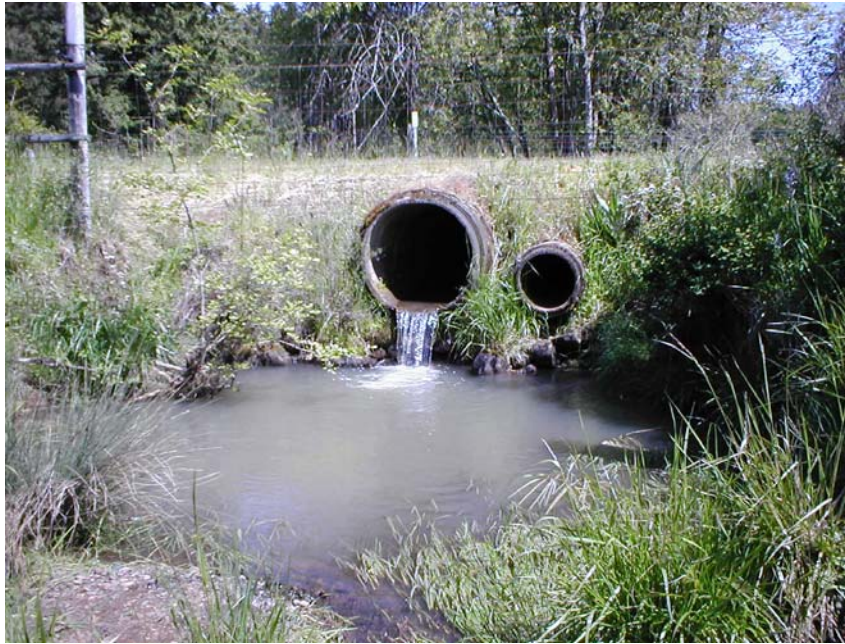
Photo 6. Culvert 203, located where Crawfordsville Drive crosses an unnamed tributary that flows directly into the Calapooia River from the north. This is an example of a highest priority culvert: stream gradient is 1.5%, bankfull width is 14 feet, jump height is ~1.5 feet, and culvert gradient is 1.0%.

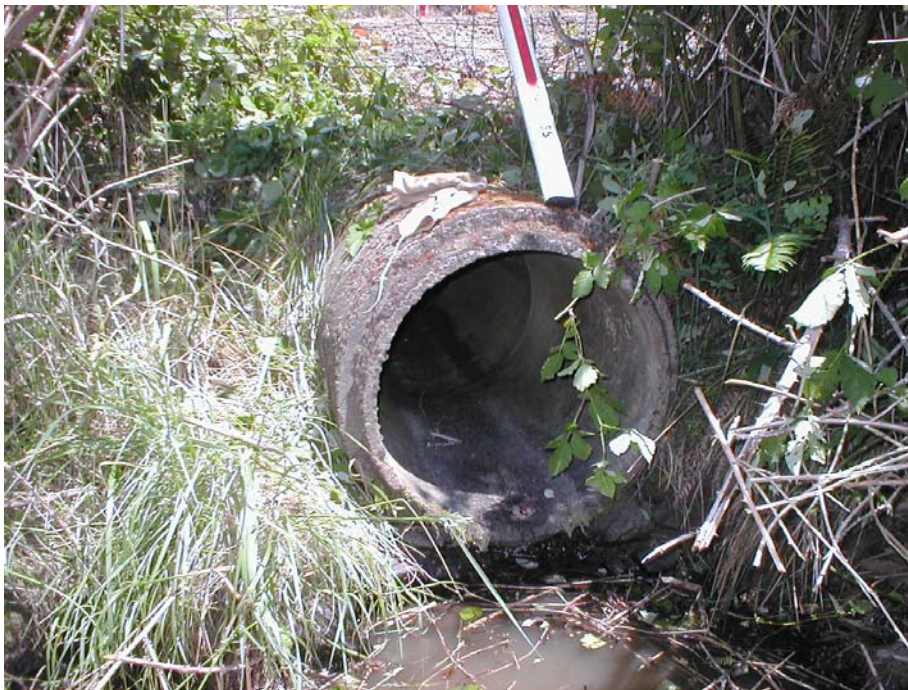
Photo 7. Culvert 54, located where Northern Drive crosses a tributary to the Calapooia River from the north. This is an example of a high priority culvert: stream gradient is 0.7%, bankfull width is 7 feet, jump height is 0.7 feet, and culvert gradient is 3.1%.

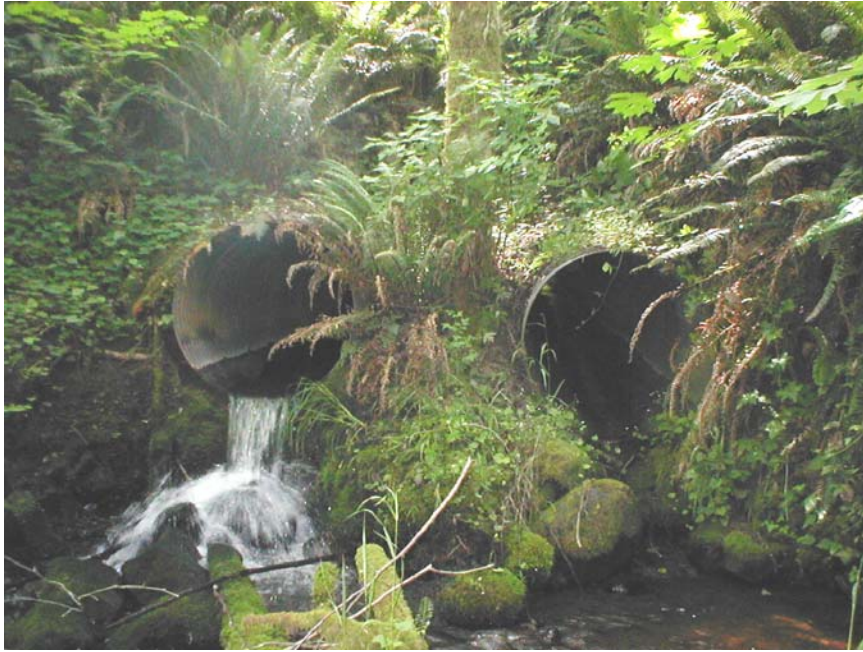
Photo 8. Culvert 412, located in the headwaters of the West Fork Brush Creek. This is an example of a medium priority culvert: the jump height into the outlet (~1.5 feet, culvert gradient is 9.6%, and the drop onto rock for these two culverts would not allow for fish passage, but the location of the crossing in a high gradient part of the watershed (5% stream channel gradient) gives it a lower priority than culverts located in low gradient (4% or less) streams.

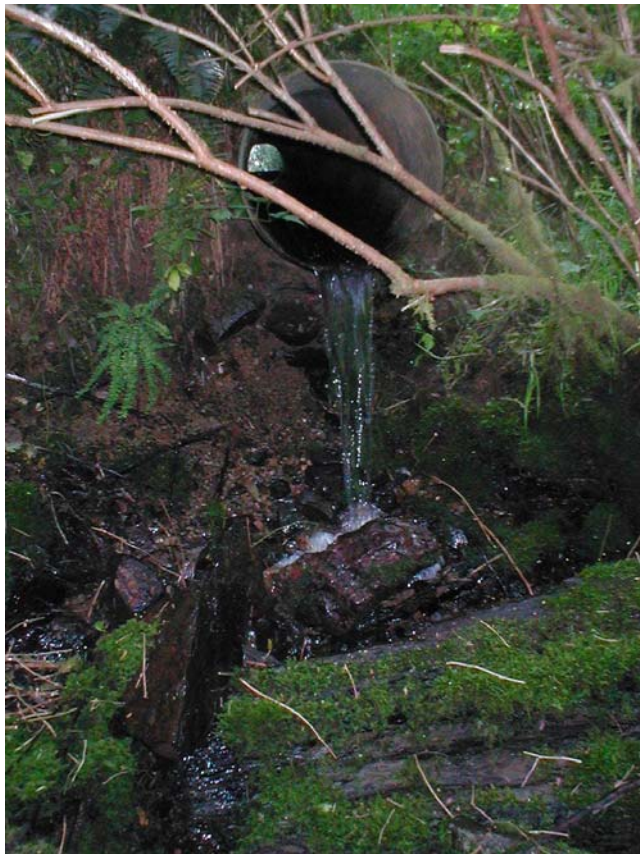
Photo 9. Crossing 382-482, located on a headwater tributary stream to Courtney Creek. This is a low priority culvert: the stream gradient (11%) is very steep and this is probably not a part of the stream used by fish.

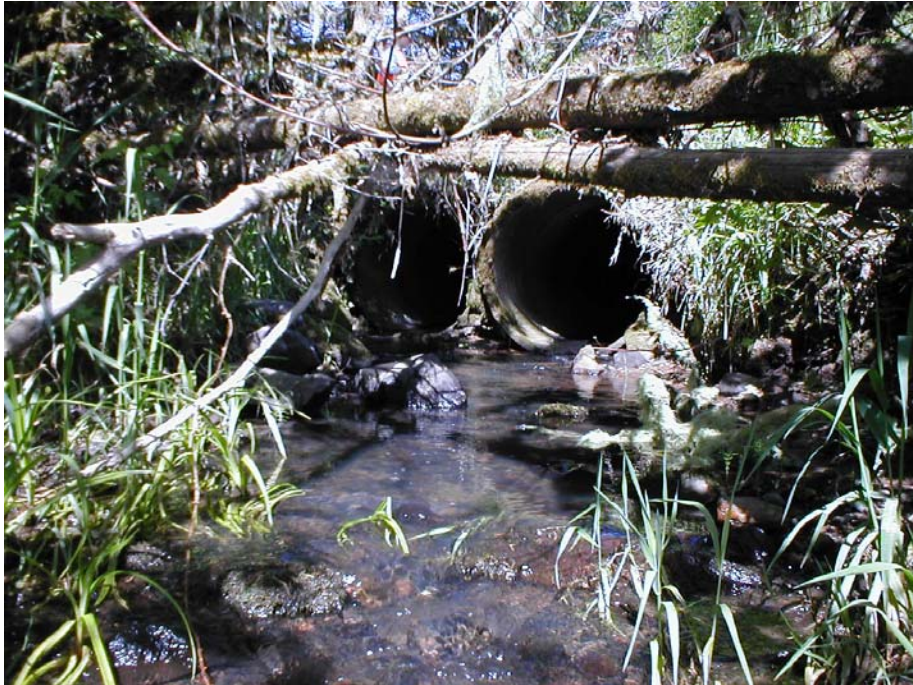
Photo 10. Culvert 12, located on a tributary to Johnson Creek. This is an example of crossing with multiple culverts that both meet ODFW criteria with a culvert gradient of less than 0.5% and a jump height into the culvert of less than 6 inches.

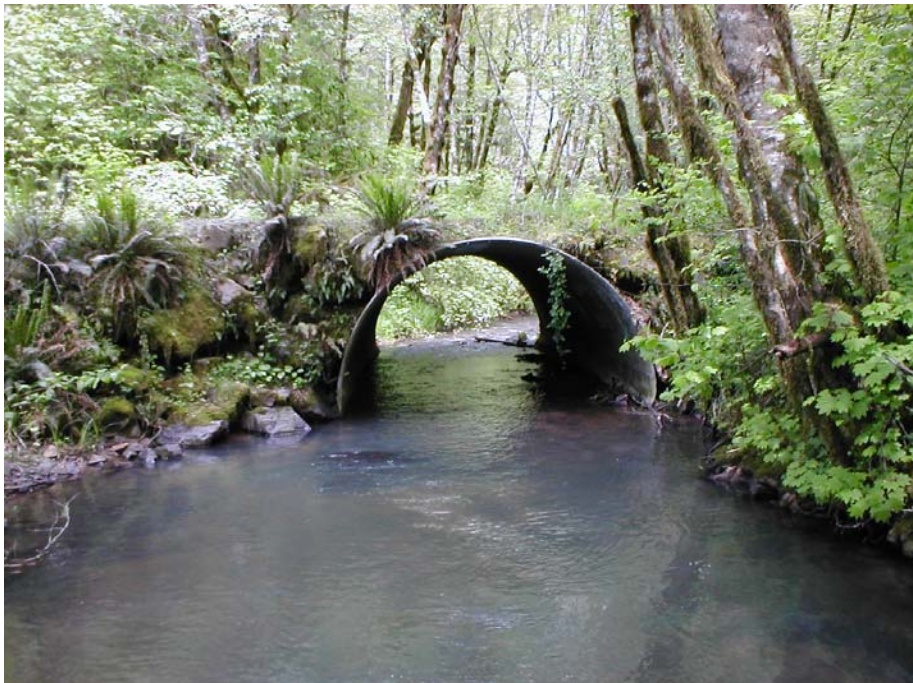
Photo 11. Culvert 323, located on the west fork of Brush Creek. This embedded culvert is an excellent example of a culvert designed to pass juvenile and adult fish. There is no outlet drop and the culvert gradient is the same as the stream channel gradient.
