A WATERSHED ASSESSMENT FOR THE SIUSLAW BASIN

Siuslaw Basin Council

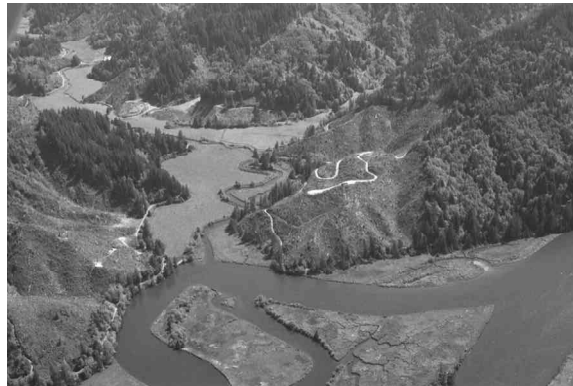
Land-use practices have resulted in a lack of large wood and log jams, keystone elements of healthy aquatic systems in the Siuslaw Sub-basin

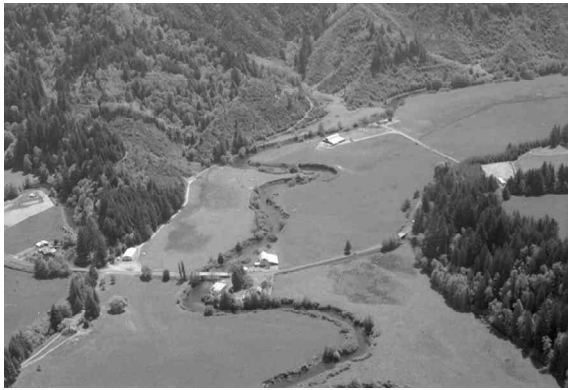
The North Fork illustrates downcut stream, altered wetlands, and lack of riparian cover

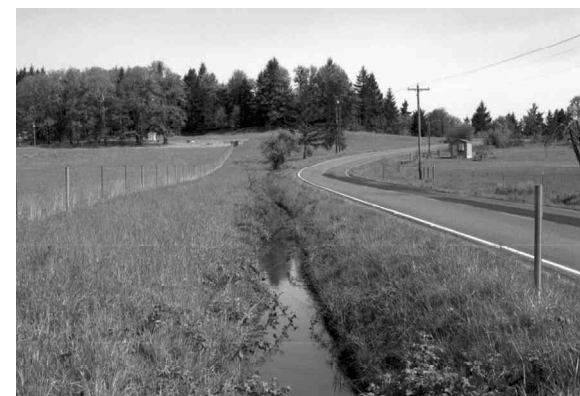
Ditching and draining of valley wetlands may result in lower water quality and reduced summer base flows

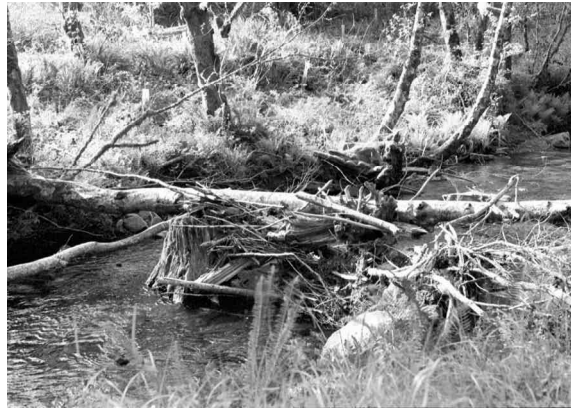
Whitaker Creek in-stream structure & riparian conversion

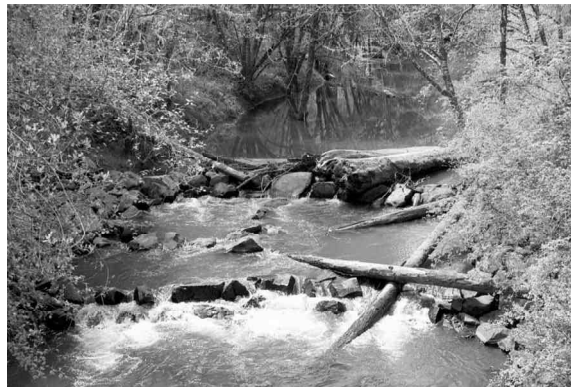
A boulder log stream structure in the upper Siuslaw

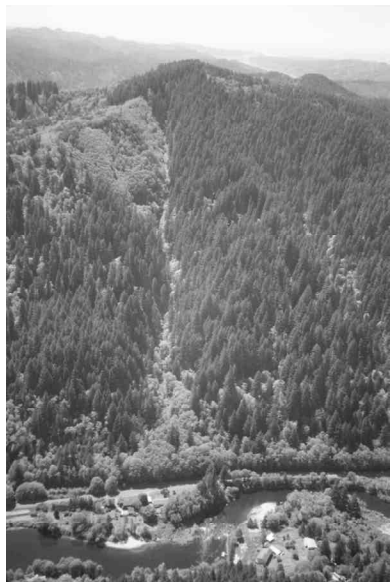
Debris flow tract that delivered to Siusaw River

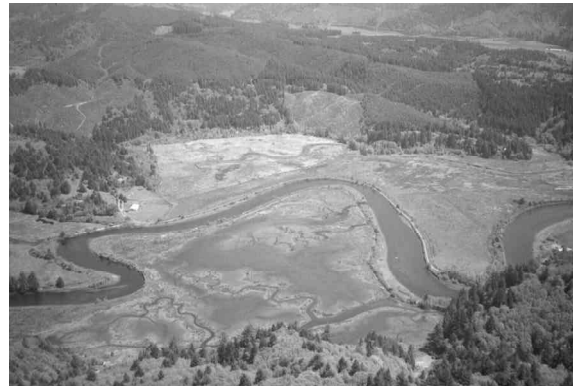
Meandering North Fork with riparian trees removed by land development

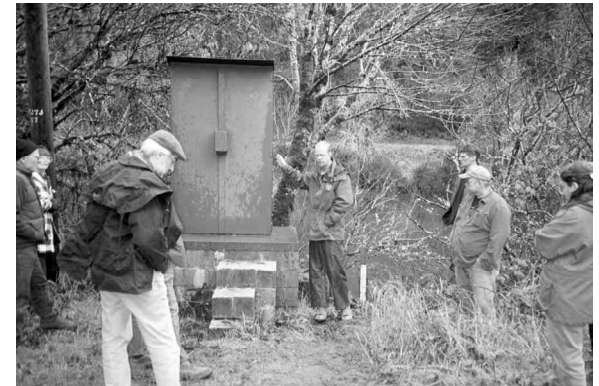
Mapleton gauging station

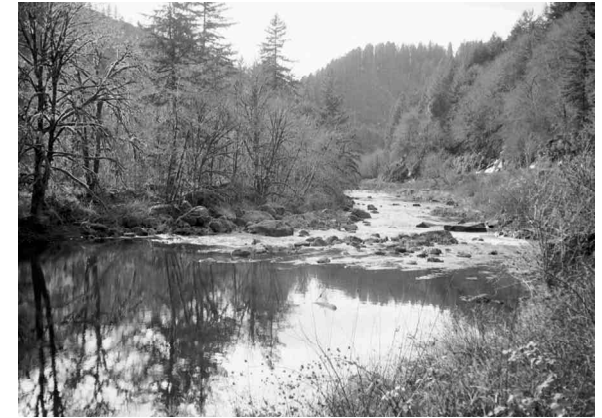
Debris flow riffle

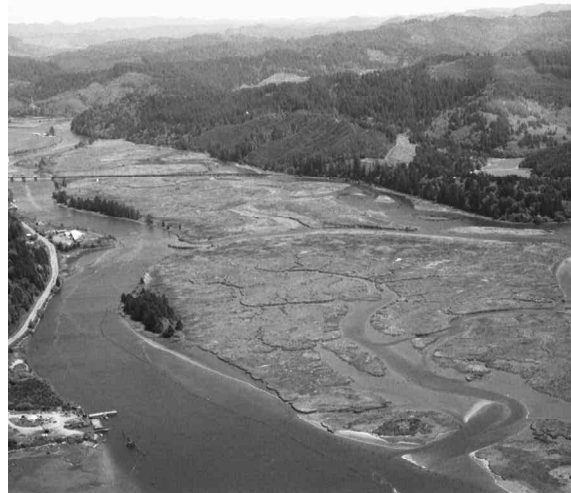
Cox Island is a remnant tidal marsh near the mouth of the North Fork. 60% of tidal marshland has been lost to diking and draining

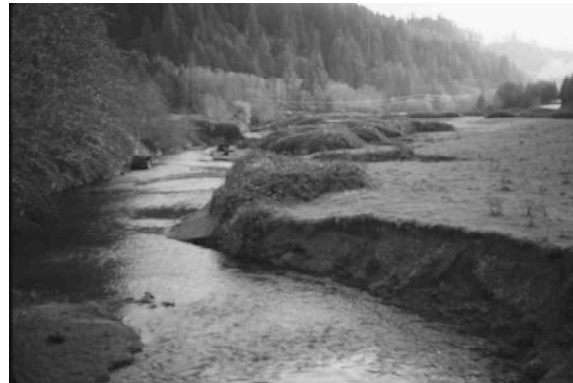
Stream bank erosion

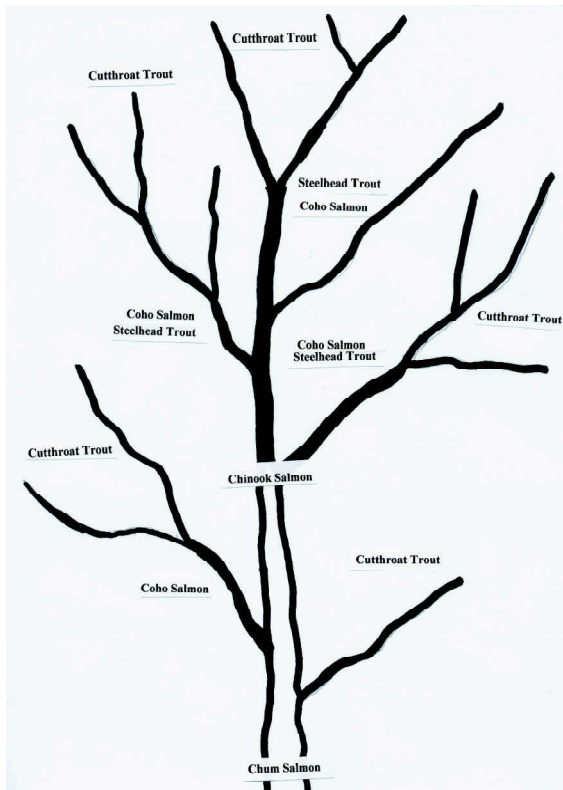
Figure 10.1A: Idealized Distribution of Salmonids

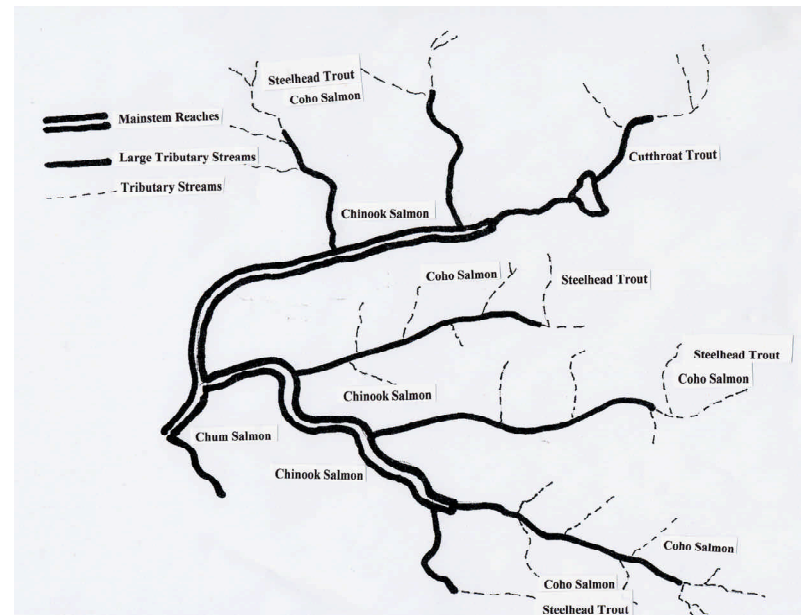
Figure 10.1B: Hypothesized Distribution of Salmonids

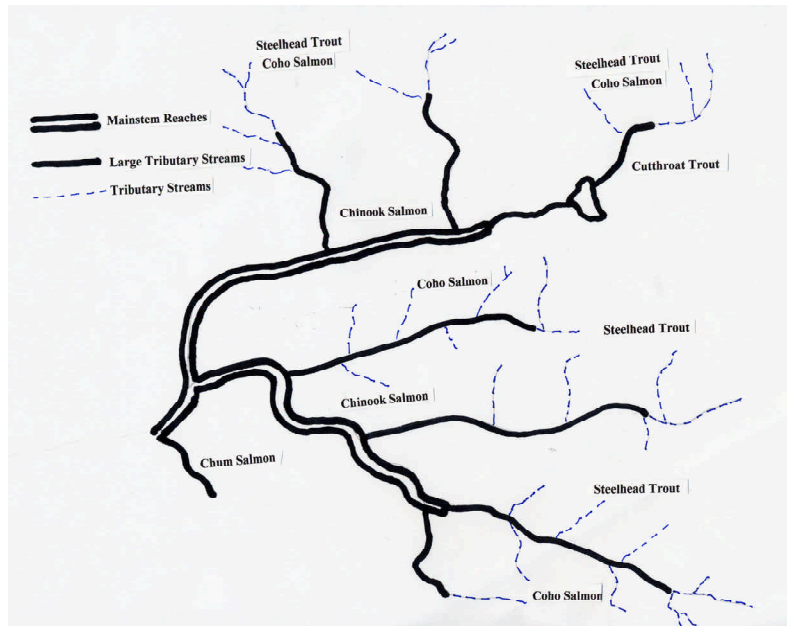
Figure 10.1C: Current Distribution of Salmonids

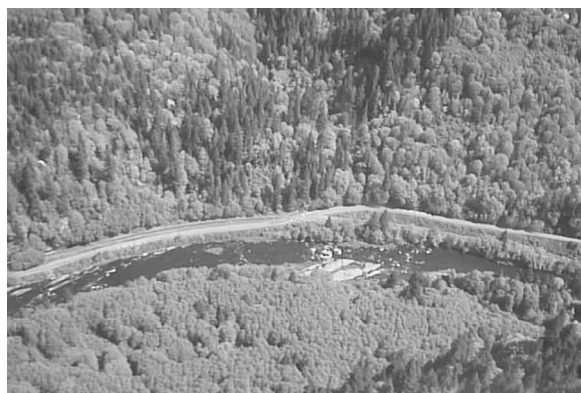
Exposed bedrock

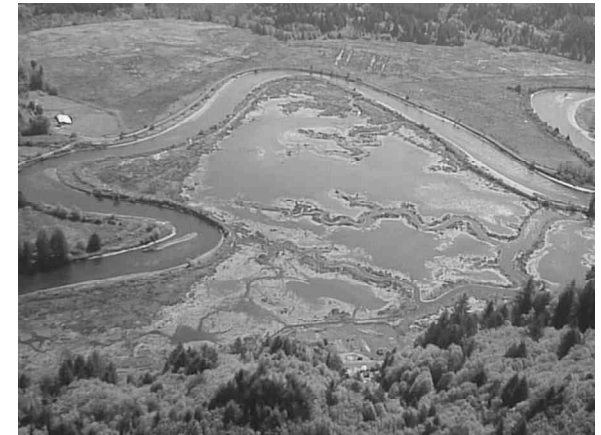
A dike breach at the North Fork
