# **Hay Creek / Scott Canyon Watershed Assessment**

Prepared by the  
Gilliam County Natural Resources Department  
for the  
Hay Creek/Scott Canyon Working Group

June, 2003

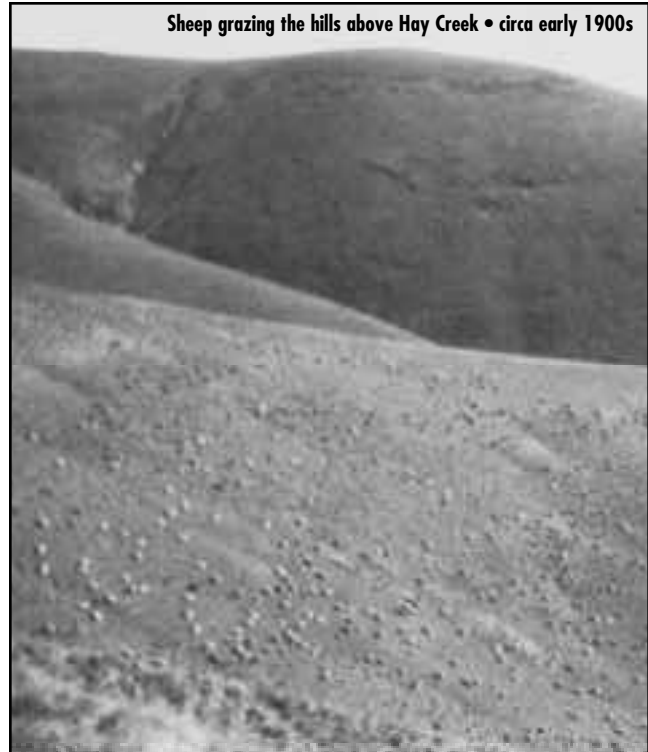
Sheep grazing the hills above Hay Creek • circa early 1900s

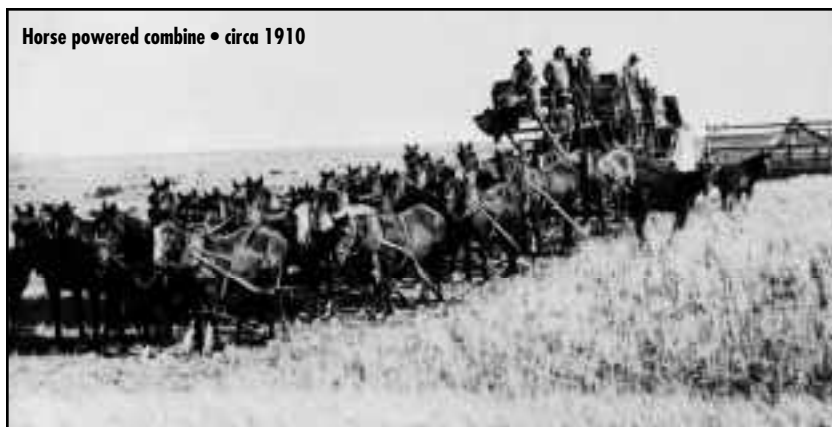
Horse powered combine • circa 1910

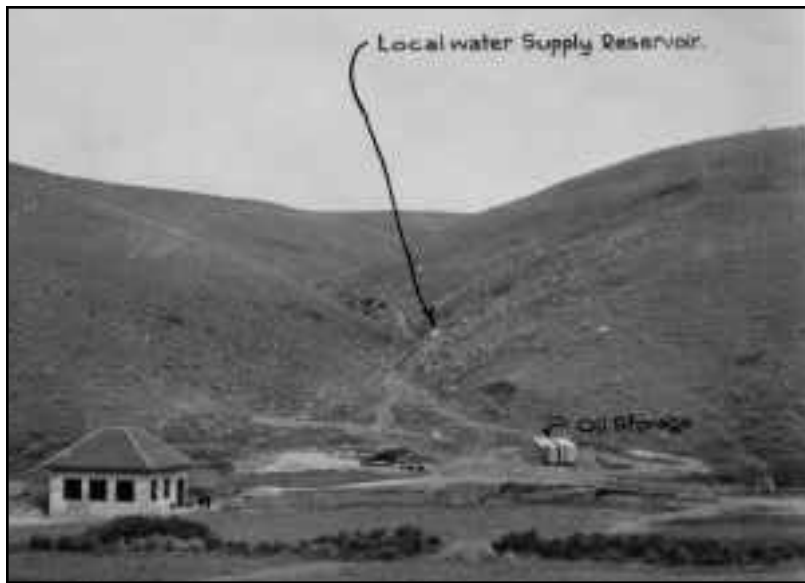
collecting and storing the water flowing from the springs which form the headwaters of Hay Creek; a pumping plant and a pipe line from the source to the city reservoirs. Tile was laid below the bed of Hay Creek at a depth varying from 6 to 12 feet. A reinforced concrete reservoir, having a capacity of 109,000 gallons received and stored the flow from the tile. This reservoir was

built across the streambed also acting as a dam. The capacity of the plant was 155 gallons a minute. The measured flow at the Hay Creek Springs before development of the supply (September 10, 1921) showed a minimum of about 127,000 gallons per day. When flow was measured into the reservoir on May 18, 1923, it was 143 gallons per minute or about 206,000 gallons per day. 1927 saw another well drilled to 65 feet and had pumping equipment capacity of 100 gpm. In 1976 five wells were registered with the water board for use at the Condon water supply. The amount of water claimed was 415 gallons per minute, being 69 gpm from #1; 90 gpm from #2; 75 gpm from #3; 60 gpm from #4; 130 gpm from #5. In 1999 an application for a change in point of diversion at the Condon Water Supply at Hay Creek was submitted. Three shallow wells were drilled ranging in depth of 43.5 feet to 103 feet. Wells tested at 90 gpm; 50 gpm; and 107.5 gpm respectively. Temperature of water during pumping testing was between 55 and 59 degrees.

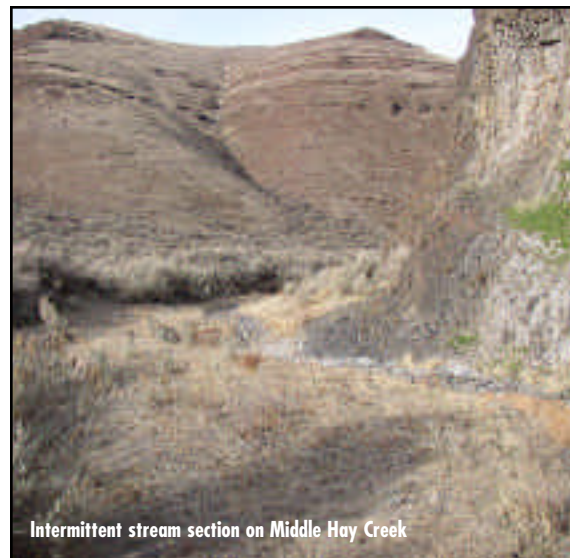
Sections of the Hay Creek stream system were documented during field studies going underground during certain times of the year. Two sections in middle Hay Creek total just under a mile (.95) and one section on upper Hay Creek went underground approx. 1/8 of a mile (.18). The field observations were noted mid-December, 2001.

Intermittent stream section on Middle Hay Creek

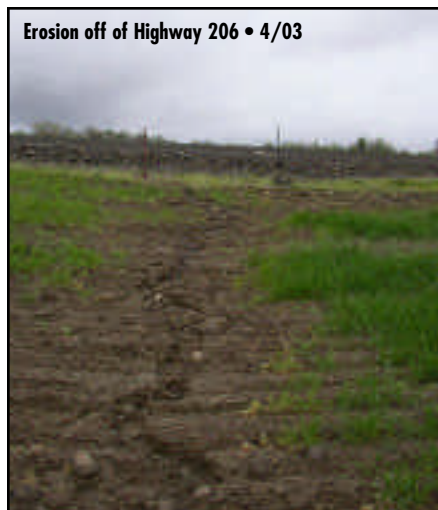
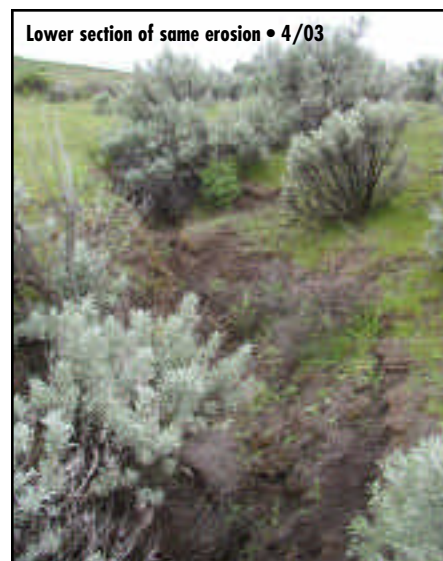
The State of Oregon Department of Transportation did not have a culvert survey for the stretch of highways bordering the watershed. However, while doing some upland field studies it was noted that runoff from Highway 206 had contributed to severe gullies through CRP and ungrazed grass areas.

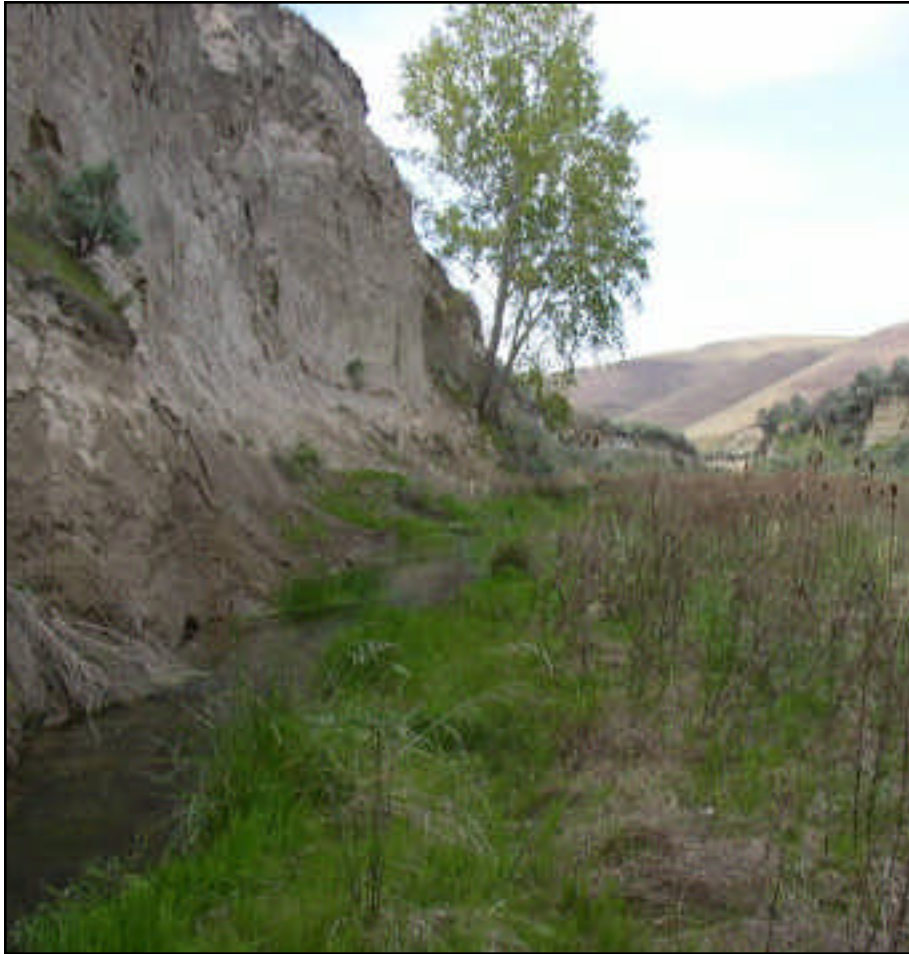
**Left: Section of Lower Hay Creek that is in CREP. This photo is at the same location as the photo on page 35, but this photo was taken on 4/03.**
