# Rickreall Watershed Assessment

January 25, 2001

Prepared for

**The Rickreall Watershed Council**

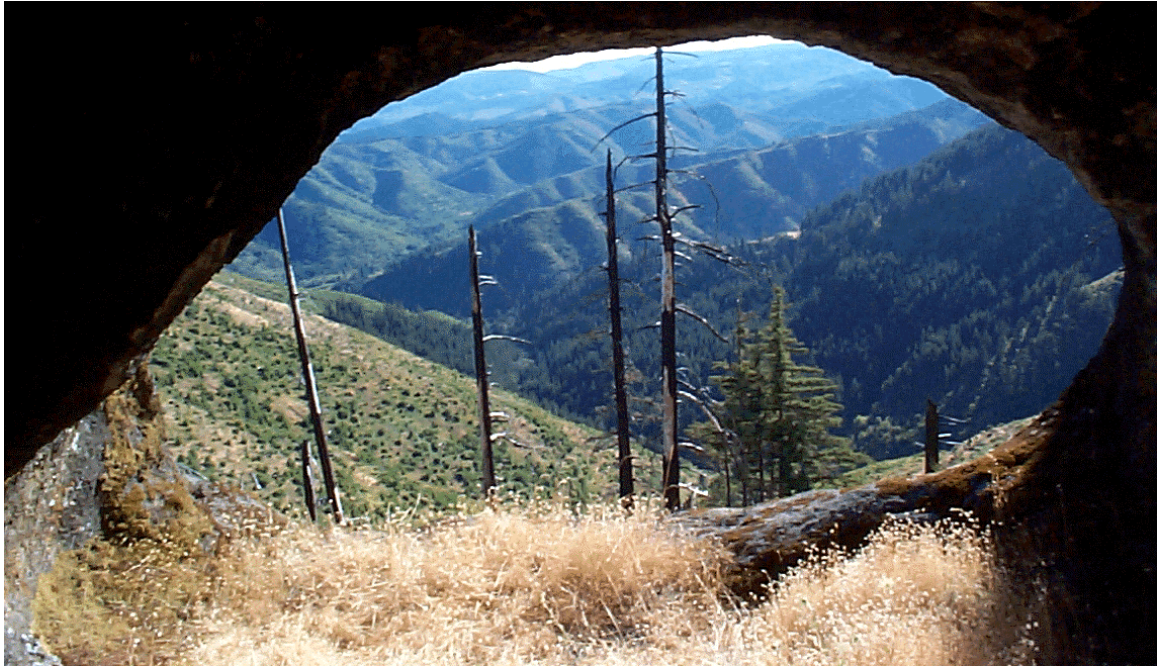
Photo 1-1: The upper watershed is a mix of recently harvested stands and second growth forests. Some grassy balds exist on south facing slopes as in this foreground. This view is towards the southwest from the mouth of Rockhouse Cave, above Rockhouse Creek. Mercer Reservoir lies off to the left of the photo; the farthest horizon is Fanno Ridge beyond the southern boundary of Rickreall watershed.

The upland forest was originally mature conifer forests intermixed with younger forests created by natural disturbances such as fire and windstorms. The hill slopes are relatively steep, even for the Coast Range, due to the larger amounts of basalt geology, which resists weathering, compared to the sandstone sedimentary common to other areas of the Coast Range. The upland forest area is now largely in private industrial forest ownerships with lesser amounts in federal. There are relatively few private holdings. The vegetation today is a mix of second growth forests with scattered recently harvested units and almost no old-growth stands. Several areas of natural grass balds occur on the south-facing slopes near the ridge tops as shown in Photo 1-1.

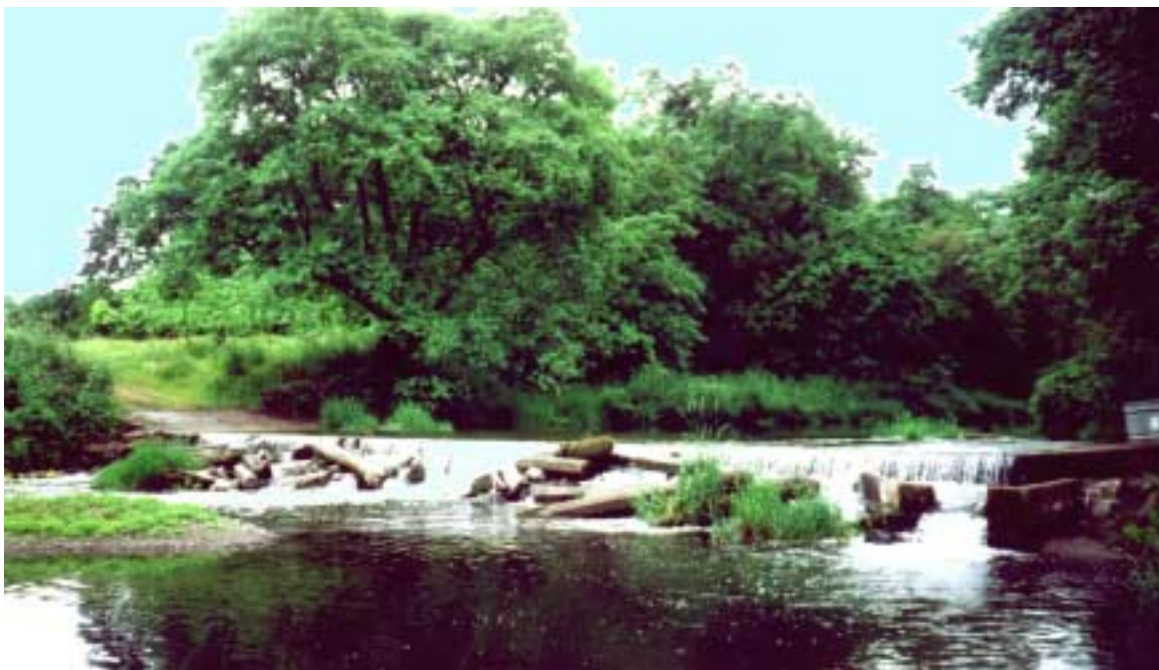
Photo 1-2: Lower Rickreall Creek at Villwoks Dam, a concrete ford over the stream at River Mile 7.5. The lower section of the Rickreall is characterized by a channel of low gradient that is somewhat entrenched. The riparian zones are narrow but well developed with mature hardwoods. Land-use along this section is agriculture beyond the riparian zone.

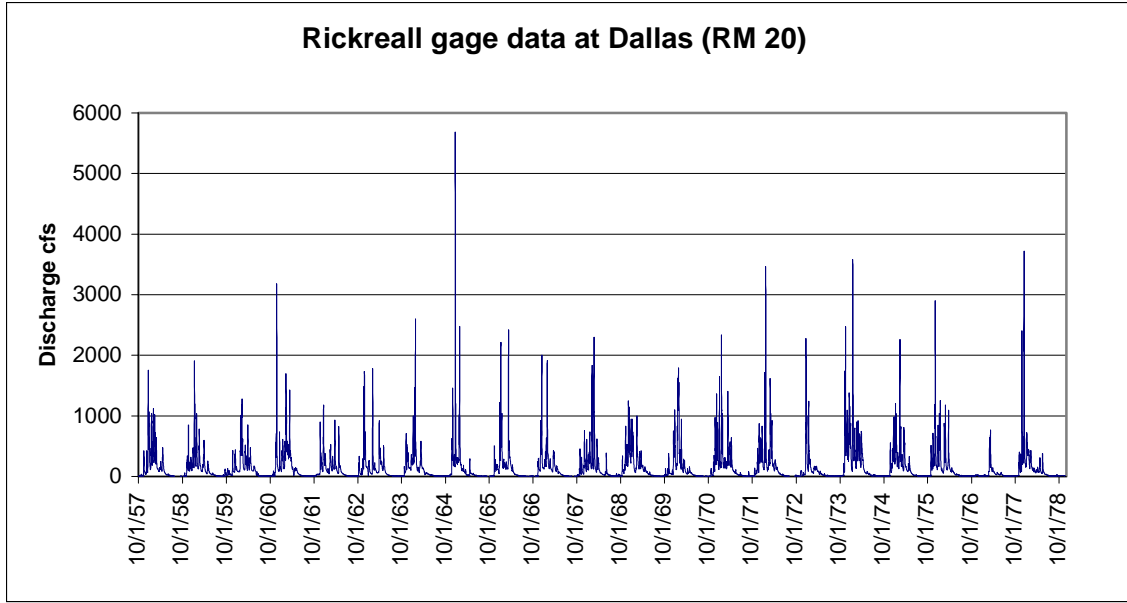
Figure 1-3: Rickreall stream discharge at USGS Dallas gaging station located just below the municipal water intake (top) and at USGS Rickreall gaging station located just above the Highway 99 bridge in Rickreall (bottom). The Rickreall station did not record the flood flow of 1964.

Data from these two stations provide a description of the stream flow from two points in the watershed (Figure 1-3). The Rickreall Creek discharge suggests a drainage area that is relatively large and steep, with high peak flows in the winter and an extended period of baseflow into the spring. Analysis of the discharge averaged by month over the period of record shows discharge peaking in January, while precipitation peaks in December (c.f. annual hydrograph, Figure 4-2 in Chapter 4). This lag between precipitation and discharge peaks results from a combination of saturated soils during the winter season and contribution from snowmelt. These factors delay the runoff peak and extend high flows into February. The period of low flow, primarily from July through October, reflect lack of precipitation and baseflow is largely groundwater discharge. This low flow discharge is important for its effects on water quality, agricultural use, and fish populations.

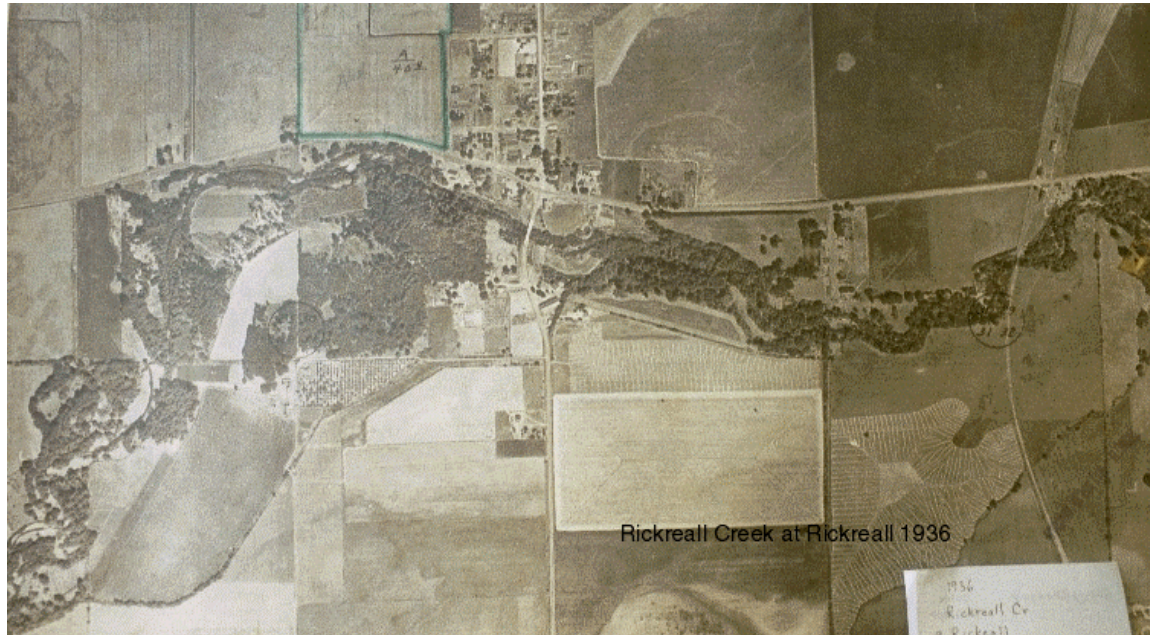
Figure 2-4 a-c Aerial photos of Rickreall watershed at community of Rickreall. Figure 2-4a top in 1936 and 2-4b bottom in 1955. Most of the land appears to have been brought under cultivation by 1936. Agriculture was shifting away from hops and prunes by 1936 and towards grains by 1955. A small stream near the lower right of 1936 photo is no longer visible by 1955 and may have been tiled. Other stream channels and riparian zones appear largely unchanged.

By the late 1930's the pattern of land uses in the Rickreall Creek watershed was becoming similar to the present situation. Dallas was a growing urban center with a large sawmill and other industries. Large and small farms occupied most of Polk County, primarily the lower portion of Rickreall watershed. Aerial photographs provide a useful way to view vegetation patterns and land use activities over time. A series of four aerial photographs spanning the period from 1936 to 1994 (Figures 2-4 a through d) show Rickreall Creek at the community of Rickreall. The photos show subtle, but gradual, changes. Over the 60 years, there is a shift away from row crops to grass seed, development of additional roads, and the establishment of the dairy. There is a small area of loss of riparian area to agriculture, channelization of a small stream, and some evidence of recent bedload movement in the stream in 1970.

Channelization of headwater, tributary streams likely occurred before the 1930's in the lower Rickreall watershed. In addition, much of the loss of riparian zones likely had occurred by this time. An examination of aerial photos taken in 1936 reveals that much of the Rickreall Creek drainage had been developed for agricultural use. Comparison of the 1936 photos to those taken in 1955, 1970, and 1994 show that small (probably less than 5%) amount of riparian habitat was lost (Photos 2-4a through 2-4d).

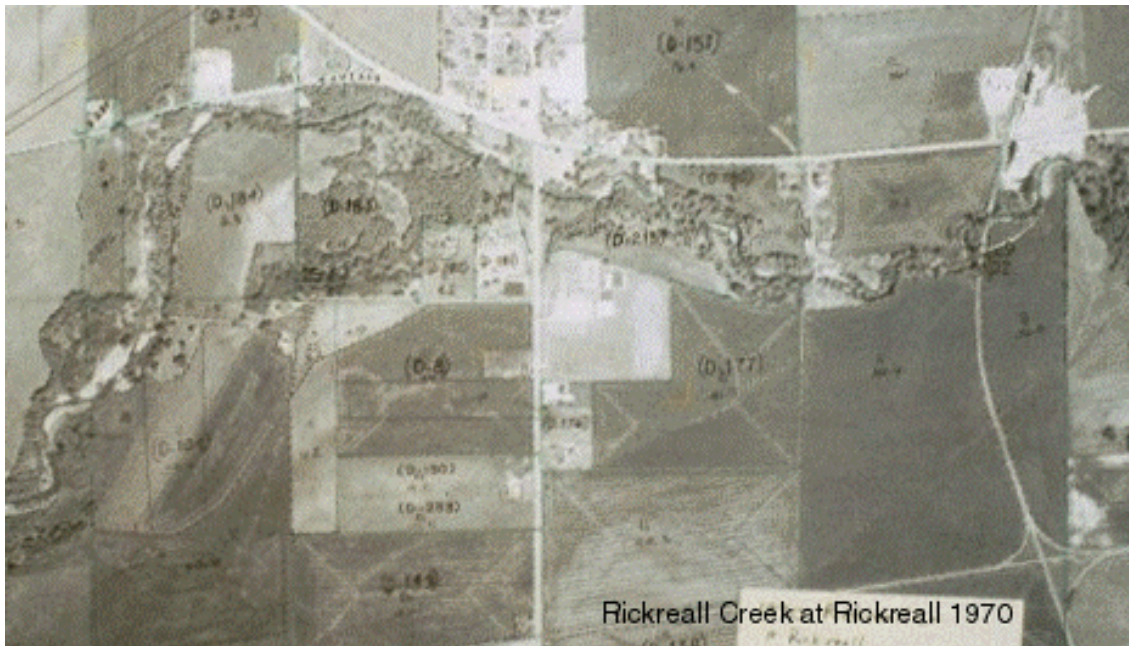
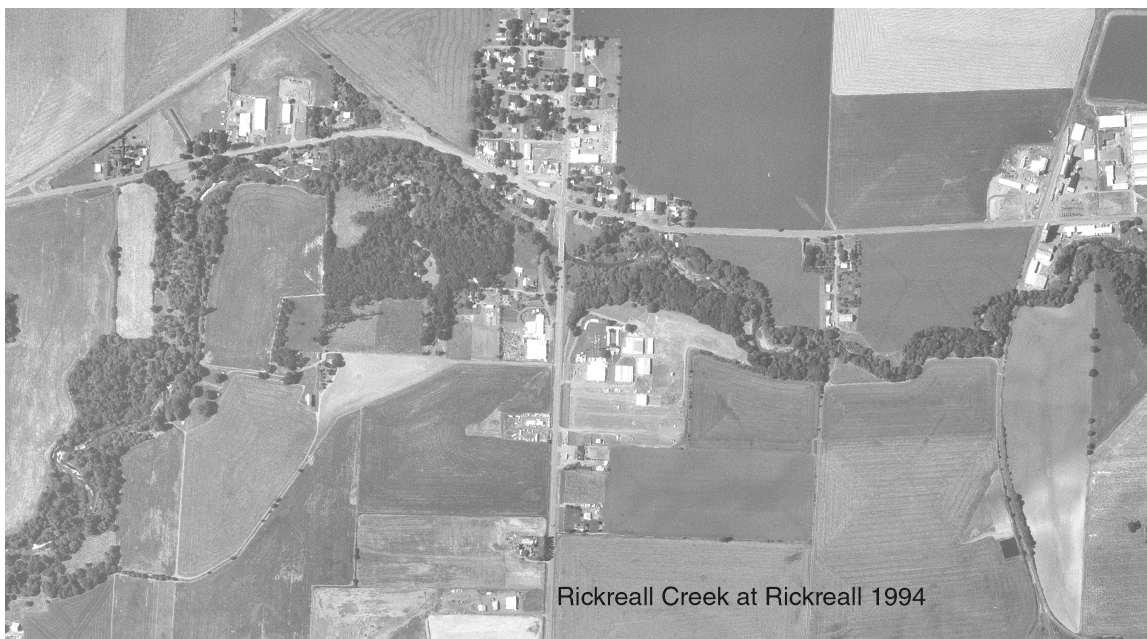
Figure 2-4c top and 2-4d bottom: Aerial photos of Rickreall watershed at community of Rickreall, 1970 and 1994. By 1970, the riparian zone west of Rickreall (left) shows some loss to agriculture and the streambed shows recent bedload deposits (white areas). By 1994, there is a greater shift toward grass seed crops, development of the dairy on far right and additional roads in upper left. The gravel bars visible in the 1970 photo are vegetated by 1994.

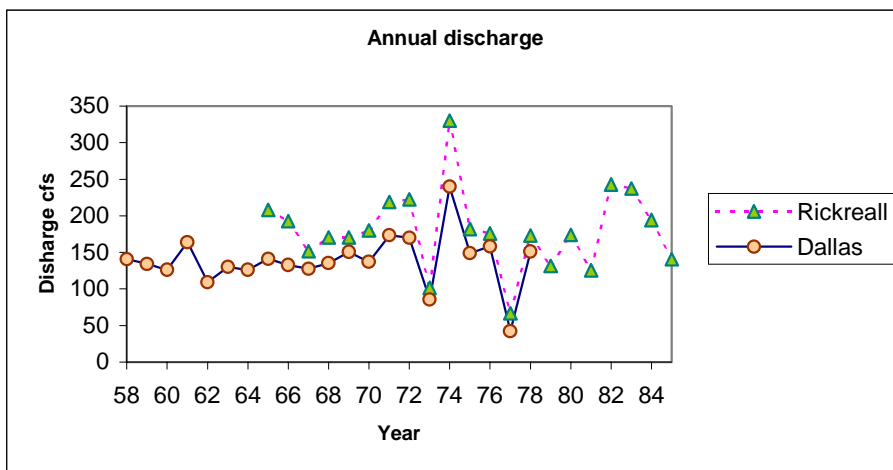
Figure 4-1: Stream discharge for Rickreall Creek at two gaging stations.

Average annual discharge was uniform for the years 1958 through 1972 and then became more variable for 1973 to 1985. Low discharges occurred in 1973, followed by a year of high discharge in 1974. Both stations track each other well; Rickreall seems to respond in greater magnitude to high water years. Rickreall has consistently higher discharge not because of the Dallas water system, but rather that the Rickreall Creek drains about a 50 % larger watershed area (43 square miles) at the Rickreall gage than at the Dallas gage (28 square miles). Ellendale Creek and several unnamed streams contribute flow to Rickreall between the two gages. Additional sources of increased flow would be from groundwater, small-unmapped seeps and streams, and even some amounts of storm water runoff from the urbanized area of Dallas.

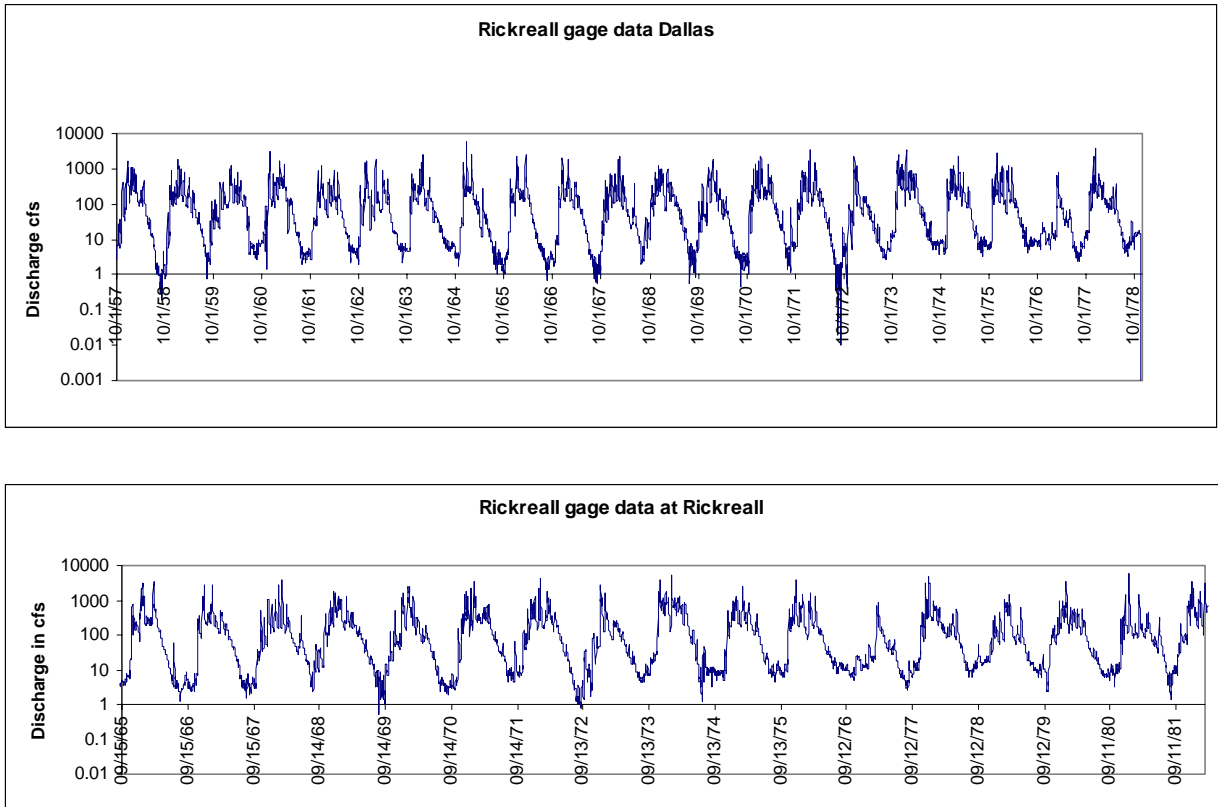
Figure 4-4: Daily discharge data for Rickreall Creek at two USGS gage stations. Dallas is at River Mile 20 and drains approximately 29 square miles; Rickreall is at River Mile 9 and drains approximately 43 square miles. Data are log scale to show low flow discharges over time.

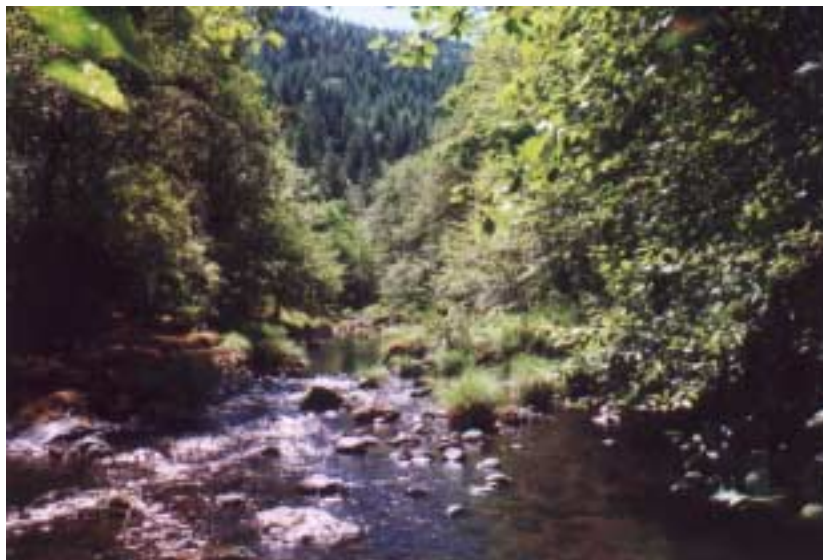
Photo 5-1: Rickreall Creek at Applegate Creek has low wood but cutthroat numbers appeared to be relative abundant.

length. Smaller cutthroat were observed in the tributaries. The habitat looked reasonably good according to the criteria in Table 5-2; however large woody debris appeared to be quite low (Photo 5-1).

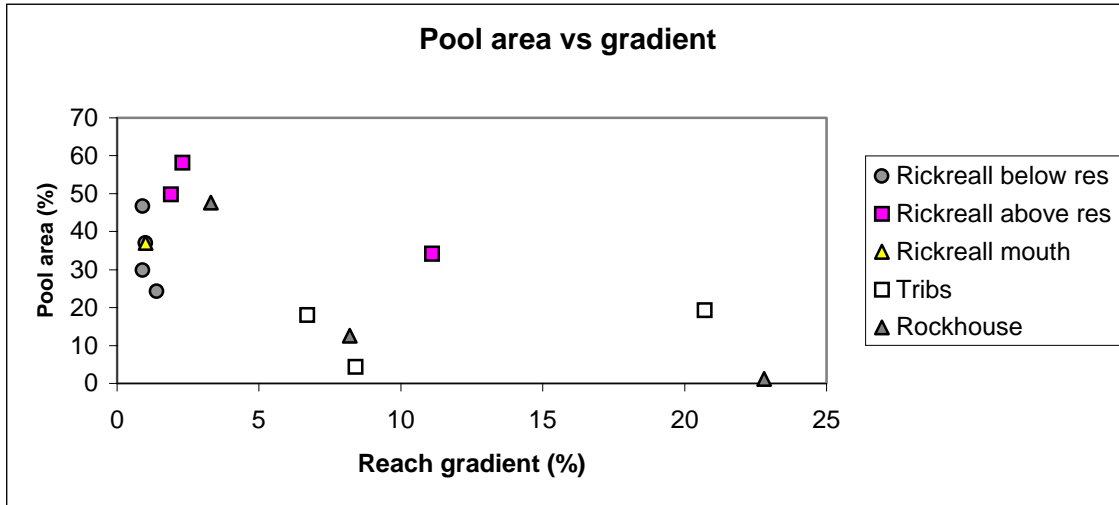
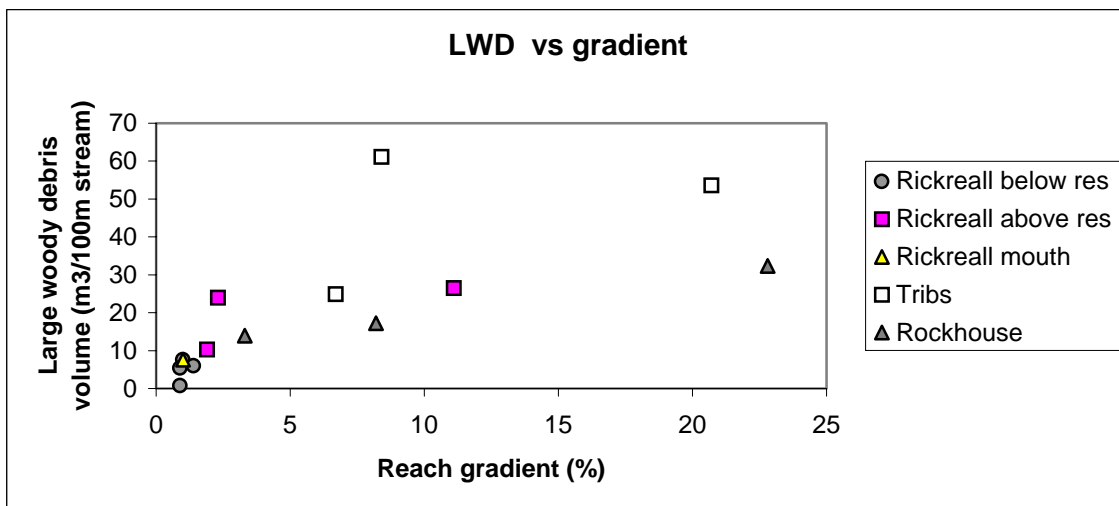
Figure 5-1: ODFW survey reach summaries versus reach gradient in Rickreall Creek.

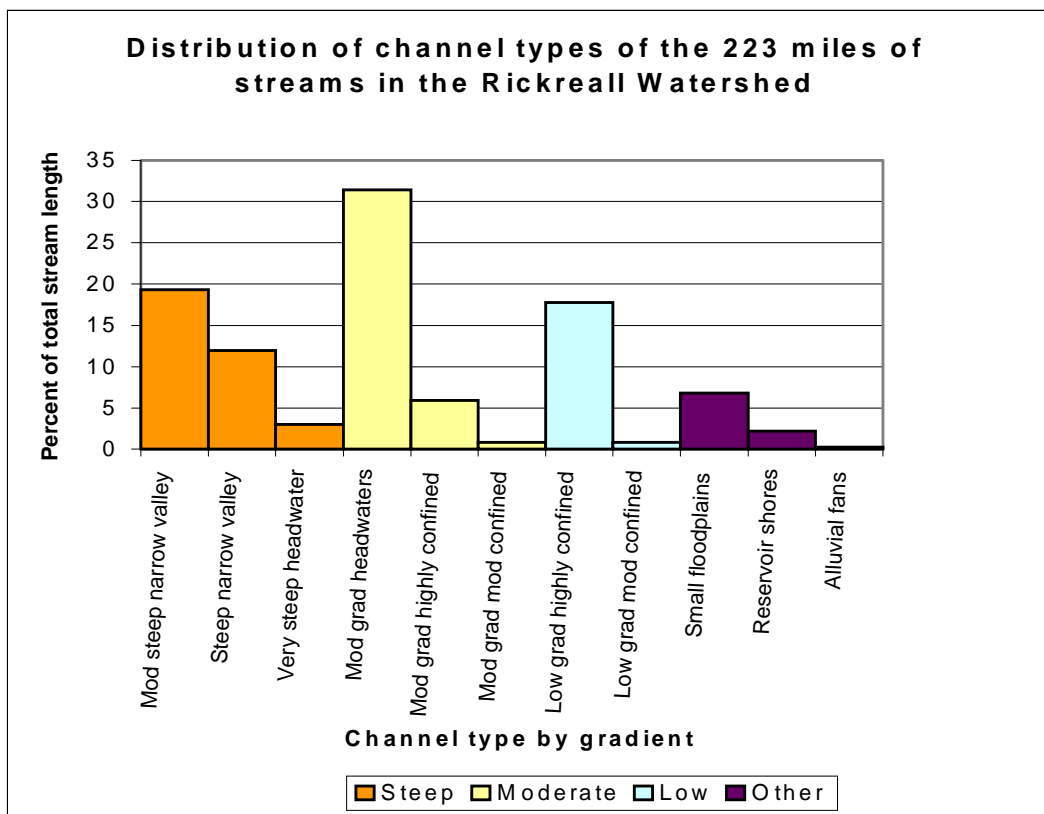
Figure 5-2: Channel habitat typing summary of streams in the Rickreall watershed. Greater miles of high gradient streams is mainly a function of a greater stream network in the headwaters of a stream system. Note that confined streams dominate

Channel habitat typing was performed on streams that are mapped on the USGS 7.5 minute topography map using the procedures outlined in the Oregon Watershed Assessment Manual (Watershed Professionals Network 1999) as a guide (Map 5-1). A summary of channel types is shown in Figure 5-2.

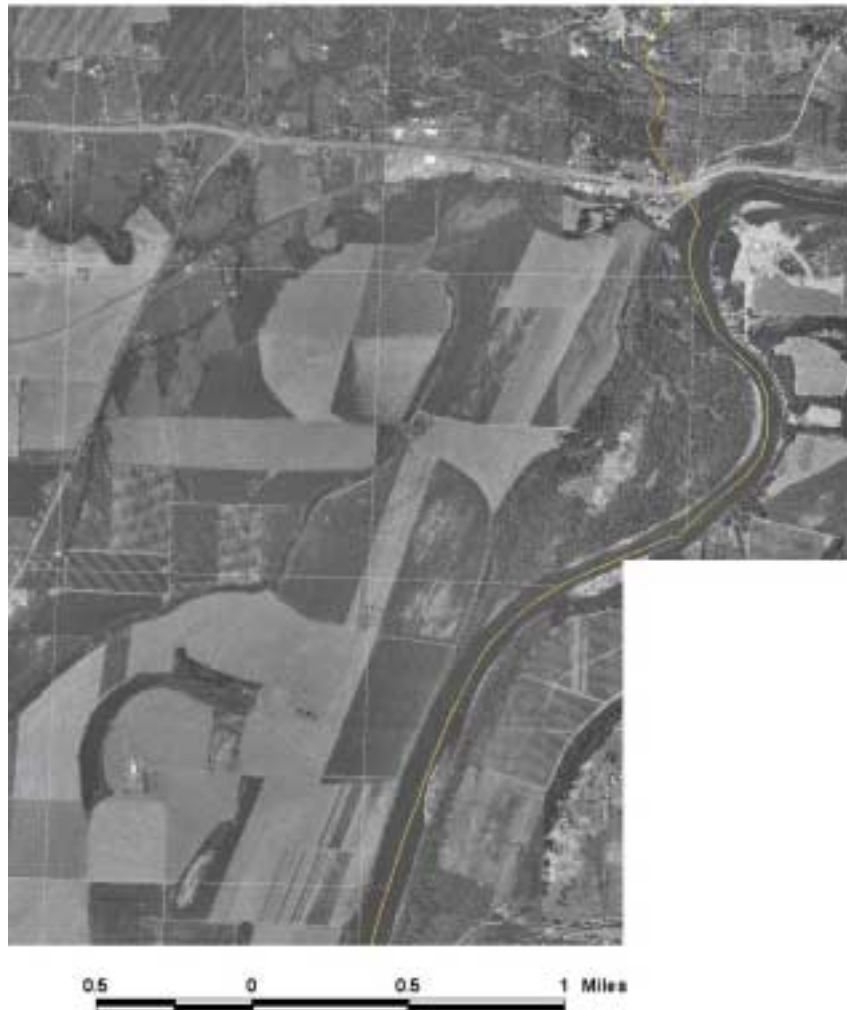
Figure 5-3: Remnant riparian forests along the Willamette River appear in the 1994 orthophoto. The forest can be seen along the inside of the sweeping bend in the river. This area likely was not converted to agriculture because of its wet soils and frequency of flooding.
