Mill Watershed Assessment

December 30, 1999

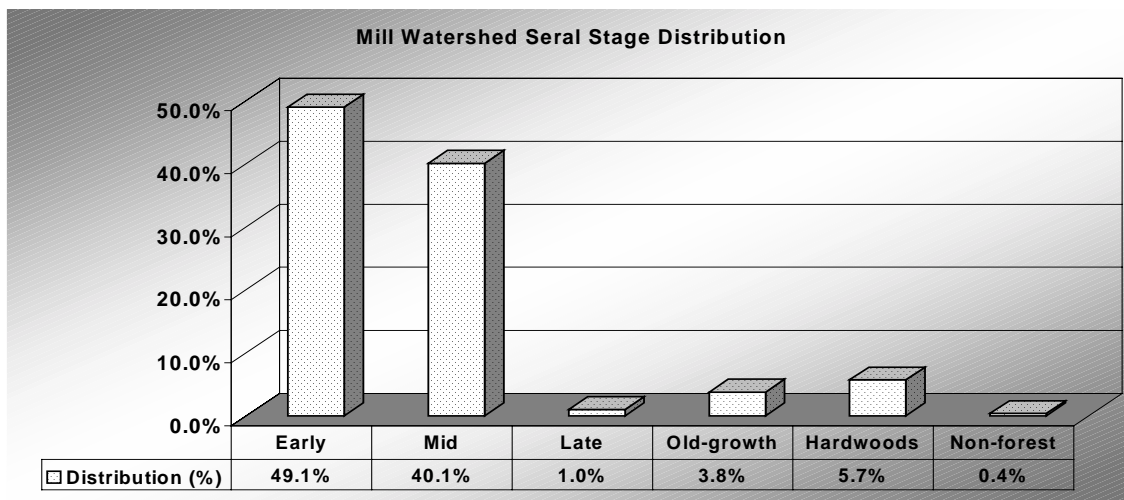
Figure 4. Vegetation Seral-stages and Age Distribution

Figure 4 shows the seral stage and age class distribution of vegetation in Mill watershed. The BLM system classifies 'Early' seral stage as vegetation between 0-39 years which includes mostly

agricultural and recently replanted-forested lands in the watershed. The 'Mid' and 'Late' seral stages are considered between 40-79 and between 80-199 year age classes respectively. Old growth is defined as vegetation known to be greater than 200 years old. A majority of the early, mid, late and old growth classifications are mixed conifers. The Non-forest is defined as areas such as rock outcroppings, ponds, parks, meadows or other areas where seral ages could not be assigned.

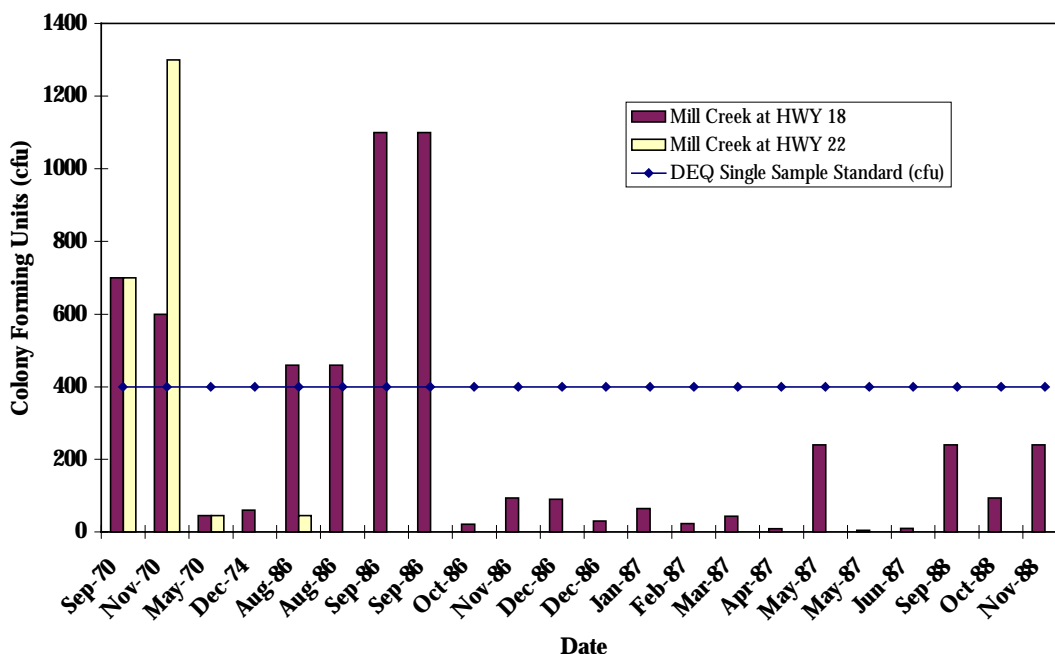
Figure 15. Fecal Coliform Data from DEQ (1970-88)

between 1970-88 for this listing is shown in Figure 15. Water samples were collected where Mill Creek intersects with State highways 18 and 22. The DEQ limit for a single fecal coliform sample is 400-cfu/100 ml (blue line). Note that redundant data collected during the same sampling day was graphed as only the higher of the two points.

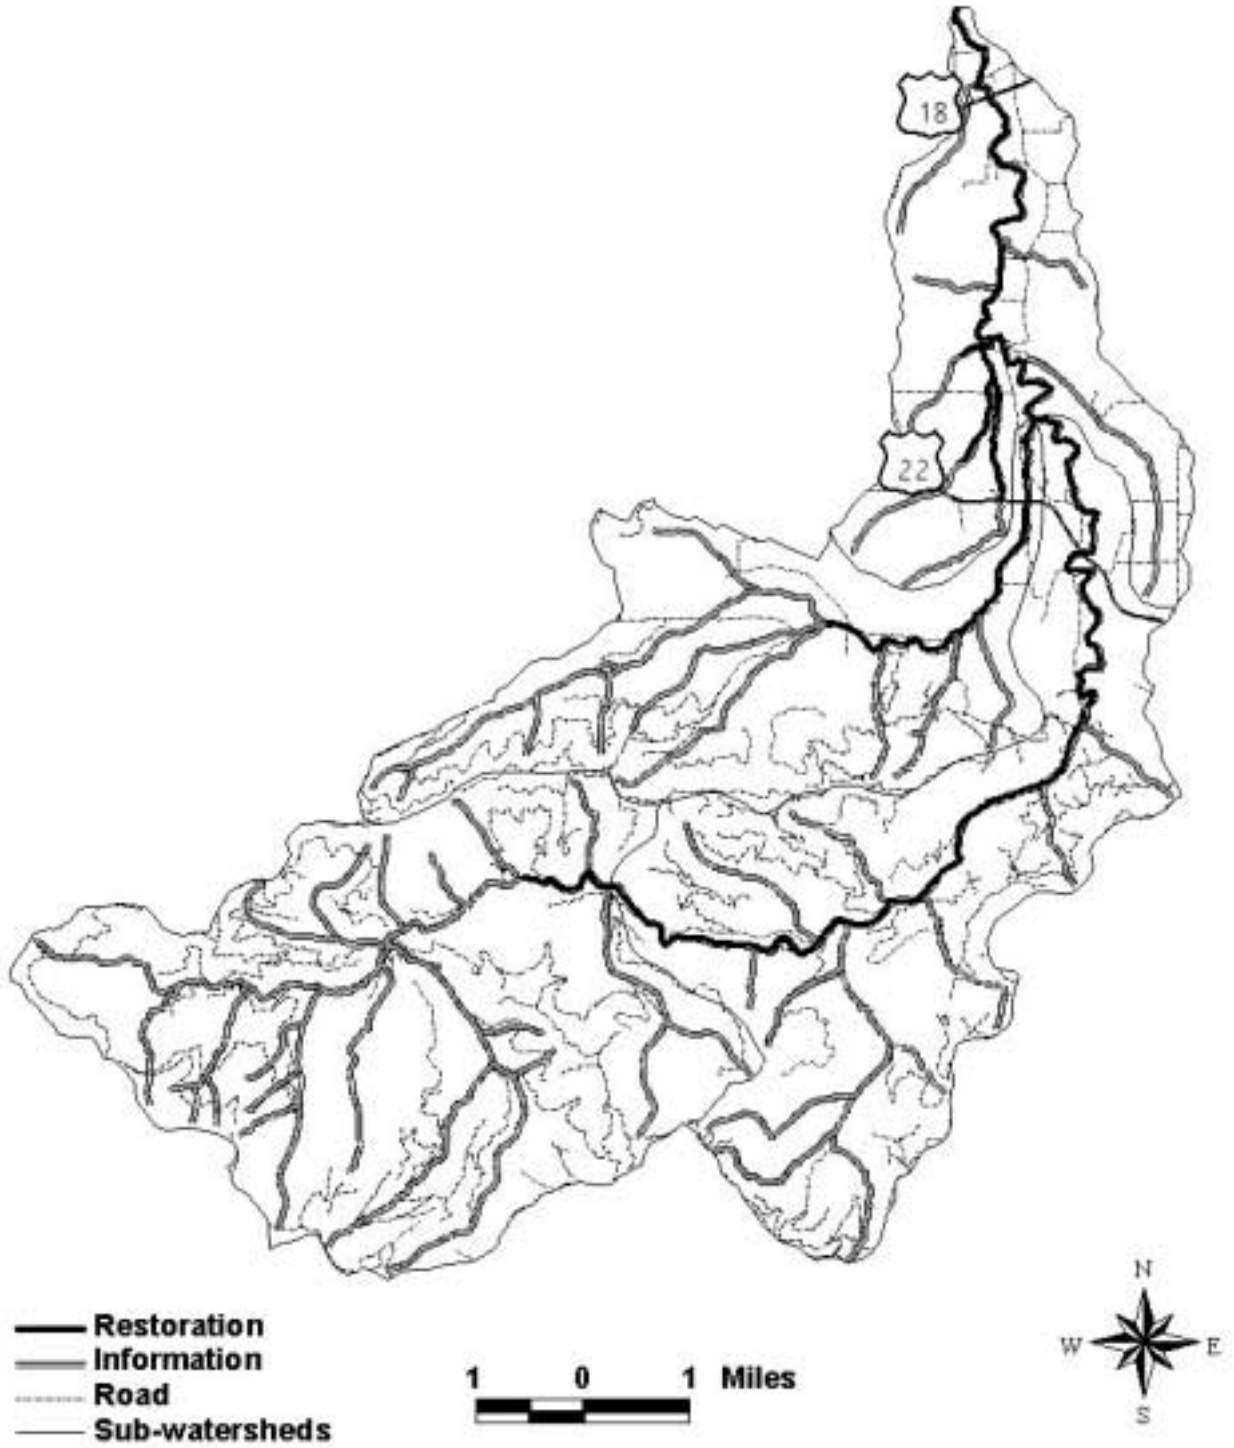
Figure 19. Condition Summary

Generally components were scored on the presence of watershed concerns in the near vicinity of the CHT segment. (e.g. Water Rights was scored 'Restore' for all of those areas where their exist water right holders because of the present over allocation of water and was scored "Protection' for all of the areas where there are no water rights permits issued.) The total number of ratings for each CHT segment were tallied and an overall segment evaluation made. The segments were mapped in Figure 19.

CHT segments that were nearly even in all three categories were designated as Restoration segments. Areas that require protection were not identified during the course of this assessment. While individual component in the matrix designated CHT segments for *protection*, the summation of these designations was never enough to rate the segment *Protect*. It is hypothesized that some of the segments currently defined as requiring *information* are in fact areas of protection.
