Clear and Foster Creek Fish Passage Assessment and Prioritization Project

Clackamas River Basin Council
P.O. Box 2439
Clackamas, Oregon 97015-2439

E. George Robison
Watersheds Northwest Inc.
1477 Fernwood Dr.
Mckinleyville CA 95519

Clear and Foster Creek Basins Fish Passage Assessment and Prioritization project: Final Report

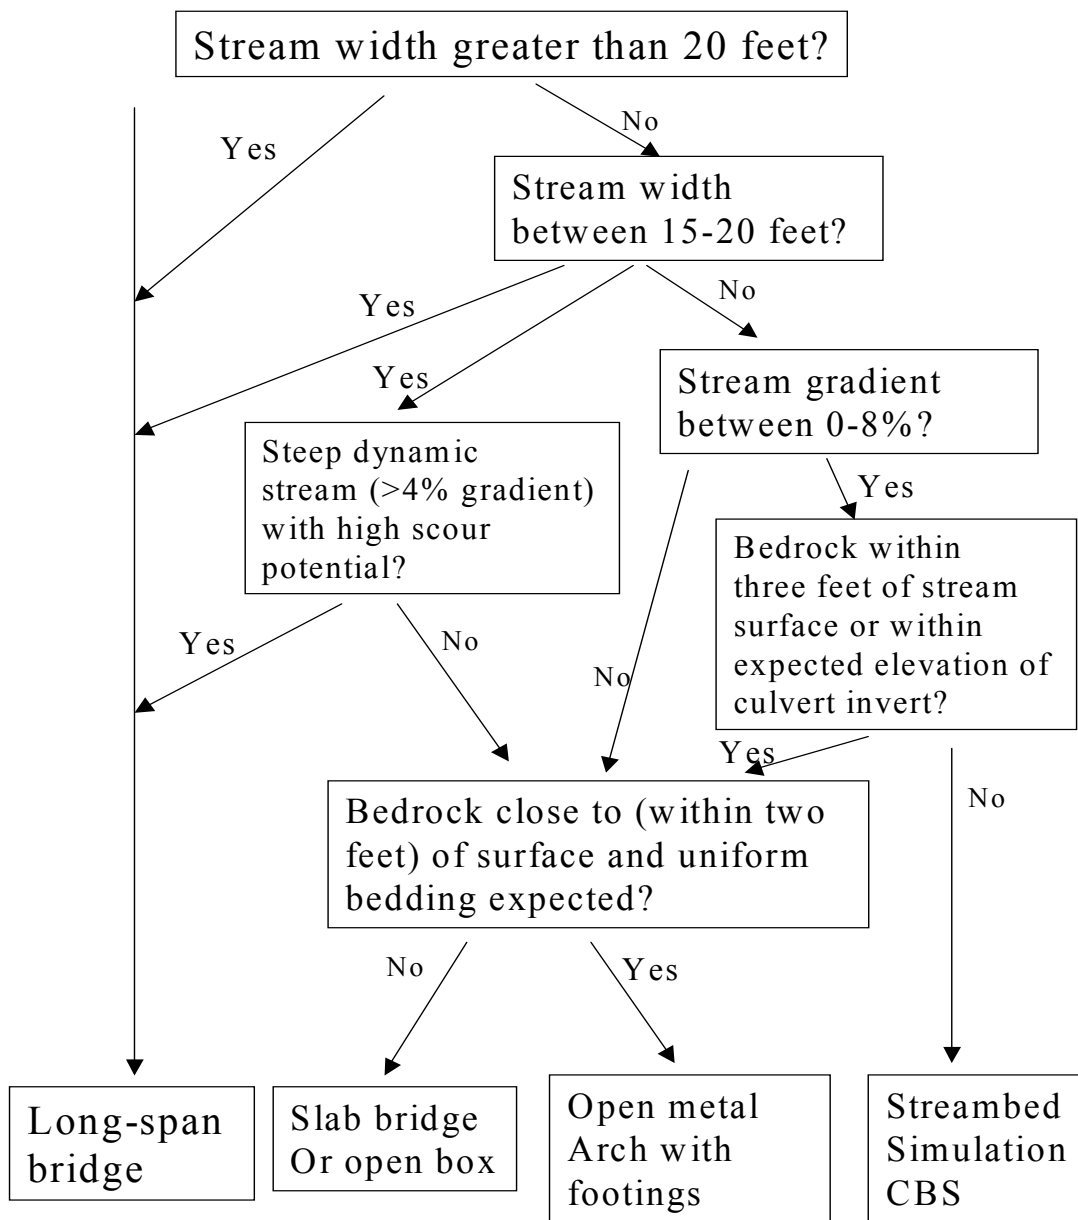
Figure 1. Design alternative decision diagram for the Clear and Foster Creek assessment/prioritization project.

Based on guidance in Robison et al. (1999); WDFW, (1999); and Ministry of Forests (MOF) et al. (2002) closed bottom designs using streambed simulation are recommended for streams with slopes of zero to eight percent (note: WDFW and MOF advise or prescribe use up to 6% but may allow at greater slopes if justification given). Depending on which guidance the maximum size of stream that these designs are allowed or advised on range in size from 9 to 15 feet in width. Both Robison et al. and the MOF guidance specify also that the stream should have deep unconsolidated fill. Open arches will be confined to areas of well confined bedrock. Open box or short span bridges will be the preferred option on high gradient streams between 0-15 feet perhaps up to 20 feet in width. For bankfull stream widths greater than 15-20 feet, the long-span-bridge becomes the preferred option. These design choice issues creates a decision flow-chart (Figure 1) that will be used for choosing between replacement options.

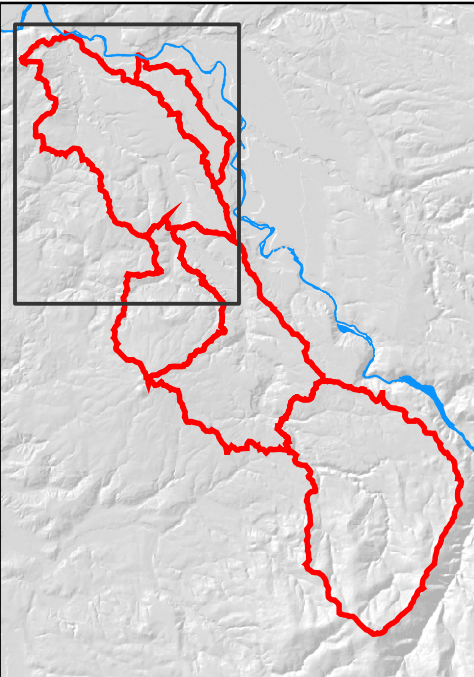
Figure 2. Lower Basin Artificial Barriers

In the Clear and Foster Basin a total of 223 artificial barriers were evaluated to some degree (see Appendix D for listing) with 159 found on fish bearing streams as per the revised fish presence map (Appendix A) along with field determinations of fish use. Of these 159 crossings, 81 were determined to have fish passage issues (Table 2; Cost Info). Of these 81 culverts, 34 were deemed to be on streams that may be used by anadromous fish species such as steelhead trout. Anadromous fish use was determined by evaluating sources of information such as the Clackamas River Watershed Atlas (Metro, 1997) and evaluating 16 key natural barriers that prevent anadromous use in the basin. These natural barriers were discovered and/or documented during fieldwork during the summer of 2002. (See Figures 2 through 4 for locations of crossings and natural barriers in the basin.)

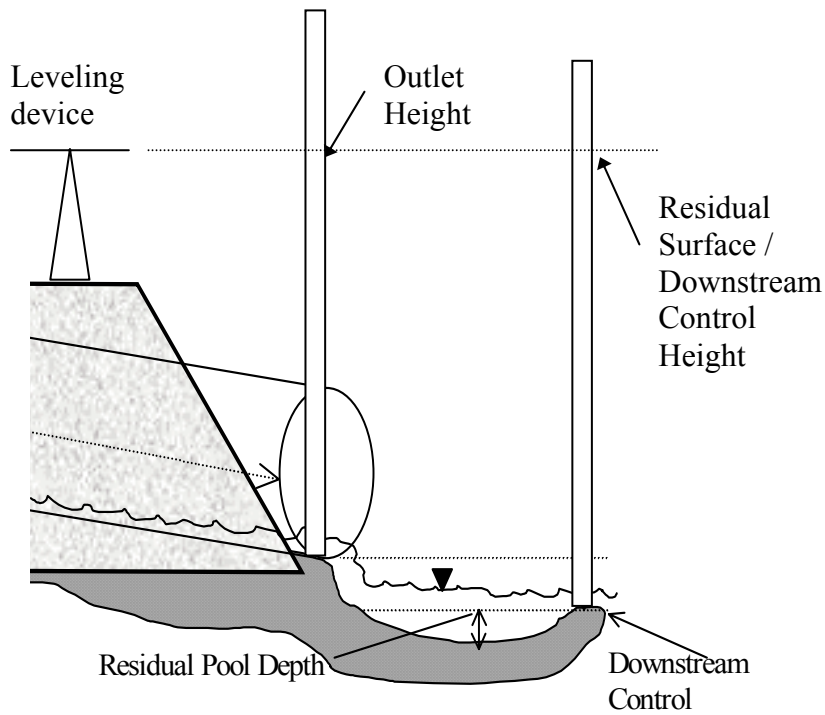
Figure B-1. Residual pool schematic using downstream weir height (Robison et al., 2000)

The amount of outlet drop is the difference in elevation between the downstream weir crest and the invert elevation at the outlet. Backwater and culvert depth calculations can be done with these elevations as well. Where the culvert inlet is beveled, care must be taken to ensure that the measured culvert length corresponds to the length over which the transit level measurements were observed. All elevations should be relative to a base elevation given at the road surface. The difference between the road surface elevation and the average elevation of the culvert inlet and outlet represents the fill height. All these parameters can be calculated on a spreadsheet.

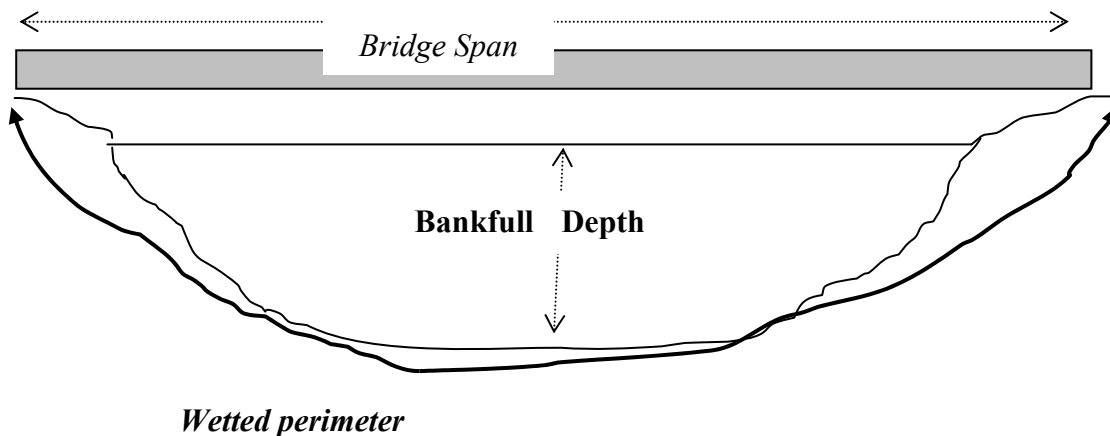
Figure B-3. Schematic of measurements needed for calculating flow capacity of bridge design (from Dent, 1999)

Bridge Span (ft): Measured from one side of the stream to the other (Figure B-3).

Opening depth (ft): Measured from channel bed to the bottom of the bridge (this measure will be used to calculate wetted perimeter and cross-sectional area) every 15 cm on streams with a wetted width less than 3 m and every 30 cm on streams 3 m and greater.

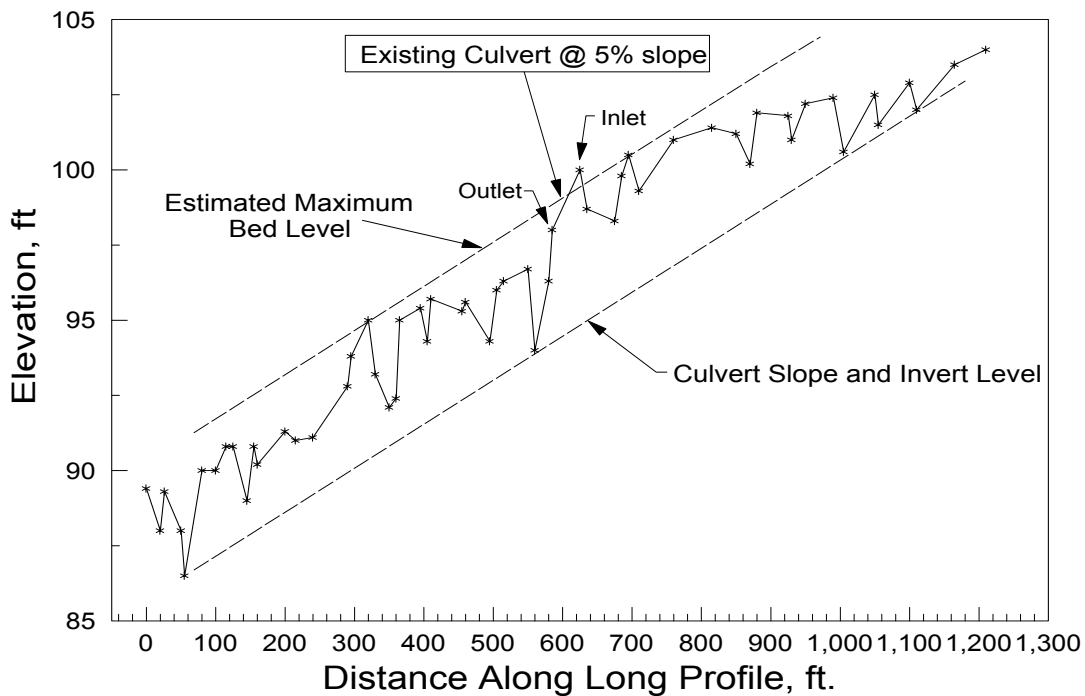
Figure B-4. Culvert elevation profile (from Reba, 2002)

Elevation Profile: (Check off on form and put measures in comments or separate sheet) This measure represents the elevation of the streambed taken generally 100 feet upstream and downstream of a culvert. Depending on channel conditions the length of this measurement can be expanded or contracted. If it appears that the inlet is backing up sediment due to bar formation or other evidence of accelerated deposition, the profile will have to be extended up to 500 feet or more upstream of the culvert. If the downstream section shows evidence of culvert induced incision the profile may need to be extended as well. To get a profile use a transit level to measure a section upstream from the culvert by taking elevation differences over a channel length. A way of doing this is to establish a “relative base elevation” perhaps on the crown of the road surface and take all

The measures can be taken in comments or on separate sheet. The final profile would look something like what is in Figure B-4. The ideal elevation of the invert of the culvert can be determined by looking at the minimum bed elevations and plotting a line as done in Figure B-4.

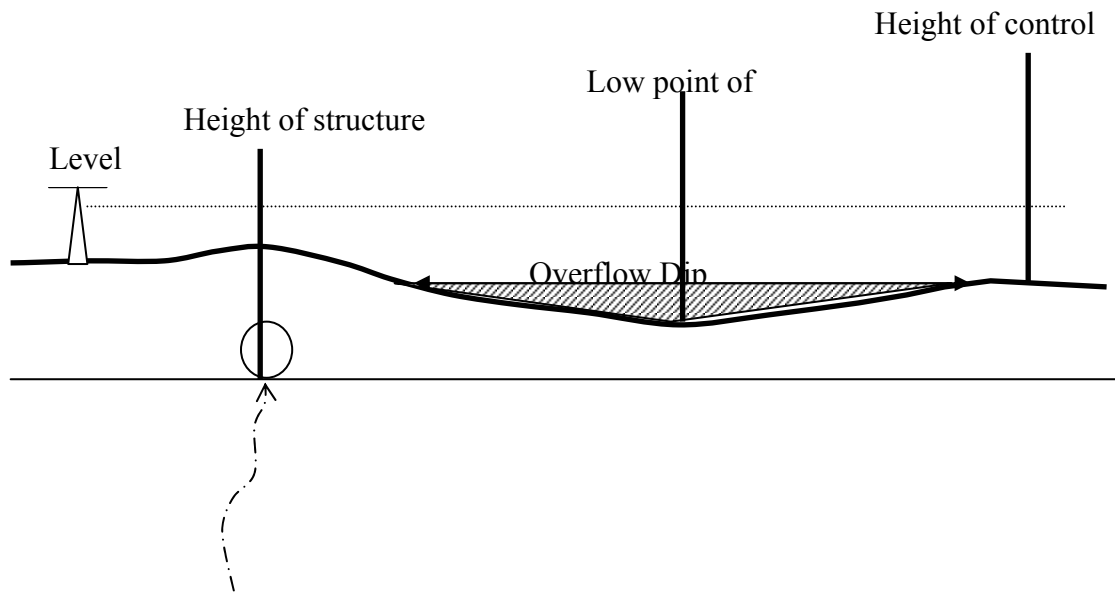
Figure B-5 – Over flow dip schematic (adapted from Dent, 1999)

Dip control point (ft): Lowest point elevation of the two upper boundaries of the overflow dip controlling the capacity of the overflow dip.

Overflow maximum depth (ft): The difference between the height of the culvert bottom and the height of the bottom of the overflow dip.
