MIDDLE COW CREEK WATERSHED ASSESSMENT AND ACTION PLAN

Heidi Kincaid, Umpqua Basin Watershed Council

April 2002

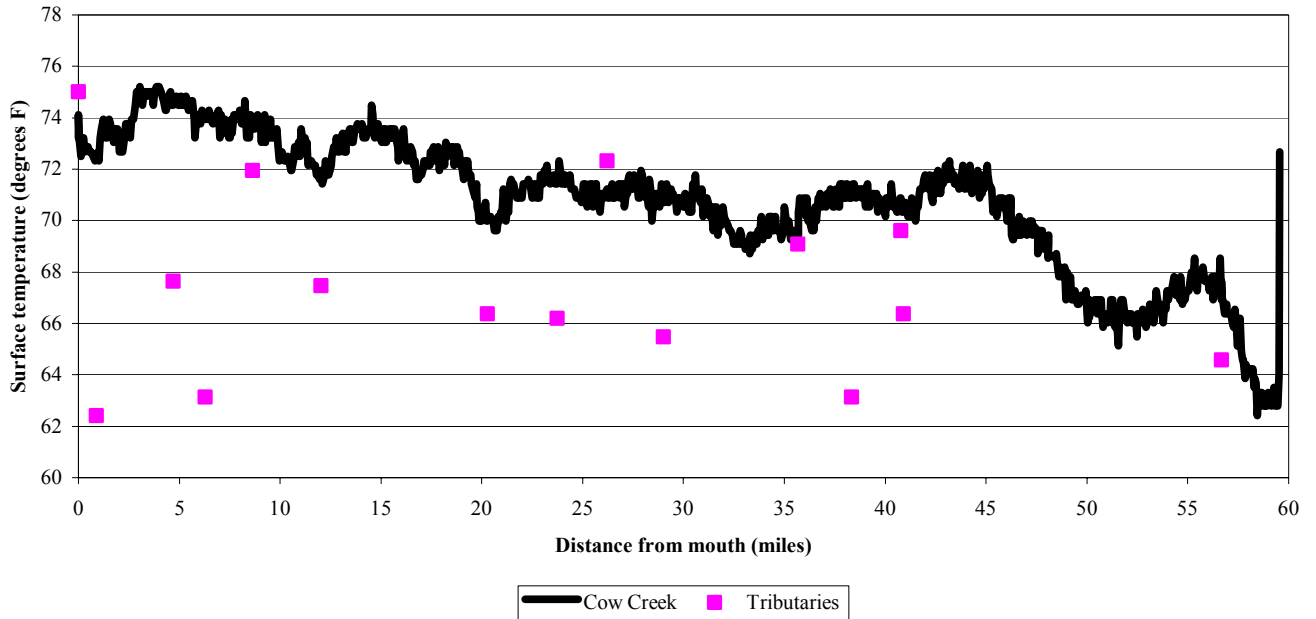
Figure 3-8 Water Surface Temperature of Cow Creek

68.9°F. Over the next 30 miles stream temperatures increased steadily to a maximum for the survey of 75.2°F at river mile 3.3. From river mile 3.3 to the mouth stream temperatures decrease to 73.2°F at the confluence with the South Umpqua River. The South Umpqua River was 75.0°F at the confluence with Cow Creek. For the survey reach, the temperatures of 14 tributaries were detected contributing flow to Cow Creek. Of the 14 tributaries we detected, 13 were contributing cooler flows to Cow Creek. Downstream of Whitehorse Creek, the surface temperature of Cow Creek did not go below 64°F again.

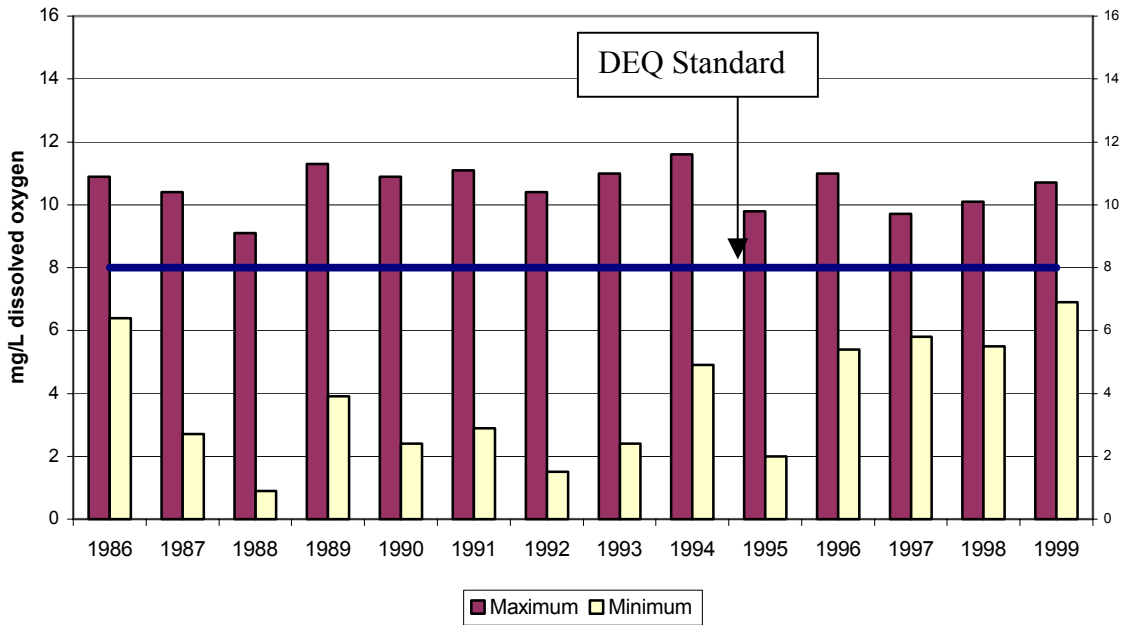
Figure 3-10 Maximum and Minimum Dissolved Oxygen Levels of the Summer in Cow Creek above Whitehorse Creek

During the summer, the most sensitive user of dissolved oxygen is cold-water aquatic life, with the criterion being a minimum of 8.0 mg/L dissolved oxygen. Where conditions of barometric pressure, altitude, and temperature preclude the attainment of 8.0 mg/L, the criterion is 95% of saturation at the ambient conditions. The seasonal minimum has been below the benchmark values in Cow Creek above Whitehorse Creek for the last 15 years (Figure 3-10).

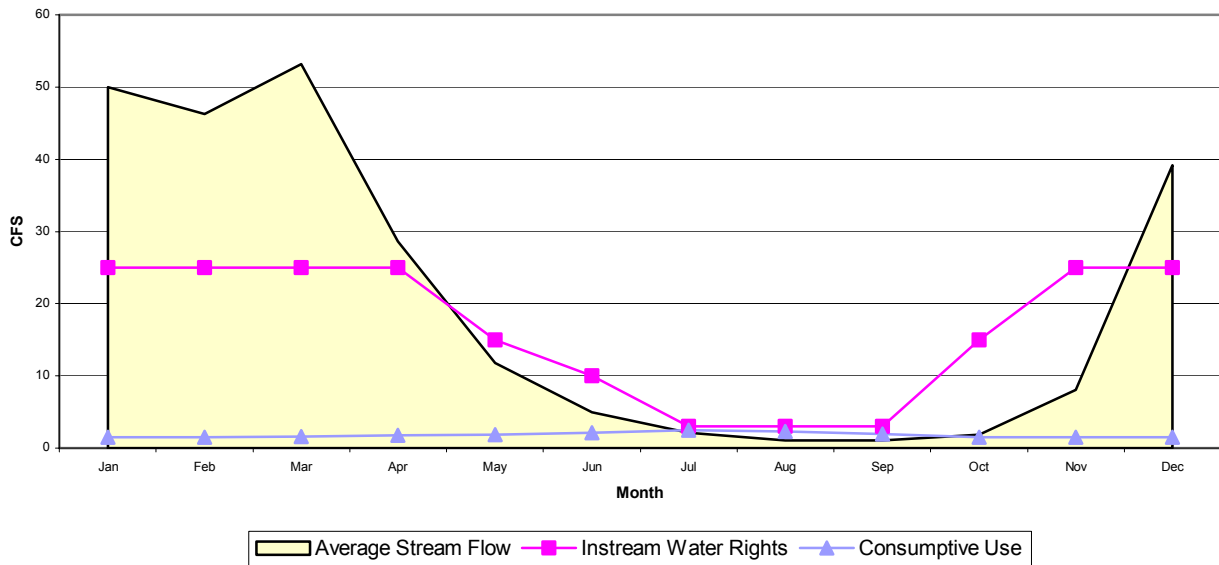
Figure 3-11 Water Availability in the Windy Creek Water Availability Basin

Data from the Oregon Water Resources Department (OWRD) has been used to determine water availability in the Middle Cow Creek Watershed. Availability is based on streamflow, consumptive use, and instream water rights. The OWRD has divided the Middle Cow Creek Watershed into seven sub-basins (Water Availability Basins – WABs) for the purpose of analyzing water availability. These WABs are not the same as the subwatersheds of this assessment. The amount of water available for any new water rights is determined by subtracting consumptive use and instream rights from streamflow.

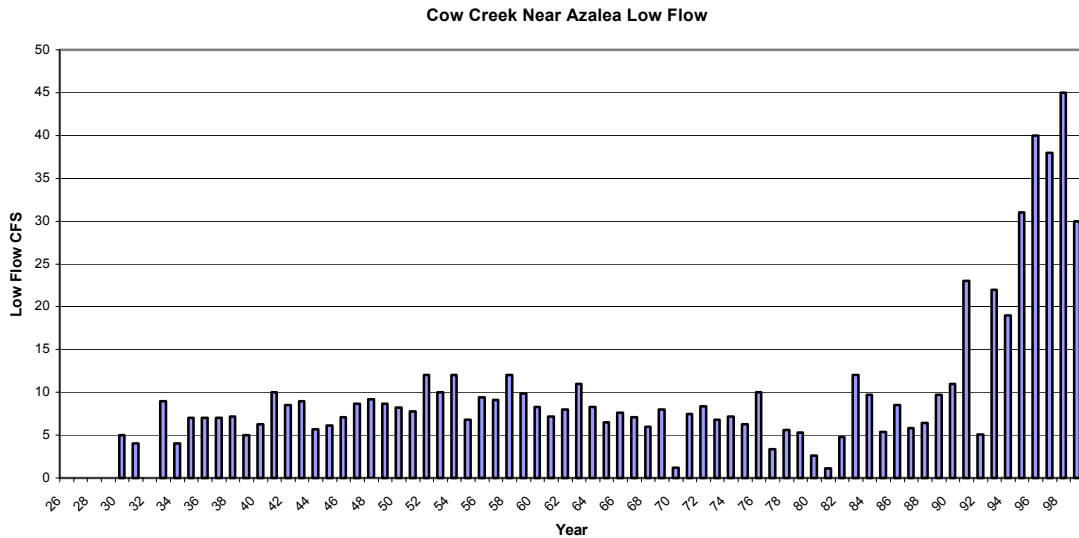
Figure 3-14 Low flow discharge of Cow Creek near Azalea

The low flows by year are displayed in Figure 3-14. The low flow level has increased significantly since 1992, once the reservoir contained enough water to release flows up to 40 CFS during the summer. The lowest flows occurred in the summers of 1971 and 1982.
