Tenmile Lakes
Watershed Assessment

Produced by the Tenmile Lakes Basin Partnership

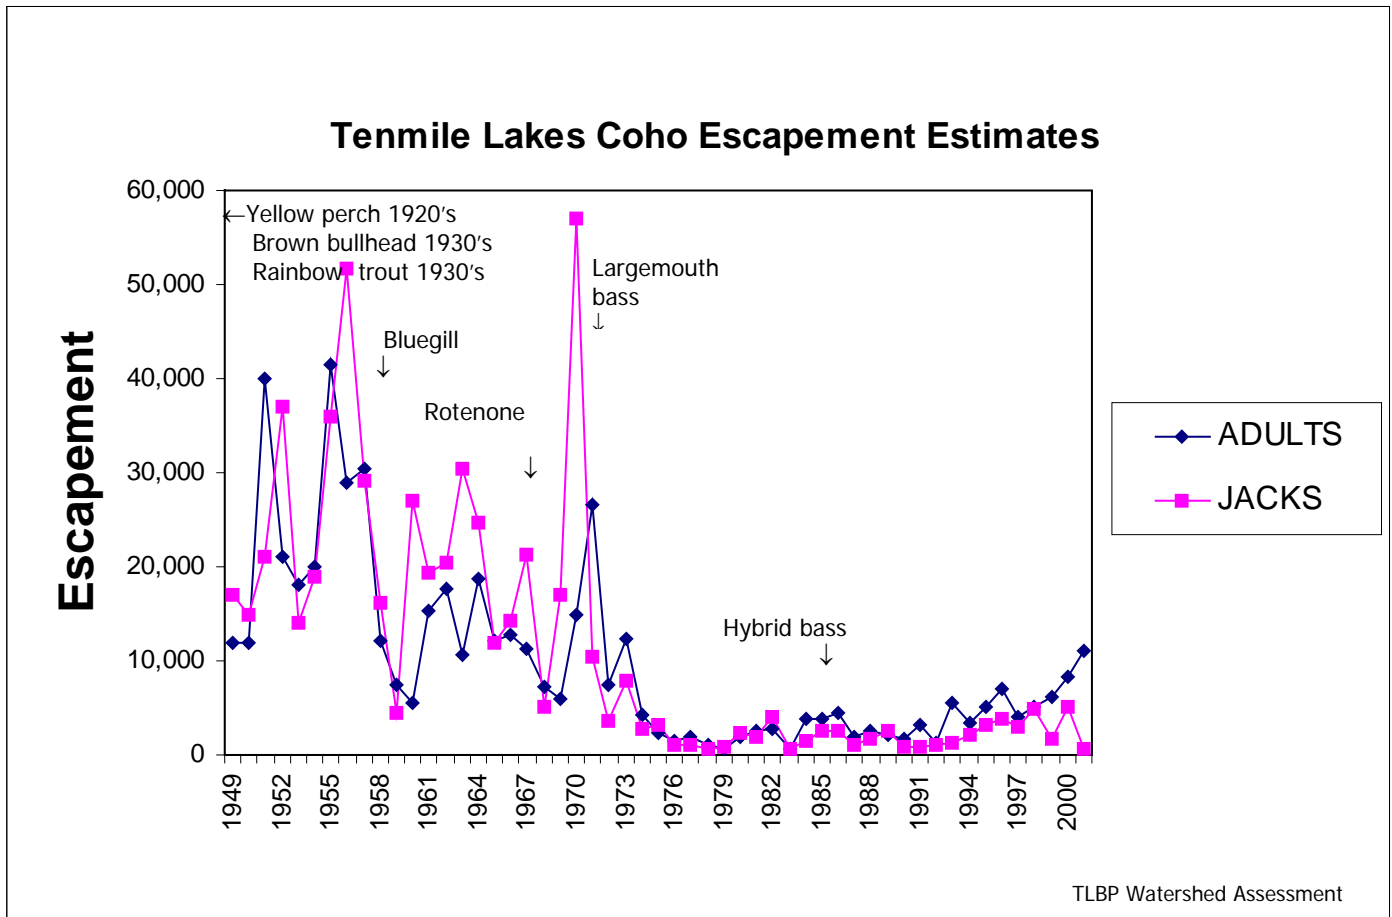
Figure 2.1. Estimated spawning run of adult and jack coho salmon in the Tenmile Lakes system. 1949-88.^{ix}

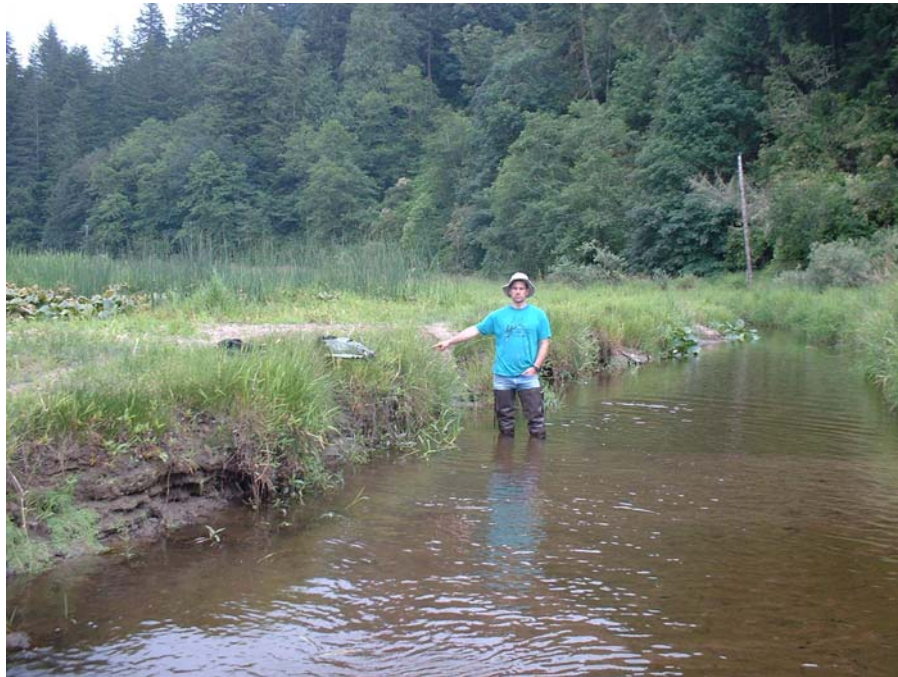
Figure 2.3. Johnson Creek delta, classified as a flood plain. Note Skunk cabbage at about 9 o'clock (surveyor is pointing at a temperature monitor site). This area is usually under water during the winter due to lake influence. Banks here are somewhat vegetatively stabilized, but are still prone to erosion due to livestock use.

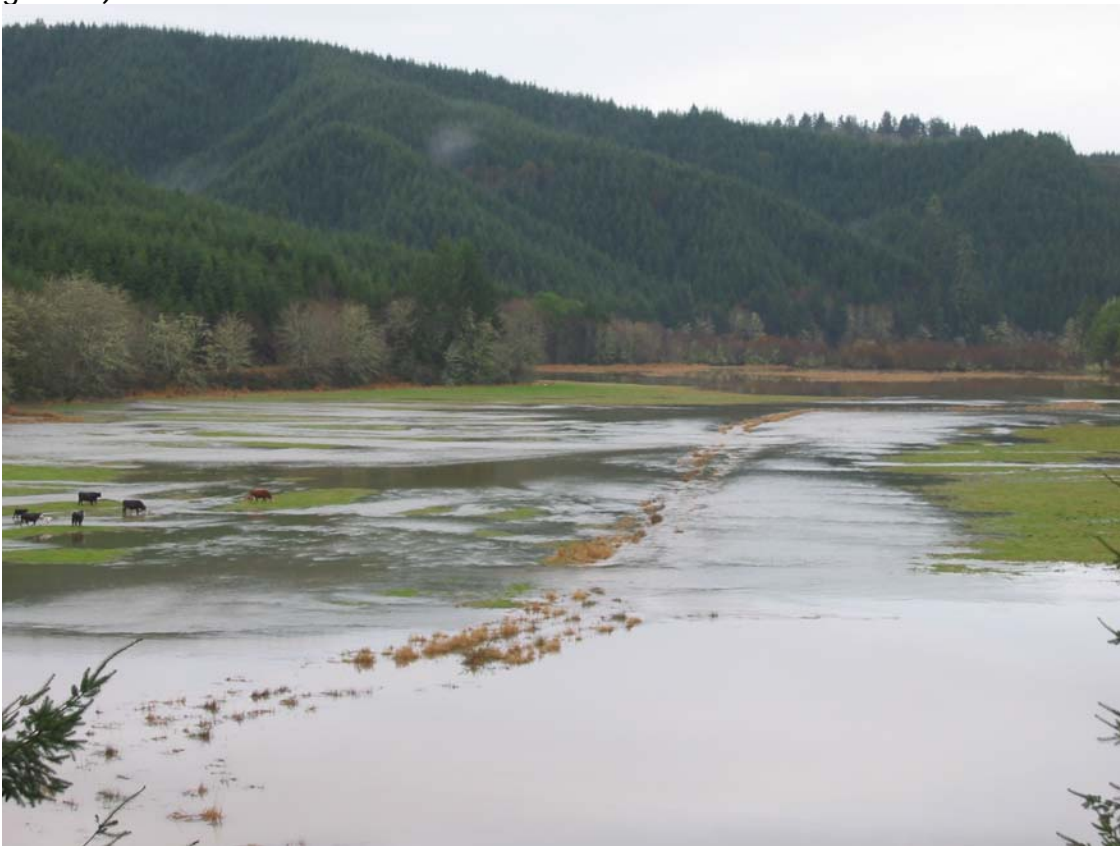
Figure 3.3 shows the mouth of Benson Creek under flood conditions. Note the line of vegetation marking the ditched channel of King Gulch (center, foreground).

Figure 3.3. Benson Creek rangeland merging into wetland.

possibly the lack of function as a wetland. The photo shows what, on the map, is described as PEMC, or palustrine (freshwater) emergent (the vegetation breaches the surface of the water, seasonally flooded (what the "C" in PEMC stands for). Despite conditions after heavy rains, when it's dry, this is prime Tenmile Lakes pasture.

Another thing to note about the picture, is that the ditch in the center will rapidly drain the field once the lake level has dropped, limiting the amount of seasonal flooding this area experiences.

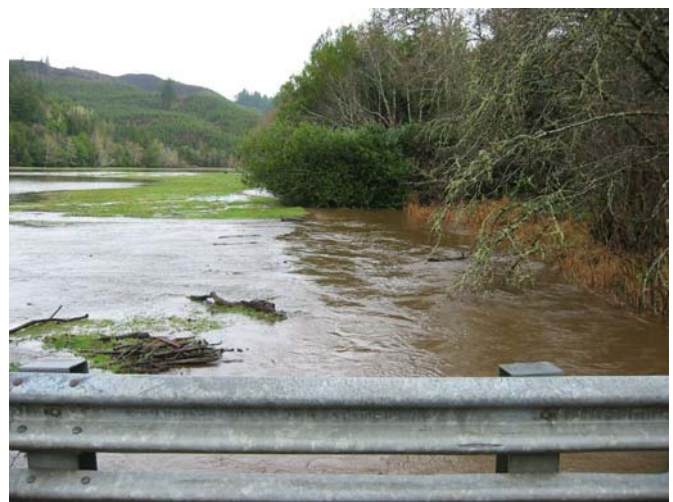
Figure 3.6. Big Creek overflows

side of this photo will become saturated with water and likely slough off into the stream when the flood waters recede. Some sediment deposition will occur in the field to the left, but due to the channelized flow and lack of riparian vegetation, most of the sediment in the floodwaters will make its way to the lake. Figure 3.7 is a photo of the confluence of Big Creek Arm and Carlson Arm after heavy rains. Notice the clear dark water coming out of Carlson Arm, and the brown, muddy water from Big Creek. Refer back to figure 3.6 and imagine what this stretch of stream might have looked like several hundred years ago. The stream probably meandered widely through the valley, bouncing off the valley walls and even reversing course occasionally. The valley bottom was so heavily vegetated that crossing from one side to the other would have been difficult. Willow, cherry, crab apple, and probably ash populated the bottom lands, while big leaf maple, Sitka spruce, hemlock, and myrtle occupied the slopes adjacent to the valley floor and high spots in the flats. The stream was likely very slow moving, with a low gradient, more prone to laying down sediments than removing them. The stream surface received a small fraction of the solar radiation that it does in some spots today, and the variety of habitat was much greater than present. Beaver were active in the system, and did their part to increase the residency time of flood waters by building and maintaining dams. Beaver dams also functioned as summertime rearing habitat for salmon fry, providing cover and deep water where there might otherwise have been none.

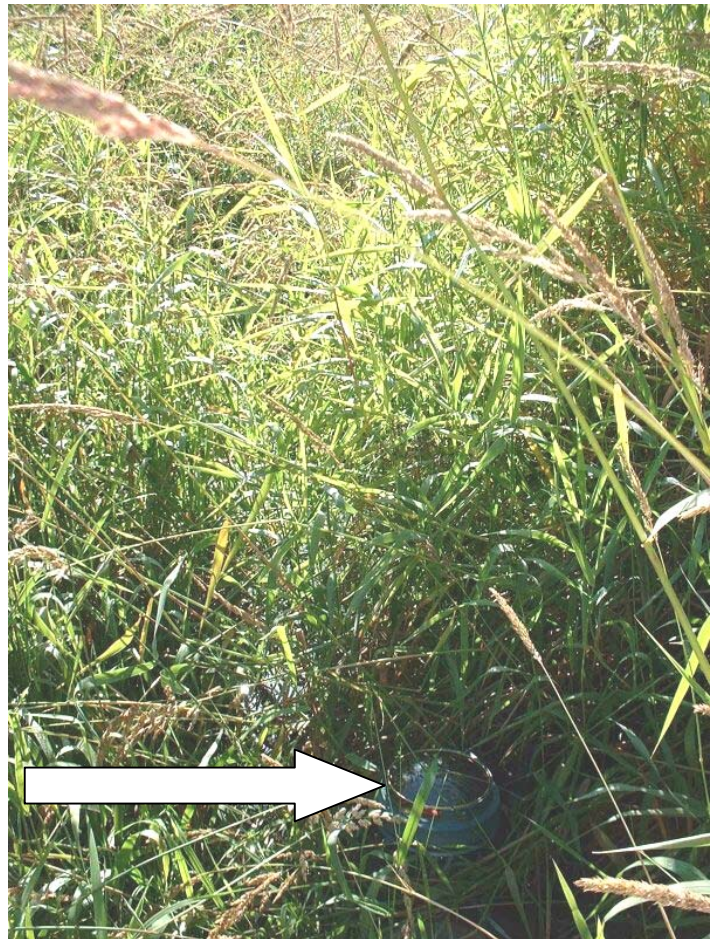
Figure 3.11. Solar pathfinder in Benson Creek.

The Solar Pathfinder has been used as an independent check on the quality of the output from SHADOW by ground truthing a reach that has been interpreted through aerial photos. The technique the Oregon Department of Environmental Quality (DEQ) uses is to identify reaches in the watershed that are close to categories chosen to represent the shade conditions. A fifty percent shade reach, for example, is identified from aerial photos, then, once on the ground, three Solar Pathfinder readings are taken, from the beginning, middle, and end of the reach. These values are then averaged and taken to be the true shade value for the reach. The idea is to train the eye of the photo interpreter to recognize the actual conditions. Unfortunately, we had trouble locating enough standard sites with the correct orientations, that hadn't been cut over to get a good representative sample of shade categories. The SHADOW model relies on the aerial photo interpretation (API) for overhang and shade density values,

so does not supply overhang or shade density as output, only total shade. Total shade for the aerial photo interpretation is not something that comes with the analysis. Shade density and overhang are estimated separately, with no estimate of total shade attempted. So...where is the value in comparing the different techniques? First, the comparison is JUST between the output from the SHADOW model and the Solar Pathfinder averages. This means we can compare total shade with total shade. Is there any utility in comparing the API values for overhang and shade density with Solar Pathfinder overhang and shade density? Possibly. But there are some caveats. First of all, the shade density measured by the Solar Pathfinder includes topographic shade, whereas the shade density measured in the API does not include topographic shade. The Solar Pathfinder looks at sunlight getting through the canopy to the dome, in contrast to the crown density estimate in the API. Therefore, the shade density from the Solar Pathfinder ought to always be higher than that of the API. The reason for mentioning this is only to point out that there is still some subjectivity involved in measuring shade.

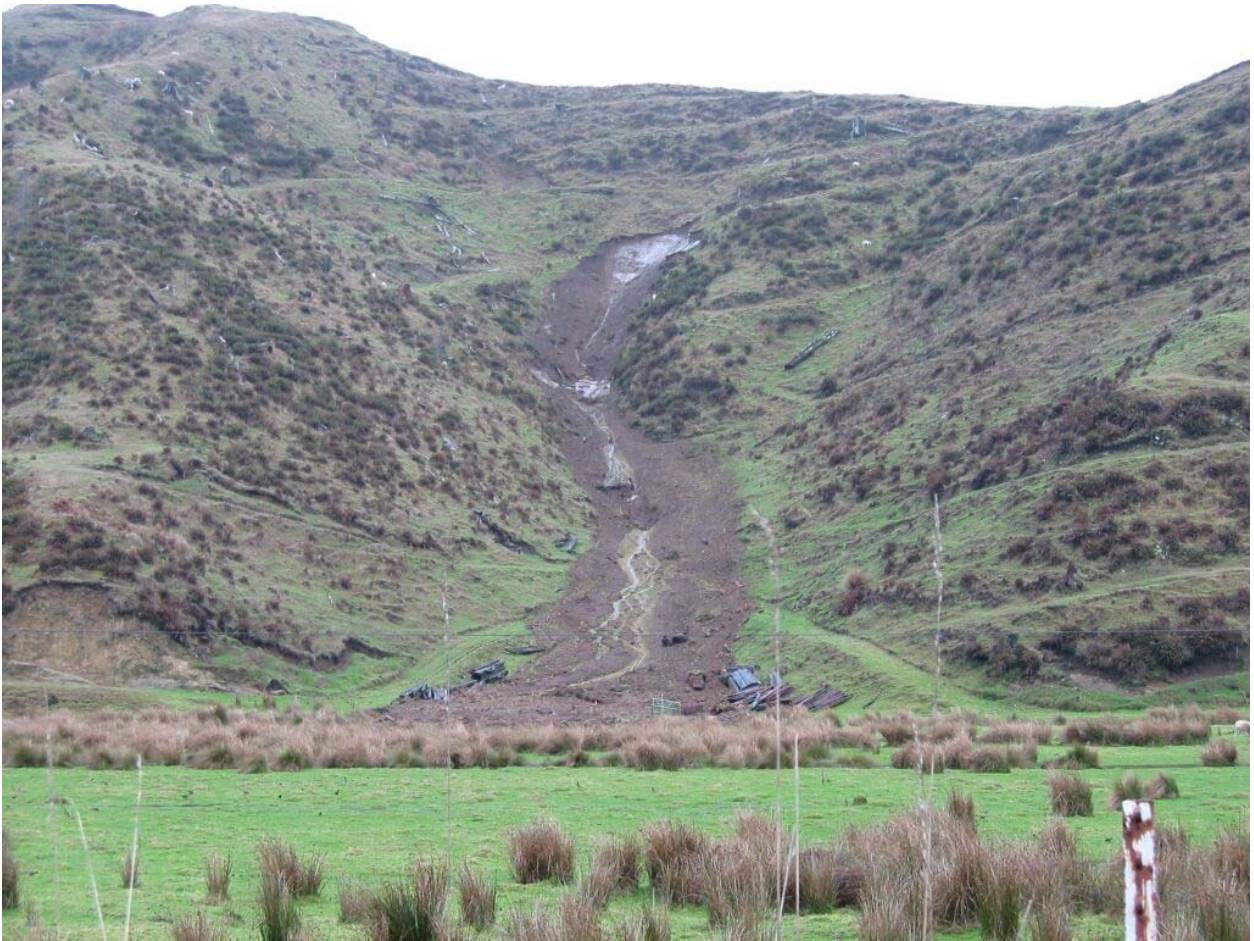
Figure 4.1. Mass wasting as a result of heavy rains.

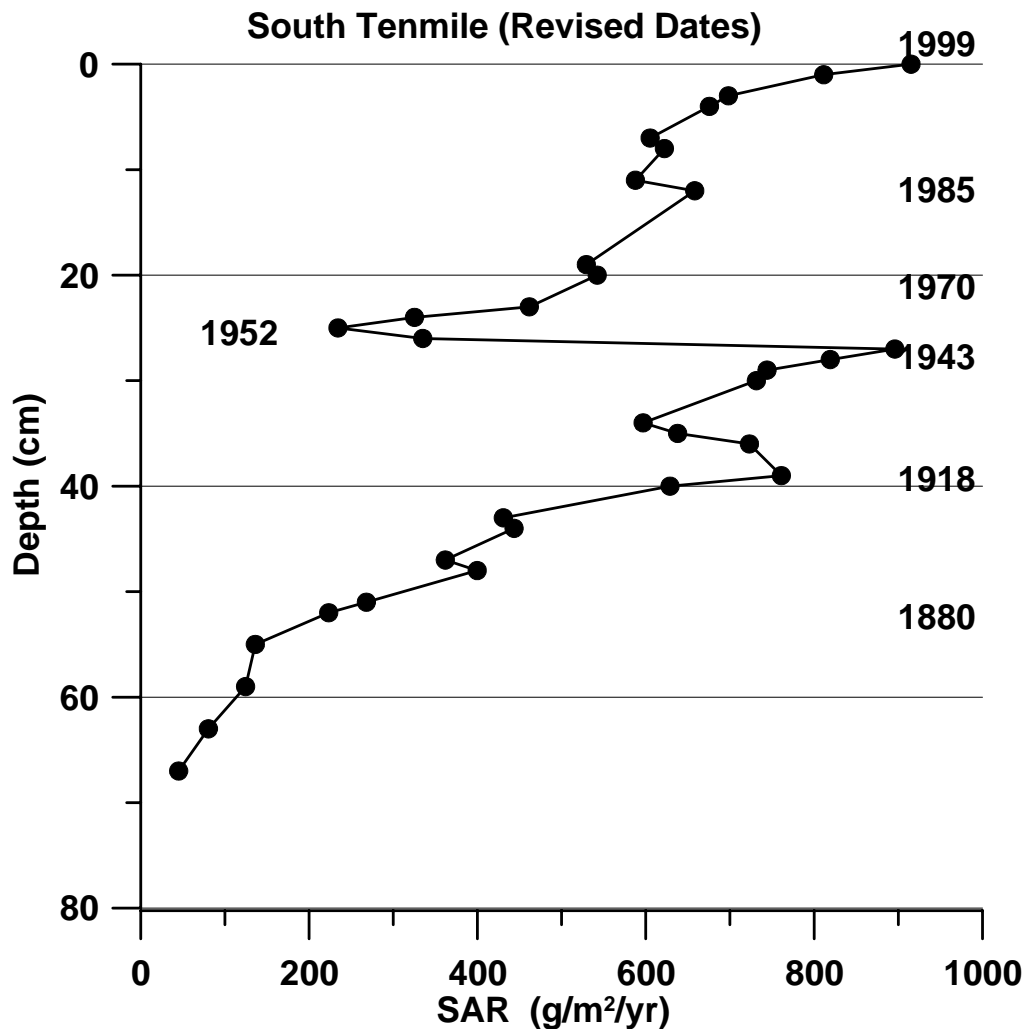
Figure 4.3. Sediment accumulation rate. J. Eilers et al.

South. It should be noted that the highest sediment accumulation rates were measured in the lakes not far from where the streams enter the lakes(see Map 4.3).

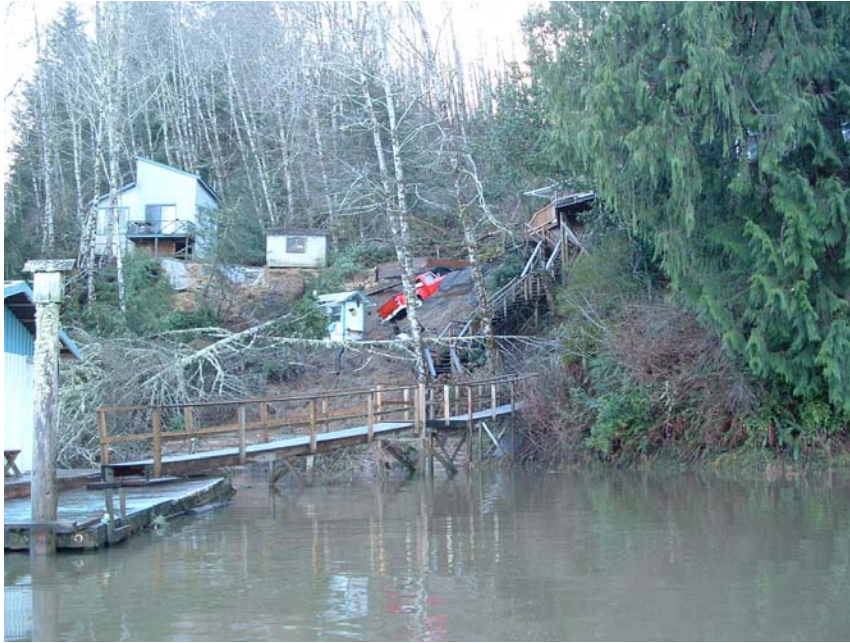
Figure 4.6 shows the effects of placing a septic system on a very steep slope. Not evident in the photo is the approximately 50% slope above the home. When a late December storm dumped eight inches of rain in thirty-six hours, the already saturated soil in the drain field gave way.

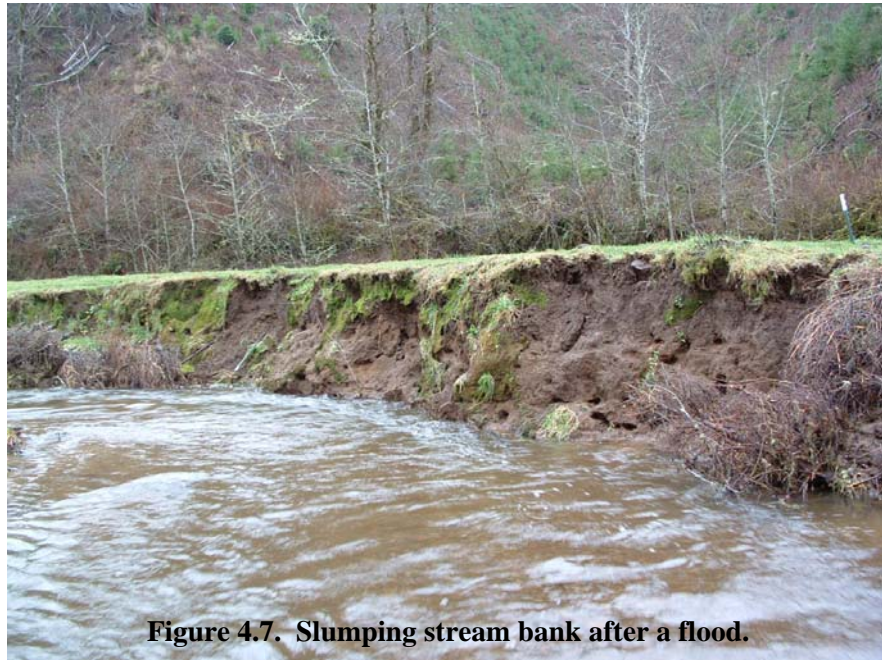
Figure 4.7. Slumping stream bank after a flood.

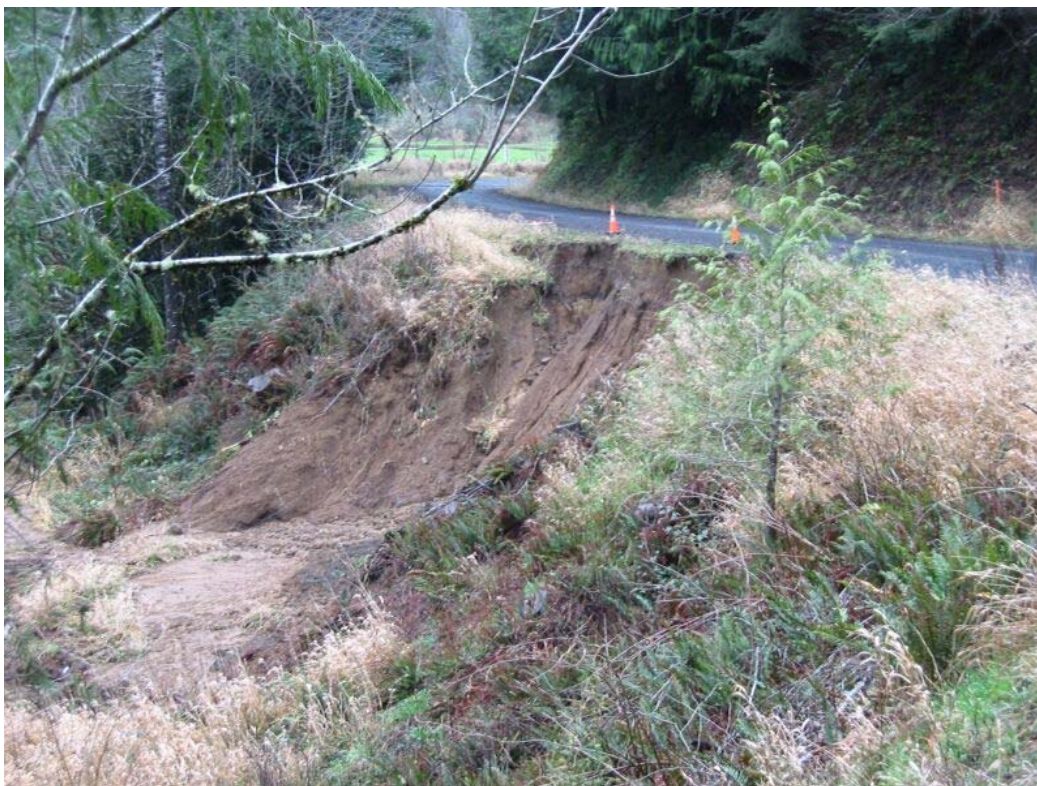
Figure 4.9. Road related mass wasting.

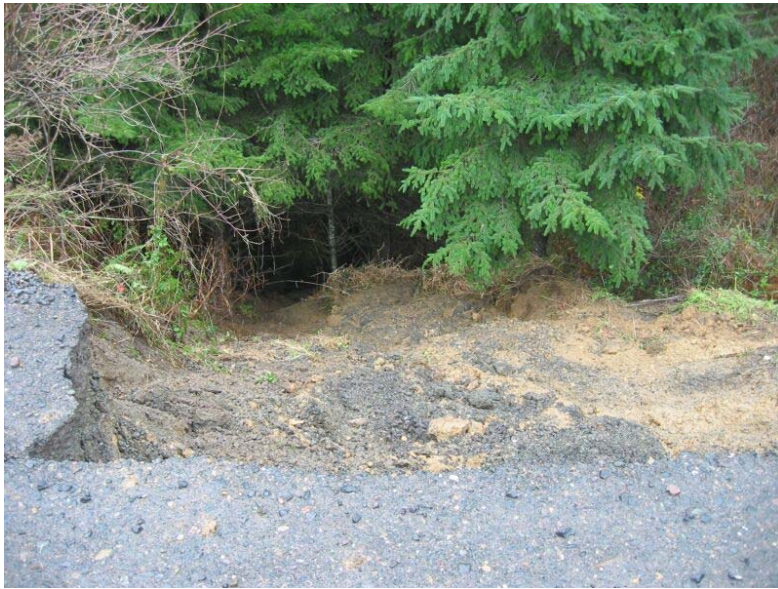
Figure 4.11. Road related landslide, moving downstream.

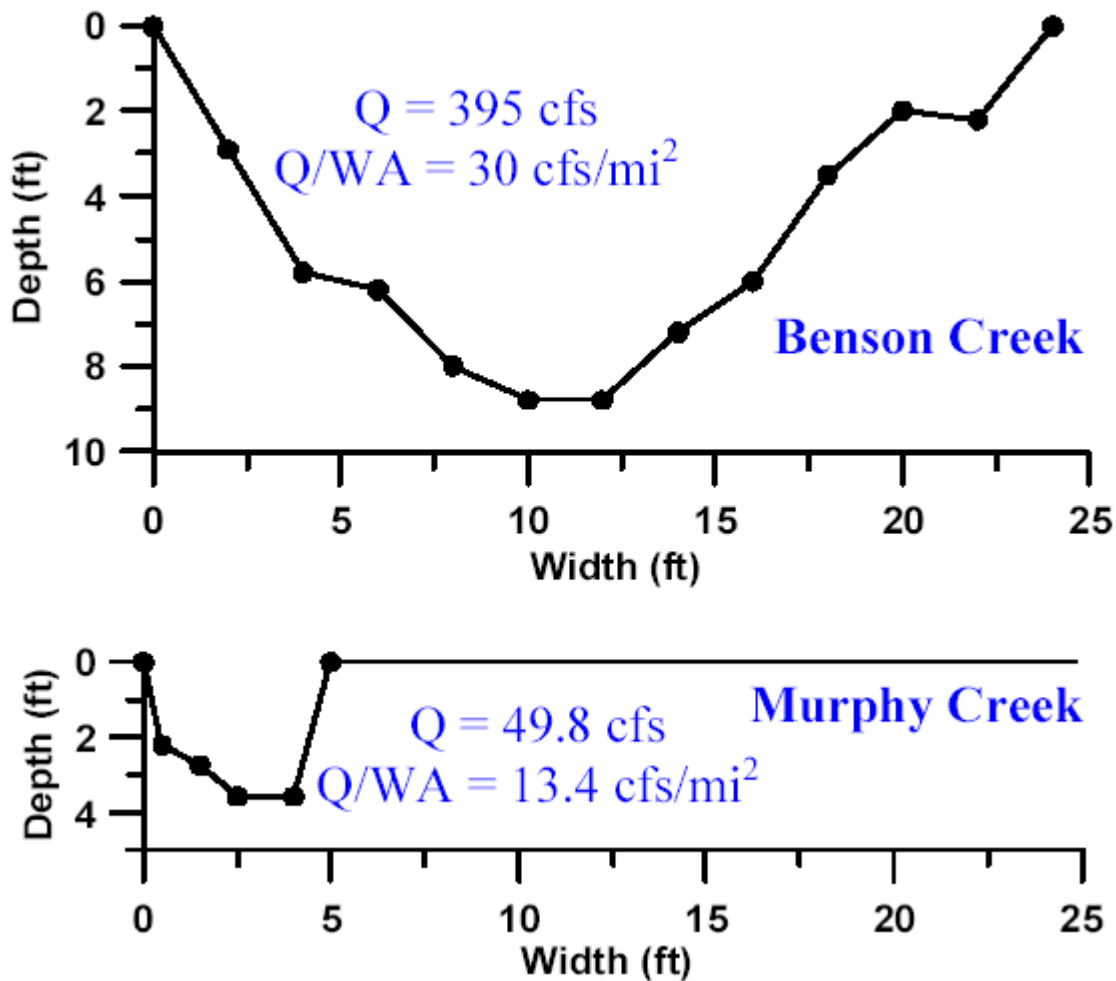
Figure 5.1. Stream channel cross sections for Benson Creek (top) and Murphy Creek (bottom) at the water quality monitoring sites. The stream discharge (Q, cfs) and discharge normalized per unit area (Q/WA, cfs/mi²) is shown for both sites at bank-full flows.¹³

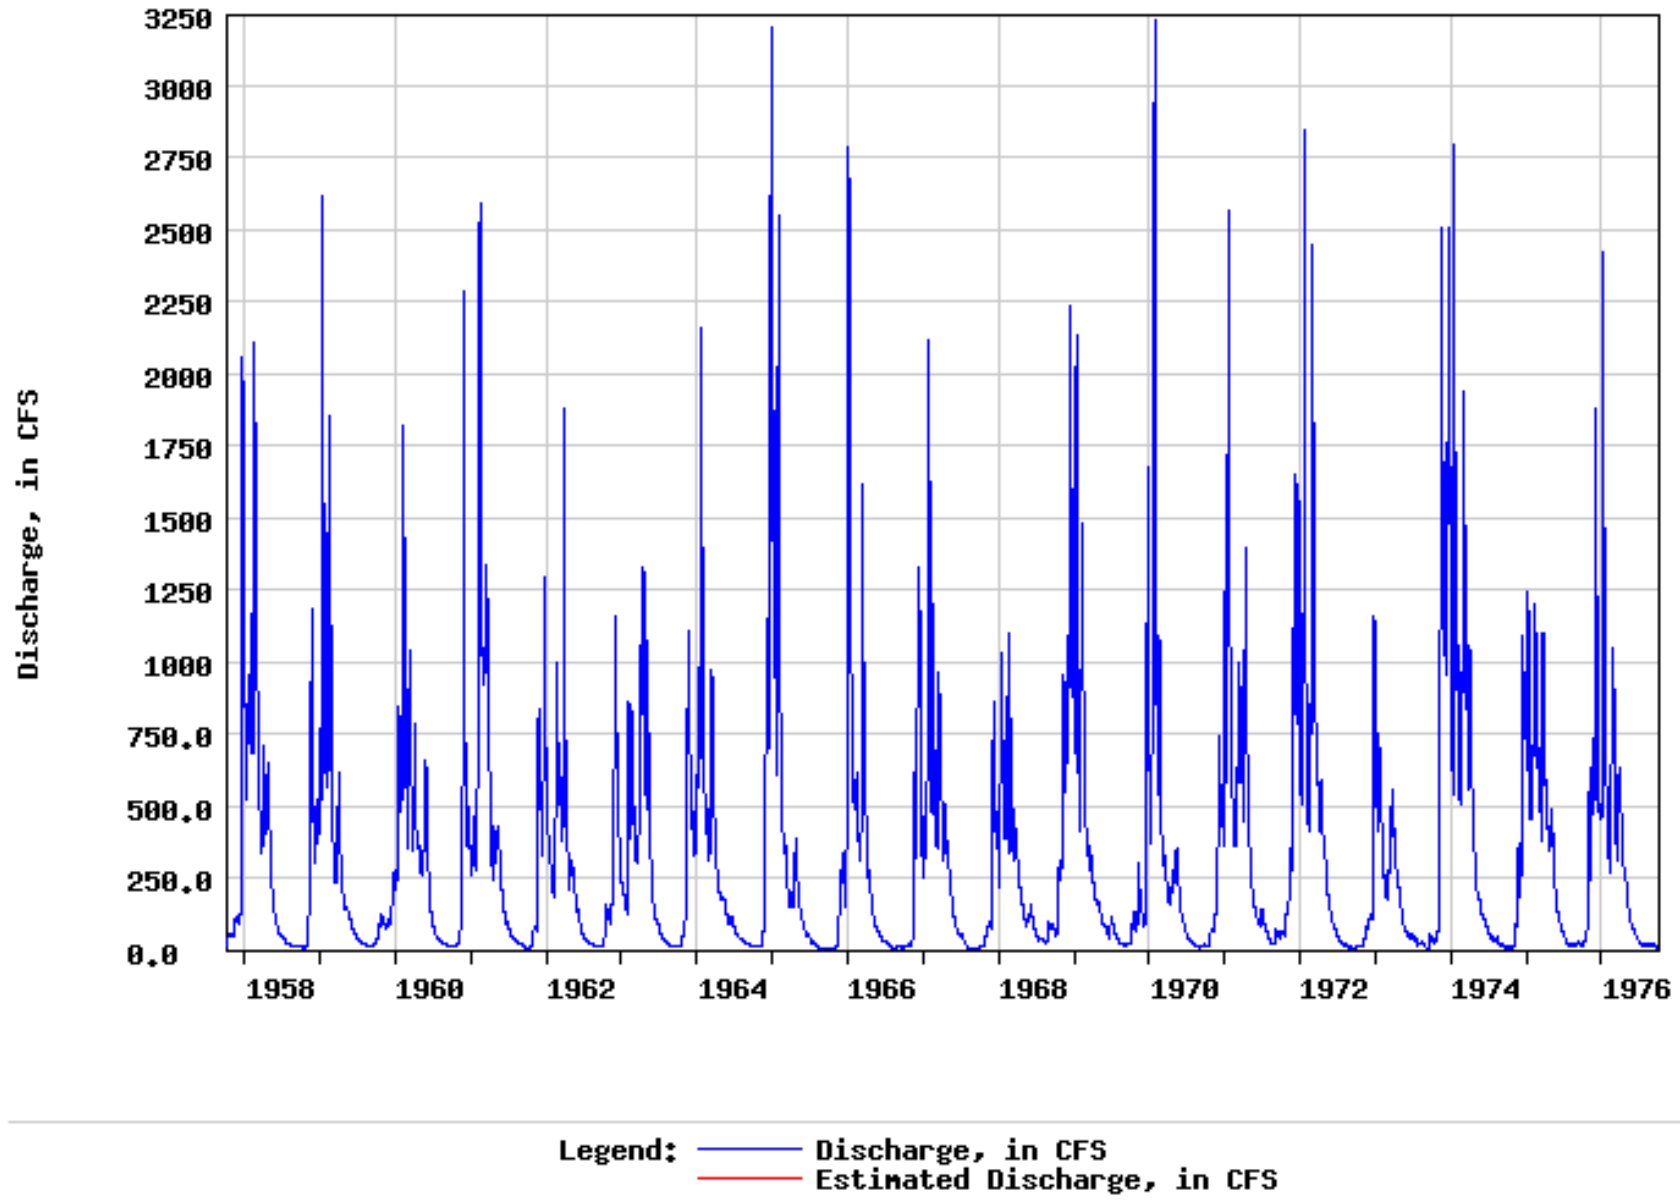
Figure 5.5. Hydrograph for Tennile Creek.
