## 98-275 Project Completion Report

**The Applegate River Watershed Council**

**ATTACHMENT B**  
**Water Quality in the Applegate River**

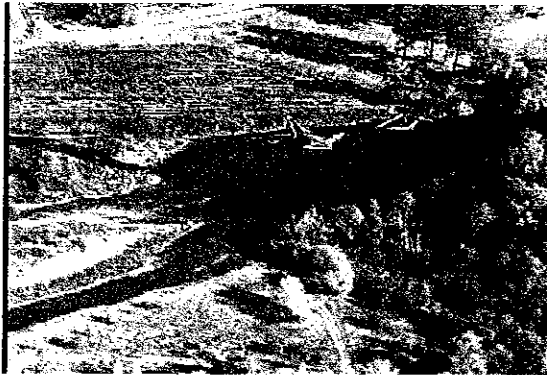
Little shade on the River

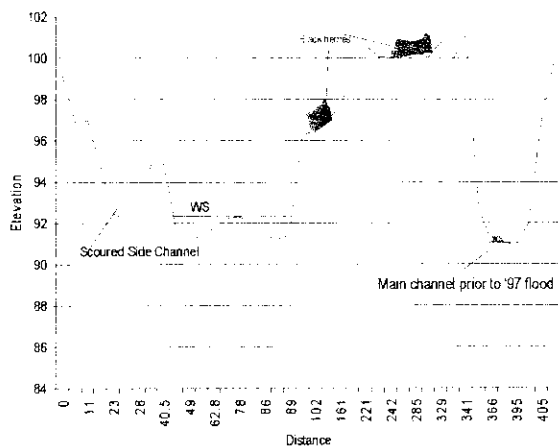
**Figure 23. Little Applegate Cross Section**

At the watershed scale, nearly all low gradient reaches have lost connection with the floodplain. Incision, or channel confinement, occurs when the channel bed drops in elevation, also known as bed degradation. Figures 23 and 25 display cross sectional profiles of channels that have incised into the floodplain.

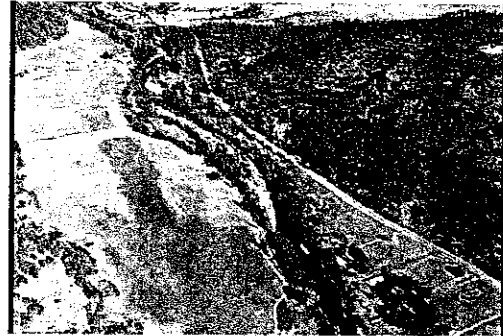
Channel incision on the Mainstem Applegate  
Photo Courtesy of Charles Rogers

Floodplains function to dissipate energy, provide off channel habitat and wetlands, and provide water storage for late summer cold water releases. These functions are essential for channel stability, rearing salmonids and riparian diversity. The ability of the floodplains to provide these functions has been greatly reduced across the Applegate River Basin.

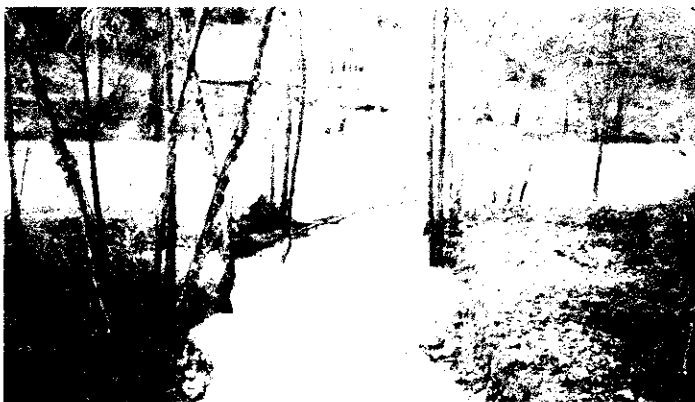
Figure 6. The mouth of Beaver Creek (2/18/99) during a 1.2 inch period of precipitation

The Applegate Dam acts as a huge settling pond for the upper Applegate River, so that the water discharged from the dam is relatively clean during winter flows. We did not sample the Applegate River above Cantrall Buckley Park, so we do not have a direct measure of the effectiveness of the dam in removing fines. Figure 6 shows that the mainstem is considerably cleaner than Beaver Creek, one of the streams with consistent low turbidity. In addition, one can estimate from data that we collected. Samples taken from the Applegate River at Cantrall Buckley Park include contributions from the Little Applegate River and Beaver and Palmer Creeks. During the November storm the turbidity at Cantrall Buckley Park was 161 and 106 NTU, while the Little Applegate was contributing water with turbidities of 358 and 498 NTU to the mainstem just a few miles upstream. This dilution in turbidity indicates that the river above the Little Applegate was relatively clean.
