**Livestock Nutrient and Sediment Monitoring for Total Maximum Daily
Load Development on Pedee Creek, Tributary to the Luckiamute River
Near Independence, Oregon**

**Conducted by
Volunteers from the
Pedee/Ritner Creeks Watershed Council**

**Livestock nutrient and sediment monitoring for TMDL development on Pedee Creek,
tributary to the Luckiamute River**

Project No.: 13-01

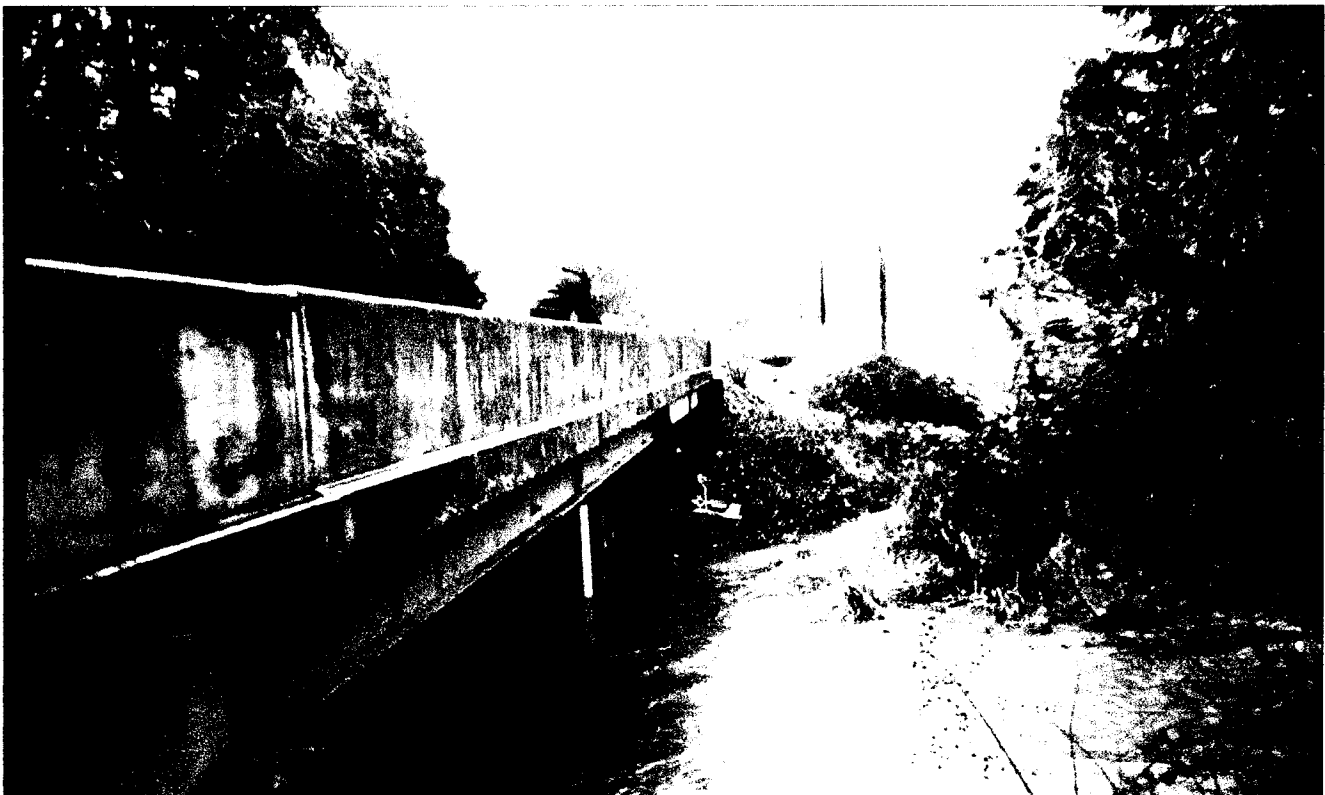
Photo 2 Bill Ferber (OWRD) measuring stream velocities from the Pedee Creek Bridge.

Water quality parameters were correlated to streamflow when possible. Two existing streamflow gaging sites on the mainstem Luckiamute were used to determine streamflow for weekly flow sampling. One site at Ira Hooker road, just downstream from the confluence of Pedee Creek was no longer maintained as an active gaging station. The staff plates located at the Ira Hooker site were only used for determining low flow minimums and were not visible during high flows. Additionally, no high flows measurements were recorded recently for accurate rating curve development. No usable data was recorded from the Ira Hooker gage. A USGS continuous recording streamflow gage operated on the Luckiamute at Helmick state park. Discharge was recorded from the OWRD realtime surface water website the day after sampling (USGS 2002) The Helmick State Park site was the lowest sampling site in the basin and was located downstream of the Little Luckiamute confluence, which is a significant tributary to the Luckiamute. Attempts were made to estimate flows at other sites based on drainage area calculations based on regional flow equations (Dunne 1978), but testing of the equations on sites with known flows gave erratic predictions so the process was abandoned. This development meant only two of the six weekly sampling sites were adequately gauged. Two additional staff plate flow gages were established on Pedee Creek. Stage heights of up to 10 feet could be read from the gage on Pedee Creek at Highway 223. An additional staff plate was installed on South Fork Pedee Creek near the confluence with the mainstem, however due to flood damage the gage was moved to the Pedee Creek road bridge abutment. This site was usable only during high flows and the data collected was of limited use. Volunteers recorded water elevation based on stage heights each time Pedee Creek was sampled. Stage levels were then correlated to flow by developing a rating curve from actual measured flows. Flows were measured using a Rickly AA current meter and a OWRD bridge mounted velocity meter.

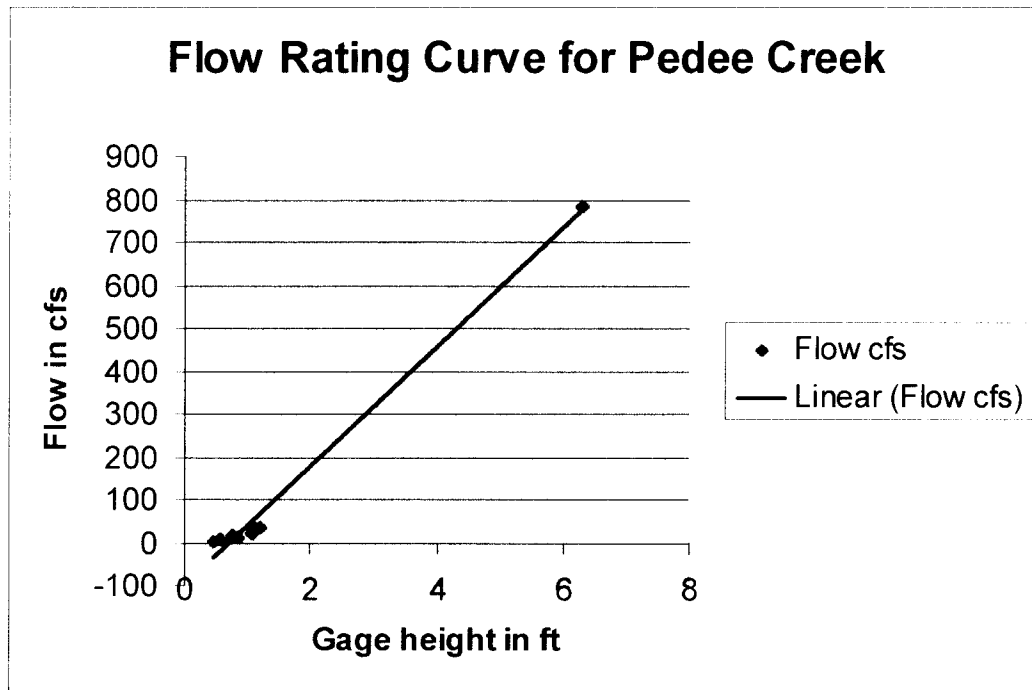
Figure 4. Rating Curve for gage on lower Pedee Creek at the Highway 223 Bridge.

Stream flow measurements at the Hwy 223 bridge over Pedee Creek resulted in a rating curve for the newly installed staff gage. Only one large storm flow was measured due to scheduling conflicts with OWRD personnel. The rating curve is shown in figure 4.

The equation for the line was $Y=138.716X-98.63$. The $R^2=0.9956$, however the standard deviation of the data set is 270.13 which indicates possible error in the line equation. The observation of negative value flows when readings are below 1 foot on the gage is oddly correct. Silt has settled around the lower portion of the gage, giving the impression that flows can not be read when flows expose the silt, which happened once during the May weekly sampling. The lack of data for large storm flows is the most likely factor limiting the usefulness of this rating curve. Future sampling plans include additional flow sampling at a wide range of flows and recalculation of the rating curve.

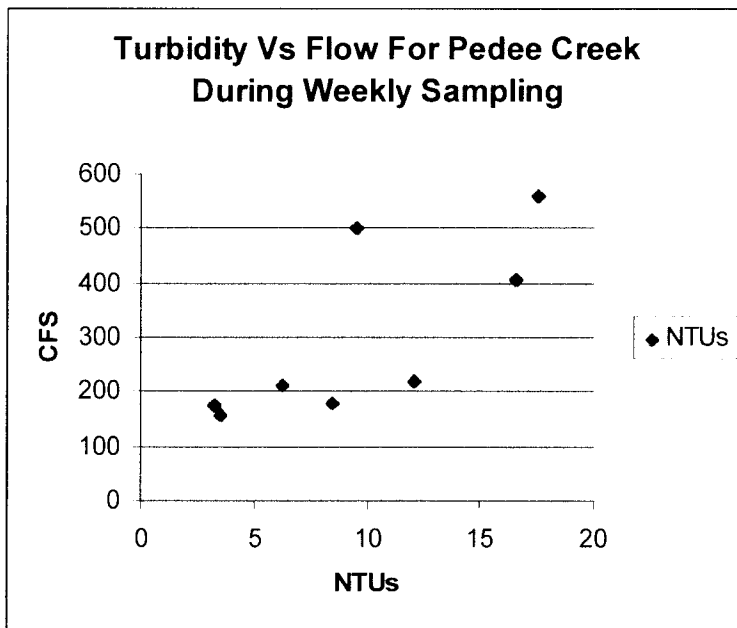
Weekly storm sampling from November through January resulted in 56 samples taken for each parameter. No weekly *E. coli* samples exceeded the single event (406 colonies/100 ml) or the monthly log mean standard (126 colonies/100 ml) more than twice in one month criteria. Turbidity values taken during weekly sampling did show a correlation with flow for Pedee Creek at the Hwy 223 bridge ($r^2=0.752$) (figure 5).

Figure 5. Turbidity vs flow for Pedee Creek during weekly sampling, winter 2001/2002
 Turbidity did not show as direct a relationship for the Luckiamute site $r^2=0.595$ (figure 6)

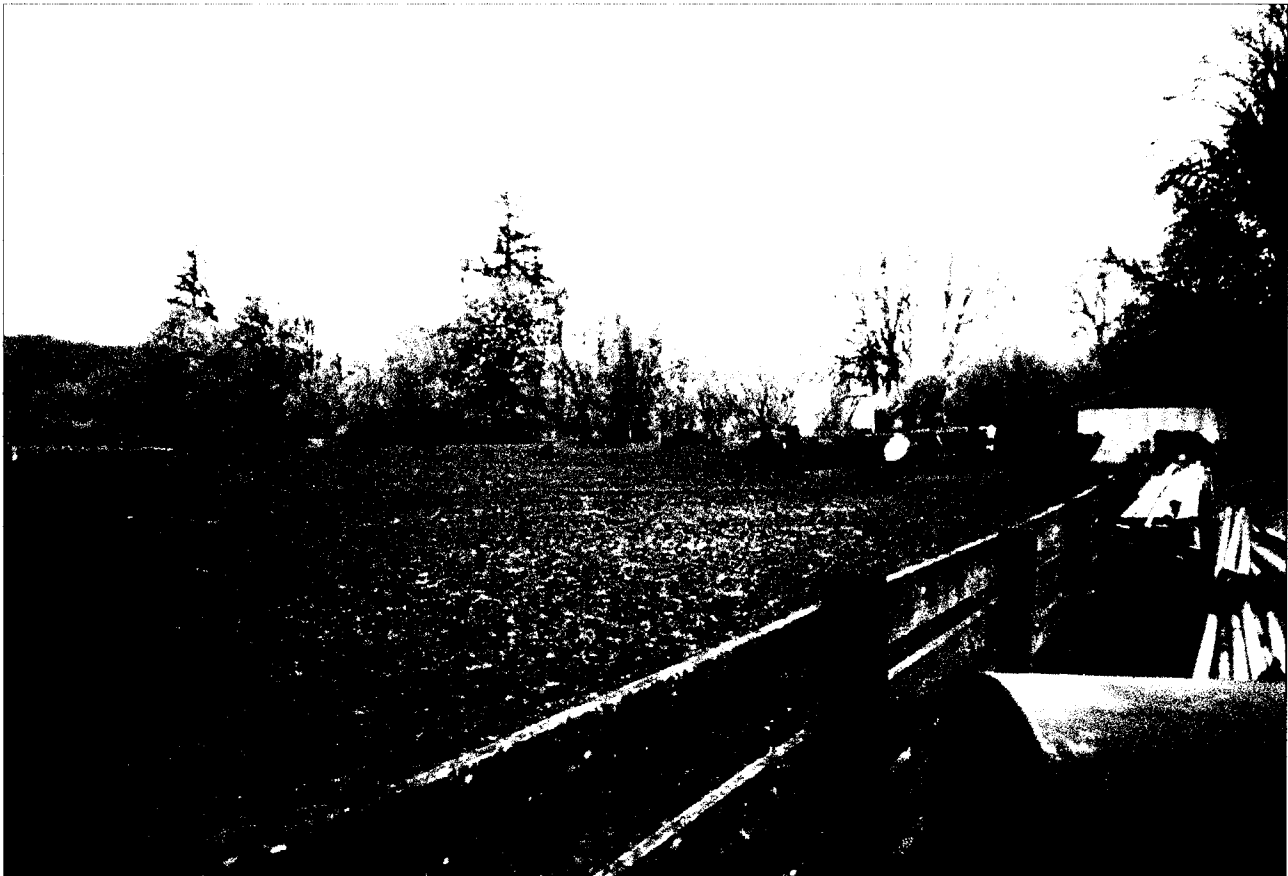
Photo 3 includes an example of denuded pasture within the 100 year floodplain

Visual estimates of soil disturbance were made on November 27, 2001 and March 6 2002. Volunteers drove along Pedee Creek Road, Ronco Road, the 1400 line Road and Kings Valley Highway within the Pedee Creek watershed and made acreage determinations of bare soil within the 100 year floodplain caused by livestock. Floodplain boundaries were difficult to ascertain, despite the map, because there are no definitive terraces or other geomorphic features to correspond to the floodplain width. Volunteers estimated only 4 acres of disturbed soils and 1 barn within the 100 year floodplain, however an additional 8 acres outside of the floodplain but adjacent to seasonal ditches were also observed within the agricultural portion of Pedee Creek during the first storm sample. Areas denuded of soil had increased by approximately 2 acres during the second storm sample. These estimates were compared to pollution data. The results are shown in table 4. No obvious connection exists between areas of denuded soil and bacteria concentrations however the relatively small sample size makes interpretation difficult. A barn and recently vacated 2-acre sacrifice pasture was observed adjacent to the South Fork of Pedee Creek but were not located on the 100 year flood hazard map, likely due to an oversight by mapmakers. Additional sacrifice pasture acreage was observed outside the 100year floodplain boundaries. These pastures were located adjacent to flowing ditches that could transport pollution to Pedee Creek in a matter of minutes. Although combining these sites with floodplain data did not change the results, it is possible these areas are contributing pollution. This issue was not sampled to avoid a point source determination, however, the issue is also not addressed in the Mid-Willamette Ag. Water Quality Management Plan.

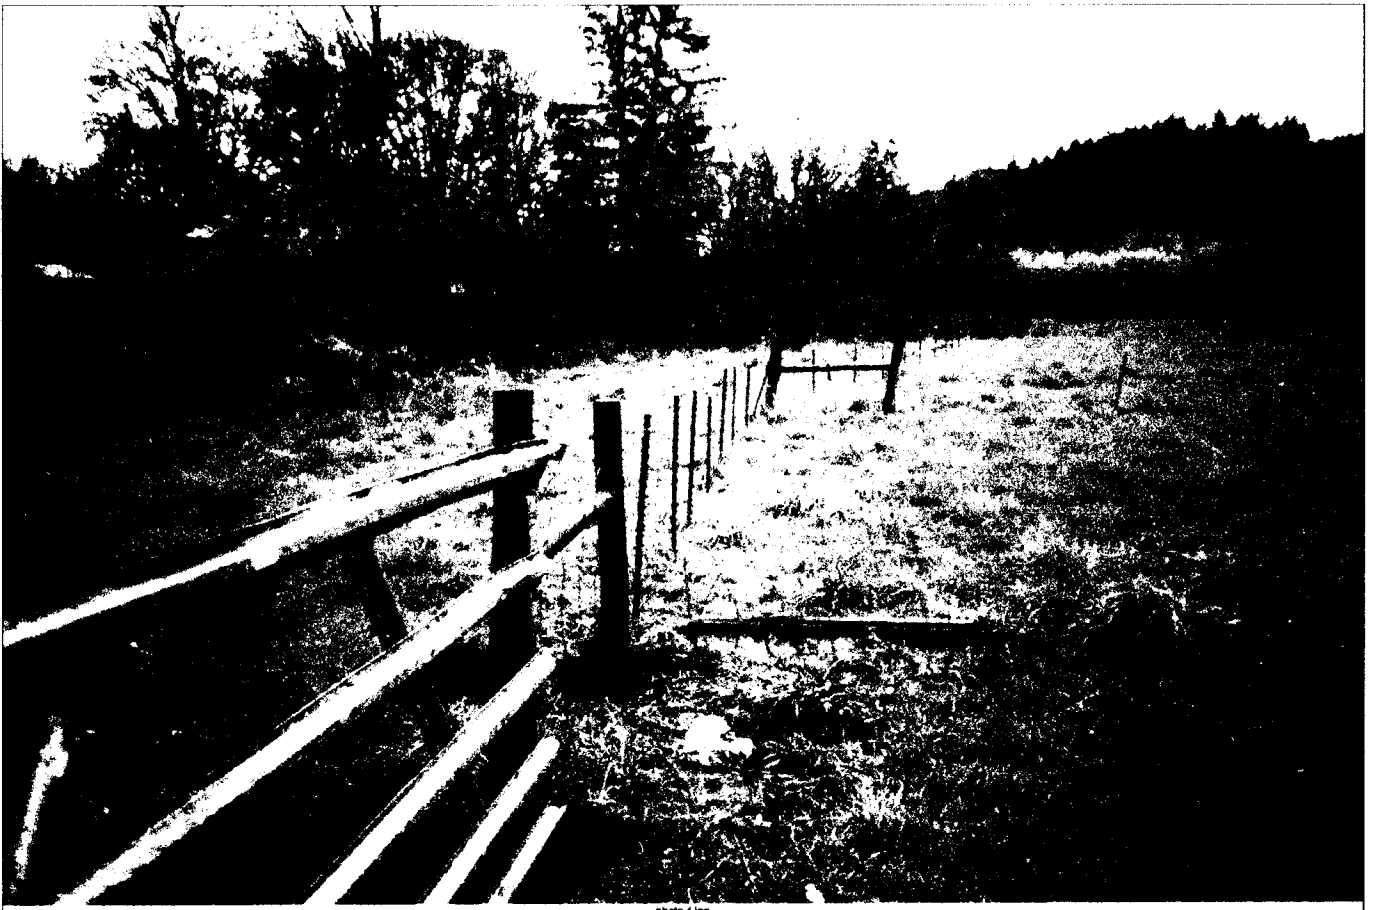
Photo 4 demonstrates some of the immediate fencing work livestock producers completed to limit livestock access to streamside areas. Note the new planting of conifer trees behind the fence

Members of the Pedee/Ritner Creeks watershed council initiated voluntary changes in an attempt to limit contribution of pollutants. All livestock producers reduced the numbers of animals they wintered in the valley. Sheep numbers were reduced by ½ and cattle numbers were reduced by 30% of 2001 levels. Additionally, some livestock producers took immediate steps to limit livestock access to riparian zones, created buffer strips, set out erosion control straw bales, planted buffer zones and made sure they conformed to incoming Agricultural Water Quality Management Plan rules. Other producers took additional interest in federal programs to create buffer zones and other water quality improvement projects. Additional livestock management changes have included designing manure storage sheds to avoid run-off from outside manure piles, moving livestock feeding locations away from waterways, placing rock to control mud production and building interior pasture fences that limit livestock access to ditches. These actions have been undertaken in order to reduce the pollution contributions and to demonstrate proactive measures in case regulatory agencies investigate. As one council members stated, “we let the cards fall where they may, now we need to play the hand.”
