New River, Sixes River, Elk River, and Euchre Creek Tidal Wetlands Assessment

September 20, 2016

In partial Fulfillment of requirements of OWEB grant #214-2050
Prepared for the South Coast Watershed Council

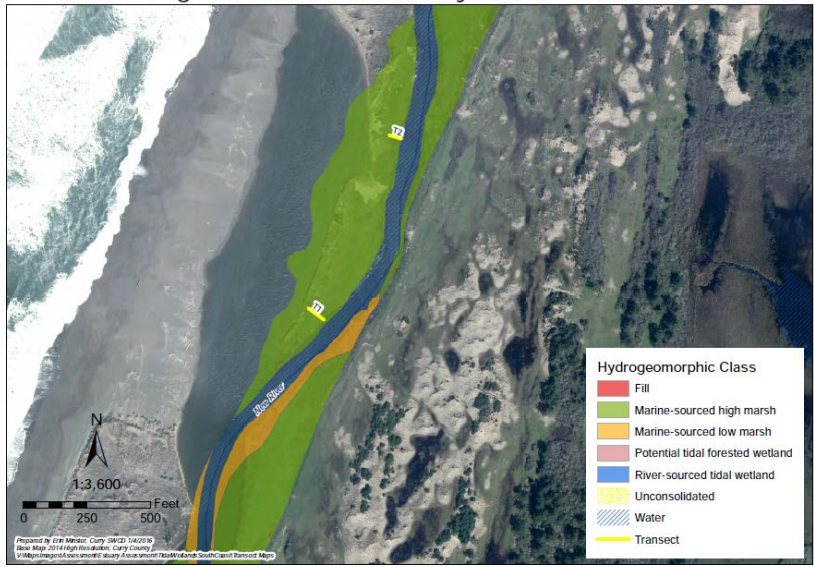
Figure 15: New River Vegetation Transects – Clay Island Breach Site

New River Tidal Wetland Assessment
Vegetation Transects--Clay Island Breach Site

Transect #1 Quadrats #1-8: The transect sampling began on the east bank and heads to the west. The transect ends at upland vegetation. The transect begins at the waters edge and the first sampled quadrat contained 95% *Sparganium emersum* and 5% *Carex obnupta*. The transect crosses a sedge marsh dominated by *Carex obnupta* in quadrats 2, 3 and 4. *Potentilla anserina* spp *pacifica*, *Agrostis stolonifera*, *Deschampsia caespitosa*, and *Juncus ensifolius* were the sub-dominant species of this transect.

Transect #2 Quadrats # 9-20: Transect 2 starts on west shore bank near the southern end of island and extends approximately 65 feet east. The transect begins in a site partially submerged containing *Lilaeopsis occidentalis* (67%), *Potamogeton crispus* (28%), *Myriophyllum spicatum* (5%), *Eleocharis palustris* (5%) and *Schoenoplectus americanus* (4%). The transect crossed a high marsh dominated by *Potentilla anserina* spp *pacifica*, *Agrostis stolonifera*, *Lotus corniculatus*, *Hordium brachyantherum* and *Juncus balticus*. The west bank of the island showed the greatest diversity of species; *Gnaphalium* spp, *Holcus lanatus*, *Juncus bufonius*, *Oenanthe sarmentosa*, *Trifolium rapens*, and *Achillea millefolium*.

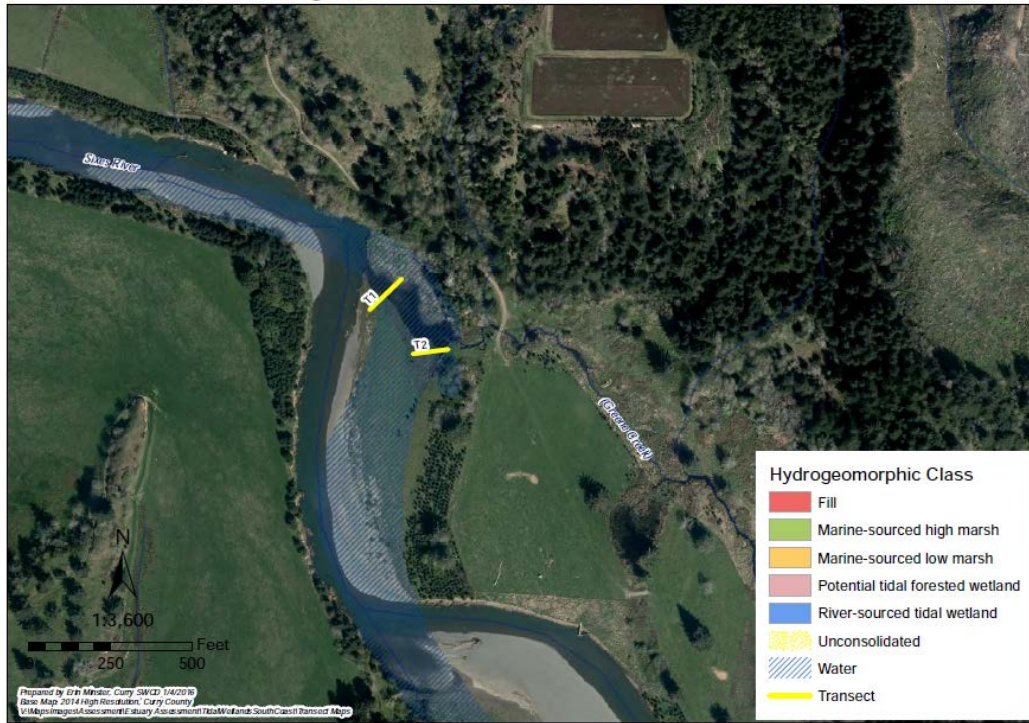
Figure 20: Sixes River Vegetation Transects Orchard Hole

Sixes River Tidal Wetland Assessment
Vegetation Transects--Orchard Hole

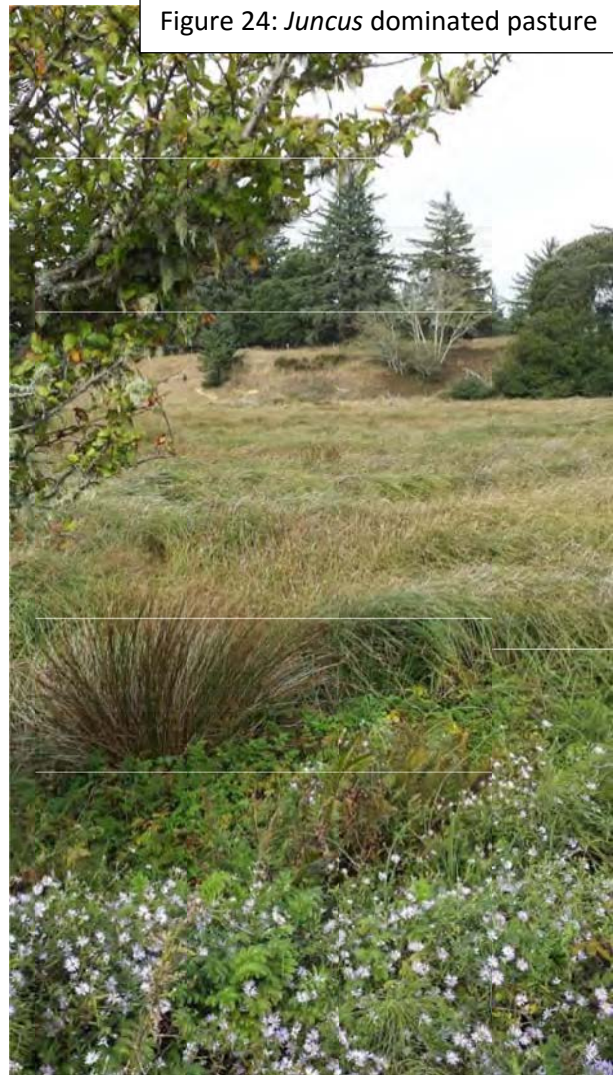
Figure 24: *Juncus* dominated pasture

Wetland indicator species increased to the north, consisting of wetland obligate *Potentilla anserina* (silverweed), and facultative wetland species, *Juncus hesperius* (bog rush) and *J. effusus* (soft rush). In two quadrats, *Carex obnupta* (slough sedge) dominated the *Juncus* species (79% maximum cover). See Figure 24.

Quadrat #3 is located in a wet swale, pugged by livestock, accounting for the estimated 10% bare soil cover. Wetland obligate species in the swale include *Eleocharis palustris* (25%), *Oenanthe sarmentosa* (10%), *Veronica americana* (8%), *Carex obnupta* (4%), and *Callitriche spp* (3%). Facultative wetland species include *Juncus hesperius* (15%), *Juncus balticus* (10%), and *Epilobium ciliatum* (3%).

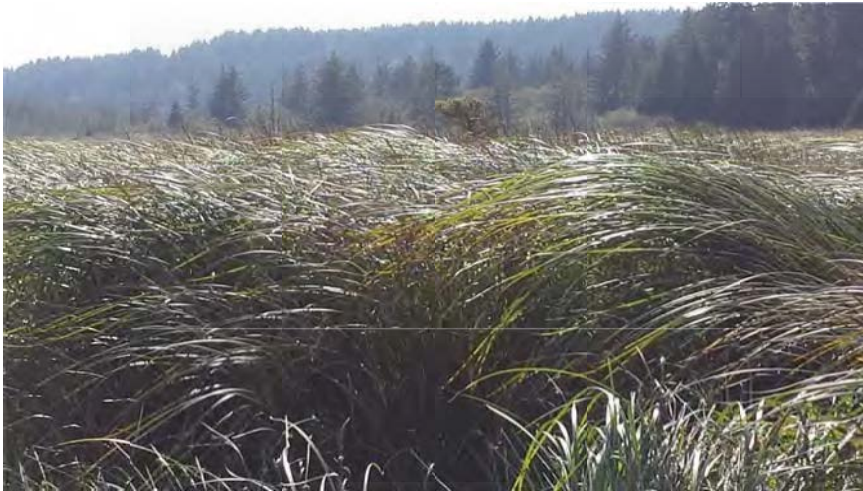
Figure 25: *Carex* dominated wetland

Transect 2 Quadrats #16-26: The photo (Figure 25) shows the view along transect 2, from the end on Cape Blanco Road to the beginning at the base of the hill. Wetland obligate, *Carex obnupta* dominates most of the quadrats, while *Juncus hesperius* is also abundant. In more open areas, *Oenanthe sarmentosa* comprises up to 35% and *Potentilla*

Figure 25 is a photograph taken from a quadrat dominated by *Carex obnupta*.

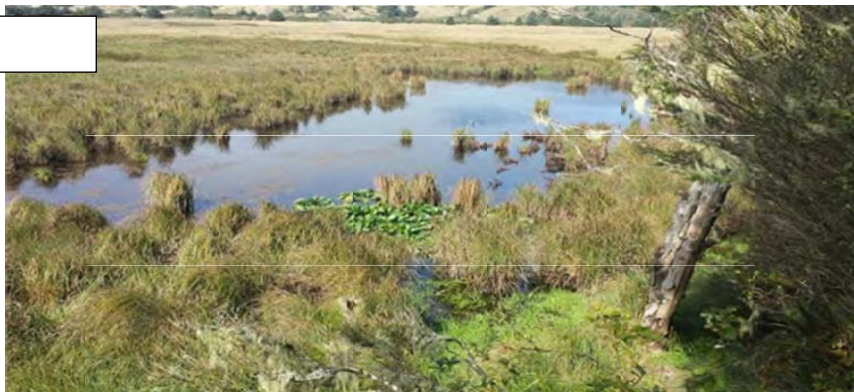
Figure 26: Ponded site

Along the margin of the ponded area to the east of the oxbow, near the hill, both wetland and upland species are in close proximity. Native wetland obligates include *Lysichiton americanus* (skunk cabbage), *Oenanthe sarmentosa* (water parsley), and *Potentilla anserina* (silverweed). Additional observations and plant collections would be required to determine whether the bur reed, *Sparganium*, is the native *S. eurycarpum* (broadfruit bur reed) or the introduced *S. emersum* (European bur reed). Also to be determined is whether the *Persicaria spp* (smartweed) is native, among 5-7 species in Curry County. From a distance, the pond lily (Figure 26) was tentatively identified as the invasive *Nuphar lutea*.

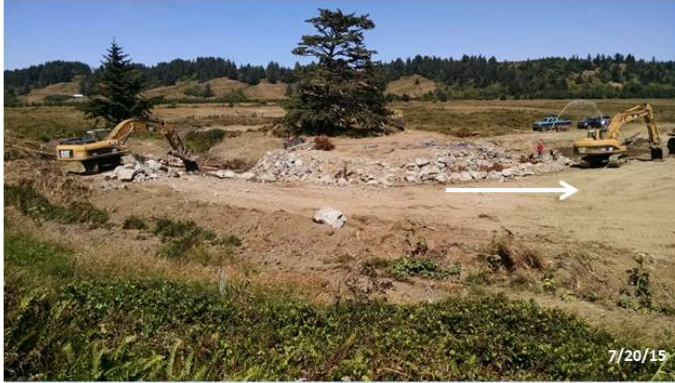
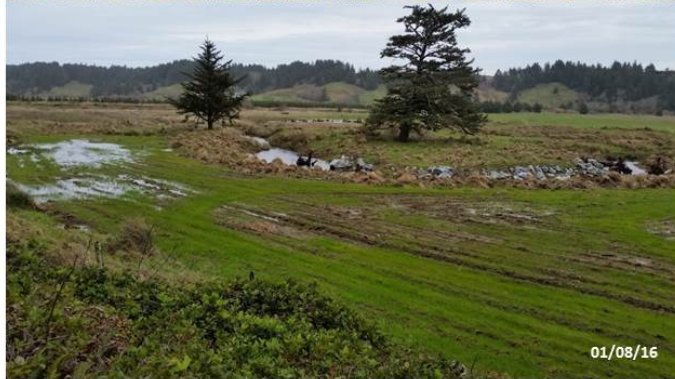
Figure 31: Sullivan Gulch Channel
Realignment and large wood placement

Sullivan Gulch
Channel Realignment
Summer 2015

Photo point 4.
Looking Northeast.

Grade control drop
structure with large
wood placement.

During and after
construction.

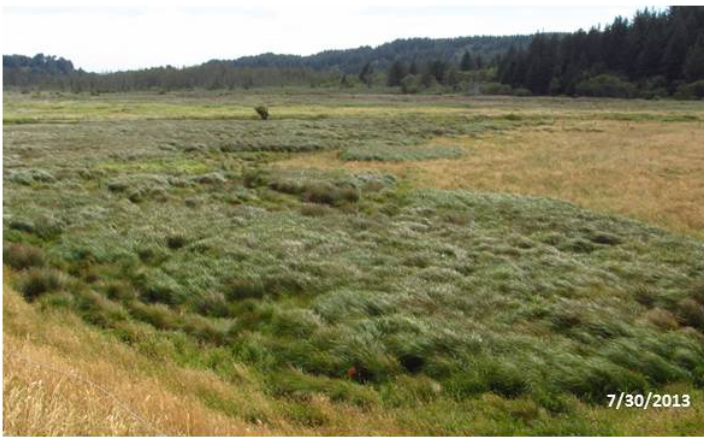
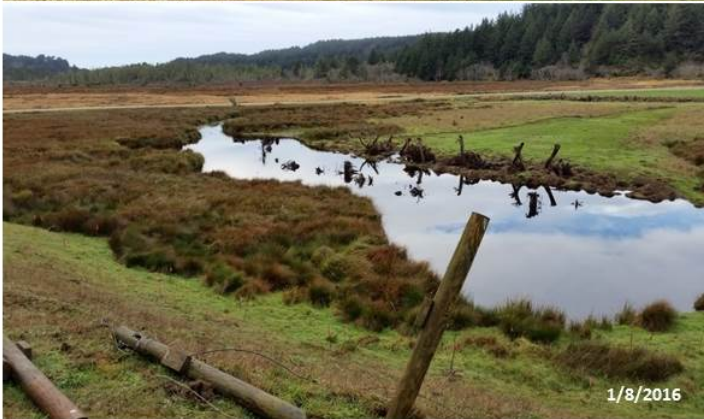
Sullivan Gulch
Channel Realignment
Summer 2015

Photo point 1.
Looking South.

Backwater area 4 with
Cape Blanco Road in
background. Before
and after construction.
