Rock Creek Region

Assessment and Action Plan

March, 2006

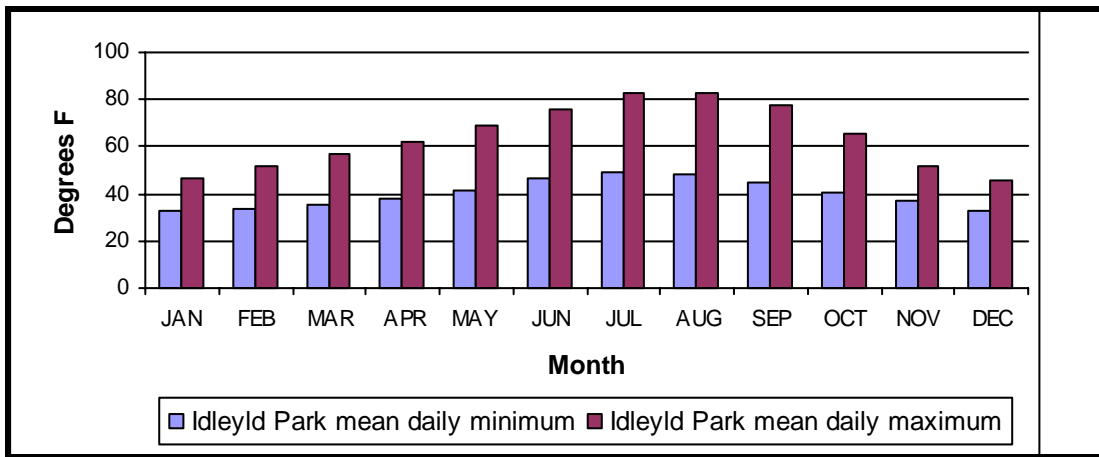
Figure 1-1: Average minimum and maximum temperature for Idleyld Park (station #4126).

A climate station (station #4126) that collects both temperature and precipitation data is located at Idleyld Park just west of the Rock Creek Region at 1,080 feet in elevation.¹⁰ This station has collected daily weather data for the last 45 years. As the ecoregion information indicates, temperatures are generally mild. Figure 1-1 shows the average daily minimum and maximum temperatures by month for Idleyld Park. Maximum temperatures in the summer are generally in the mid 70s or low 80s. Minimum winter temperatures are usually just at or above freezing.

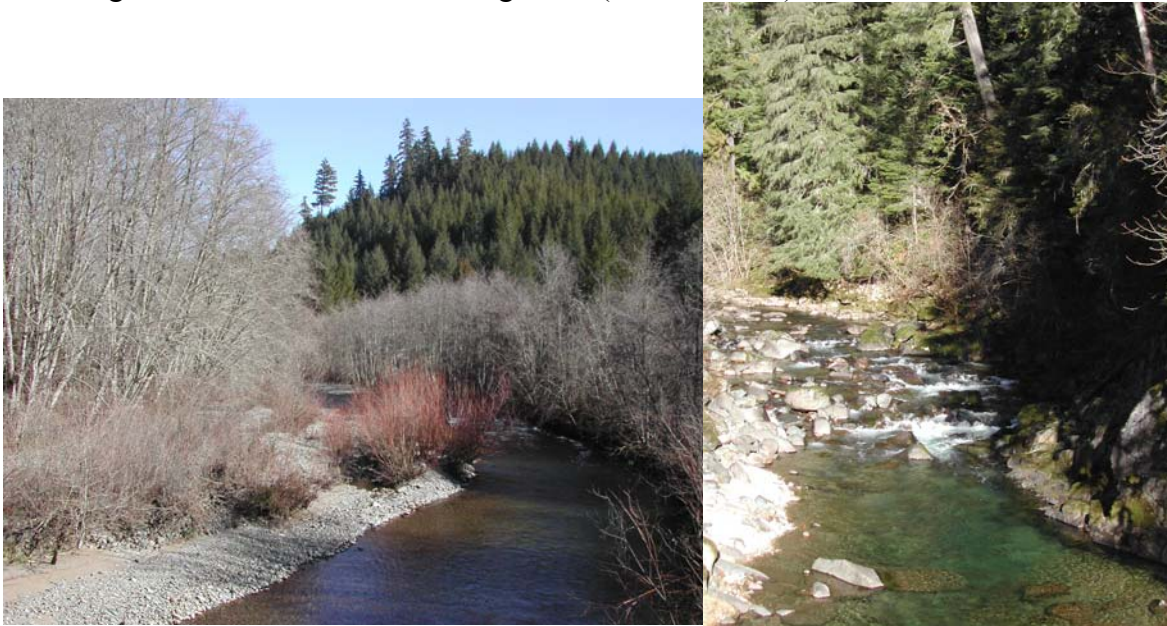
Photo 3-1: Rock Creek (at left) is an unconfined channel with frequent gravel bars and wide meanders. Flooding of the riparian vegetation is not uncommon. Canton Creek (at right) is a confined channel with more cobble and boulder substrate. Riparian vegetation is more dominated by conifers.

Canton Creek is a mostly confined depositional stream that moves water at higher velocity between step-pools. Water slows at the pools allowing deposition of material before again picking up speed to the next step-pool. There are a few small moderately confined segments on Canton Creek that allow some channel widening. Overall, it tends to move water at higher speeds than Rock Creek and the substrate that is deposited tends to be larger cobble rather than smaller gravels (see Photo 3-1).

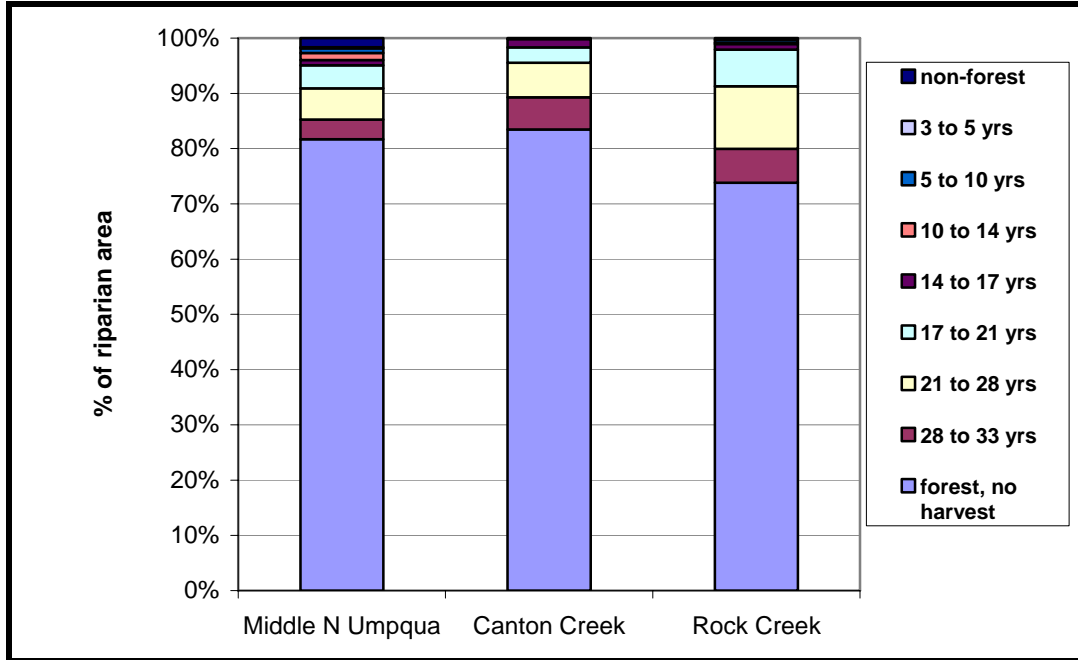
Figure 3-1: Timber harvest, non-forest, and forest, no harvest acres between 1972 and 2002 for all ownership within 200 feet of streams in the Region.

Figure 3-1 shows that over 80 percent of the riparian areas in the Middle North Umpqua and Canton Creek watersheds and 74 percent in the Rock Creek Watershed have not been harvested in the last 33 years. However, approximately 21 percent of the riparian areas in the entire Rock Creek Region have been harvested since 1972.

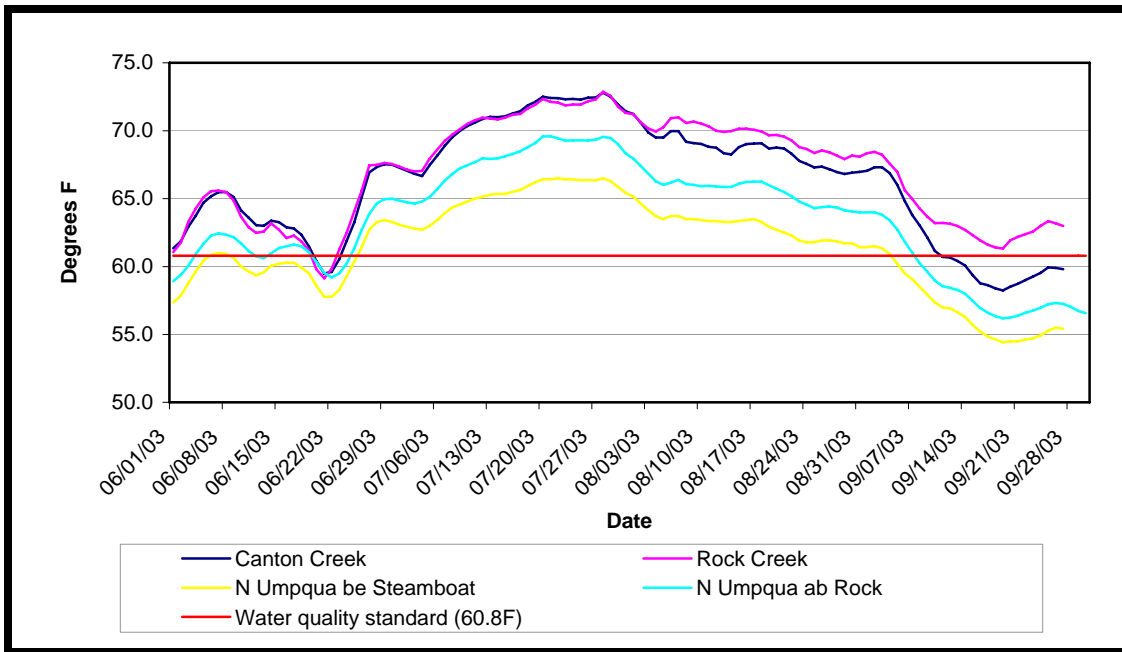
Figure 3-3: Seven day moving average maximum stream temperatures in 2003 for the main channels in the Rock Creek Region.

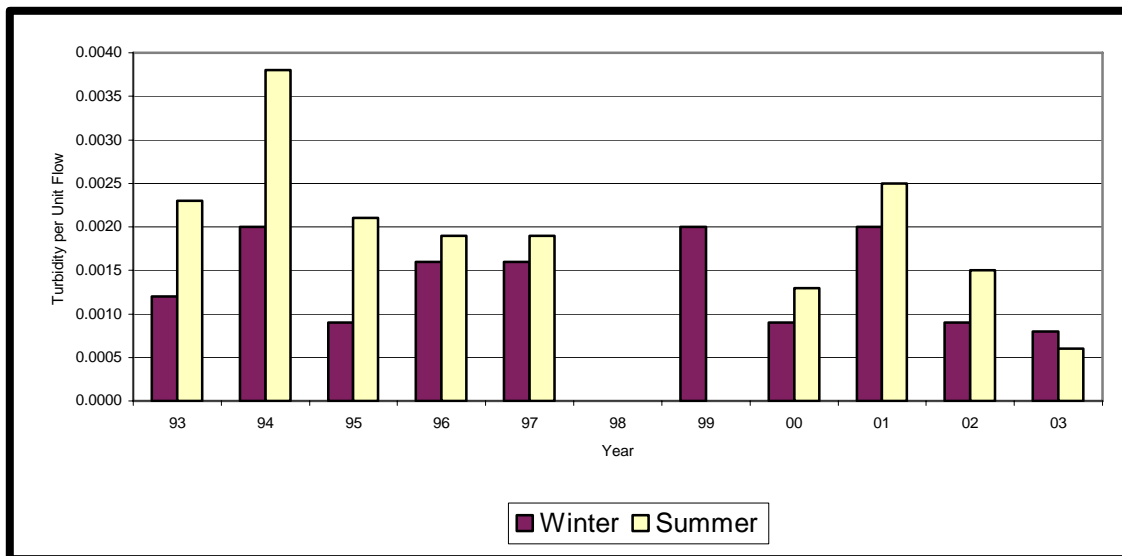
Figure 3-7: Turbidity in the summer and winter relative to stream flow in the North Umpqua River above Rock Creek.⁶⁹

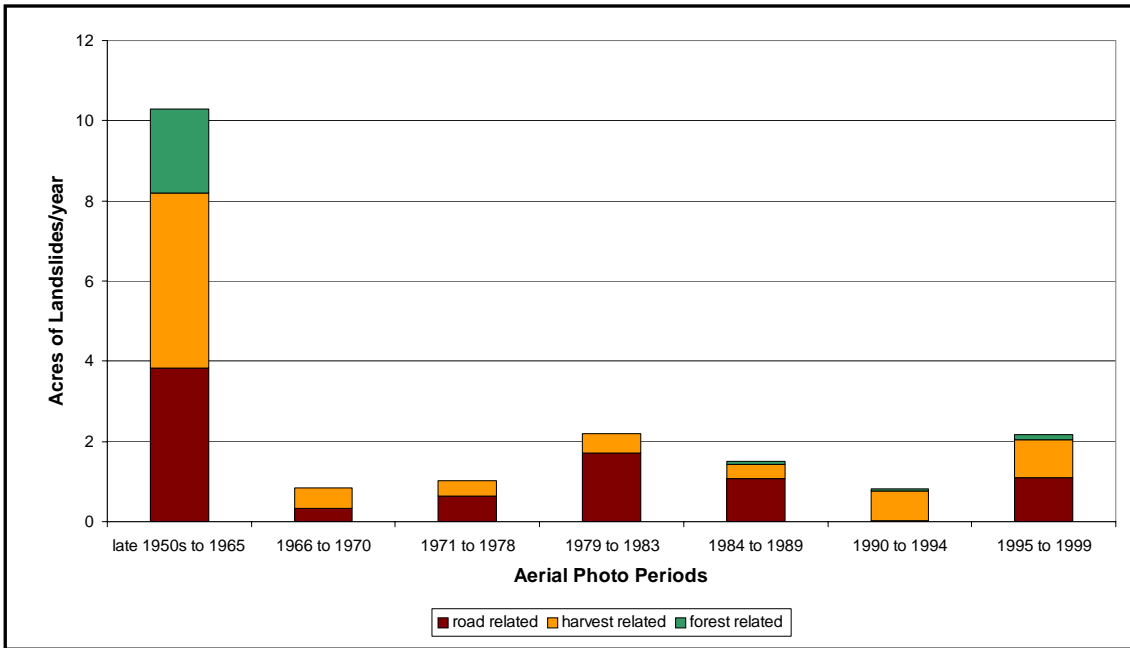
Figure 3-8: Chronology of landslide acres per year related to management in the Old Fairview sub-watershed.⁷⁷

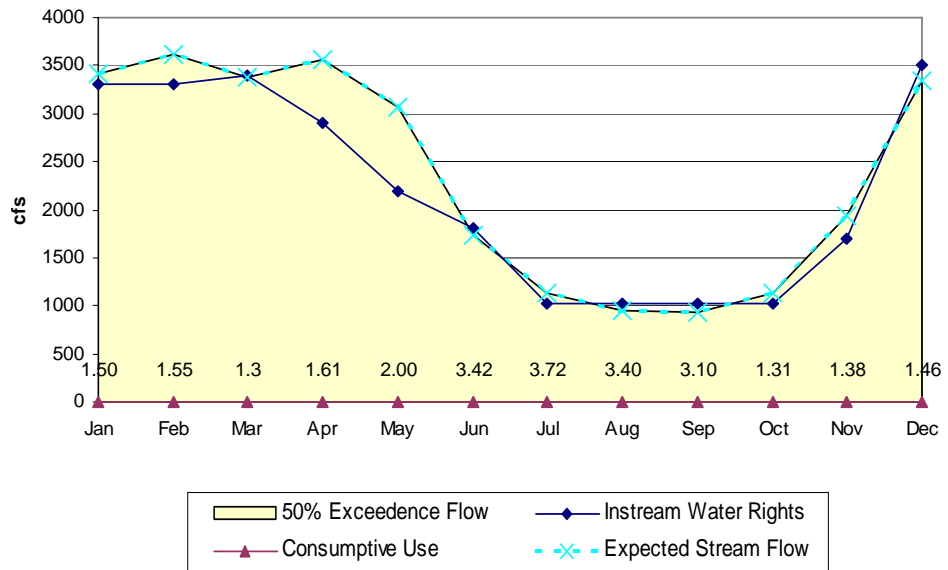
Figure 3-9: Water availability in all three WABs within the Rock Creek Region.
