Ashland Watershed Assessment & Action Plan

December, 2007

BEAR CREEK
Watershed Council

**Funded by the Oregon Watershed Enhancement Board
OWEB Grant #204-281**

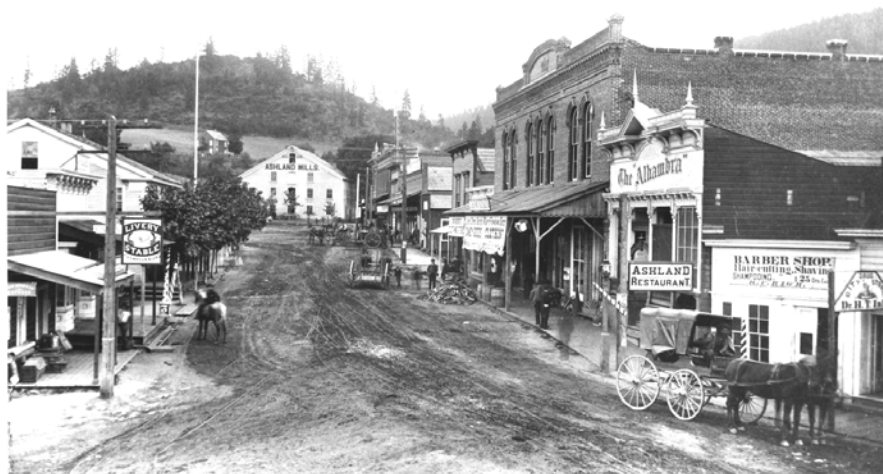
Figure II-1: The Plaza, circa 1880's, already 40 years after Helman and Hargadine posted claims. Ashland Flour Mill is at the end of the street, at the entrance to what is now Lithia Park. Flumes brought the water from the creek to the mill, so it was not situated right on the stream. The buildings across from the IOOF hall burned later in a fire. Photo courtesy of Paul Hosten.

In a 2000 report for the City of Ashland, Greg Bennett describes Ashland Creek as a “workhorse,” providing electricity, drinking water, and recreation for the citizens of Ashland. Not only does Ashland Creek “work hard” today, but it has been working hard for Ashland’s citizens since Abel Helman and Robert Hargadine staked the first Donation Land Claims along its banks in 1852. Within three years, Helman and a handful of others, had built a water-powered saw mill, a water-powered flour mill, and given away plots of land near the creek to start a town. Within another year, several businesses had started up and the Plaza was born. Ever since, Ashland Creek has been the economic and recreational center of town (Fig. II-1).

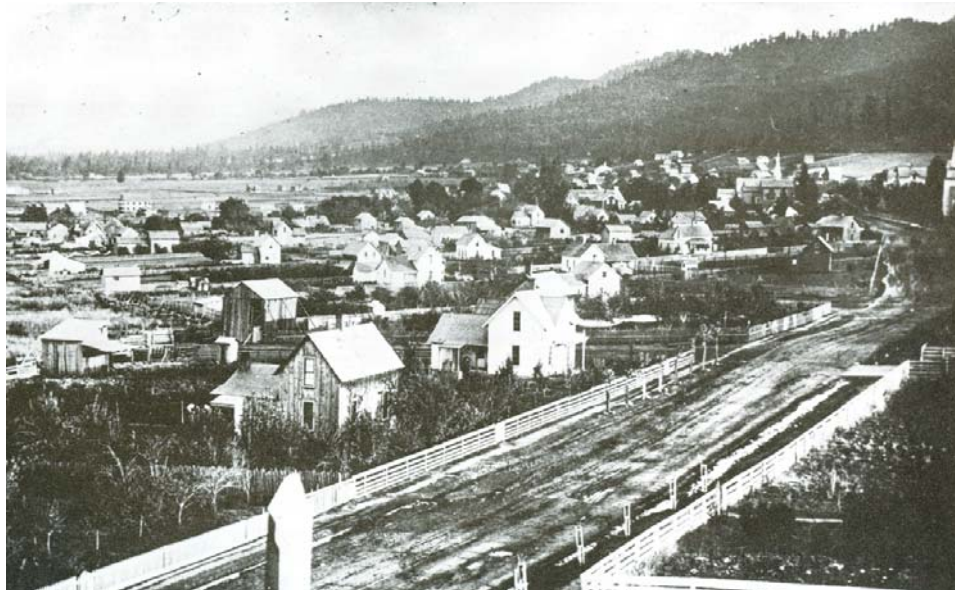
Figure II-2: North Main Street in 1881 (40 years after first Eastern settlers). The little town of Ashland fanned out from Ashland Creek along the terrace. The line of dark trees from Right to Left in the background is Ashland Creek. The tiny row of trees in the far background is probably Roca or Clay Creek. Photo courtesy of Terry Skibby and Glenn Northcross.

Because of the location of town center, the floodplains and shady banks of Ashland Creek were cleared much earlier than other, smaller streams (Figs. II-2, II-3). Not surprisingly, the flat terrace was also developed first. The hillslopes surrounding town were grazed or developed into orchards (Fig. II-4). However, much of the hillslopes were still covered with chaparral and conifers (Fig. II-5). In Fig. II-5, conifers are growing in what is likely an intermittent stream channel.

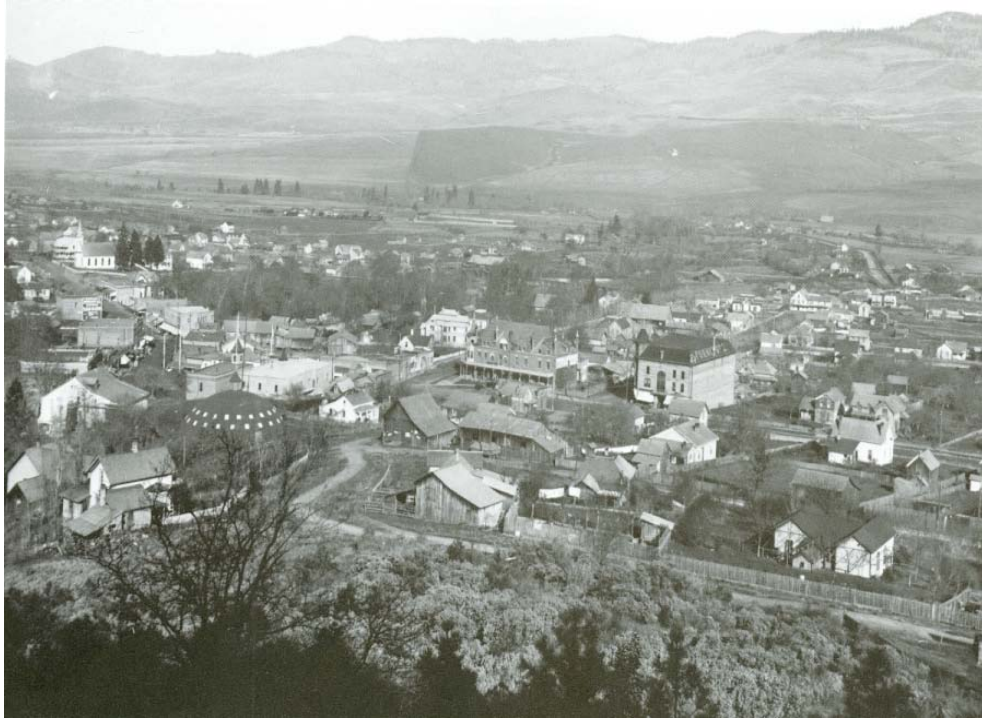
Figure II-3: Ashland circa 1900 (60 years after first Eastern settlers). Note the Chautauqua dome where the Elizabethan theatre now stands. The Ashland flour mill is to the left of the dome, the plaza behind it. Water Street already runs down the stream course and most of the stream's banks are developed. Bear Creek is visible in the top left of the photo and follows the scattered conifers in the background. Photo courtesy of Terry Skibby and Glenn Northcross.

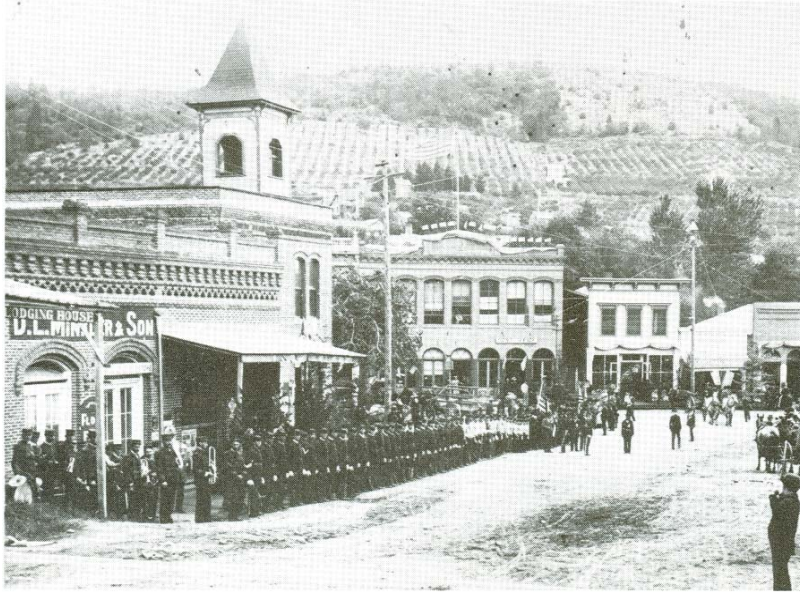
Figure II-4: Looking down East Main Street to the Plaza circa 1892. The dark trees behind the Plaza buildings are growing along Ashland Creek, where Guanajuato Way is today. Note the orchards and the mixed chaparral/oak woodlands above. Photo courtesy of Terry Skibby.

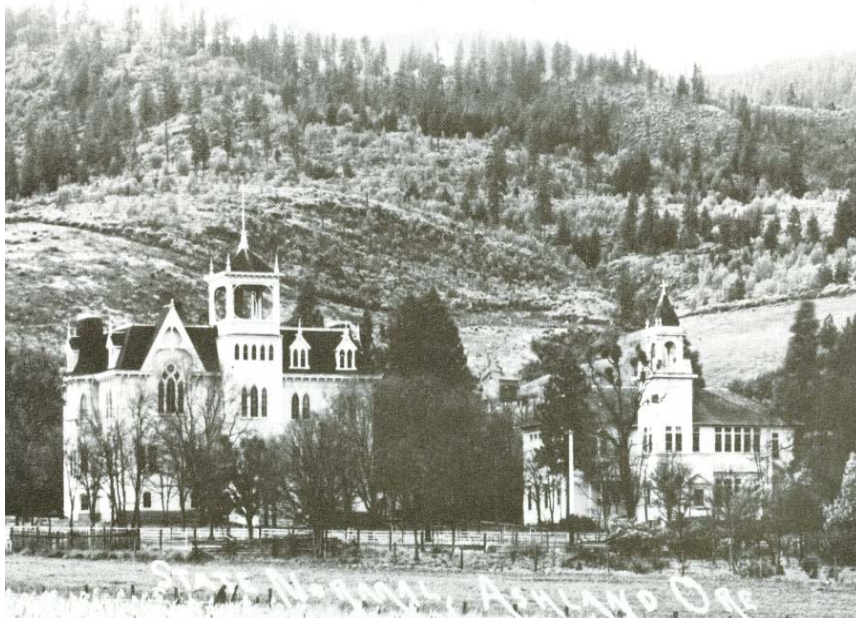
Figure II-5: Southern Oregon Normal College in 1909. This was “out of town”, off of what is still called Normal Street. Note the relatively intact mixed chaparral/woodland above, on a slope between Paradise and Clay Creeks (not pictured). The small drainage behind the right tower is probably an intermittent stream. Conifers grow in the channel. Photo courtesy of Terry Skibby.

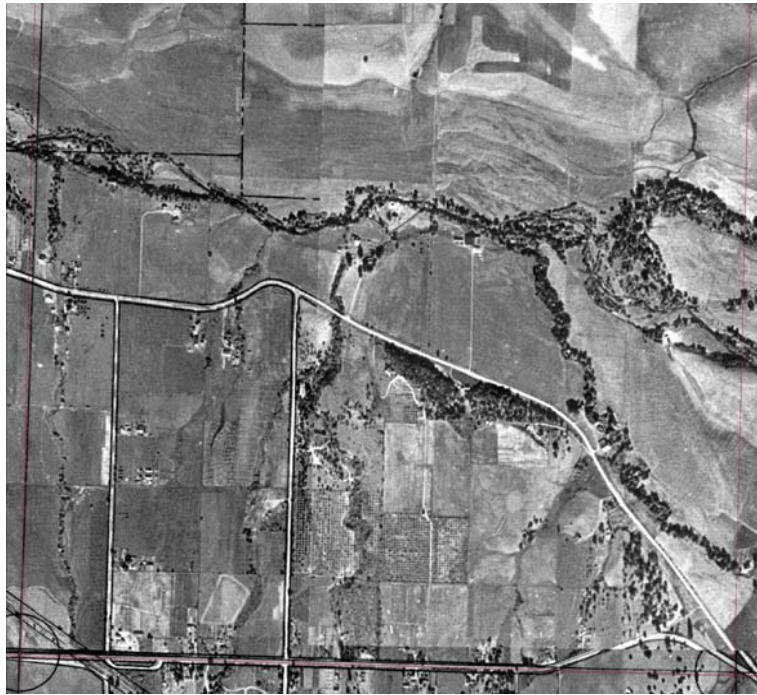
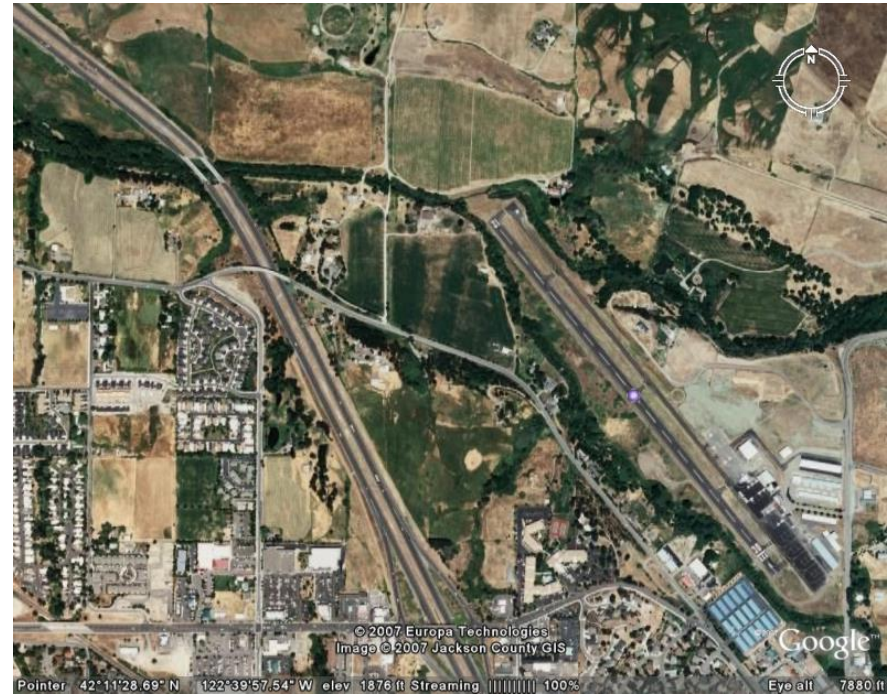
Figure II-8: 1939 aerial photo on the left; 2005 aerial photo on the right. Neil Creek flows from the lower right to the right center of the photo, and enters Bear Creek. Just upstream (to the right) of where Neil and Bear Creeks join is an example of a braided channel with shrubs in the braided channel area. Hamilton Creek flows from the lower center of the photo straight north to the upper center of the photo where it meets Bear Creek (almost under I-5 in the 2005 photo). A little ribbon of green shrubs marks the course of Clay Creek, to the left of and paralleling Hamilton Creek. The road on the bottom is Ashland Street (Hwy. 66). The road on the top in both photos is East Main Street. The recent photo, of course, shows Interstate 5 and the Ashland City airport.

One of the most obvious changes apparent in the photo comparisons is the amount of land surface that was developed with buildings; most of this development happened after the 1960's. The result was the conversion of rain-absorbing soil and plants into impervious surfaces. Rain water now runs off roofs, parking lots, and streets into storm drains and directly into creeks. In addition to washing oils, chemicals, and other residue into streams, the sudden influx of water from storm drains quickly increases the height and force of water flowing down a stream, which can cause erosion and flooding. Please see Chapters IV ("Hydrology"), VI ("Sediment"), and VII ("Channel Modification") for more information.

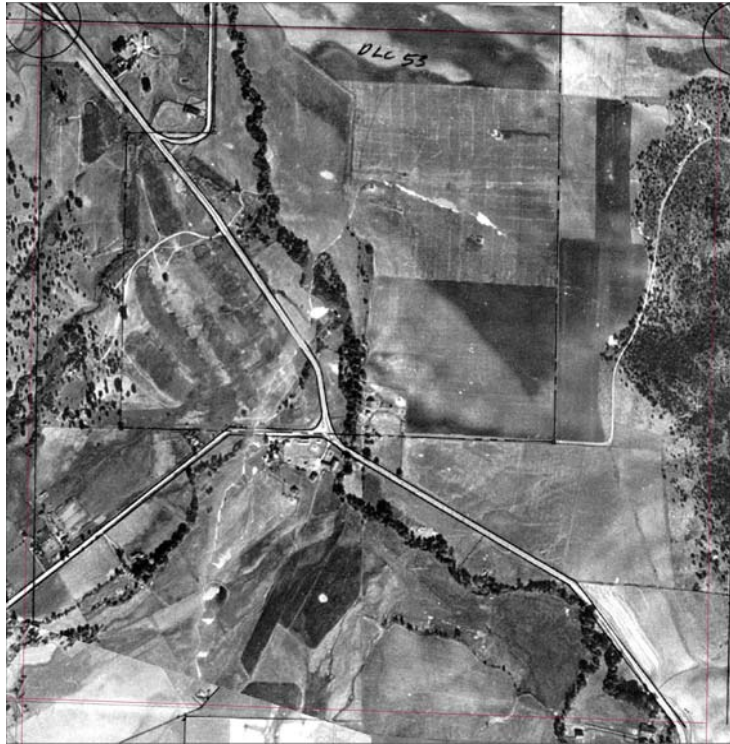
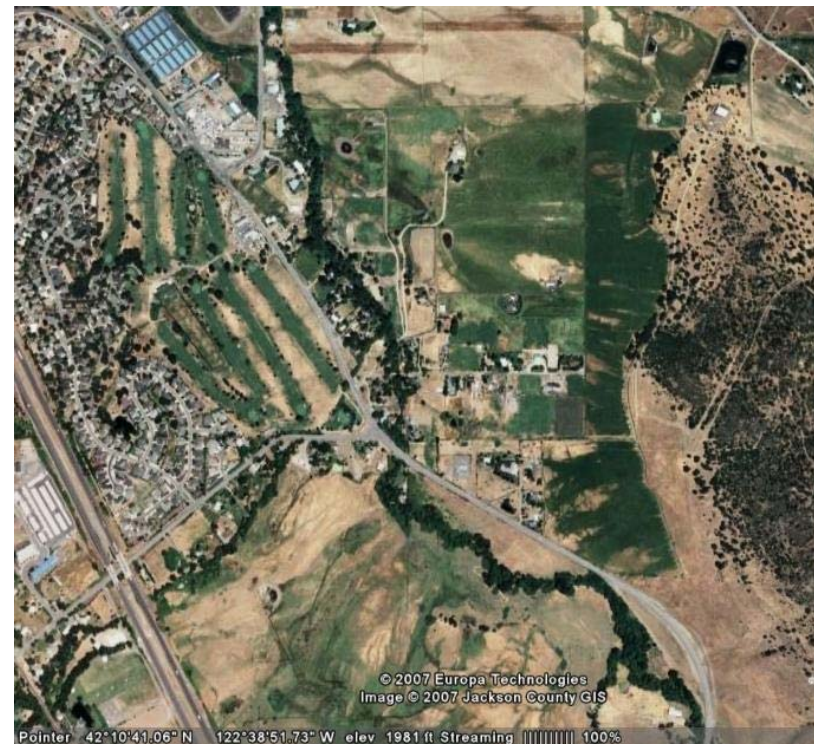
Figure II-9: 1939 aerial photo on the left; 2005 aerial photo on the right. Neil Creek flows from the lower right hand corner through the middle of the photos to the upper right corner. Hwy. 66 almost parallels the stream. Crowson Road and Tolman Creek enter from the lower left and meet with Hwy. 66 and Neil Creek, respectively, in the center of the photos. The 2005 photo shows the Oak Knoll golf course and the blue rectangles of storage units along Neil Creek.

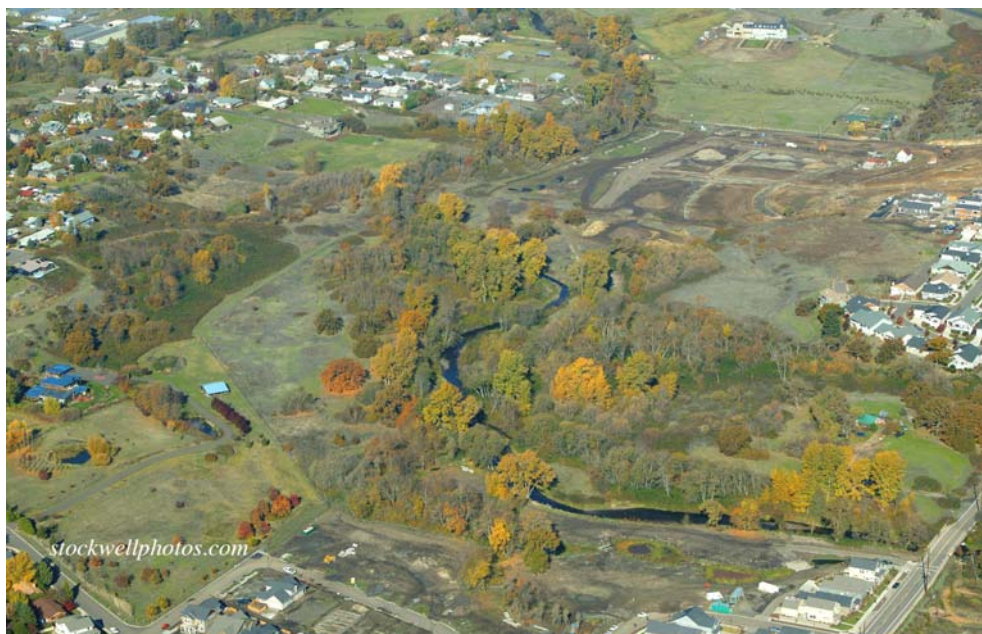
Figure II-10: Oblique view of Bear Creek. North Mountain Avenue runs across the bottom right corner of the photograph. Oak Street cuts diagonally across the top left corner. The brown squares and short dirt roads in the upper right are the beginning of the new housing development off of North Mountain Avenue, and the grey and white houses in the bottom right corner are constructed on old stream channels within the floodplain. The densely situated houses on each side of the photo are located higher up on terraces. Photo © Fred Stockwell, Stockwell Photography.

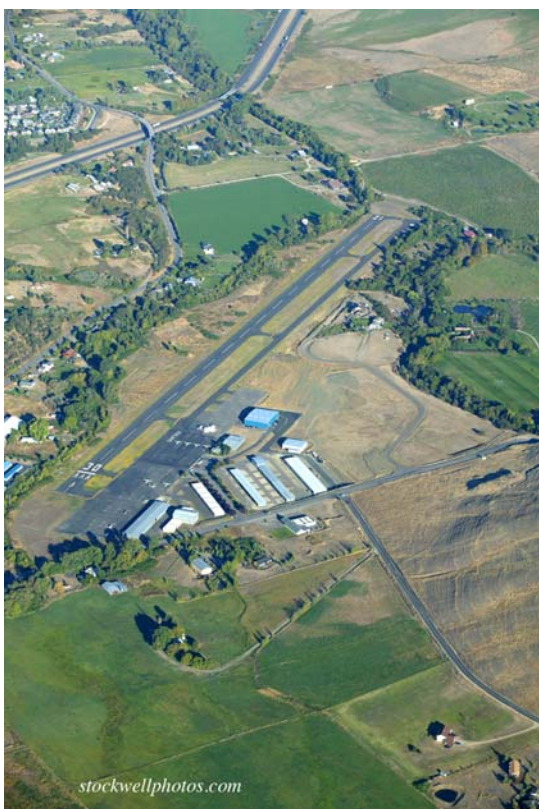
Figure II-11: Oblique view of Neil and Bear Creeks with the Ashland airport between them. Interstate-5 crosses the top left corner of the photograph and East Main Street crosses I-5 and then snakes alongside Neil Creek. Photo by Fred Stockwell, Stockwell Photography

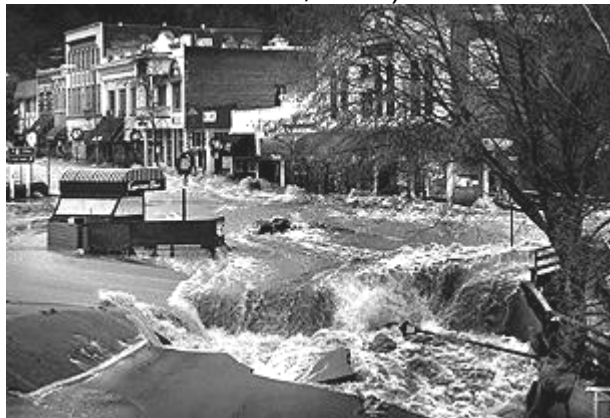
Figure II-12: Ashland Creek roars past the Plaza businesses during the 1997 New Year's Day Flood. Photo: Mail Tribune.

The 1997 New Year's Day flood was another 30-year event, but seemed larger. There were \$4.5 million in damages in Ashland alone. Ashland Creek completely flooded Lithia Park and all the plaza businesses along the creek (Fig.II-12). There was so much water in Websters that the shelves were tipping over (J. Fields, personal communication, 2007). Ashland Creek poured down

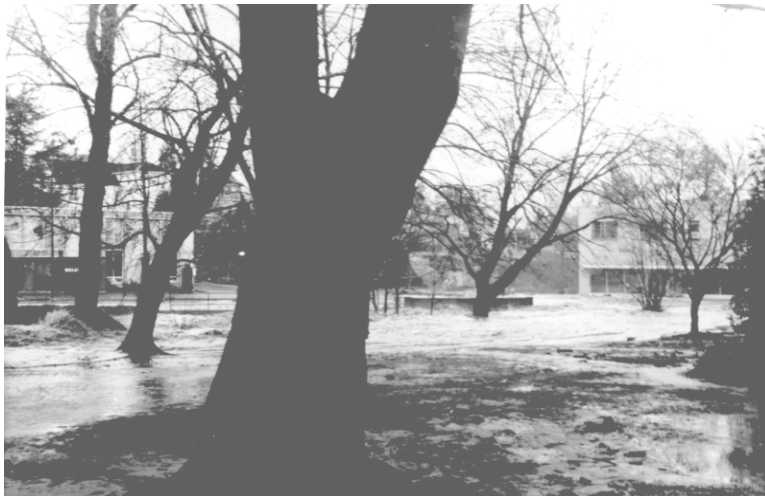
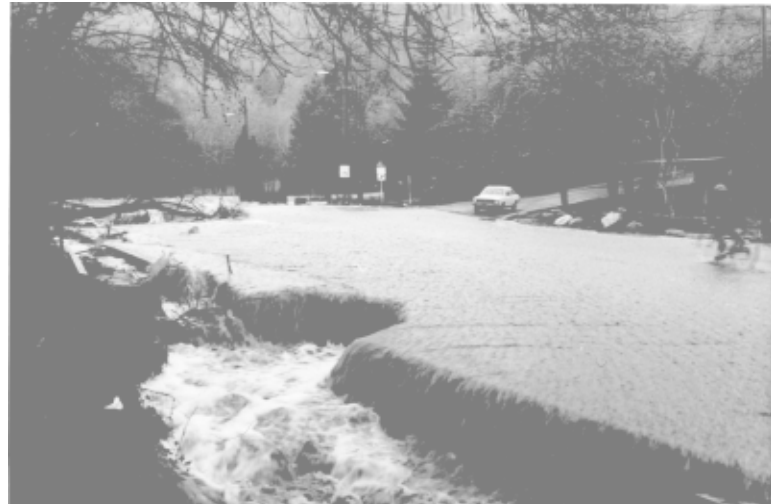
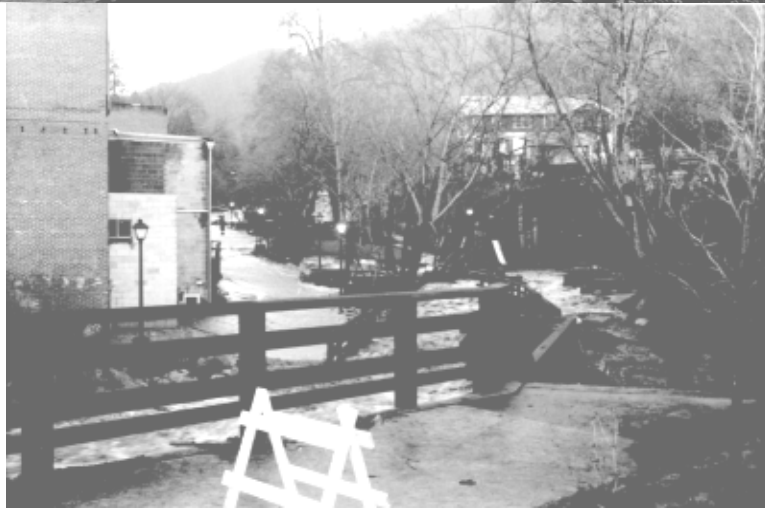
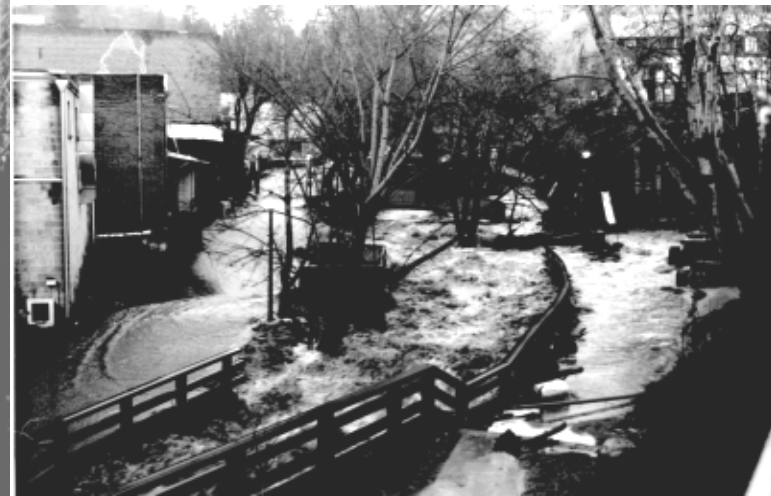
Figure II-13: 1974 Flood. Top Left: Ashland Creek flooding Lithia Stationers viewed from Lithia Park. Top Right: Winburn Way covered with water. Bottom Left and Right: Guanajuato Way from North Main Street. There used to be a walkway on each side, with a playground. Photos © by Connie Battaile.

Although only a 30-year event, the 1974 flood interrupted Ashland's domestic water system, destroyed bridges, and caused an estimated \$1.5 million in damage to Ashland city property alone (in 1974 dollars). Water poured down Winburn Way (Fig.II-13) and Water Street. Guanajuato Way took the brunt of the damage (Fig.II-13). Peak discharge of Ashland Creek was 1350 cubic feet per second (cfs) (City of Ashland, undated).

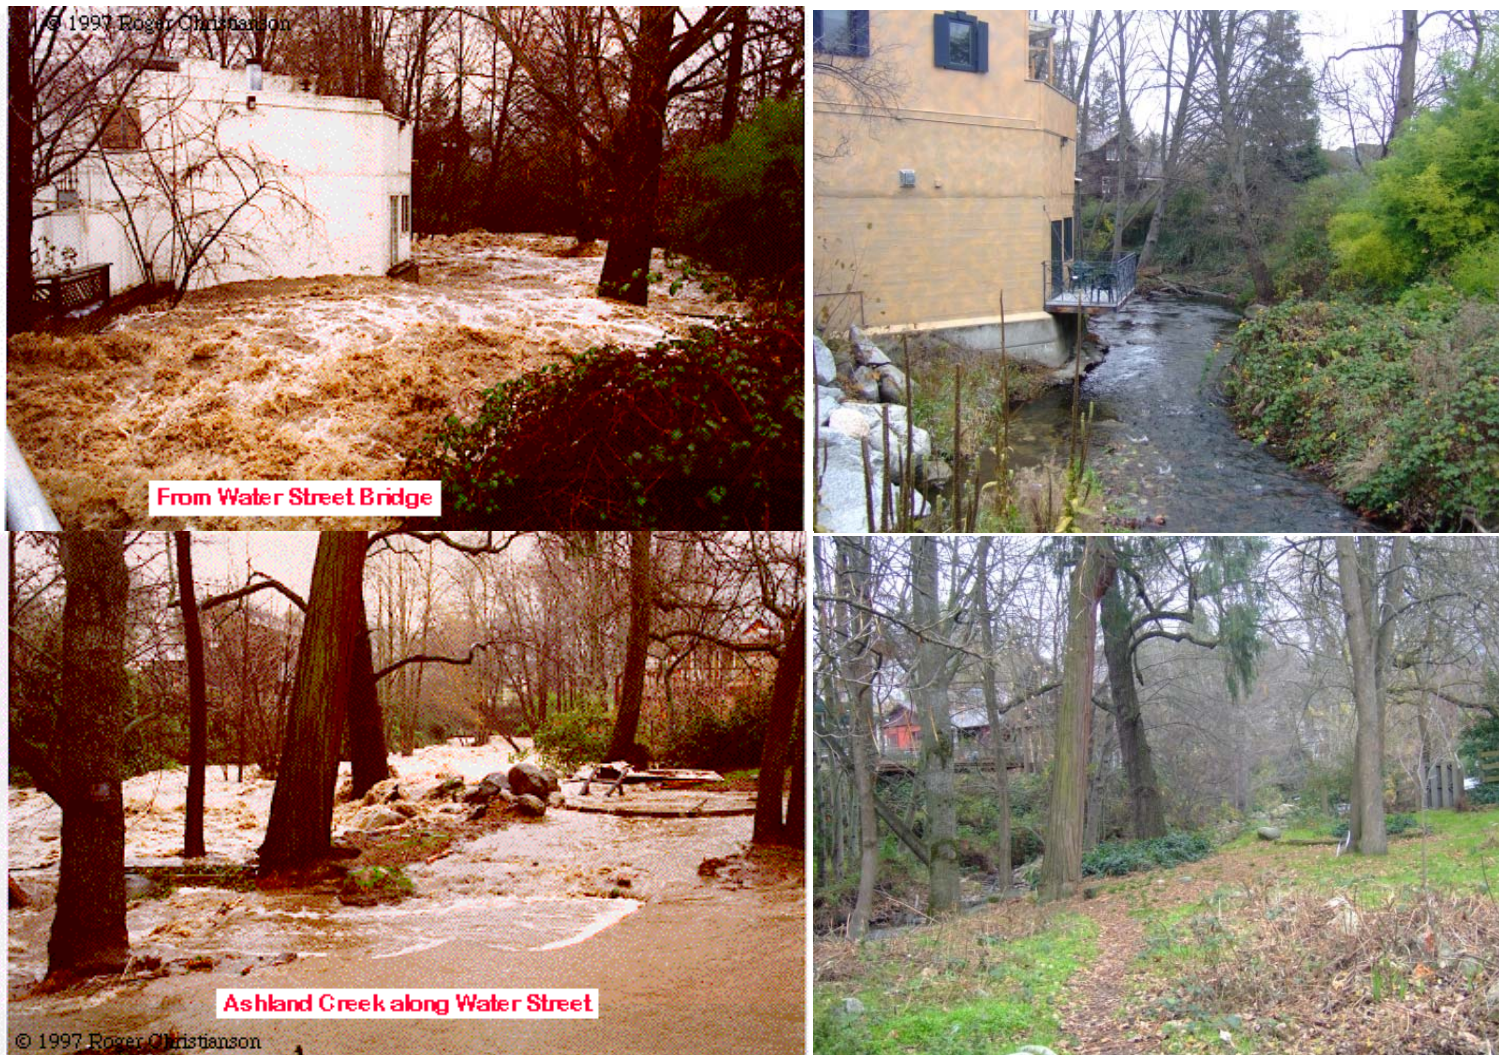
Figure II-14: The 1997 flood, and today. Top: from Water Street Bridge, looking downstream. Bottom: From Water Street looking across empty lot downstream of the Ashland Creek Inn, today. The present-day photo of this bottom pair is not an exact match of the 1997 flood photo, but was taken at the same location (note tree branch shape and trunk angles). Photos on the left © Roger Christianson, on the right by Jeannine Rossa.

Water Street (Fig.II-14), finally spreading out onto the fields below the Community Gardens which provided a relief area for floodwaters to spread without causing severe property damage. The smaller mountain streams also raged. A local Ashland resident remembers Hamilton Creek “sounded like a train rushing down the ravine³.” Southern Oregon University professors Eric Dittmer and Charles Lane calculated Ashland Creek’s peak discharge in upper Lithia Park at 3000 cubic feet per second (E. Dittmer, personal communication, 2007).

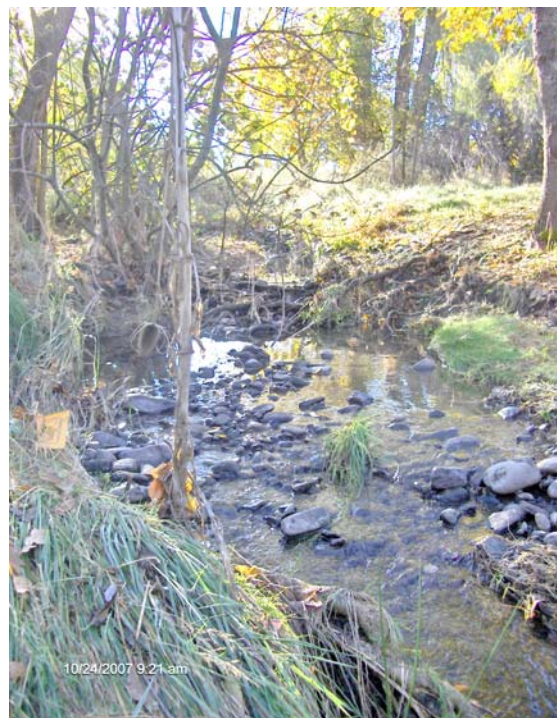
Figure V -2: Beach Creek as restored in North Mountain Park. Note wider gravel/cobble channel, diverse naturalized streamside vegetation.

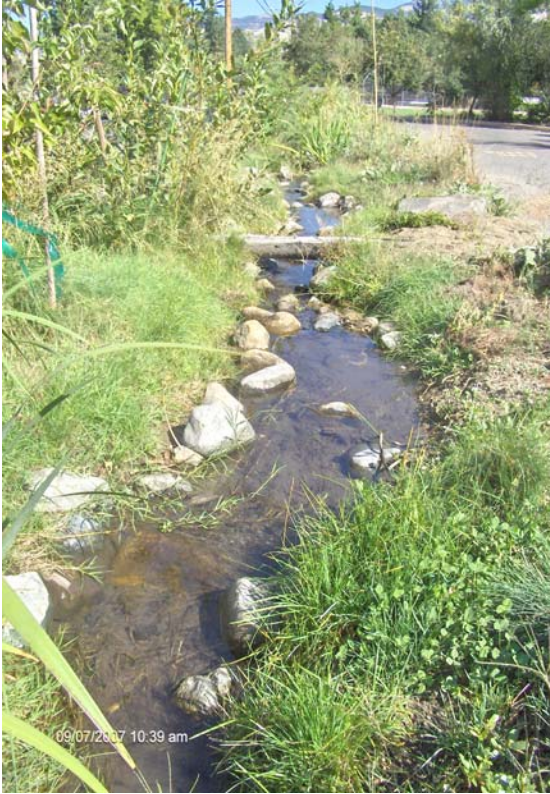
Photo V-3: Paradise Creek brought above ground (daylighted) at Walker School.

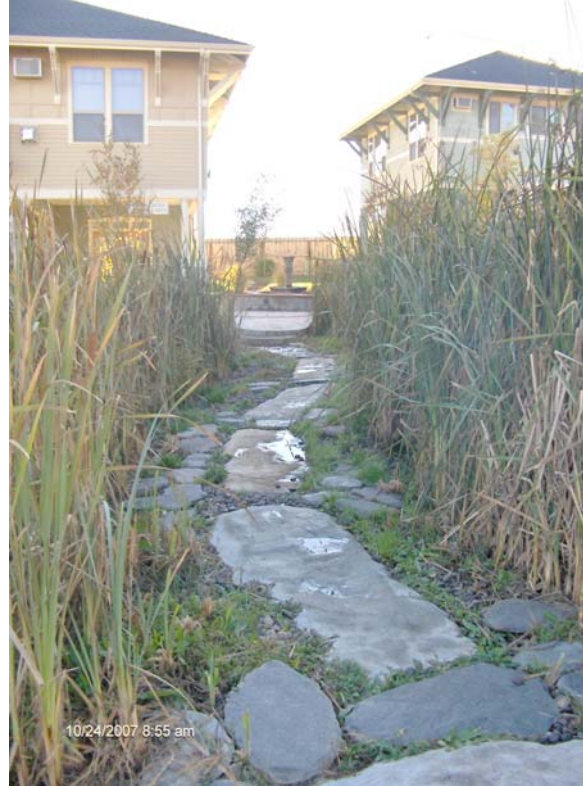
Photo V-4: Created wetland in recent development near Hersey St.

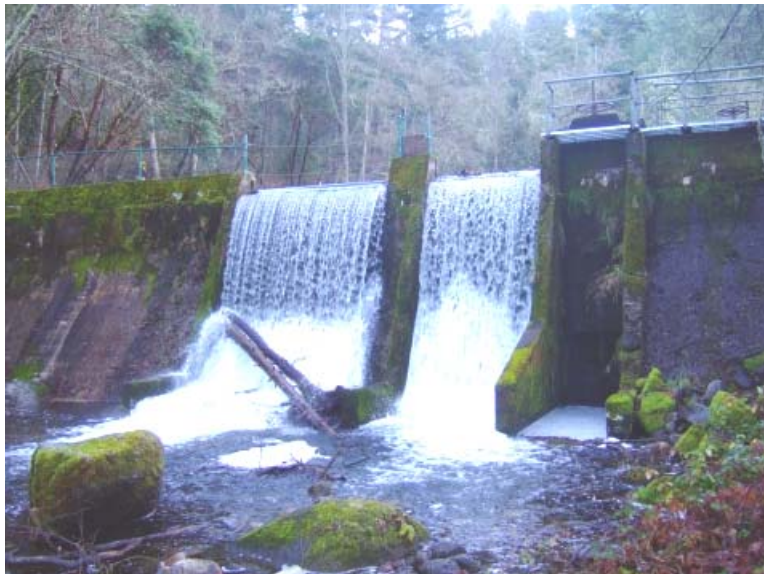
Figure IX-4: Granite Street Dam. Photo © Jeannine Rossa, December 2005.

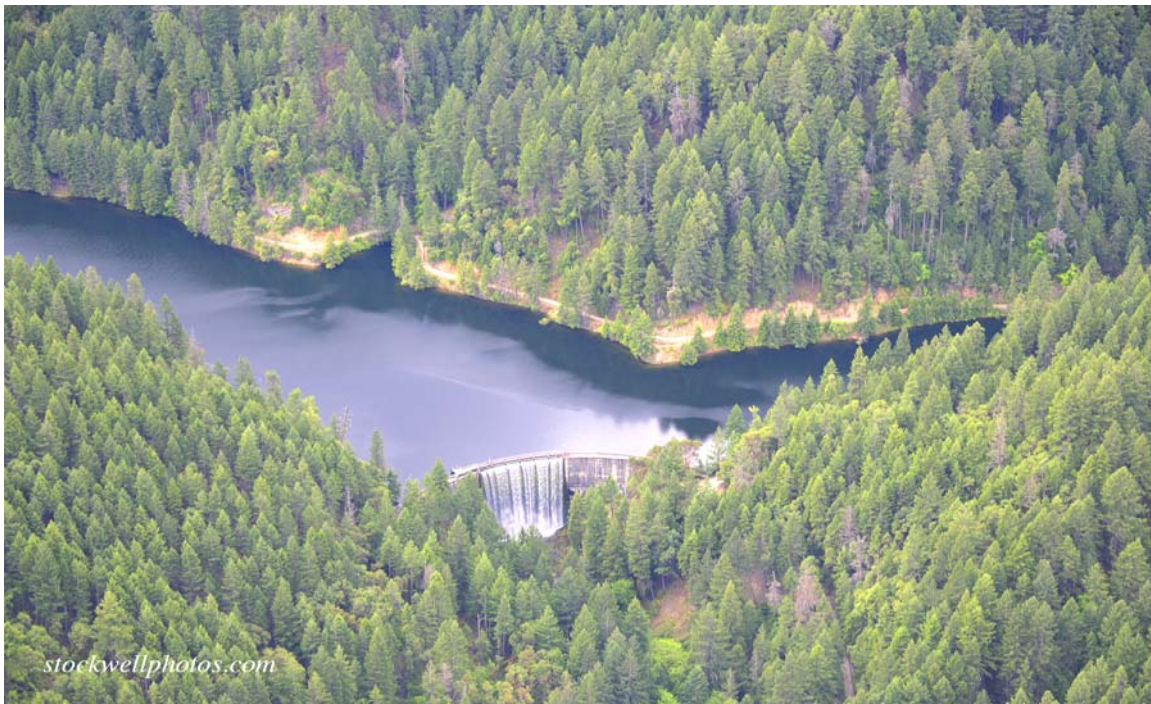
Figure IX-5: Hosler Dam and Reeder Reservoir. Photo © Fred Stockwell, Stockwell Photography.

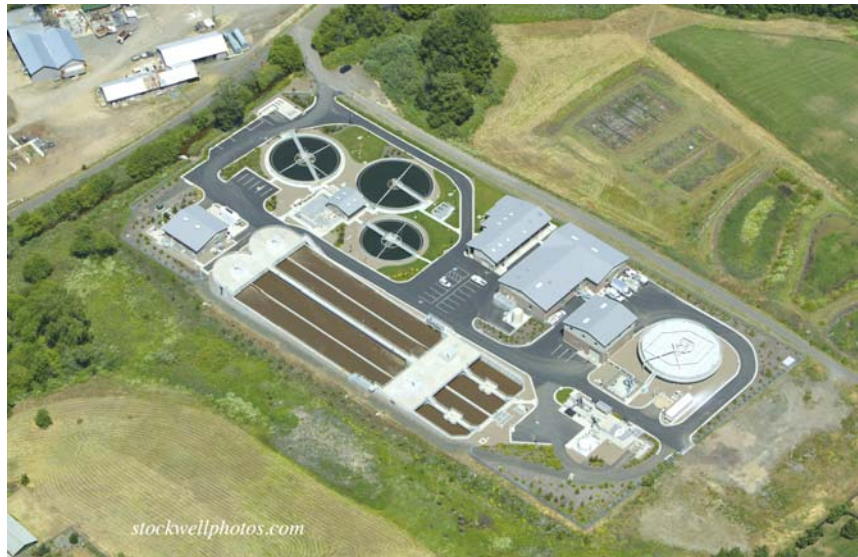
Figure IX-8: Ashland's wastewater treatment facility. Ashland Creek flows diagonally across the upper left corner of the photo, squeezed into a narrow channel. Photo © Fred Stockwell, Stockwell Photography.

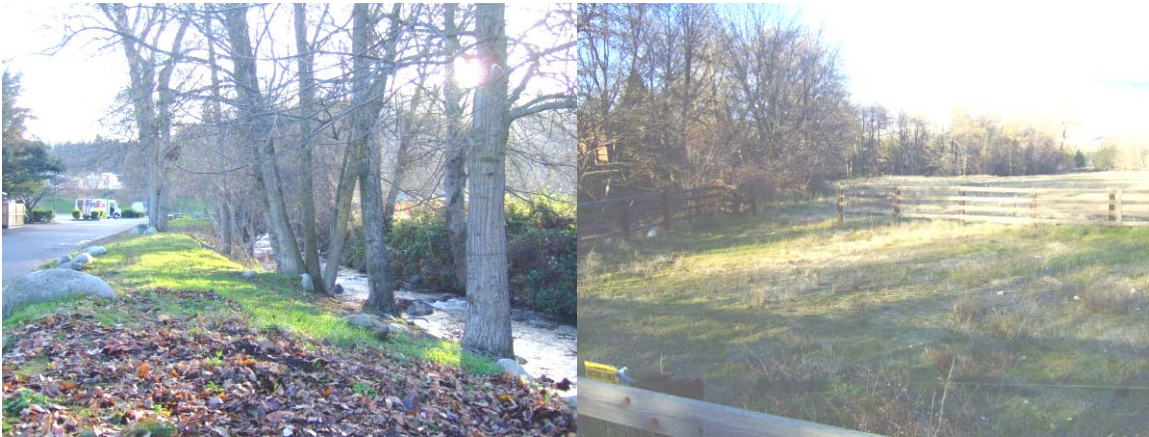
Figure IX-10: Lower Ashland Creek, upstream and downstream of Hersey Street bridge. Left: Looking upstream. Note single line of trees with no understory shrubs on the left side of the stream and the blackberries on the right. Note also that the parking lot of the church is in the floodplain of the stream, and any flooding will wash parking lot oil and residue into the stream. Right: City of Ashland land near the Ashland Community Garden (aka "Vogel Park," or "Ashland Creek Park") looking downstream from Hersey Street. Note that although the stand of riparian trees grows in a strip along the stream, Ashland Creek can flood into this pasture, which could slow floodwaters and potentially reduce damage to adjacent properties. Photos © Jeannine Rossa, December 2007.

Upstream of the water treatment plant, Ashland Creek flows by the dog park and the community gardens (to be named Ashland Creek Park) with the backyards of Helman Street houses on the opposite side (Fig. IX-10). Between the Hersey Street Bridge and Lithia Park, the stream is completely confined to a narrow channel by the skate park, the recycling center, Water Street, and various buildings, one of which was constructed after the 1997 flood but others of which were built before the turn of the century (Fig. IX-11). The riparian area through this section is extremely narrow, if present at all.

One result of this confinement is that the stream does not have a place to flow during floods. That is one reason why Ashland Creek flooded Guanajuato Way, Water Street and the adjacent buildings during December 1974 and January 1997 (See Chapter II, "History"). Another result is that this section of stream is extremely biologically compromised. Without a functioning adjacent floodplain, riparian area full of trees and shrubs, and underground hyporheic zone, this section of stream produces little food, provides little shelter, cannot attenuate flood waters, and provides only poor quality stream habitat. On top of that, water diversions, berms, and trash further degrade the stream environment (Bennett 2000).

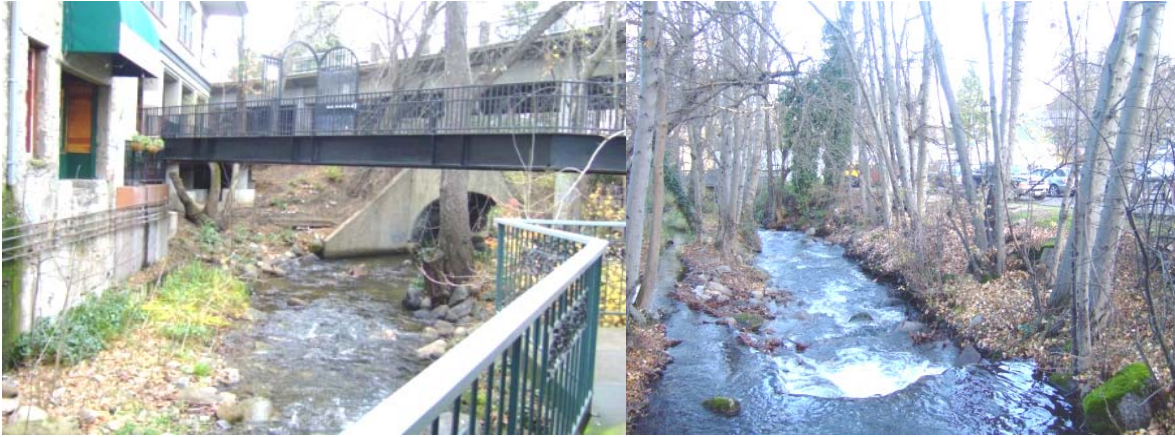
Figure IX-11: Ashland Creek through the urban corridor. Left: Ashland Creek flows between buildings on its left and right and is forced through the Lithia Way culvert (background) by road fill. The Lithia Way culvert did not contain all the flood water in the 1997 flood. Right: Looking downstream from the walking bridge next to the Lithia Way culvert. The white area in the lower center of the photo shows where the stream drops over a diversion dam (and partial fish migration barrier) shunting water into the Helman ditch, in the left of the photo. There is only a single line of trees on both sides of the stream through this section. A parking lot next to Water Street is immediately adjacent to the narrow riparian area. During the floods of 1974 and 1997, this lot and Water Street itself were flooded. Photos © Jeannine Rossa, December 2007.

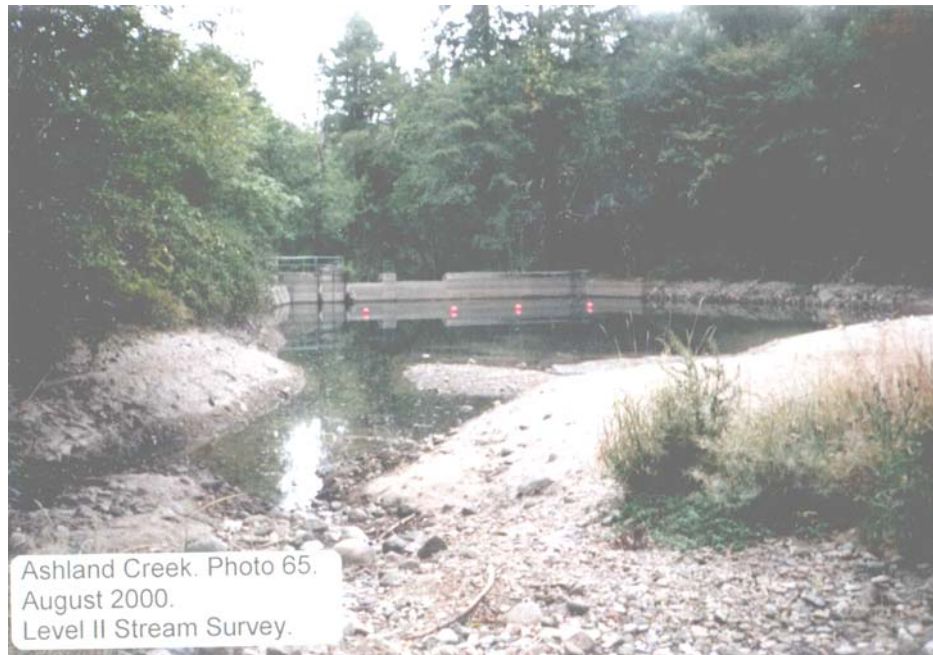
Figure IX-14: Fine sediment and coarse granitic sand stored in Granite Reservoir. Photo by Siskiyou Research Group, September 1999 (SRG 2001).

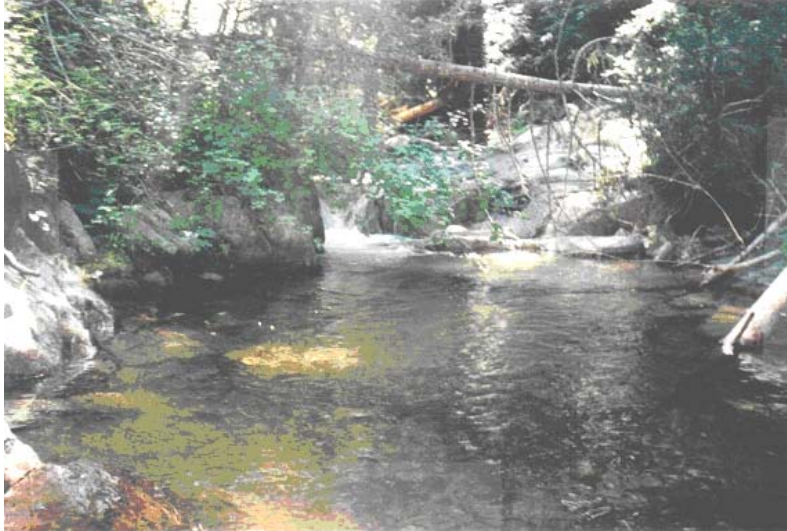
Figure IX-15: East Fork Ashland Creek, bedrock-controlled pool in Reach 1. Photo: Gar Abbas, July 1997 (Abbas 1999).

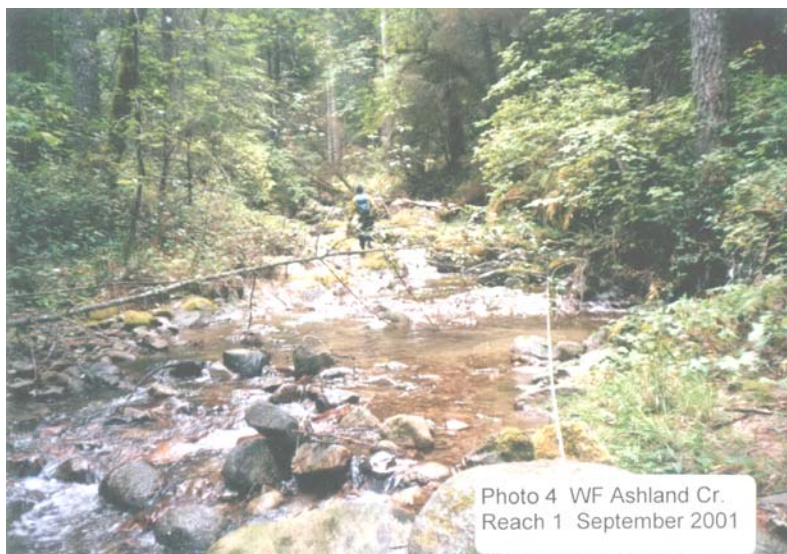
Figure IX-16: Typical lower canyon habitat in West Fork Ashland Creek. Siskiyou Research Group, September 2001 (SRG 2002b).

granitic soils (Fig. IX-16); however because of instream structure (fallen logs, boulders, and complex bed composition), spawning gravels, and cobbles are still abundant (Abbas 1999). Fish populations in both East and West Forks are healthy. Snorkel and electrofishing surveys found fish of many age classes far upstream in both watersheds (Abbas 1999; SRG 2002b). The presence of mineral springs in the West Fork watershed may contribute to high fish production in this stream (Nawa 1997).

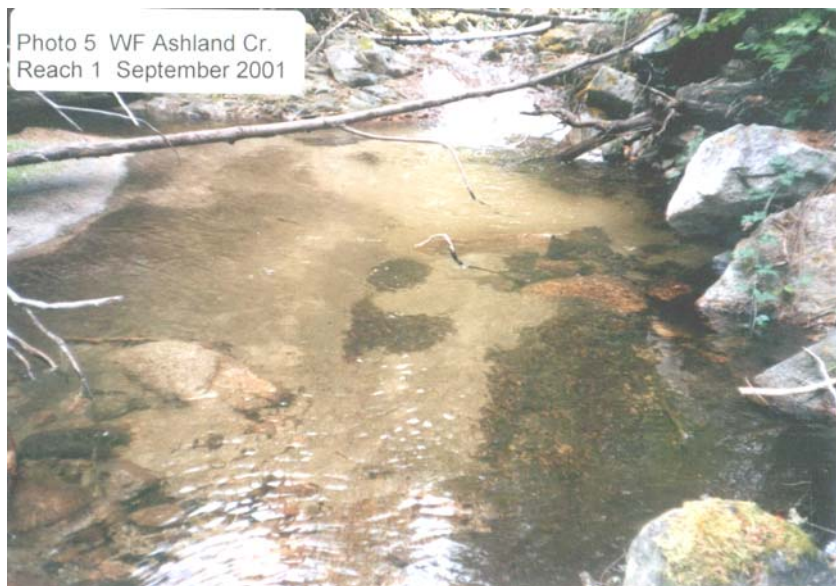
Figure IX-18: Coarse granitic sand accumulating in pool (looking upstream). This photo was taken in West Fork, but it illustrates the phenomenon of high sand content in streams draining granite batholith geology. Photo: Siskiyou Research Group, September 2001 (SRG 2002b).

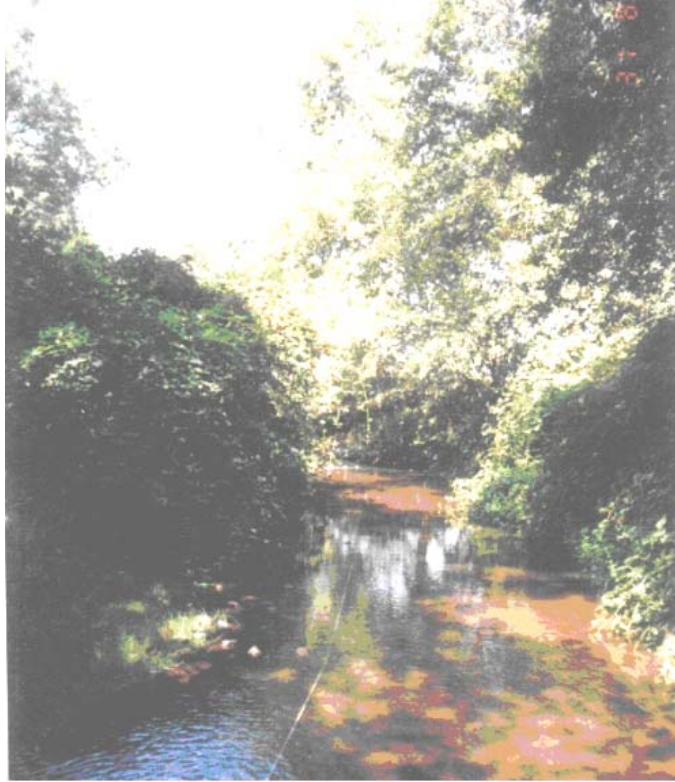
Figure IX-19: Neil Creek – a sand-filled pool. The brown color is due to excessively high turbidity levels during the stream survey. Note the blackberry-dominated riparian corridor and lack of structure or other forms of cover. Photo Siskiyou Research Group, September 1999.

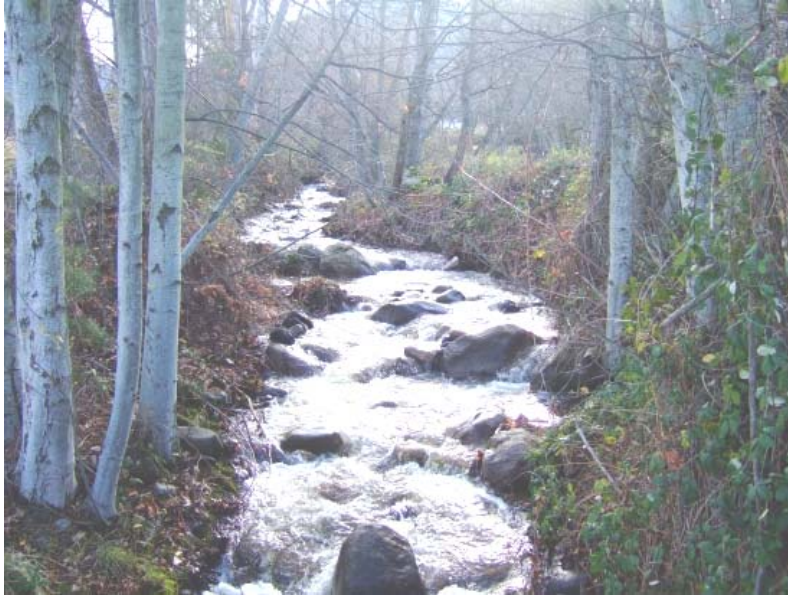
Figure IX-20: Neil Creek upstream of Reiten Drive crossing. Photo © Jeannine Rossa, November 2007.

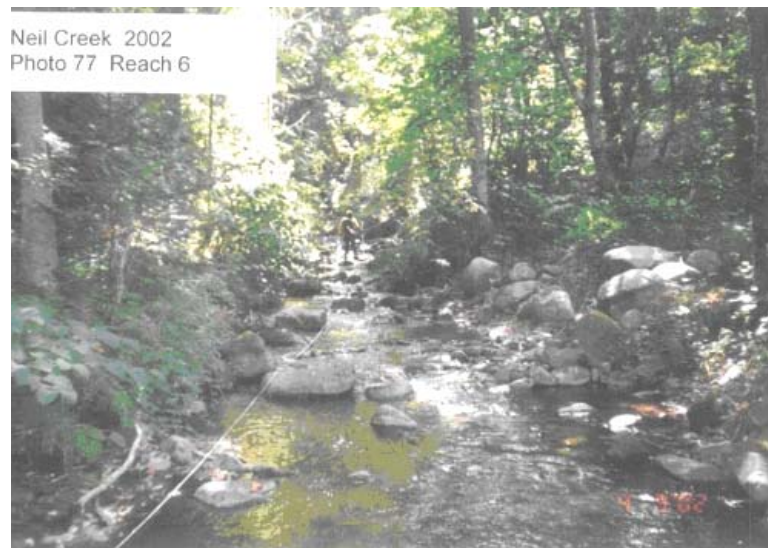
Figure IX-21: Neil Creek, within 1/4 mile of Interstate 5. The character of the stream and the riparian area improves dramatically and more robust fish numbers reflect that improvement. Photo by Siskiyou Research Group, September 2001.

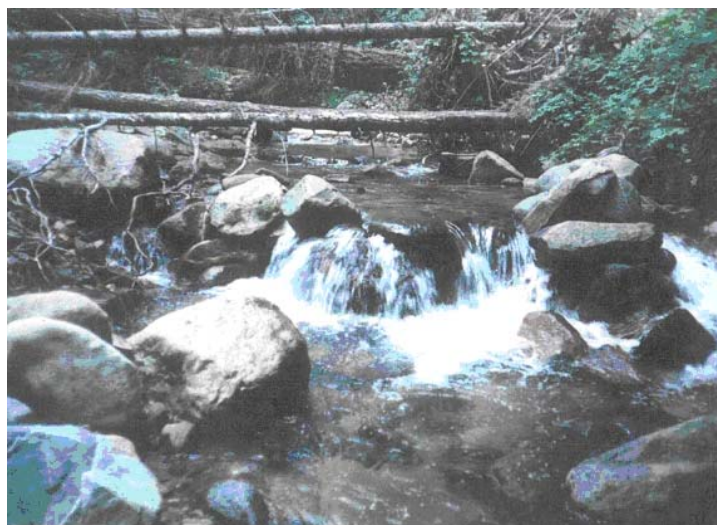
Figure IX-22: Neil Creek upstream of Quartz Gulch. Note smaller-diameter fallen trees. These would not be counted in a stream wood survey, but may eventually fall in and contribute to a debris jam after a large flood. Photo by Ecosystems Northwest, September 1999.

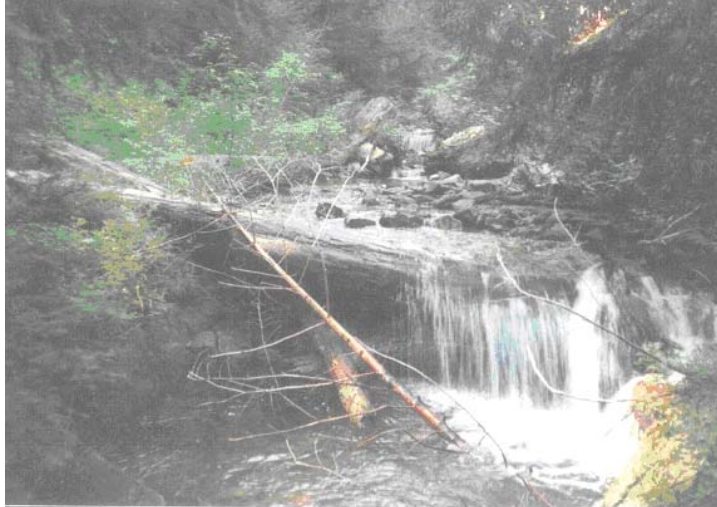
Figure IX-23: Large wood creates a spectacular plunge pool, which was filled with cutthroat. Photo by Ecosystems Northwest, September 1999.

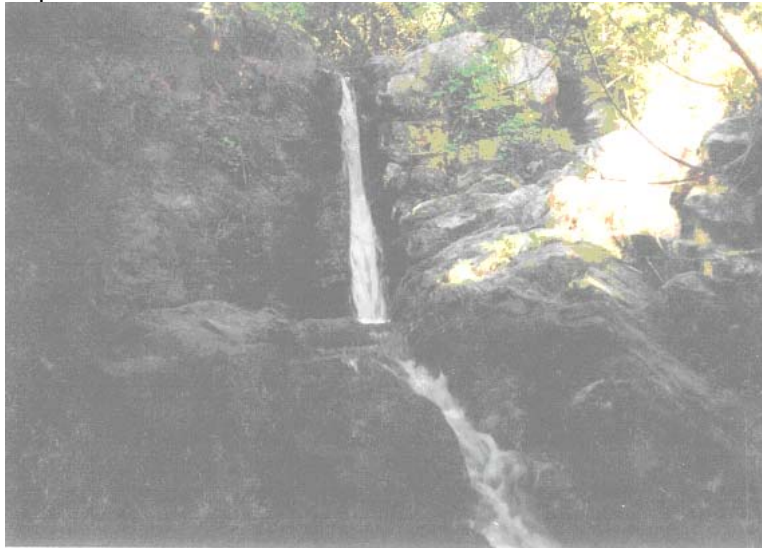
Figure IX-24: A 10' waterfall on a small tributary about 500' upstream of its confluence with Neil Creek. Fish were abundant upstream of this waterfall for another 5000'. Photo: Ecosystems Northwest, September 1999.

adequate amounts of clean gravel for fish spawning as well as cobble to provide aquatic insect habitat (Table IX-9; Ecosystems Northwest 2000). Upper Neil Creek supports a very healthy cutthroat trout population – or rather, populations, as some are isolated in tributaries upstream of steep waterfalls (Fig. IX-24).

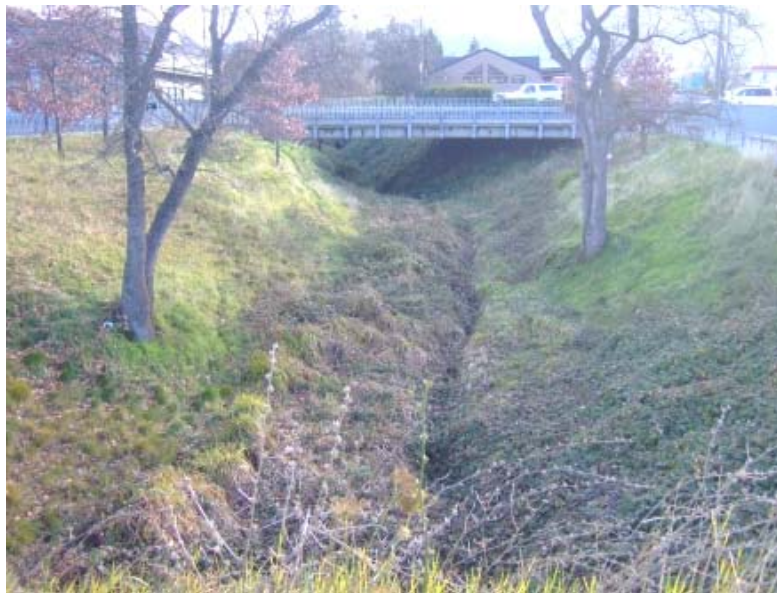
Figure IX-25: Hamilton Creek flowing between the parking lots of Albertson's and Rite Aid, off of Ashland Street. Stream channel is extremely simplified. Riparian vegetation is almost exclusively blackberries. Oak trees are native and were present before shopping center constructed. Photo by Jeannine Rossa, December 2007.

Hamilton, Clay, Roca, and Paradise also have a large proportion of their stream channels flowing through the urban area (e.g. Figs. IX-25, IX-26). As such, they can easily collect toxins washed into them during rainstorms, as well as fertilizers and insecticides applied in yards. As far as Bear Creek is
